REPORT

JB 2013/01

REPORT ON RAILWAY ACCIDENT AT DOMBÅS STATION 13 JANUARY 2012, TRAIN 5701

Date of issue: 11.01.2013
RW Report: 2013/01

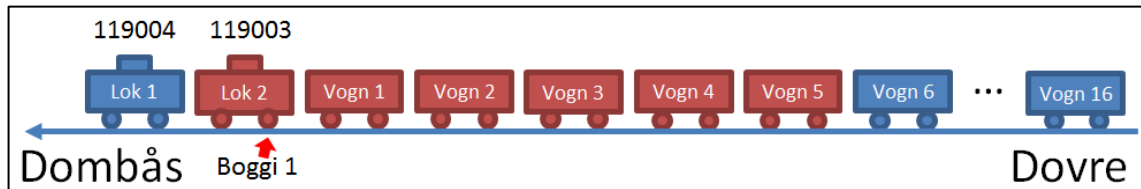
Locomotive number 2 and 5 wagons derailed at points no 3 at Dombås Station.

Figure 1: Train 5701; rolling stock that derailed is shown in red.

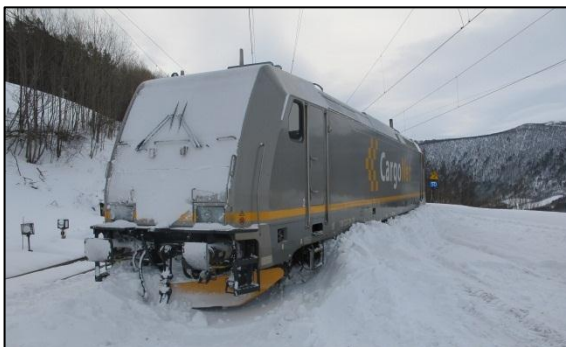
Prior to the derailment, there had been other problems with locomotive 2, registration number 119-003. This locomotive had been pulling wagons from Alnabru to Dovre, where it stopped because of a fault message. The driver explained that there had been some vibration in the locomotive at speeds over 60 km/h. The first fault message was noted at 17:02, and the train stopped at Dovre at approximately 17:06. The fault message in the locomotive indicated that there were problems with bogie no 1, which was the rearmost bogie in the direction of travel, see Figure 1. The problem was that this bogie was not receiving tractive power, and the train had to remain stationary, blocking any traffic past Dovre. With the assistance of the duty officer at CargoNet AS, the driver attempted to find the fault on the locomotive, but they gave up after a while. Locomotive number 119-003 still had tractive power to bogie 2, but was not capable of moving under its own steam. Heavy snow was falling that day, and this contributed to making the driving conditions difficult. The traffic controller agreed to allow passenger train 45 to help push freight train 5701 onto track 2 at Dovre. When train 5701 had been pushed onto track 2 at Dovre, the driver was relieved at about 19:00.

Figure 2: Locomotive no 119-003.

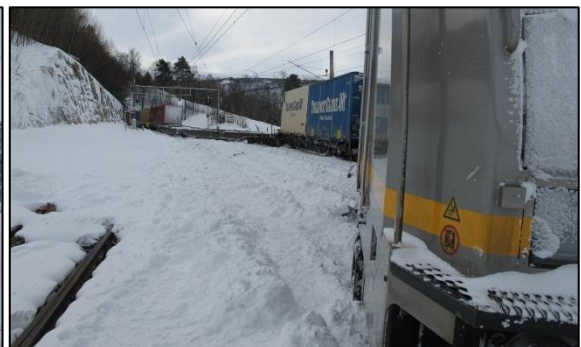
Figure 3: Derailed wagons.

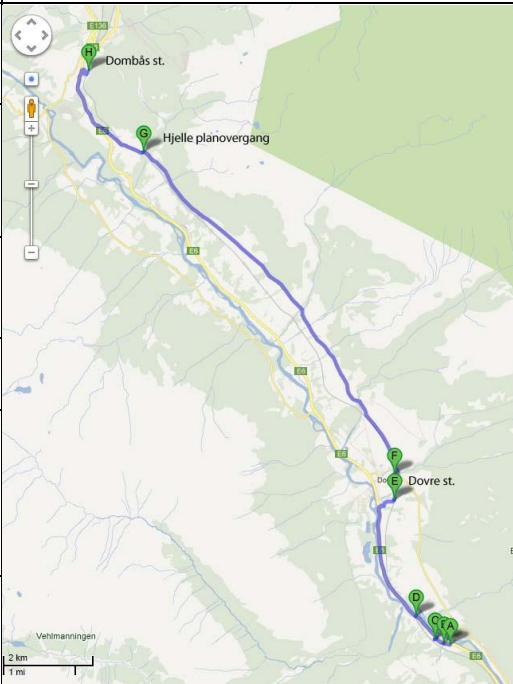
Object	Km	Description	Map
A - Level crossing	326.522	The first traces in the snow were observed 15 metres after the level crossing.

E - Points 1 Dovre	330.281	Clear traces in the snow that something was hanging too low under the train, and more obvious traces where it had moved onto track 2.	
F - Points 2 Dovre	331.976	Damage to left blade, and a metal fragment from the lower part of the engine of number 119-003 was found in the track.	
G - Hjelle level crossing	340.490	Damage to Strail panels. The panels became caught on the train, and these fell off along the track. The bolt for the emergency support was found just north of the level crossing.	
H - Points 1 Dombås	342.570	Extensive damage.

Figure 4: Map of findings (source: Google maps)

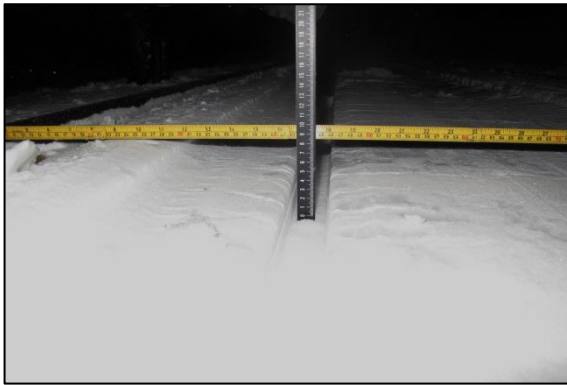
Figure 5: Traces in the snow - Finding E.

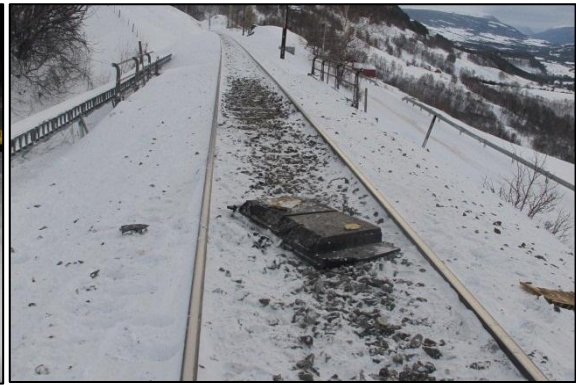
Figure 6: Strail panel at Hjelle level crossing finding G

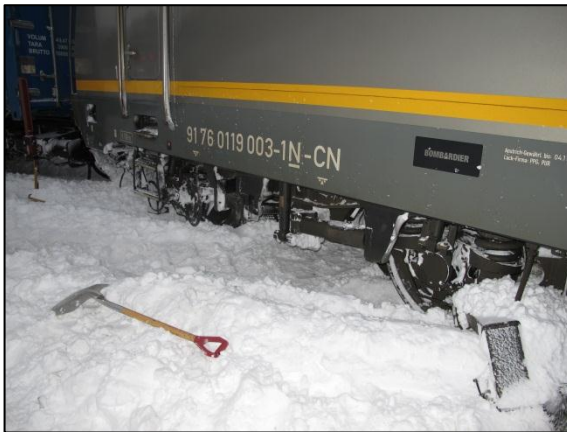
After the track was examined, locomotive number 119-003 was examined. This examination confirmed that the torque link and the emergency support for engine 2 on bogie 1 were broken.

Figure 7: Bogie 1 of locomotive 119003

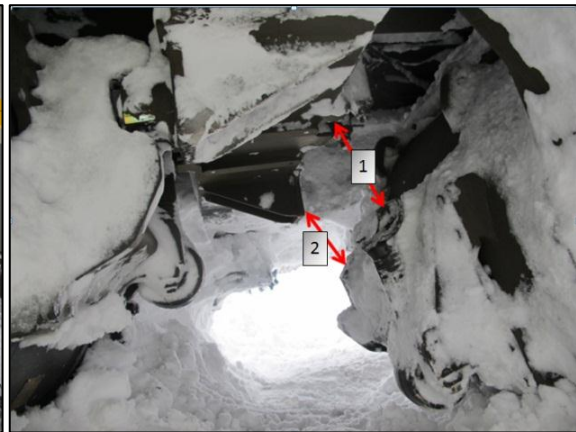
Figure 8: Broken torque link (1) and emergency support (2)

The locomotive was examined at Grorud repair shop on 23 January by representatives from the AIBN, CargoNet AS and Bombardier, the manufacturer of the locomotive. The torque link and emergency support were removed and sent to the Norwegian Armed Forces Laboratory Services for examination. On 25 January, the body of the locomotive was lifted off the bogies, revealing traces of arcing and damage to the cables to the engine that had broken loose.

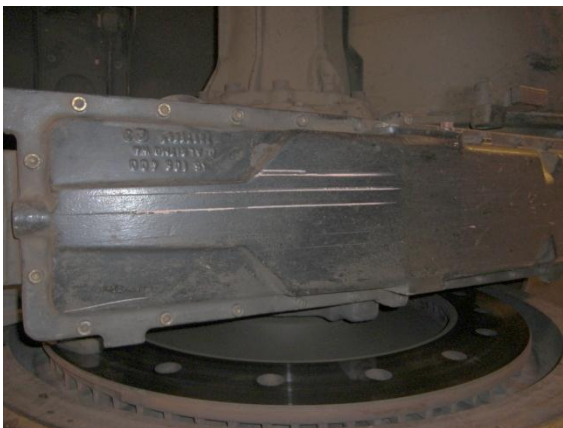
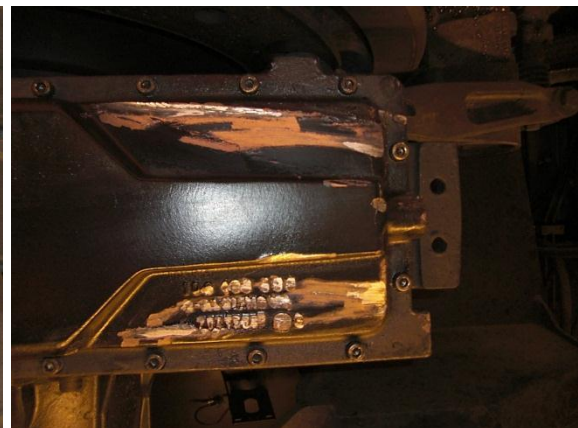
Figure 9: Marks on axle 1 (Source: CargoNet AS) Figure 10: Marks on axle 2 (Source: CargoNet AS)

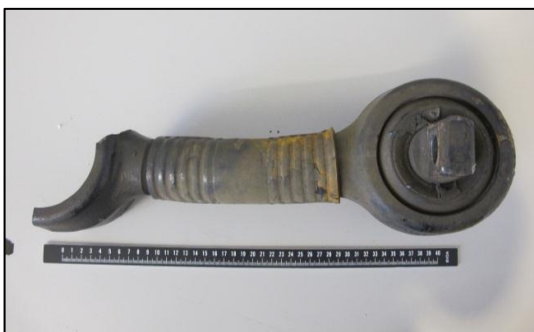
The Norwegian Armed Forces Laboratory Services concluded that the torque link did not show any signs that it had been underdesigned [2] [3]. This was based on the fact that the damage had mainly occurred during high-cycle fatigue² and that the extent of the final fracture (overload) was negligible. The report also indicates that the torque link could have been subject to shock loads³ in the two incidents described earlier (derailment at Dalane and collision damage to the transmission). It is possible that these overloads caused local stress deformations⁴ in the component and contributed to the initiation of fatigue damage. The report is unable to establish with any certainty that the shock loads alone were the cause of the fracture initiation. The report also shows that micro-cracks could be observed in the surface of the engine support in the area of crack initiation, and that these are related to the forging process. The Norwegian Armed Forces Laboratory Services recommend improving how the surface is treated after forging, in order to improve the component's properties.

Since crack propagation had been going on for some time, the Norwegian Armed Forces Laboratory Services believe that it could have been detected during maintenance, if this had been conducted at suitable intervals and if suitable procedures had been followed.

Figure 11: Torque link examined.

very difficult, using this method, to detect small cracks or possible deformation of a torque link that is covered in black paint. However, it is clear that the torque link became considerably deformed (bent; see Figure 11) during the derailment at Dombås, and it would not have been possible to use such a badly bent torque link. It is unclear to what extent the torque link may have been damaged in the previous incidents, and whether such damage could be detected by visual inspection.

After the derailment at Dombås, Bombardier sent a letter to all its clients, stating that if a locomotive had been involved in a derailment or similar incident, it recommended replacing the torque link.

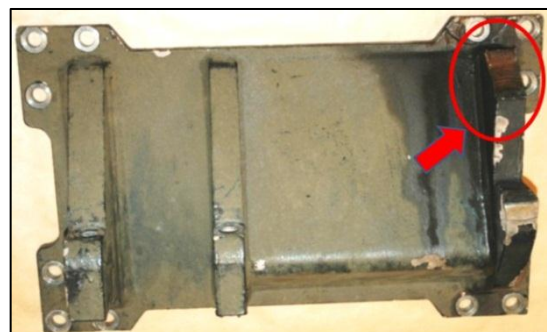
Furthermore, the examination showed that the emergency support had a fatigue crack as a consequence of the loads to which it was subjected after the torque link failed; see Figure 12. The loads on the support were considerable, since the final 30% of the crack surface is due to overloading.

Figure 12: Emergency support examined.

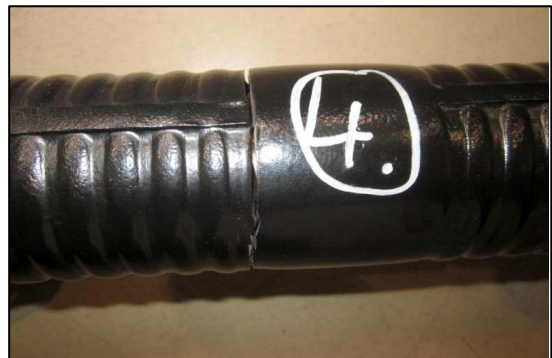
Figure 17: Break in tube during durability test 4 [10].

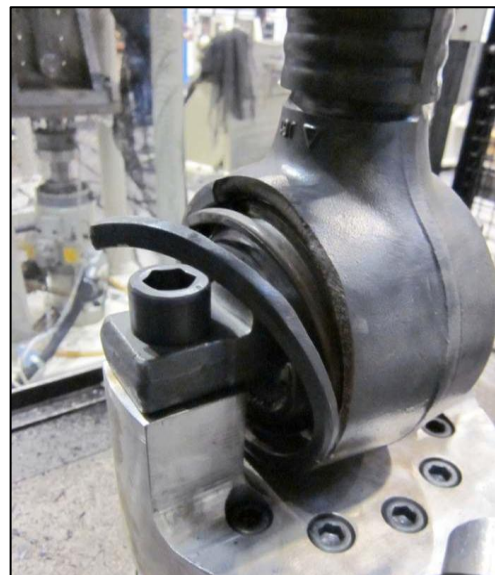
Figure 19: Cracks in ring around the bearing [10]

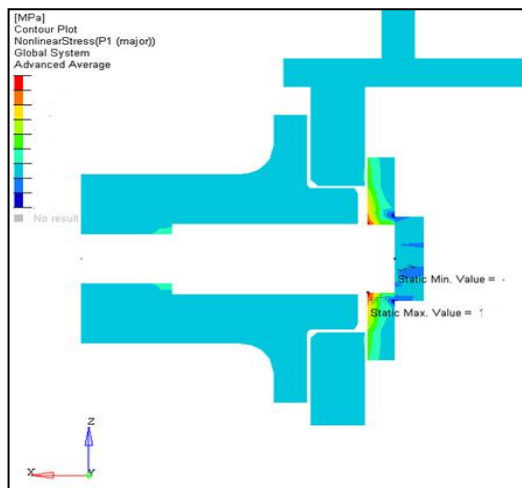
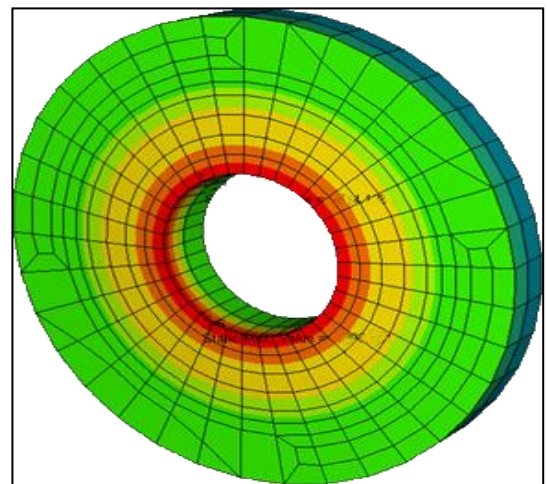
Figure 22: Strength analyses of bolt and washer [15]. Figure 23: Strength analyses of washer [15]

During the examination of the emergency support, it became apparent that the bolt and washer had been under-designed. This is consistent with the way in which the emergency support was observed to fail at Dombås. The AIBN believes that the best way to ensure safety in this connection is by establishing procedures to detect any failure in the engine's primary supports and to confirm, if applicable, that the engine is supported by the emergency support, and has therefore decided not to consider the design of the emergency support any further in this report.

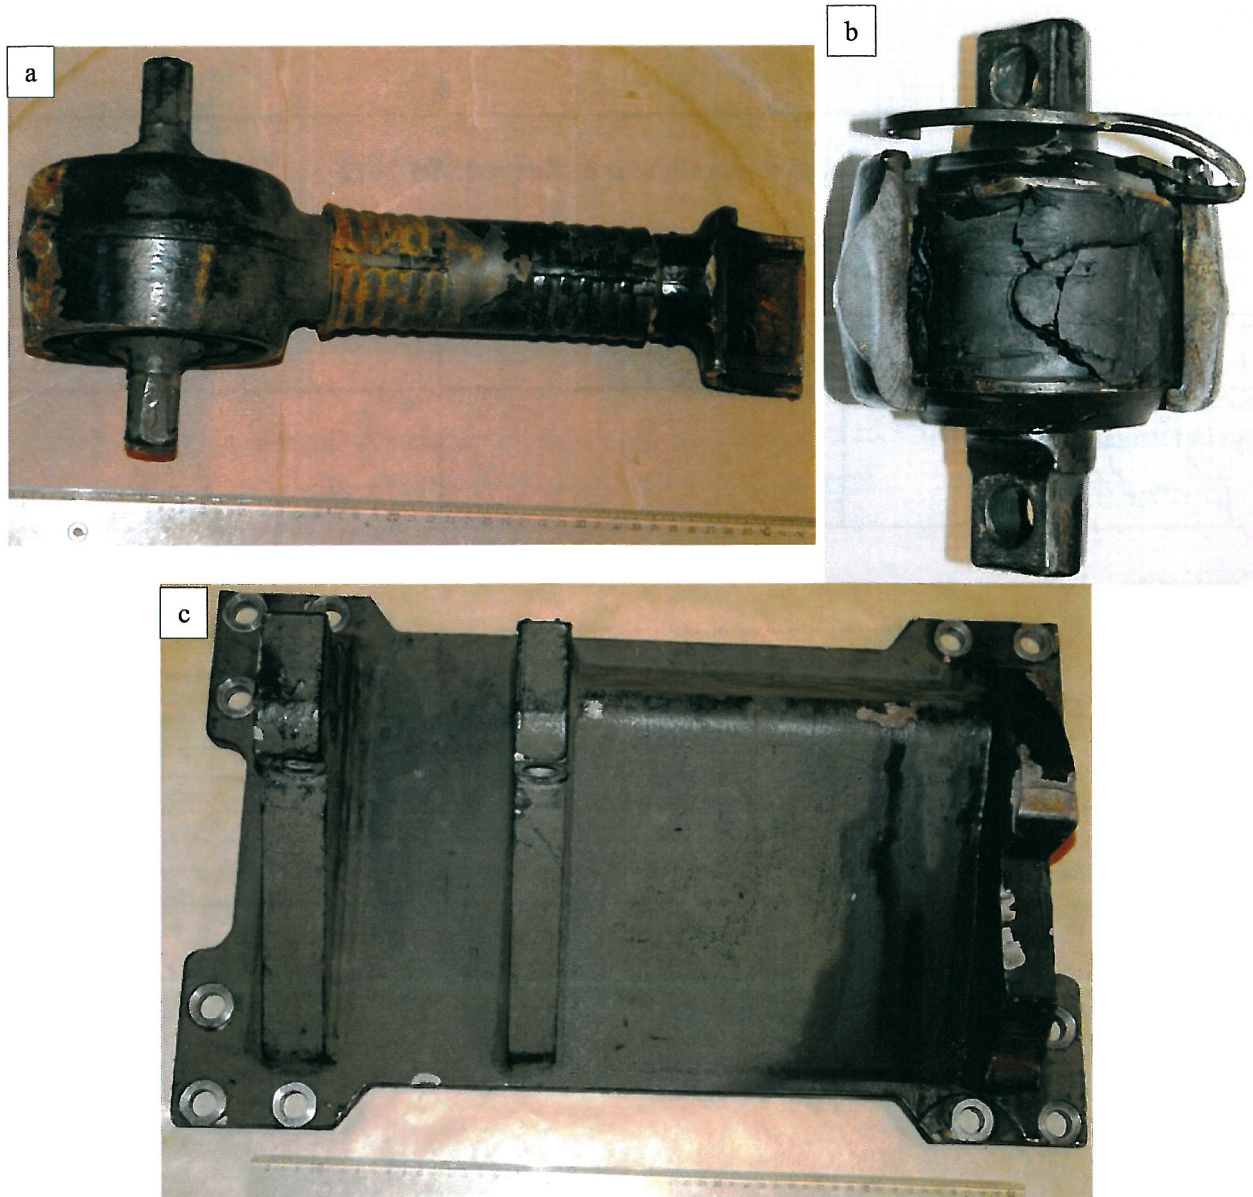
Figure 1a-b: Pictures of failed torque link. c: Picture of failed engine side panel.

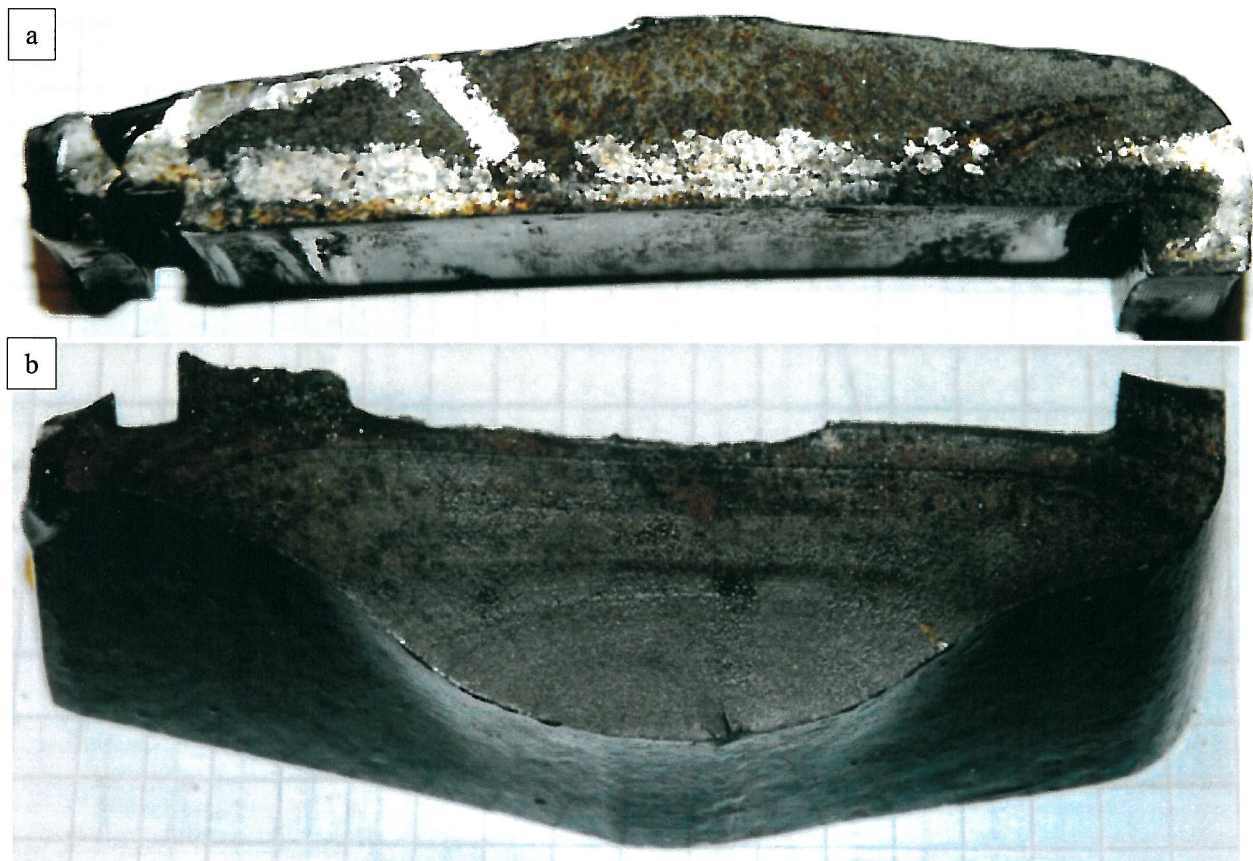
The fracture surfaces were cut out from the failed component as shown in Figure 2ab. A visual examination of the fracture surfaces revealed a large number of crack arrest lines often associated with fatigue. Based on the profile of the crack arrest lines, a probable crack initiation location was identified as shown in Figure 3. The initiation area was examined further in SEM equipped with EDS. The observations were that the crack initiations seemed to originate from the component surface. Irregularities associated with corrosion/pitting were not observed, see Figure 4. The two layers identified with EDS spectrums are most likely paint coating. Further characterization of the fracture surface in SEM reveals a corroded and contaminated surface (dust/sand), some areas showing a striated surface could also be observed; see Figure 5a-d.

Figure 2ab: Fracture surfaces cut from the failed torque link.

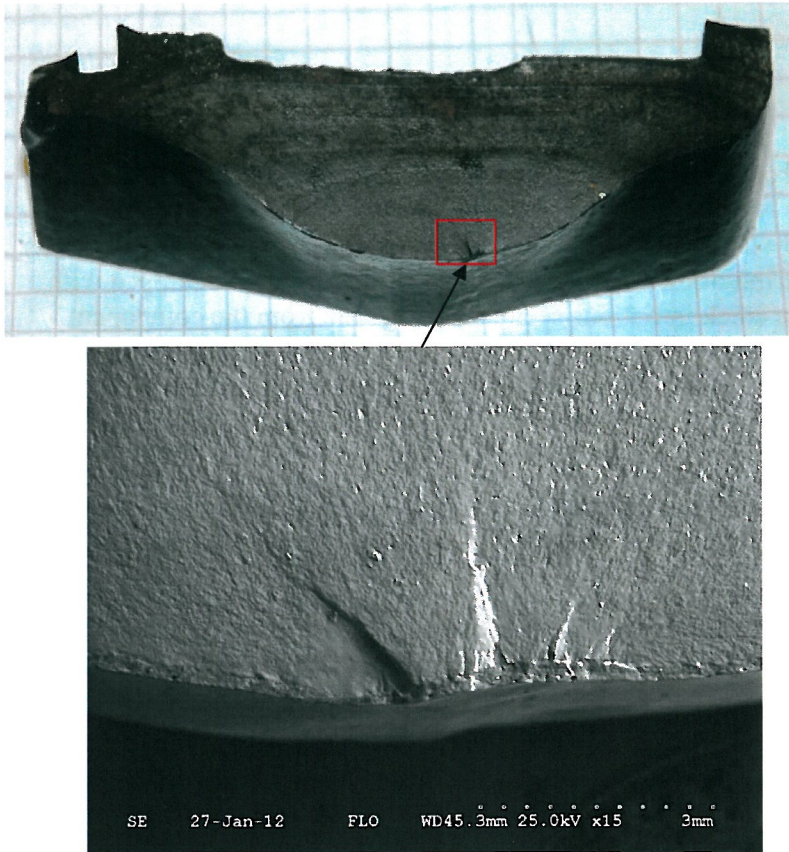
Figure 3 Location for probable crack initiation location based on crack arrest line orientations.

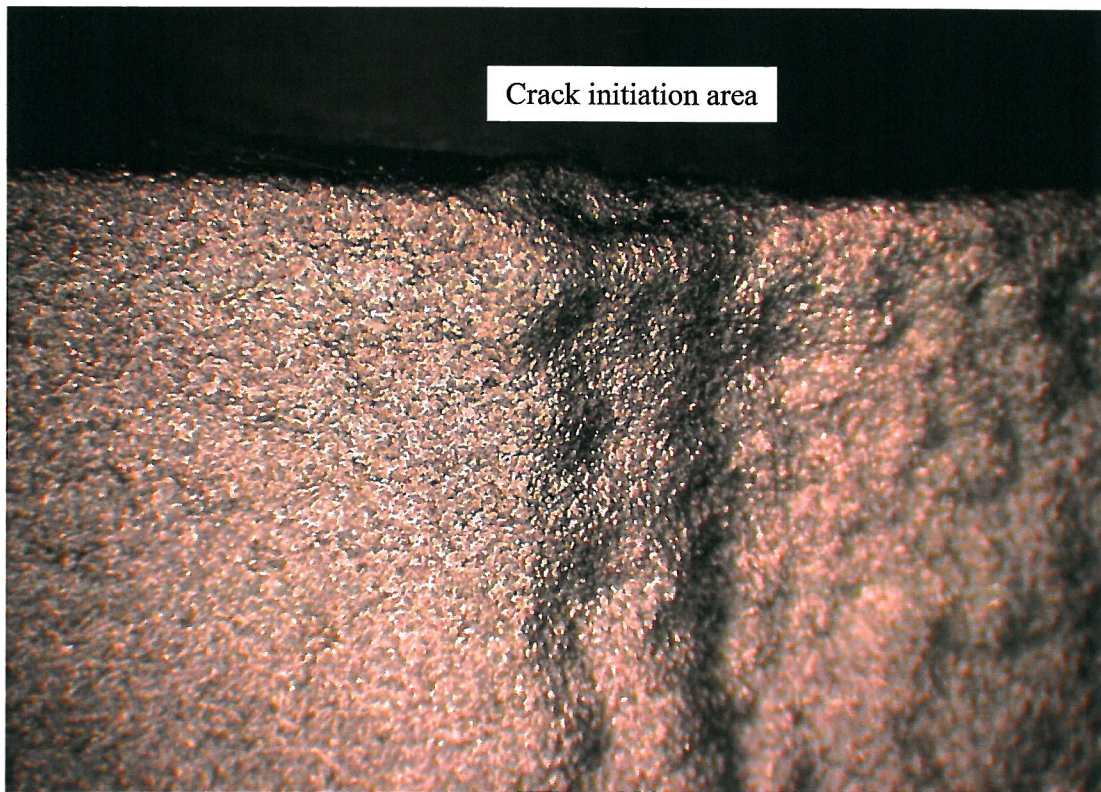
In order to reveal possible secondary cracking adjacent to the observed failure, the paint was removed using light glass blasting. No additional crack initiations were observed as shown in Figure 6.

Figure 6 Image of component surface towards the crack initiation area after paint removal.

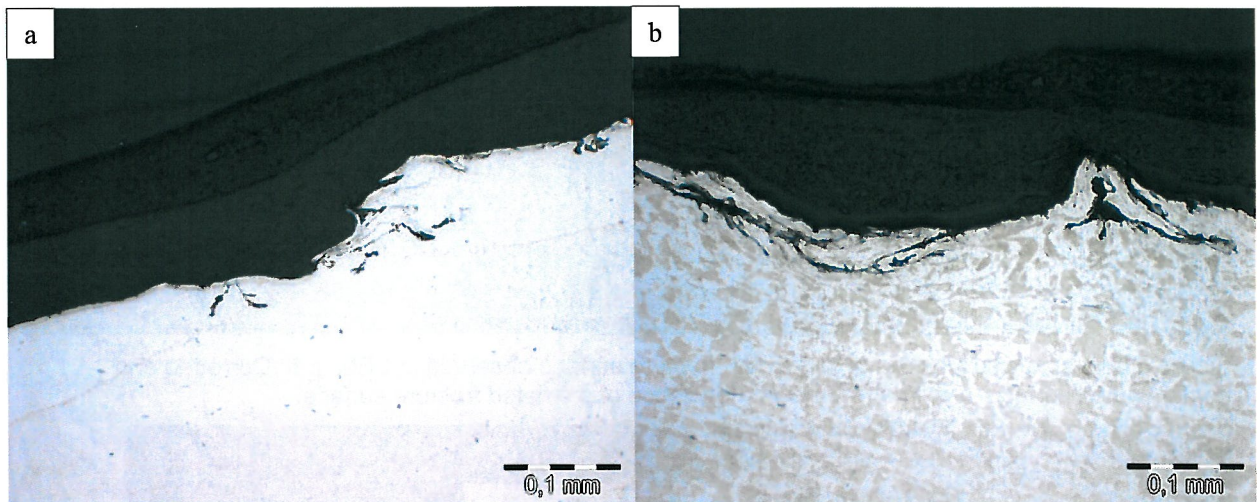
Figure 8 Picture of metallographic sample towards the surface showing an irregular surface appearance with micro cracks associated with forging.

Based on the obtained results it seems likely that the torque link failed due to fatigue. The fatigue crack initiation originates from surface micro cracks introduced during the forging process. There has not been possible to identify a final fracture overload region, indicating low stresses when the final fracture occurred and consequently a long period of time for the crack to develop to its full length.

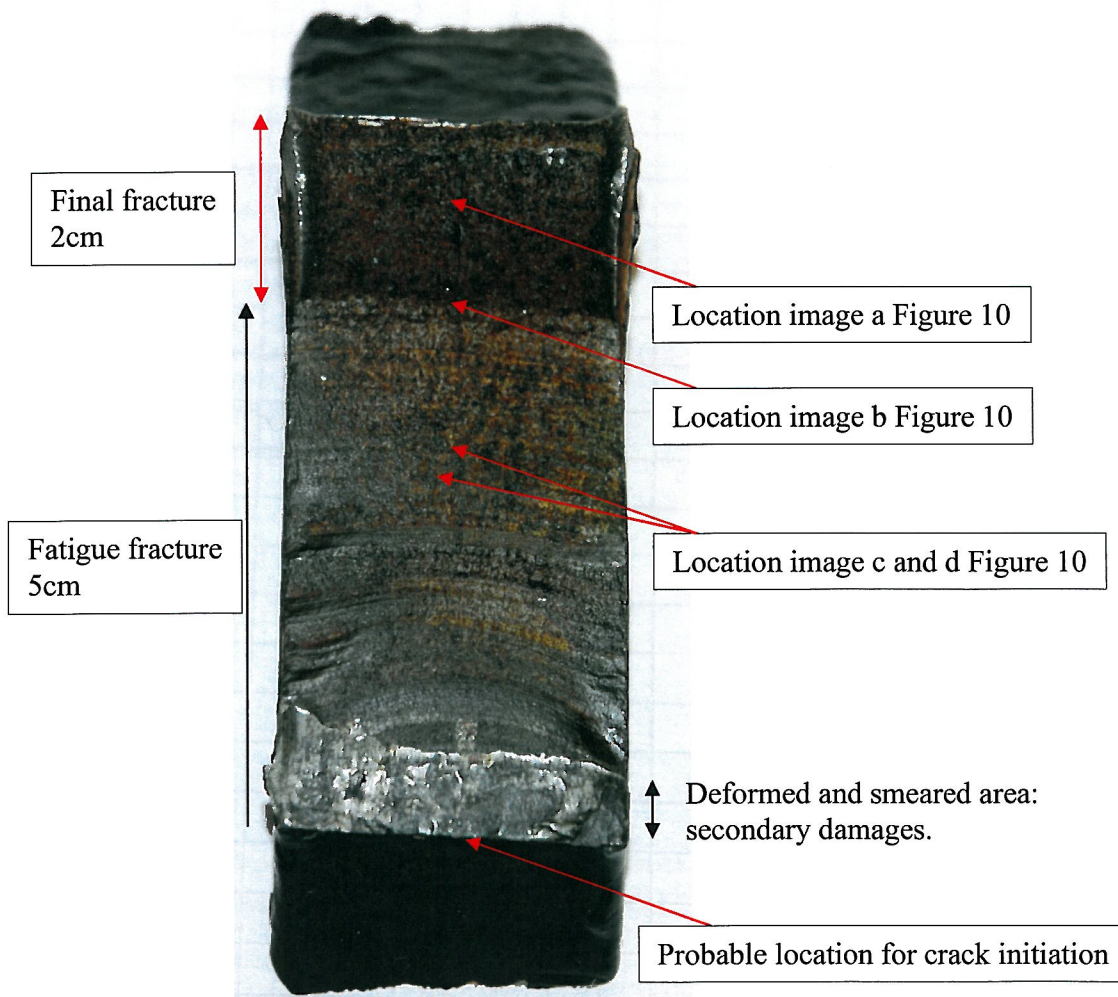
The engine side panel fracture surface was cut from the component for further analysis. A picture of the fracture surface is shown in Figure 9 with comments from the visual examination attached. The observations are that the fracture surface consists of numerous crack arrest lines that seems to originate from the position indicated as probable crack initiation area in the picture. The actual crack initiation area is not possible to observe due to secondary damages/smearing of the surface.

A clear 2cm final fracture was also observed as indicated in Figure 9.

Figure 9 Overview picture of the engine side panel fracture surface including comments from the visual examination.
