# REPORT

## JB 2019/04

## REPORT ON RUNAWAY WORK MACHINE AT ENSJØ METRO STATION, 7 JUNE 2018

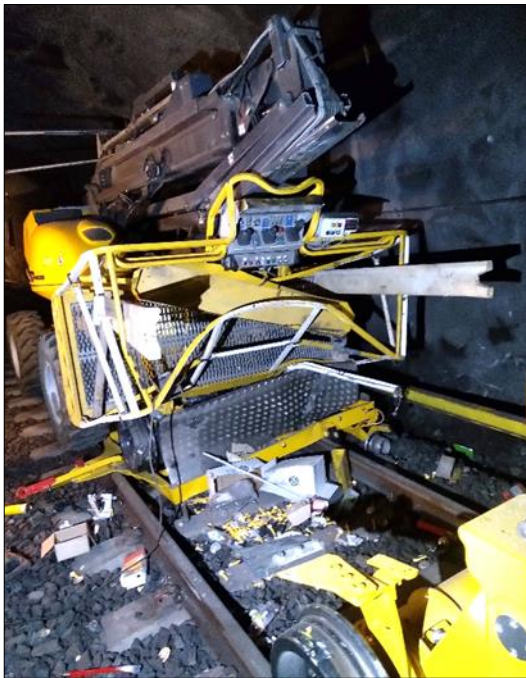
Figure 1: The MEWP after the collision. Photo: BMO Entreprenør AS

The personnel basket and boom were damaged; see figure 1. A trailer attached to another work machine was broken.

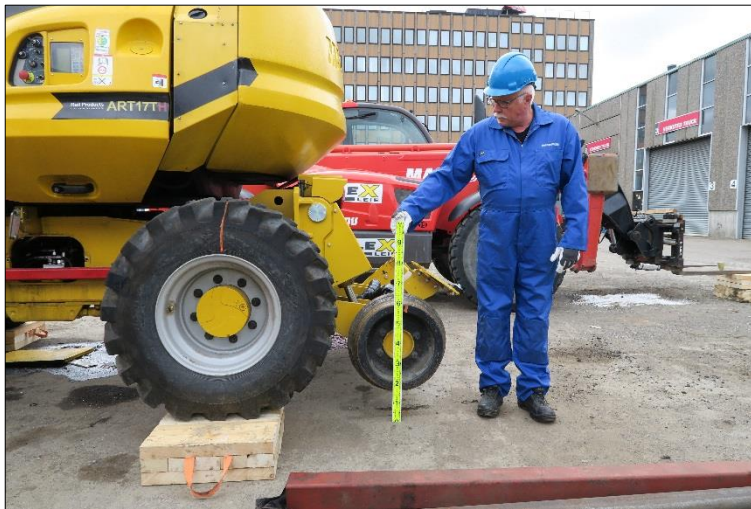
In one of the tests, the machine was jacked up and the road wheels placed on wooden boxes so that the rail wheels were freely suspended. According to BMO, the company that salvaged the MEWP, the machine had not been modified since the accident and the rail wheels were in the same position.

Figure 4: Test of the machine on 21 June 2018. Photo: AIBN

The conclusion from the test was that the parking brakes were released automatically on lowering or raising the rail wheels. The test also showed that if the emergency stop function was activated while lowering the rail wheels, the parking brake was engaged automatically. See Appendix A for more information about the tests.

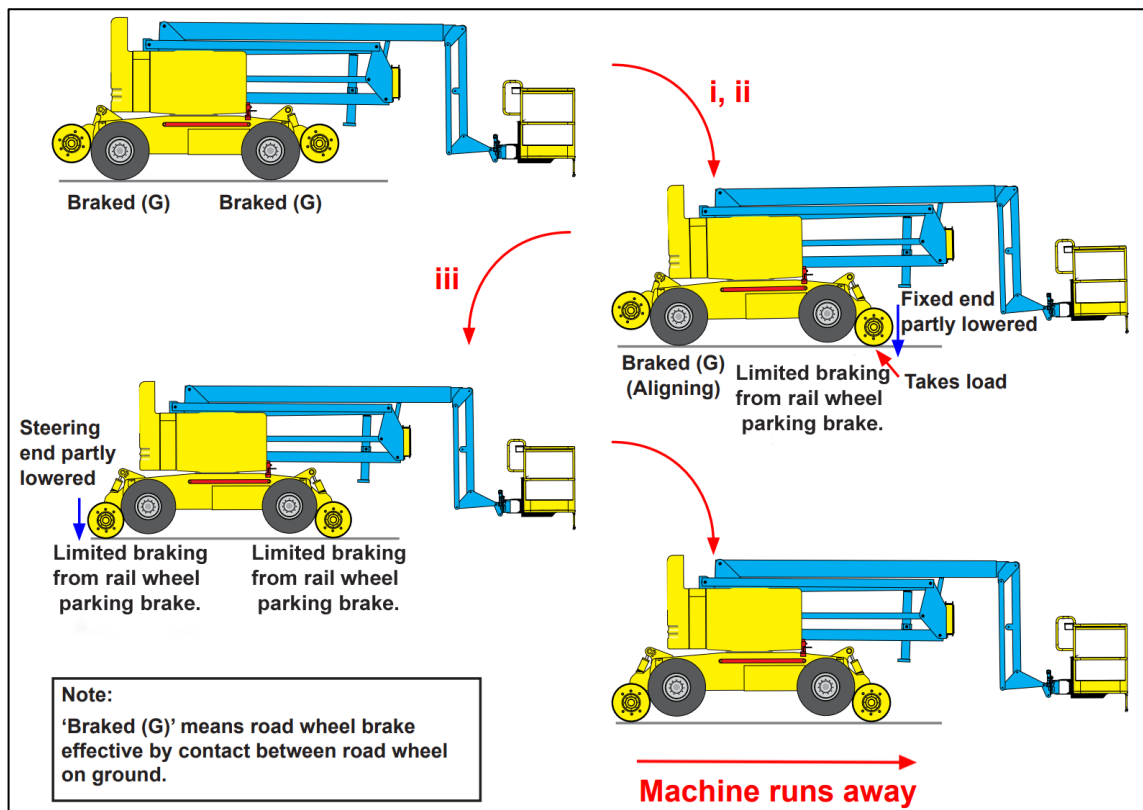
On 6 July 2018, the incident was reconstructed and the MEWP that derailed was compared with two other machines of the same type. The purpose was to determine what force was needed to move the MEWP with the rail wheels in the mid position.

Figure 5: Illustration showing the on-tracking method that was tested. Source: RAIB, © Crown copyright 2019, modified by AIBN

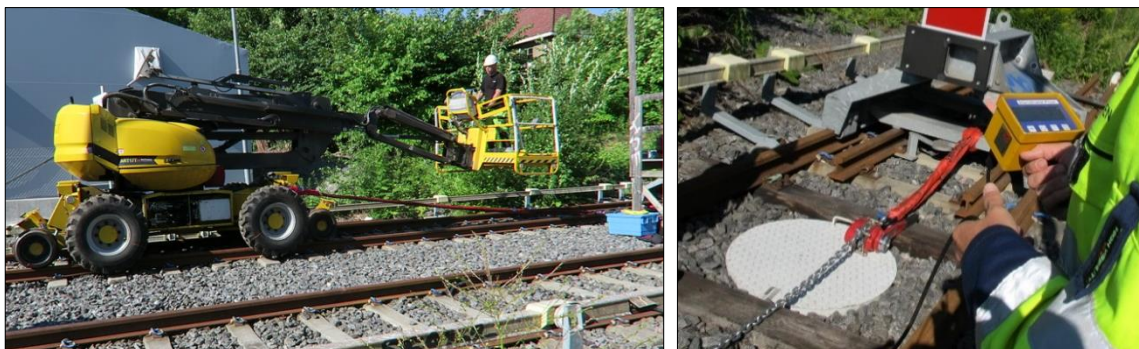
Figure 6: Test of the machine on 6 July 2018. Photo: AIBN

The test was carried out on Oslo Metro's dead-end track at Majorstuen. The MEWP that was involved in the accident was parked on the track for approximately 13 hours before the test was carried out, the same amount of time as the MEWP was parked before the accident. For the test, the machine was chained to an end stopper, a jack was used to tighten the chain and the force needed to move the machine was measured using a dynamometer. In addition, a work machine was used to pull the MEWP over a longer distance in order to test the emergency stop function at speed. See Appendix B for more details about the test.

(Appendix F) show that approximately 500 kg<sup>1</sup> braking power is required at a gradient of 40‰. In the test, the MEWP moved when it was pulled with a force of 300 kg. By adding the safety factor of 1.4 it is required that the machine has a braking force of 750 kg in a gradient of 40‰.

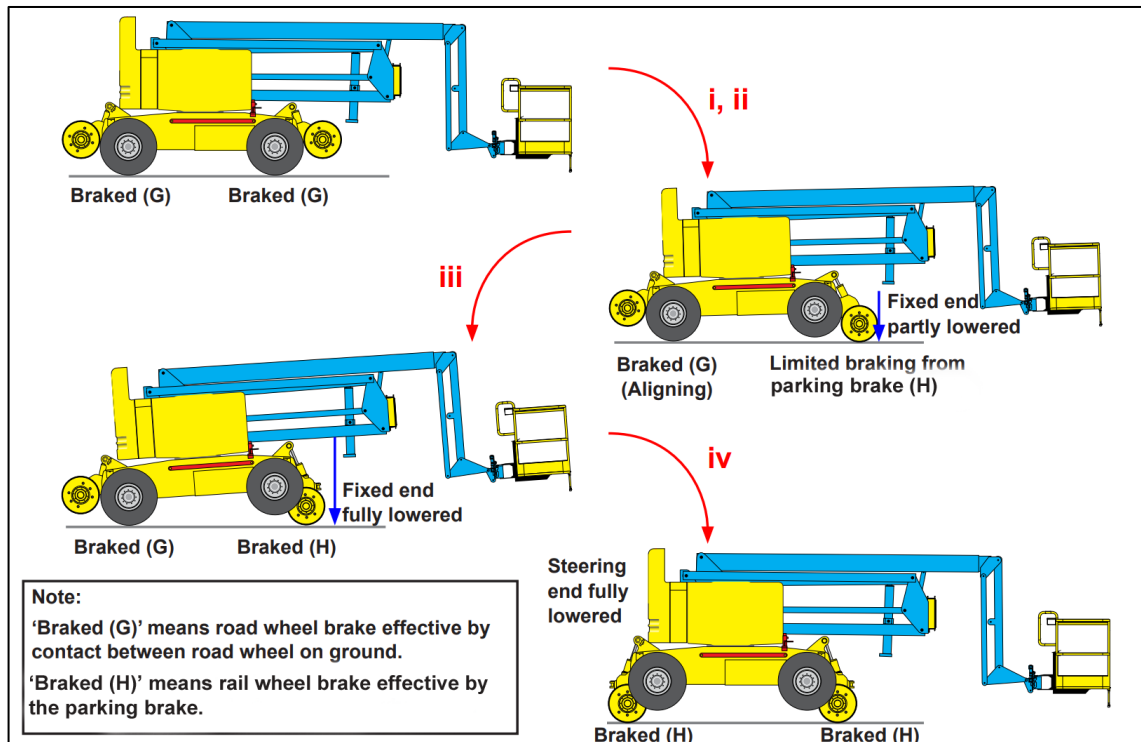
For the machine's brakes to be effective during on-tracking, one set of rail wheels must first be lowered all the way to ensure that the parking brake is effective before lowering the other set.

Figure 7: Illustration showing the correct on-tracking procedure. Source: RAIB, © Crown copyright 2019, modified by AIBN
