THE AIRCRAFT ACCIDENT INVESTIGATION BOARD/NORWAY

REP.: 07/96

**REPORT ON THE ACCIDENT TO DHC-6-300 TWIN OTTER,
LN-BNM NEAR NAMSOS, NORWAY ON 27 OCTOBER 1993.**

**REPORT ON THE ACCIDENT TO DHC-6-300 TWIN OTTER, LN-BNM
NEAR NAMSOS, NORWAY ON 27 OCTOBER 1993**

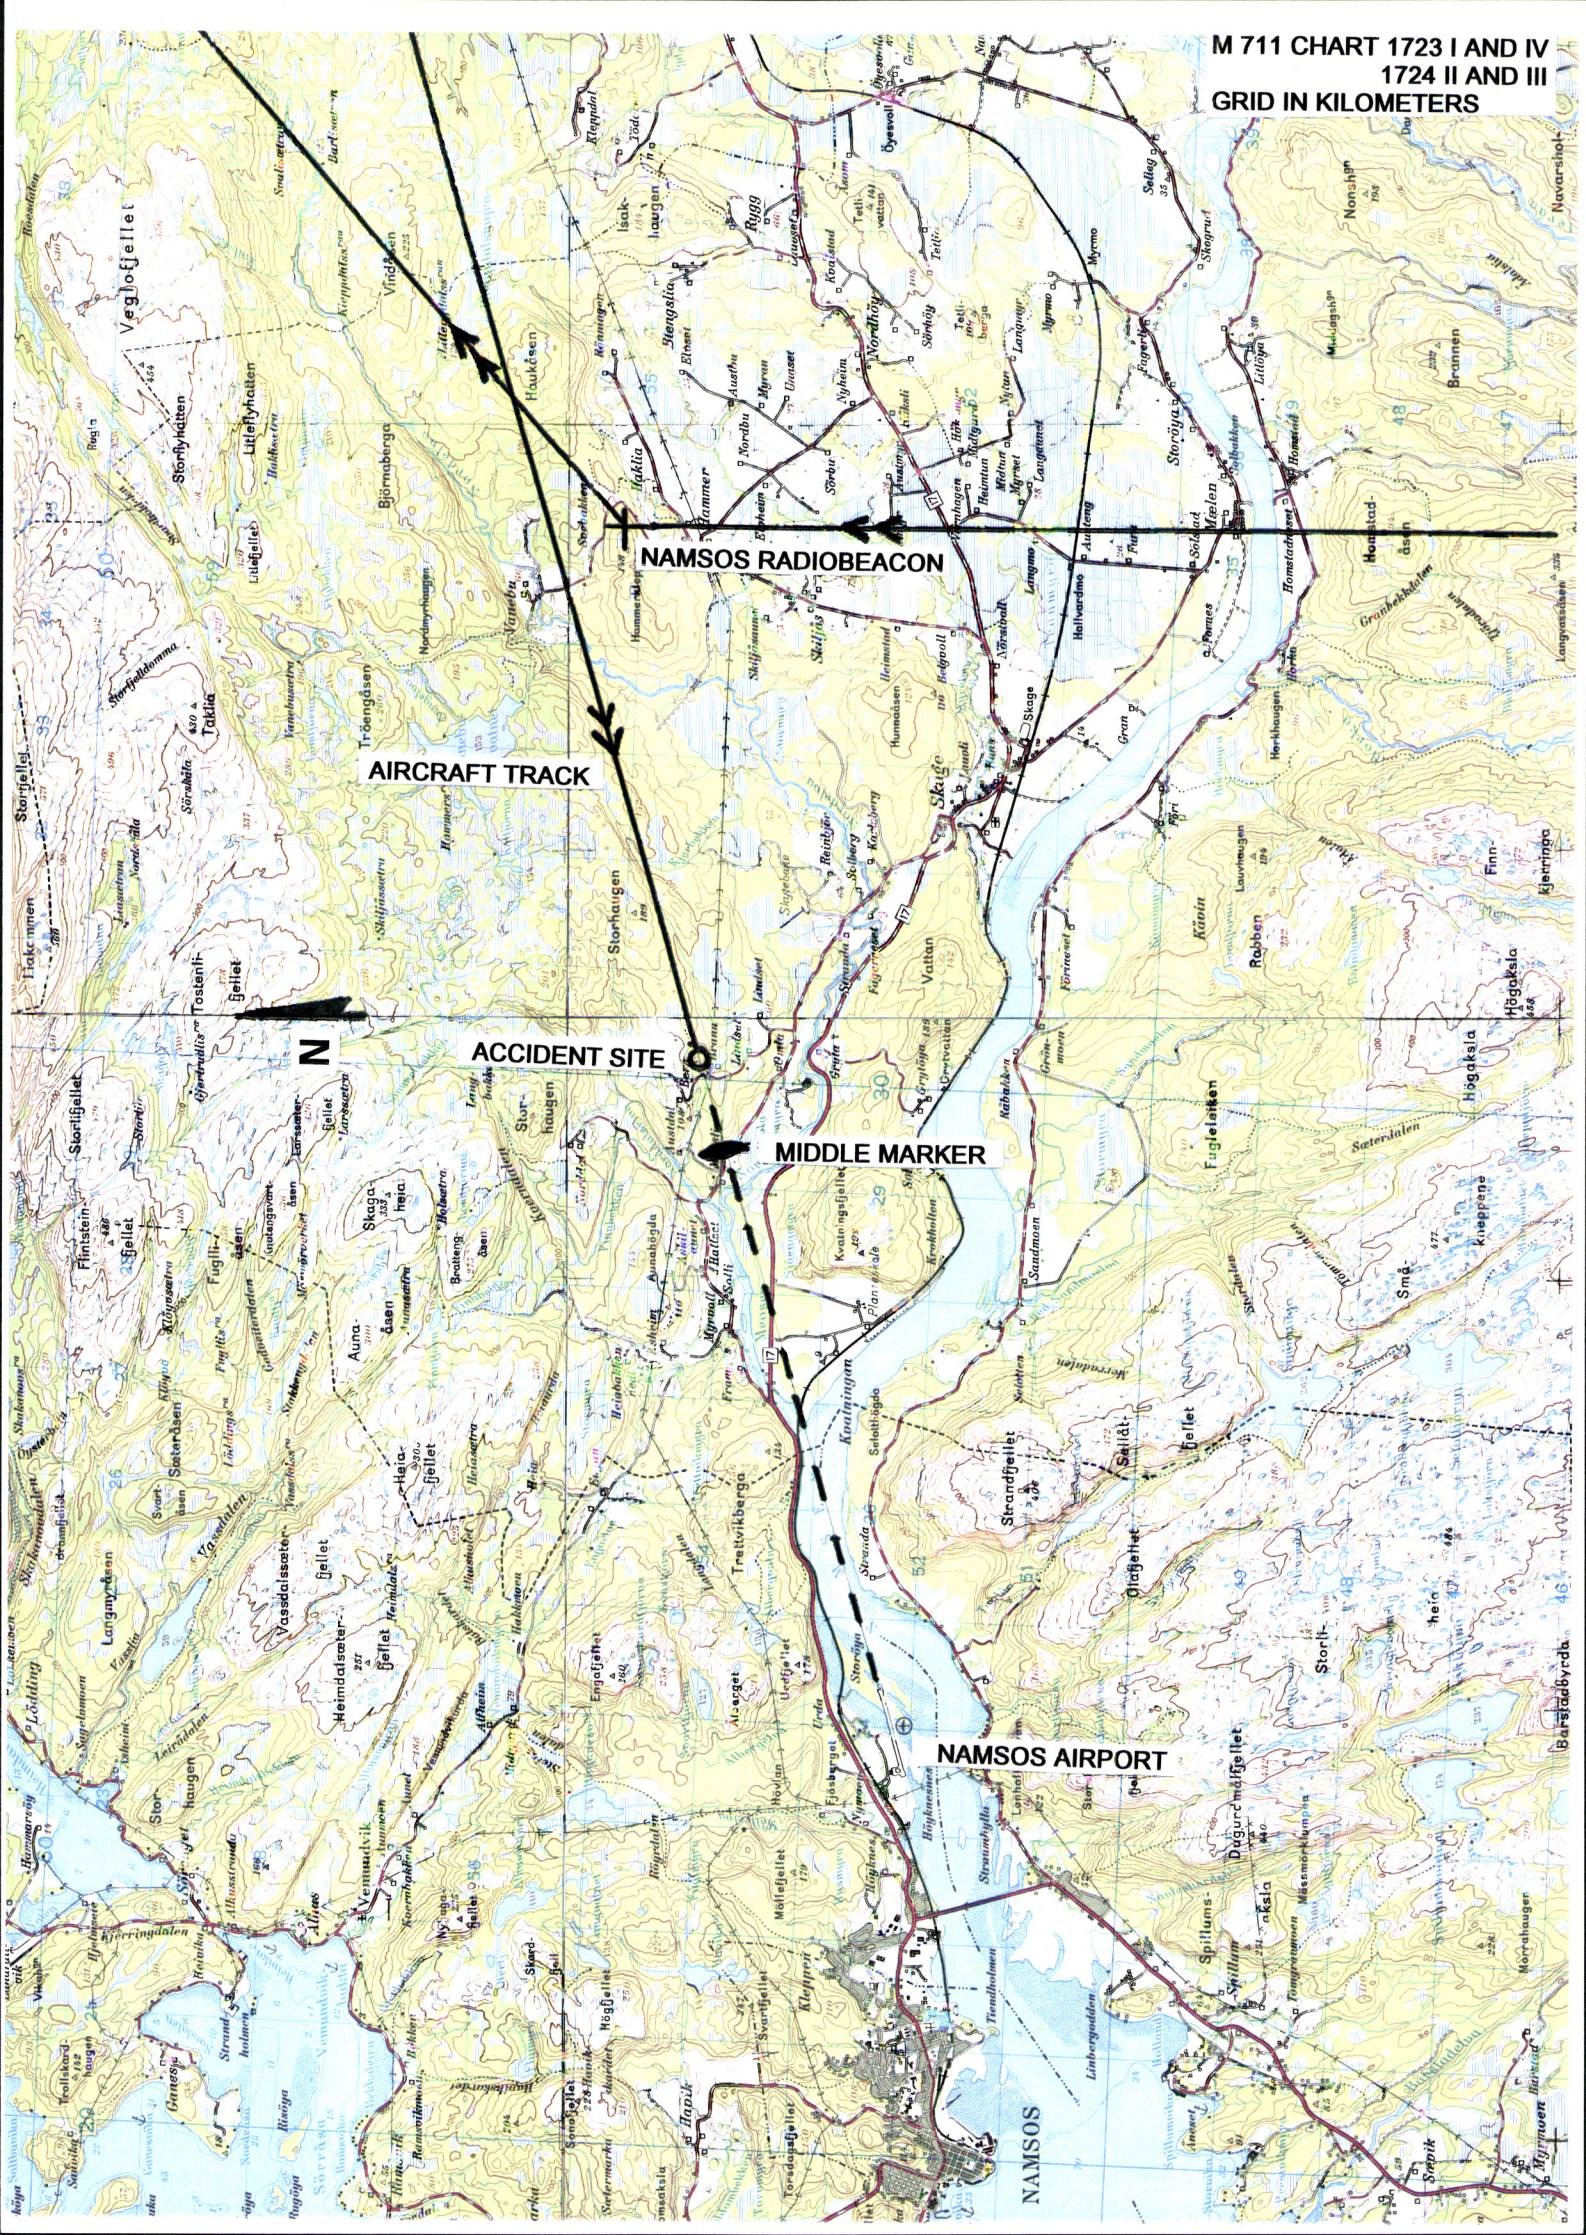
NAMSOS RADIOBEACON

AIRCRAFT TRACK

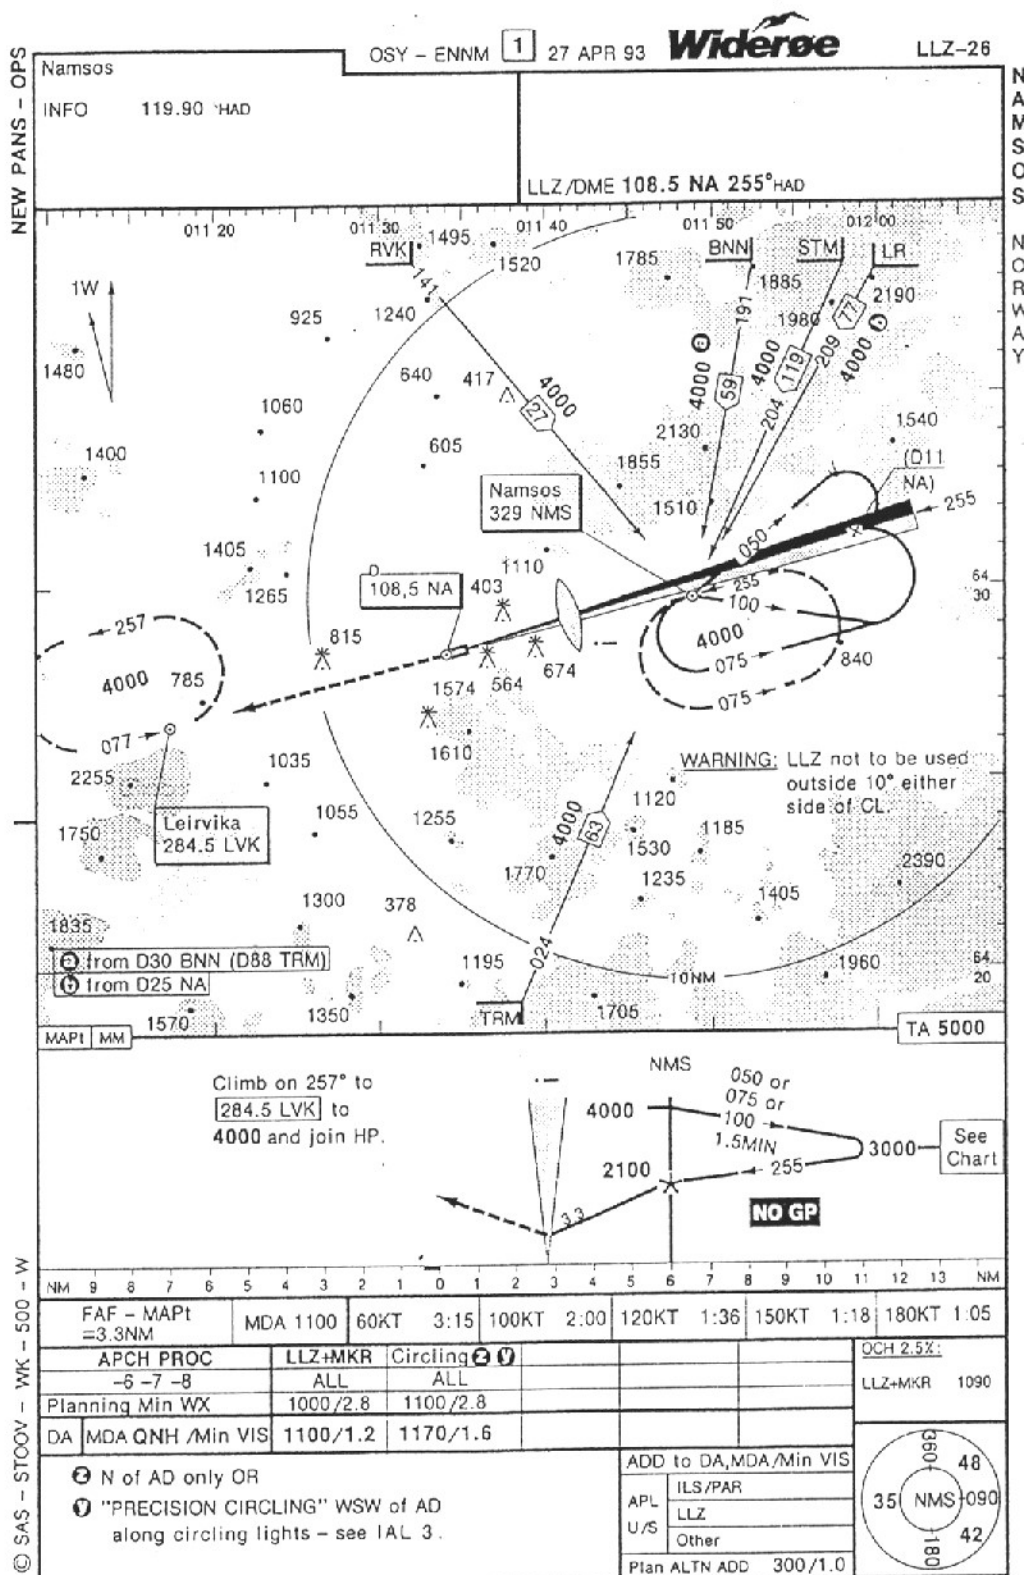
Approach chart

DME 11 is written in brackets on the chart as a suggested value to be observed when established on track inbound towards NMS NDB. The crew did not observe this and flew considerably further out than the approx. 10 NM limit they should have been within, taking into account the effect of the wind. In the opinion of the AAIB/N, the purpose of DME 11 should have been more clearly indicated on the chart. It would also have been a support to the crews if a nominal glide path with altitudes relating to DME distances had been printed, as is given on some IAL charts.
