THE AIRCRAFT ACCIDENT INVESTIGATION BOARD/NORWAY
(AAIB/N)

REP.: 02/98

AIR ACCIDENT INVOLVING EUROCOPTER SUPER PUMA 332L,
LN-OBP, IN THE NORTH SEA ON 18 JANUARY 1996, APPROX. 40
NM SOUTH-WEST OF SOLA, NORWAY

SUBMITTED MARCH 1998

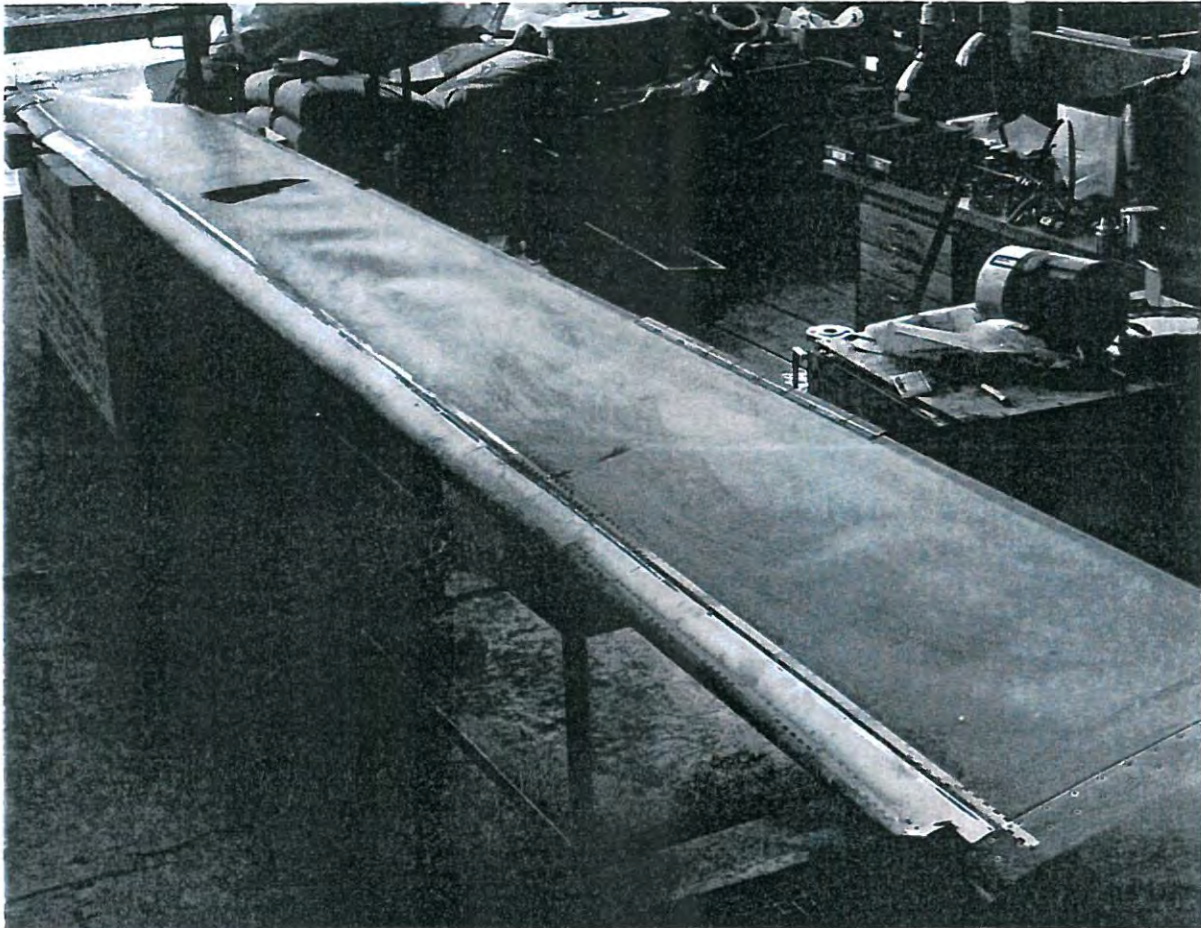
General view of the upper surface of the failed main rotor blade. The tip cap is seen down to the right. Adjacent to this cap a local section of the protective Ti-strip is seen deformed by bending (lift separation).

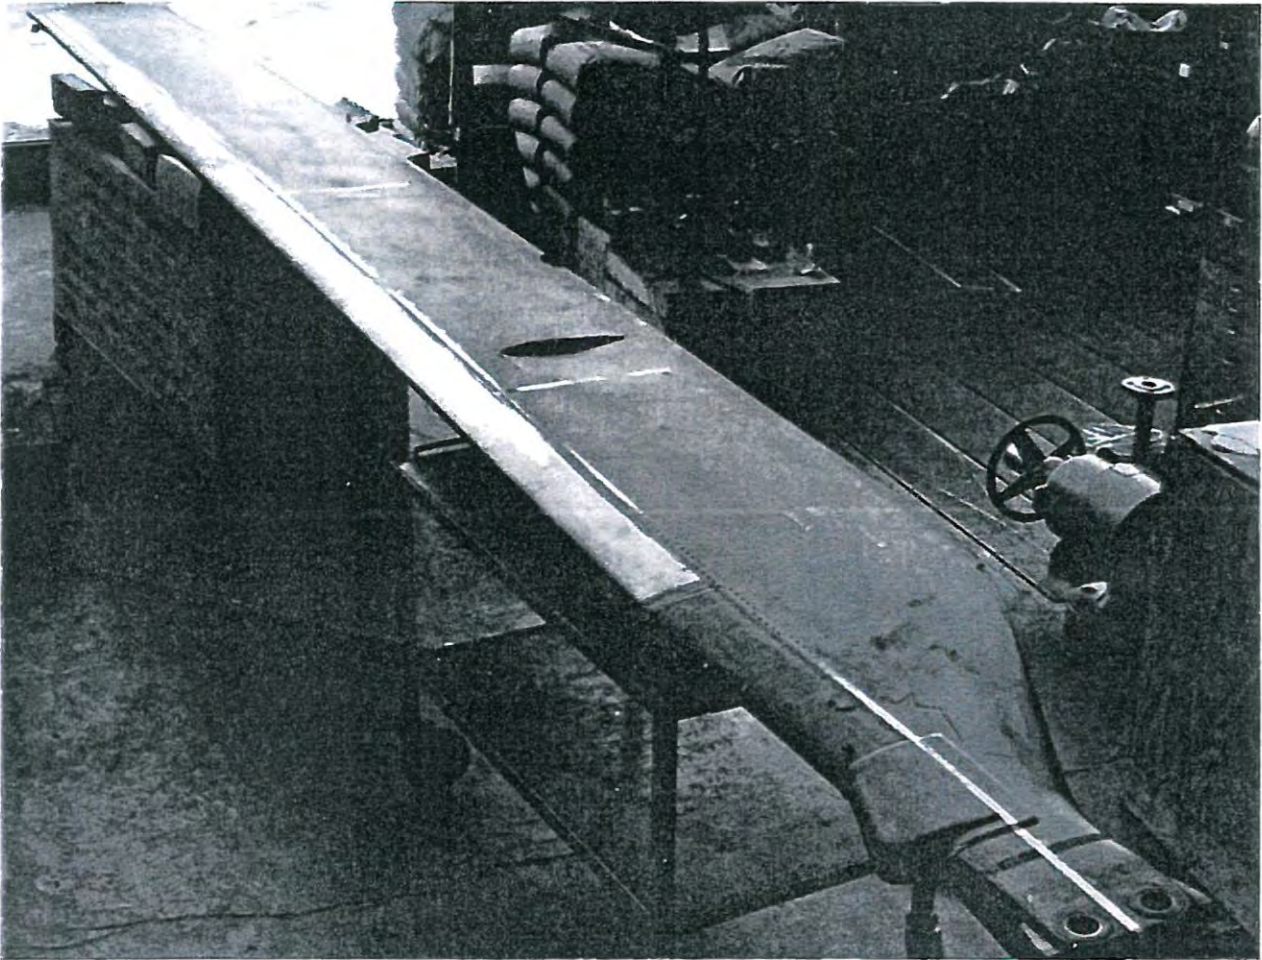
General view of the lower surface of the failed main rotor blade. The outer end of the blade is located at the top of the photo.

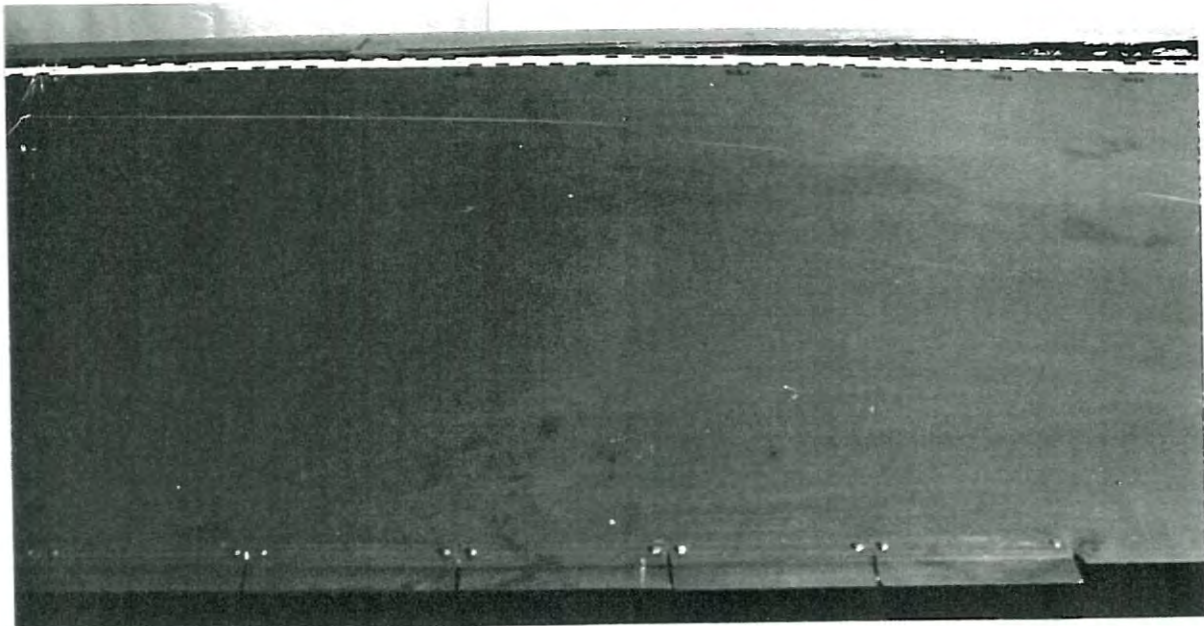
MRB upper surface 1.3 - 2.1 m away from the "zero line", seen towards the leading edge. Separation between the protective Ti-strip and the underlying skin is noted, as well as internal skin separation by rupture (seen uppermost).

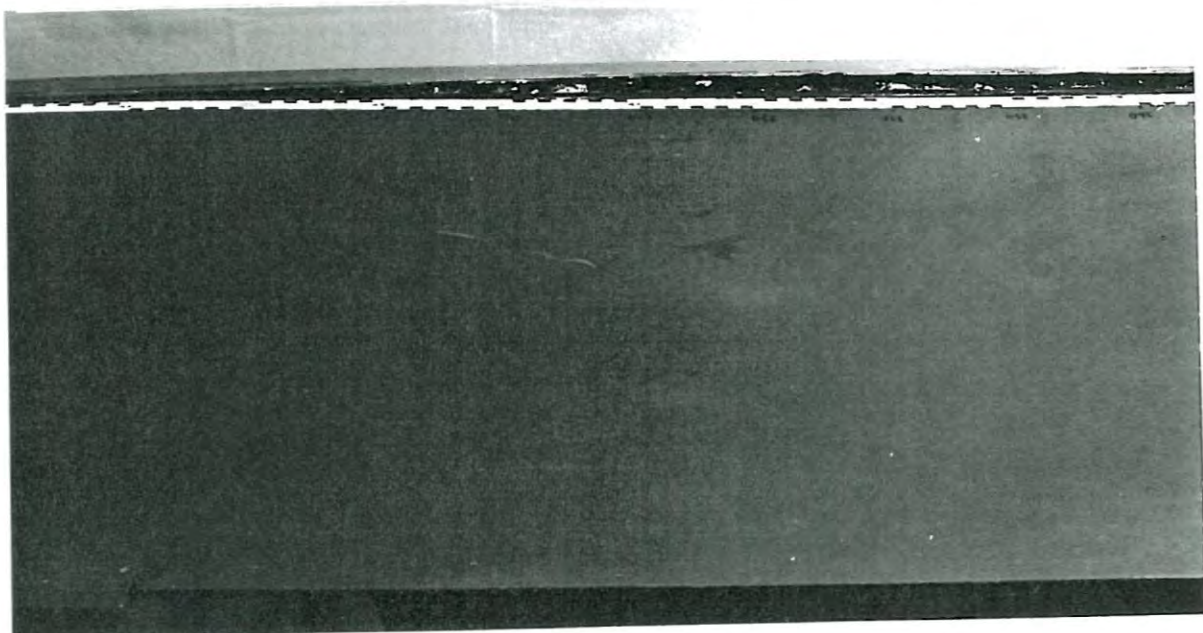
MRB upper surface 1.8 - 2.6 m away from the "zero line", seen towards the leading edge. Internal skin separation by rupture below the protective strip is noted.

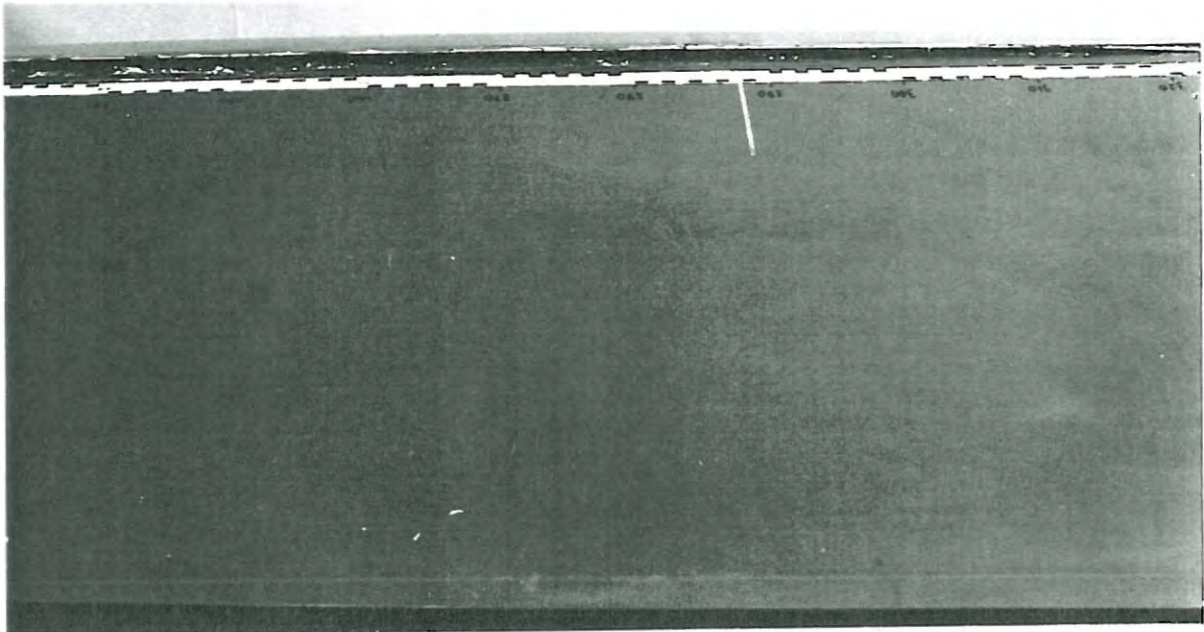
MRB upper surface 2.4 - 3.2 m away from the "zero line, seen towards the leading edge. Internal skin separation by rupture below the protective strip is seen.

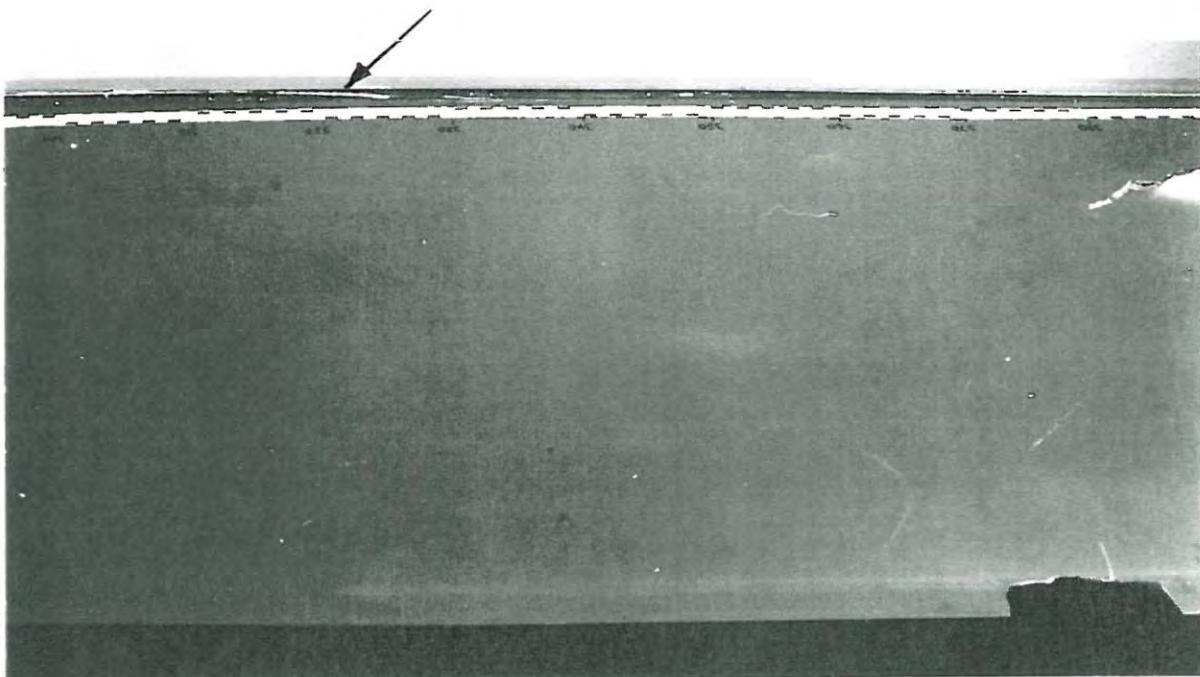
MRB upper surface 3.0 - 3.9 m away from the "zero line", seen towards the leading edge. Internal skin by rupture (left) as well as strip bonding separation (right) are observed.

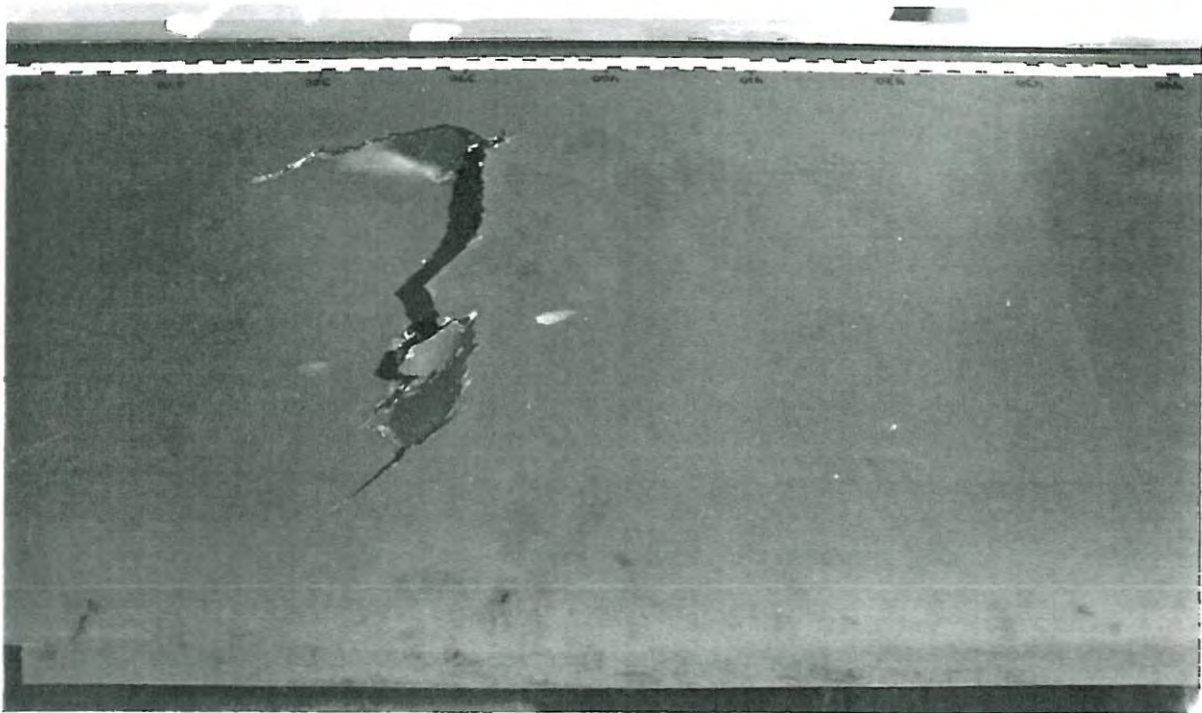
MRB upper surface 3.6 - 4.4. m away from the "zero line", seen towards the leading edge. Separation between the protective strip and the underlying blade structure is noted.

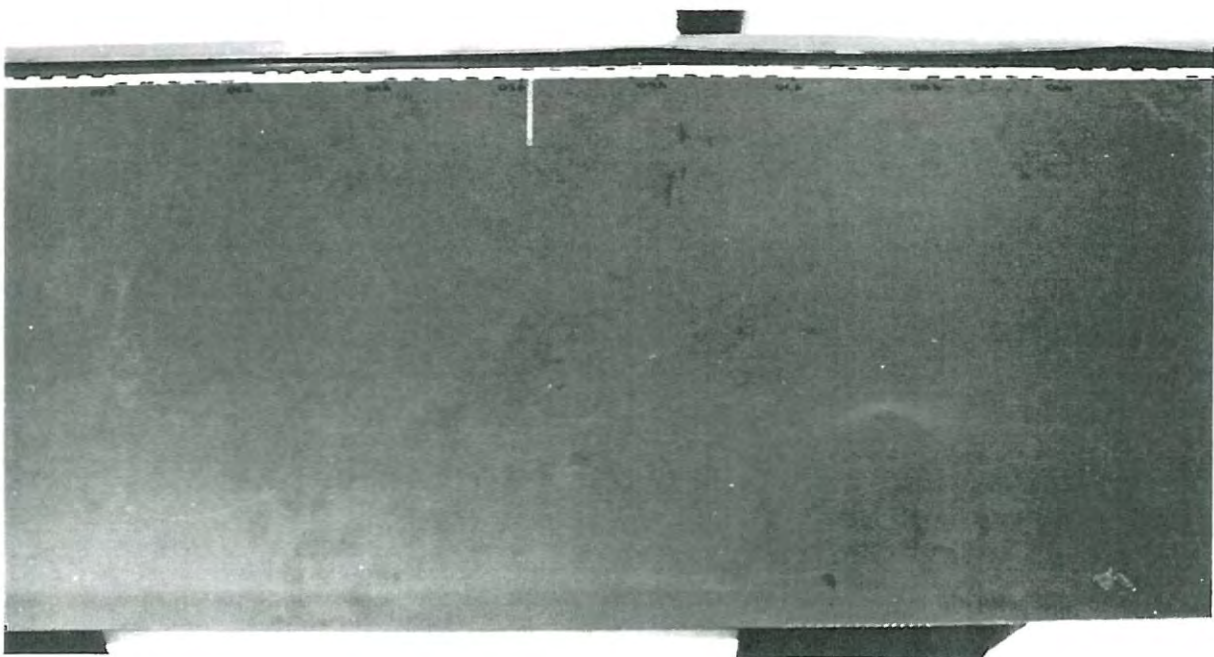
MRB upper surface 4.2. - 5.0 m away from the "zero line", seen towards the leading edge. Separation between the protective strip and the underlying blade surface is seen.

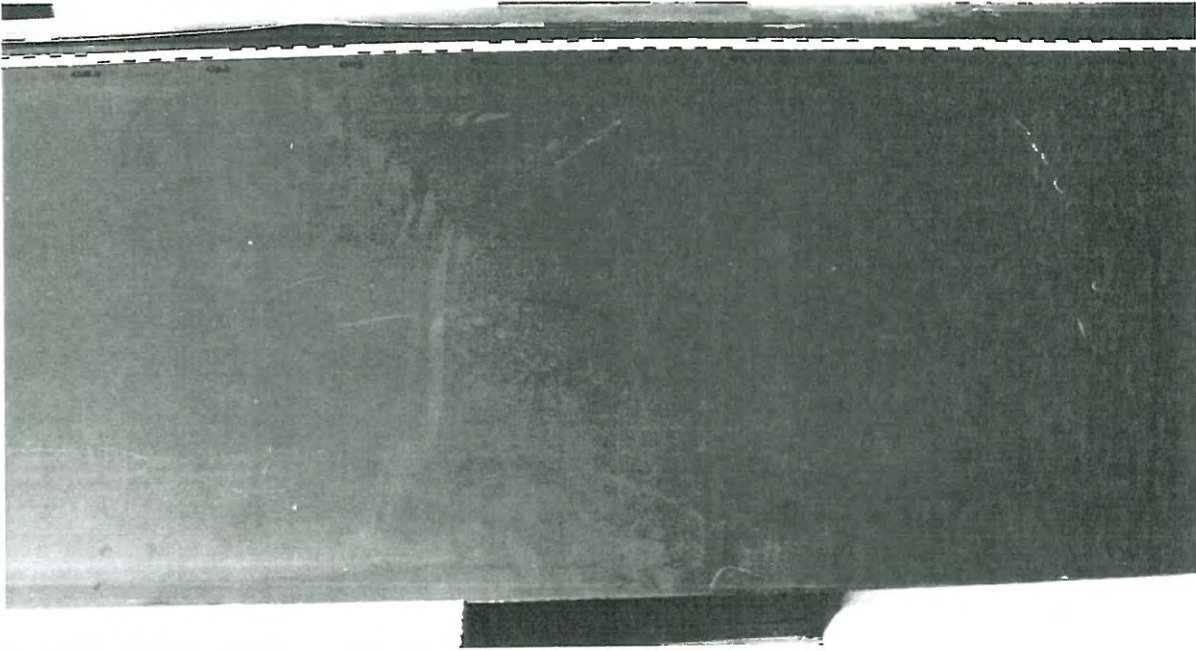
MRB upper surface 4.8. - 5.6. m away from the "zero line", seen towards the leading edge. Protective strip separation is noted locally.

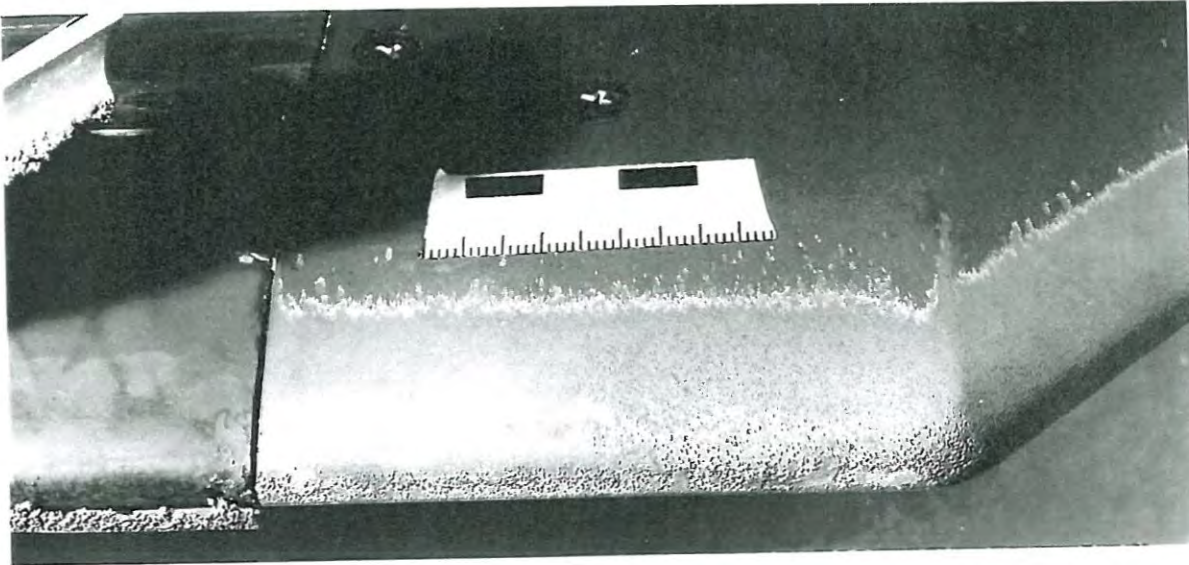
Detail registration photo showing the surface wear suffered by the leading edge and the adjacent upper surface of the tip cap.

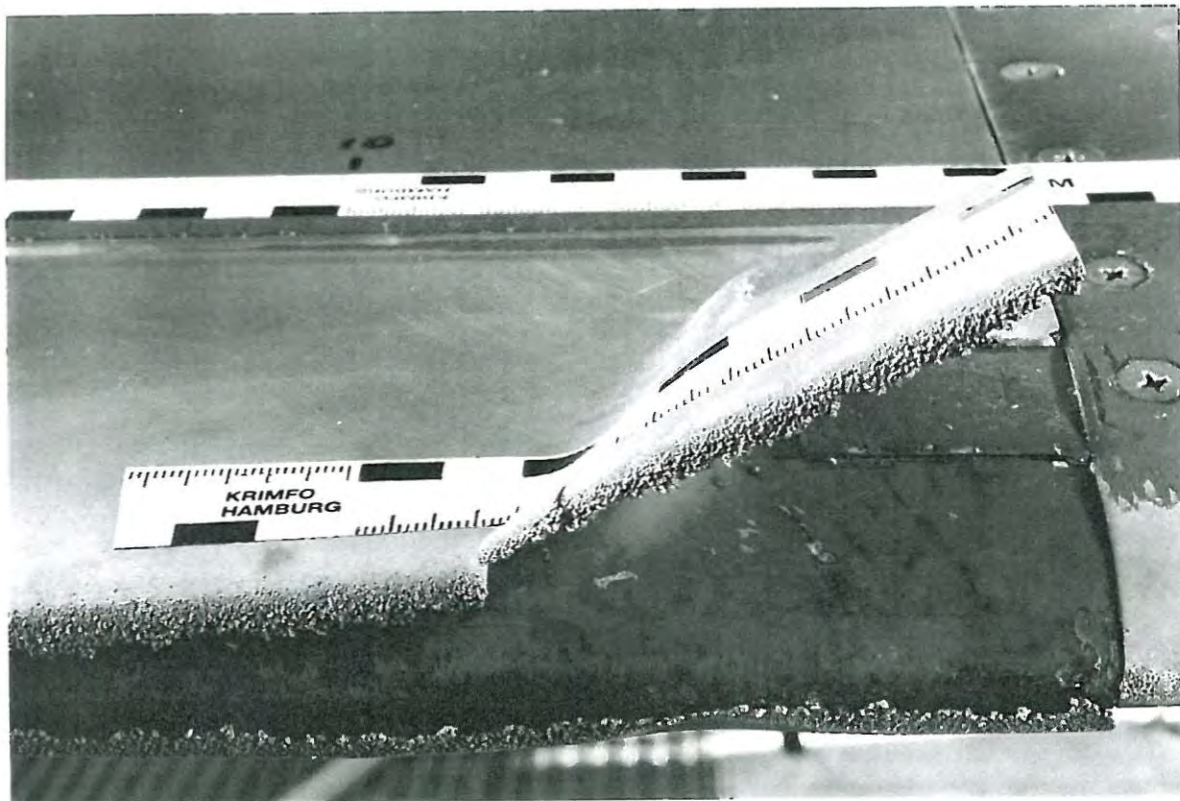
Detail registration photo showing the fracture deformation and surface wear suffered by the leading edge and the adjacent upper surface of the outer 0,12 m of the protective Ti-strip.

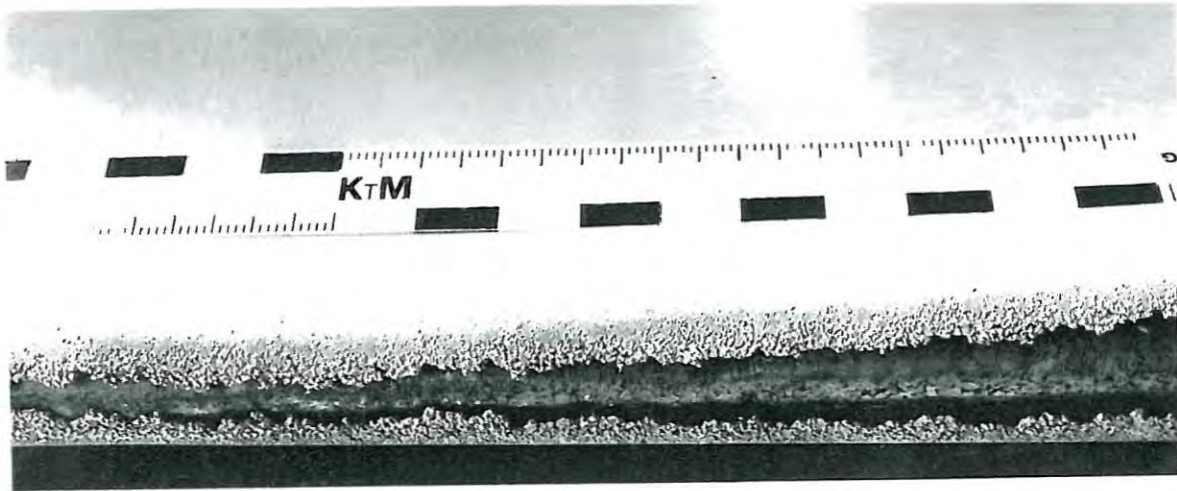
Detail registration photo showing the fracture deformation and surface wear suffered by the leading edge and the adjacent upper surface of the protective Ti-strip, 0,10 - 0,24 m away from the “zero line”.

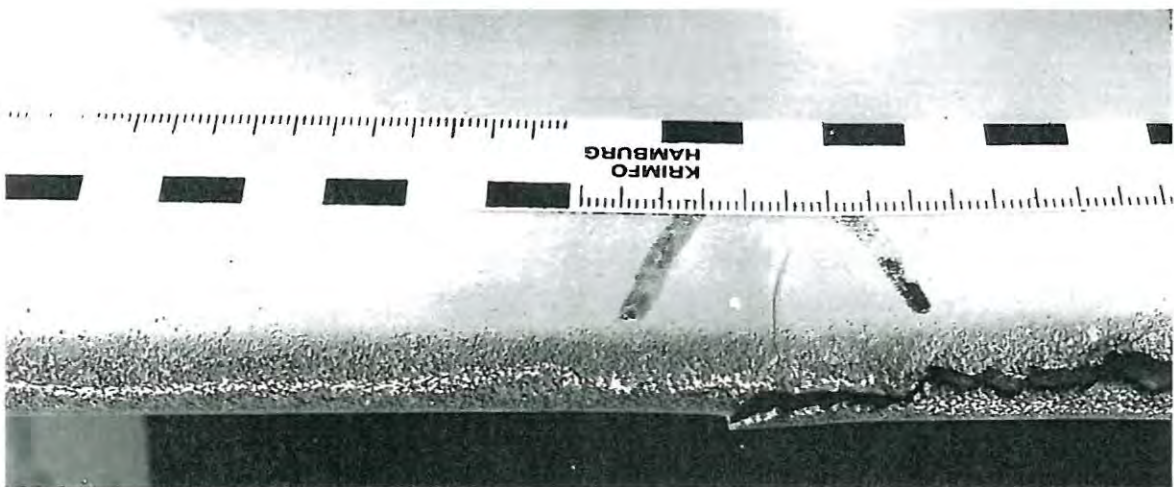
Detail registration photo showing the fracture deformation and surface wear suffered by the leading edge and the adjacent upper surface of the protective Ti-strip, 0,23 - 0,38 m away from the “zero line”.

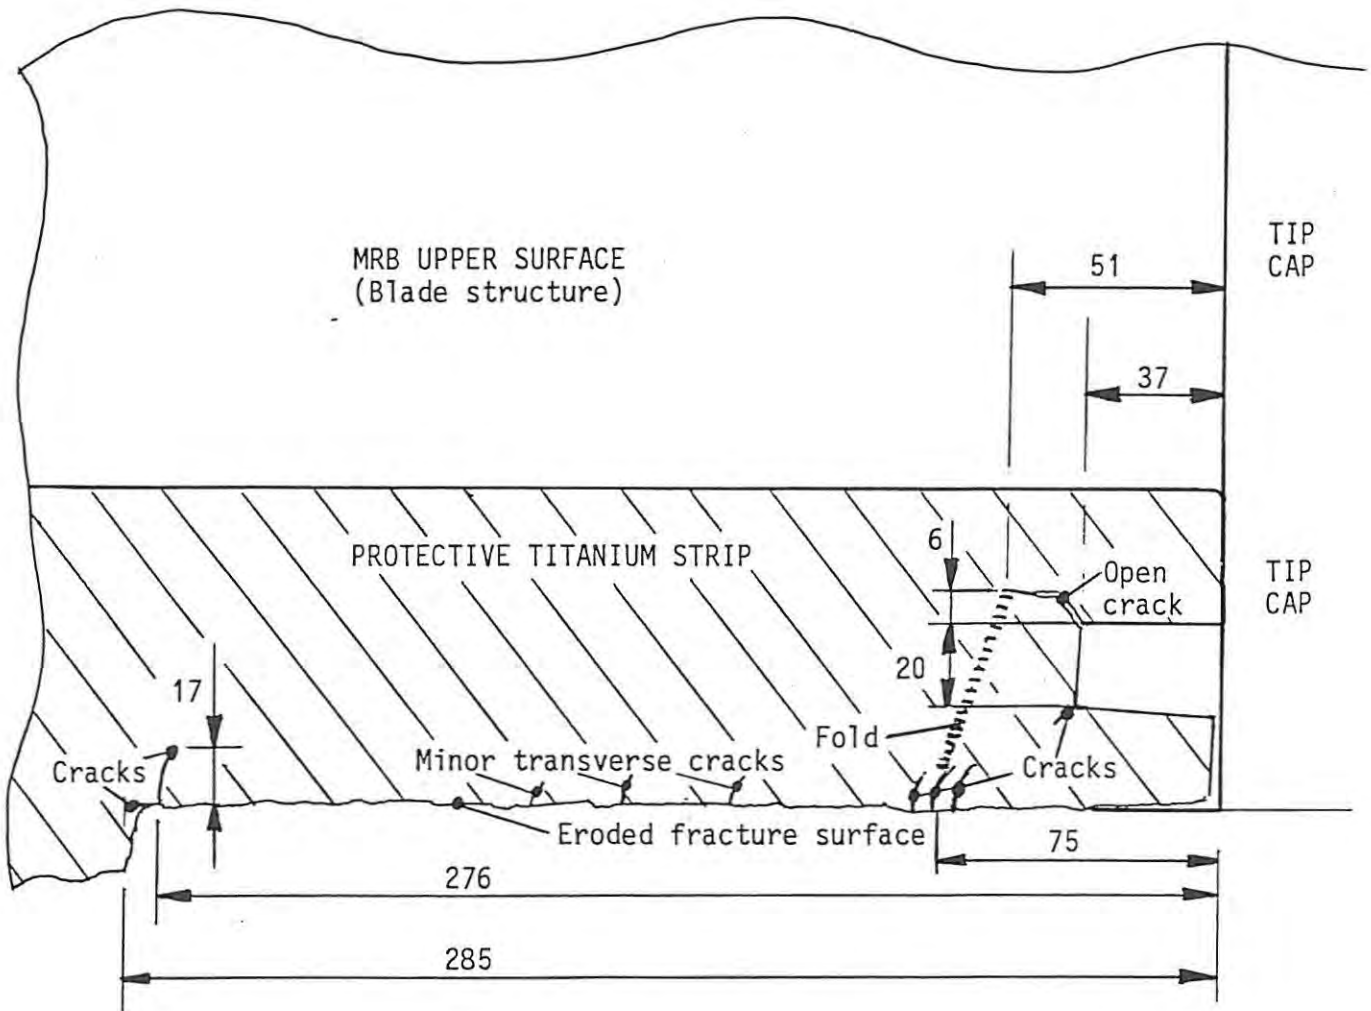
Sketch illustrating the pattern of folds, cracks and fractures seen at the outer end of the protective Ti-strip of the MRB S/N 617. All dimensions given in millimetres (mm).

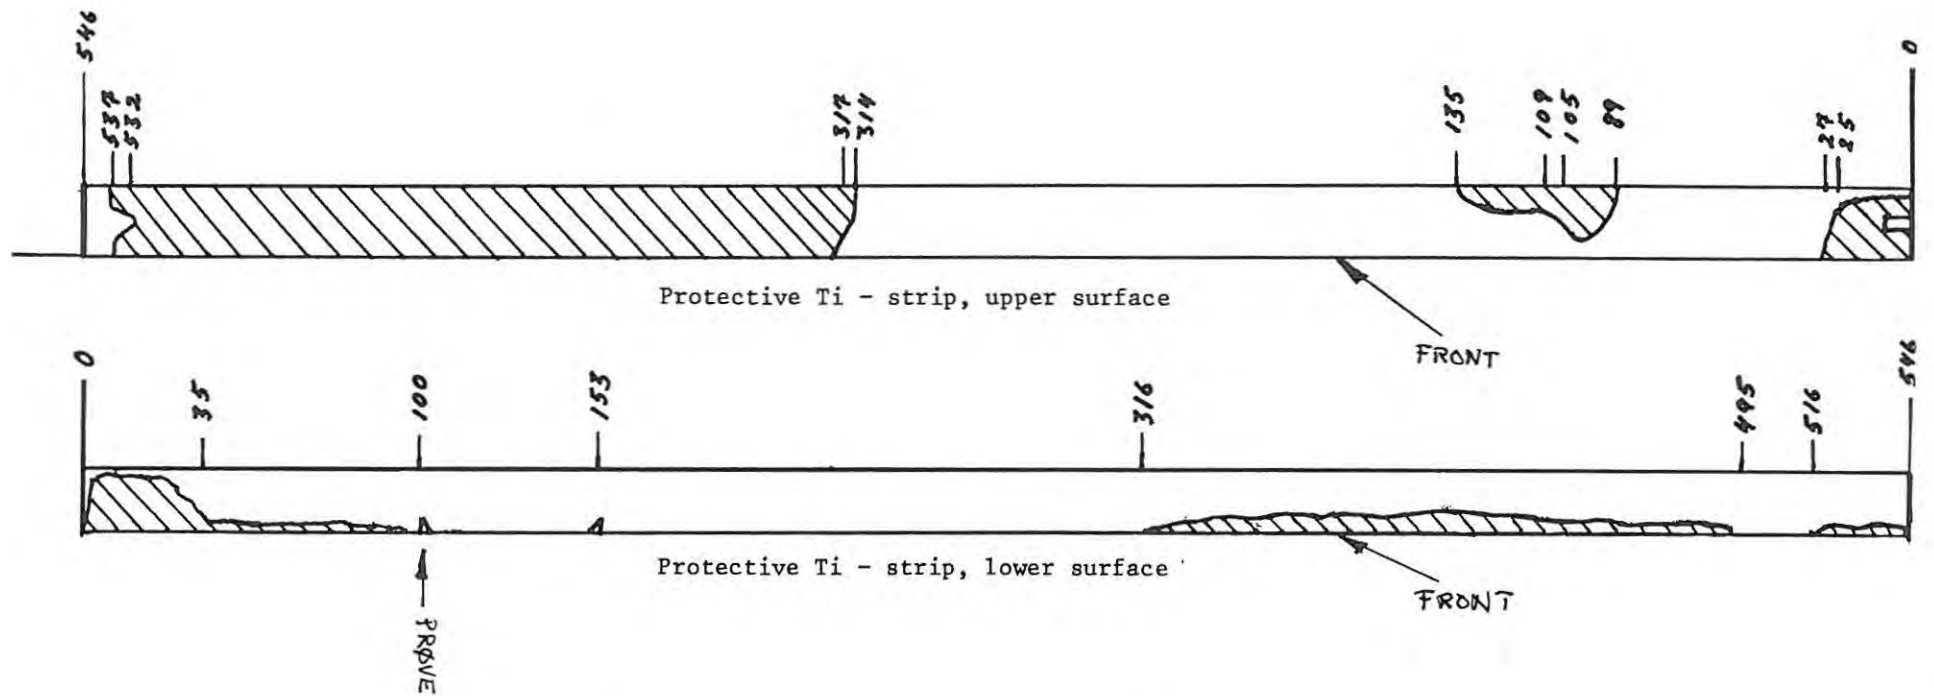
Sketch showing the pattern of bonding, based on the acoustic tapping method. The shaded areas represent areas where lack of bonding was indicated. All locations given in centimetres (cm) away from the "zero line".

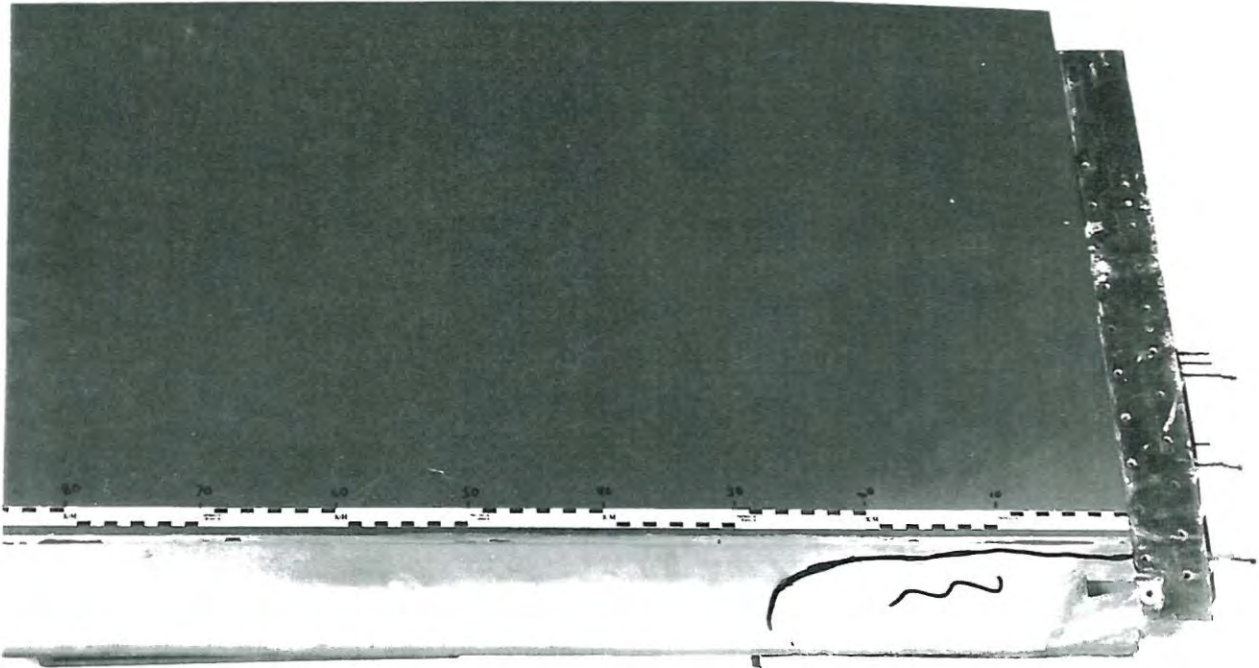
General view of the upper surface of the outer section of the failed MRB, illustrating the borderline of bonding for the protective Ti-strip at the outer end. The borderline determination is based on acoustic tapping.

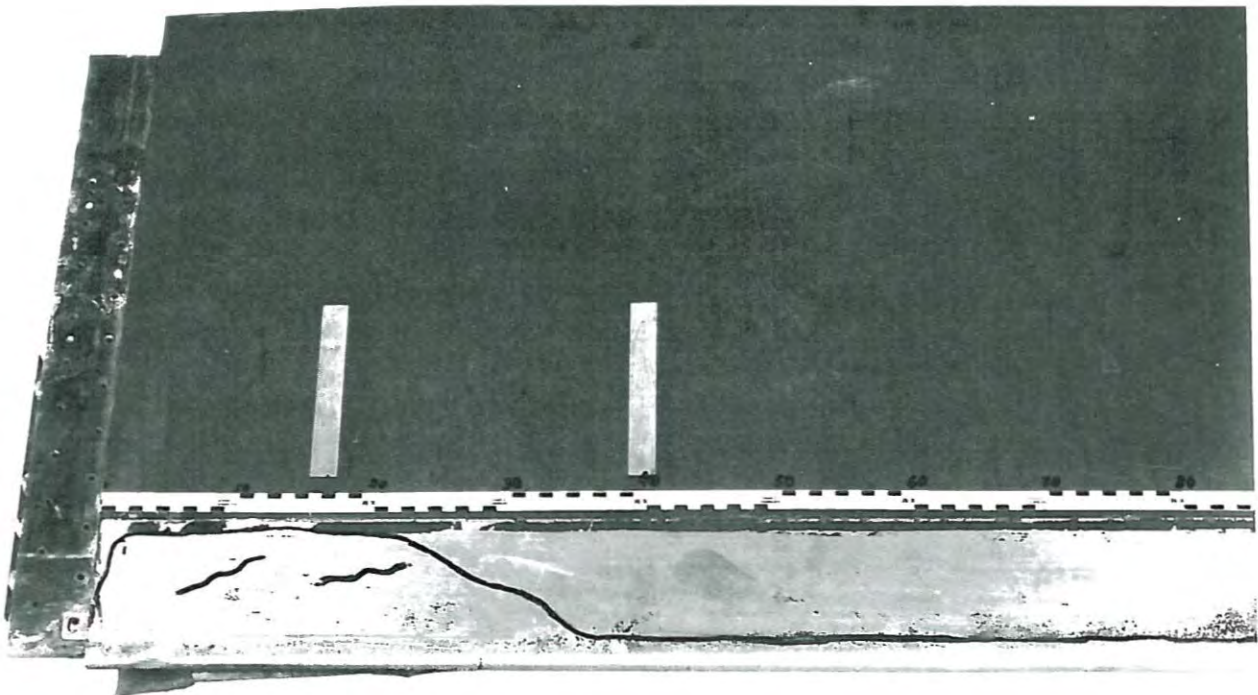
General view of the lower surface of the outer section of the failed MRB, illustrating the borderline of the bonding for the protective Ti-strip at the outer end. The borderline determination is based in acoustic tapping.

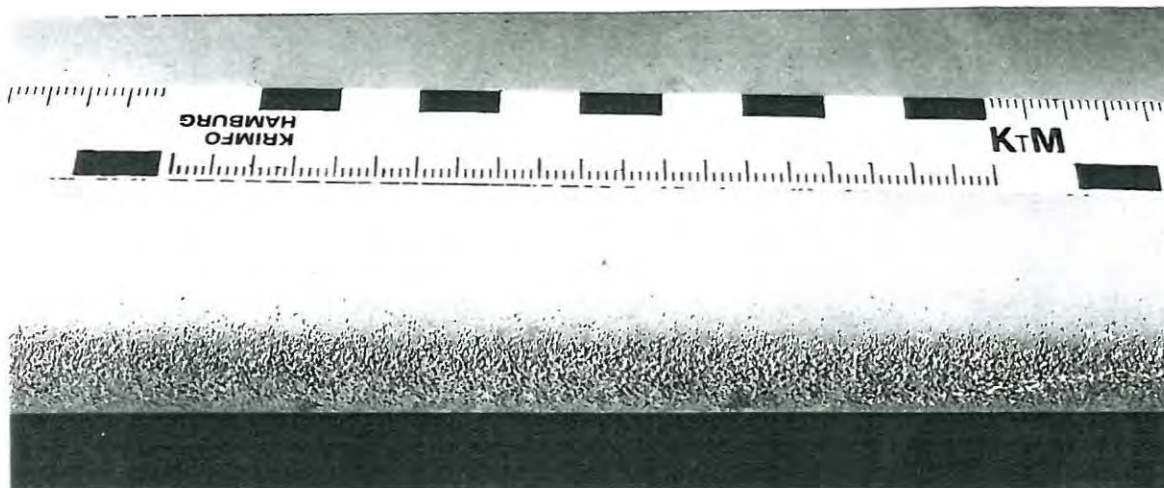
Detail registration photo showing the surface wear suffered by the leading edge and the adjacent upper surface of the protective Ti-strip, 0,38 - 0,52 m away from the “zero line”.

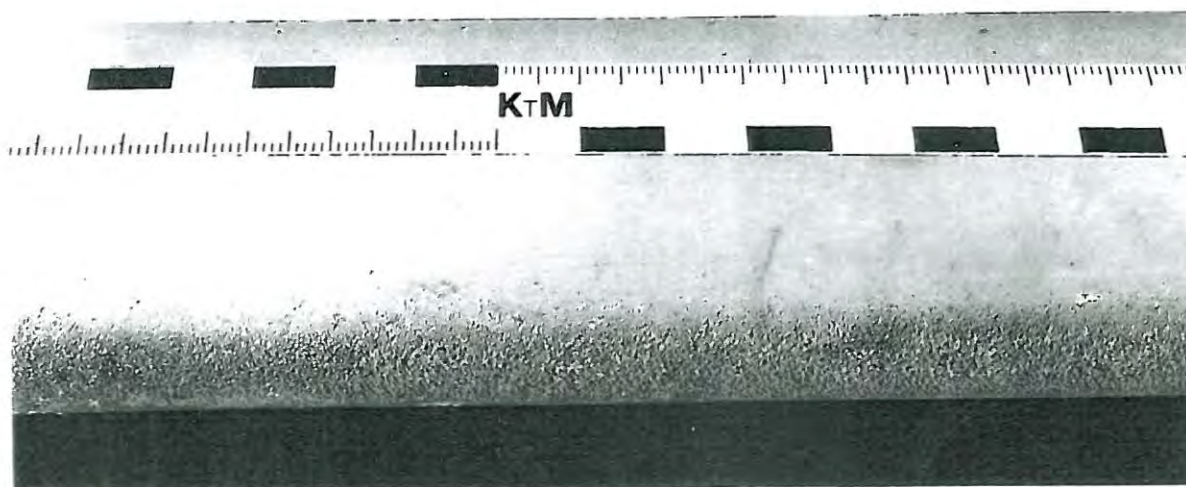
Detail registration photo showing the surface wear suffered by the leading edge and the adjacent upper surface of the protective Ti-strip, 0,53 - 0,66 m away from the “zero line”.

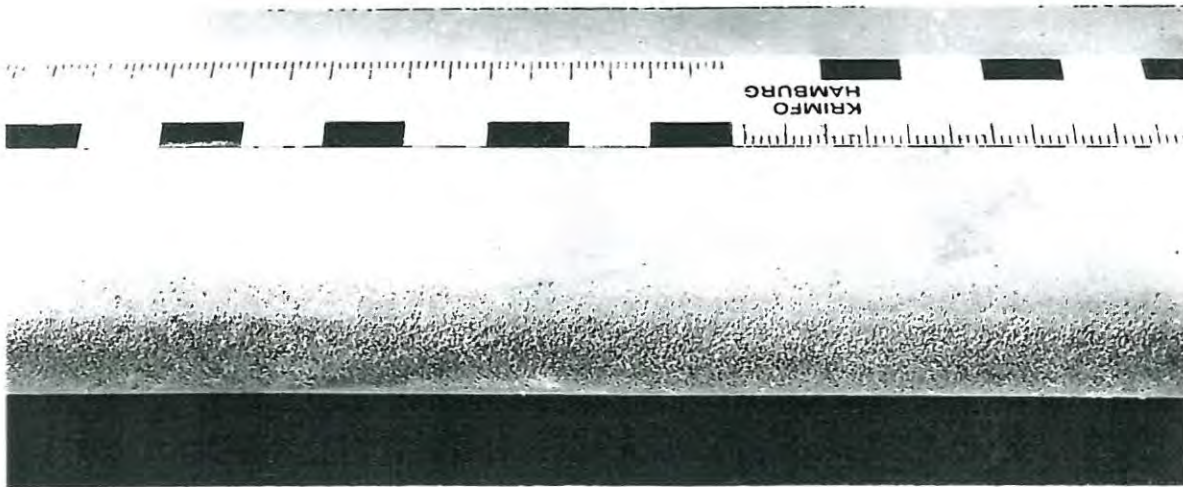
Detail registration photo showing the surface wear suffered by the leading edge and the adjacent upper surface of the protective Ti-strip, 0,66 - 0,79 m away from the "zero line".

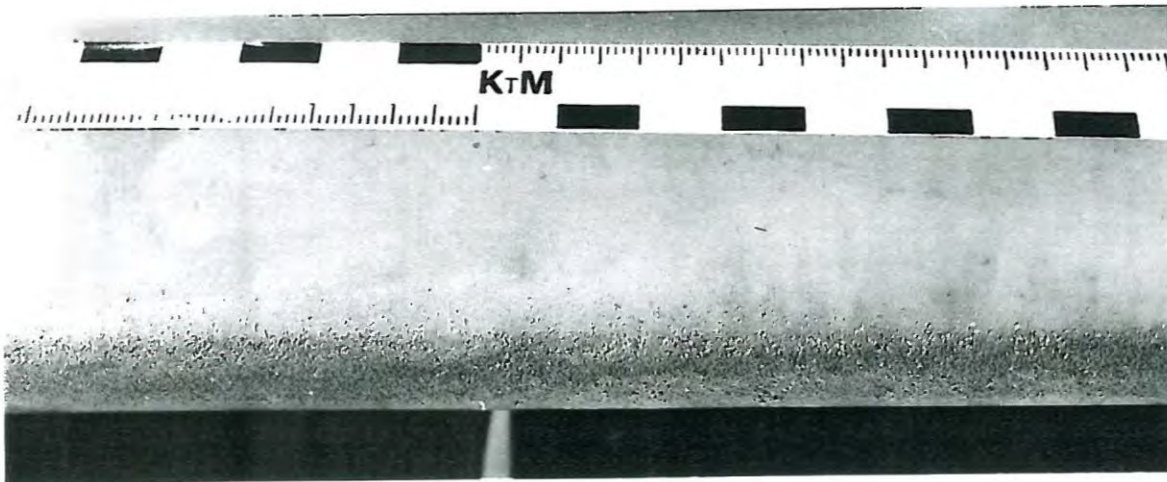
Detail registration photo showing the surface wear suffered by the leading edge and the adjacent upper surface of the protective Ti-strip, 0,92 - 1,05 m away from the "zero line".

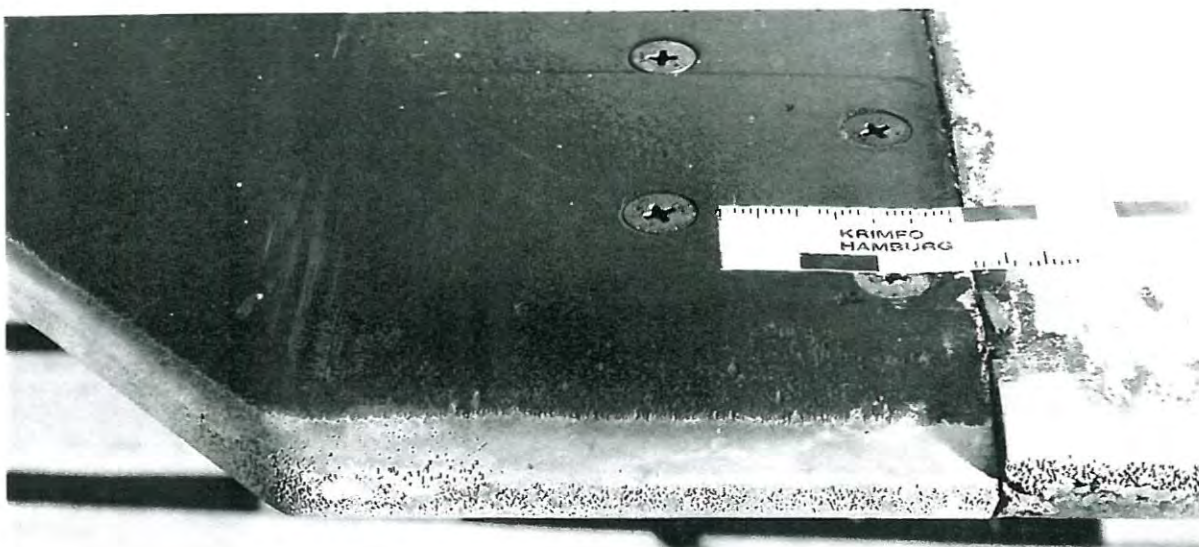
Detail registration photo showing the surface wear suffered by the leading edge and the adjacent lower surface of the tip cap.

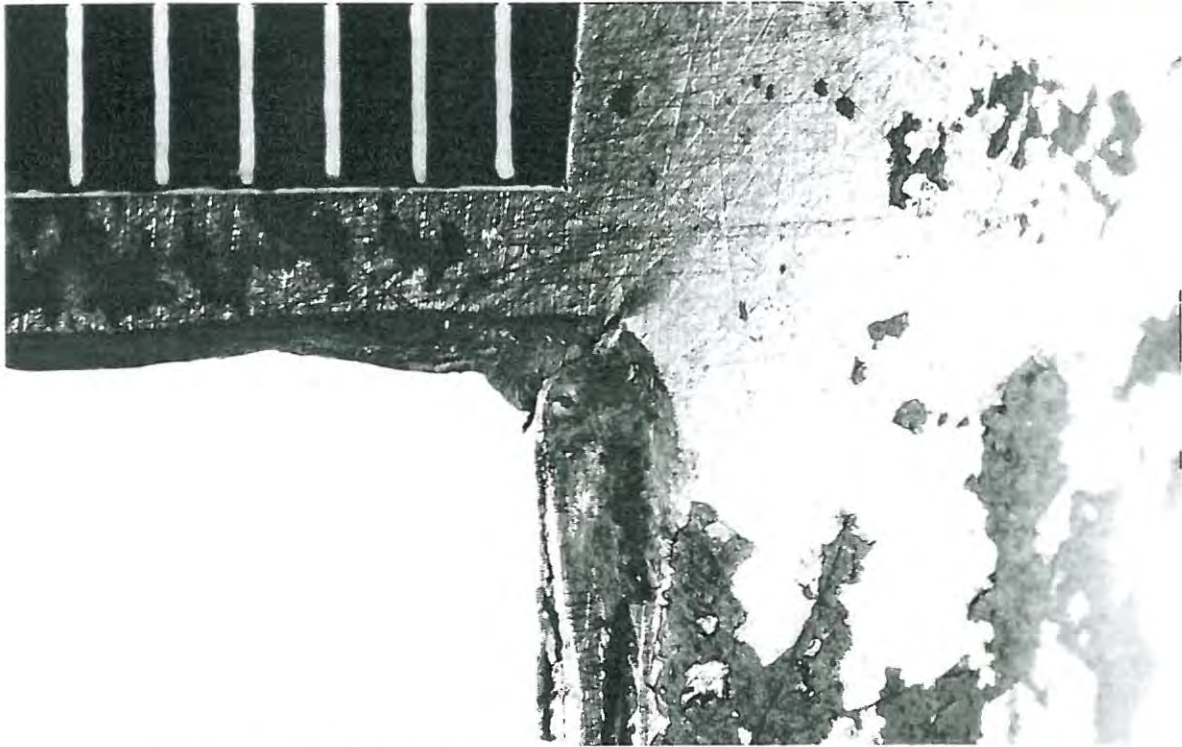
Detail photo from interior corner of modification cut-out. The crack in this corner of the protective Ti-strip is found somewhat open due to material deformation.

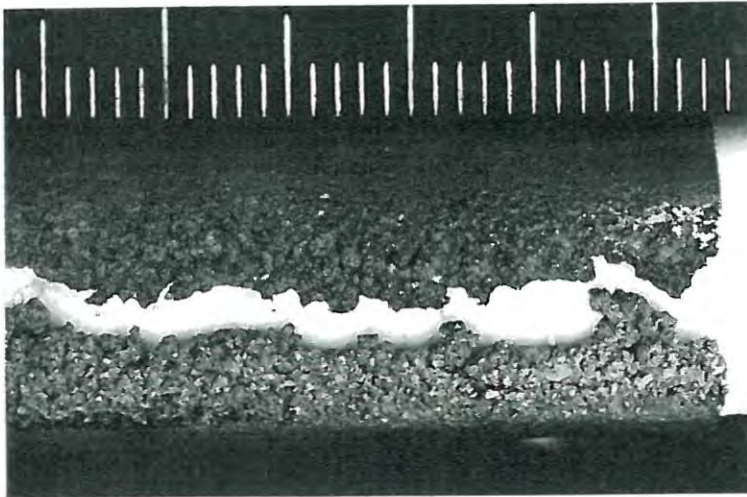
Detail photo showing the fracture profile and the leading edge wear of the outer cut section of the protective Ti-strip. The "zero line" is located at the right hand side of this photo.

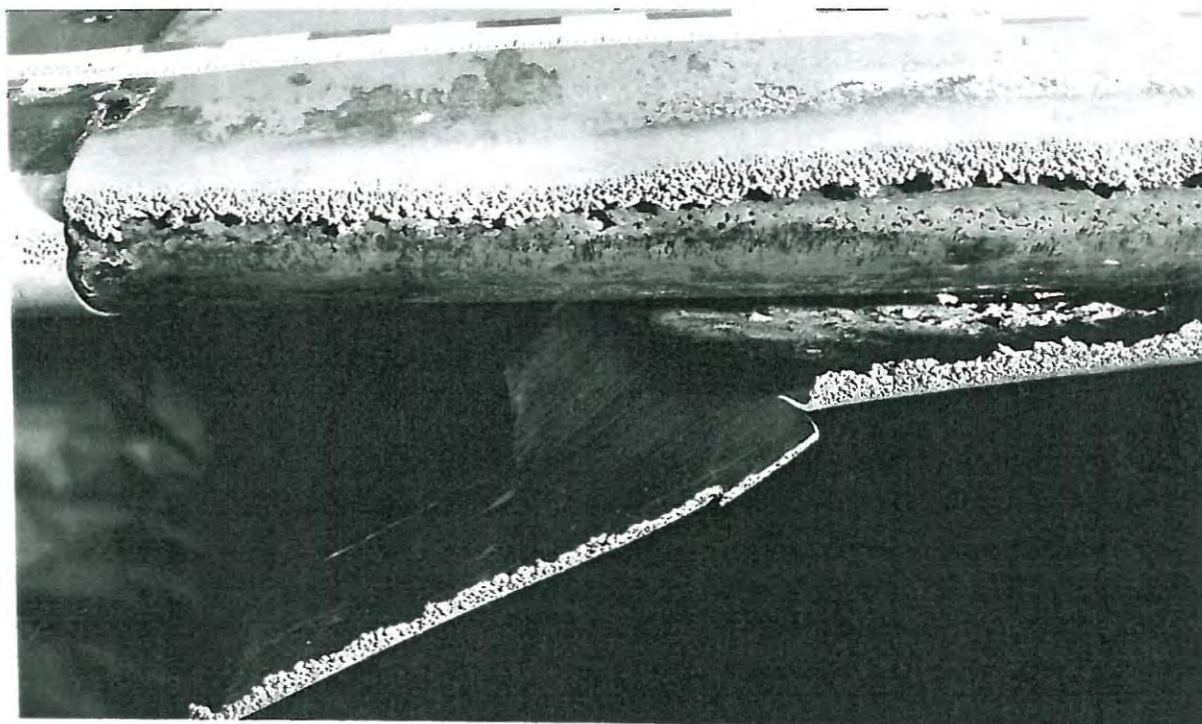
Detail registration photo showing the fracture deformation and surface wear suffered by the leading edge and the adjacent lower surface of the outer 0,12 m of the protective Ti-strip.

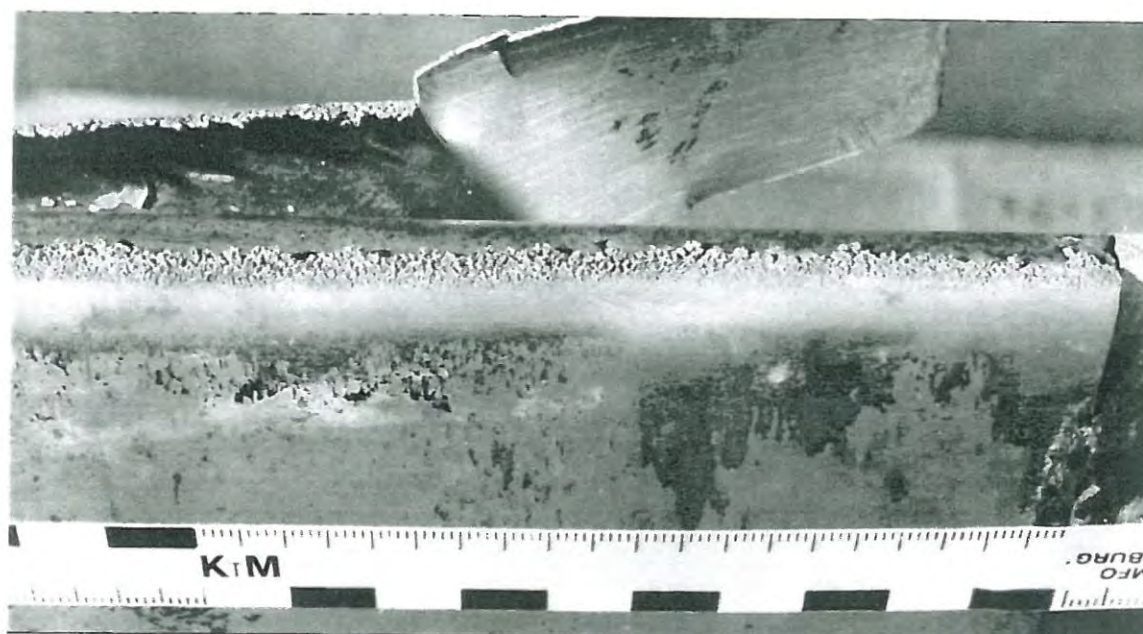
Another detail registration photo illustrating the fracture deformation and surface wear suffered by the leading edge and the adjacent lower surface of the outer 0,12 m of the protective Ti-strip.

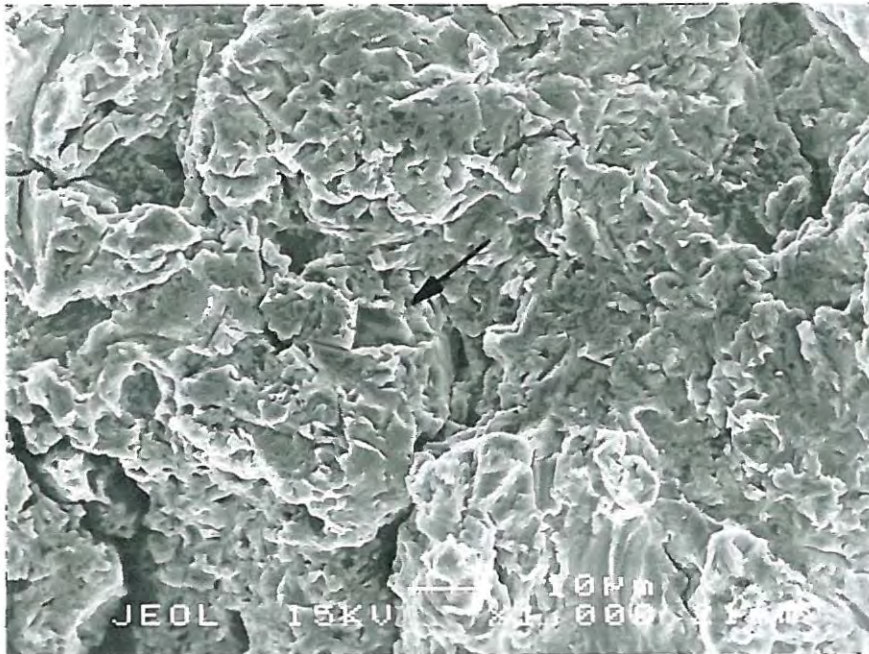
General micropattern appearance of the fracture surface from the section S1. A foreign matter particle is seen embedded in the Ti surface (arrowed). SEM-photo, magnification x 1000.
