THE AIRCRAFT ACCIDENT INVESTIGATION BOARD/NORWAY
(AAIB/N)

REP.: 02/98

AIR ACCIDENT INVOLVING EUROCOPTER SUPER PUMA 332L,
LN-OBP, IN THE NORTH SEA ON 18 JANUARY 1996, APPROX. 40
NM SOUTH-WEST OF SOLA, NORWAY

SUBMITTED MARCH 1998

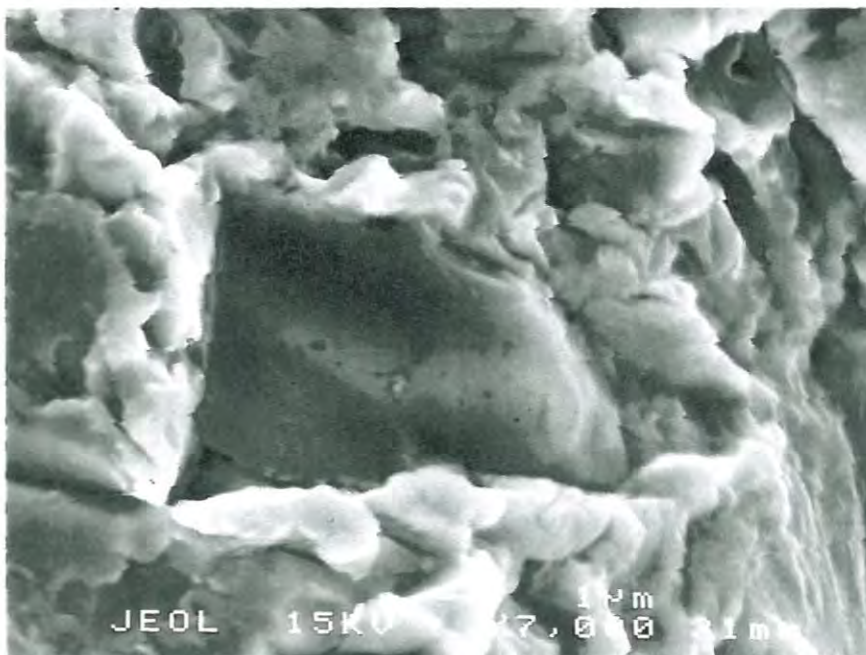
SEM close-up photo of the particle arrowed in Fig. 33A. By the EDS analysis carried out, the particle in question was found to be a sand particle. Magnification x 7000.

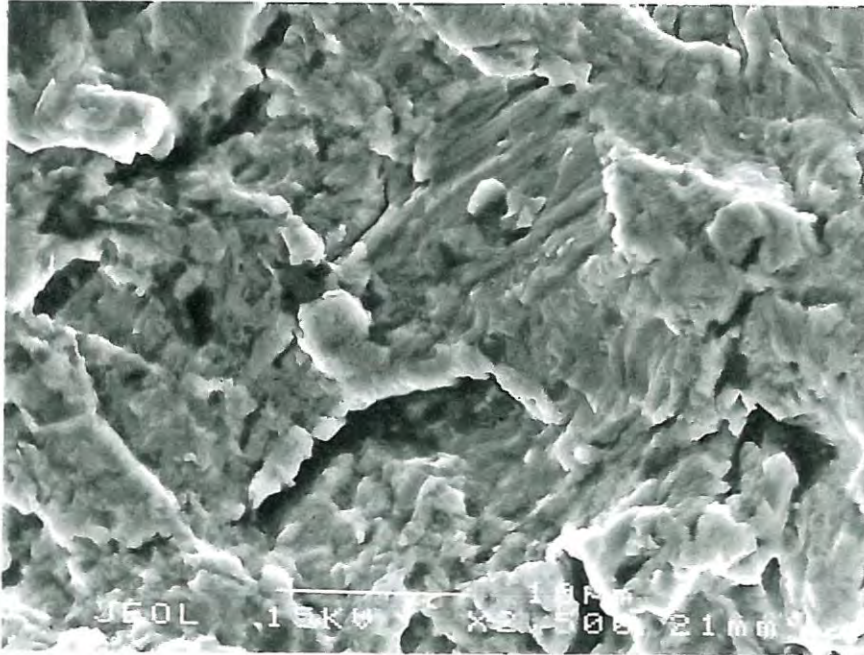
SEM-photo of a fracture micropattern from section S1, showing fatigue striations.

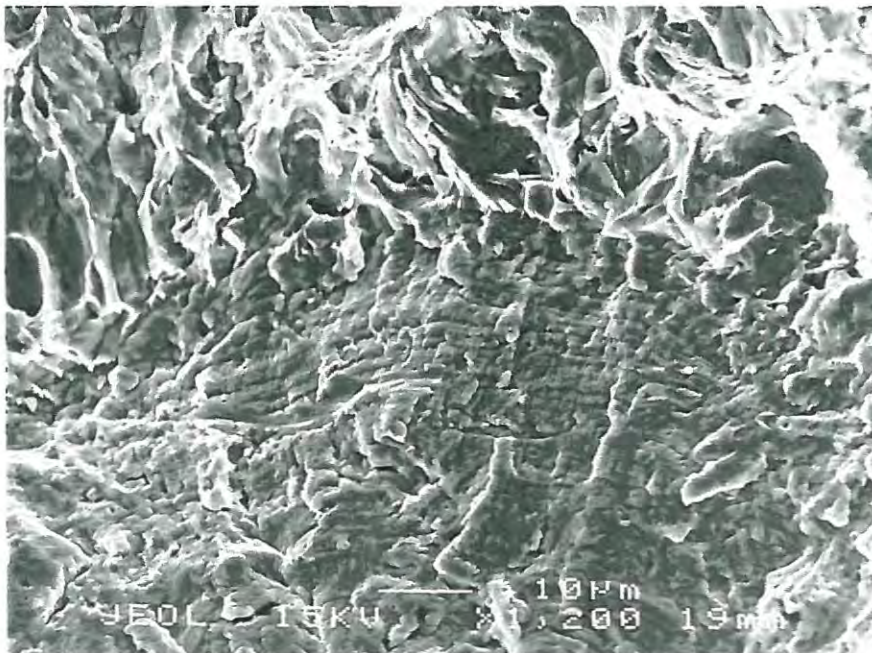
SEM-photo illustrating the transition zone between the fatigue and the final rupture (top of photo) towards the inner surface.

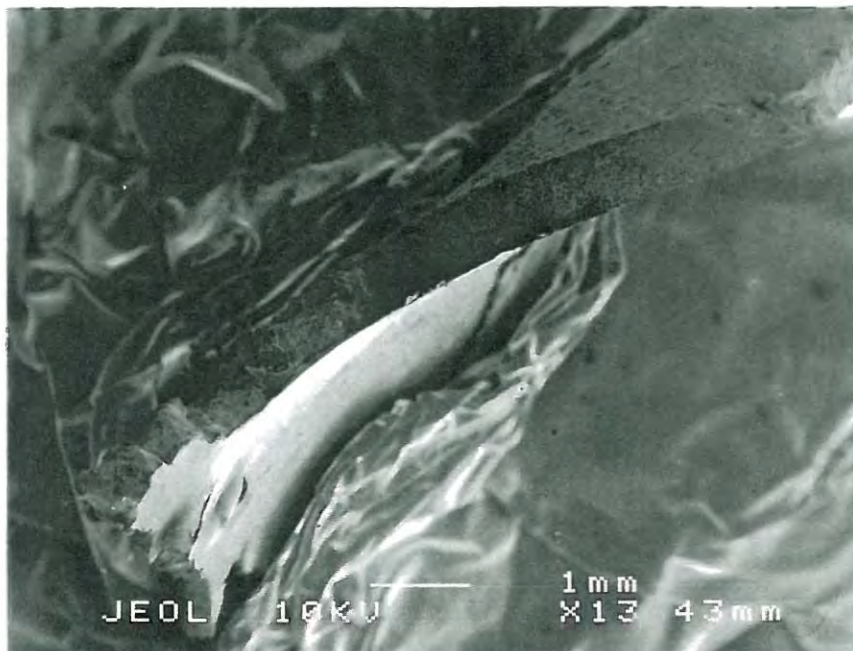
A transverse crack surface in the protective Ti-strip. The longitudinal fracture through the eroded zone is seen down to the left. Section S3. SEM-photo, magnification x 13.

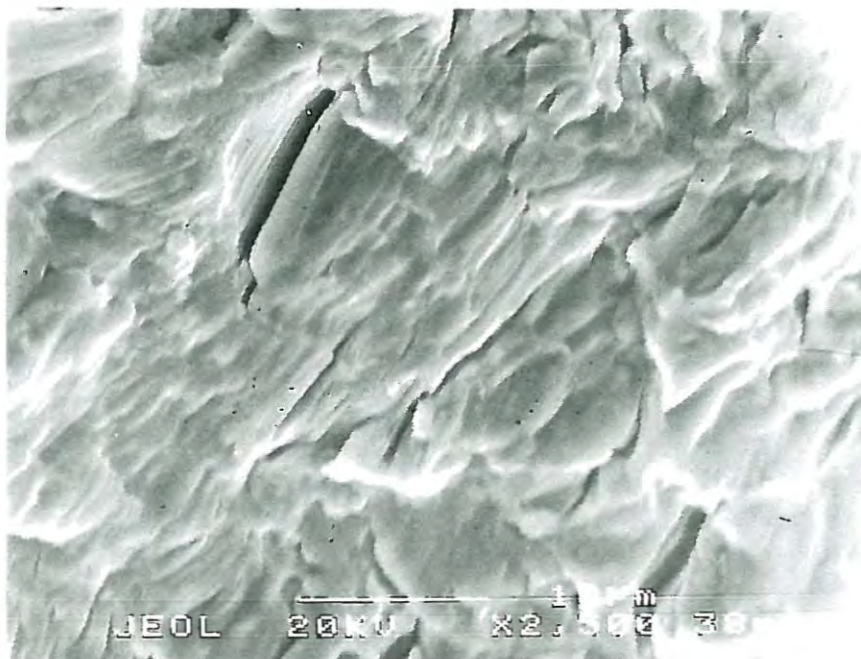
SEM detail photo representing the micropattern close to the crack toe.
A fatigue mode of cracking is seen.
Magnification x 2500.

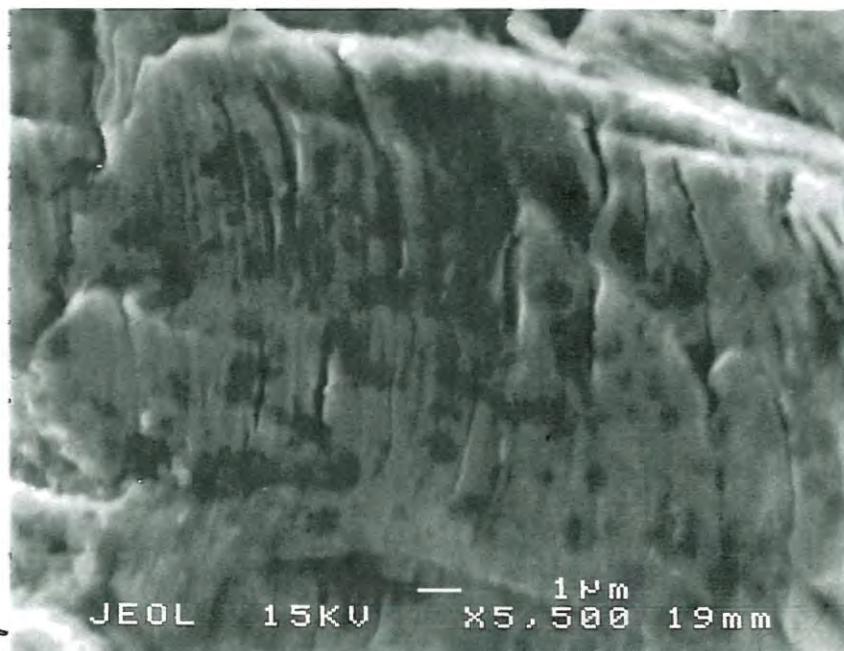
SEM detail photo representing a local area close to the toe of the transverse crack surface shown in Fig. 37A. Fatigue striations are stated. Magnification x 5500.

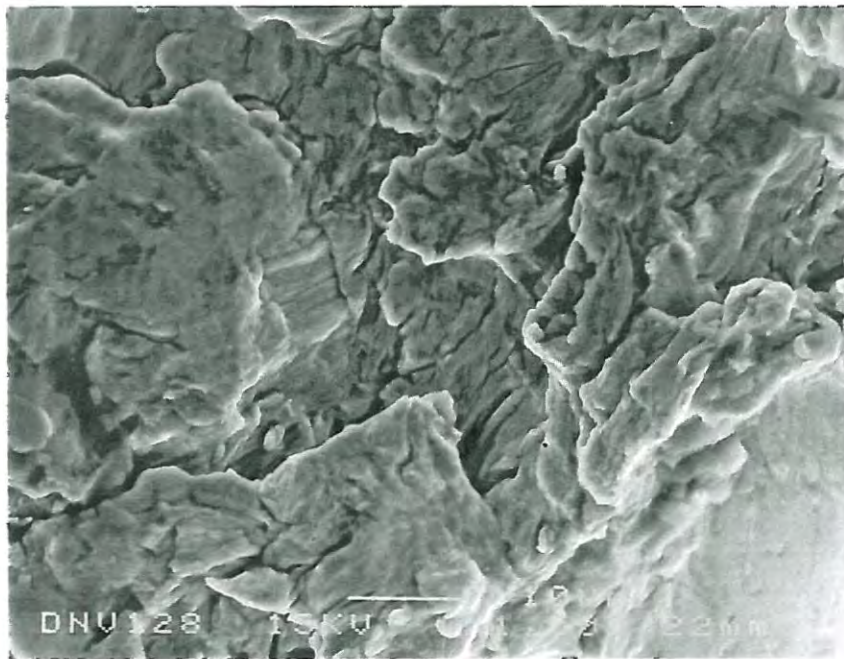
Fracture micropattern at the toe (inner end) of the crack from the modification corner.
SEM-photo, magnification x 1500.

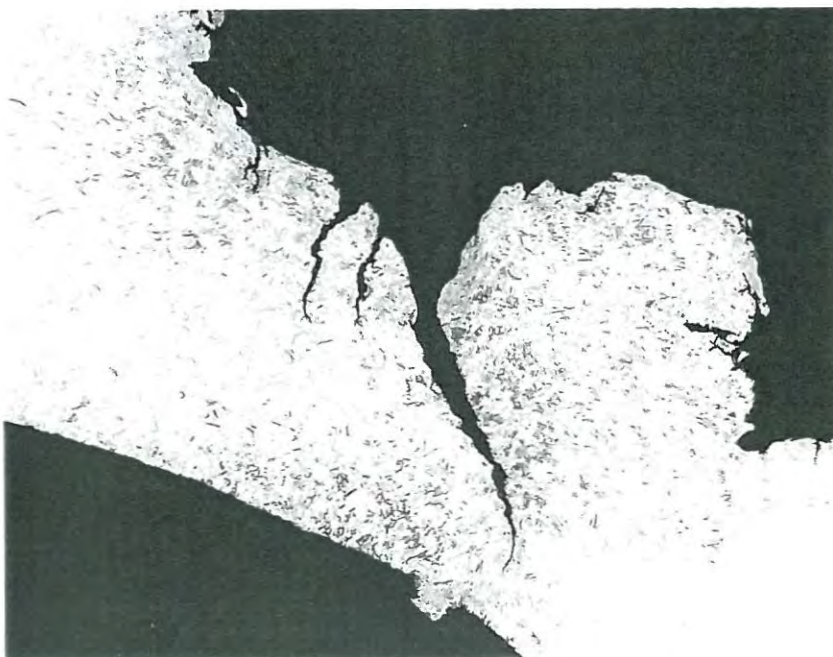
Close-up photo of a cracked and severely eroded area shown in Fig. 41A.
Magnification x 100.

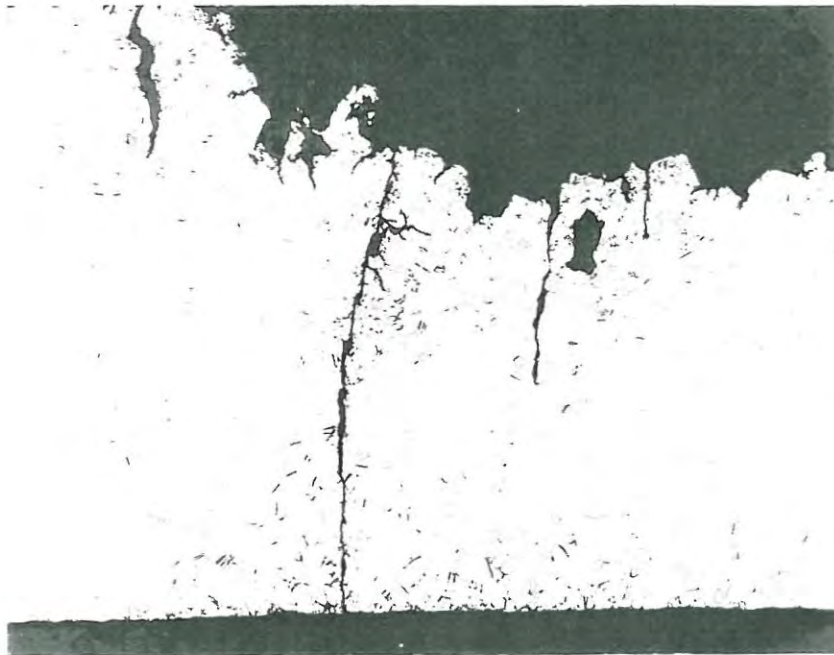
Micrograph illustrating the situation of erosion and cracking within a local transverse section of the protective Ti-strip, leading edge position. Magnification x 160.

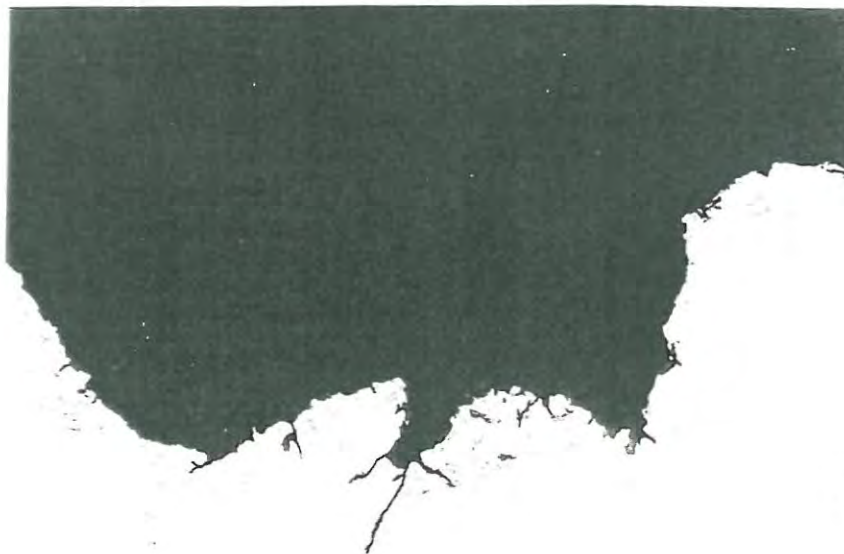
Micrograph illustrating a branched, local cracking, initiated from the complex geometry of the bottom surface of the eroded pits. Magnification x 200.
