SERIOUS INCIDENT TO APEX AIRCRAFT CAP 10B, LN-KAP, AT KJELLER AIRFIELD 8 JANUARY 2010 - PRELIMINARY REPORT

Date: 27 Jan 2010
Reference: SL2010/01P
10/23 - 09

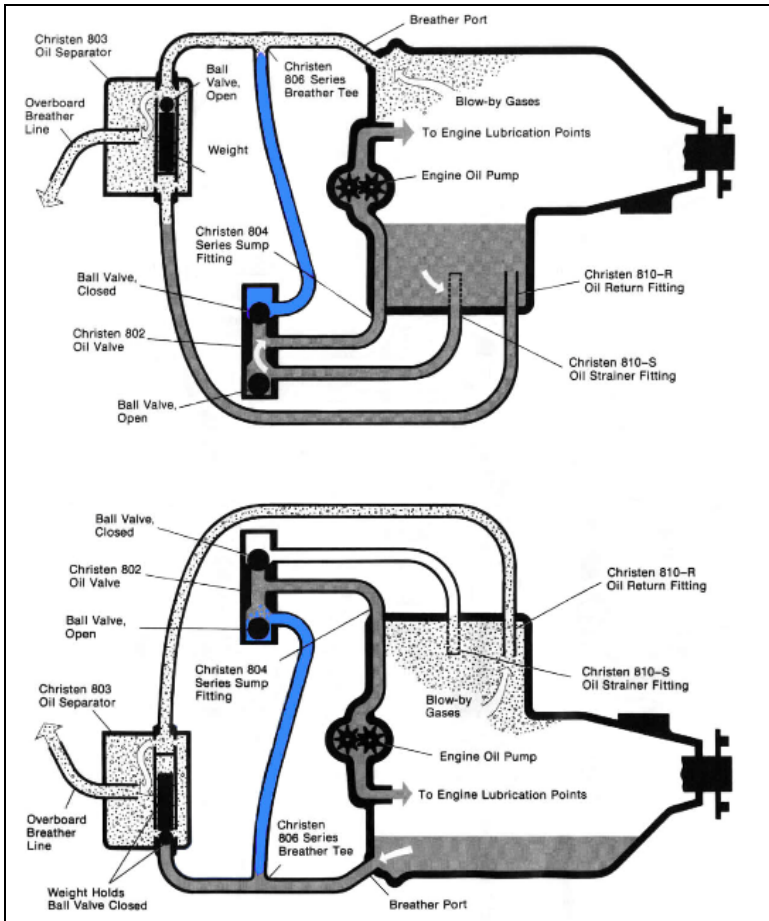
The investigation was initiated in the unheated hangar and it was found that the hose from the T-fitting down to the Christen 802 valve was totally filled with solid ice (indicated blue on the figure below). Furthermore, it was found that the balls in the Christen 802 valve were blocked by ice.

Figure 1: Christen 801 inverted oil system schematic. Blue colour indicates ice/water. (Engine inverted on lower figure)

It is likely that the following caused the loss of oil pressure. The mentioned 4-point roll was the first time in nearly two flight hours where manoeuvres involving negative g were flown. During these two hours a lot of humidity from the crank case ventilation probably condensed at the inner walls of the hose leading from the crank case to the oil separator. This drained down from the t-fitting into the “blue hose”, filling it up with water. As no negative g-manoevres had been flown last two flight hours, the water was not flushed out of the hose. It is likely that all components at the fire wall had temperatures below freezing level during the night prior to the flight 8 January. Further it is likely that the area between the engine baffle plates and the fire wall stayed below freezing temperature during the entire flight. Engine oil at about 60 °C is likely to have been the only heat source in that area. This would heat the lower portion of the Christen 802 valve and the two associated hoses. When the airplane became inverted it is likely that ice and probably water from the “blue hose” entered the Christen 802 valve. This blocked the oil from entering the oil pump and the oil pressure dropped. When the airplane completed the roll, the bottom ball (during normal flight) was probably kept on its seat by suction produced by the turning oil pump. It is also a possibility that the balls were jammed by ice.

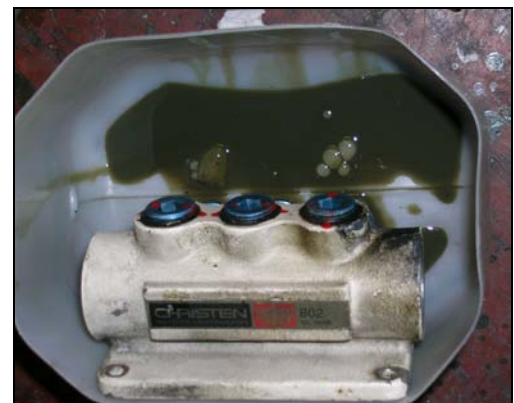
Figure 2: Ice and oil drained from the Christen 802 valve

The valve and the hose was brought inside a warm hangar and heated up slowly. Oil and ice came out of the ports of the valve and the balls became gradually released (see figure 2). Figure 3 and 4 show the amount of ice that was trapped inside the hose.

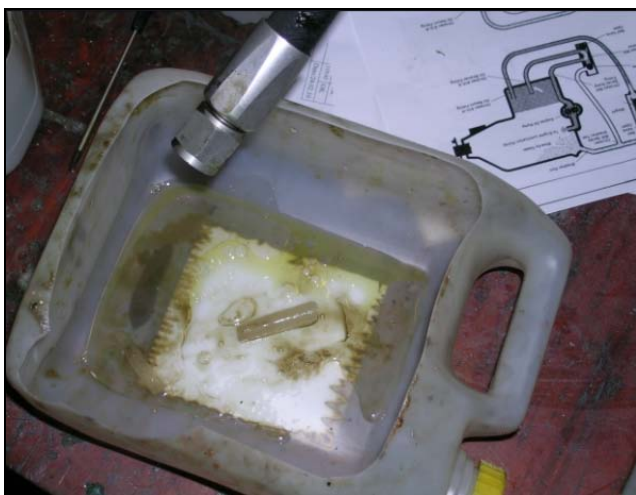
Figure 3: Ice removal from hose

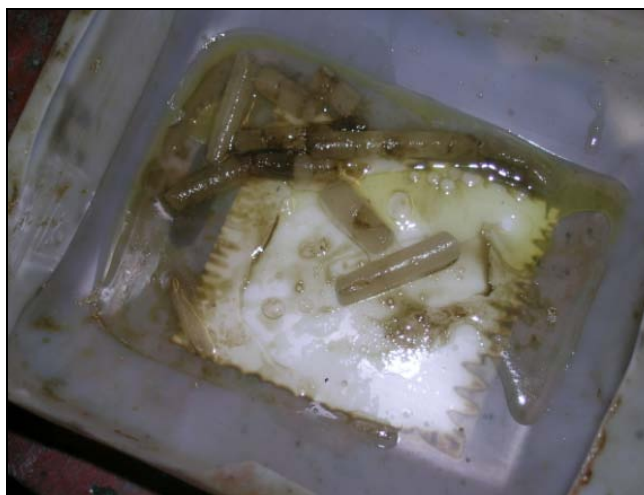
Figure 4: Ice amount from hose
