REPORT

SL 2012/05

REPORT ON SERIOUS INCIDENT DURING
DESCENT TO SØRKJOSEN AIRPORT, NORWAY
ON 21 FEBRUARY 2006 WITH BOMBARDIER
DHC-8-103, LN-WIE OPERATED BY WIDEREØES
FLYVESELSKAP AS

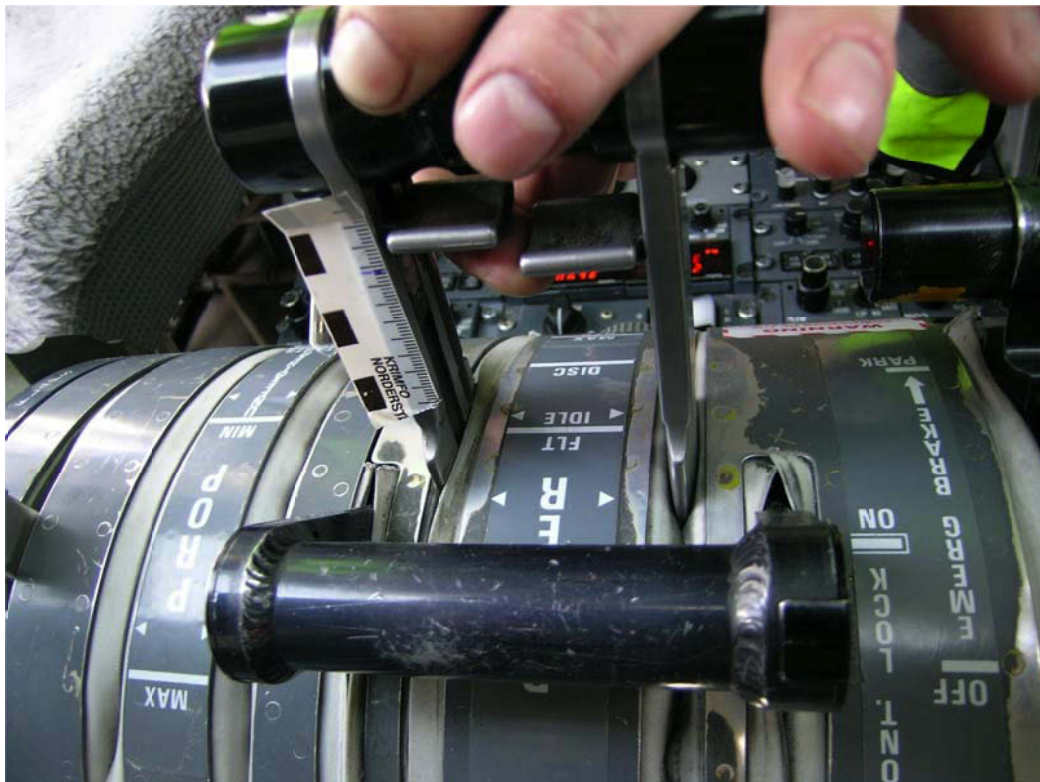
Figure 3: The Power Lever trigger mechanism shown must be lifted by the pilot in order to allow the Power Levers to pass through the FLT IDLE gate while moving aft into the ground Beta-range. The trigger for the right engine (left in picture) has been disengaged. The picture is taken from the instrument panel looking aft. The black lever in front is the flight control lock. The measuring tape is attached by AIBN.

Any movement of the Power Levers behind Flight Idle while the aircraft is airborne has an element of risk. The propeller rotational speed can exceed permitted values and at worst cause mechanical damage. Furthermore, the aerodynamic drag increases severely, which might cause loss of control of the aircraft. To prevent unintended moving of the Power Lever into the Beta-range, each Power Lever has protection and warning mechanisms. To enter the Beta-range, a small release trigger must be lifted about 5 mm to disengage a mechanical stop (se Figure 3).

The Accident Investigation Board Norway recommends that Transport Canada and EASA require the type certificate holder (Bombardier) to introduce measures to prevent propeller overspeed during unintended management of Power Levers.

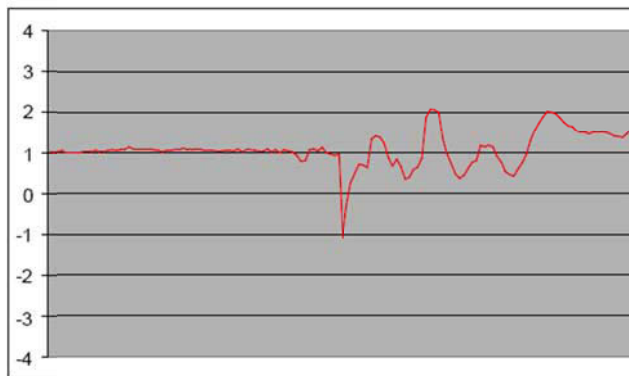
- 34 seconds passed from the engine power was reduced on the left engine until it was up to full effect (98.8 % torque)
- Vertical accelerations were recorded in accordance with the graph below. The lowest value of -1.07 g was recorded in the same second that the torque on the right engine fell from 42.6 % to 6.1 %.

Figure 6: Vertical acceleration forces (g) over a period of 20 seconds.

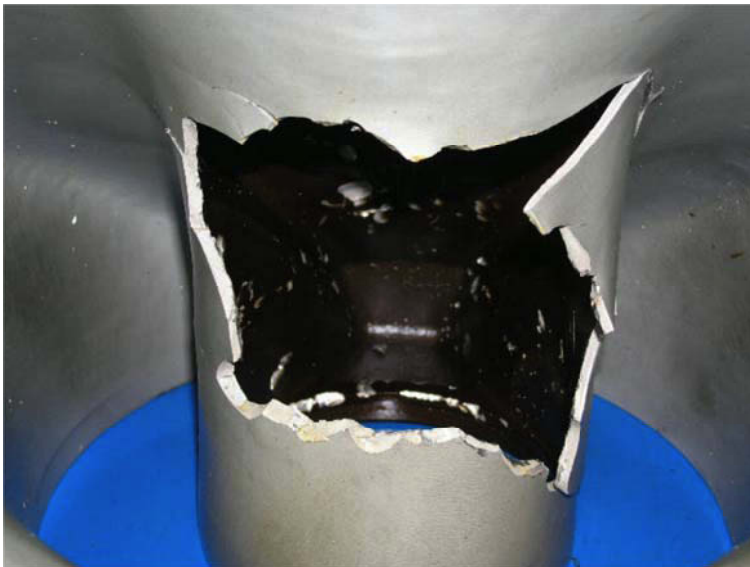
- 1.12.1 Following the landing, it was discovered that the right engine had suffered considerable damage. For example, it was discovered that the shaft between the engine and the gear box had thrown fragments through the shaft housing and into the air intake.

Figure 7: Damage to the air intake on the right engine which arose when the shaft between the engine and gear box separated.

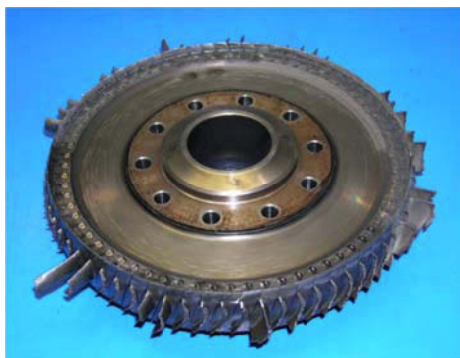
1.16.1.2 With the exception of the damage to the engine's air inlet, the engine was externally intact. However, the internal damage was extensive. Of the more serious damage, we mention:

- The engine-to-gearbox shaft had separated
- Significant damage to the compressor due to metal fragments passing through it
- The low pressure turbine shaft had separated and partially melted (see Figure 9)
- The high pressure turbine shaft had separated and partially melted
- Major damage to the vane rings for the power turbine's second stage (see Figure 8)
- Most of the turbine blades on the power turbine's second stage had been completely destroyed
- Considerable damage in several places due to contact between rotating and stationary parts

Figure 8: Damage to the power turbine's second stage.

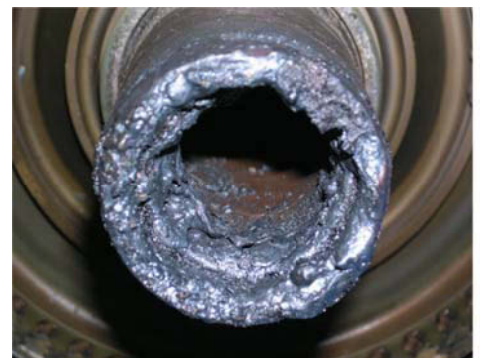
Figure 9: The low pressure turbine shaft had separated and partially melted.

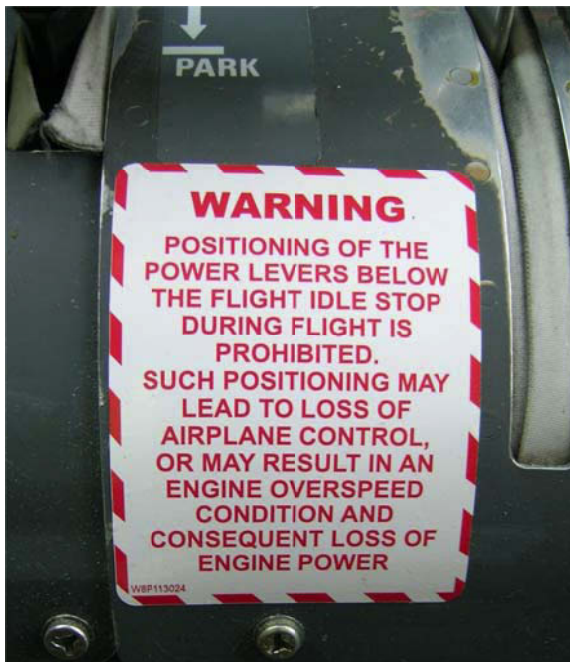
Figure 10: Warning sign installed near the Power Lever.

As it became clear to Widerøe what had happened, the company installed warning signs near the Power Levers of all aircraft of the types DHC-8-103 and DHC-8-311 in May/June 2006 (see Figure 10).

1.18.3.1 The installation was based on Bombardier Service Bulletin 8-11-103.

- 1.18.3.2 The warning sign was considered a temporary solution, and Widerøe attempted to find a solution that entailed a type of mechanical barrier. On the basis of Bombardier Service Bulletin 8-76-28, Widerøe prepared a technical work order (8TO76-109) for installation of a modified protection function on the Power Lever. The modification necessitates pulling the Power Lever all the way back to Flight Idle before the blocking devices can be passed. The first aircraft had this modification installed in February 2010 and the plan calls for all aircraft to be modified by 2012.
