# REPORT

SL 2012/13

REPORT ON AIR ACCIDENT AT DALAMOT IN  
ULLENSVANG, HORDALAND COUNTY, NORWAY  
ON 4 JULY 2011 WITH EUROCOPTER AS 350 B3,  
LN-OXC, OPERATED BY AIRLIFT AS

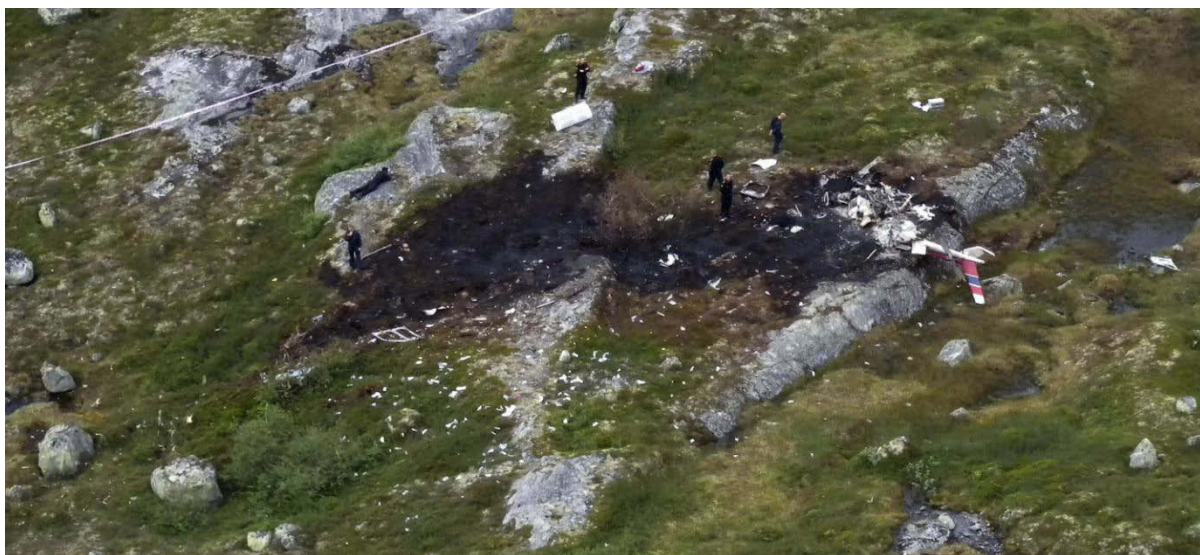
*Figure 5: The accident site seen from the east. The helicopter moved from the left to the right in the picture and hit the ground to the far left of the burned area. Cf. also site mapping in Appendix B.*

- 1.12.2 The distance from the south end of the crash site, where there was a visible hollow where the helicopter fuselage first hit the ground, to where the main wreckage came to rest, was about 25 metres. The compass heading for the first part of the trail was 005°. Vegetation in an area up to 15 metres wide that ran from the point of impact to the helicopter had burned. Wreckage was also scattered outside of the burned area, cf. Appendix B.

- 1.12.8 There were clear ground impact marks from the main rotor blades about 4 metres to the right of the right skid. At least 7 tracks were counted, each 1-2 metres long. This row of tracks was 17 metres in total and started about 6 metres ahead of where the rear end of the right skid was stuck in the ground. The distance between the first and second rotor impact was about 2.9 metres, and the distance between the second and third impact was measured to about 2.8 metres.
- 1.12.9 Tracks in the terrain and damage to the helicopter wreckage indicate that the bank angle on impact was about 45 degrees to the right.

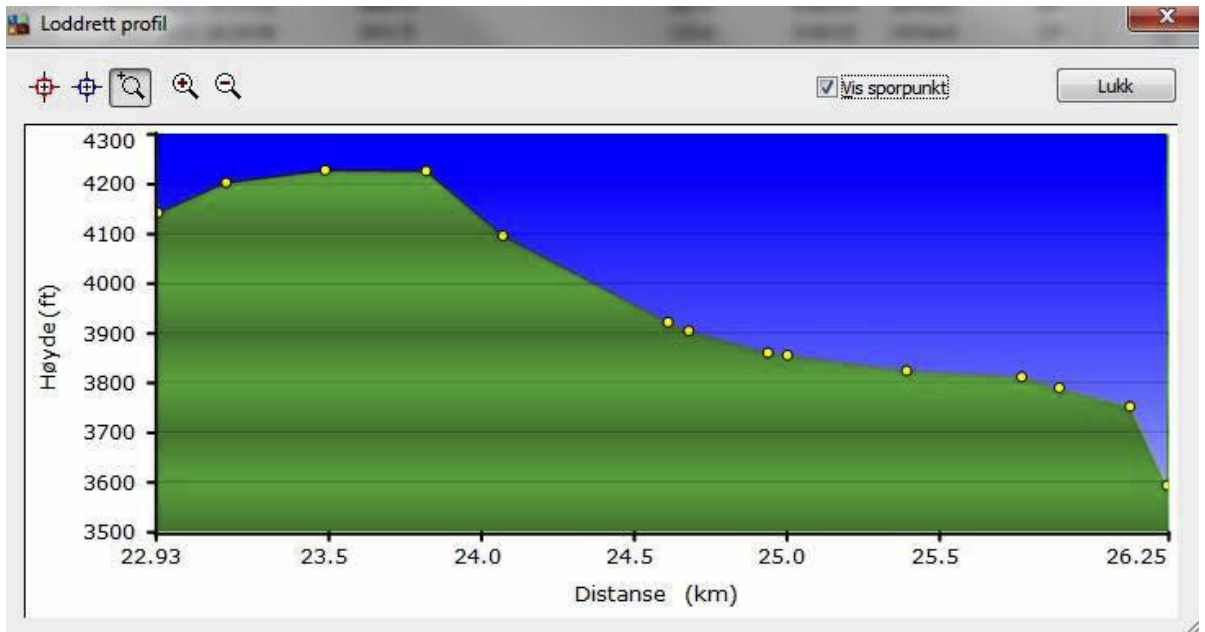
Figure 7: Vertical profile recorded in the GPS receiver on board LN-OXC (Garmin Base Camp). Note that the position of the final point is very near the crash site, but 470 ft. above ground level.

- 1.16.1.3 The track log was sent to both Garmin Norway and BEA for analysis. Garmin reacted to the unusually large error in the last altitude recording, 471 ft (143 metres) in total, but could not provide any good explanation of why, or help establish why the error may have arisen.
- 1.16.1.4 The BEA experts believe that the last point was probably predicted, and that it should be completely disregarded when making calculations. They evaluated the accuracy of the rest of

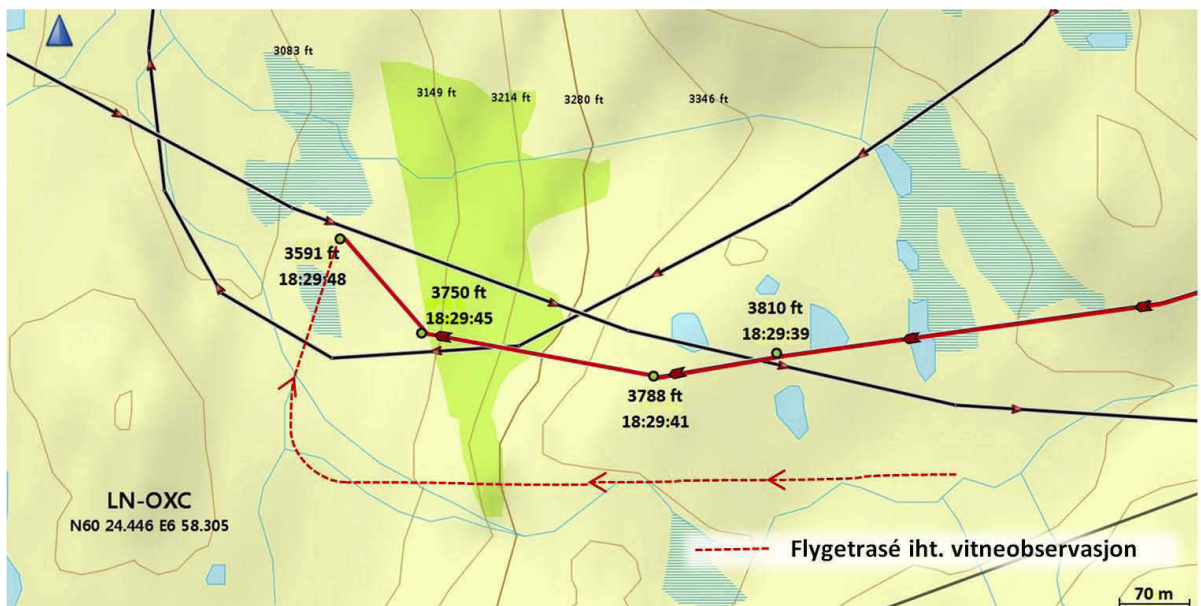
- 1.16.1.5 Based on the GPS, the average speed between the last two points which BEA considered reliable was 113 kt, while it was 121 kt in the preceding seconds. Average ground speed over the last 36 seconds was about 125 kt, reducing somewhat just before the impact.
- 1.16.1.6 The obvious altitude deviation caused uncertainty with regard to the quality of the final registrations. Eye witnesses are insistent that the helicopter flew further south than indicated by the final GPS points prior to the impact, cf. Figure 8.

Figure 8: Part of the track log of LN-OXC superimposed on a topographical map. The accident flight is marked in solid red, with altitude and time indicated for the last four positions. The final position is directly above the accident site, but there is uncertainty with respect to some of the points. The dotted red line is the route according to the eye witnesses.

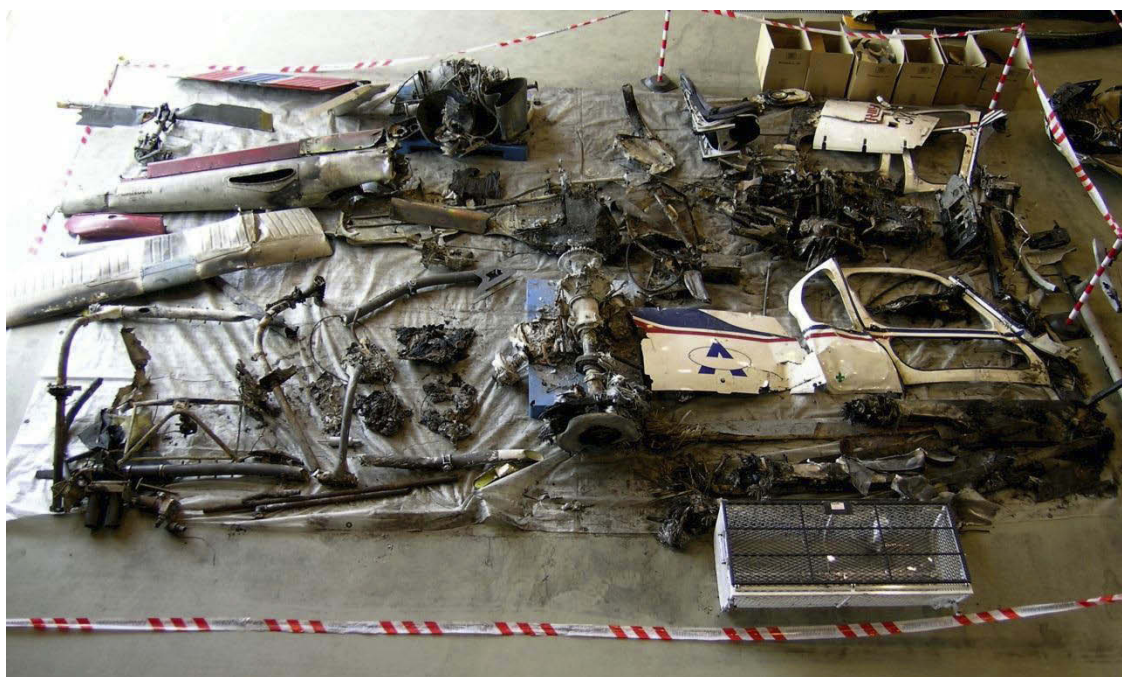
- 1.16.3.2 The helicopter wreckage was transported to AIBN's premises at Lillestrøm for closer examination. All wreckage components were examined and a simplified reconstruction prepared (cf. Figure 9). In general, the remaining wreckage components were those made of steel, plus parts thrown off because of the impact and therefore not burned. There were also some flight control linkages, i.e. controls in the forward part of the cockpit, which were in such a condition that an examination could be carried out. Engine controls and other aluminium alloy components melted in the fire and were only to a limited extent available for examination.

Figure 9: Simplified reconstruction of the wreckage in the Accident Investigation Board's hangar.

1.16.3.4 It was established that the engine was running, supplying power to the rotors, when the helicopter hit the ground. The examinations showed that the damage had been caused by a sudden stop of the main rotor system, collision forces and fire. For example, the drive gear securing nut was found to have rotated approx. 4 mm. This movement indicates, according to the BEA, an overtorque corresponding to three times the normal load, which is a clear sign that the engine was delivering power when the main rotor blades hit the ground.

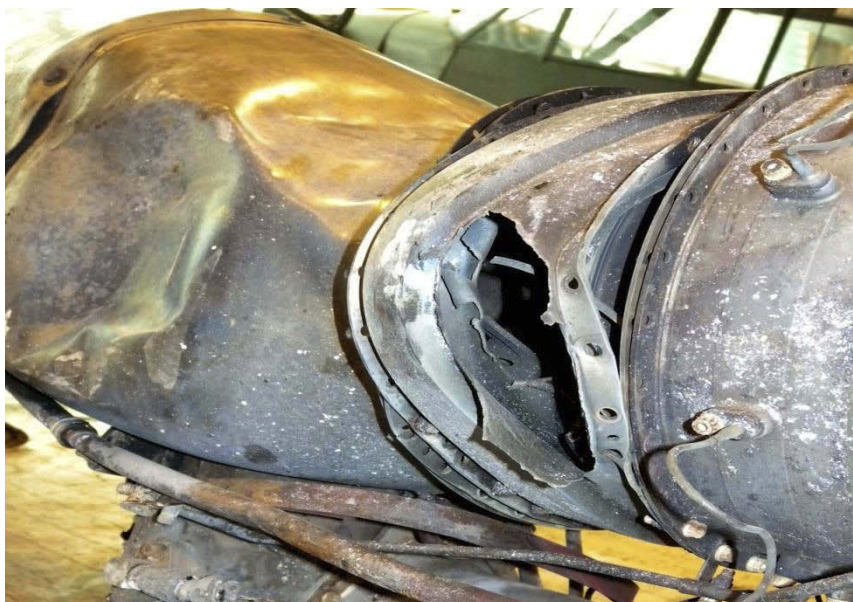
<sup>7</sup> Each turbine blade has a calibrated weak point designed to break during overspeed. This is to prevent disintegration of the whole turbine disc (blade shedding).

Figure 10: The penetrated containment shield.
