RAPPORT

SL 2013/03

RAPPORT OM ALVORLIG LUFTFARTSHENDELSE PÅ BERGEN LUFTHAVN MED ATR-42-300, OY-JRY, 9. NOVEMBER 2007

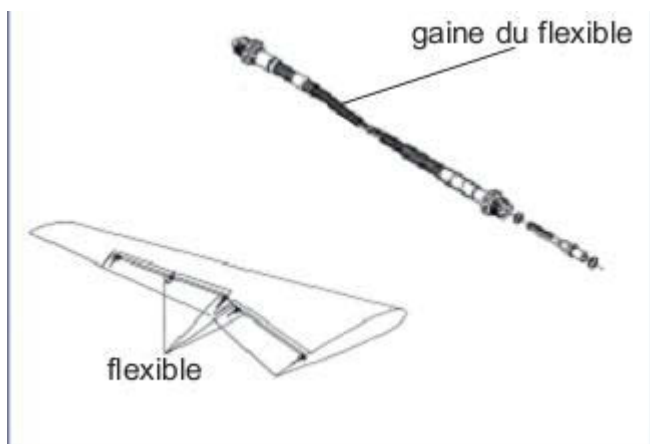
The failure message was related to a failure in the mechanical flap system: hoses, worm screws, transmission brakes. The transmission of movement is made by hoses composed of steel / carbon cables passing through Teflon ducts.

Water had entered when these hoses were removed. This water froze during the flight, which took place entirely at negative temperatures, and caused blockage of the flap movement transmission. The operator launched an inspection campaign of all hoses in flap systems. Services responsible for monitoring of airworthiness were informed about this event and its circumstances.

Hose

Hose duct

Note: It is possible that high pressure injection of the de-icing fluid from the trailing edge facilitated this condition. The ICAO manual on ground de-icing and anti-icing operations describes the usual wing and stabiliser de-icing / anti-icing procedure that consists of spraying fluid from the leading edge to the trailing edge and from the highest point of the camber to the lowest point.

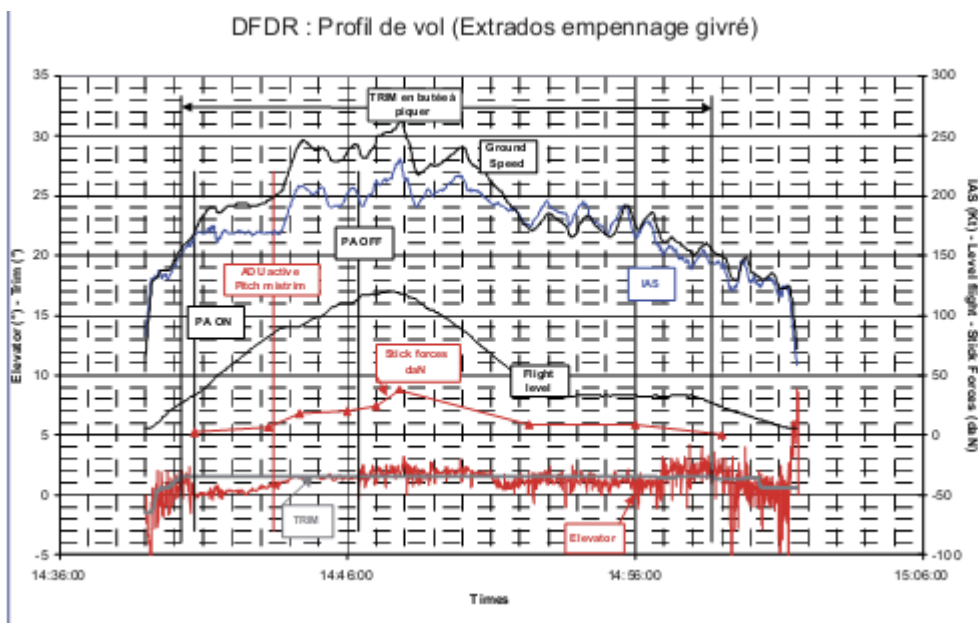
DFDR: Flight profile (tail assembly upper surface iced up)

The FCOM (manufacturer’s operations manual) specifies that during a takeoff with residual ice or during severe icing, the elevator hinge moment may be affected. This is what happened during this flight, and the consequence was a mistrim of about 2°.

The analysis of flight parameters verified that the aircraft stability was not affected because the elevator deflections recorded showed no significant differences with deflections calculated for a non-contaminated aircraft, with identical mass and centre of gravity.

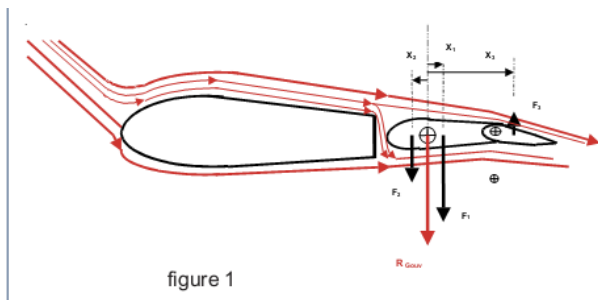
To move or balance the elevator, the pilot or the autopilot needs to create a force which will be applied through the kinetic system to oppose the aerodynamic forces applied onto the elevator and the trim tab. This force is contrary to the elevator hinge moment.

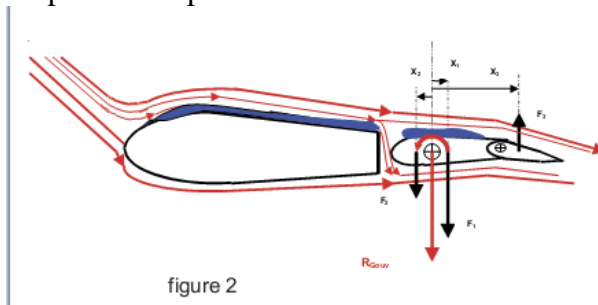
If ice forms on the upper part of the horizontal stabiliser and the elevator, the boundary layer in the aft part of the profile is modified with the result that the elevator tends to pull up.

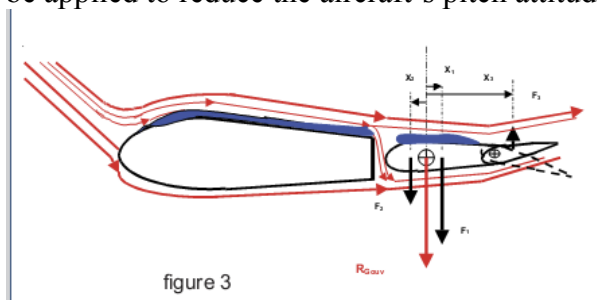
Therefore, to restore equilibrium, the nose-down trim has to be increased which reduces the capacity of the trim to stabilise the aircraft when the speed increases. When the "down" trim stop is reached, the elevator hinge moment can no longer be compensated for, which increases the forces to be applied to reduce the aircraft's pitch attitude (see Figure 3).

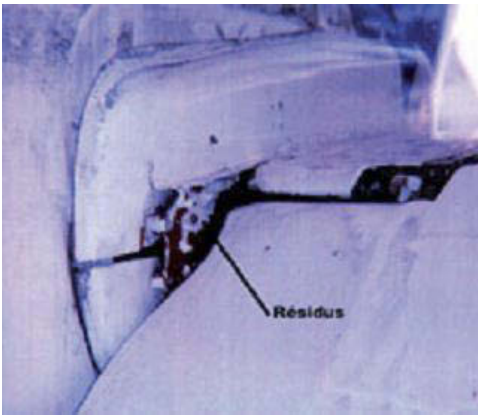
The crew recovered use of the elevator at about 1,000 feet and landed without damage 17 minutes after the warning appeared. On the ground, residues from the de-icing fluid that were still melting were found in the joints between the elevators and the control tabs.

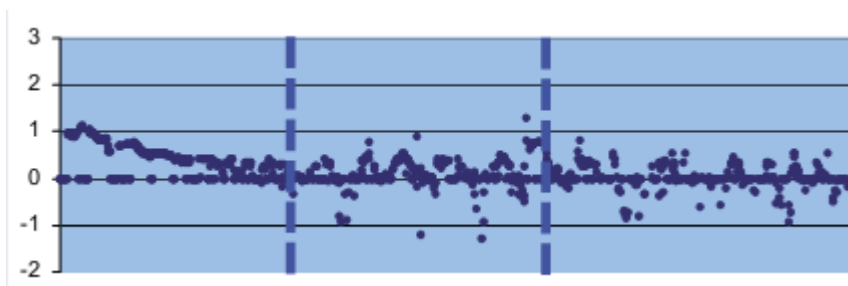
Position of the elevator control

The following figure shows variations of FDR parameters at about the time of the event reported by the crew. The recording was not of very good quality, and there are several aberrant points. However, the trend in changes to these parameters can be seen.

- The third phase is characterised by relative stabilisation of the trim, while oscillations of the elevator control around the neutral are observed. Rapid displacement of the trim towards a nose-down position then occurs, immediately followed by a return to a slightly negative position.

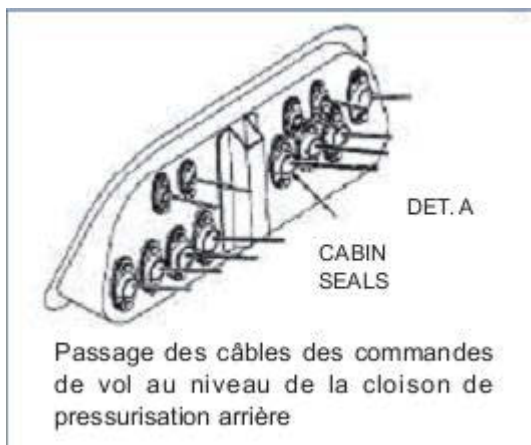
Passage of flight control cables at the aft pressurized bulkhead

The snow covering the aircraft before departure was probably heavy and sticky. It stuck to the fuselage particularly and consequently to the horizontal stabiliser. As the outside temperature was increasing before takeoff, the snow was transformed into water which penetrated into the tail fin box, probably through the vent panel. This water could not all escape through the drains provided for this purpose before takeoff, because this area of the aircraft was more or less covered with debris. The climb under freezing conditions caused this stagnant water to freeze. Friction phenomena at the cable passage generated large forces on the elevator control. Consequently, operation of the autopilot was abnormal, creating particular difficulties in stabilising the aircraft, thus causing the oscillations observed in phase 2. Observing unusual movements of the elevator control, the crew disconnected the autopilot and performed the pitch trim procedure. The high forces felt on the controls could also be the result of this abnormal friction.
