REPORT

SL 2013/26

REPORT ON AIR ACCIDENT AT SKJELBREIA IN SKI, AKERSHUS ON 2 APRIL 2009 WITH DIAMOND DA40-D, LN-NEX

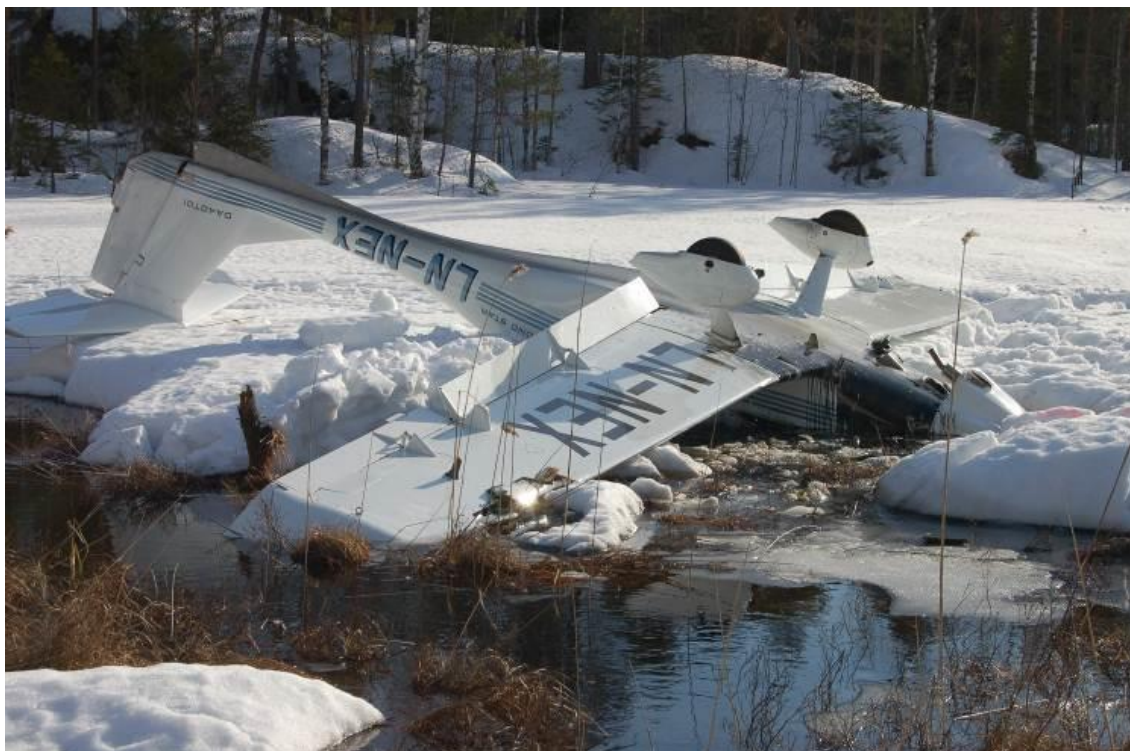
- 1.1.11 LN-NEX covered nearly the entire length of the lake before settling on the snow-covered ice. The tracks showed that the aircraft gradually came into deeper snow towards the end of the landing run. The heavy braking force from the snow led to the noseleg breaking. The aircraft then turned over onto its back. LN-NEX came to rest upside-down in an open water-filled pool in the mouth of a river at the southern end of Skjelbreia (see Figure 1).

Figure 1: LN-NEX resting upside-down after the forced landing. The photo shows oil spillage on the fuselage behind the engine cowling and on the lower left wing (in front of the L/H main landing gear leg). Photo: AIBN

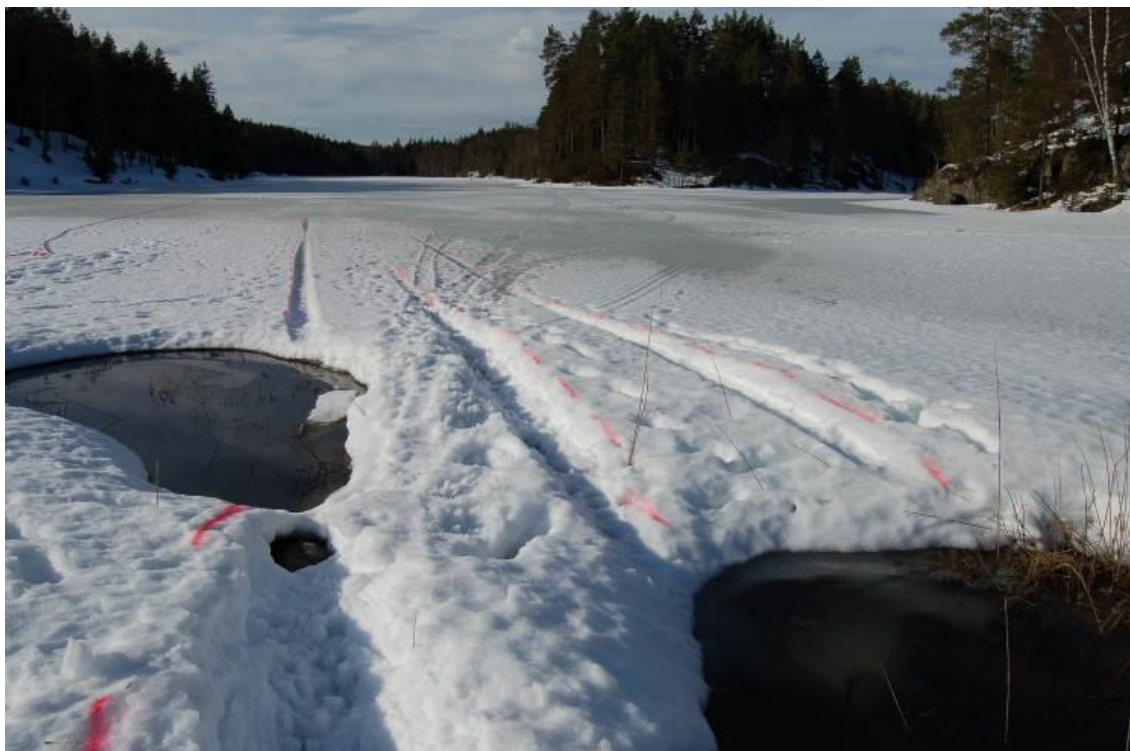
- 1.1.12 The distance from the site where the aircraft came to rest and the first point of contact on the ice was 70 m, 50 m and 27 m for the left main wheel, right main wheel and nose wheel respectively (see Figure 2).

Figure 2: The wheel tracks in the snow (dyed red) seen from where the aircraft stopped. Photo: AIBN

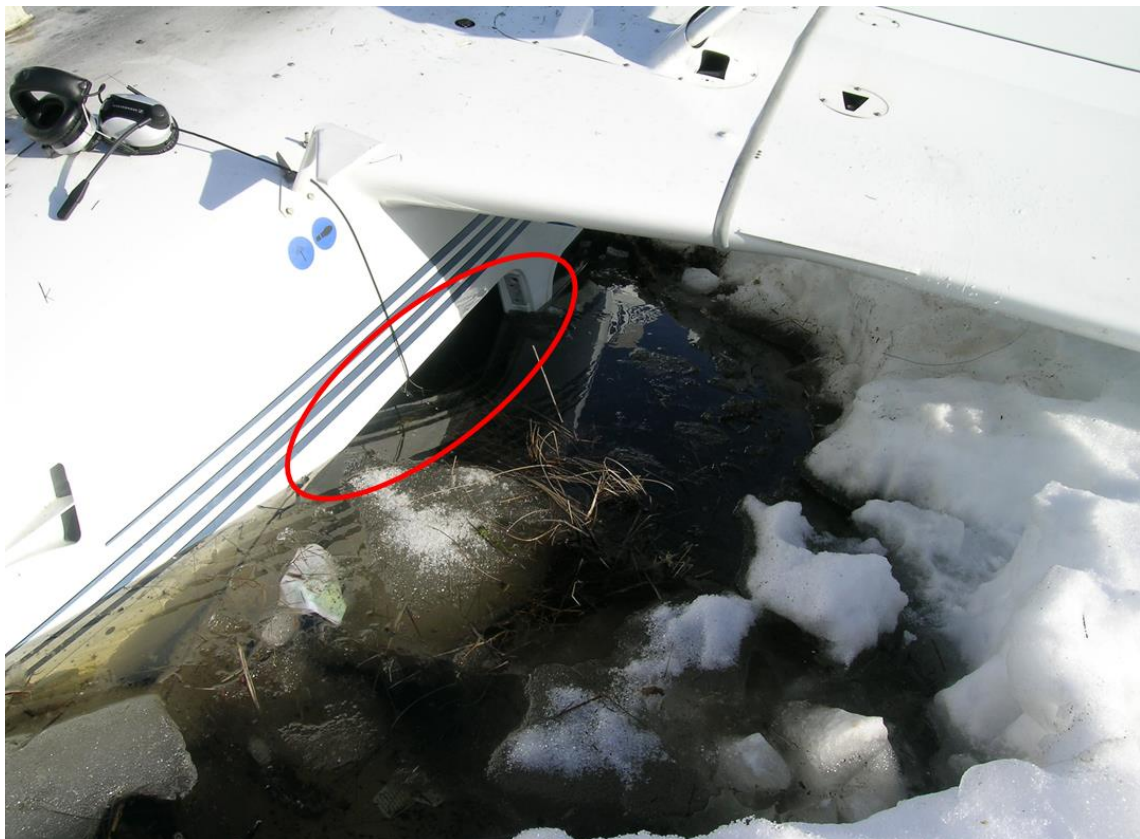
- 1.1.15 The commander then discovered an opening on his right side which was partially under water. Both persons on board managed to evacuate the aircraft through this opening. It proved later that it was the canopy that had partially opened so that it was through this opening they came out (see Figure 3).

Figure 3: The opening through which the commander and the student pilot evacuated. Photo: AIBN

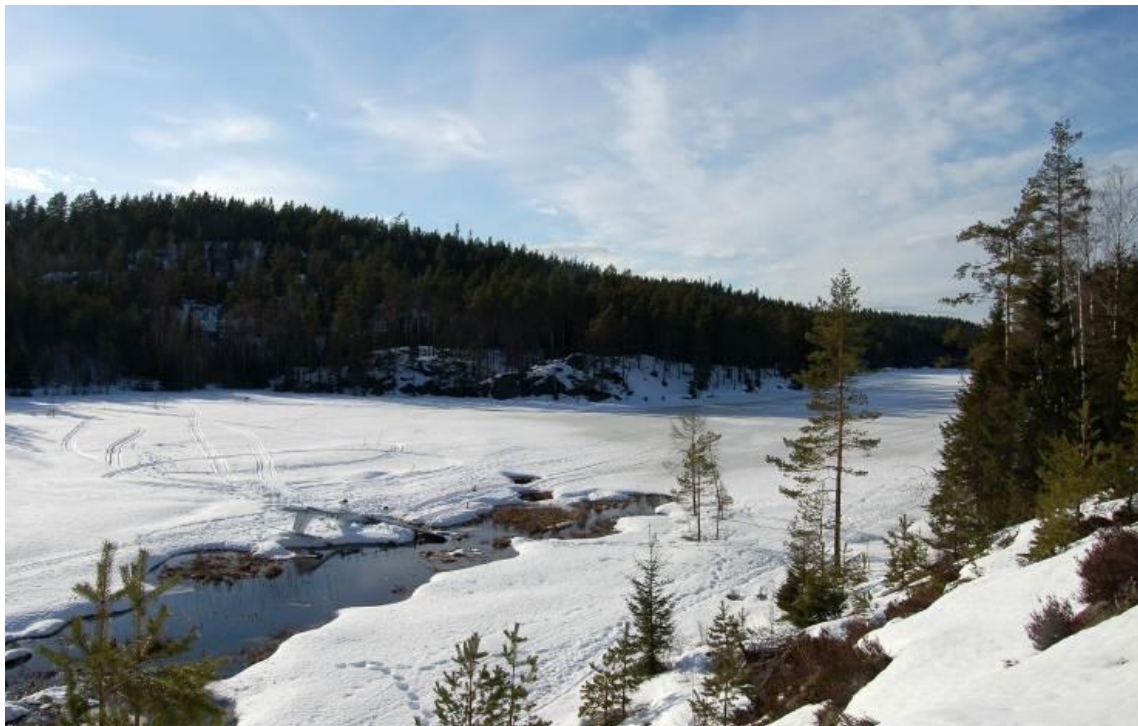
1.15.1.3 The starting point for the search was LN-NEX's last position on the air traffic controller's radar screen and their distress call which contained information to the effect that they would attempt to land on a lake. As the aircraft's colour was mostly white where it laid upside-down at the end of the ice and snow-covered lake, it was not easy to spot from a distance (see Figure 4).

Figure 4: The accident site with LN-NEX laying upside-down. The aircraft wreckage was not easily visible from a distance. Photo: AIBN

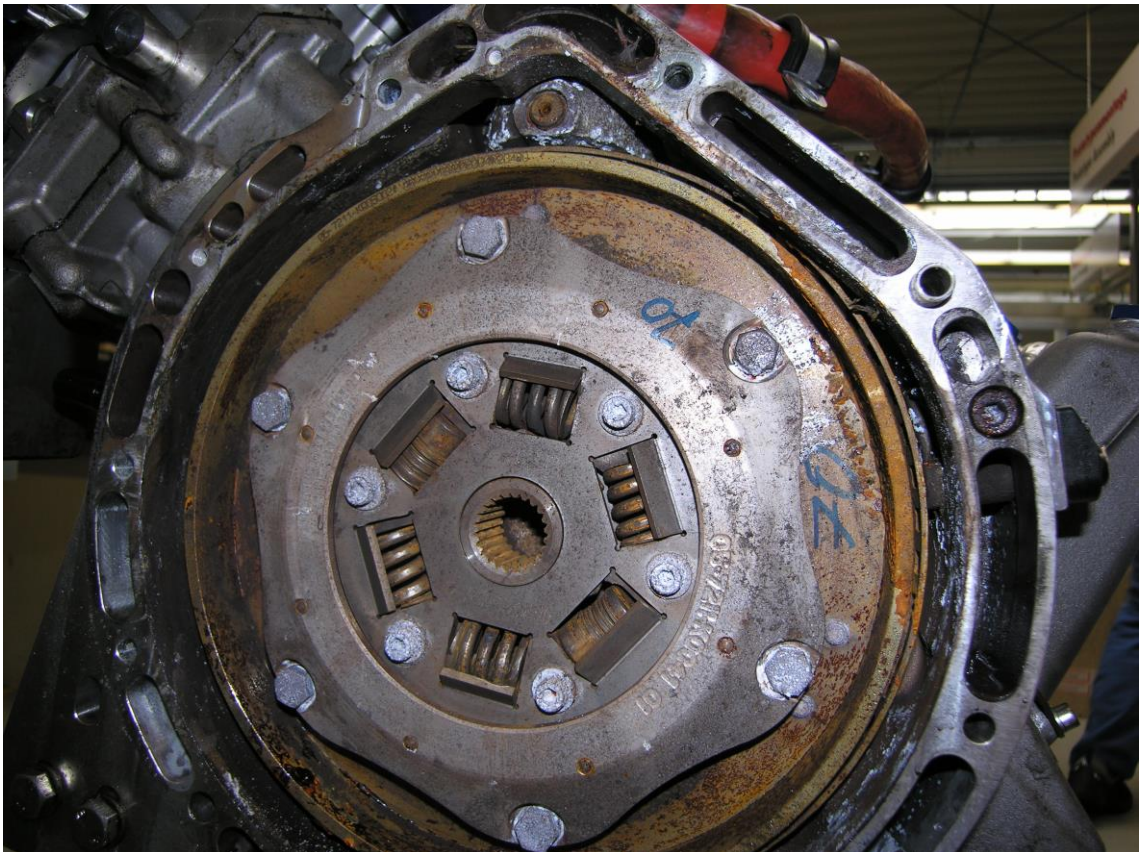
1.16.1.1 When the gearbox was dismantled, one could see that the inner power transmission hub in the clutch, Clutch Hub (P/N 05-72211-K011) had disintegrated (see Figure 5). A further description of the findings in connection with the inspection of the clutch can be found in Section 1.16.2.

Figure 5: Photo taken after the gearbox had been removed. The clutch is located on the engine's flywheel. Photo: AIBN

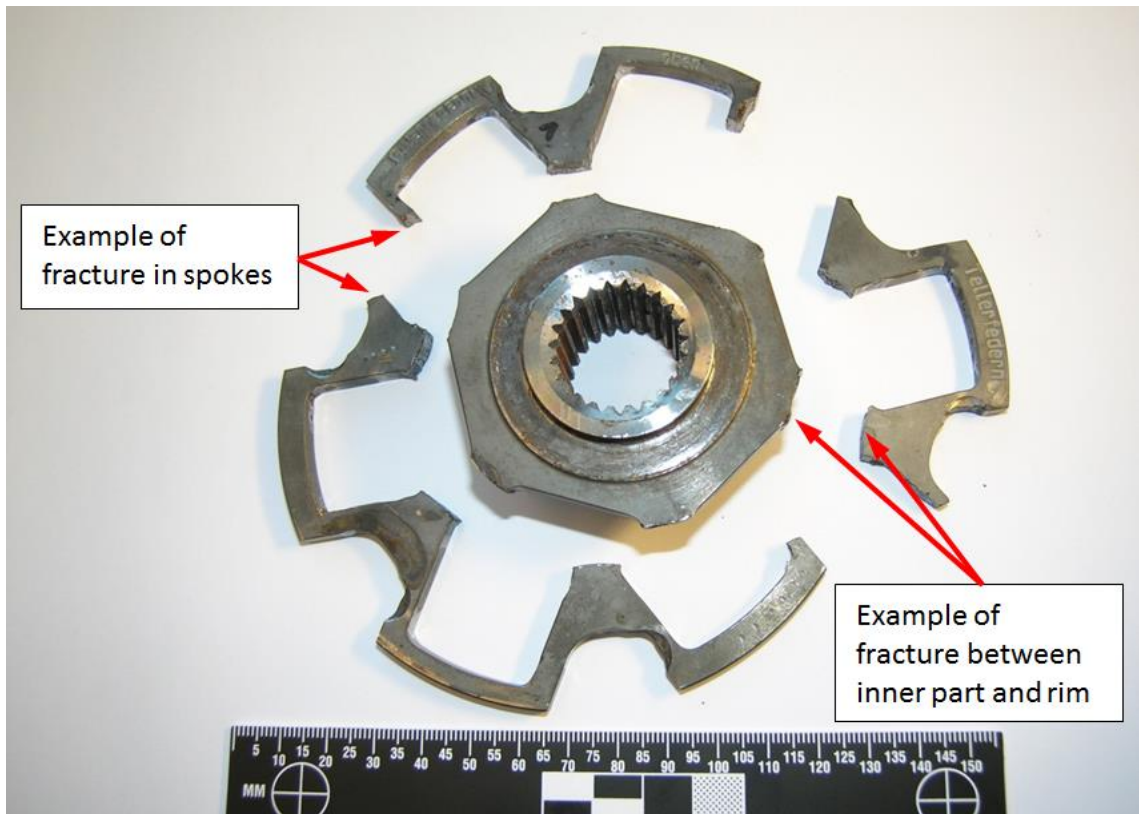
- 1.16.2.3 Before delivery of new clutch units, the factory tests and adjusts spring tension (see Section 1.6.4.6).
- 1.16.2.4 When the AIBN measured the dimensions of the springs, it proved that both of the two coil springs that had the greatest diameter did not have the correct length. The length of the two springs was measured at 23.8 mm and 24.8 mm respectively. According to information from TAE the correct length is 27.5 mm. The other coil springs were also somewhat shortened (in the order of 1 mm).
- 1.16.2.5 The Clutch Hub was broken in six places so that the rim was separated from the inner part. In addition, three of the twelve radial spokes between the cut-outs were broken (see Figure 8).

Figure 8: There were a total of nine fractures in the Clutch Hub which had been split into four pieces. Photo: AIBN

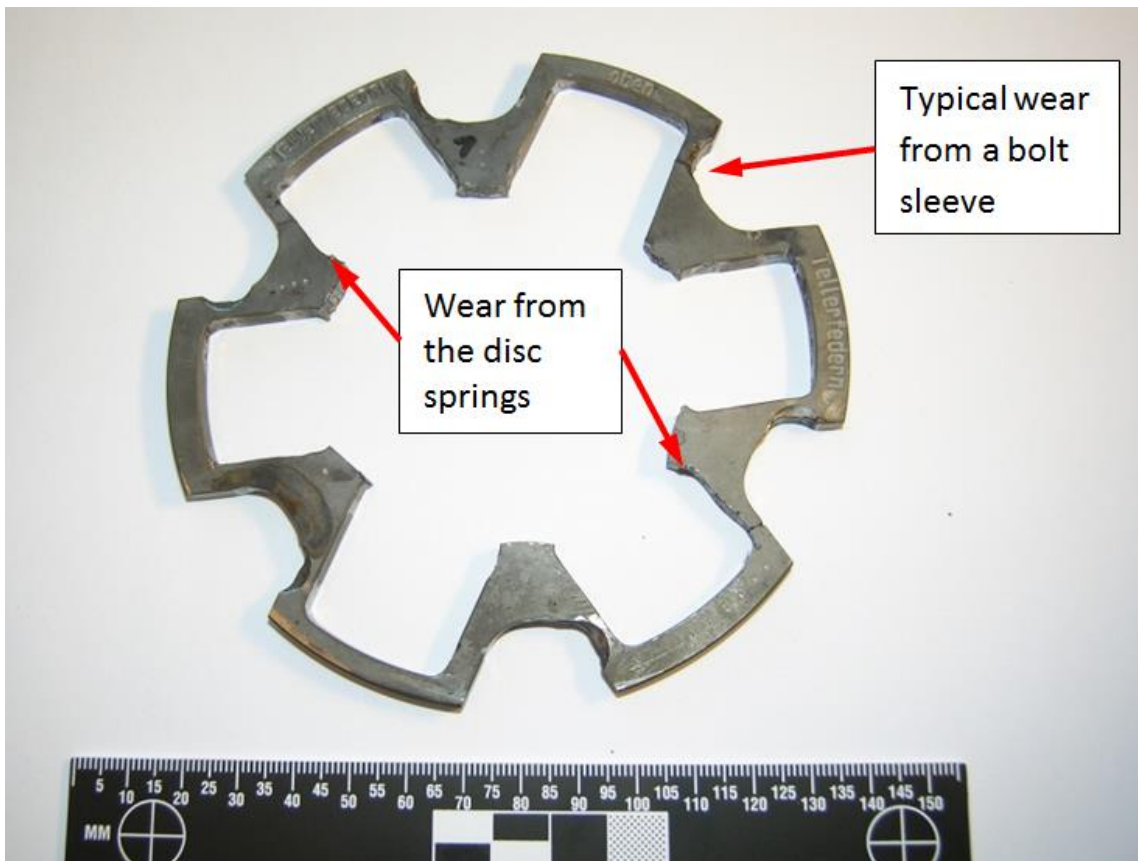
- 1.16.2.6 The fracture surfaces were examined more closely in an electron microscope. Signs of fatigue were found in several of the fractures, both those between the inner part and the rim, and those in the spokes.
- 1.16.2.7 In addition to the fractures there was substantial wear where the disc springs had been sitting. There was also wear that showed that the Clutch Hub had struck the bolt sleeves (see Figure 10) which also function as spacers between the two adjacent clutch hubs (see Figure 11). Each disc spring had worn away about 3 mm of the material in the rear spoke (see Figure 9).

Figure 9: Wear on the Clutch Hub (inner part left out for clarity). Photo: SHT

2.2.2 The damage to the Clutch Hub and bolt sleeves show that the hub had struck against the bolts a repeated number of times (see Figure 10). The abnormal level of wear on the spokes in the Clutch Hub (see Figure 9) caused an increasing relative movement in relation to the adjacent hubs. This increased play gradually became about 3 mm before the disc springs were subject to any load at all. This in turn led to the impacts being increasingly stronger until the Clutch Hub finally disintegrated. The wear pattern and the character of the fatigue fractures indicate that the abnormal wear has occurred over time, probably several flights.

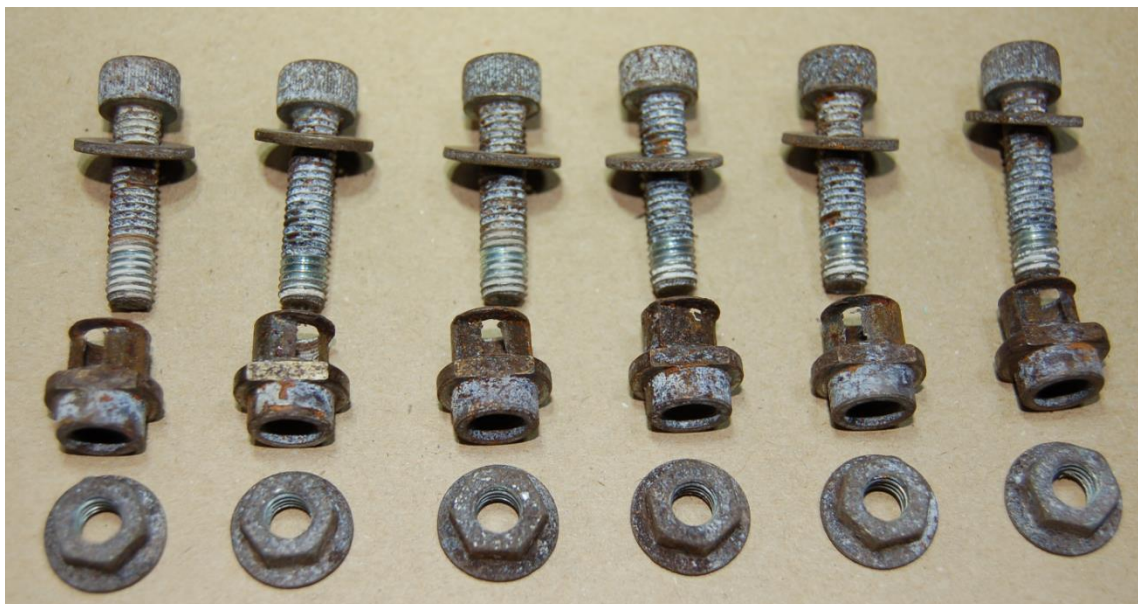
1.16.2.8 Similarly, all the sleeves mentioned in Section 1.16.1.5 were completely worn down where the Clutch Hub had struck against the bolts (see Figure 10). On the reciprocal impact points on the Clutch Hub there were marks from the bolts' threads.

Figure 10: The bolts that hold the Clutch Hub and the adjacent hubs together. Impacts from the Clutch Hub have worn a hole through all the sleeves. Photo: AIBN

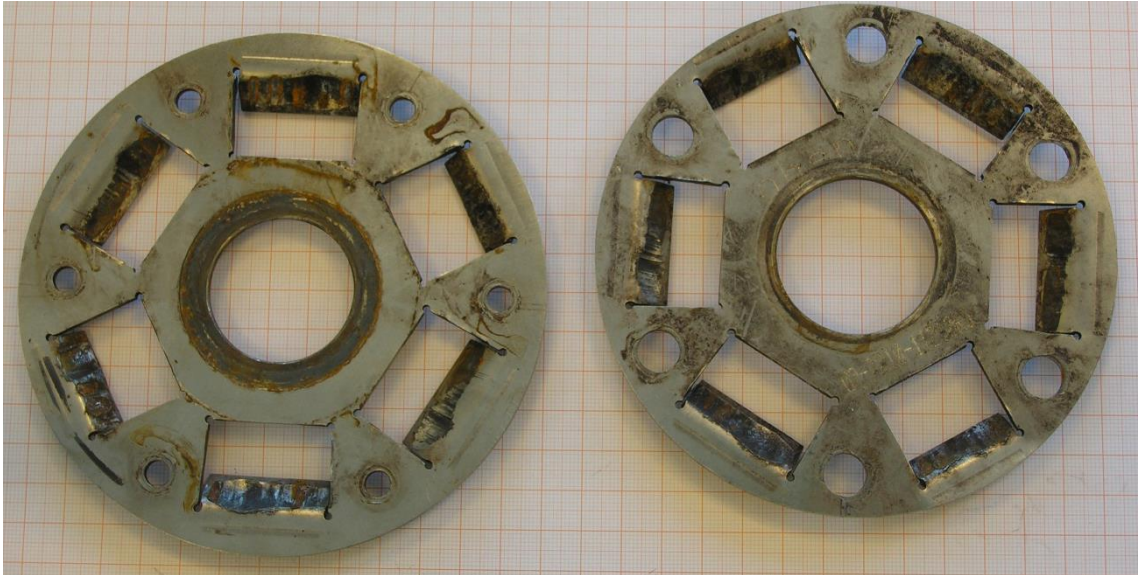
1.16.2.9 The two adjacent clutch hubs both had wear depressions from the springs (see Figure 11).

Figure 11: Adjacent clutch hubs with wear depressions from the springs. Note the different dimensions (both in width and length) of the cut-outs in the hubs. These are adaptations to the different types of springs. Photo: AIBN

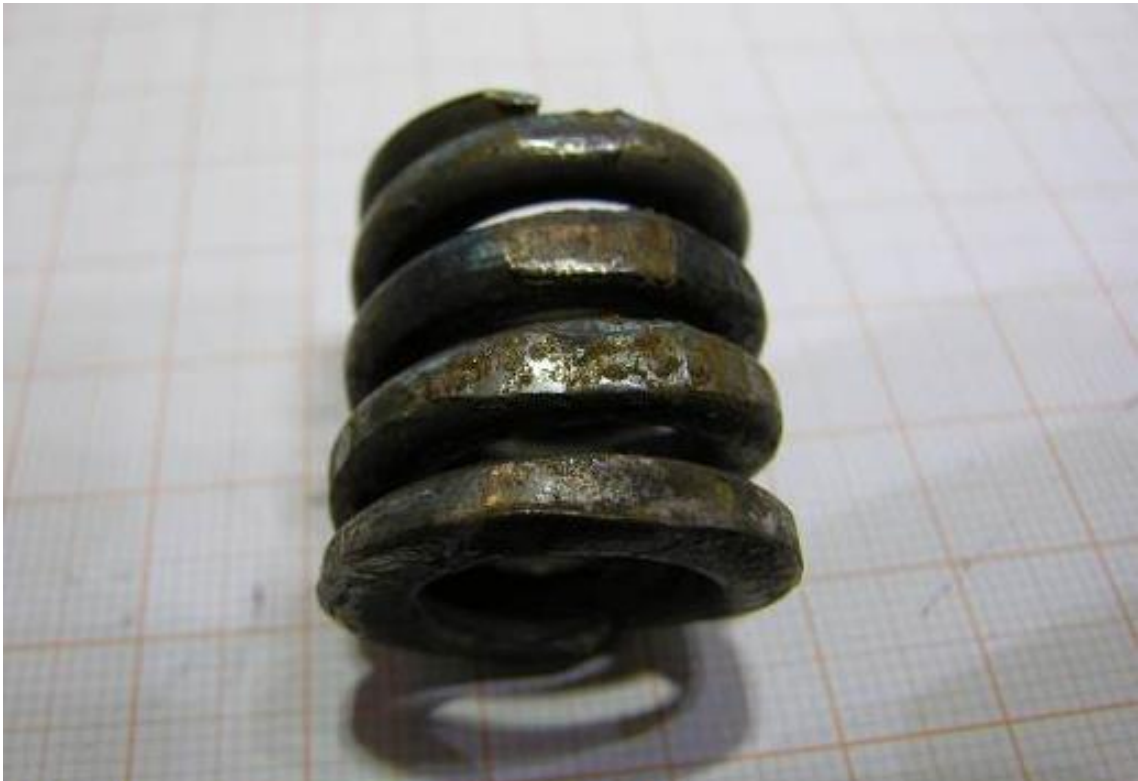
- 1.16.2.10 Wear marks on the springs, in addition to the fracture surfaces on the inner part of the Clutch Hub, indicate that the springs and fracture surfaces have scraped against each other. This shows that the inner part of the Clutch Hub and adjacent hubs have rotated with different speeds after the Clutch Hub disintegrated. This means that the rim and the springs spun along with the adjacent hubs without any power being transmitted to the propeller (see Figure 12).

Figure 12: Wear marks on one of the coil springs after scraping against the fracture surfaces in the inner part of the Clutch Hub. Photo: AIBN

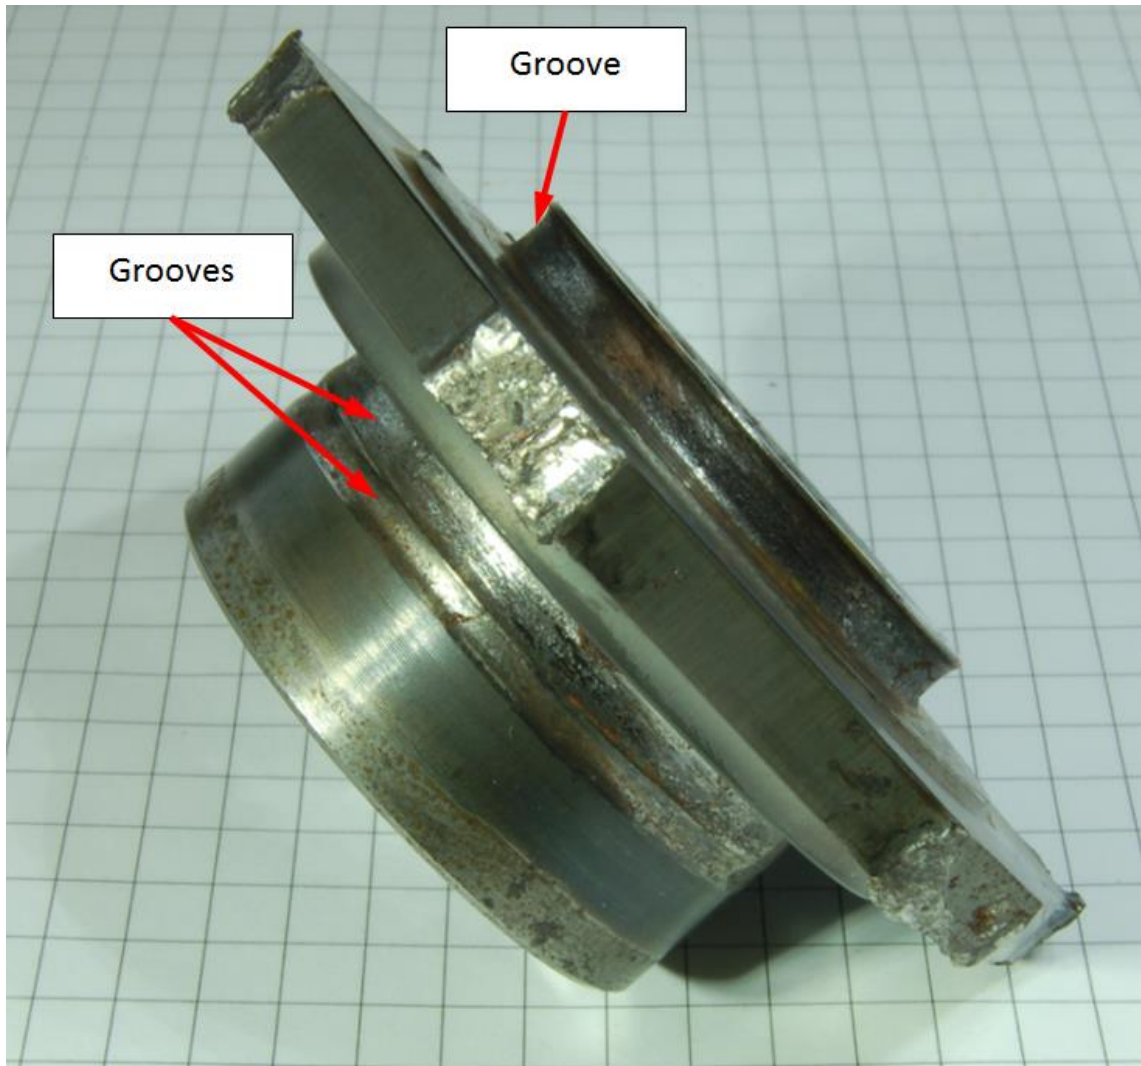
- 1.16.2.11 Wear marks were found on both sides of the flanges on the Clutch Hub (see Figure 13). There were signs of overheating (discolouration) from rubbing against the Clutch Hub in the opening in one of the adjacent hubs.

Figure 13: Wear marks (grooves) on both flanges on the Clutch Hub. The photo also shows wear on the inner part fracture surfaces after scraping against the coil springs. Photo: SHT

2.2.4 It has been discussed whether an incorrect installation led to the abnormally high level of loads, which in turn resulted in the Clutch Hub failure. The wear marks on both flanges on the Clutch Hub (Figure 13), and the wear marks from the friction disc against the brackets of the clutch's pressure plate (Figure 14), show that at one point in time there must have been significant eccentric rotation.

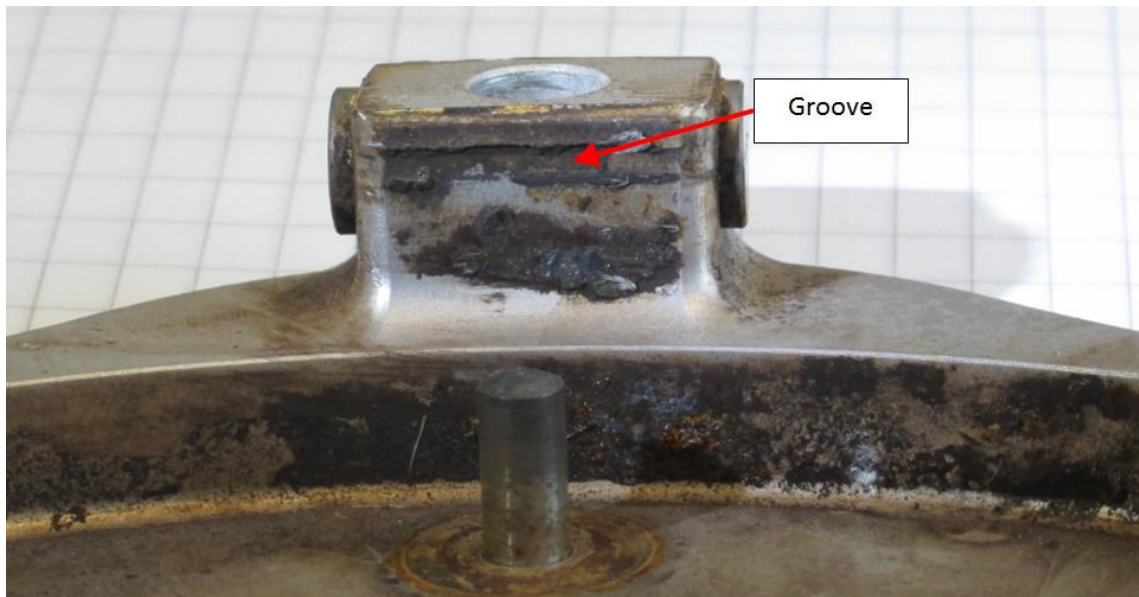
- 1.16.2.12 Wear marks from the friction disc shown in Figure 5 were found on the brackets of the clutch pressure plate (see Figure 14).

Figure 14: Bracket with wear marks (groove) from the friction disc. Photo: AIBN

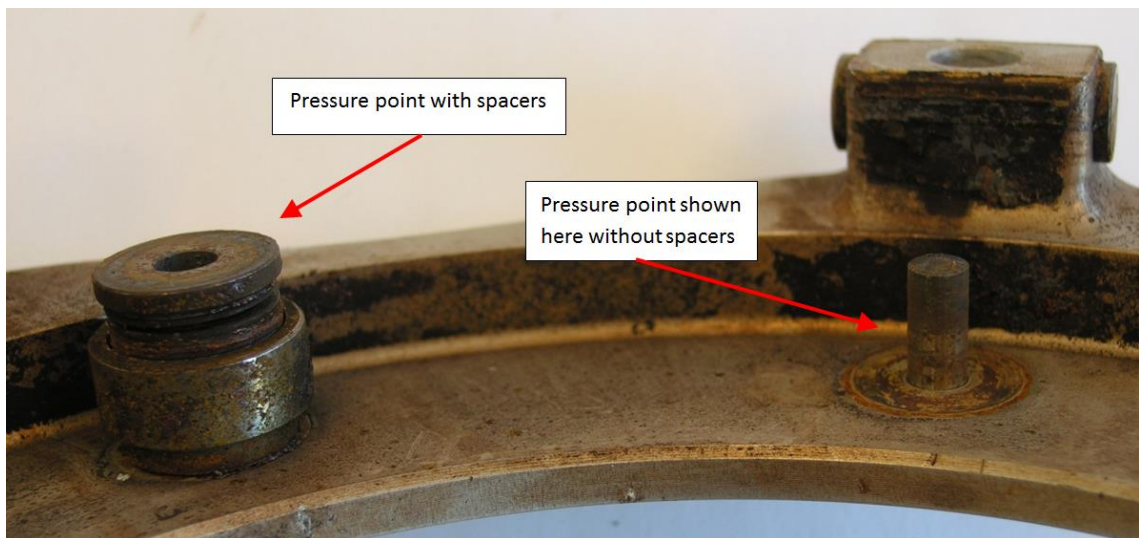
- 1.16.2.13 All the spacers were in place on the pressure plate's eight pressure adjustment points (see Figure 15).

Figure 15: Pressure adjustment point with spacers. Photo: AIBN

The AIBN has checked the pressure adjustment points and found that all the spacers were in place.

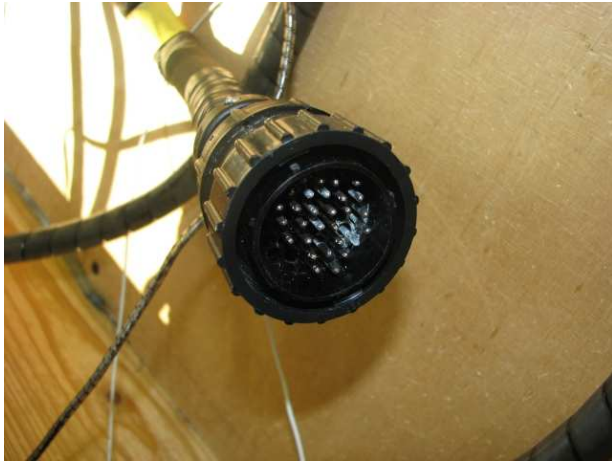
First, a visual inspection of the loom was conducted. Some of the connectors were showing signs of oxidation (see picture 2 and 3), likely because parts of the loom were exposed to water due to the accident. In addition, some connectors and the loom were slightly damaged which was likely caused by the accident (pictures 4 and 5). None of the connectors was showing any signs of unusual wear.

Picture 2 Signs of oxidation

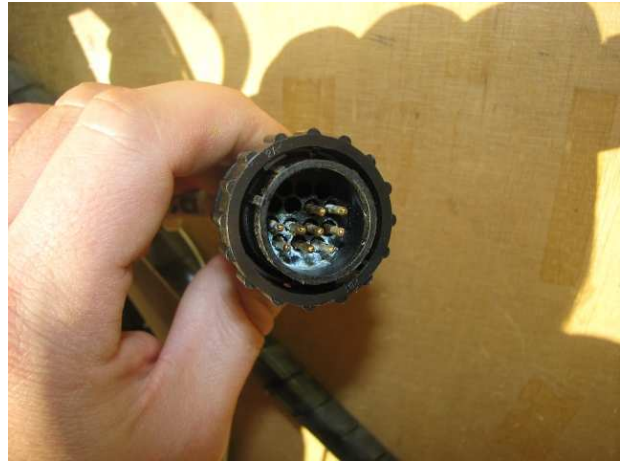
Picture 3 Signs of oxidation

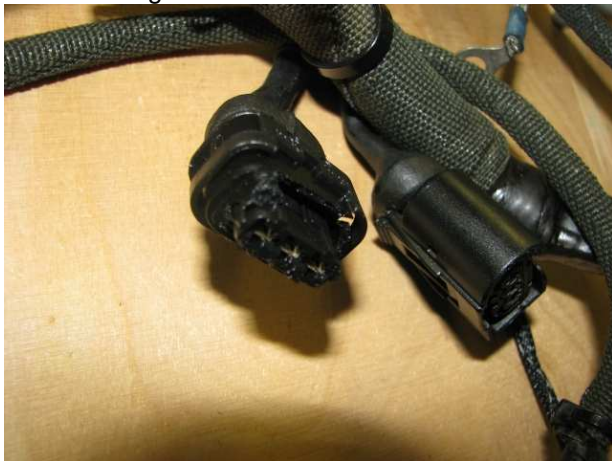
Picture 4 Damage to the connector shell

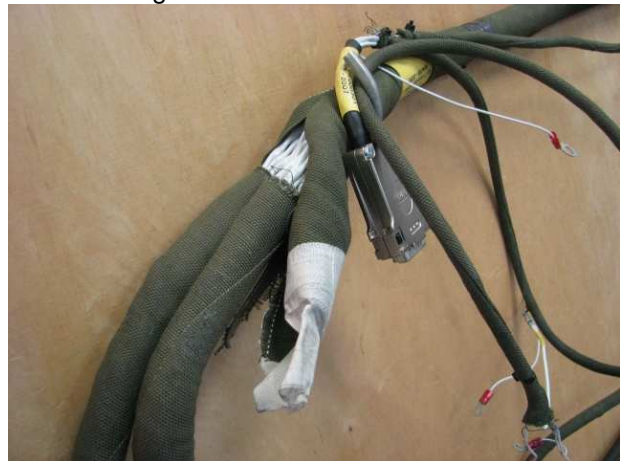
Picture 5 Damage of the loom
