SL 2014/05

REPORT CONCERNING SERIOUS AVIATION INCIDENT ON THE ÅSGÅRD B PLATFORM ON 12 JANUARY 2012 WITH EUROCOPTER EC 225 LP, LN-OJE

Date of submission: 06.05.2014
SL Report: 2014/05

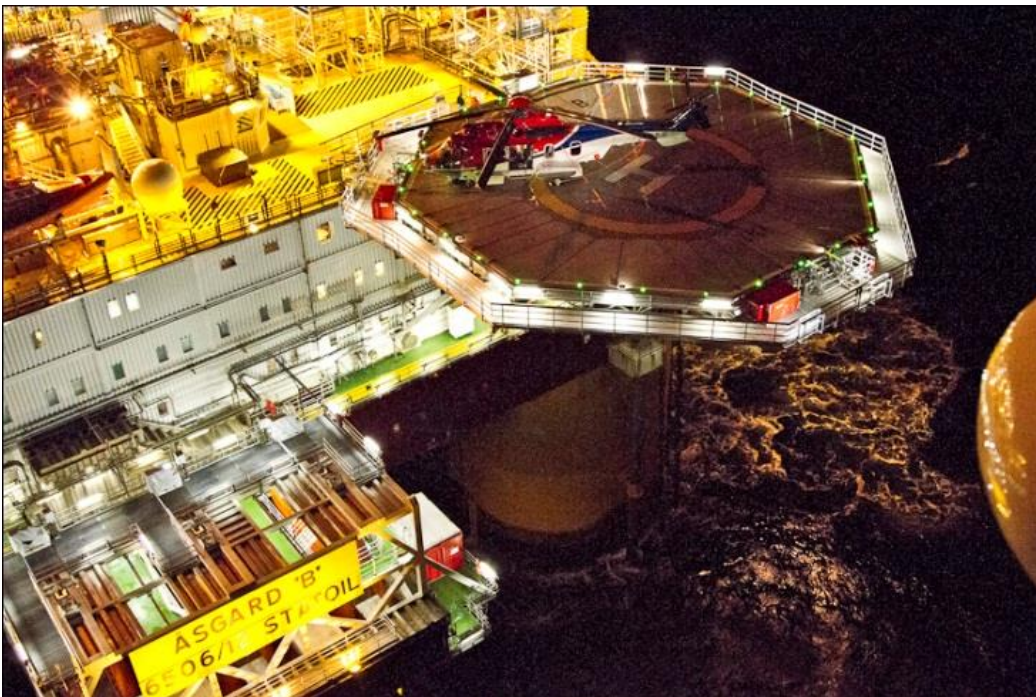
Figure 2 LN-OJE on the helicopter deck on Åsgard B after landing. The helicopter is secured to the deck in the position where it came to rest. Photo: CHC Helicopter Service

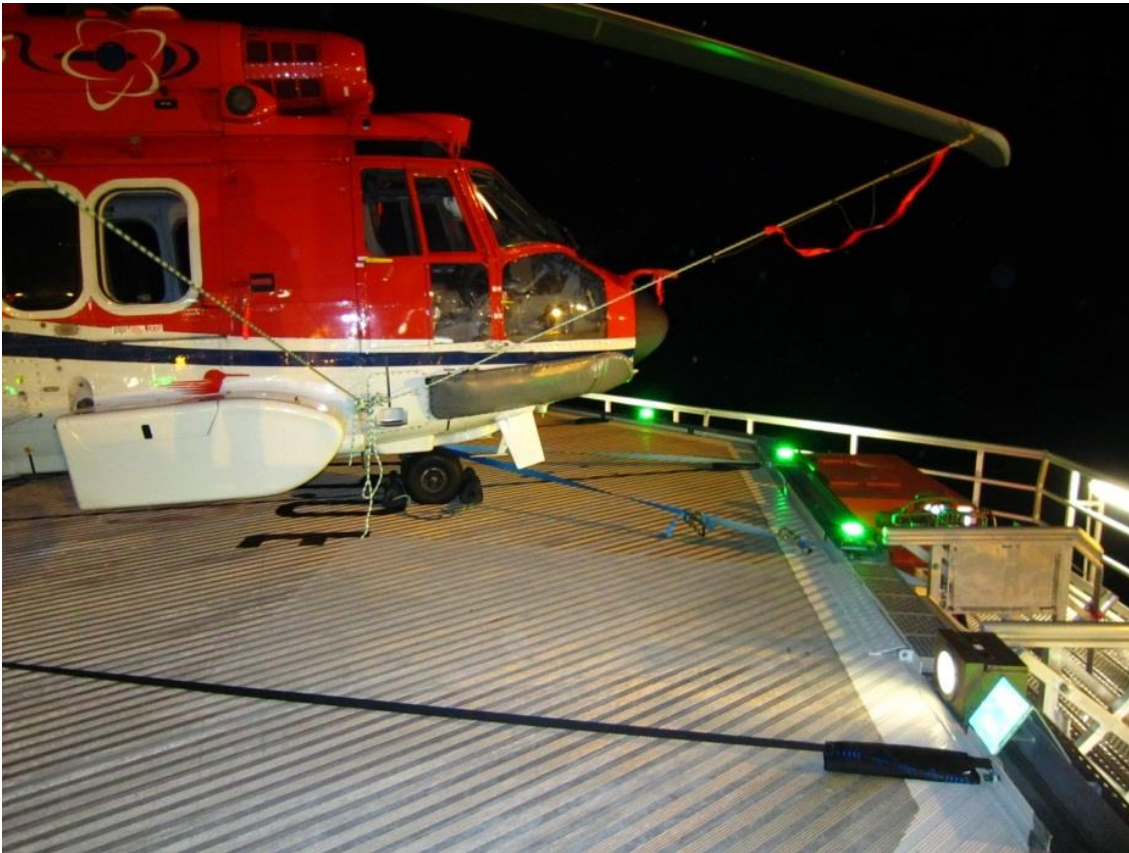
Figure 3: LN-OJE where it stopped on the helicopter deck on Åsgard B after the landing. The picture also shows the edge of the helicopter deck, the gutter and the walkway. Photo: STATOIL

The crew observed that the helicopter came closer and closer to the edge of the deck. When the movement seemed to stop, the commander ordered both engines shut down. The rotor brake had no effect, and the speed of the main rotor wound down by itself. The helicopter was, however, still moving and the commander ordered evacuation of the passengers. The first officer ordered the passengers to evacuate via the PA system.

to quickly get the chocks in place on the right main wheel, and the helicopter came to a stop². (See Figure 3)

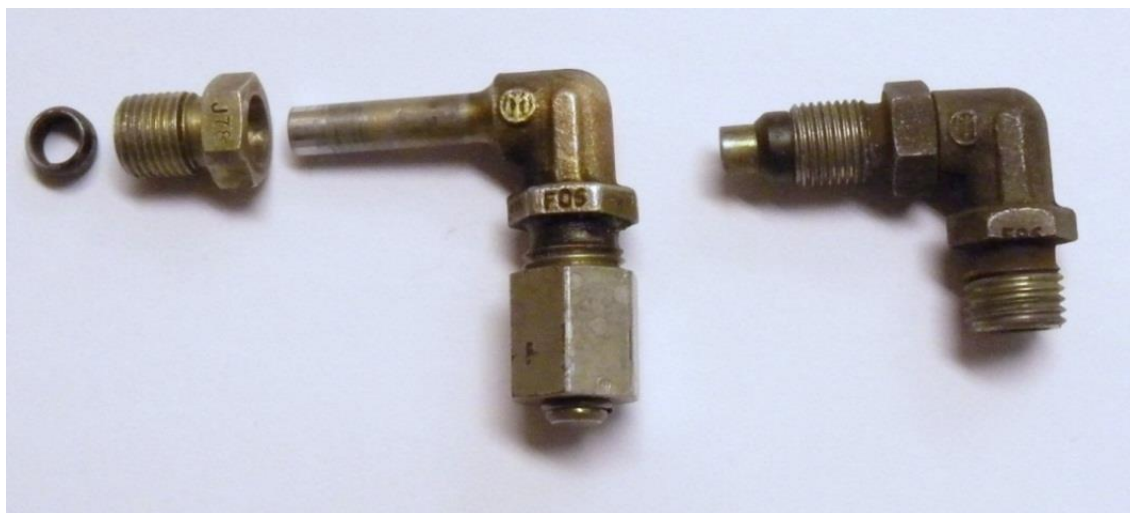
An elbow union connects the supply pipe and the brake unit. The unit is equipped with external threads on the side where the pipe is connected. The supply pipe is connected to the elbow union with a nut. The other end of the union is fitted on the brake unit itself with a nut that is attached to the union with a compression ring. This compression ring is compressed around the pipe end of the elbow union. (See Figure 5).

Figure 5: The elbow union from LN-OJE to the left. An elbow union with a correctly installed compression ring to the right. The compression ring (dark) that came loose to the left. Photo: AIBN

In February 2012, the AIBN received a preliminary report from the manufacturer of the braking unit, Safran Messier-Bugatti-Dowty (MBD), concerning their examination. The report mainly covers the examination of a similar incident with another operator in April 2011. In that case, it turned out that the compression ring had not been sufficiently compressed around the pipe end in the elbow connection.

During production, this ring was crimped with a special tool, but the torque applied to the special tool was not specified. It turned out that this did not always give a satisfactory result, and in November 2011, MBD changed the crimping procedure by specifying a higher torque. The elbow unions produced in accordance with the new procedures were marked with the production date by hand to ensure traceability. The elbow union from LN-OJE was produced before this and was thereby not marked.

On 14 November 2012, Eurocopter issued Service Bulletin (SB) EC225-32-002 with a procedure for checking the brake units on the entire affected fleet. The procedure entailed physically checking whether the compression ring could be rotated. If it could not, the unit was serviceable and could be refitted to the brake unit after being marked in accordance with the procedure in the mentioned SB. If it could be rotated, the part failed to meet the acceptance criteria and had to be replaced.

The AIBN considers that the problem with insufficient fastening of compression rings on elbow unions was resolved by Helikopterservice's "Maintenance Alert Notice" and EC Service Bulletin EC225-32-002.

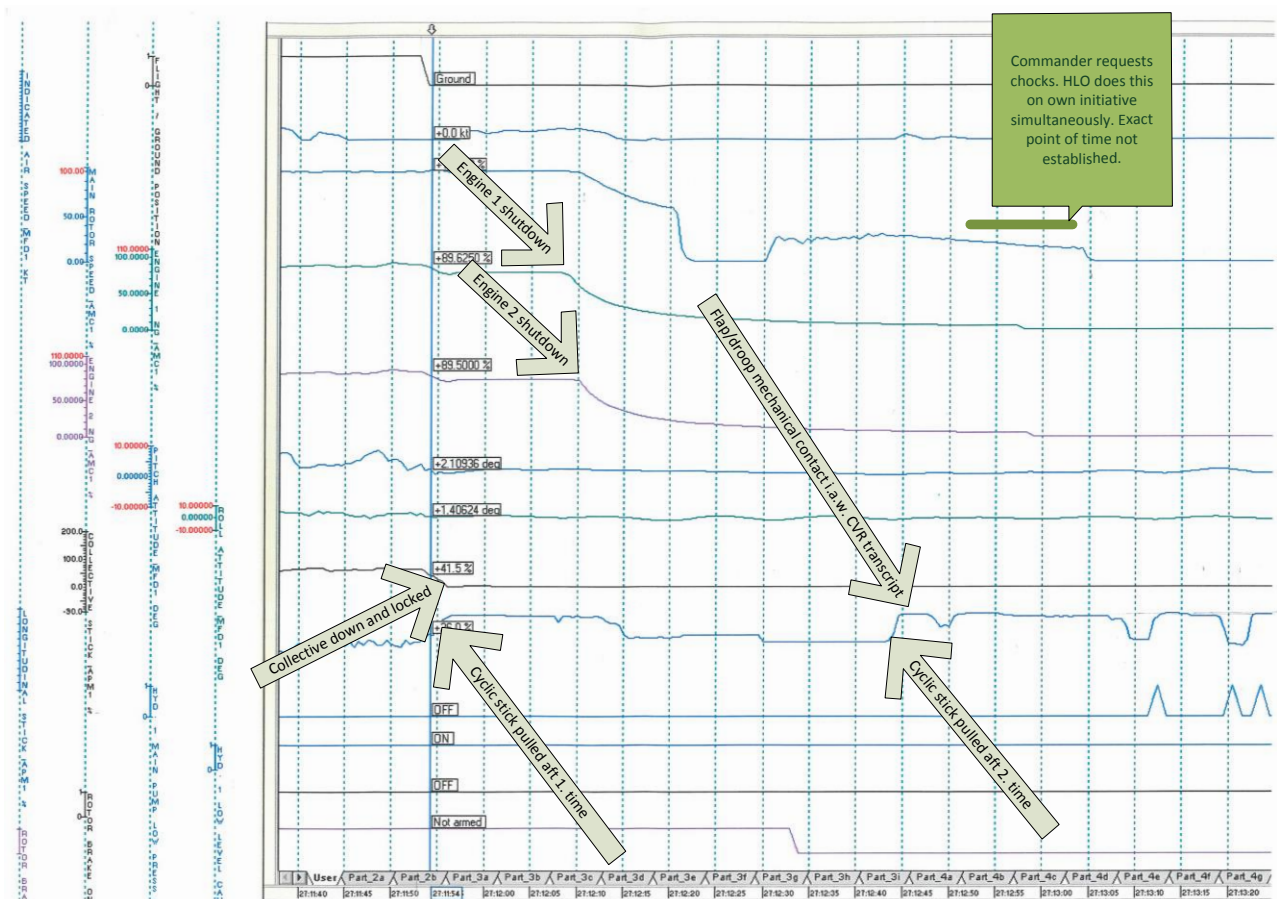
Immediately after landing, the collective was set to flat pitch and locked. When the helicopter started moving forward towards the edge of the helideck, the parking brake was checked and ordinary wheel brakes were tried, but without effect. The cyclic was then pulled back to prevent this movement, but as the collective was locked in flat pitch, this had little or no effect. See figure 7.

Figure 7: Relevant FDR parameters illustrating the course of events upon landing on Åsgård B. Source: CHC Helikopterservice, comments by AIBN

Application of the collective combined with the cyclic stick would probably have resulted in improved control of the helicopter's movements after landing.
