RAPPORT

SL 2015/01

RAPPORT OM ALVORLIG LUFTFARTSHENDELSE UNDER INNFLYGING TIL KITTILÄ LUFTHAVN FINLAND (EFKT) 26. DESEMBER 2012 MED BOEING 737-800, LN-DYM, OPERERT AV NORWEGIAN AIR SHUTTLE ASA

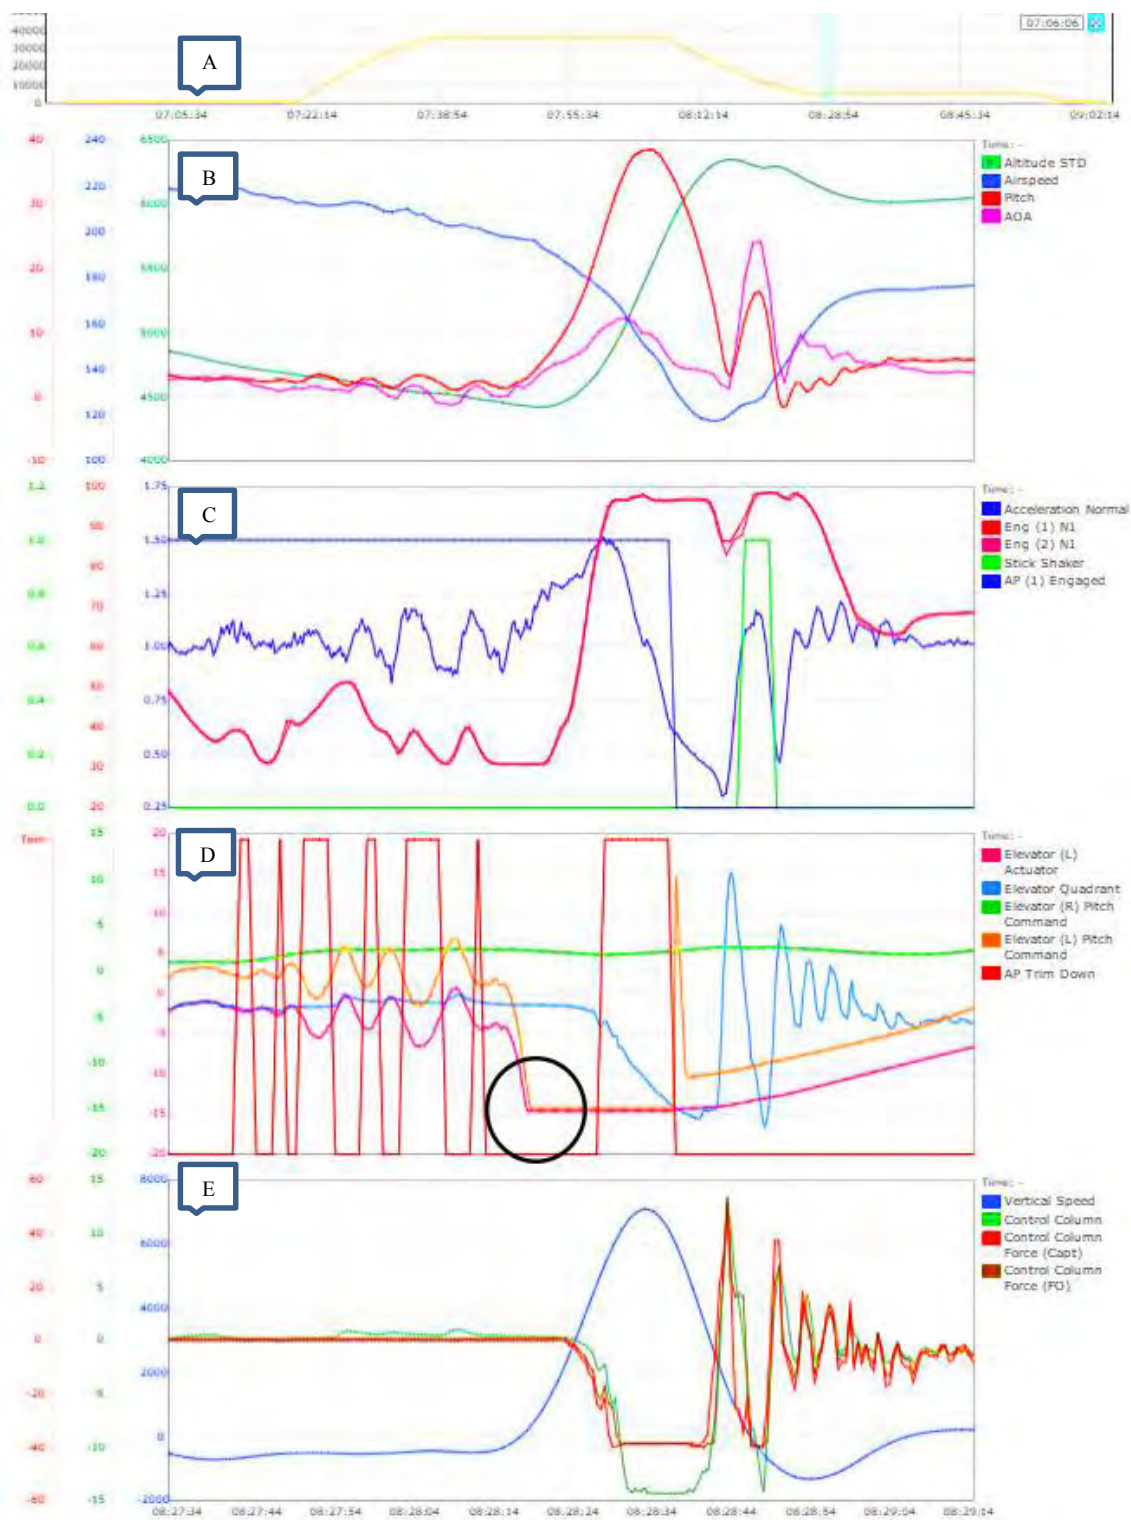
1.1.2.4 Dette førte til at flyhastigheten raskt avtok, dermed initierte flyets autothrottle system full motorkraft. På Boeing 737 er motorene plassert lavt nede under flyets tverrakse (pitch). Full motorkraft fikk flyets nese til å heve seg ytterligere, med tilhørende ytterligere tap av flyhastighet. Figur 1 viser utdrag fra flyets ferdskriverdata i forbindelse med hendelsen.

Figur 1: Utdrag av ferdskriverdata i tidsrommet da hendelsen pågikk.

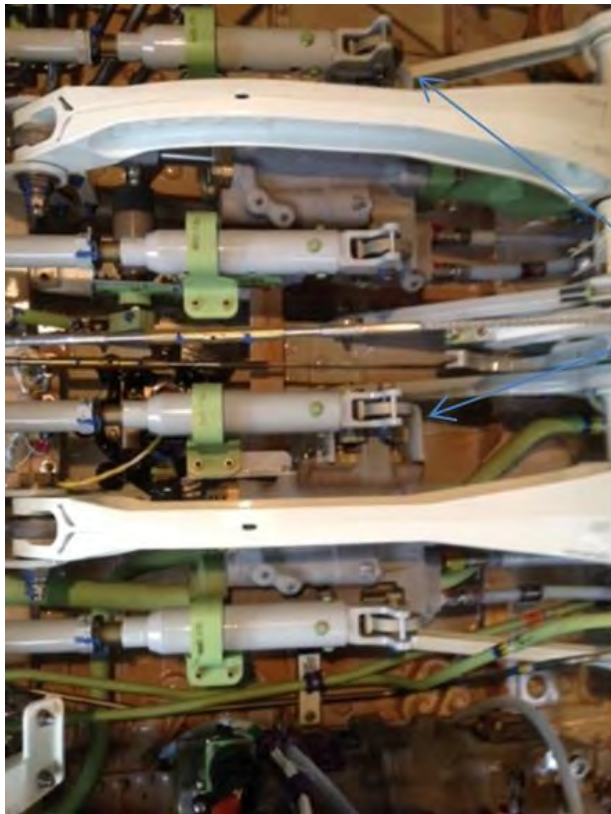
- 1.6.3.9 Slik Havarikommisjonen har forstått det, er PCU'ene utstyrt med et deksel fordi samme type PCU også benyttes til styring av balanserorene på Boeing 737. De to balanserors PCU'ene er montert i hjulbrønnen med styrearmene horisontalt og er derfor mer eksponert for fremmedlegemer. For å bidra til å forhindre at eventuelle fremmedlegemer skal falle ned og blokkere styrearmene på balanserors PCU'ene, er disse utrustet med deksel over den styrearmen som ligger øverst (sekundær). Se figur 5.

Figur 5: Bilde fra Boeing 737-800 hjulbrønn tatt i flyets fartsretning. Bildet viser at hver PCU har et beskyttelsesdeksel over de sekundære styrearmene. Foto: SHT

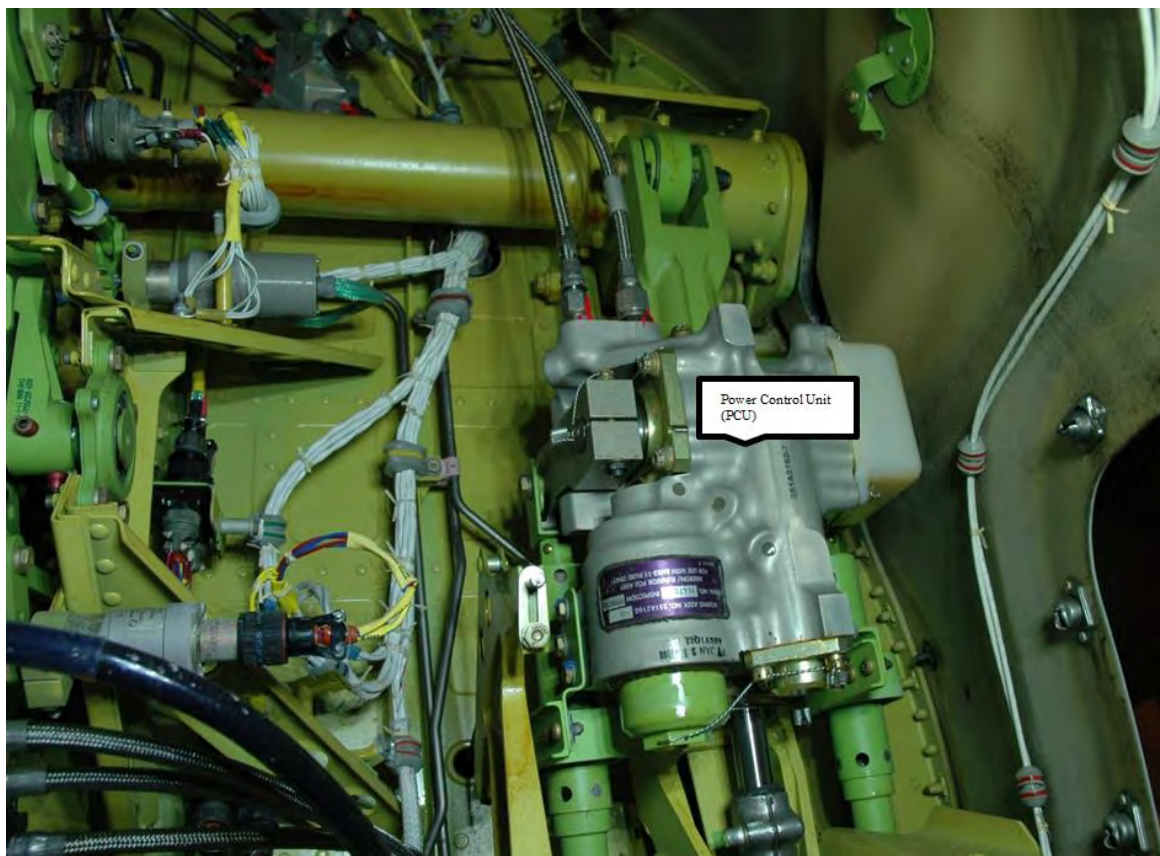
Figur 7: Foto tatt inne i Tail Cone Compartment og viser baksiden av høyre PCU på LN-DYM (31. januar 2013). Foto: SHT

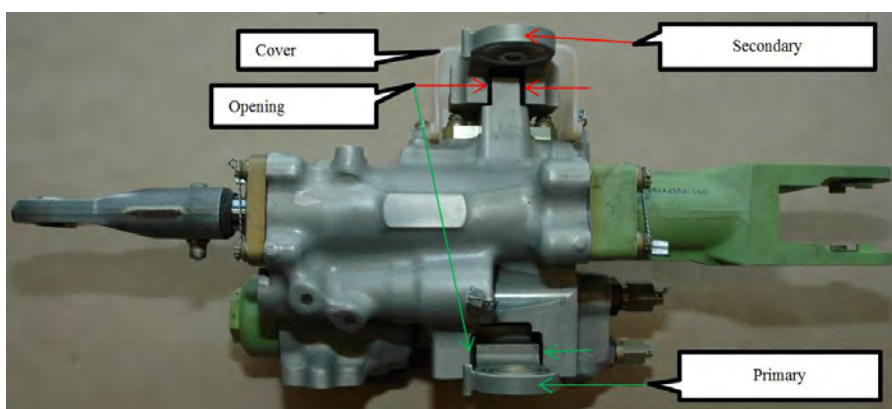
- 1.6.3.8 Som det fremkommer av figur 8, har sekundærarmene på PCU'ene et deksel som delvis omslutter styrearmene, mens primærarmene ikke har noe beskyttelsesdeksel. Dekselet omslutter styrearmen bakover, men har åpning i flyets fartsretning.

Figur 8: Viser framsiden av en PCU. Legg merke til de trange spaltene ("opening") hvor et fremmedlegeme/is kan blokkere bevegelse av primær og sekundær styrearmene og dermed hindre normale utslag på PCU (aktuator) Foto: SHT

- 1.6.3.11 Havarikommisjonen har målt spalteåpning på en Power Control Unit til å være ca. 1,9 mm (0,075 tomme) (merket "opening" på figur 8). Styrearmene skal således bevege seg svært lite fra nøytralposisjon hvor høyderoret blir stående i den posisjon det er, og til å gi styresignal om at PCU'en skal bevege høyderoret i retning opp eller ned. Dette medfører at dersom det legger seg et fremmedlegeme/is som blokkerer spalteåpningen, vil dette påvirke normal styring av høyderoret.
- 1.6.3.12 Basert på at ferdskriverdataene påviste at blokkering av Power Control Unit hadde forhindret flyets normale høyderorsfunksjon (se figur 1 og kapittel 1.11.1), har

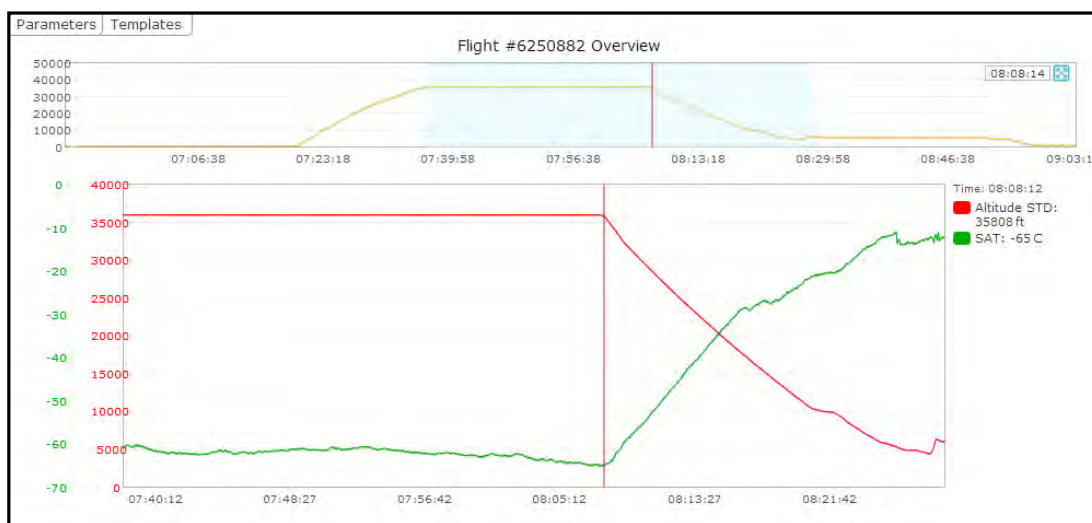
- 1.7.3 NAX5630 fløy Helsinki – Kittilä i flygenivå FL360, tilsvarende ca. 36 000 ft. På flyets ferdskriver er det registrert en utvendig temperatur på mellom -60 og -65 °C i marsjhøyden (se figur 9).

Figur 9: Viser utvendig temperatur (SAT) fra flyet var etablert på marsjhøyde og frem til like etter hendelsen i Kittilä. Kilde: SHT (data hentet fra flyets ferdskriver)

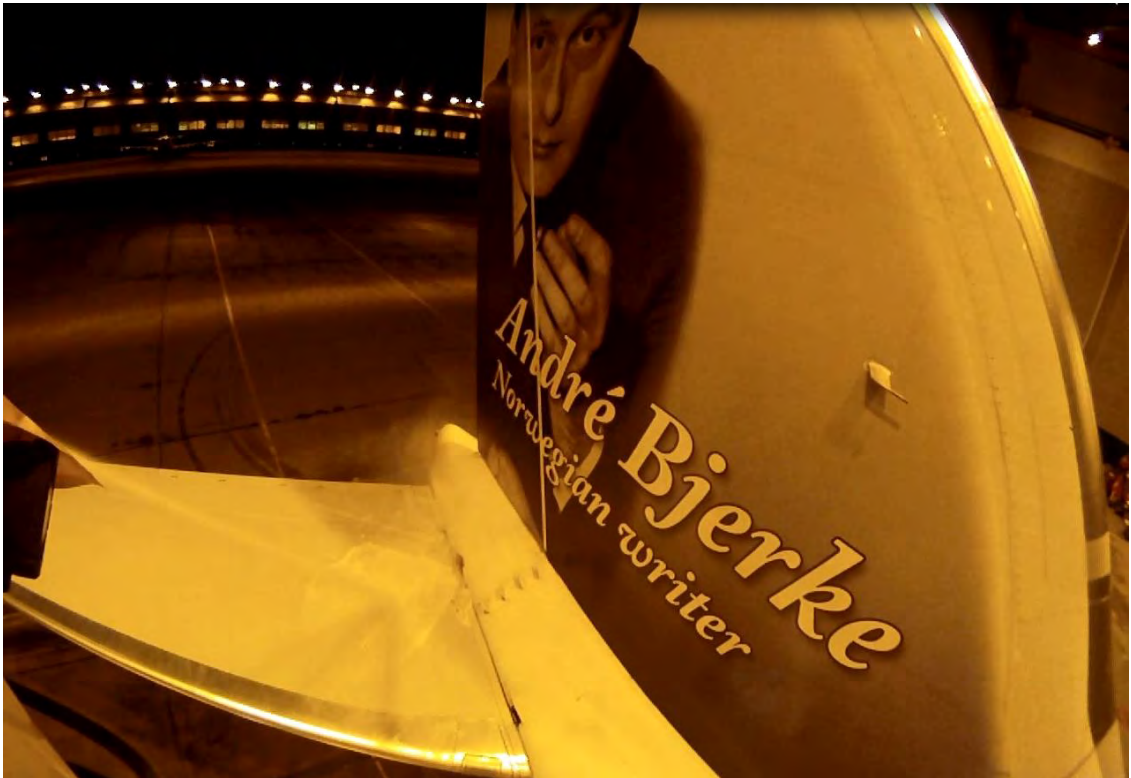
Figur 10: Spraytesting med oppmerkede forskjellige vinkler på LN-DYM horisontal stabilisator og høyderor. Foto: SHT

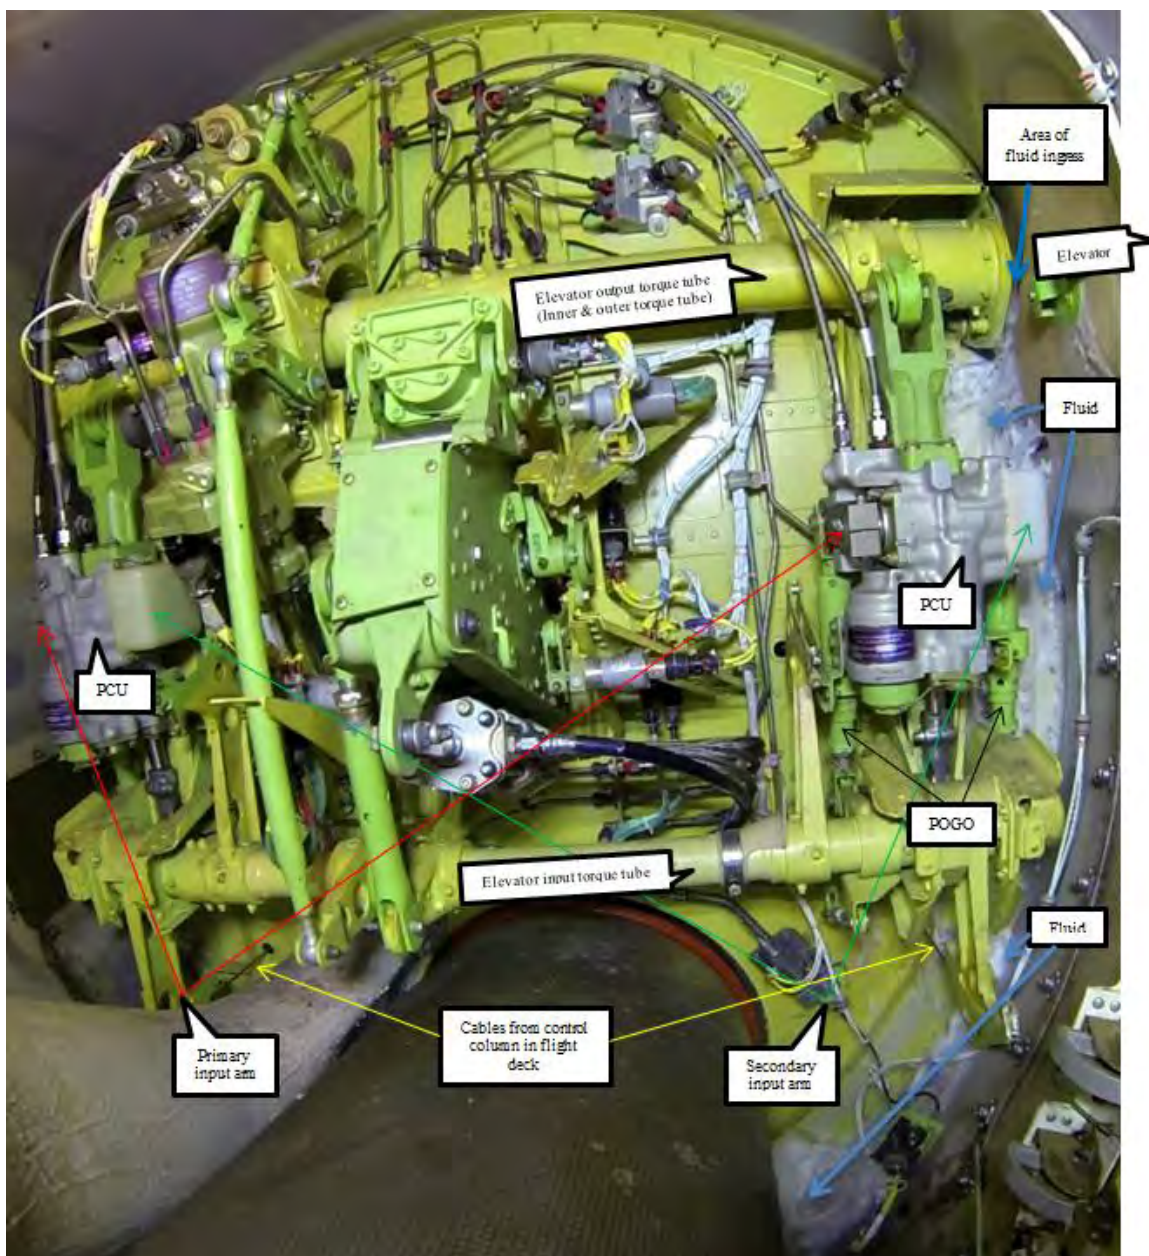
Figur 11: Viser væskeinntrengning og mulighet for sprut mot styrearmene på PCU'ene. (Foto tatt i flyets fartsretning i forbindelse med simulert avising av flyets høyre side.) Røret nederst på bildet er eksosrøret fra flyets hjelpemotor (Auxiliary Power Unit APU). Foto: SHT

2.4.1.3 SHTs undersøkelser avdekket at det kom relativt betydelige mengder væske og fuktighet inn i Tail Cone Compartment på flytypen Boeing 737 og at alle de fire styrearmene på flytypens to høyderors PCU'er er eksponert for sprut fra væskeinntrengingen ved avising. Dette i kombinasjon med kalde metalliske styrearmene, kan medføre at det dannes is i den smale spalten (se figur 8). Dette forhindrer normal operasjon av høyderor. SHT mener det, etter all sannsynlighet, var is som blokkerte LN-DYM sitt høyderor 26. desember 2012.

- c) I forbindelse med avising av Boeing 737 vil væske og fuktighet trenge inn i halepartiet (Tail Cone Compartment). Høy fuktighet og sprut mot kalde styrearmene kan gi isdannelse.

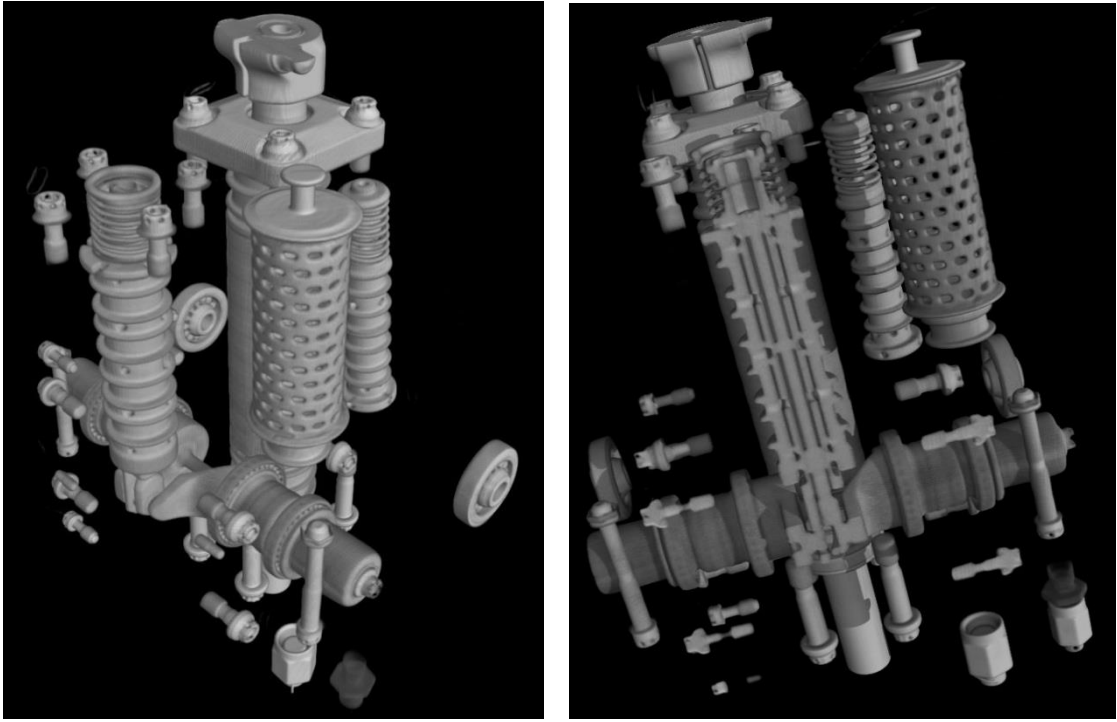
- 1.19.3 Under CT-scanningen ble det benyttet kraftig utstyr med 1 MeV spenning for å generere røntgenstrålen. Totalt ble det laget et antall på 655 snittbilder langsetter PCU'ene for hver 0,4 mm avstand. Hvert pixel innen hvert snittbilde målte 0,137 x 0,137 mm. Alle snittbildene ble deretter, av NTSB, lagt inn i et 3-dimensjonalt dataprogram som gjorde det mulig å presentere tydelige bilder av de innvendige komponentene (se eksempel i figur 19).

Figur 19: Eksempler på bildene fra CT-scanningen. Foto: NTSB

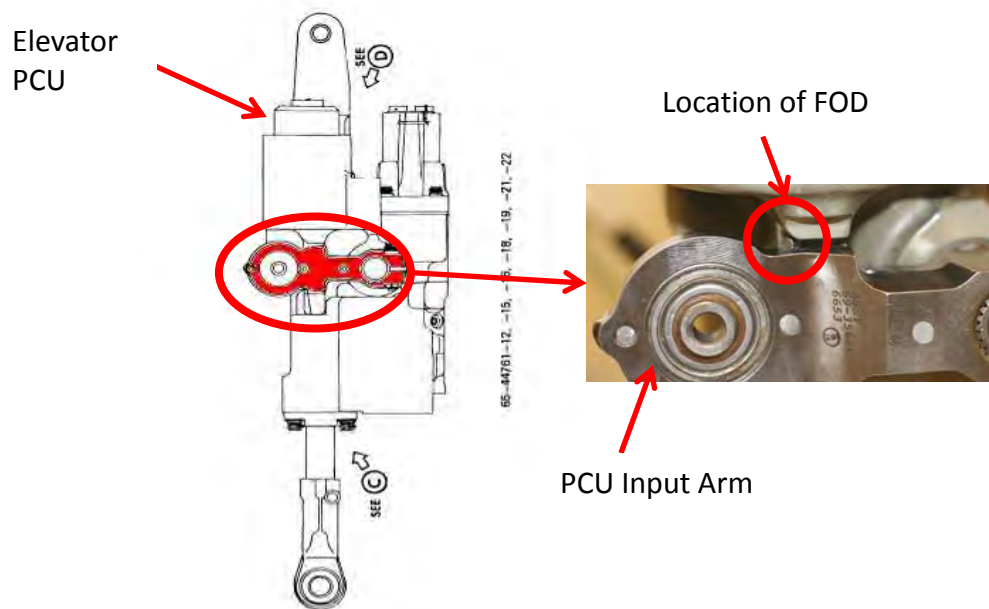
The NTSB's investigation found that the incident was caused by an uncommanded elevator deflection as a result of a left elevator power control unit (PCU) jam due to foreign object debris (FOD). The FOD was a metal roller element (about 0.2 inches long and 0.14 inches in diameter) from an elevator bearing. During its investigation of this incident, the NTSB identified safety issues relating to the protection of the elevator PCU input arm assembly, design of the 737 elevator control system, guidance and training for 737 flight crews on a jammed elevator control system, and upset recovery training.

Figure. Location of FOD.

⁷ In addition to the metal bearing roller that caused the jam, a second metal bearing roller was found resting at the bottom of the tailcone near the drain hole, mostly buried in debris. Boeing's metallurgical analysis revealed that both metal bearing rollers had the same dimensions and material as the rollers that are installed in two locations in the aft elevator control system (the right and left ends of the elevator upper output torque tube crank assembly).

Once Boeing has developed a method to protect the elevator power control unit input arm assembly on 737-300 through -500 series airplanes from foreign object debris as requested in Safety Recommendation A-11-7, require operators to modify their airplanes with this method of protection. (A-11-8)
