REPORT

SL 2015/06

REPORT ON AIR ACCIDENT AT SOLLIHØGDA IN BUSKERUD, NORWAY 14 JANUARY 2014 WITH AIRBUS HELICOPTERS EC 135 P2+, LN-OOI OPERATED BY NORSK LUFTAMBULANSE AS

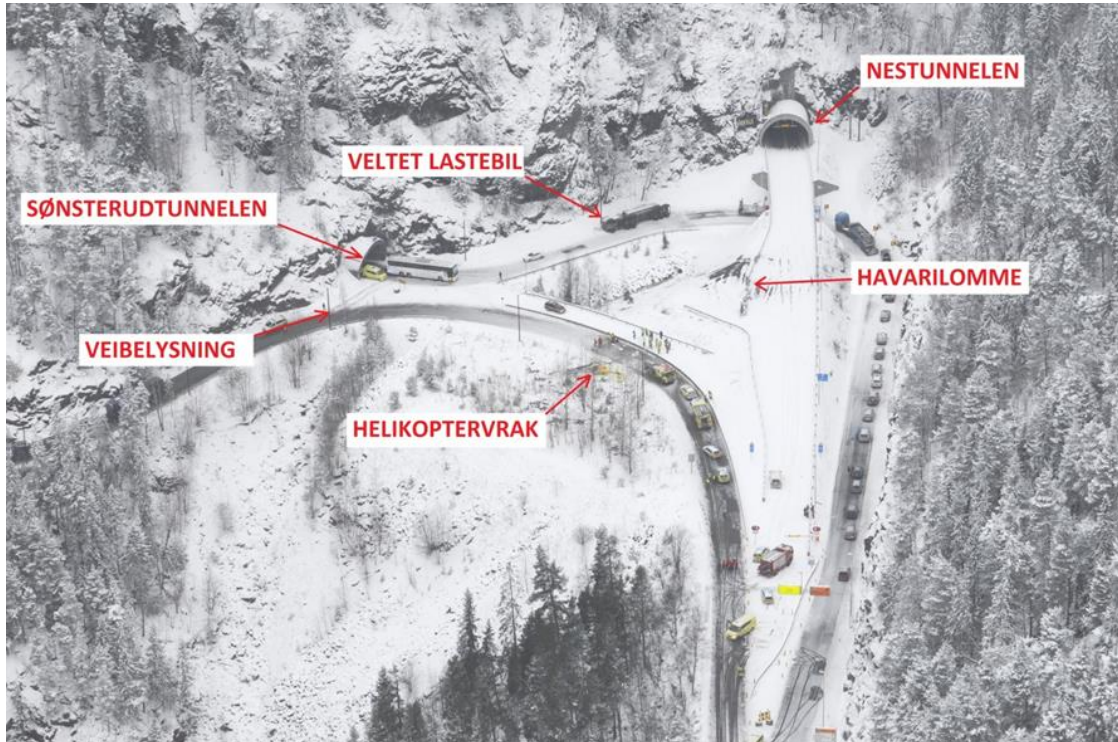
Figure 1: Photo of the crash site seen towards north shortly after the accident had occurred.
Photo: the Police

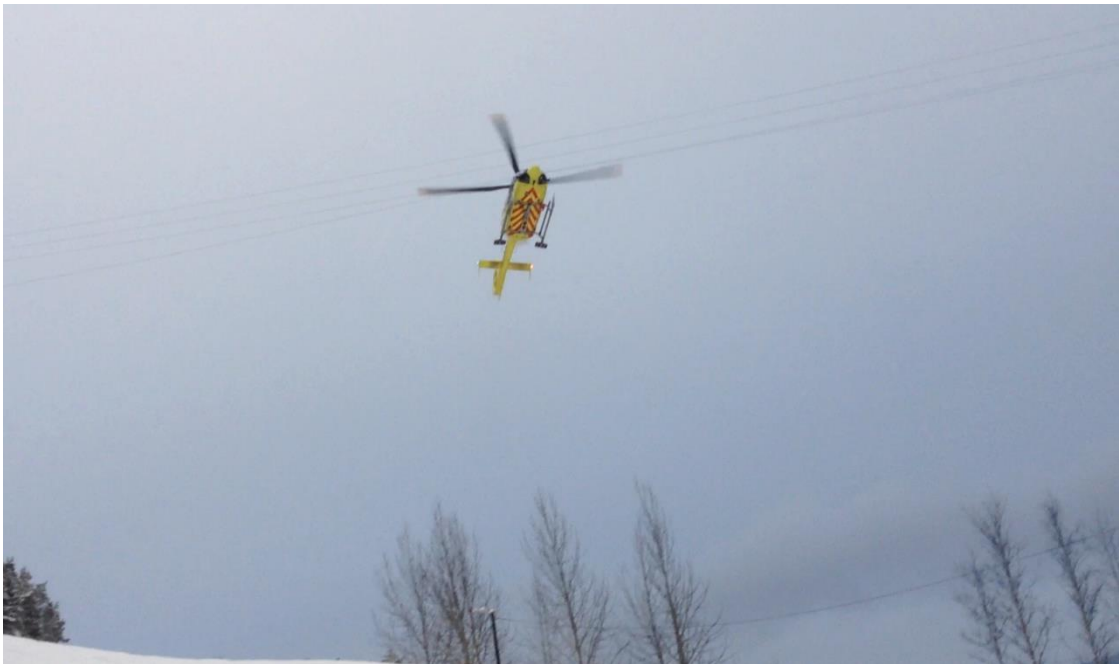
Figure 2: The helicopter has hit the lower line with the wire cutter and pulled it in the direction of flight. The main rotor rotate under the live lines. The line between the street lights along the E16 entry ramp is visible in the bottom of the photo. Photo: Still image from a private video recording

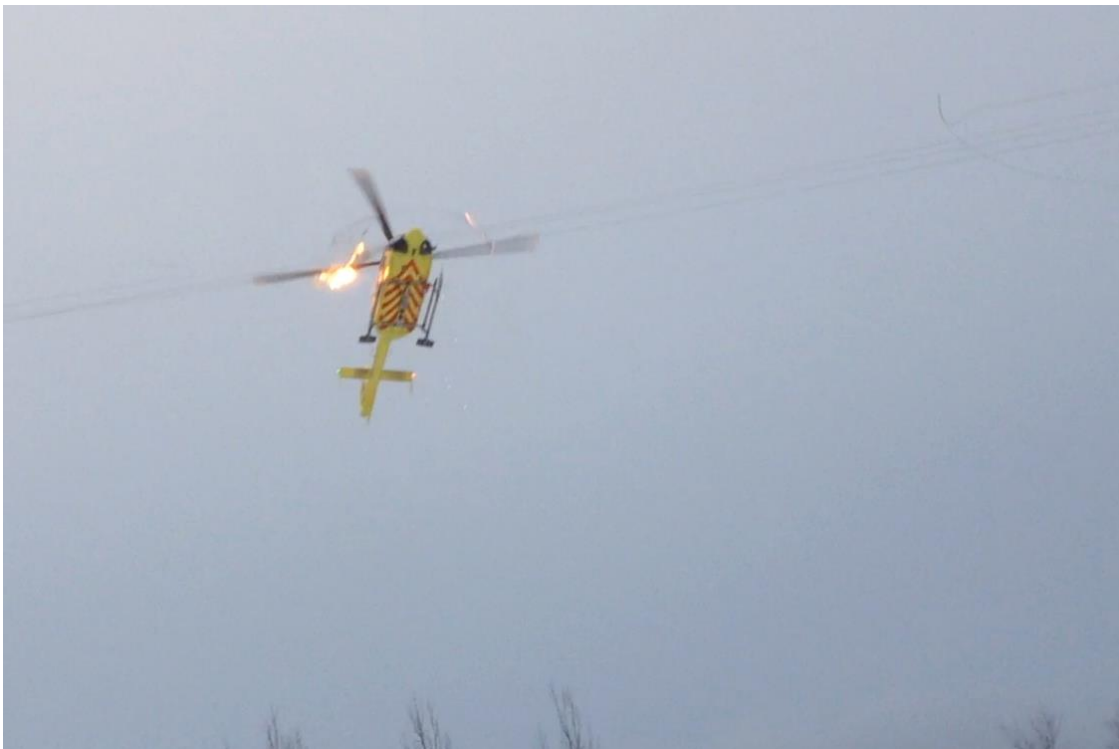
Figure 3: Immediately after the main rotor has cut one of the live lines. One of the ends of the line is moving out of the image towards the right. Another section of the line is about to be slung by the rotor. Photo: Still image from a private video recording

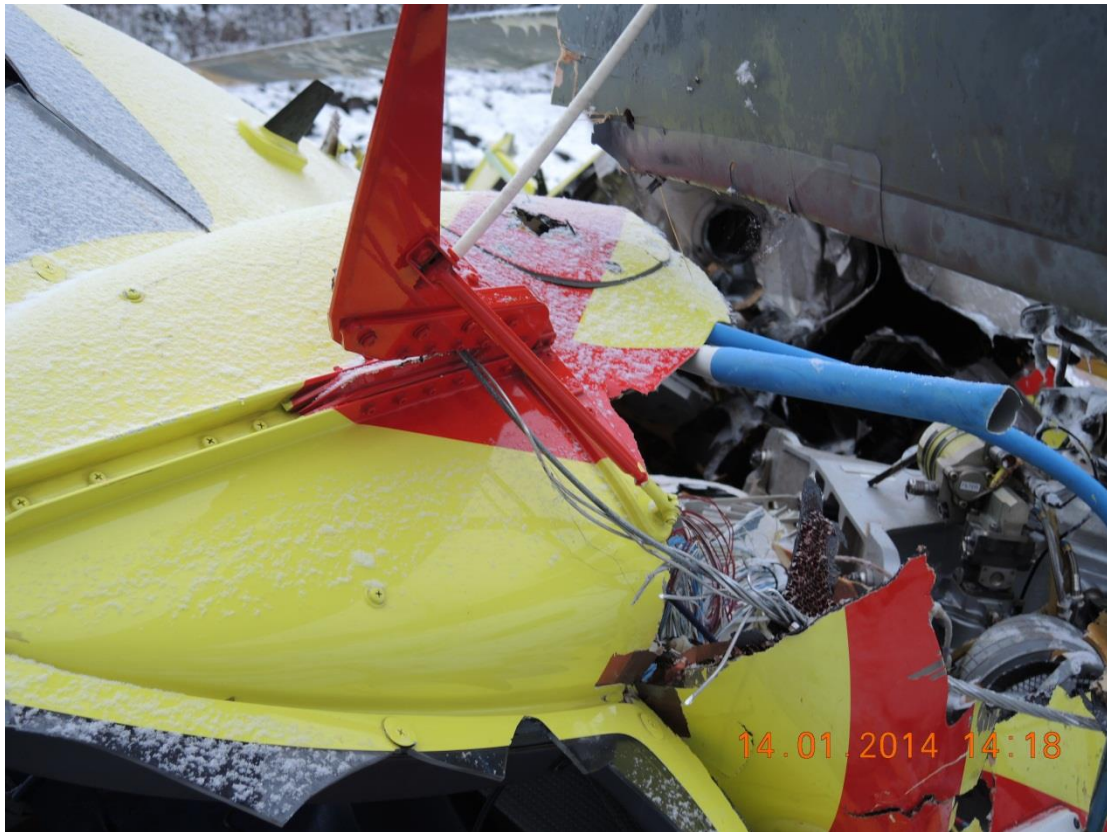
Figure 5: One of the lines from the power line stuck in the wire cutter on the cockpit roof on LN-OOI. Photo: AIBN

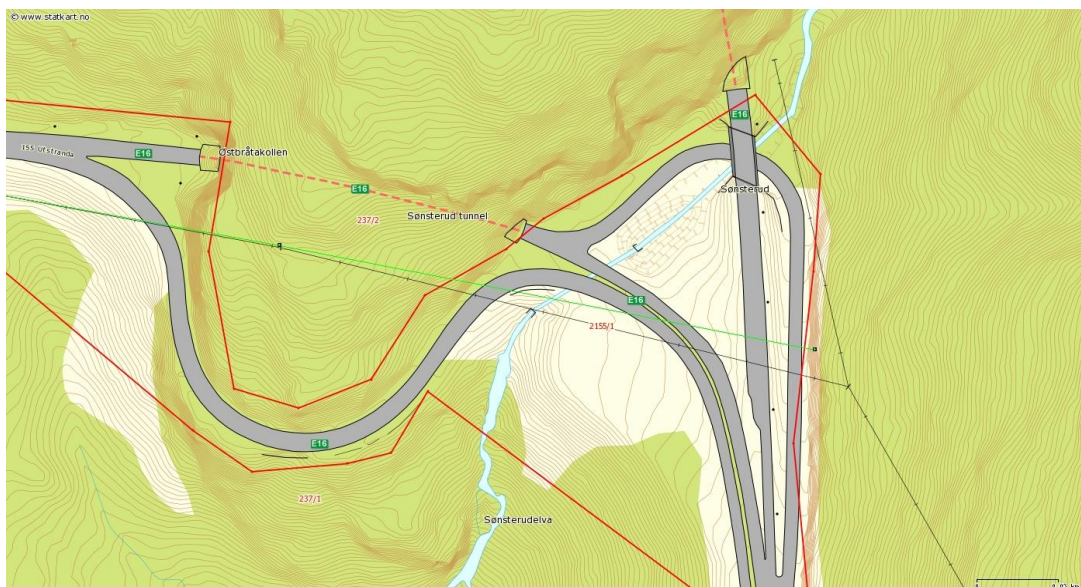
1.8.3.6 The power line at the accident site had a maximum height of 35 metres above the terrain¹³. It was thus subject to reporting requirements, but not subject to marking requirements in accordance with the applicable regulation (see Item 1.17.5.1). The low power lines between the lamp posts were not subject to reporting or marking requirements.

Figure 6: Segment from the Norwegian Mapping Authority's map of the accident site with obstacles from FKB. The green line represents the power line in question, drawn in with data from the NRL. The power line is registered in the NRL because it is higher than 15 m. The black line is the same line drawn in with data from FKB. See Figure 10 for more information.

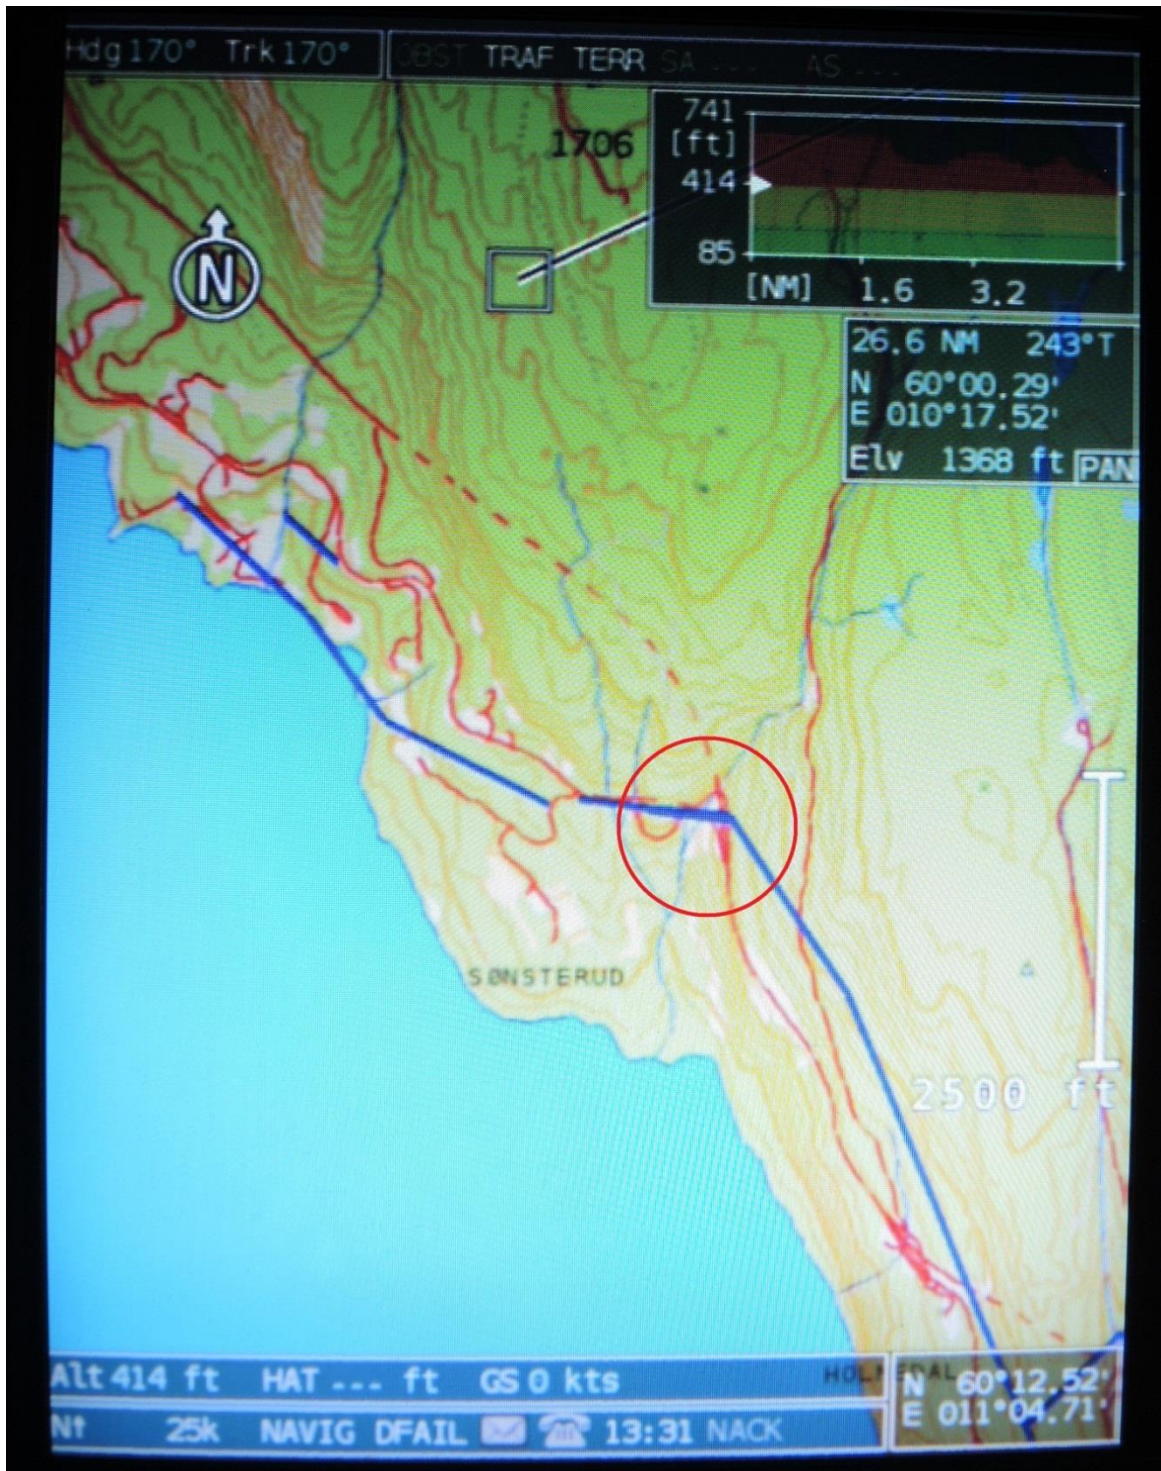
- 1.8.4.3 In Figure 9 below there is a picture of the accident site with the power line as presented on EURONAV with normal display of 1:25 000 vectorised map (see also Item 1.8.6.1). Figure 10 shows the same area with a maximum zoom on 1:25 000 vectorised map. Power lines lower than 60 m have no height indication and are represented as a blue line. The presentation seemingly indicates two lines. This is because the presentation is reiterating two obstacle databases. One of the databases is from 2007 and is currently managed by Norsk Luftambulans AS. The database contains several aviation obstacles

Figure 9: The accident site and overhead line with a normal display of 1:25 000 vectorised map from EURONAV. The red ring around the crash site was added by the AIBN. Photo: AIBN

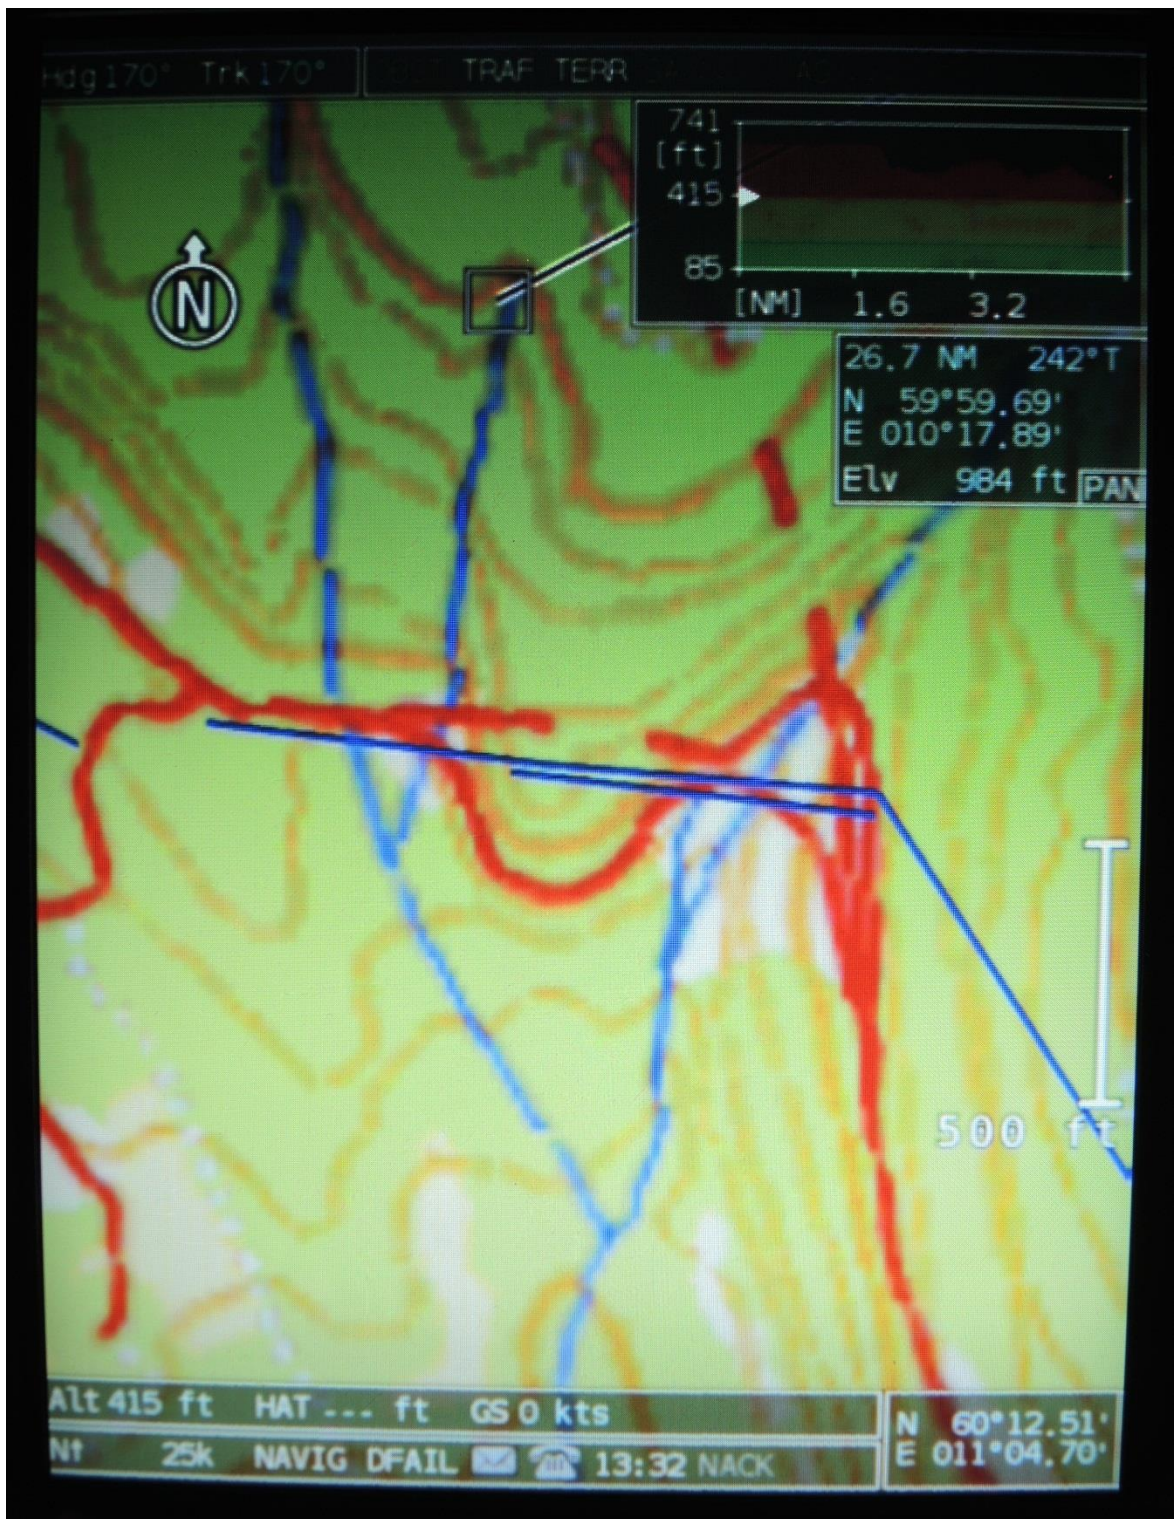
Figure 10: Segment from the same map as Figure 9 with maximum zoom. The presentation seemingly indicates two overhead lines. There is really only one power line, but with data collected from two different databases that both contain inaccuracies. Photo: AIBN

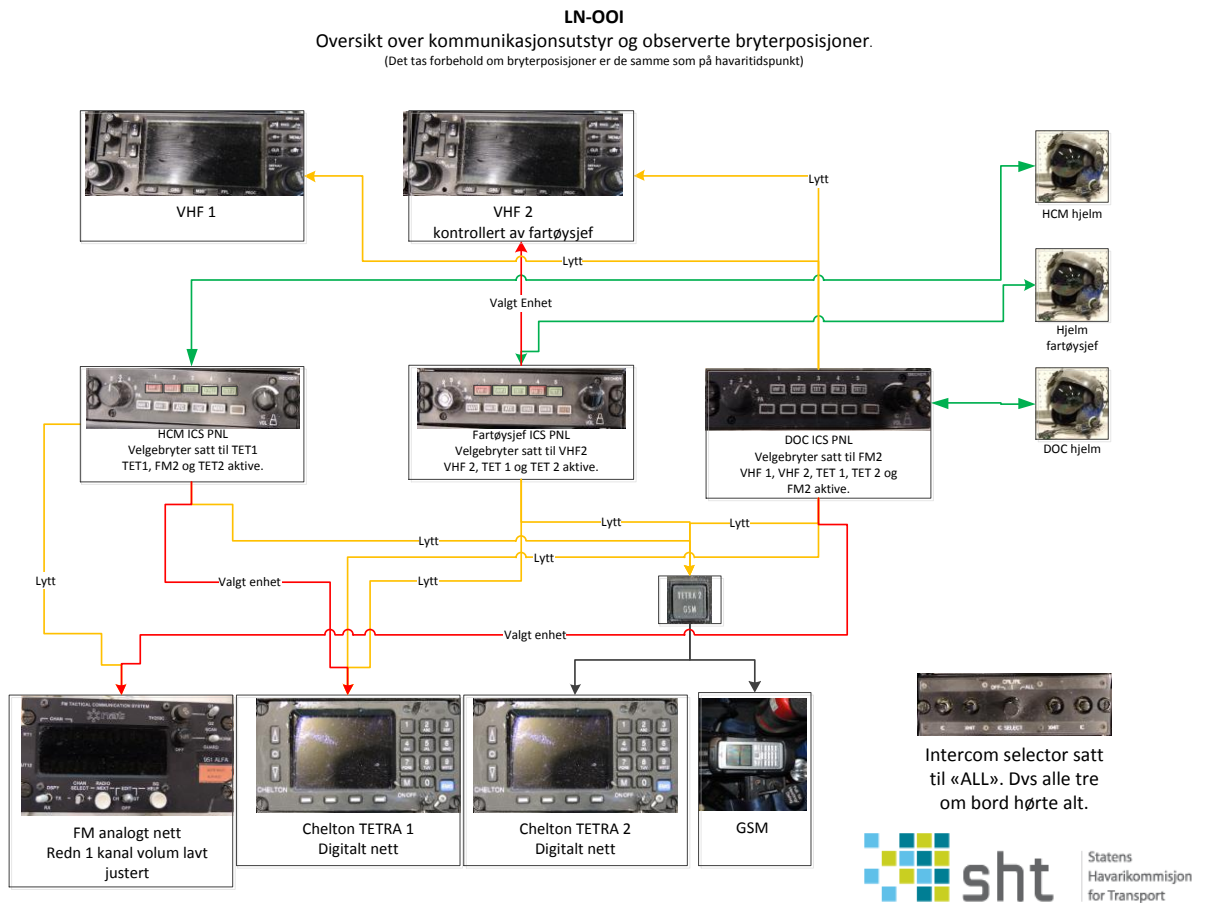
- 1.9.1.3 Below is a simplified principle drawing with the relevant settings when LN-OOI crashed, as found by AIBN when the helicopter was investigated. The red line represents the unit selected for transmission (and listening) and the yellow line indicates the unit that could only be listened to.

Figure 11: Diagram of communications equipment in LN-OOI. Source: AIBN

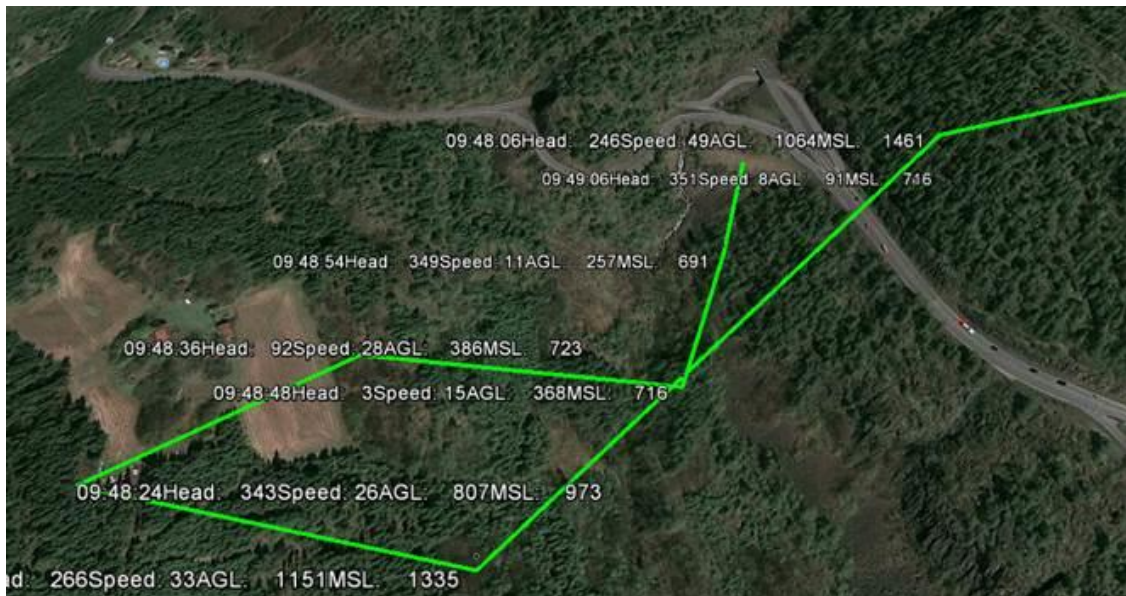
Figure 12: Approach repeated with Time, Heading, Speed, AGL and MSL Map source: NLA/Google Earth

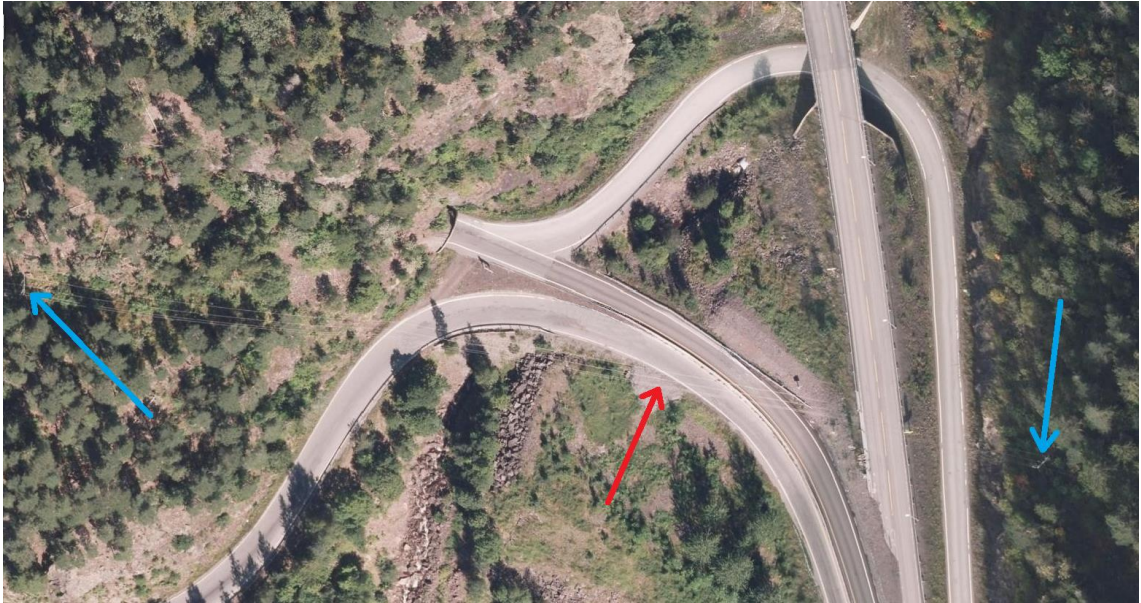
Figure 13: Photo from the area showing the crash site (red arrow) and power line towers (blue arrow). The lamp posts and lines between these are not shown in the photo. E16 runs north-south in the photo. The work on the emergency lay-by south of the tunnel had not started when the photo was taken. Source: National Roads Database (cars on the roads have been removed using Photoshop)

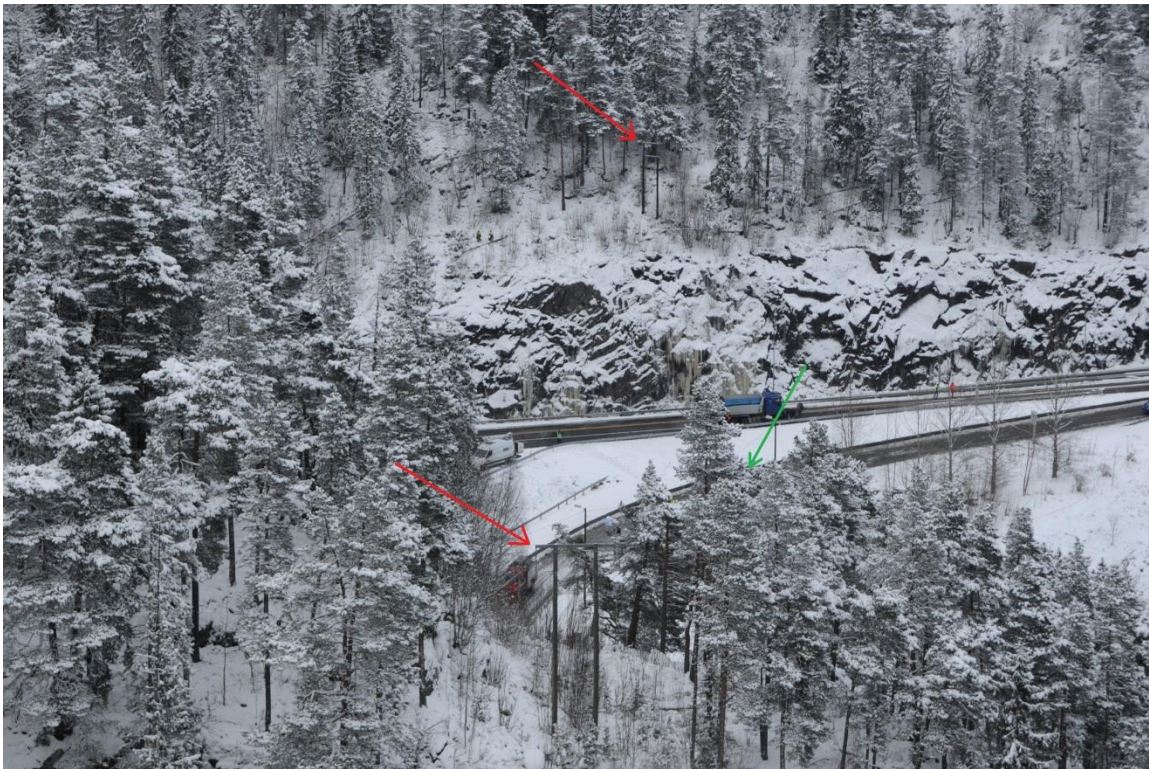
Figure 15: Photo taken facing east on the same day as the accident. The power line poles are marked with red arrows. The helicopter wreckage is located behind the trees marked with a green arrow. Photo: The Police

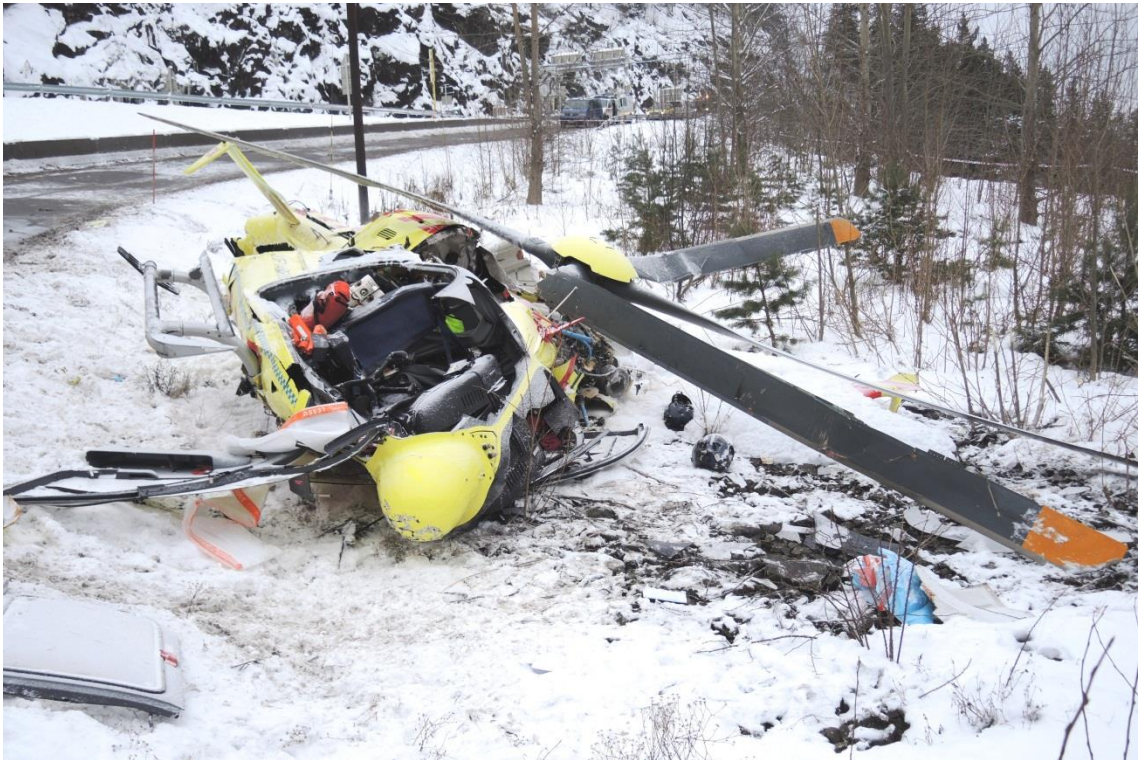
- 1.12.2.1 The helicopter wreckage remained in mostly one piece next to the road (see Figure 16). Only a few small parts, mainly composite materials, fell off. The helicopter was partially leaning to the left. The entire top of the cabin structure was pushed sideways to the left. The left skid was split into three parts, and had broken off at the attachment.

Figure 16: The helicopter wreckage lying next to the road. Photo: AIBN

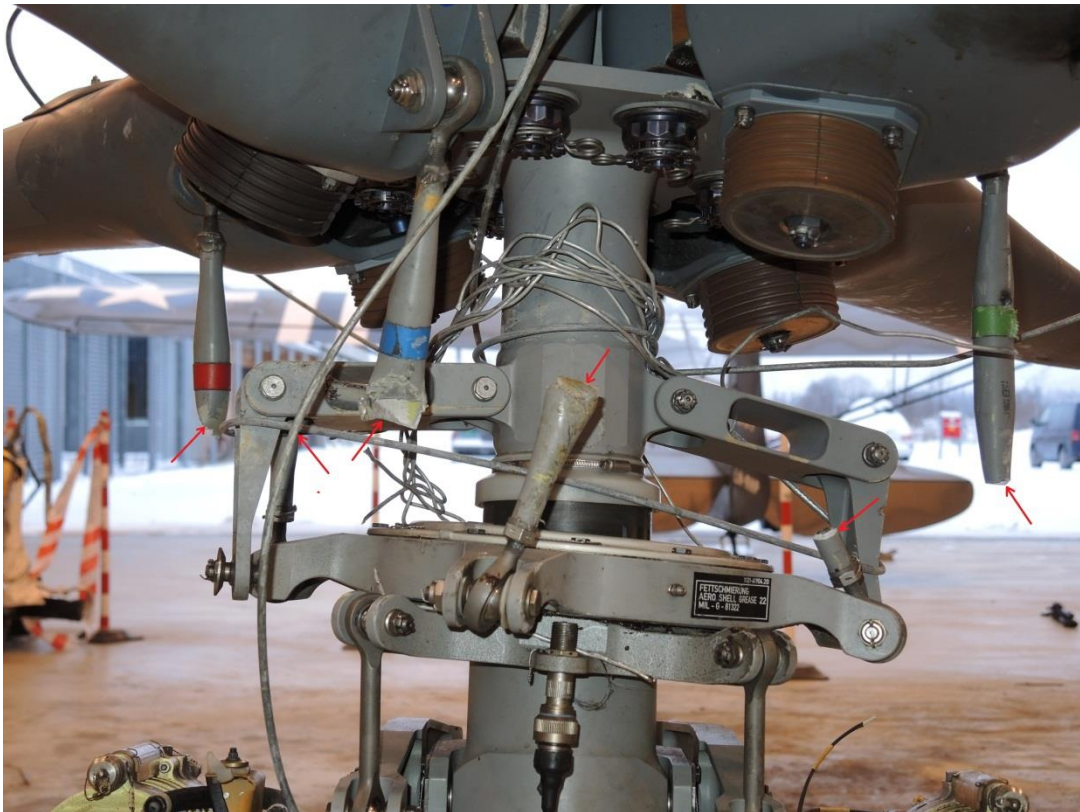
- 1.12.2.6 The four main rotor blades were attached to the rotor head, but the "red" blade had snapped 90 cm from the blade root. Large parts of the "green" blade had delaminated and the embedded bonding had burned away at a length of 304 cm. Two other blades also bore clear signs of contact with the high voltage lines and traces of arc faults. All four pitch links had been cut, and part of a high voltage line was coiled around the main rotor mast (see Figure 17).

Figure 17: Rotor head, rotor mast, pitch mechanism and parts of the power line. Cut pitch links are marked with red arrows. Photo: AIBN

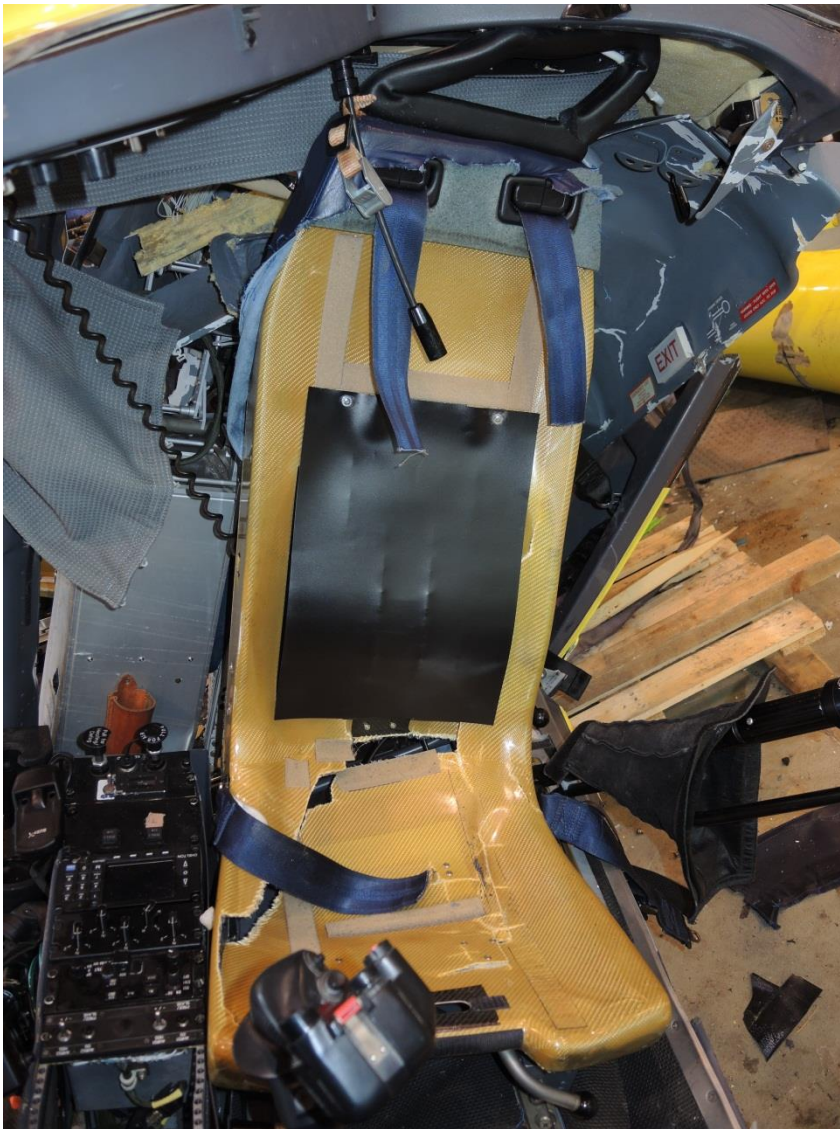
- 1.15.3.5 The seat structure in the three seats that were occupied has been overloaded, causing both the seat plate and back to tear (see Figure 18). The seats are designed and tested to withstand loads of 20 G vertically and 8 G sideways (horizontally). Fischer+Entwicklungen has stated that the loads that occur during collisions at speeds of 18.5 m/s, far exceed the loads which the seats are designed to withstand.

Figure 18: The HEMS crew member's seat after seat cushions and padding were removed. Both the seat back and seat plate tore. On the top you can see the headrest, which is crushed down to the left of the cockpit ceiling. The seatbelts were cut in connection with the rescue operation.
Photo: AIBN
