# REPORT

SL 2015/08

## REPORT ON AVIATION ACCIDENT 24 JUNE 2014 AT HJERKINN IN DOVRE MUNICIPALITY, OPPLAND COUNTY INVOLVING AIRBUS HELICOPTERS AS 350 B3E, LN-OSY

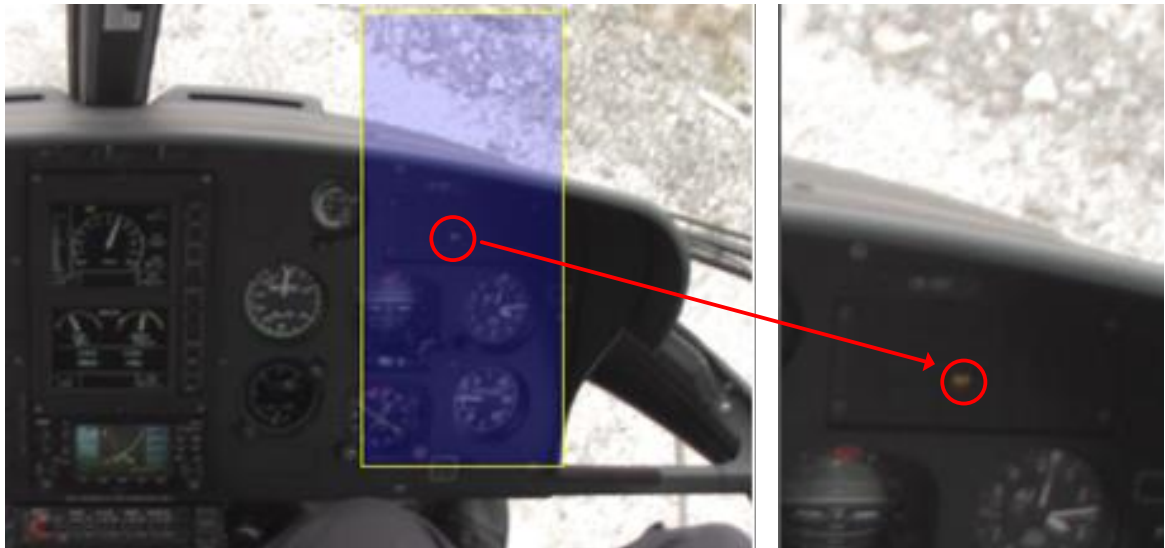
Immediately after take-off from the helipad, the yellow GOV light on the Caution and Warning Panel (CWP) illuminated, and a few seconds later, the engine started losing power.

- 1.1.4 All passengers fastened their seatbelts, and a normal start was performed. The helicopter lifted to hover and rotated approximately 30 degrees right due to wind and choice of appropriate take-off path. The helicopter then accelerated. When the commander glanced at the instrument panel again, he observed the yellow GOV light on the CWP (see Figure 1). The helicopter had then moved outside the edge of the helipad.

Figure 1: First data frame from Appareo Vision 1000 showing lit yellow GOV light. Source: Pegasus Helicopter

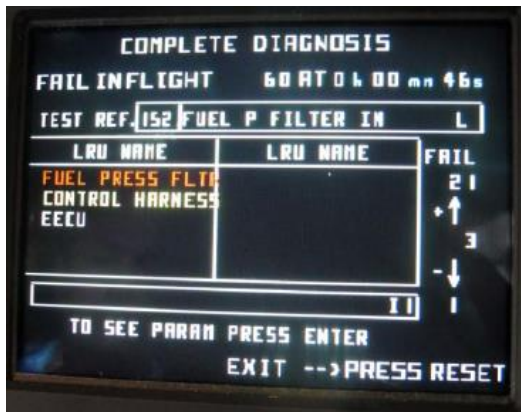
1.11.4.3 It was possible through sub-menus to see that the VEMD had registered failures in the fuel pressure at both the inlet and outlet of the fuel filter (see Figure 9). This was registered simultaneously via both channels in FADEC 1 minute and 32 seconds after VEMD had started to register data for the flight (from engine start). The pressure sensors are located as indicated in Figure 10.

Figure 9: Fuel Press. failure report VEMD. Photo: Airbus Helicopters

Loss of fuel pressure was the most likely cause of the engine's loss of power. The pressure sensors on each side of the HMU fuel filter registered the pressure drop simultaneously. When the engine did not respond to the fuel demand signal from the FADEC, the yellow GOV light on the CWP lit. Five seconds after the pressure break, the engine no longer had the expected performance due to lack of fuel, and the FADEC generated a P3 drift signal, which was saved as a fault message in the VEMD.

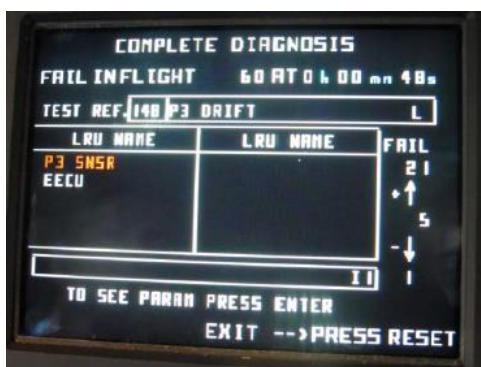
1.11.4.4 Four seconds after the VEMD reported loss of fuel pressure, a variation in the P3 sensor parameter was registered. The P3 sensor gauges air pressure at the outlet of the engine's compressor section. This was also registered in both channels in FADEC (see Figure 11).

Figure 11: P3 sensor failure VEMD. Photo: Airbus Helicopters

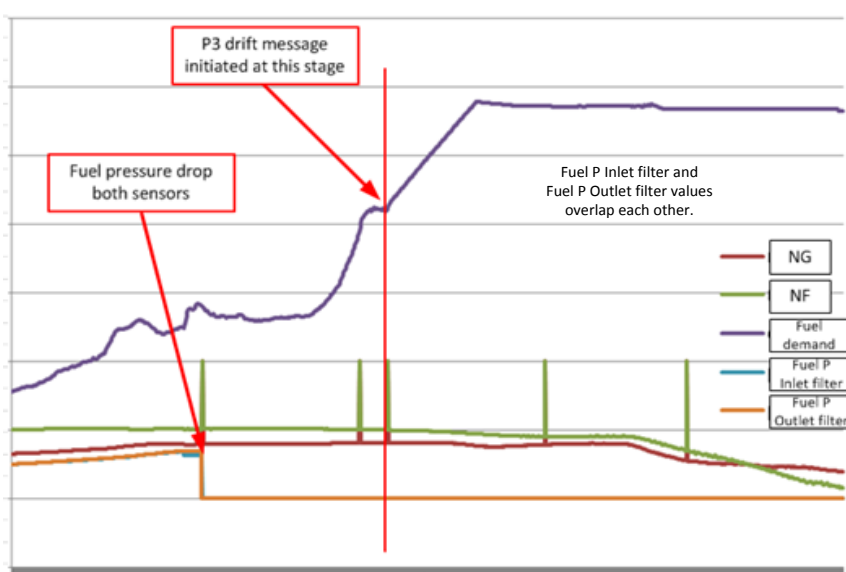
1.11.5.2 The graph in Figure 12 is an excerpt of the data available in FADEC. It shows the course of events for the period just before the fuel pressure was lost until just after the engine started losing power. Again, both fuel pressure sensors simultaneously registered pressure drop. Due to lack of engine response, the FADEC gave increasing fuel demand signal to the HMU. Approximately four seconds after loss of fuel pressure, the P3 drift message initiated, at the same time as the “fuel demand” signal from FADEC to HMU increased.

Figure 12: Graph with FADEC parameters. The five peaks on the NF and NG parameters are probably signal failures, and can be disregarded. Source: Turbomeca

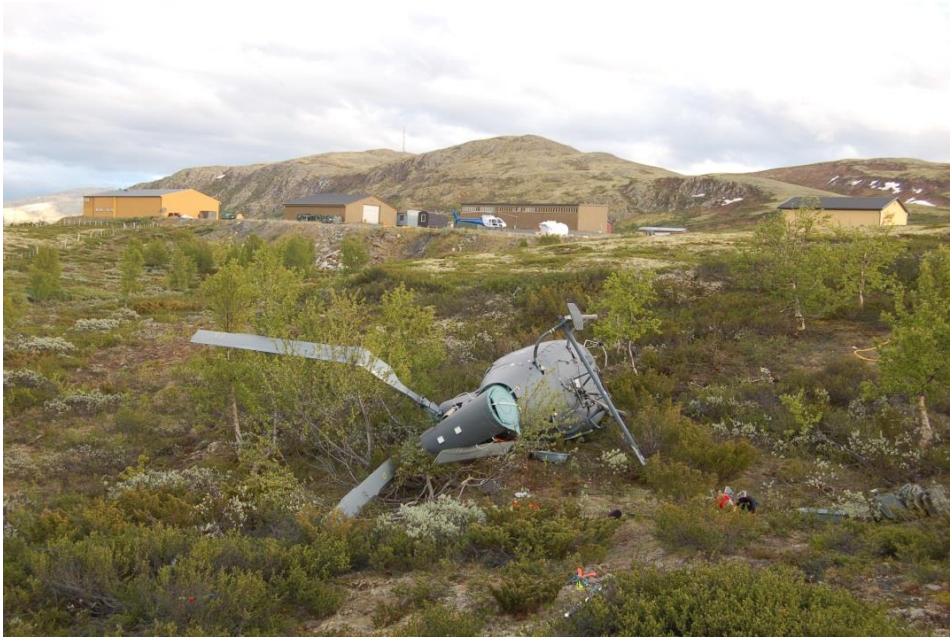
original flight direction. The tail boom broke off in the rotation, and the landing gear was deformed and partly detached (Figure 15). The main rotor blades and the starflex (rotor hub) were damaged as the helicopter hit the ground, while the suspension bars attaching the main gear box to the fuselage remained intact. The helicopter cabin and cockpit got extensive damage (see Figur 16).

Figure 15: Crash site and take-off site (in the background). Photo: AIBN

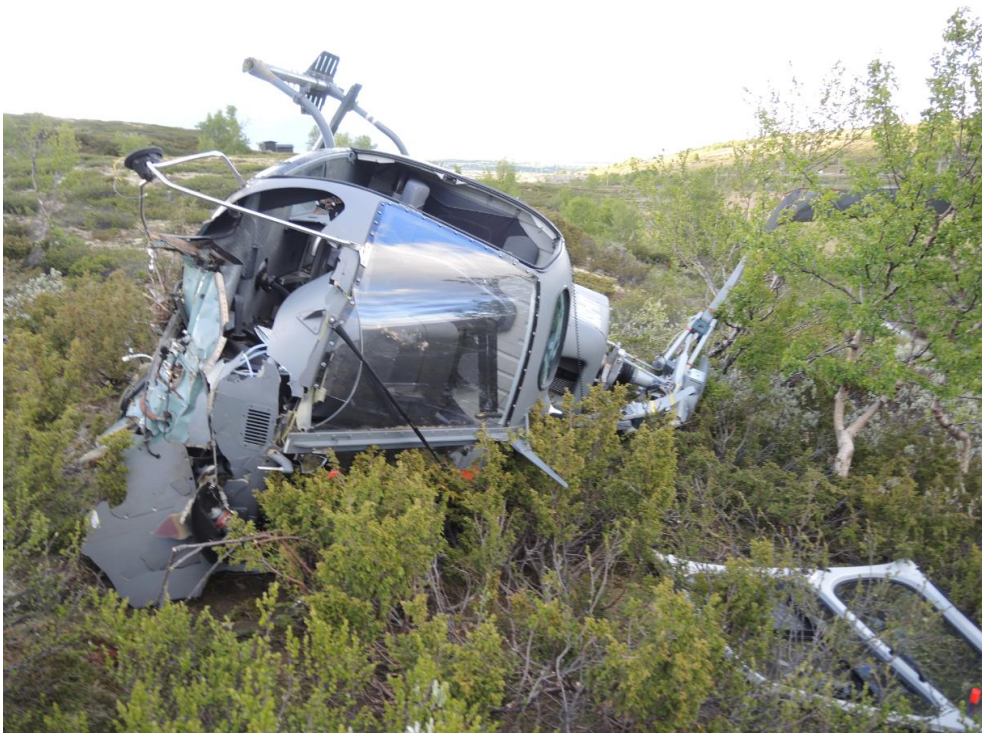
Figure 16: Damages in the nose section. Photo: AIBN

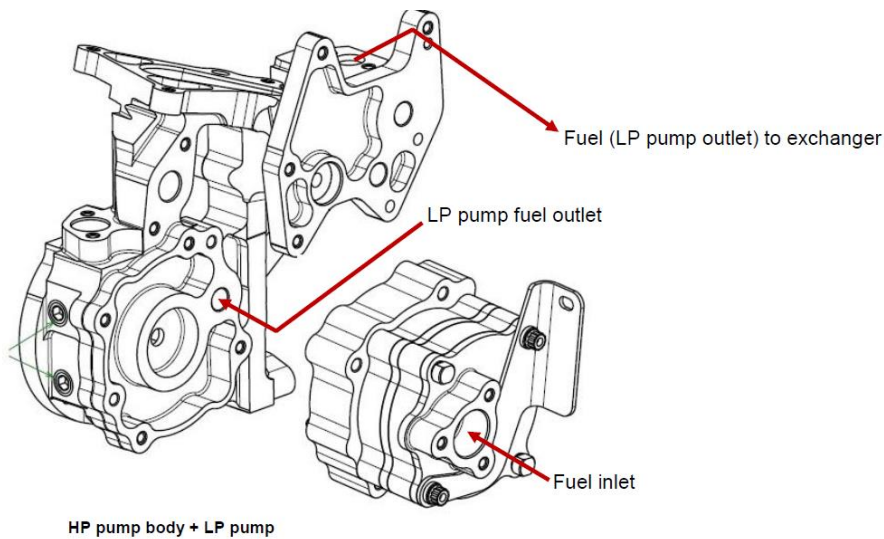
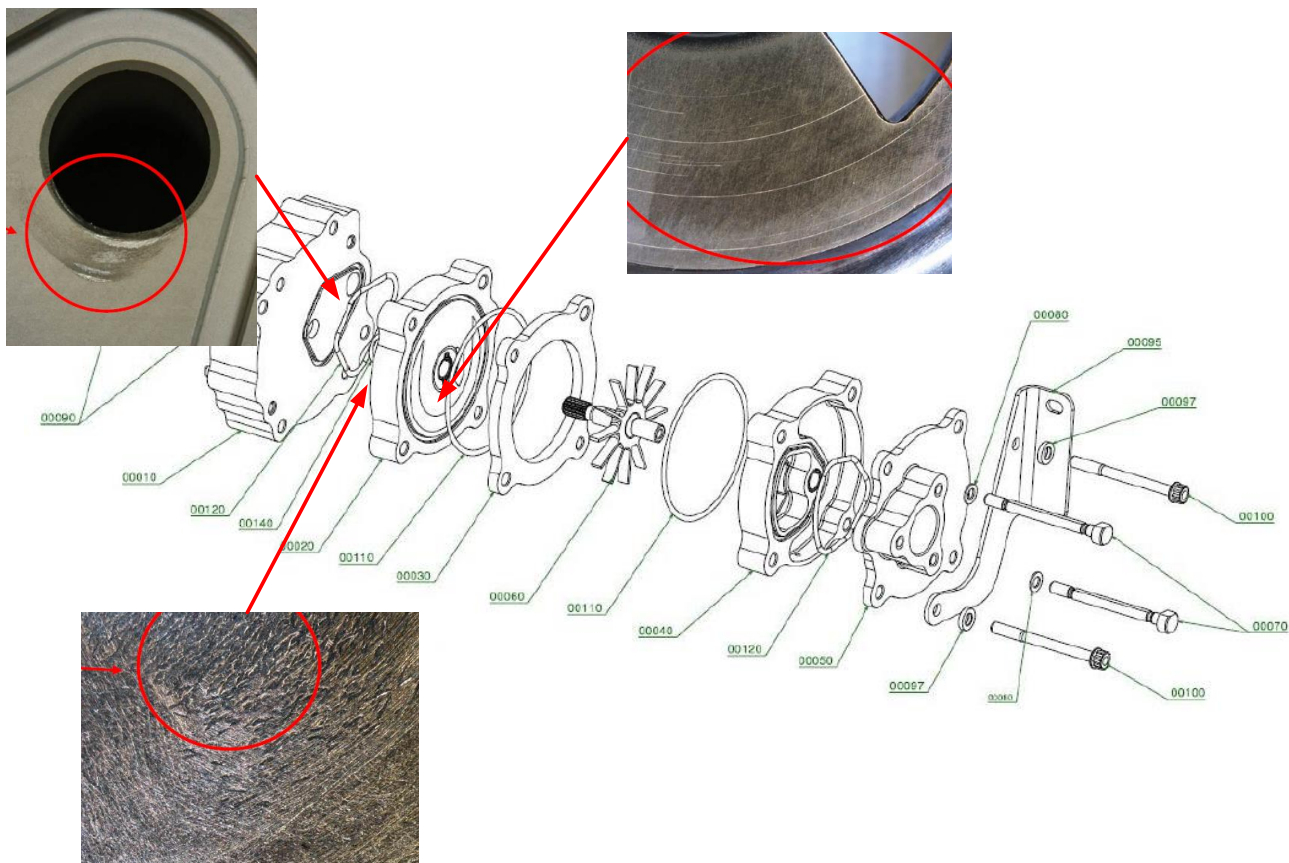
Scratches were found in the HMU aluminium casing. This indicates that foreign objects had passed the low-pressure pump and continued to the engine's fuel/oil heat exchanger (see Figure 19 and Figure 20).

Figure 19: HMU findings. Source: Turbomeca

Figure 20: Photos of some of the damage with location in the HMU. Source: Turbomeca

1.16.3.2 BEA completed a more detailed analysis of the damage in an attempt to establish what may have caused it. Using a scanning electron microscope (SEM), steel deposits were discovered, and in one instance, a 30µm particle was found embedded, consisting of aluminium oxide and zirconium.

- d) Malfunction of the engine's electronic and hydromechanic control systems has not been found.
- e) Nicks from foreign objects were found in the low-pressure pump housing and channels in the HMU. These nicks are not of such a nature that they would explain the fuel supply blockage.

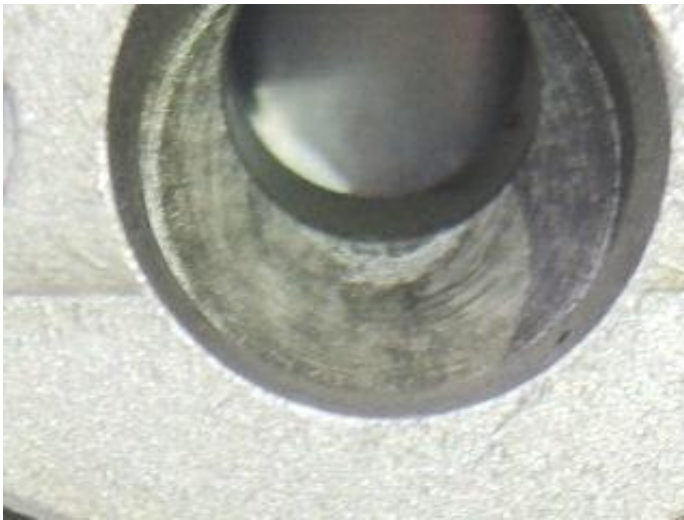
The engine's heat exchanger was dismantled after the test cell run for inspection. A mark was found in the fuel inlet port of the heat exchanger, but no foreign objects explaining the loss of fuel pressure were found inside the unit.

Figure 21: Mark in fuel inlet heat exchanger. Photo: AIBN

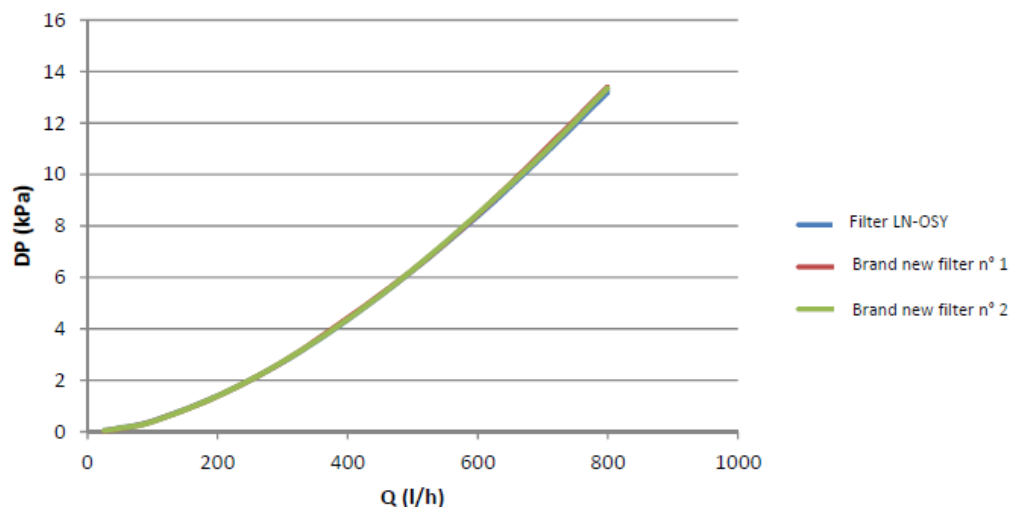
Figure 22: Test of fuel filter. Source: Turbomeca

The test showed that the filter installed on LN-OSY at the time of the accident followed the pressure drop characteristics of a new filter, and thereby did not have a larger pressure drop than a new filter.

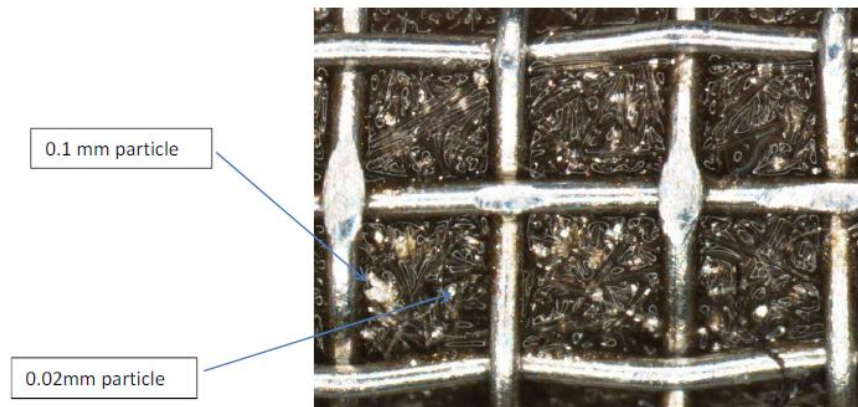
1.16.5.2 The filter was also examined for contamination. Some foreign elements in the form of metal particles and fibres were observed. The area on the filter that was closest to the fuel flow inlet from the low-pressure pump had the largest concentration of particles. This

area of the filter comprises approximately 1 % of the filter's total surface. The particles varied in size from 0.1 mm to 0.02 mm.

Figure 23: Fuel filter, particles at the filter inlet. Image: Turbomeca

The rest of the filter's surface (99 % of the filter's surface) was clean.
