REPORT

SL 2015/09

REPORT ON SERIOUS INCIDENT EN-ROUTE OSLO – TRONDHEIM, NORWAY, ON 25 SEPTEMBER 2014 TO BRITISH AEROSPACE ATP, SE-MAF OPERATED BY WEST AIR SWEDEN AB

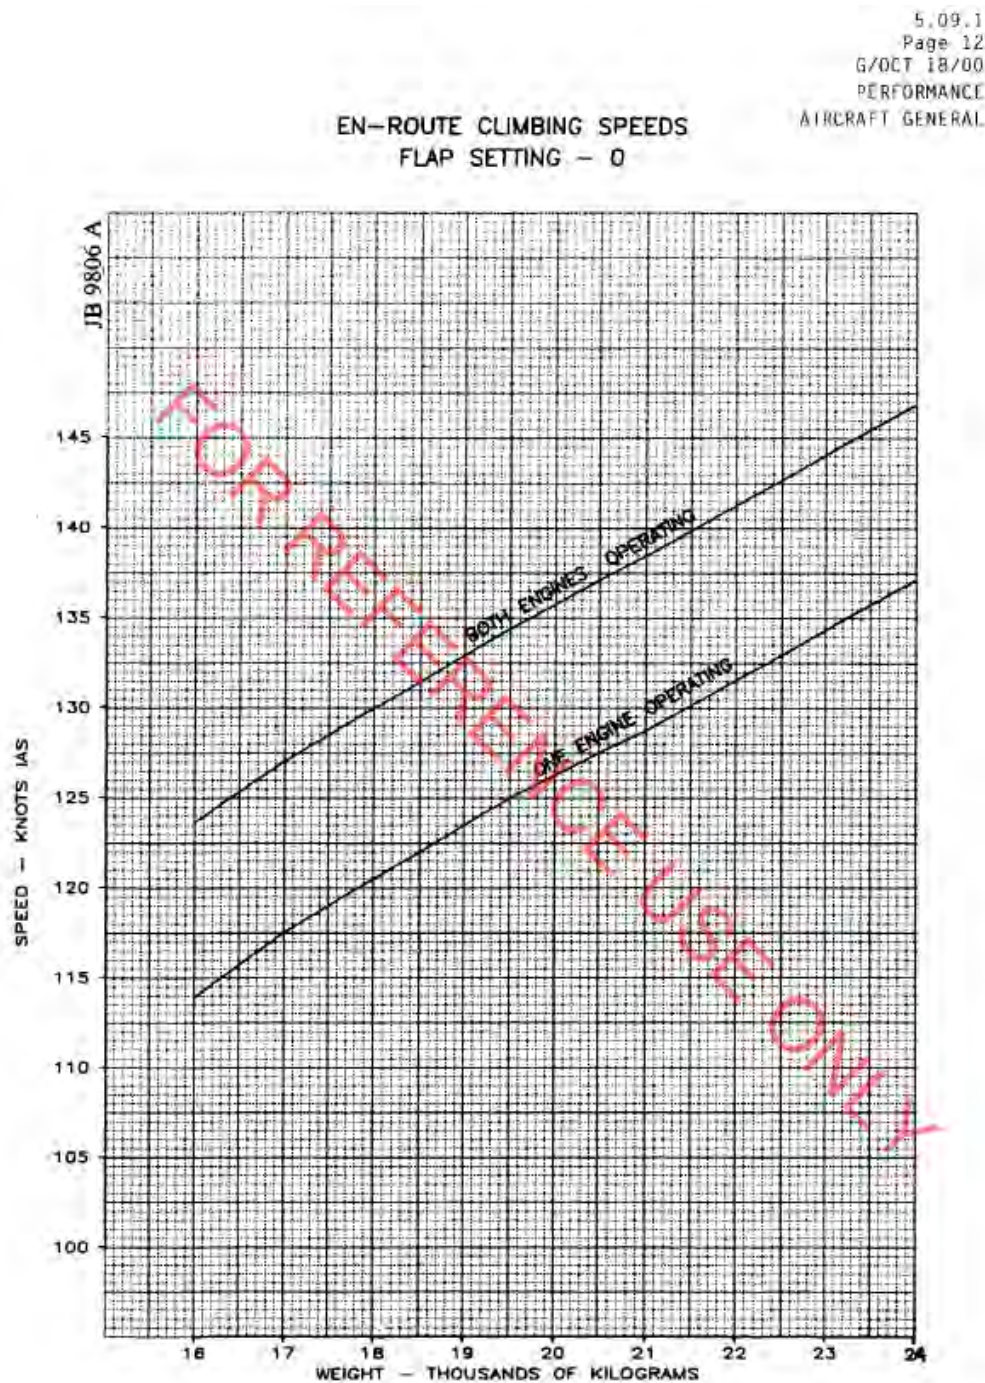
1.6.7.4 The procedure states that the speed in icing conditions should not be less than "Both engines operating en-route climb speed plus 15 knots". The figure referenced, 5.09.6 (here shown in Figure 4) is titled *En-Route Climbing Speeds Flap setting – 0*, it does not mention icing, and it is not found in the procedure text. It is located 120 pages further back, in the AFM's performance chapter.

Figure 4: British Aerospace's figure, which forms the basis for the calculation of the lowest recommended speed in icing conditions. (See also Figure 11.) Source: BAE Systems

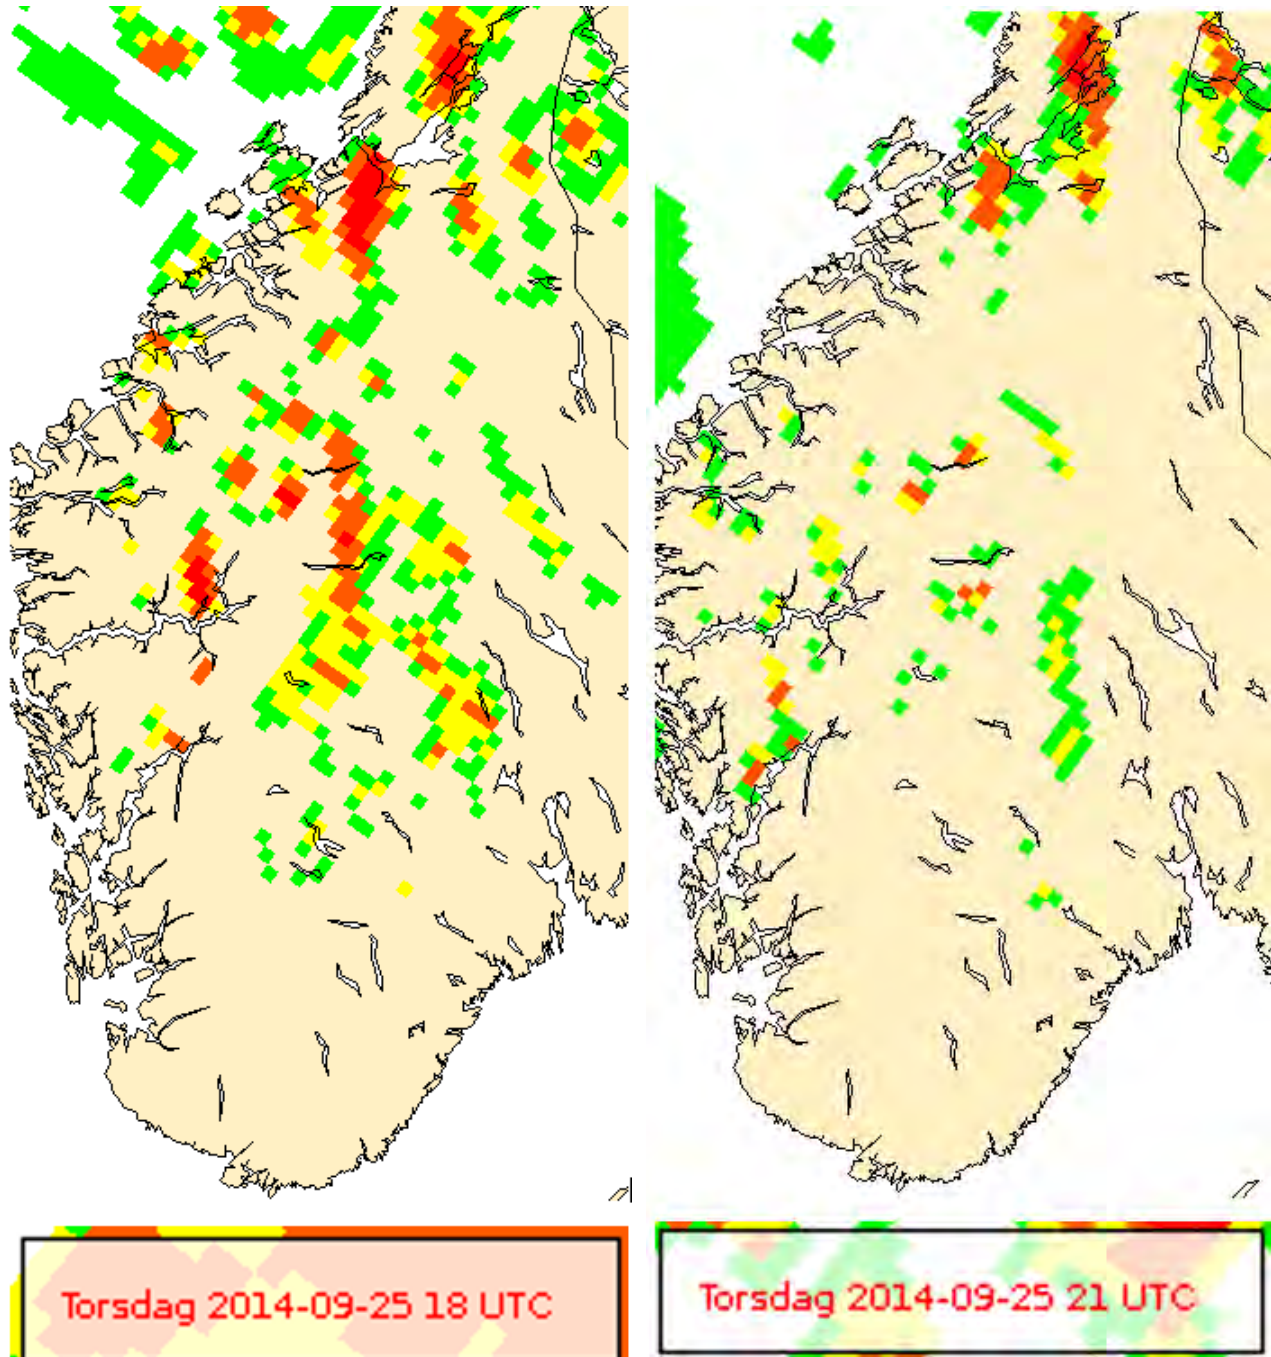
- 1.7.3.3 MI also used model data to support the preparation of a retrospective statement about the weather. These showed moderate to severe icing formed as some narrow bands in the north-south direction above Trøndelag and the northern part of south-eastern Norway, mainly west of the track and earlier in the evening than the relevant period. The scale ranges from 4-9, where green is 4, corresponding to light-moderate icing, and red is 9, corresponding to severe icing.

Figure 9: Icing conditions (Model data) at 18 and 21 UTC. Source: The Norwegian Meteorological Institute

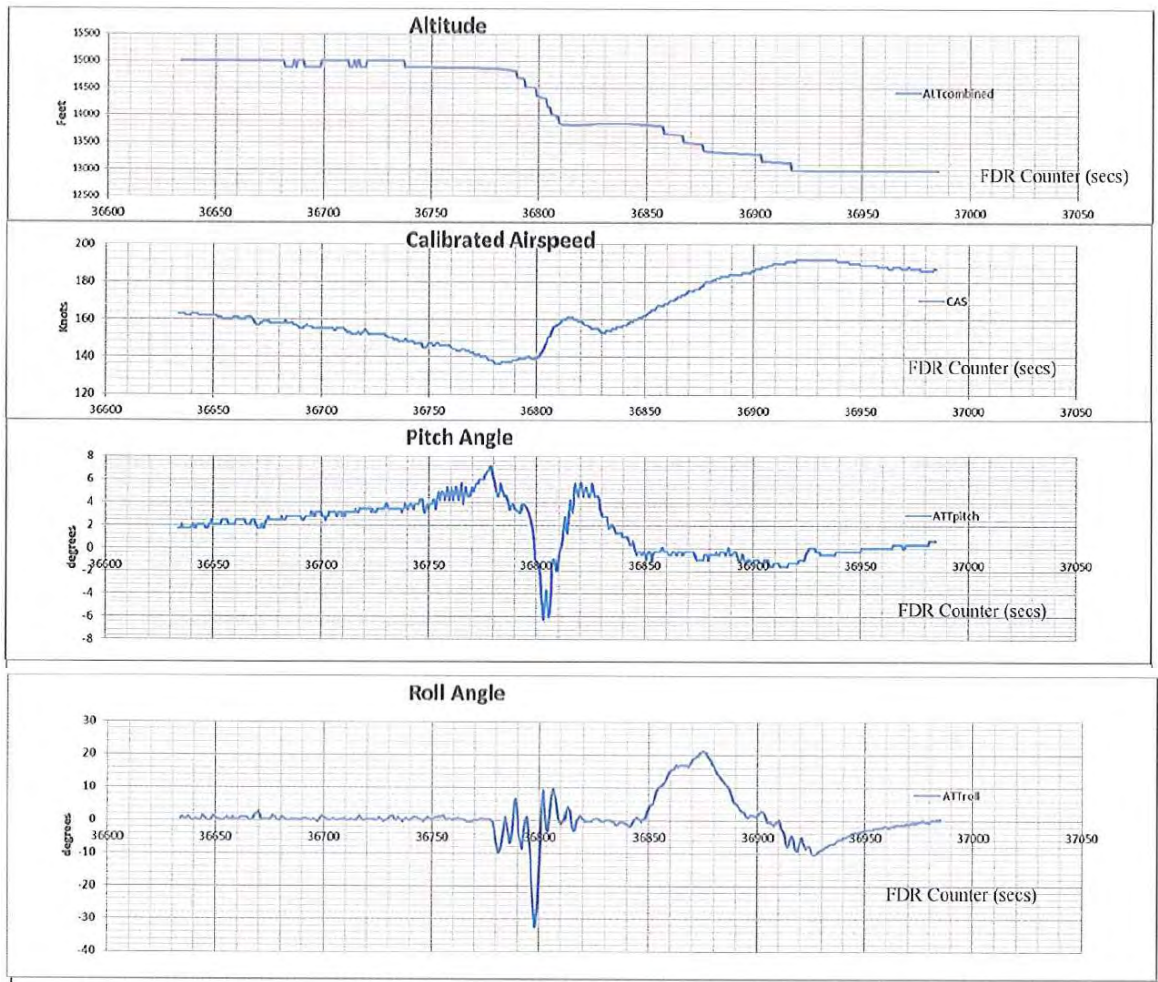
- 1.1.9 The crew members had no clear opinion on how extreme the flight attitude was during the incident. The first officer estimated 10° pitch up and 10° uncontrolled bank, and believed to remember having seen a descent rate of more than 3,000 ft/min. The commander believed to remember that the speed was somewhat above 130 kt at the lowest. (Data from the flight recorder with exact value readings can be found in Figure 10.)

Figure 10: Recorded parameters for altitude, speed, pitch and roll angle during the period from approx. 3 minutes before to approx. 3 minutes after the incident

1.11.2.4 At the time of the most extreme roll angle, the vertical speed (loss of altitude) was 2,500-3,000 ft/min, with the following recorded values for speed, flight control surfaces⁷ and flight attitude:

1.11.2.5 This means that the roll was 32.3° to the left while the airspeed was 19 kt below the recommended speed in icing conditions, while the pitch was still above the horizon. Maximum flight control input were not made by the crew at any time during the incident.

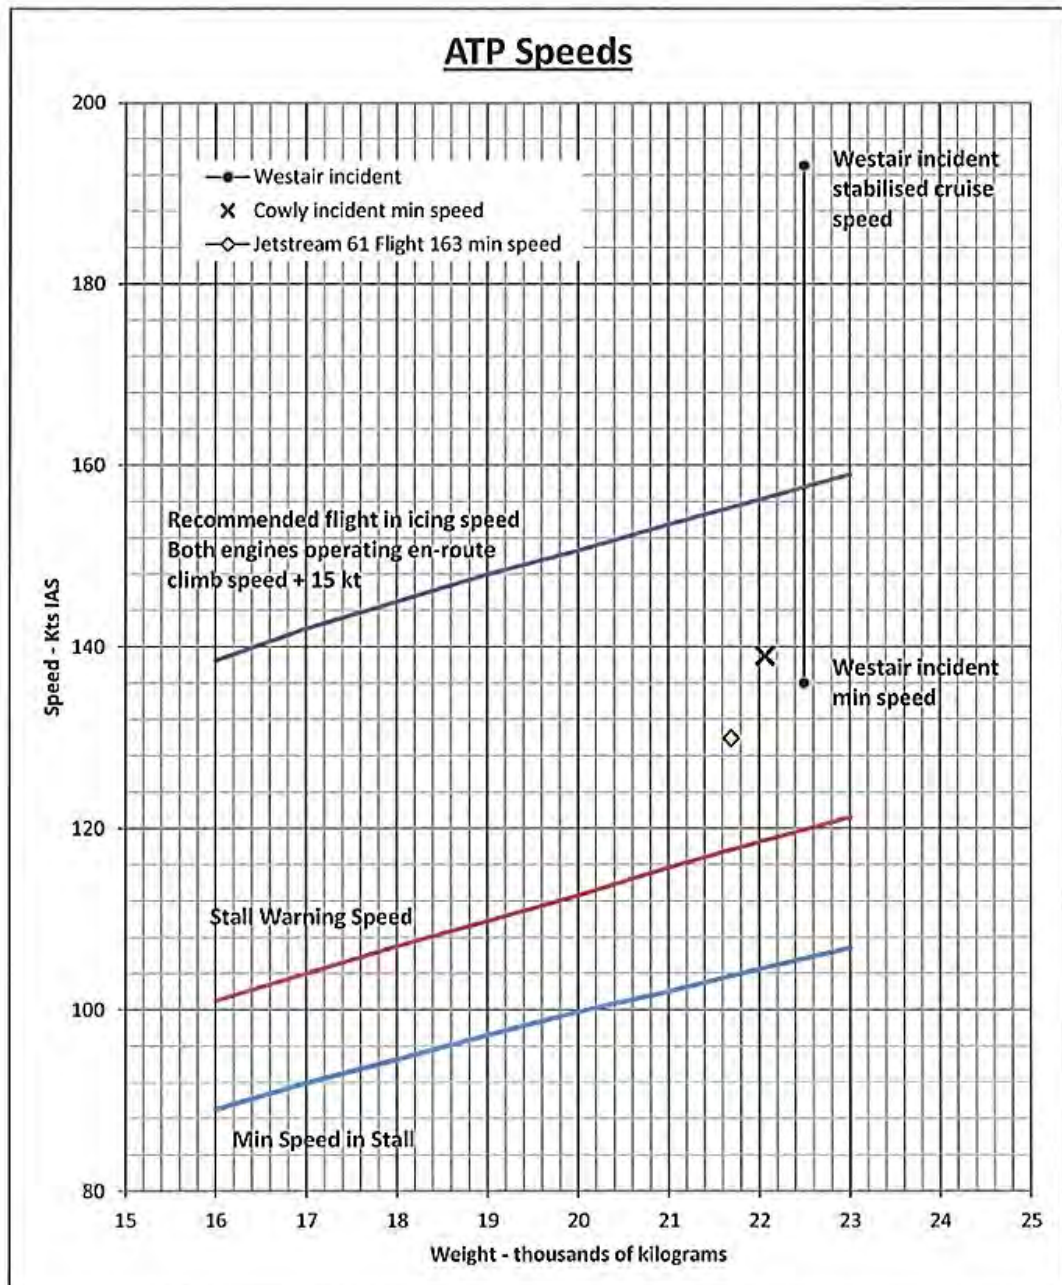
1.16.1.1 BAE Systems analysed the FDR data and prepared a figure to illustrate the speed loss during the incident. The figure compares the recorded minimum speed with both the manufacturer's recommended speed in icing conditions, the speed for activation of the stick shaker and the lowest stalling speed (see Figure 11). The figure also shows data from a previous icing incident with an similar aircraft (the Cowley incident, see 1.18.1.2) and experience values from the test flight program for icing conditions on the further developed aircraft type (BAe ATP Jetstream 61, Flight 163 min speed).

1.16.1.2 It emerges that the lowest speed during the incident with SE-MAF was 30 kt higher than the "clean" stalling speed and 16 kt higher than the "clean" stick shaker onset speed, but 22 kt lower than the recommended minimum speed in icing conditions:

Figure 11: Speed loss for SE-MAF and the recorded minimum speed compared to the recommended minimum speed in icing conditions, stall warning speed and stall speed. The figure also shows minimum speed for the Cowley incident and values from the Jetstream 61 test flight. Source: BAE Systems

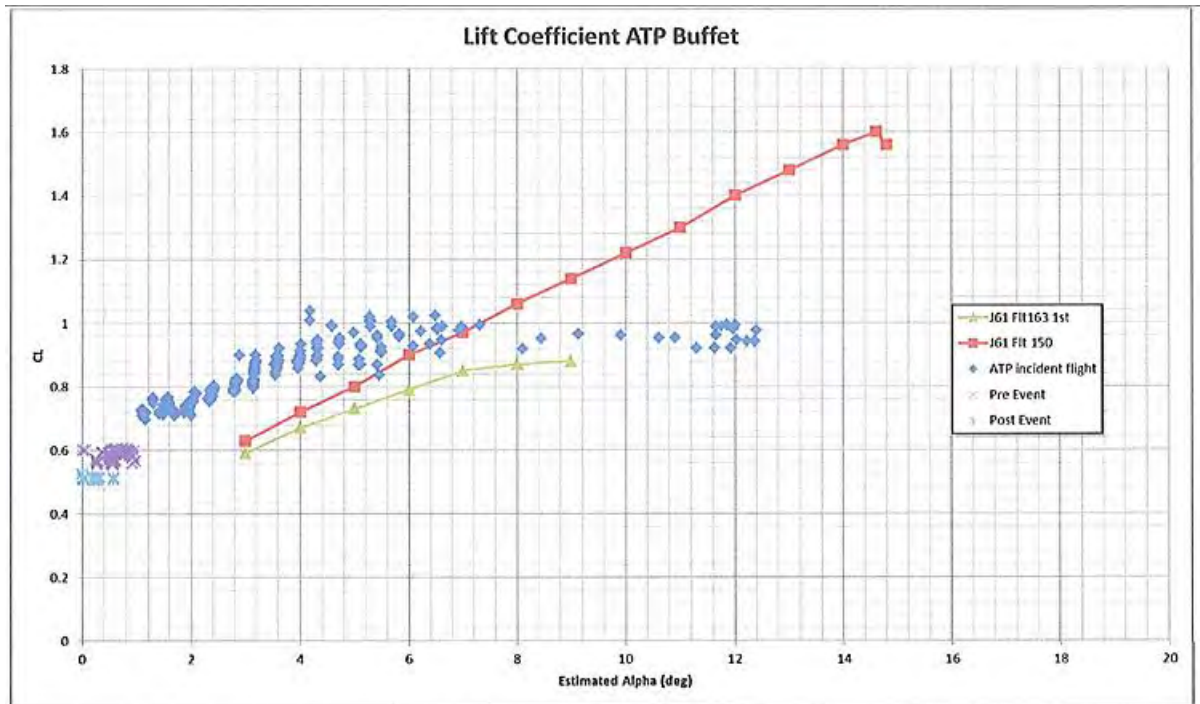
- 1.16.2.1 BAE Systems analysed data from the flight recorder in SE-MAF extensively to assess whether the aircraft reached a stall condition. The angle of attack was estimated as the difference between the measured pitch attitude and the estimated flight path angle⁸. It was found that the lift coefficient (C_L) and therefore the lift, deviated substantially from normal (cf. Figure 12). Maximum C_L was approximately 1.05 at around 4° and remained

Figure 12: The lift coefficient for estimated angles of attack for the relevant flight (blue symbols) compared with Jetstream 61 with a clean wing (red graph) and a wing artificially contaminated with ice (green graph). Source: BAE Systems

- Analysis of the FDR data for the incident flight indicates a maximum C_L value significantly below that for the clean aircraft at higher angles of attack.
- The minimum speed achieved during the incident was significantly higher than the clean wing (i.e. ice free) aircraft stall warning and minimum speed in the stall speeds.
- The minimum speed during the incident was substantially below the Both Engine Operation En-route + 15kt speed advised by BAE Systems for flight in icing conditions.
