REPORT

SL 2015/11

REPORT ON INCIDENT APPROX. 120 NM SOUTHWEST OF SOLA, NORWAY 4 OCTOBER 2013, WITH SIKORSKY S-92A, LN-ONW, OPERATED BY BRISTOW NORWAY AS

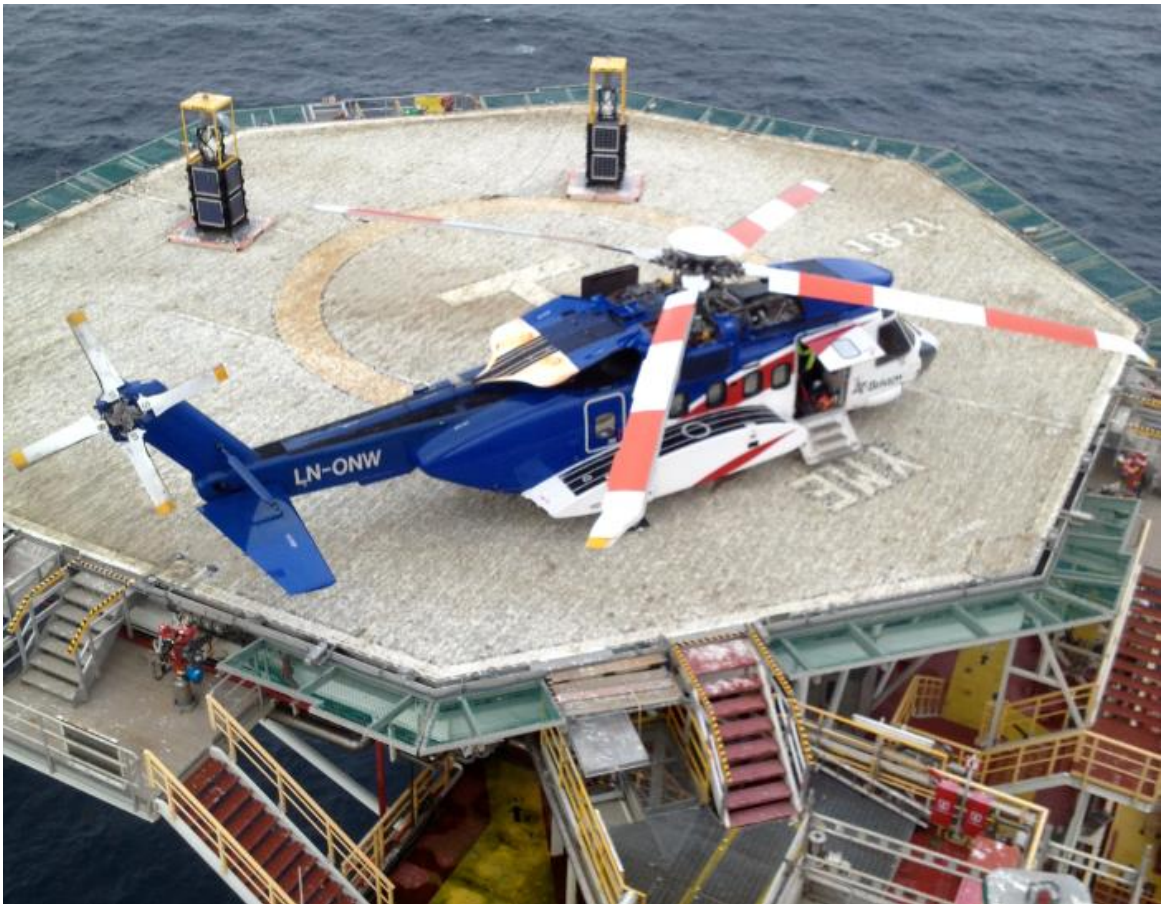
Figure 2: The helicopter photographed on Yme 6 October, prior to being flown to Sola. Photo: Bristow Norway

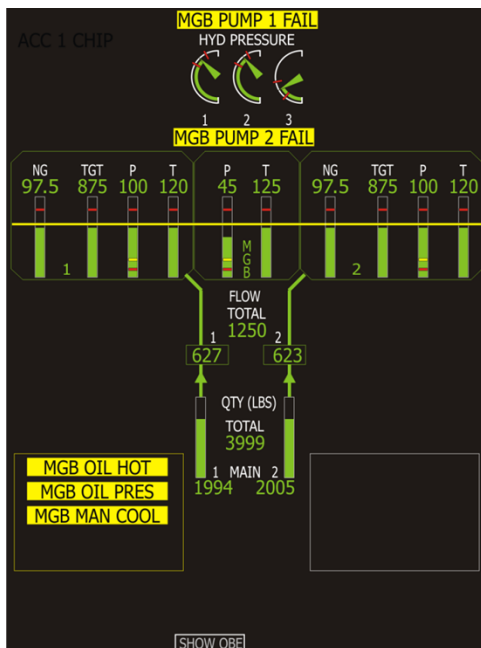
The indications in Item 3, 6 and 8 are affected by a circuit breaker installed in the overhead panel in the cockpit marked M XMSN OIL WARN. If the circuit breaker trips, five yellow cautions will be shown on the MFD (see Figure 4 below).

Figure 4: EICAS indications on MFD corresponding to those the crew saw in LN-ONW. Source: Sikorsky

- An electrical short in certain components or wiring will cause the M XMSN OIL WARN circuit breaker to trip.
- If this happens, the **MGB PUMP 1 FAIL**, **MGB PUMP 2 FAIL**, **MGB OIL HOT**, **MGB MAN COOL** and **MGB OIL PRES** cautions will be triggered.

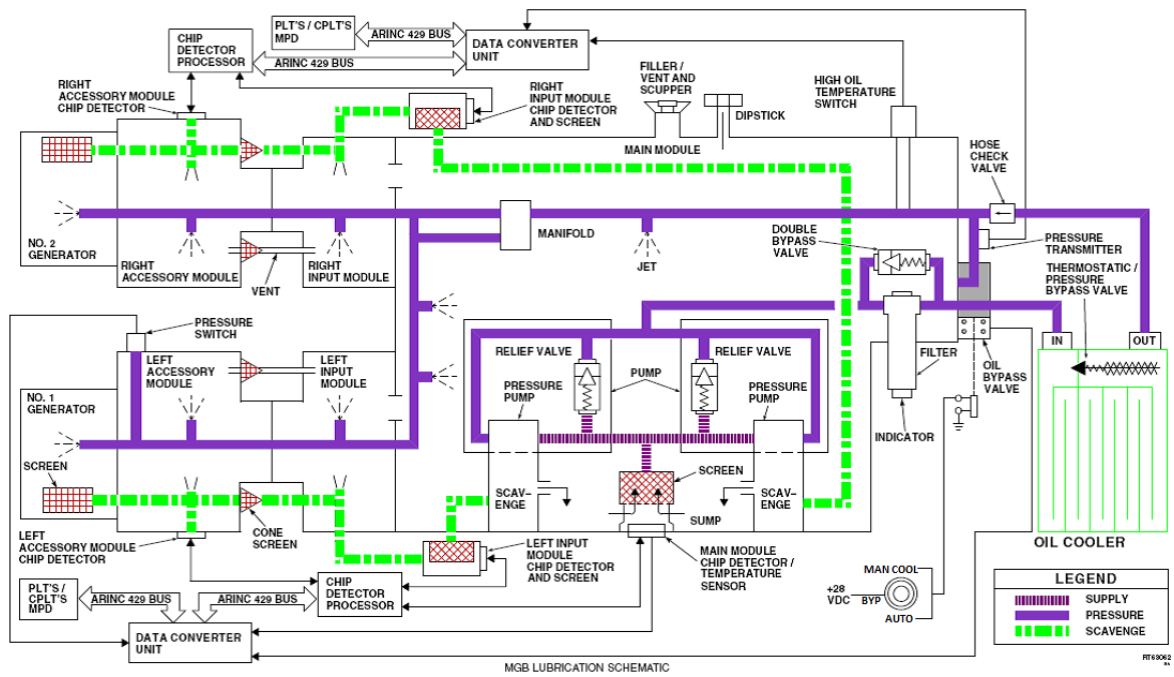
The main gearbox has an oil system with two combined pressure and scavenge pumps and an external oil cooler (see Figure 5). An Oil Bypass Valve can lead the oil directly from the pressure pumps to the components in the gearbox without running through the oil cooler. This function will prevent loss of gearbox oil if there is a leak in the oil cooler circuit. The valve is usually controlled automatically, but can also be controlled manually via a switch in the overhead panel in the cockpit. The switch has the following positions: AUTO, BYP and MAN COOL. An expected consequence of the oil going directly to the gearbox, bypassing the oil cooler, is an increase in the oil pressure. However, the design of the valve causes the oil pressure to drop when it is in bypass (BYP).

Figure 5: Simplified drawing of the oil system in MGB. Source: Sikorsky

2.2.1.1 When the fault occurred in the Main Transmission High Temperature Switch (see Item 1.1.24), the circuit breaker M XMSN OIL WARN tripped and the bypass valve automatically switched to the position that prevented the oil from going to the external oil cooler circuit. This was the only physical change in the main gearbox. The indications received by the crew were a result of the circuit breaker tripping, and were consequently not real warnings. Because the oil was no longer flowing through the oil cooler, the oil temperature gradually started to rise. This caused the caution for **INPUT/ACC 1 HOT** to switch on after about 30 minutes into the flight. The caution is triggered when the oil temperature in the area exceeds 130 °C. However, the main gearbox could have withstood far higher oil temperatures before a critical situation would occur. This is reflected with the fact that the emergency checklist only prescribes that the engine in question shall be set to idle. The Accident Investigation Board assumes that the helicopter could have flown all the way back to Sola without flight safety being threatened by high oil temperature.

2.2.1.2 Logically, a direct routing excluding the oil cooler circuit should lead to the oil pressure rising at the sensors in the pressure line inside the gearbox. However, due to the design of the bypass valve, the automatic switching caused the oil pressure to drop from the normal value of around 58 psi, down to 49 psi. This was above the minimum pressure of 45 psi, but the pressure drop further convinced the crew that something had happened inside the gearbox.
