REPORT

SL 2016/01

REPORT ON THE SERIOUS AIRCRAFT INCIDENT 12 AUGUST 2014 AT RØRVIK AIRPORT, NORWAY, WITH AIRBUS HELICOPTERS EC 130 B4, LN-ORR, OPERATED BY HELICOPTER UMLEIE AS

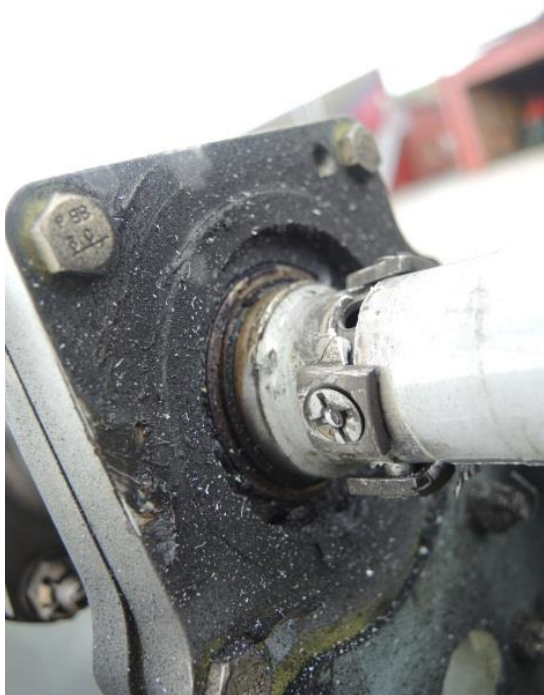
A technical investigation revealed that the tail rotor shaft had fractured due to incorrect installation of the tail rotor shaft bearing no. 1. The incorrect installation led to cyclic loads in the tail rotor

The helicopter landed approximately 100 metres past the threshold on runway 22, and was moved from the runway to an apron for closer investigation after the landing. It was quickly concluded that the tail rotor (fenestron) no longer was mechanically connected to the engine's reduction gearbox. When the Accident Investigation Board arrived the following day, the covers over the tail rotor shaft were opened, and a fracture was found in front of bearing no. 1 on the tail rotor shaft (see Figure 4).

Figure 4: Fracture in the rivet joint on the intermediate tail rotor shaft section installed in LN-ORR.
Photo: AIBN

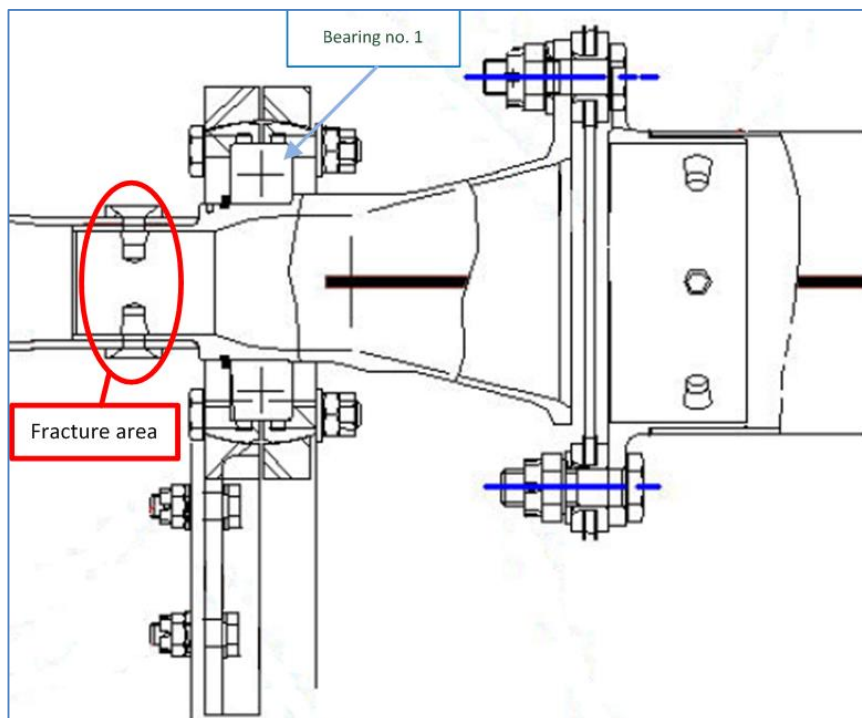
The fracture occurred in the rivet joint between the shaft and the adapter for aft flexible coupling (see Figure 5).

Figure 5: Details bearing no. 1. The flexible coupling on the right. Damage area marked in red.
Source: Airbus Helicopters

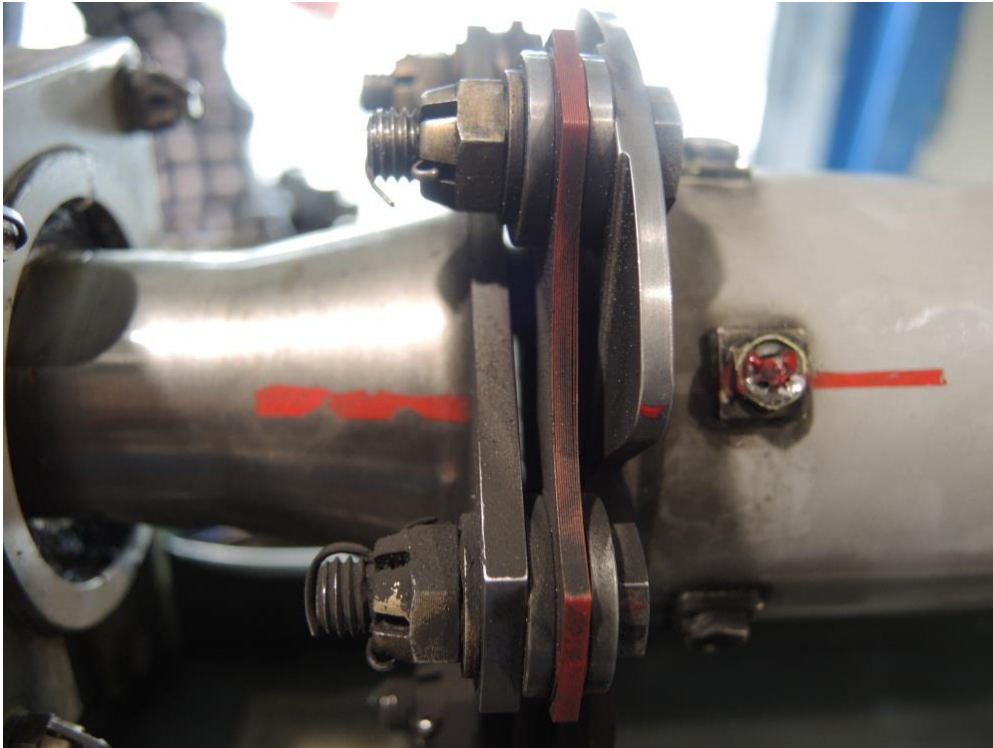
- 1.16.1.2 The position² of bearing nos. 2, 3, 4 and 5 was measured in relation to the shaft, and they complied with acceptable criteria. There were no abnormalities in the actual bearings.
- 1.16.1.3 The brackets attaching bearings nos. 2, 3, 4 and 5 to the tail boom were intact and correctly installed.
- 1.16.1.4 The tail boom and bearing support brackets were inspected with optical measuring equipment and were found to be within acceptable criteria as regards geometry.
- 1.16.1.5 The condition of the flexible connections behind bearing no. 1 and in front of bearing no. 5 was normal, apart from an indication of separation between the flexible plates in the coupling behind bearing no. 1 (see Figure 6).

Figure 6: Sign of separation in the flexible coupling behind bearing no. 1. Photo: BEA

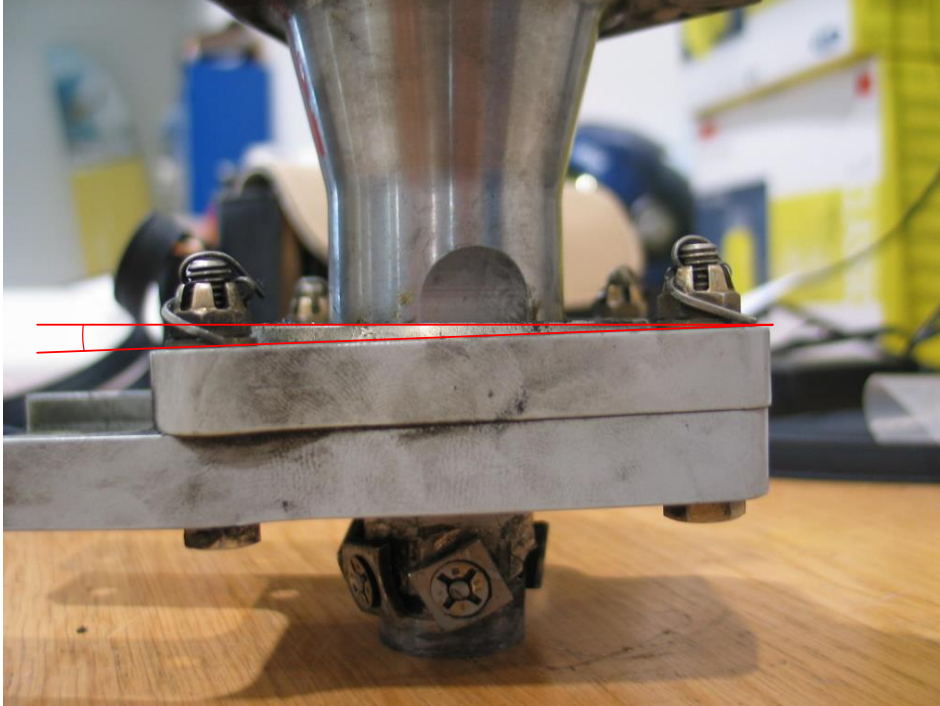
- 1.16.1.6 Bearing no. 1 was subject to special attention as the shaft fracture occurred in its vicinity. It became evident that the position of the bearing in relation to the shaft did not comply with the Aircraft Maintenance Manual (AMM) requirements. The measured discrepancy was approximately 1 millimetre, whereas the maximum permitted value in the AMM is 0.1 millimetre (see Figure 7).

Figure 7: Bearing no. 1, clamped between Bearing Drive and Bearing Flange. Angular discrepancy marked with red lines. Photo: AIBN

Bearing no. 1 did not have the correct position in relation to the shaft. The bearing outer race was clamped in the "Bearing drive/Bearing flange" assembly and there were no signs of the bearing moving after installation. This observation led to further examinations of bearing no. 1 performed by the manufacturer of the bearing (FAG). The bearing races showed abnormal wear caused by asymmetric bearing ball track. FAG could not explain the reason for the asymmetric wear in the bearing races. The reason for this was that FAG was not informed about the skewed installation of the bearing. FAG's findings were consistent with faulty alignment when installing the bearing causing the tail rotor shaft to be exposed to repeated cyclical forces, and that these forces were introduced due to incorrect installation of bearing no. 1 during replacement.

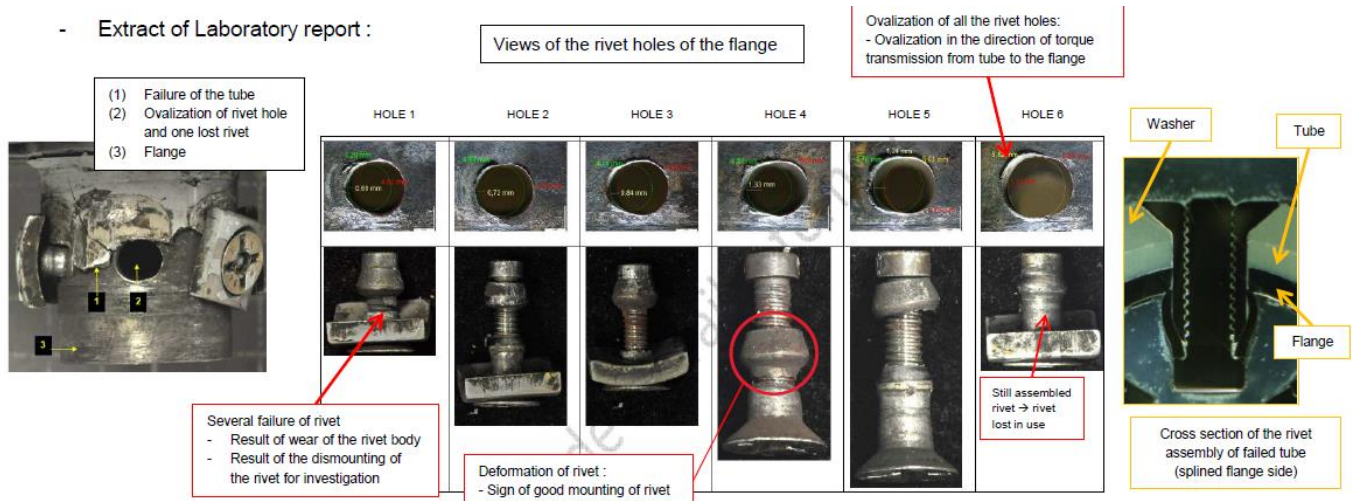
1.16.2.2 The connection has six rivets (see Figure 5). The adapter and shaft were removed, and the rivet holes in the adapter showed signs of the rivets moving (see Figure 8).

Figure 8: Rivets and rivet holes in adapter. Photos: Airbus Helicopters

1.16.2.3 The deformation in the holes and the wear on the rivets appears to have occurred over time. The wear pattern indicates that the rivets lost their grip after installation. This caused movement, and the holes in the adapter were deformed and rivet material became worn.

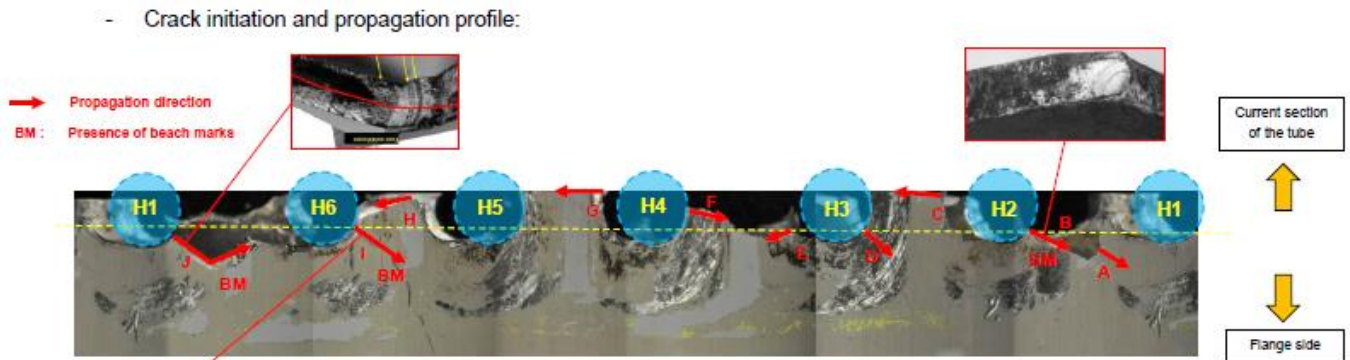
1.16.2.4 When the rivets came loose gradually, the load increased to such a point that fatigue fractures occurred in some of the rivet holes on the shaft. There were also signs of a ductile fracture in one of the rivet holes (see Figure 9).

Figure 9: Fractures and surface of fractures in the shaft. Source: Airbus Helicopters

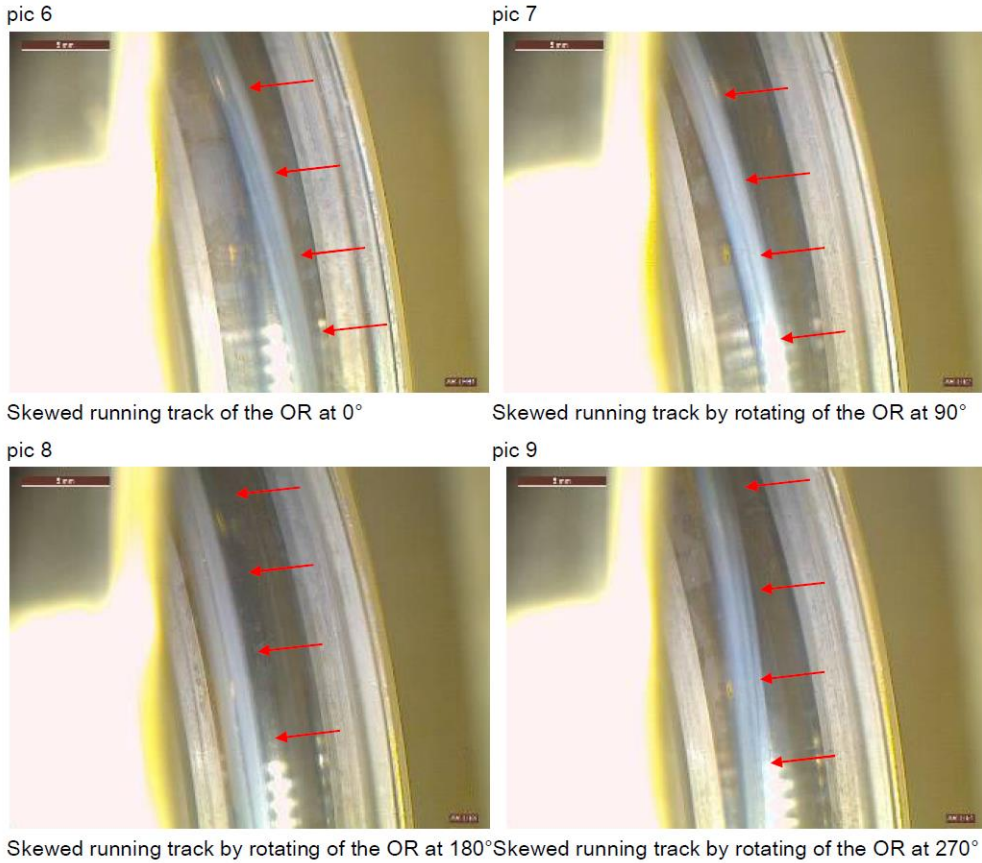
In consultation with AIBN, Airbus sent bearing no. 1 to the manufacturer, FAG, for analysis. The analysis showed that the bearings balls had made an abnormal track in the outer race (OR "Outer Race" on Figure 10).

Figure 10: Abnormal tracks in the outer race. Source: FAG

This detrimental operation must have occurred for a number of hours before the fracture of the drive shaft in order to cause the distinctively degenerated running tracks. The misalignment of the bearing requires a bending moment induced from / to the shaft and this is the reason for the fretting of the inner ring bore essentially on one side only. Accordingly, the reason for the fracture of the drive shaft could be the incorrect misaligned assembly of the bearing. However, the reason for the misaligned assembly in the spherical bearing housing is not understood.

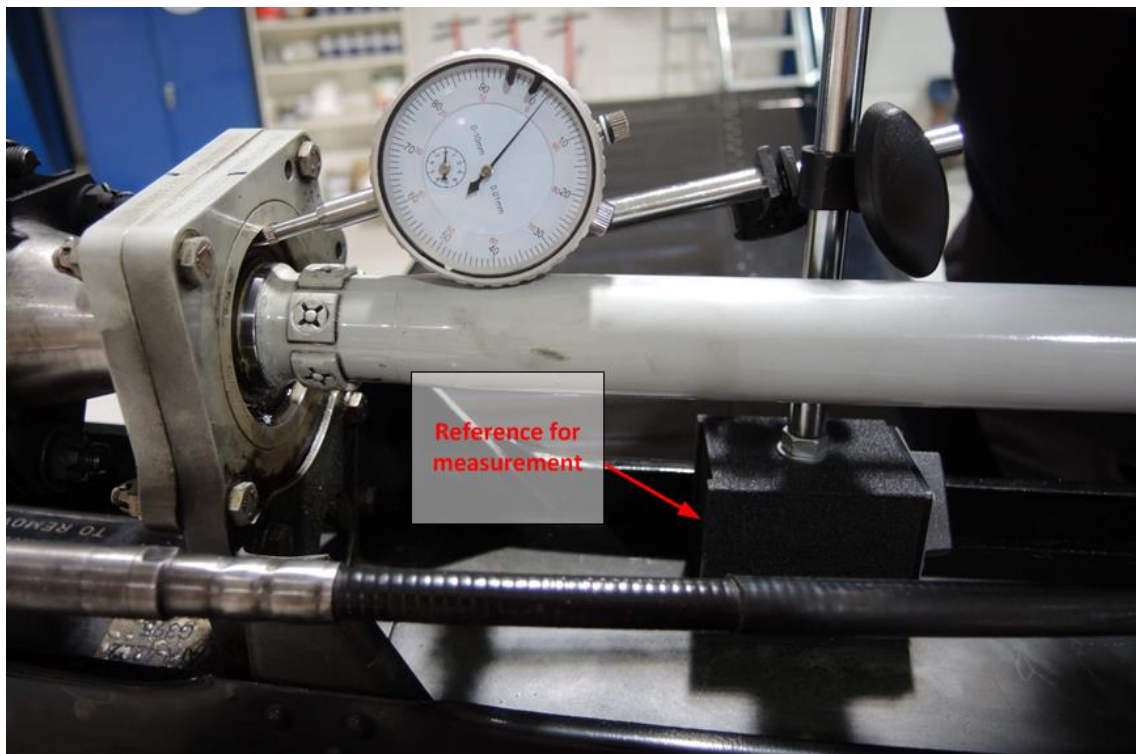
AIBN asked the technician who installed the bearing to demonstrate the measurement method for verifying the bearing's position in "Bearing drive/Bearing flange". The measurement demonstrated to AIBN did not comply with the method described in the helicopter's AMM. The tail boom was used as a reference for the measurement in the demonstration (see Figure 11).

Figure 11: Technician's measurement demonstration. The tail boom structure is the reference for the measurement. Photo: AIBN

- c) The technician replaced bearing no. 1 without using the correct tools to verify the bearing's position, and executed the measuring procedure incorrectly.

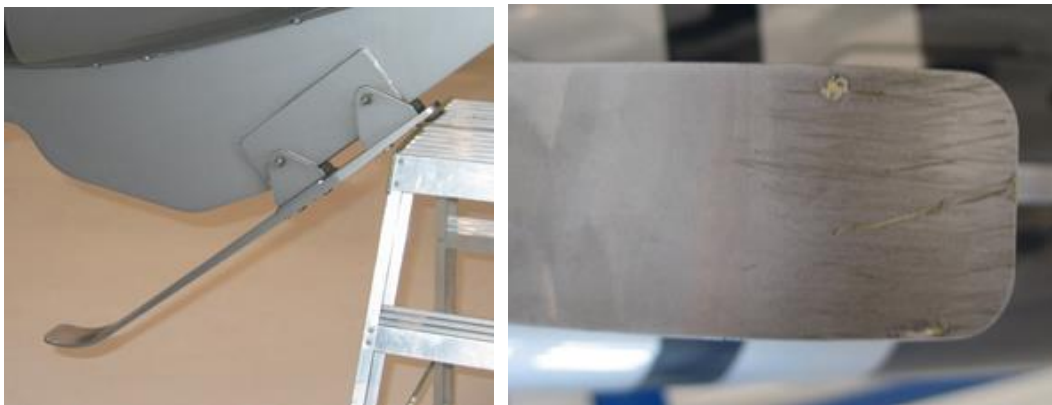
- 1.16.4.1 Scratches were detected on the underside of the skid underneath the tail (see Figure 14). The purpose of this tail skid is to protect the tail structure from hitting the ground. These scratches indicated contact with the ground, and the tail boom was therefore subject to closer investigation.

Figure 14: Skid underneath tail structure. Photo: BEA

The first part of the investigation focused on the possibility of deformation of the tail structure, which could have introduced abnormal loads in the tail rotor shaft. Scratches on the underside of the tail skid indicated that it had been in contact with the ground. However, there were no signs of deformation of the skid or its attachment in the tail structure. This indicates that neither the skid nor its attachment structure have been exposed to excessive forces. It was not found that the tail structure was exposed to deformation that could have caused displacement of bearing no. 1. AIBN knows that scratch marks such as the tail skid of LN-ORR are not uncommon to this helicopter type.
