REPORT

SL 2018/03

REPORT ON AVIATION ACCIDENT AT HATTEN IN LESJA MUNICIPALITY, OPPLAND COUNTY, 24 SEPTEMBER 2015 WITH ALEXANDER SCHLEICHER GMBH & CO SEGELFLUGZEUGBAU ASW 24, LN-GNA

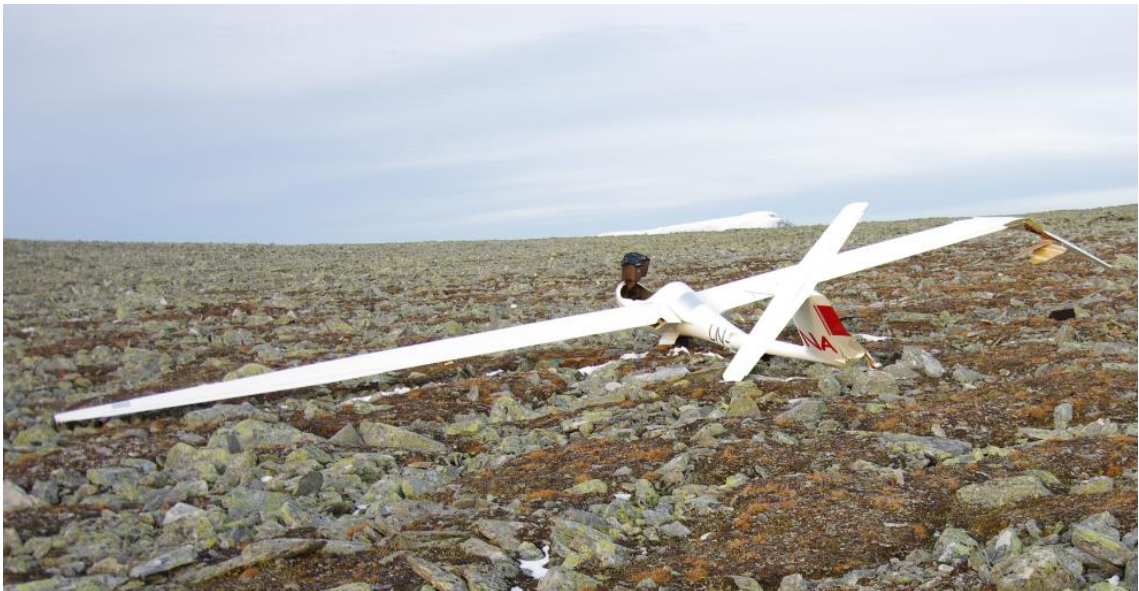
1.12.2.1 Investigations at the accident site indicate that the sailplane struck the rocky ground at a relatively flat angle with its nose first. It then rotated about 90 degrees to the right, thus coming to rest with its nose in a northerly direction approx. 15 metres from first contact with the ground.

Figure 10: The sailplane LN-GNA as it was discovered after the accident. The image also shows the rocky ground. Photo: Gudbrandsdal police district

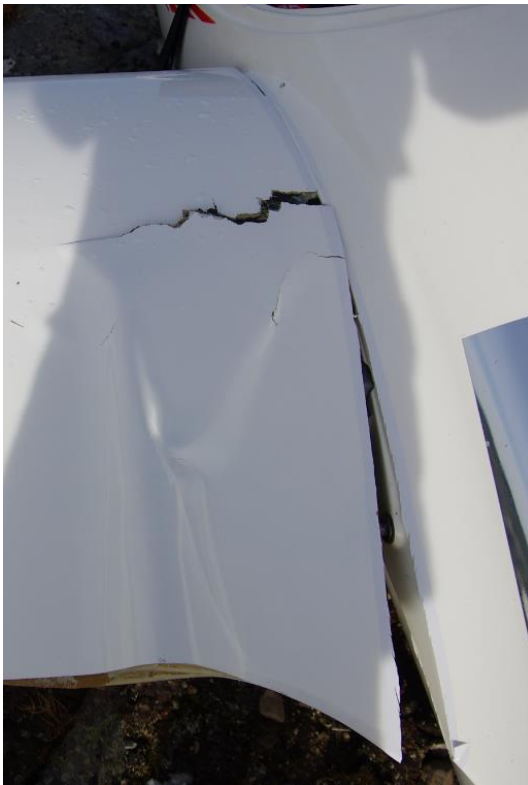
- 1.12.2.2 The sailplane was discovered with its landing gear deployed, potentially caused by forces affecting the sailplane when it impacted the ground. The right wing and tail boom were broken (see Figure 10, Figure 11 and Figure 12). The left wing suffered damage at the wing root where it attaches to the fuselage. Both winglets, as well as smaller parts from the aircraft's nose, fuselage and wings had come loose. The aircraft's nose was punctured and scratched. The canopy was missing and a search was carried out along the presumed direction of travel without finding it. A mountain ranger discovered it approx. two years later. The location of the canopy was close to the last registered GPS position.

Figure 11: Damage to left wing root. Photo: Gudbrandsdal police district

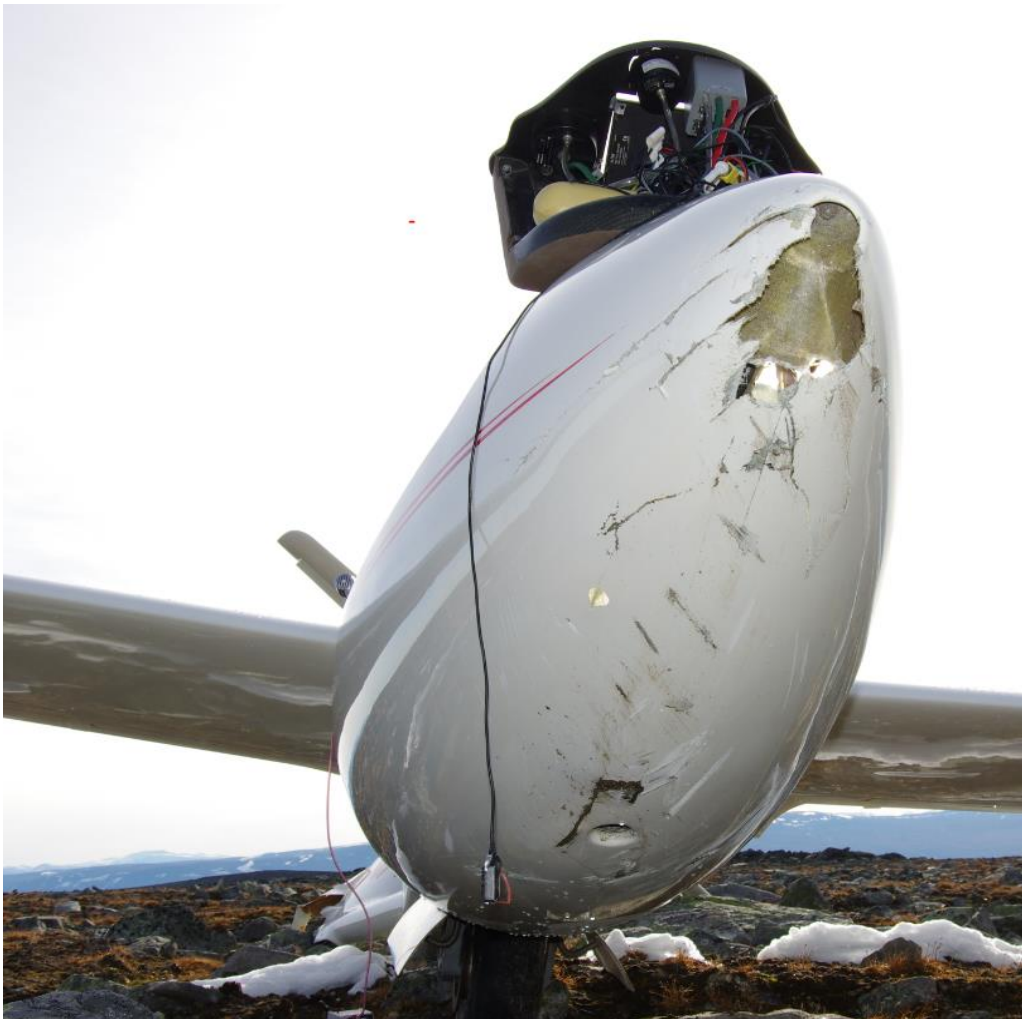
Figure 12: Damage on the sailplane's nose section. Photo: Gudbrandsdal police district

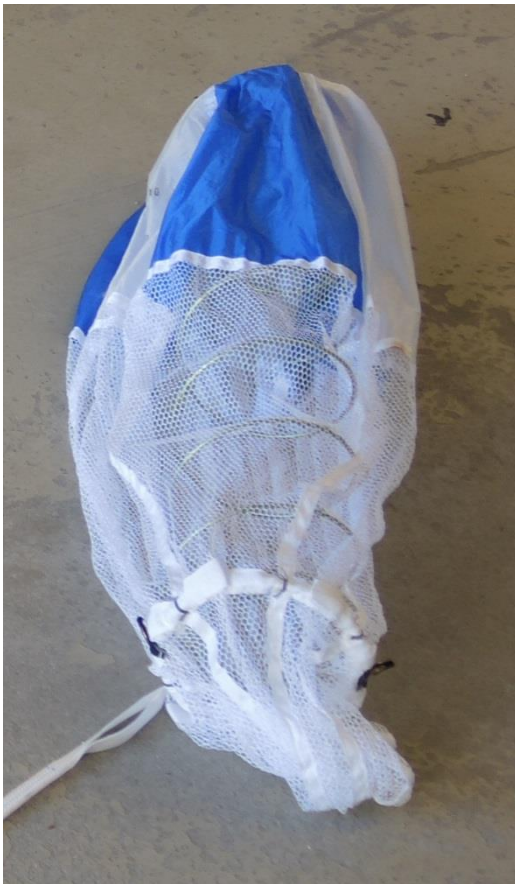
- 1.15.3.4 The normal procedure is for the user to exit the aircraft and pull the release handle. This deploys the pilot chute using a powerful coil spring under tension. The pilot chute will then be filled with air and pull out the parachute lines before the actual parachute opens. The parachute has 20 lines bundled individually with elastic bands.

Figure 16: The pilot chute was found deployed. Photo: AIBN

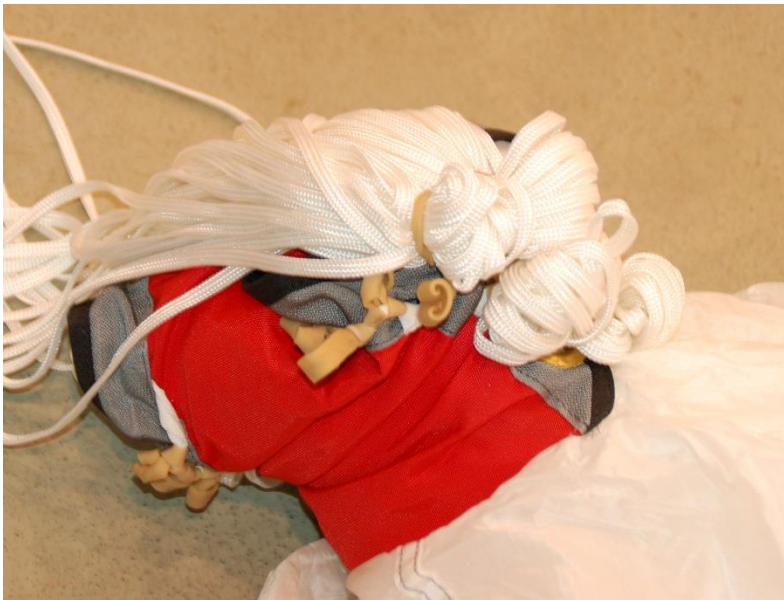
- 1.15.4 The parachute's functionality
- 1.15.4.1 After the accident, life support specialists at Norwegian Defence Materiel Agency (NDMA) at Kjeller reviewed the parachute's functionality. The inspection showed that the deployment handle had been pulled and that the pilot chute had been deployed. Several of the parachute lines had been released from the elastic bands keeping them together, while most of the lines were still bound together. The specialists concluded that the parachute's deployment sequence had started and was in accordance with the specifications.

Figure 17: The parachute's lines bound together. Photo: AIBN

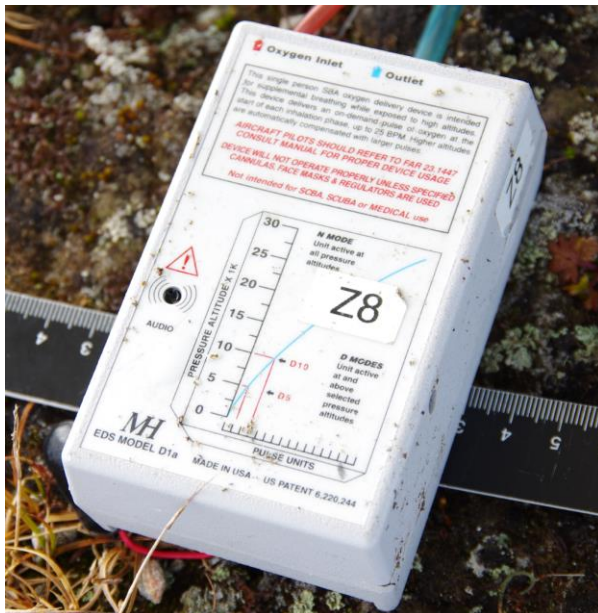
- 1.15.7.1 When flying in aircraft without a pressurised cabin, and when the altitude exceeds 10 000 feet (3 050 m), the flight medical recommendation is to always use extra oxygen⁷. The pilot was found with an oxygen hose connected. The oxygen regulator was of the type MH EDS Model D1 (see Figure 18).

Figure 18: Oxygen regulator MH EDS Model D1a. Photo: Gudbrandsdal police district

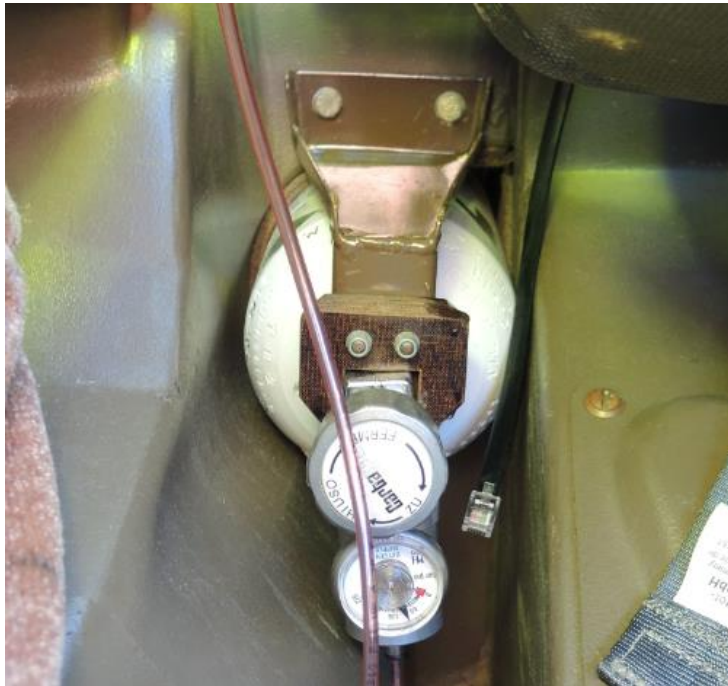
- 1.15.7.4 The oxygen bottle was attached to the right side in the back of the cockpit (see Figure 19). When the sailplane was found, the pressure gauge on the bottle indicated approx. 1 400 psi. The oxygen bottle was in the open position with the valve handle attached above

the gauge. The low level marking on the gauge, indicated with a red field, runs from 0 to approx. 400 psi.

Figure 19: The sailplane's oxygen bottle. Photo: AIBN
