APPENDIX D: METALLURGICAL EXAMINATION

LN-OJF EC225 Super Puma Accident Summary of the Metallurgical Examination of the Epicyclic Gearbox Components at QinetiQ

QINETIQ/18/00263/1.0

26 January 2018

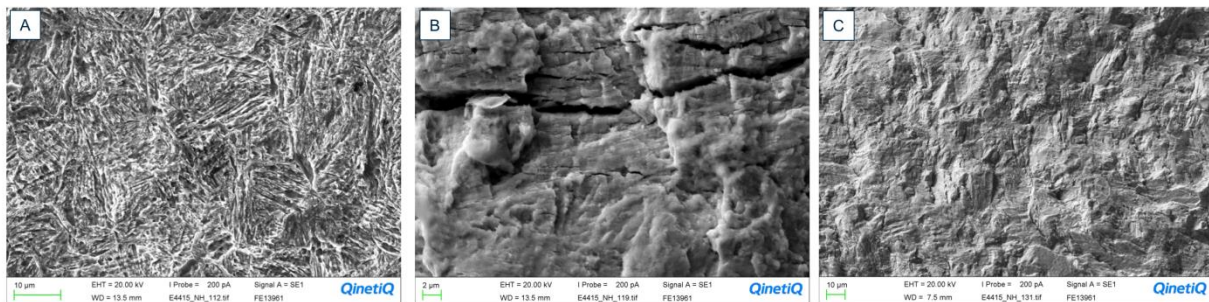
Fractured Second Stage Planet Gear Sample FE13961 – As Received

SEM examination of the as-received fracture surface shows indications of fatigue (B & C) along with areas of corrosion (A).

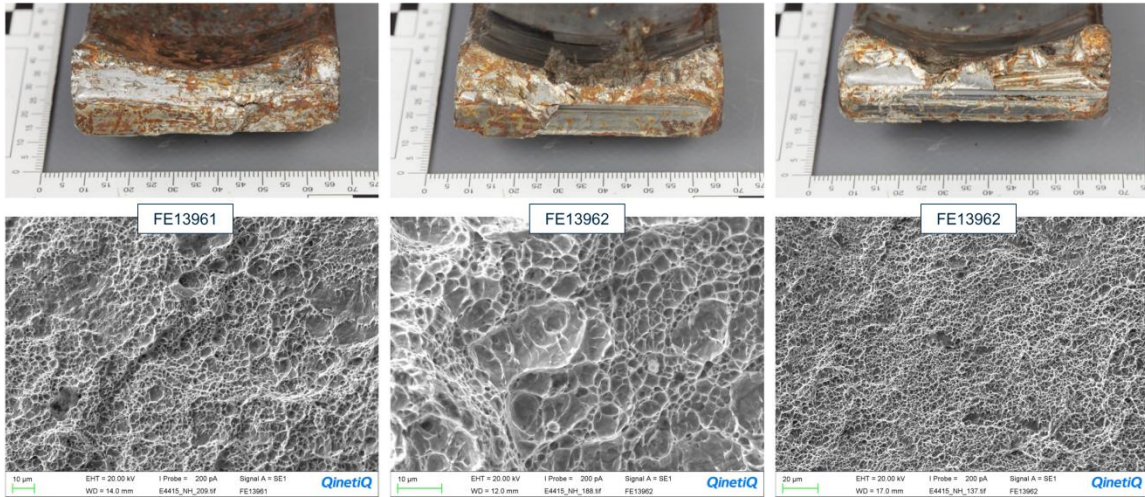
Fractured Second Stage Planet Gear As received

All remaining 2nd stage planet gear fracture surfaces exhibit ductile overload failure

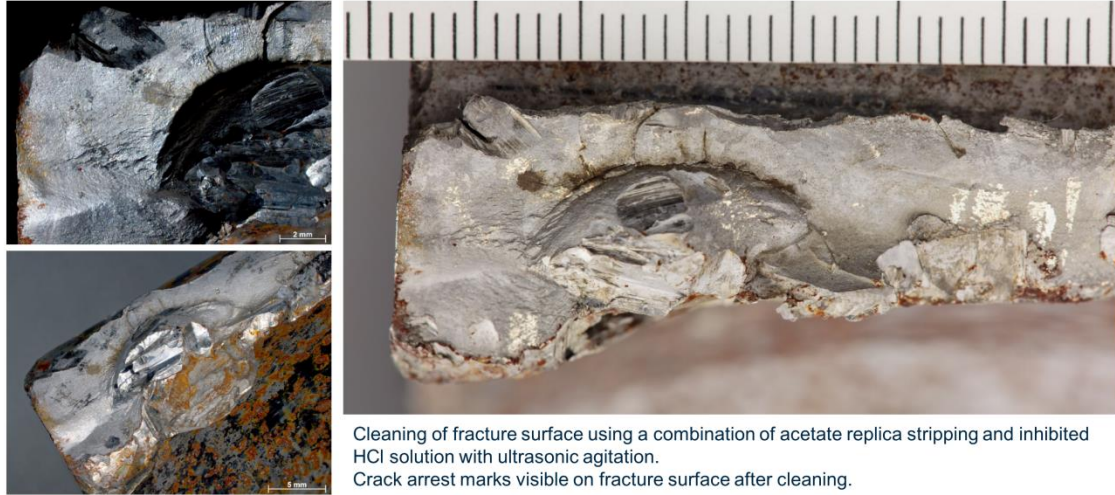
Fractured Second Stage Planet Gear Sample FE13961 – After Cleaning

Cleaning of fracture surface using a combination of acetate replica stripping and inhibited HCl solution with ultrasonic agitation. Crack arrest marks visible on fracture surface after cleaning.

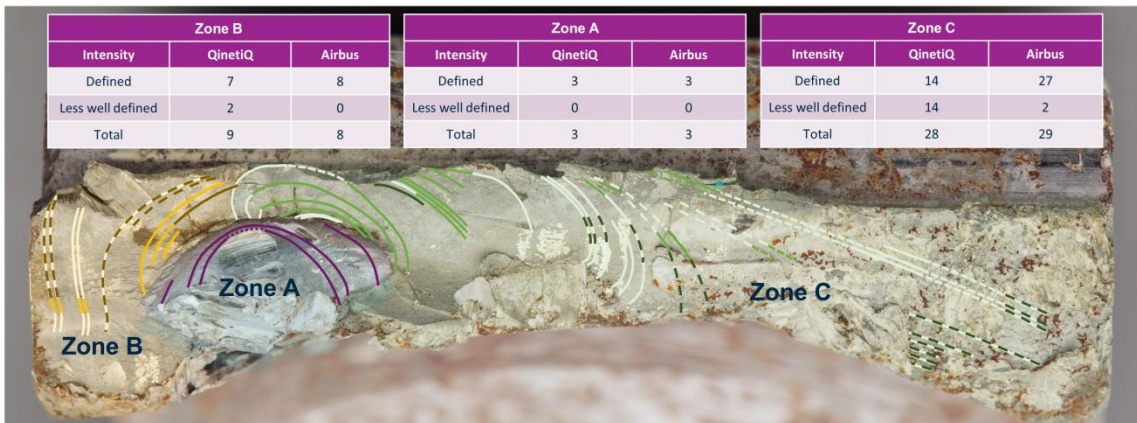
Fractured Second Stage Planet Gear Sample FE13961 – Summary of Macro Mark Observations

Summary of macro mark observations, solid line – well defined, dashed line – less well defined, see reference [1] for further details. A number of attempts were made to correlate the macro marks with flight data, including engine stop starts, take-off and landings etc. No successful correlations were made.

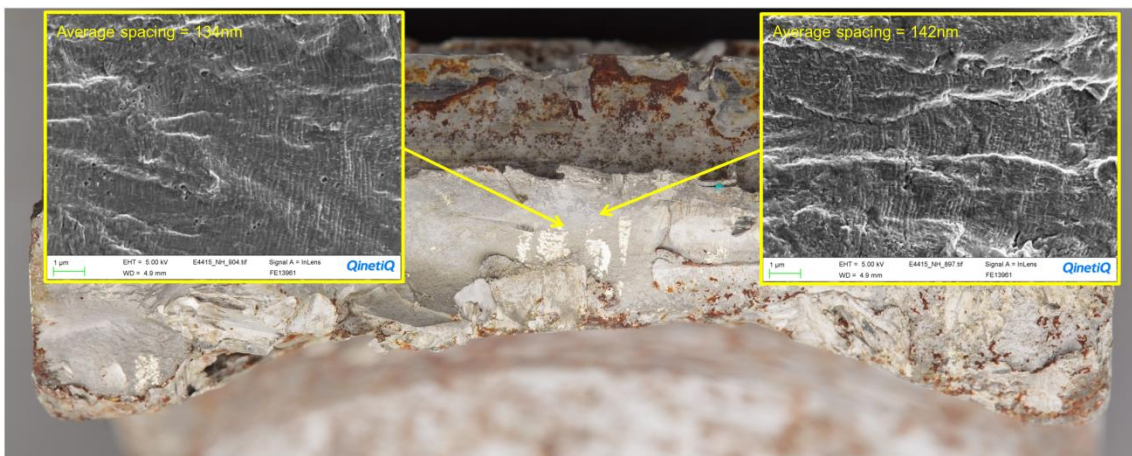
Fractured Second Stage Planet Gear Sample FE13961 – Fatigue Crack Progression Marks (Striations)

Positive identification of fatigue striations observed on a small region of the through thickness fracture surface, towards the centre of the gear.
Insufficient evidence to determine the crack growth rate from striation spacing measurements.

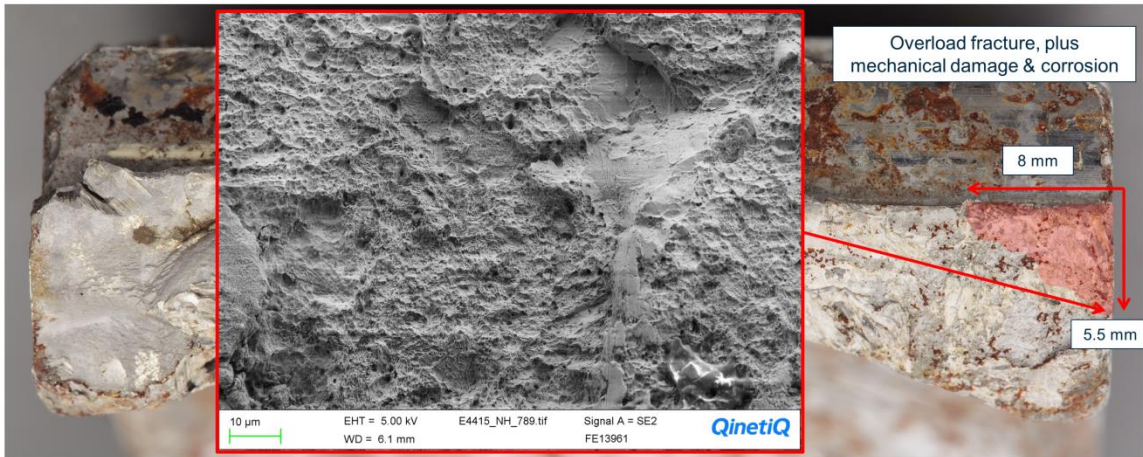
Fractured Second Stage Planet Gear Sample FE13961 – Final Overload Fracture

Fatigue crack propagation accounts for approximately 95% of the through thickness fracture.

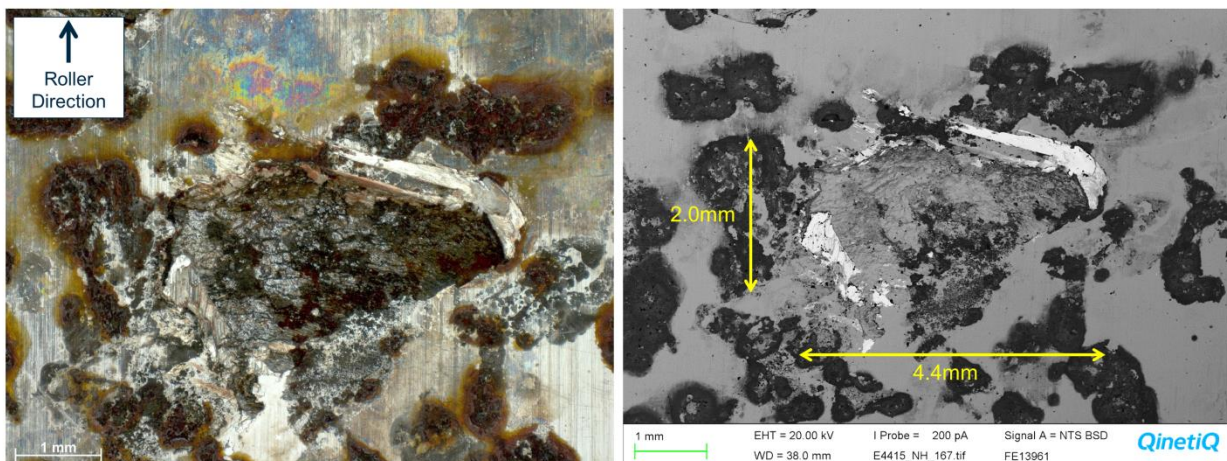
Fractured Second Stage Planet Gear Sample FE13961 Race Surface – Spall 1 As-Received

Mean depth of spall = 282µm, maximum depth 325µm

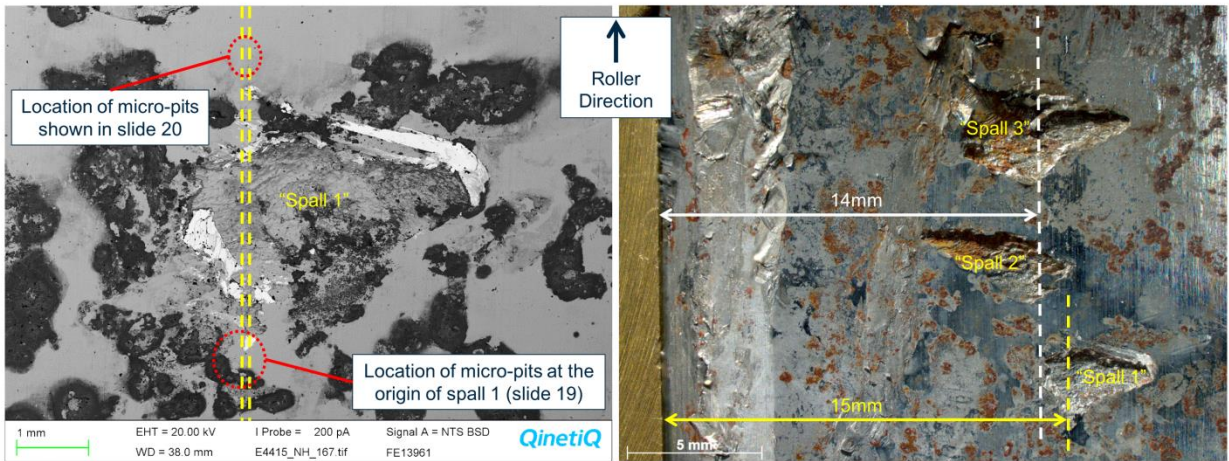
Fractured Second Stage Planet Gear Sample FE13961 Race Surface – Between Spall 1 and Spall 2

The location of the observed micro-pitting is approximately 15mm from the upper edge of the planet gear – dotted yellow lines.

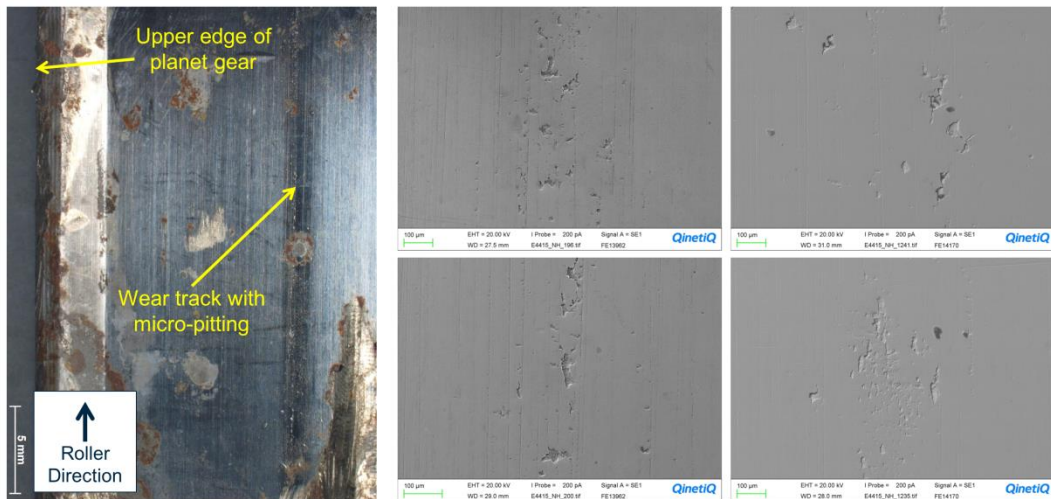
Fractured 2nd Stage Planet Gear Sample FE13962 Race Surface – Micro-pitting

A wear track containing micro-pitting is also observed on the upper outer-race surface of the second planet gear fragment (sample FE13962).

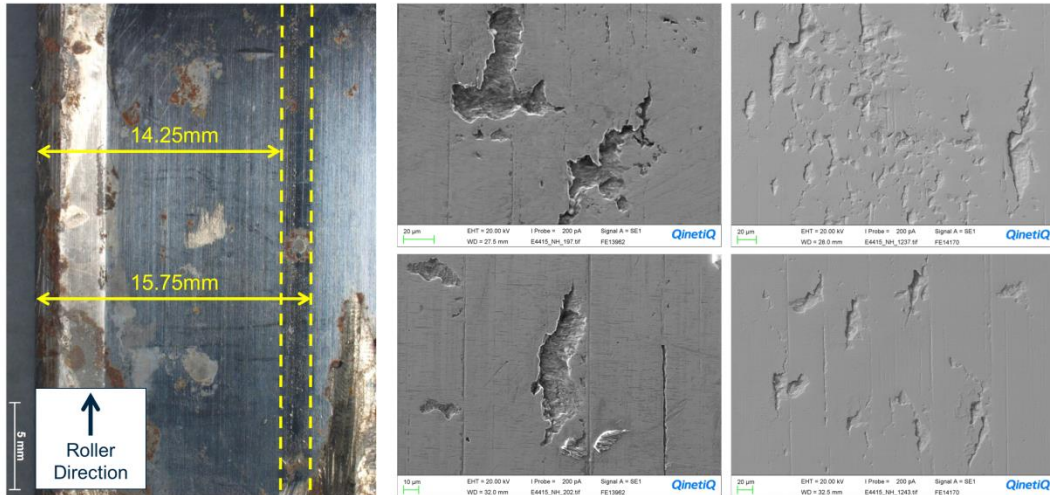
Fractured Second Stage Planet Gear Sample FE13962 Race Surface – Micro-pitting

These micro-pits are also located approximately 15mm from the upper edge of the gear and again exhibit undercutting cracks.

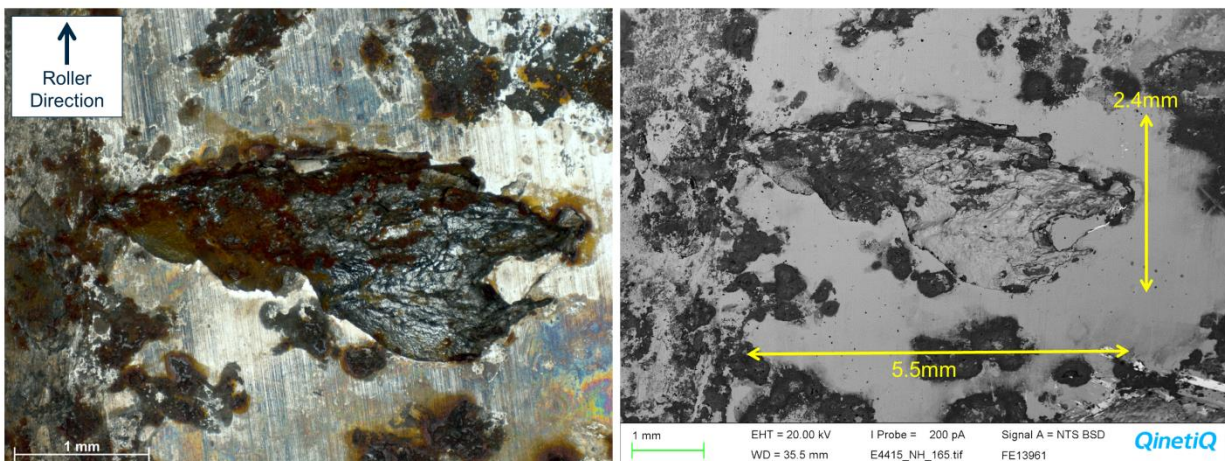
Fractured Second Stage Planet Gear Sample FE13961 Race Surface – Spall 2 As-Received

Mean depth of spall = 317µm, maximum depth 349µm

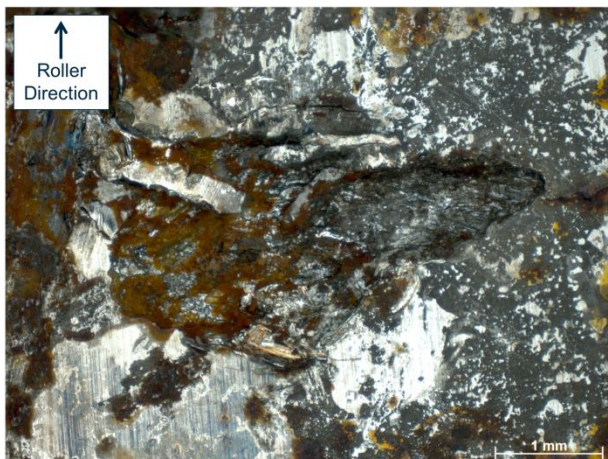
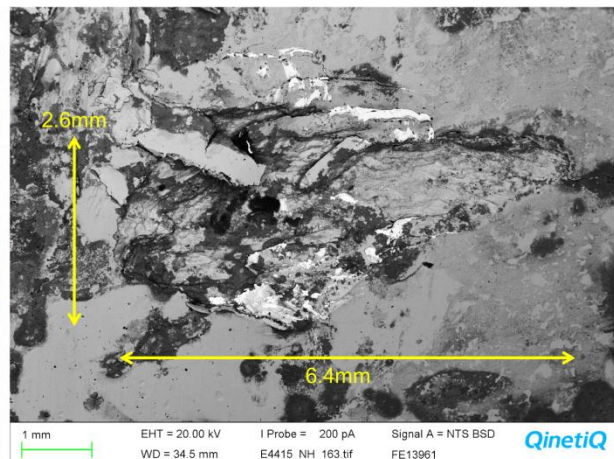
Fractured Second Stage Planet Gear Sample FE13961 Race Surface – Spall 3 As-Received

Mean depth of spall = 451µm, maximum depth 561µm

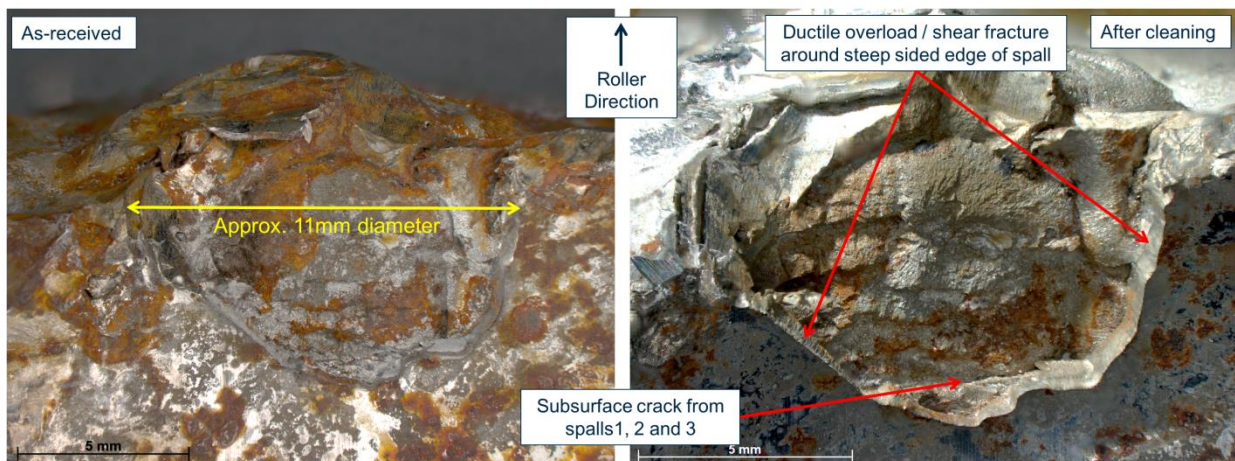
Fractured Second Stage Planet Gear Sample FE13961 Race Surface – Spall 4

Mean depth of spall = 1.40mm, maximum depth 1.69mm

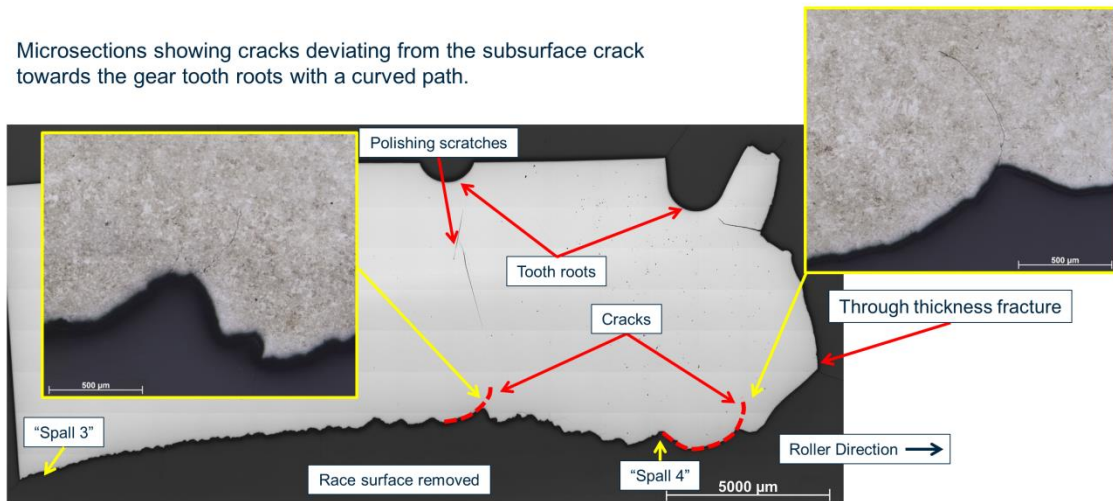
Fractured 2nd Stage Planet Gear Sample FE13961 – Microsection 15.0mm From Upper Edge

Microsections showing cracks deviating from the subsurface crack towards the gear tooth roots with a curved path.

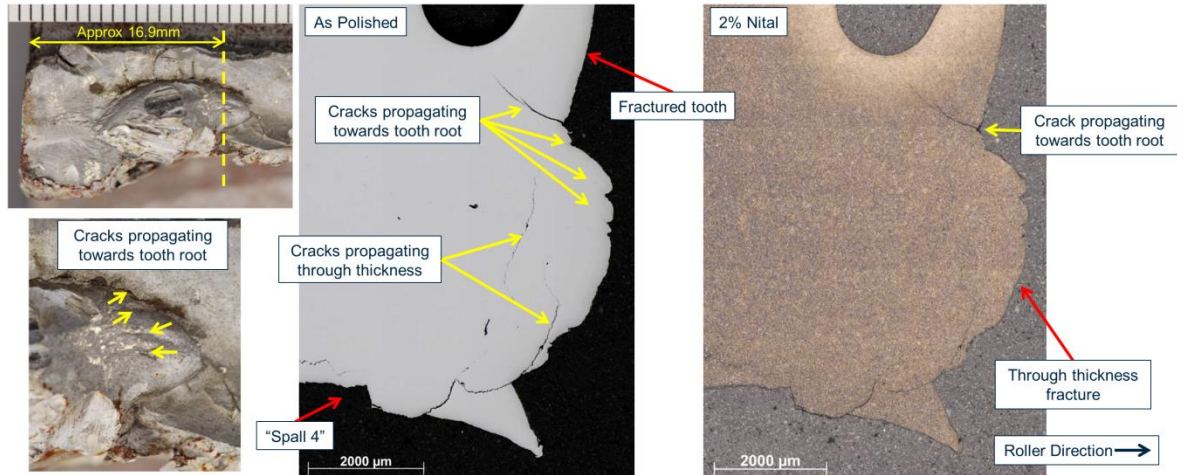
Fractured 2nd Stage Planet Gear Sample FE14227 – Microsection 16.9mm From Upper Edge

Microsections showing a number of cracks deviating from the subsurface crack and propagating through thickness. A number of cracks also observed propagating towards the tooth root.

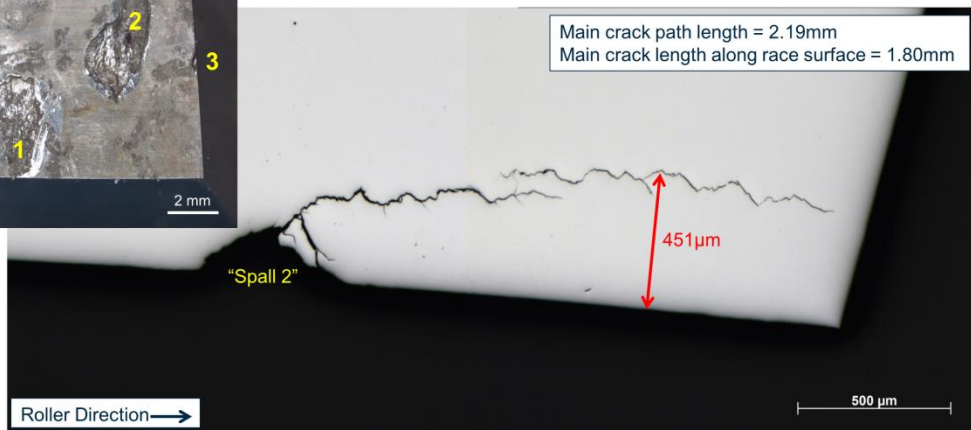
Fractured 2nd Stage Planet Gear Sample FE14226 - Longitudinal Microsection Spall 2

Main crack path length = 2.19mm
Main crack length along race surface = 1.80mm

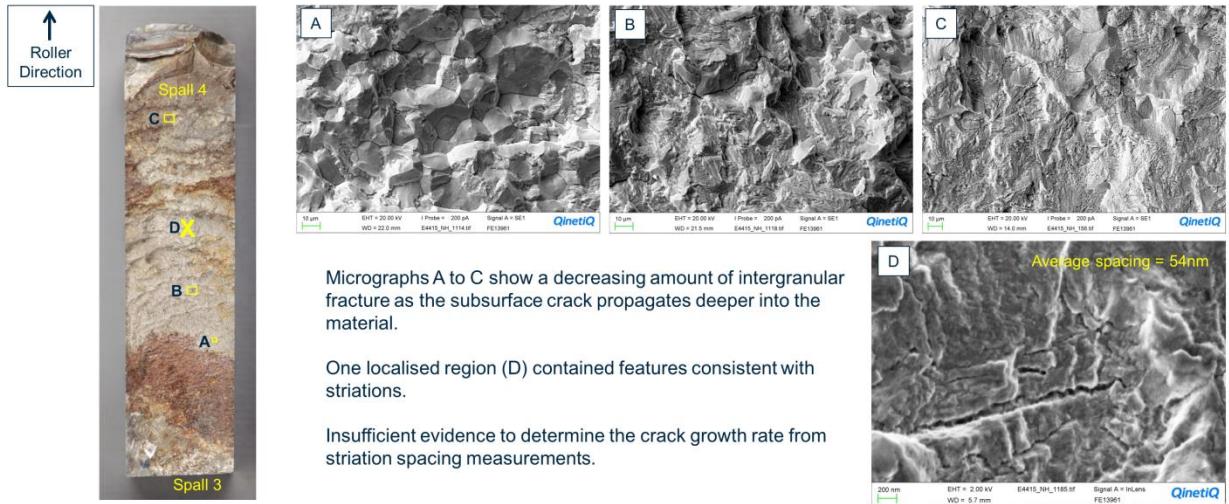
Fractured 2nd Stage Planet Gear Sample FE13961 – Fractography Spall 3 to Main Fracture

Micrographs A to C show a decreasing amount of intergranular fracture as the subsurface crack propagates deeper into the material.

One localised region (D) contained features consistent with striations.

Insufficient evidence to determine the crack growth rate from striation spacing measurements.

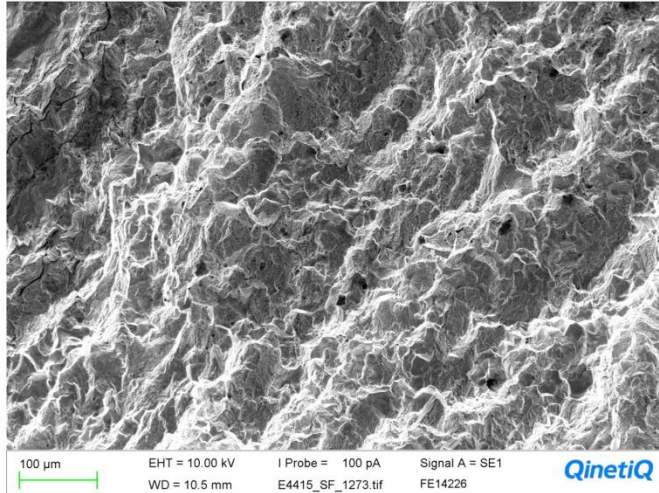
Fractured 2nd Stage Planet Gear Sample FE14226 – SEM Fractography

Subsurface crack has a predominantly intergranular fracture surface.

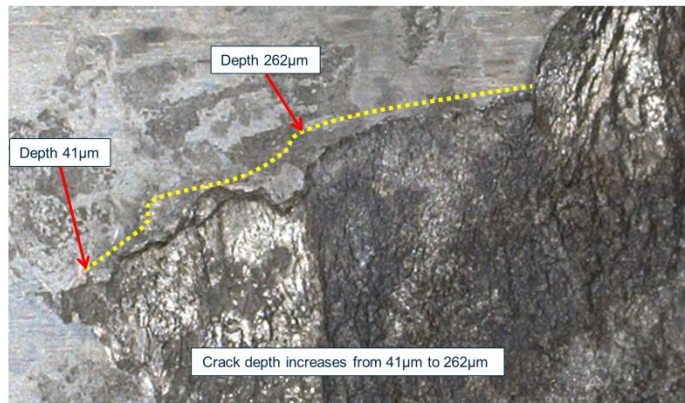
Fractured 2nd Stage Planet Gear – Sample FE14226

Approximate location of subsurface crack

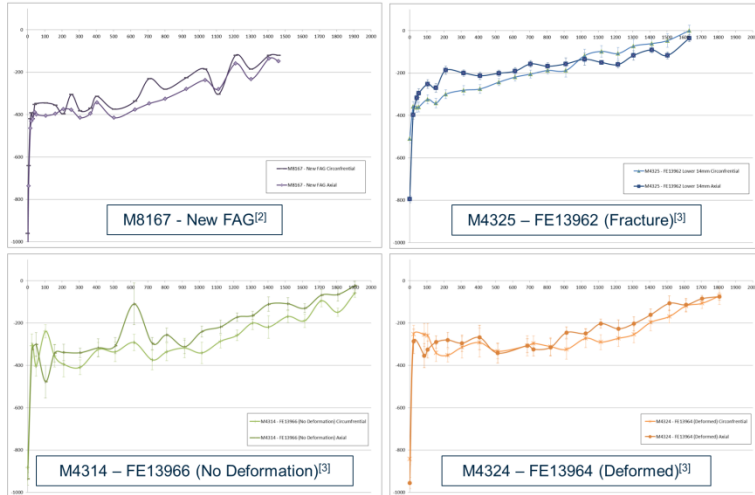
Fractured Second Stage Planet Gear Materials Conformity – Residual Stress

Comparison of the measured residual stress profiles from the outer race surface of three planet gears recovered from the LN-OJF accident, including the failed gear M4325, with the profile obtained from a new FAG planet gear outer race.

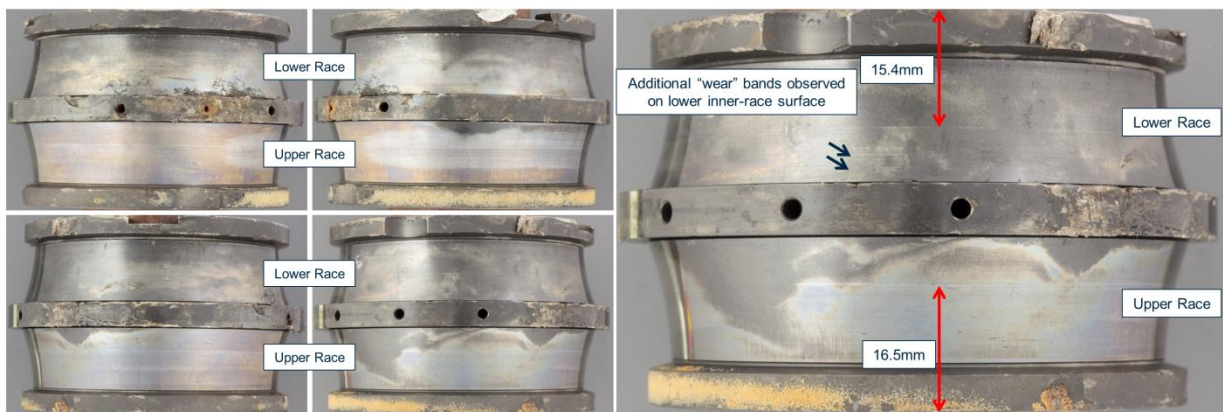
Circumferential "wear" bands observed on the inner-race surfaces

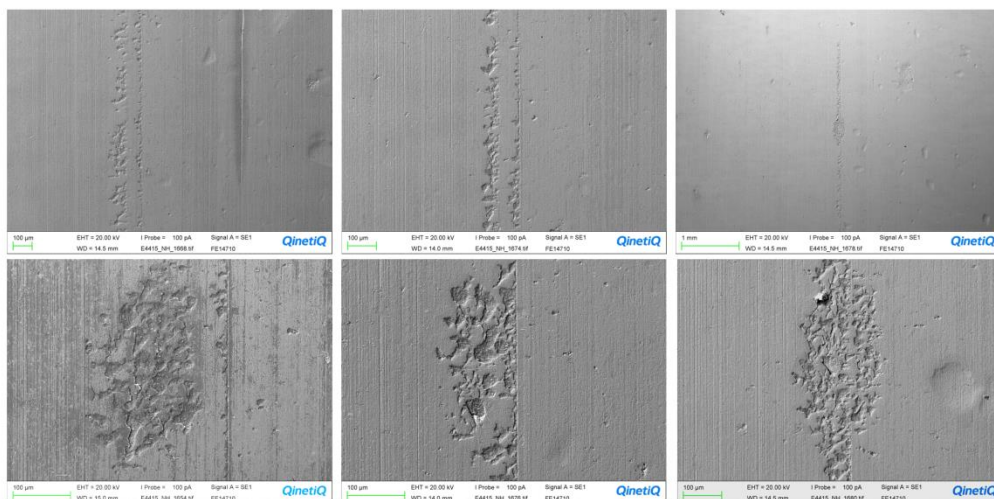
SEM examination of the micro-pitting on the upper inner-race surface shows features similar to the micro-pitting observed on the outer race.

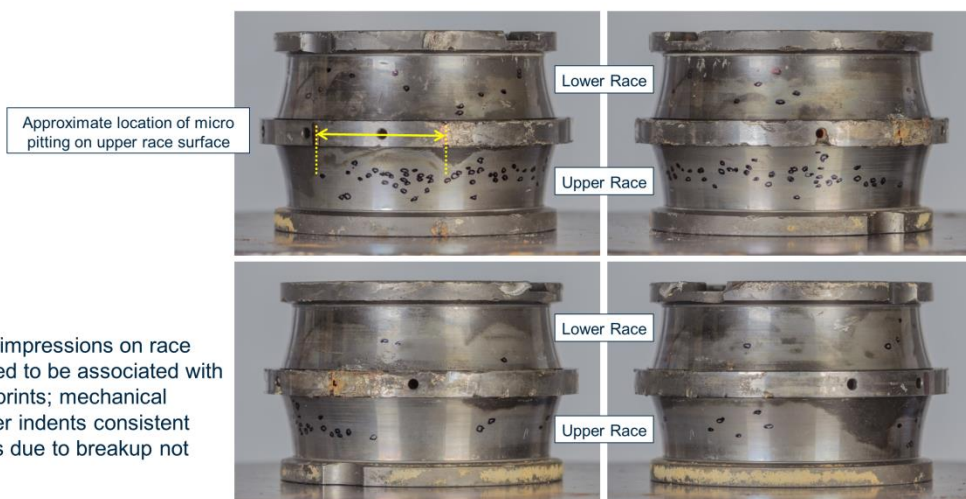
Location of small impressions on race surfaces suspected to be associated with debris particle imprints; mechanical damage and larger indents consistent with roller impacts due to breakup not identified.

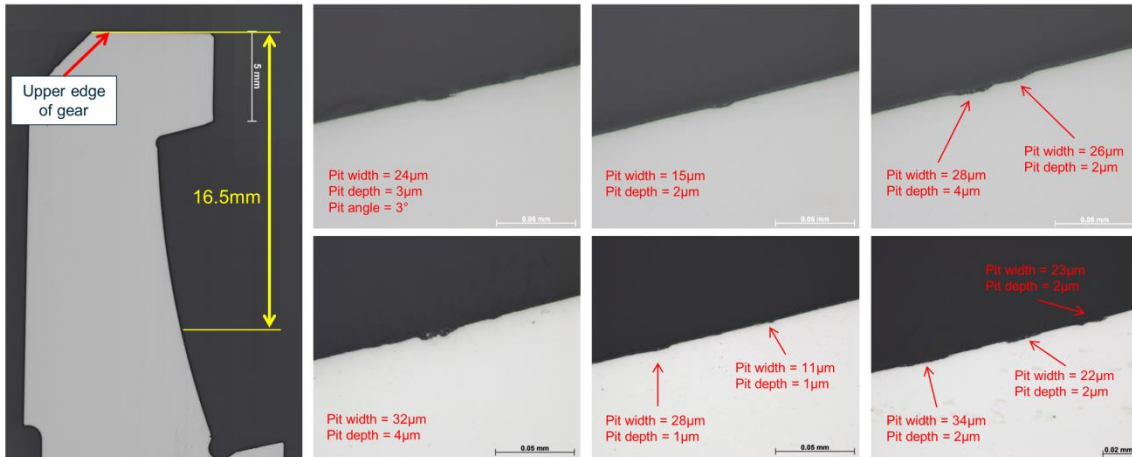
Micro-pitting observed on the upper race surface, approximately 16.5mm from upper edge of gear. No indication of micro-pitting on the lower race surface after several iterations of polishing.

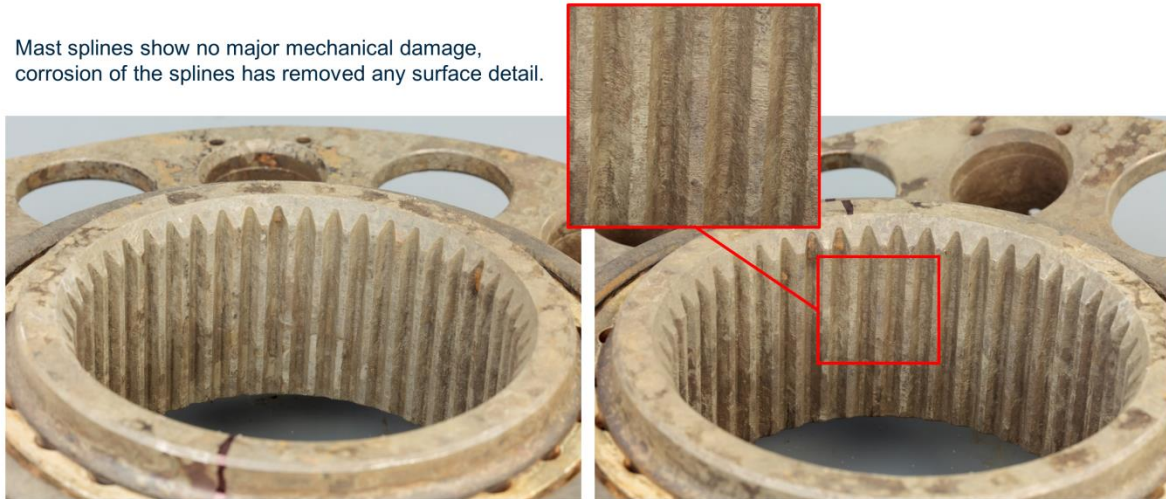
Mast splines show no major mechanical damage, corrosion of the splines has removed any surface detail.

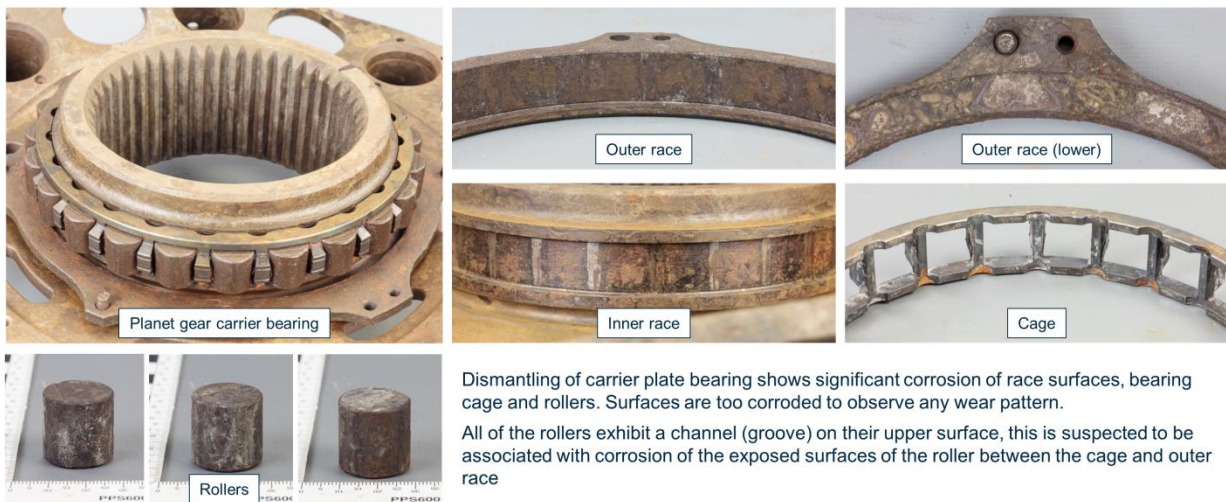
Dismantling of carrier plate bearing shows significant corrosion of race surfaces, bearing cage and rollers. Surfaces are too corroded to observe any wear pattern.
All of the rollers exhibit a channel (groove) on their upper surface, this is suspected to be associated with corrosion of the exposed surfaces of the roller between the cage and outer race
