**PRELIMINARY REPORT ON THE AIR ACCIDENT NEAR TURØY, ØYGARDEN  
MUNICIPALITY, HORDALAND COUNTY, NORWAY 29 APRIL 2016 WITH AIRBUS  
HELICOPTERS EC 225 LP, LN-OJF, OPERATED BY CHC HELIKOPTER SERVICE AS**

28 April 2017

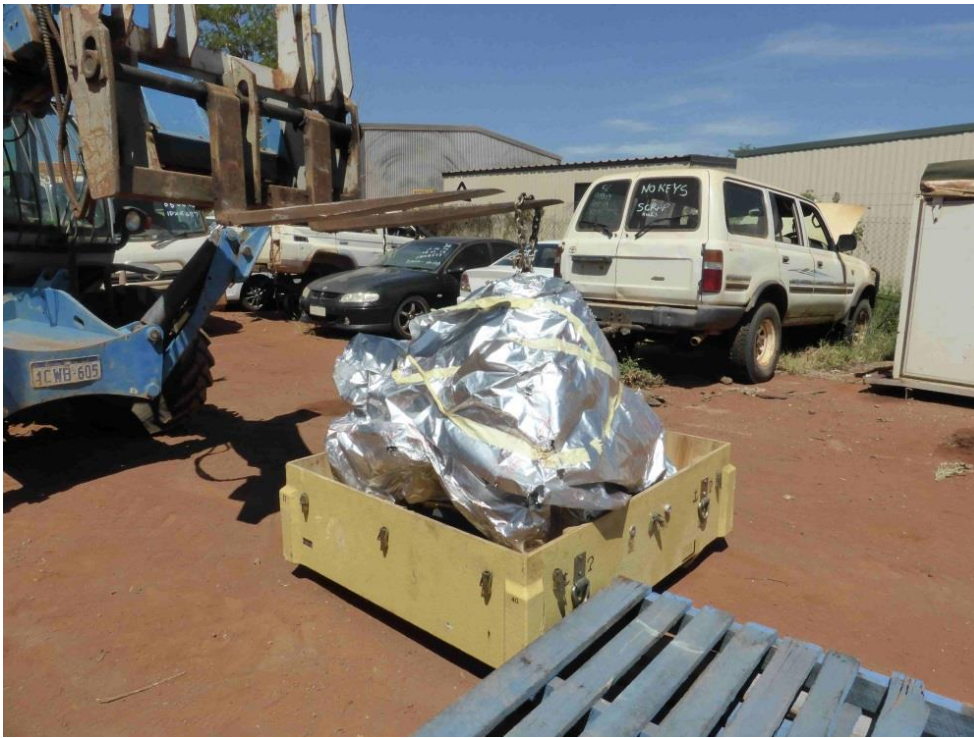
The MGB was involved in a road accident in Australia at 13 March 2015. The gearbox was transported by road on a small truck, installed in an original Airbus Helicopters MGB transport container. The truck went off the gravel road trying to avoid kangaroos crossing the road, the truck rolled over and the gearbox container fell off. There was visible damage to external parts of the gearbox.

Figure 13: MGB in transport container after the transport accident. Photo: Airbus Helicopters

The gearbox was returned to Airbus Helicopters in Marignane, France for inspection and repair. The damage was assessed by the Part 145 organization and a repair program initiated. It involved replacement of damaged external parts, NDT inspection of the MGB casing and removal of bearings and gears for visual inspection. No anomalies on internal components were detected, and all bearings and gears were re-installed.

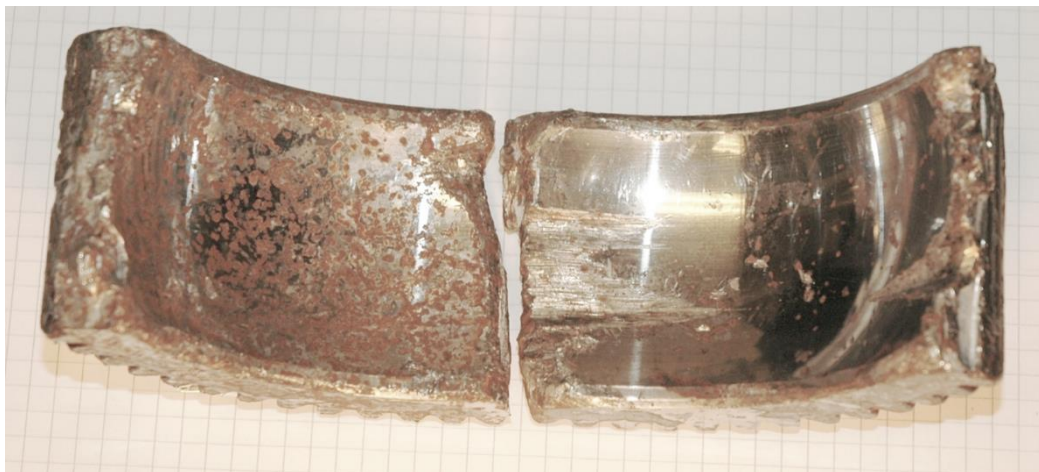
Figure 27: The two fractured gear segments. Appearance of wear marks on the right, while not on the left indicate separation while other parts still have been in motion. Photo: AIBN/NDL

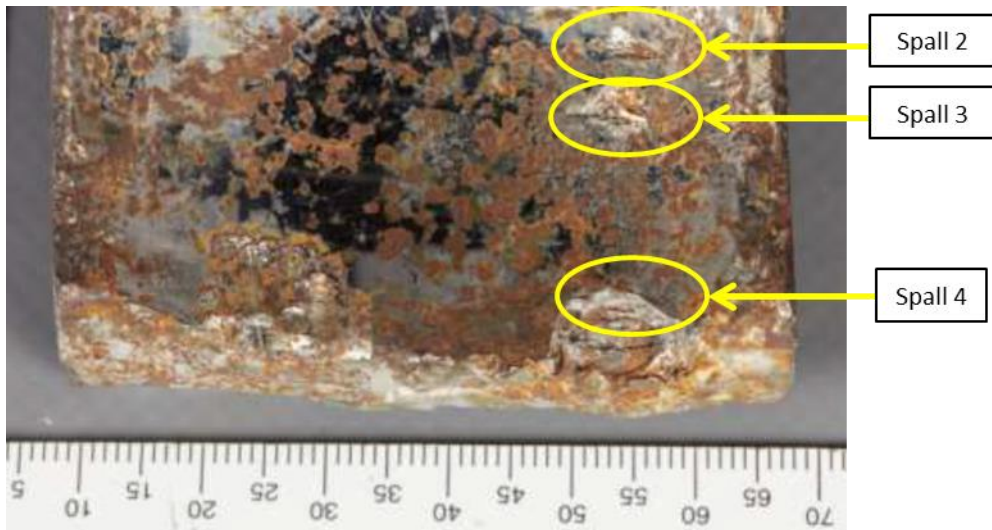
Figure 30: The fatigued surface as received at QinetiQ before cleaning. Along a line approximately 14 mm from the upper surface of the gear (right hand edge in photograph) some holes or spalls are observed, with the largest (named spall 4) located at the edge of the through-thickness fracture. Photo: AIBN/QinetiQ

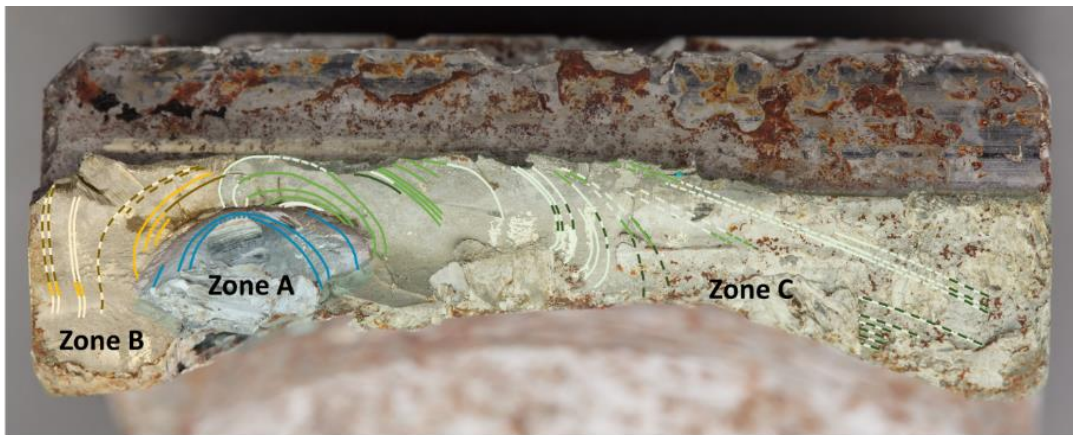
Figure 32: The fracture surface divided into three different zones. The macro marks /features observations are indicated: solid line – well defined, dashed line – less well defined. Photo: AIBN/QinetiQ and Airbus Helicopters

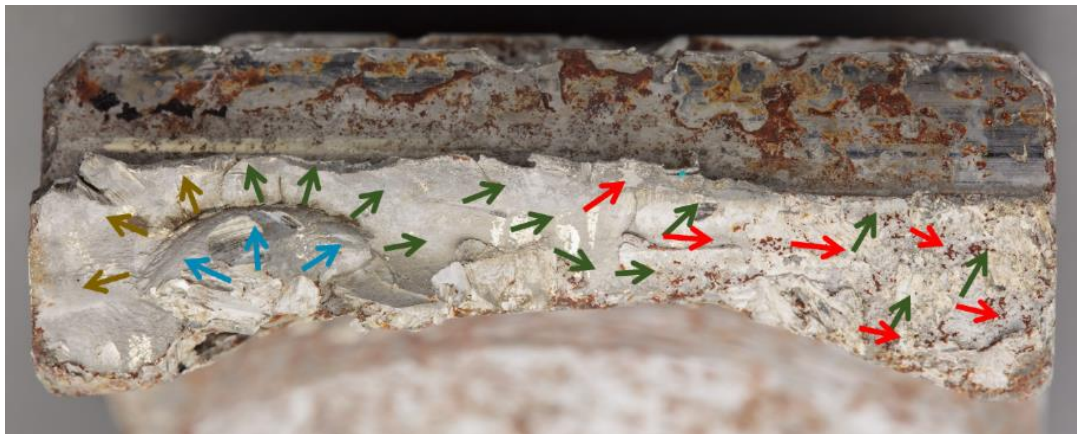
Figure 33: Crack propagation directions concluded from macro mark orientations in zones A (blue), B (brown) and C (green). Propagation in zone C concluded from striation and micro crack orientations is shown by the red arrows. Photo: AIBN/QinetiQ

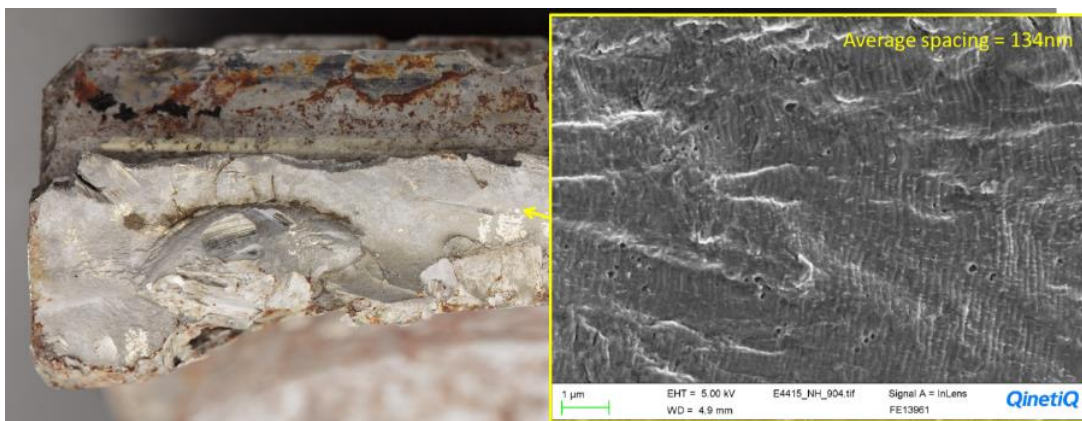
Figure 34: Fatigue crack progression marks – striations. Average spacing between the striations in this area are 134 nm. Photo: AIBN/QinetiQ

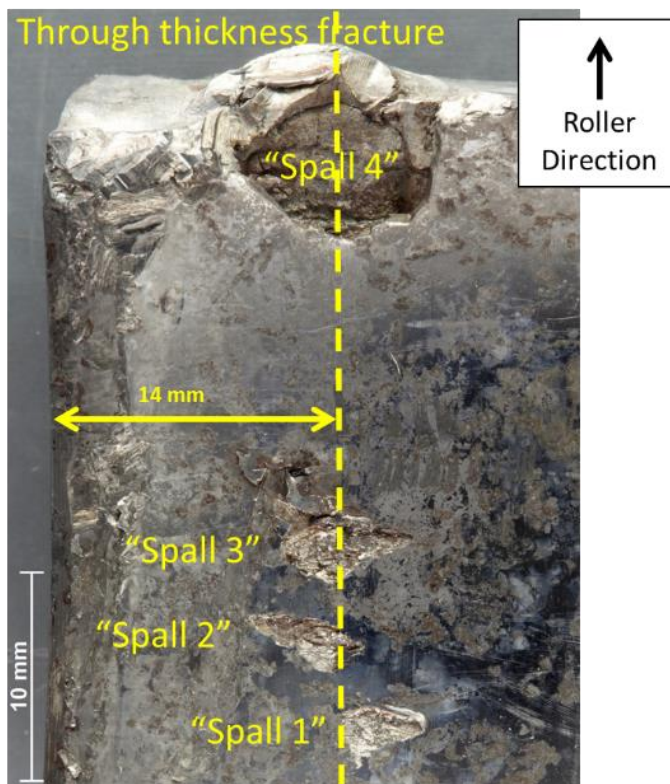
Figure 35: Showing spall one, two, three and four together with the max Hertzian stress line of 14 mm. Photo: AIBN/QinetiQ

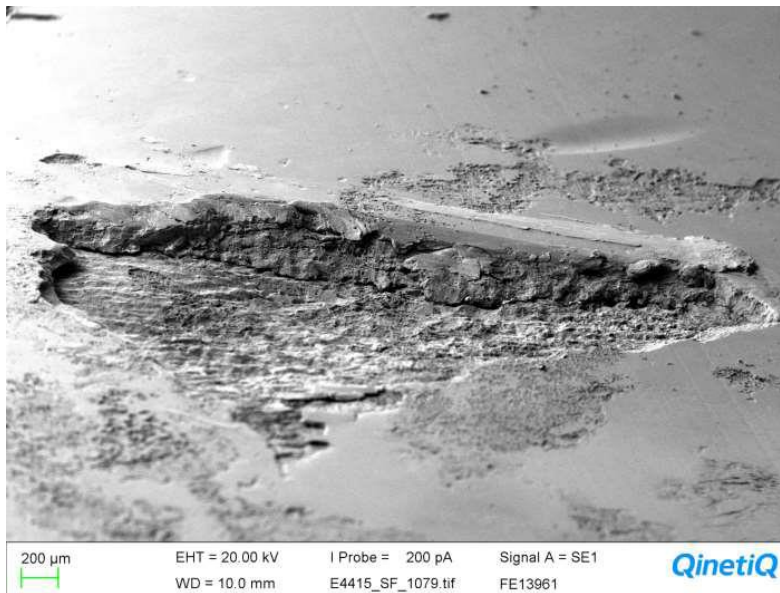
Figure 36: Spall one looking in the direction of spall two (in roller direction). A crack continuing under the surface is observed. Photo: AIBN/QinetiQ

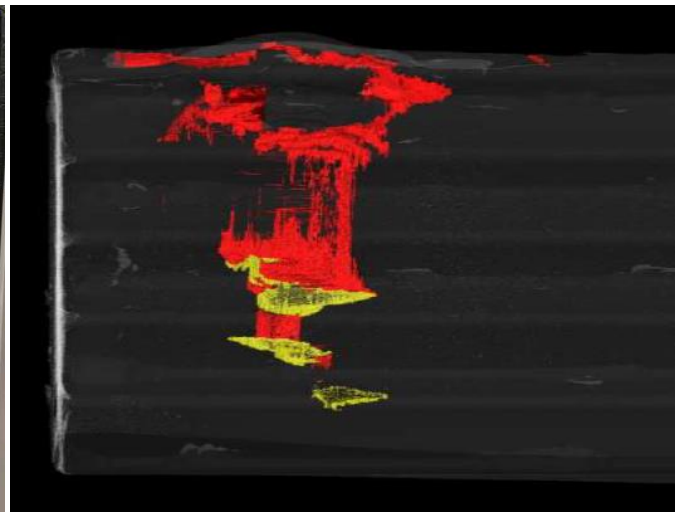
Figure 38: CT-scan of the specimen in Figure 35. The yellow areas are spall one, two and three. The red area indicates a sub-surface crack. Photo: Threshold CT-scan image from AIBN/Southampton University

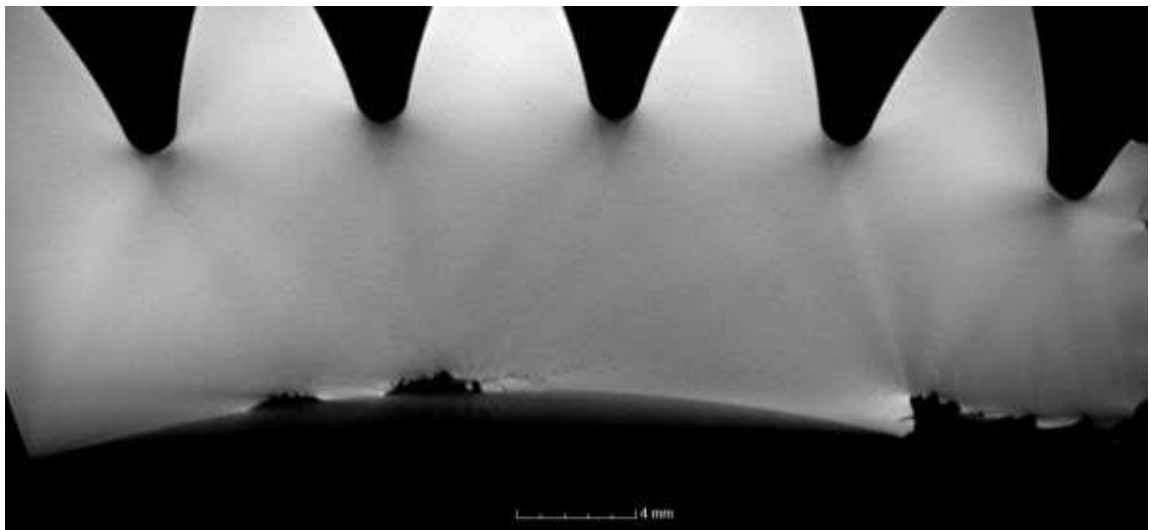
Figure 39: Longitudinal slice from CT-scan showing several cracks below the surface of the outer race. One crack runs below the surface between spalls (areas of surface damage). Photo: CT-scan from AIBN/Southampton University

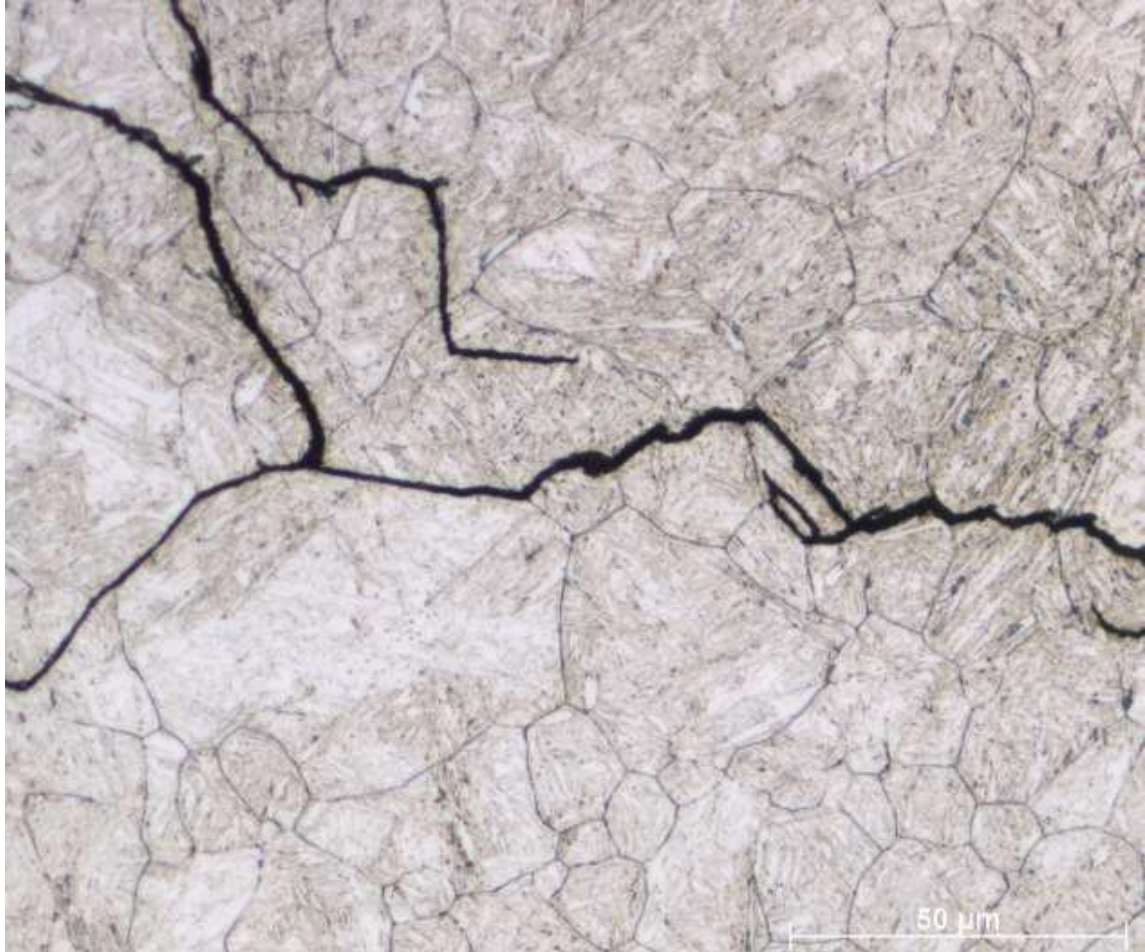
*Figure 41: The sub-surface crack propagation is both trans- and inter-granular. Polished surface etched with saturated Picric acid solution (with HCl). Roller direction to the left.  
Photo: AIBN/QinetiQ*

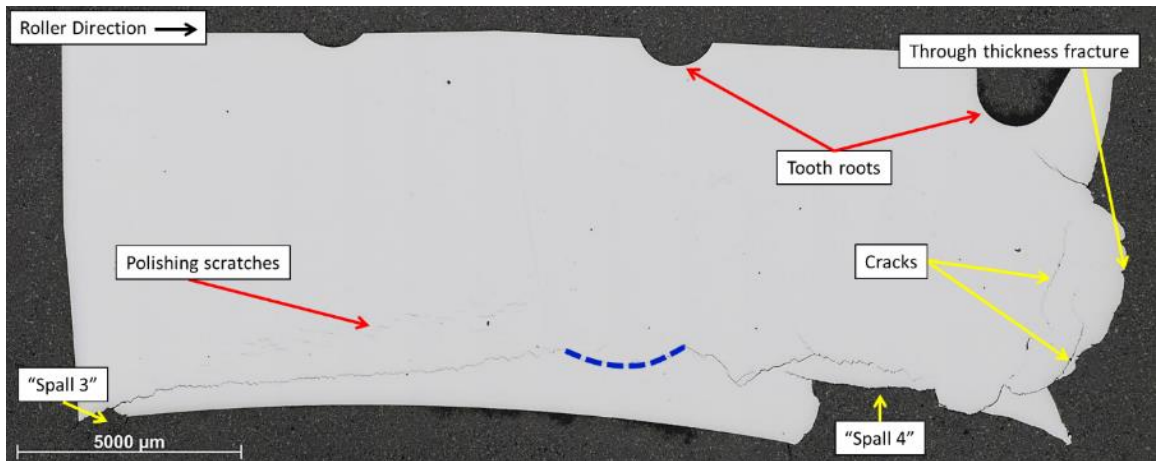
Figure 42: Sample FE13961 (see Figure 40). The microsection is 16.8 mm from upper edge. Cracks deviating towards the race surface stop and thus do not release particles. Photo: AIBN/QinetiQ

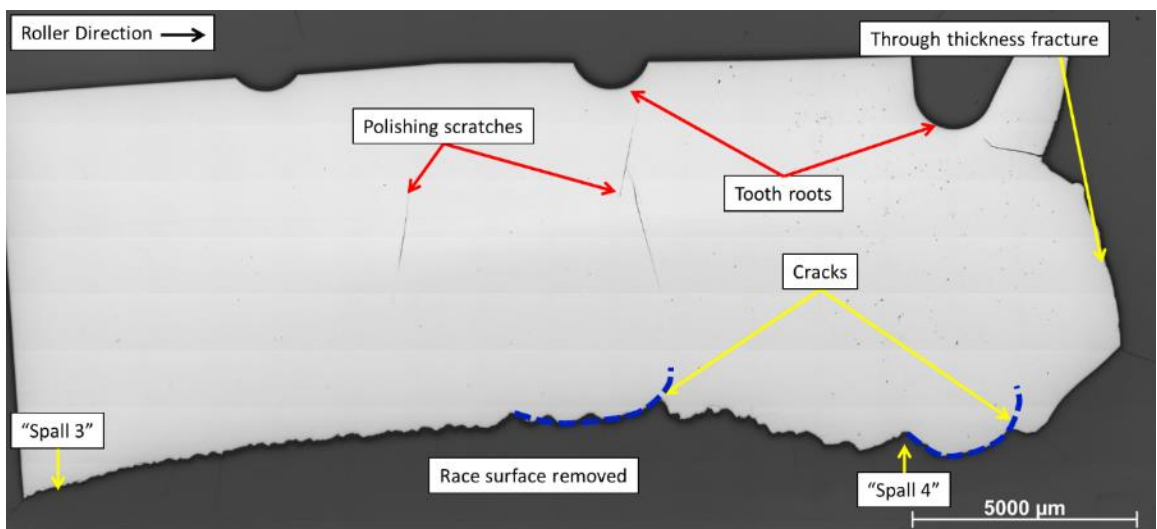
Figure 43: Sample FE13961 (see Figure 40). The microsection is further polished to 15 mm from upper edge. The microsection shows deviations towards the gear teeth roots. Photo: AIBN/QinetiQ

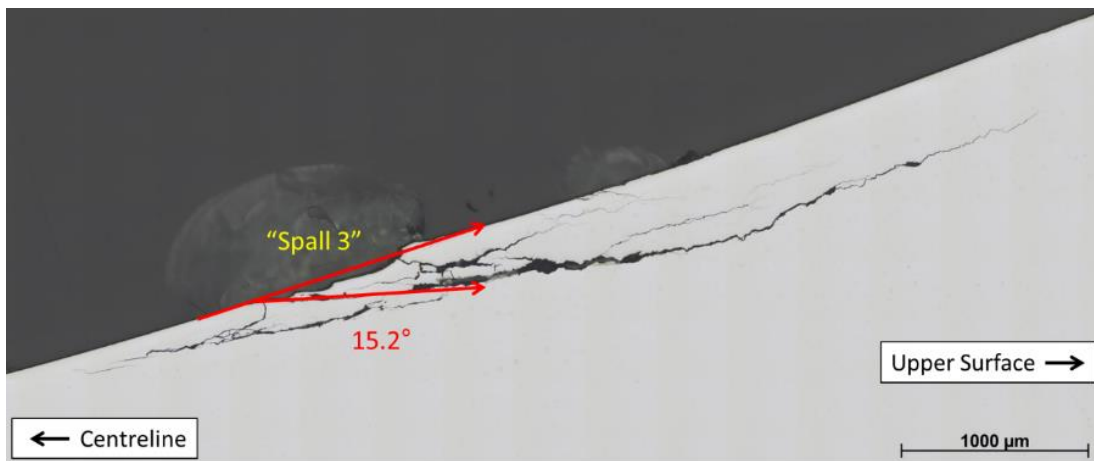
Figure 47: A transverse microsection of spall 3 with the angle crack propagation of 15.2°. Photo: AIBN/QinetiQ

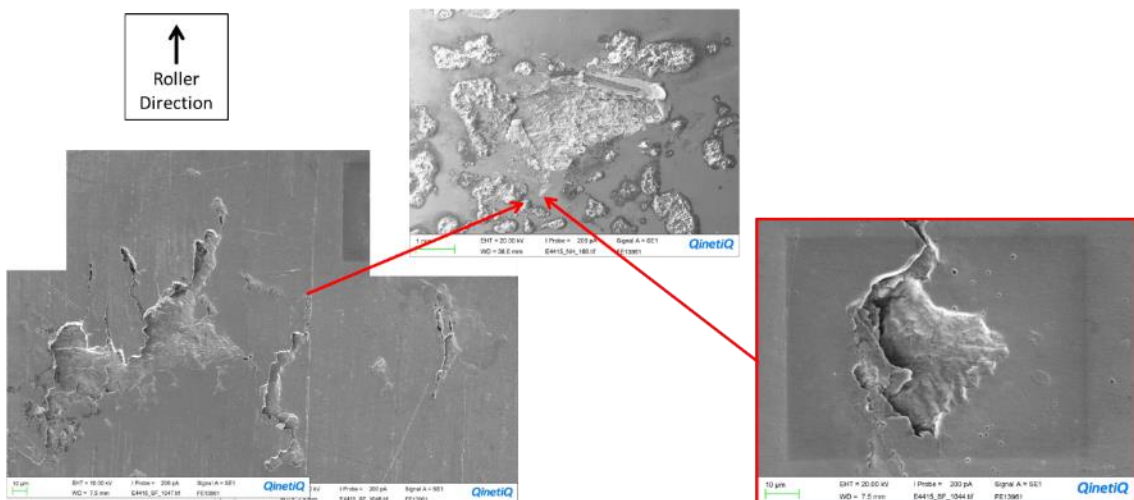
Figure 48: The micro-pits in the area in front of spall one and the pit (lower right) that appears to grow into the area of spall one (upper centre). Photo: AIBN/QinetiQ

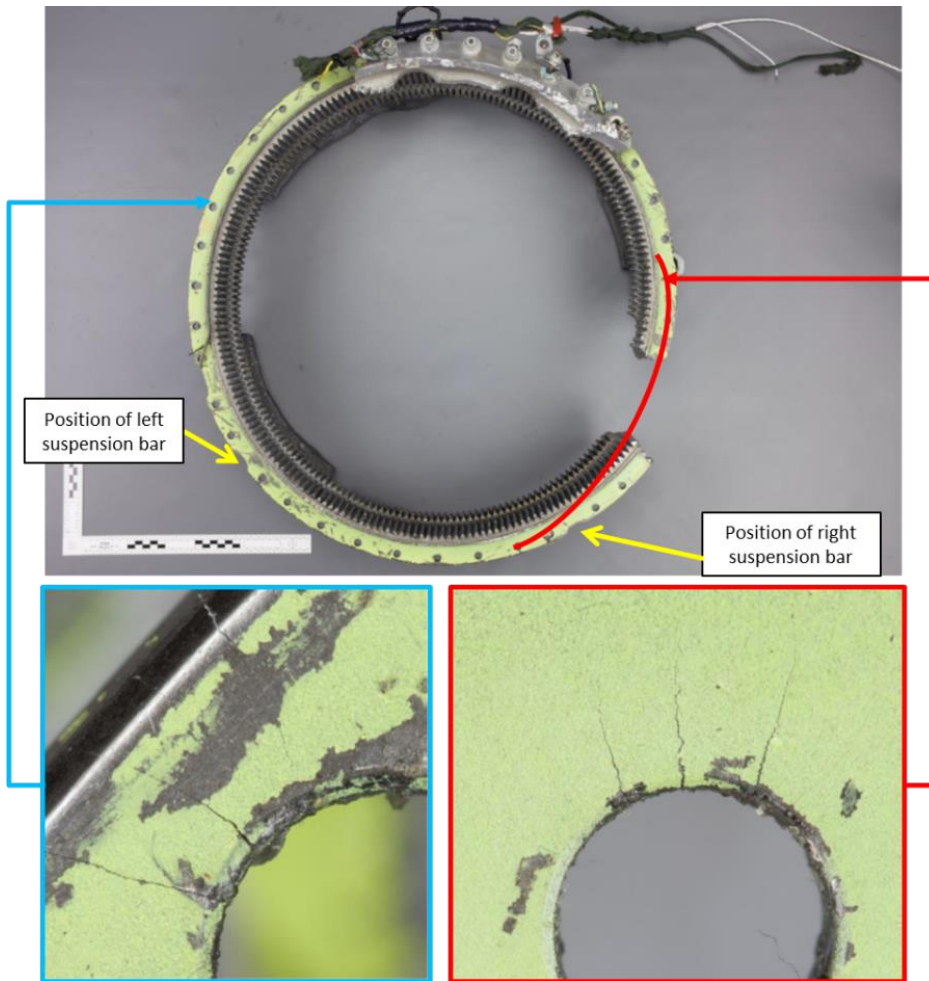
Figure 52: Epicyclic ring gear. Cracks at fastener holes suggests flange of conical housing were intact when fixed ring split and moved outwards. Photo: AIBN/QinetiQ

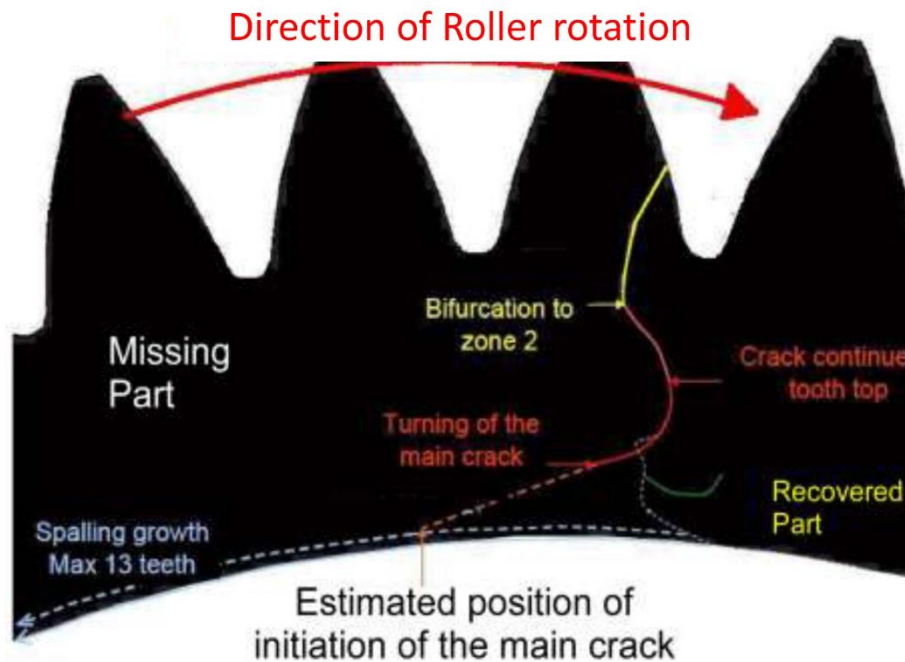
In the case of G-REDL, the origin of the crack was in a section of the failed gear which was not recovered. The G-REDL report displayed a stress model prediction of crack growth in the missing section of the planet gear. The crack propagation path in the retrieved second stage planet gear in this accident (LN-OJF) appears to be very similar to the estimated crack growth in the G-REDL.

Figure 62: Stress model estimation of crack growth. Source: Airbus Helicopters
