REPORT

SL 2018/04

REPORT ON THE AIR ACCIDENT NEAR TURØY, ØYGARDEN MUNICIPALITY, HORDALAND COUNTY, NORWAY 29 APRIL 2016 WITH AIRBUS HELICOPTERS EC 225 LP, LN-OJF, OPERATED BY CHC HELIKOPTER SERVICE AS

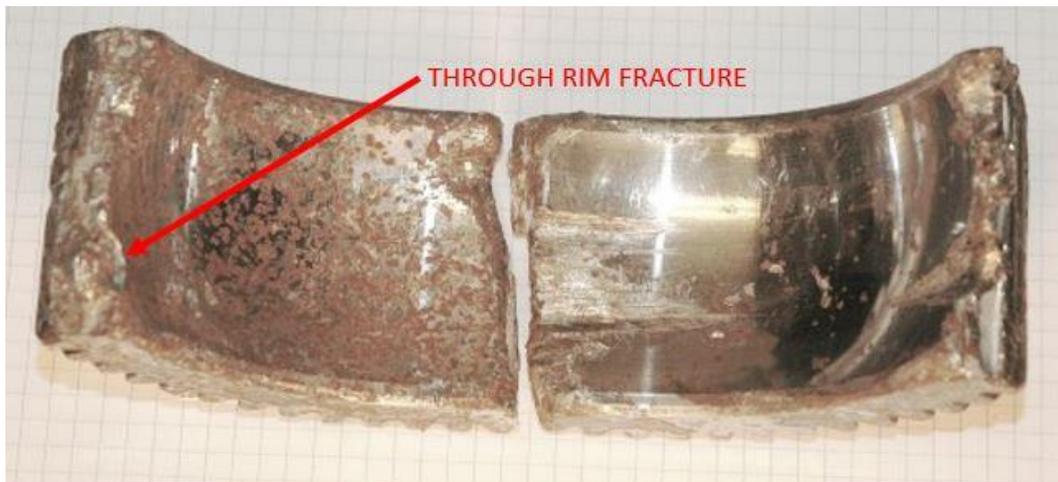
Figure 27: The two segments of the fractured second stage planet gear (serial number M4325). The fatigue fracture through the rim (through-thickness fracture) started in the outer upper race of the planet gear wheel where the red arrow is pointing (spall 4). Photo: AIBN/NDL

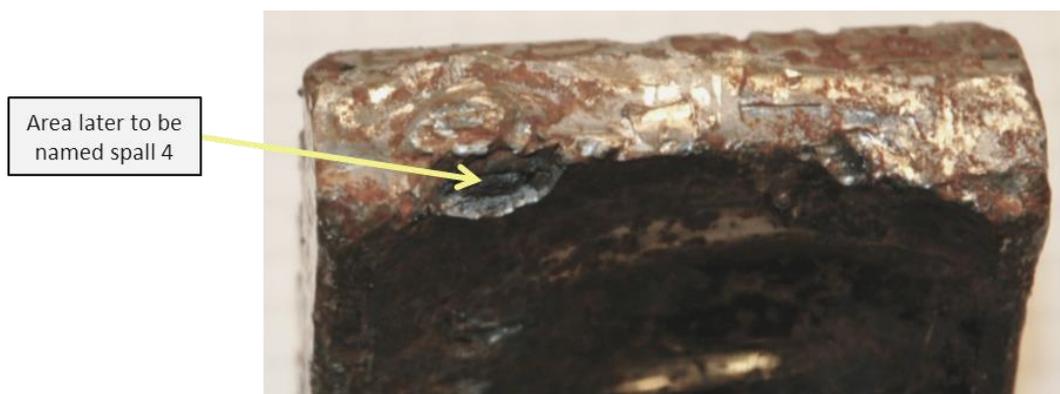
Figure 28: The fracture surface to the left in Figure 27. This surface appeared not to be ductile overload, but possibly fatigue. Photo: AIBN/NDL

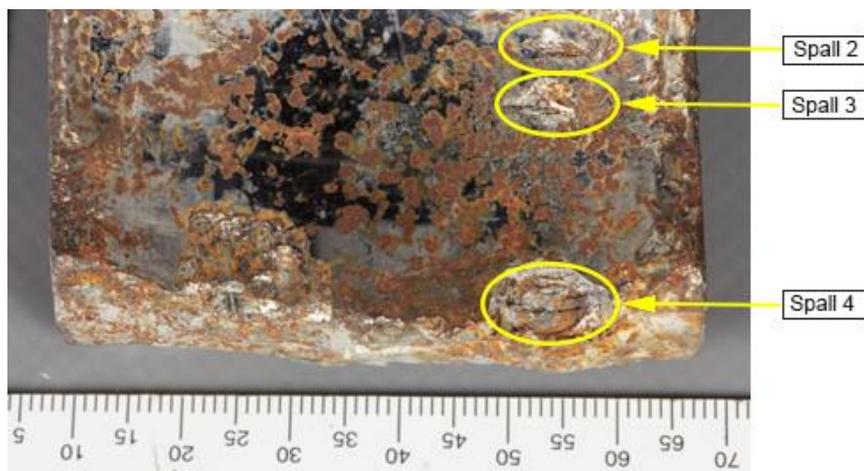
Figure 29: The fatigued surface as received at QinetiQ before cleaning. Along a line approximately 14 mm from the upper surface of the gear (right hand edge in photograph) some holes or spalls are observed, with the largest (named spall 4) located at the edge of the through-thickness fracture. Photo: AIBN/QinetiQ

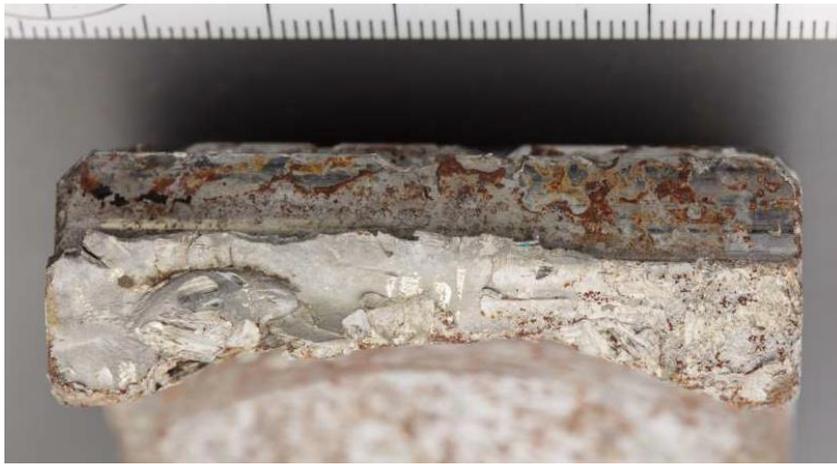
Figure 30: The cleaned through-thickness fracture surface. Macro marks (beach marks) are visible towards the upper edge of the gear (left hand side in photograph). Photo: AIBN/QinetiQ

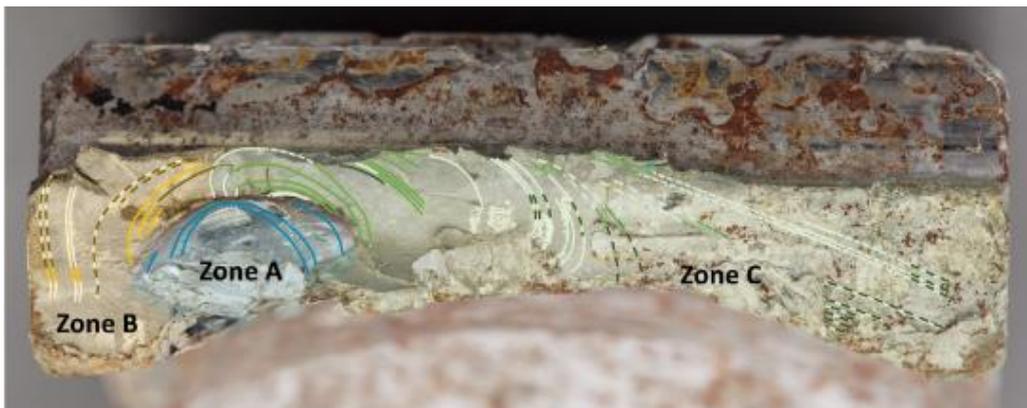
Figure 31: The fracture surface divided into three different zones. The macro marks/features observed are indicated: solid line – well defined, dashed line – less well defined. Photo: AIBN/QinetiQ

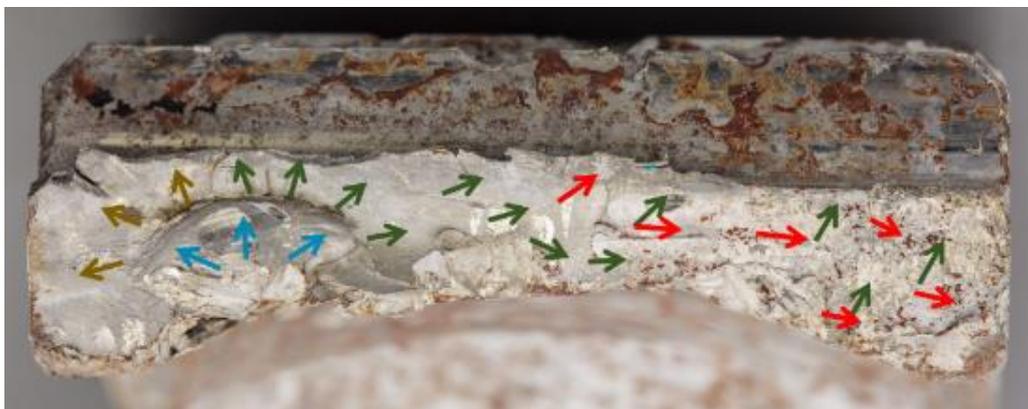
Figure 32: Crack propagation directions concluded from macro mark orientations in zones A (blue), B (brown) and C (green). Propagation in zone C concluded from striation and micro-crack orientations is shown by the red arrows. Photo: AIBN/QinetiQ

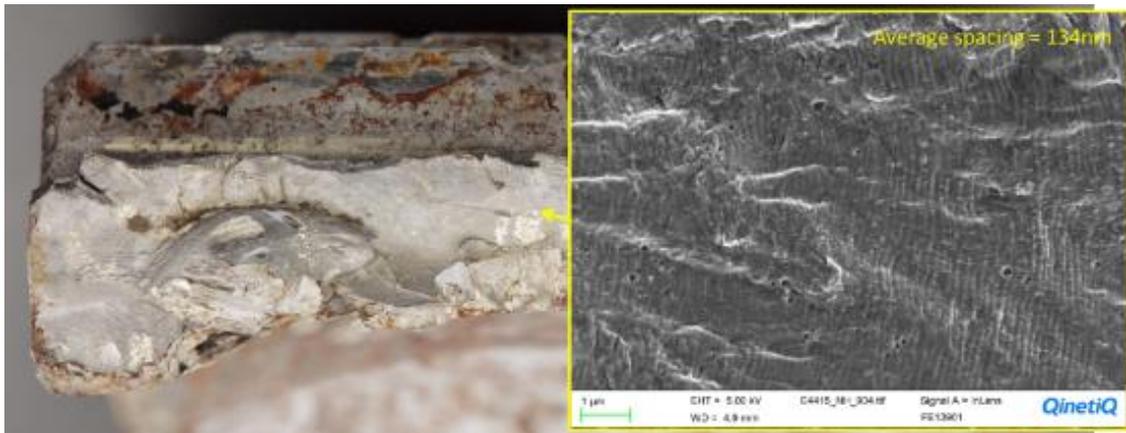
Figure 33: Fatigue crack progression marks – striations. Average spacing between the striations in this area are 134 nm. Photo: AIBN/QinetiQ

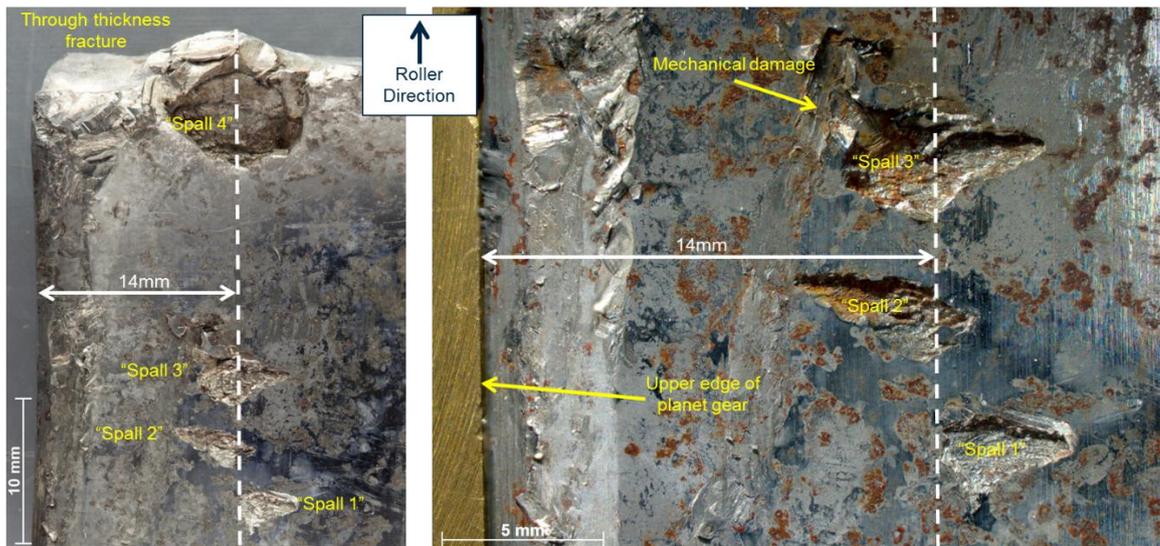
Figure 34: Showing spall 1, 2, 3 and 4 together with the max Hertzian stress line of 14 mm.
 Photo: AIBN/QinetiQ

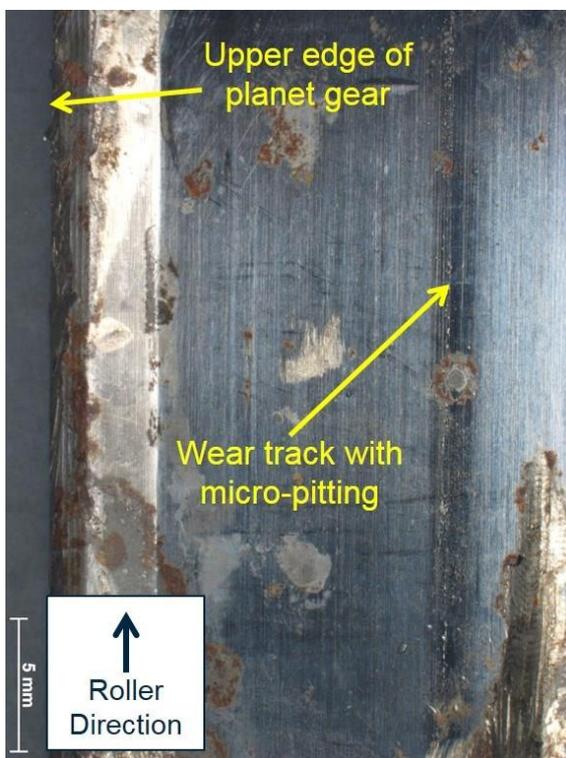
Figure 35: A wear track containing micro-pitting is also observed on the upper outer-race surface of the second planet gear fragment. Photo: AIBN/QinetiQ

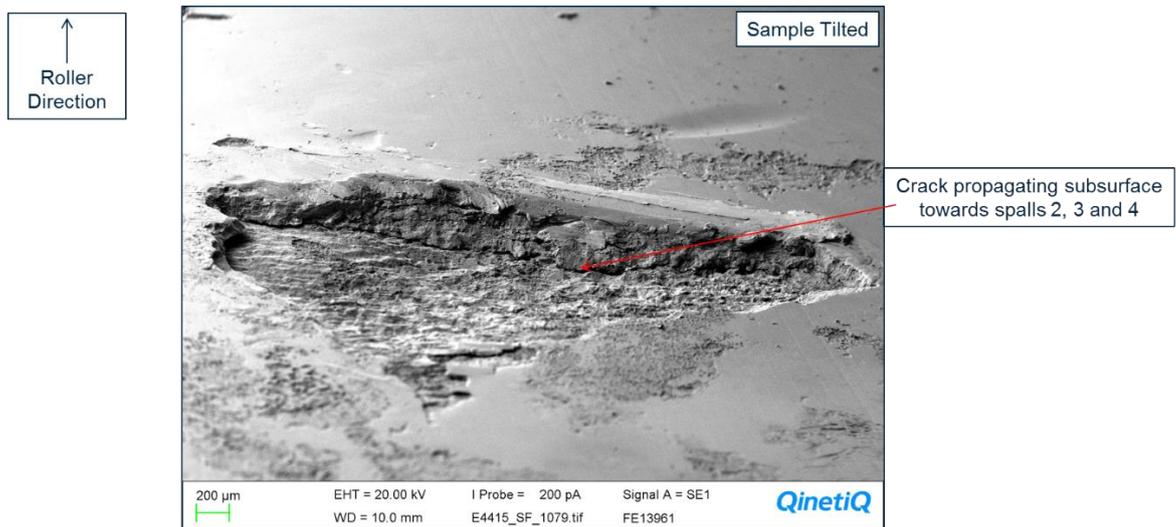
Figure 36: Spall one looking in the direction of spall two (in roller direction). A crack continuing under the surface is observed. Photo: AIBN/QinetiQ

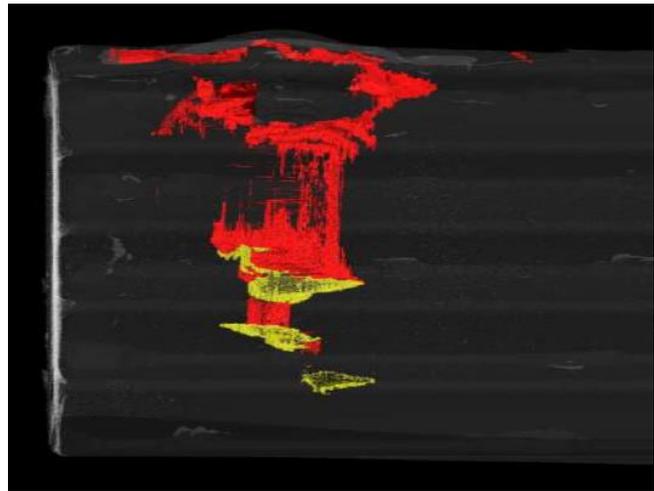
Figure 38: CT-scan of the specimen in Figure 34. The yellow areas are spall one, two and three. The red area indicates the resolvable part of the subsurface crack. Photo: Threshold CT-scan image from AIBN/Southampton University

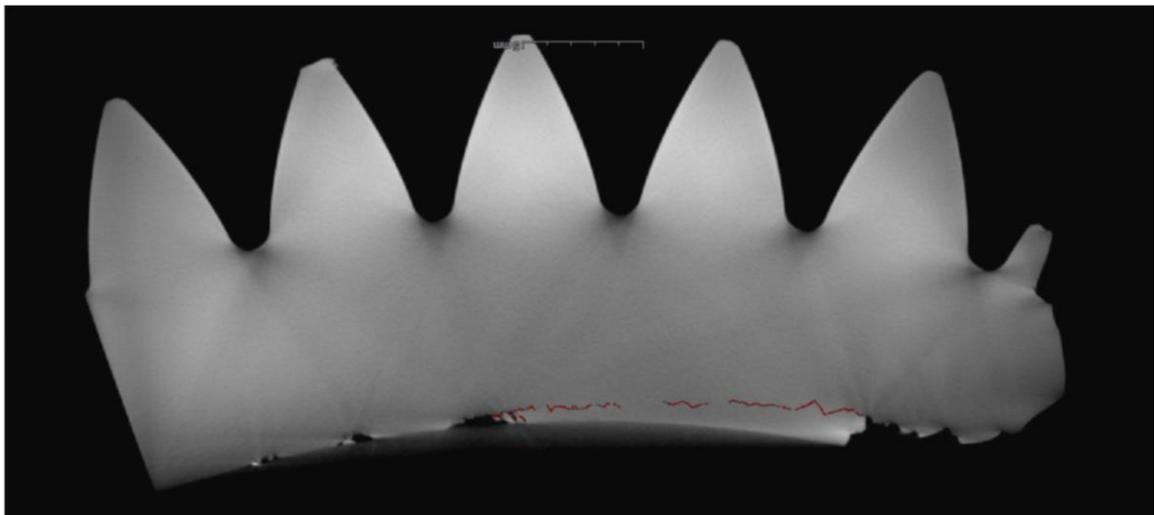
Figure 39: Longitudinal slice from CT-scan showing several cracks below the surface of the outer race. One crack runs below the surface between spalls (areas of surface damage). The main crack is marked in red. Photo: CT-scan from AIBN/Southampton University/QinetiQ

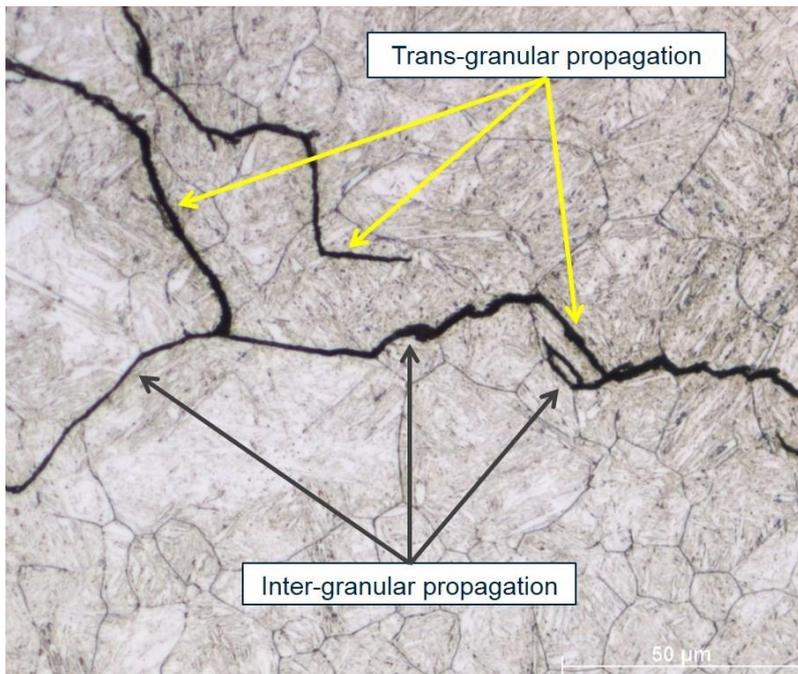
Figure 41: The subsurface crack propagation is both trans- and inter-granular. Roller direction to the left. Photo: AIBN/QinetiQ

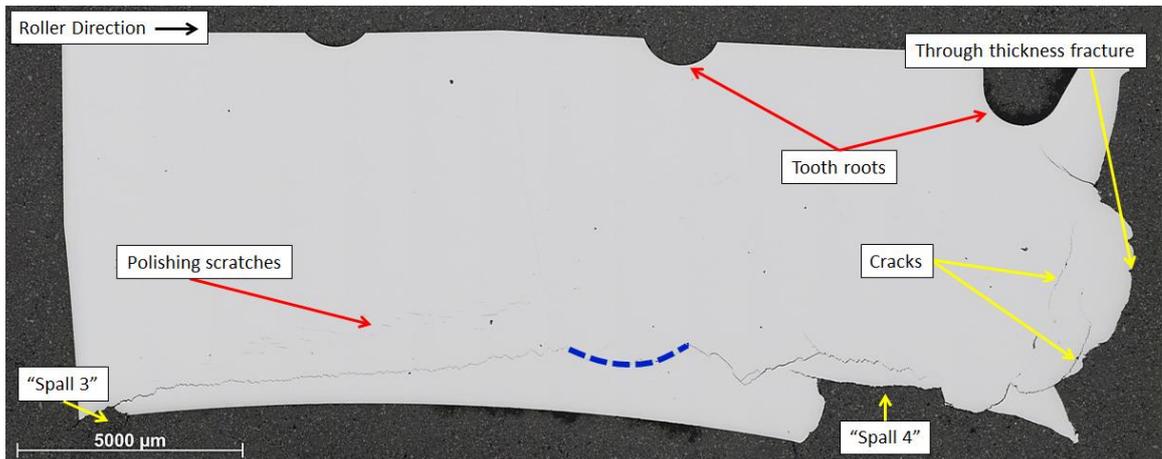
Figure 42: Sample FE13961 (see Figure 40). The micro-section is 16.8 mm from upper edge. Cracks deviating towards the race surface stop and thus do not release particles. Photo: AIBN/QinetiQ

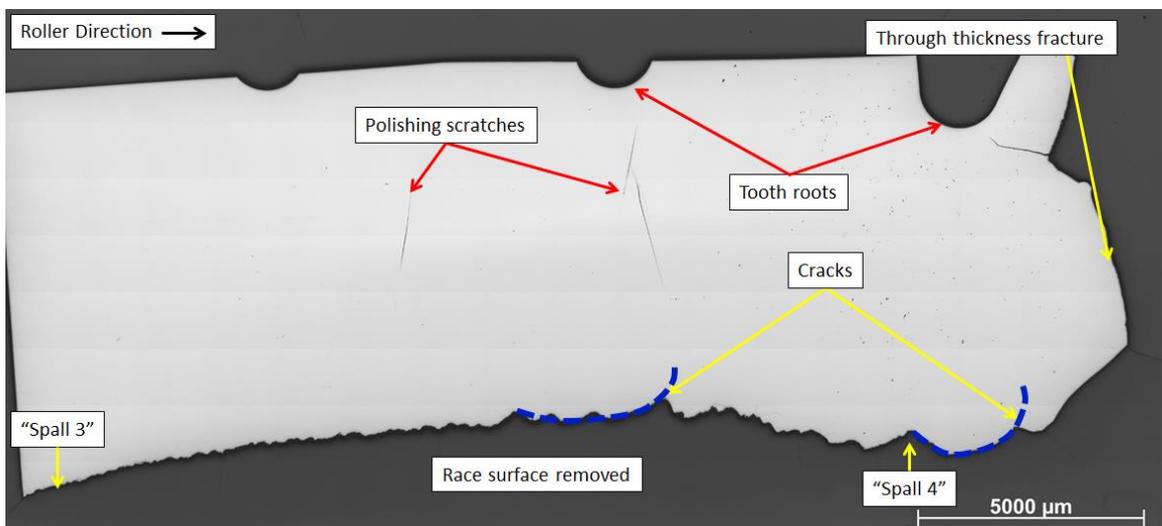
Figure 43: Sample FE13961 (see Figure 40). The micro-section is further polished to 15 mm from upper edge with the raceway removed. The micro-section shows deviations towards the gear teeth. Photo: AIBN/QinetiQ

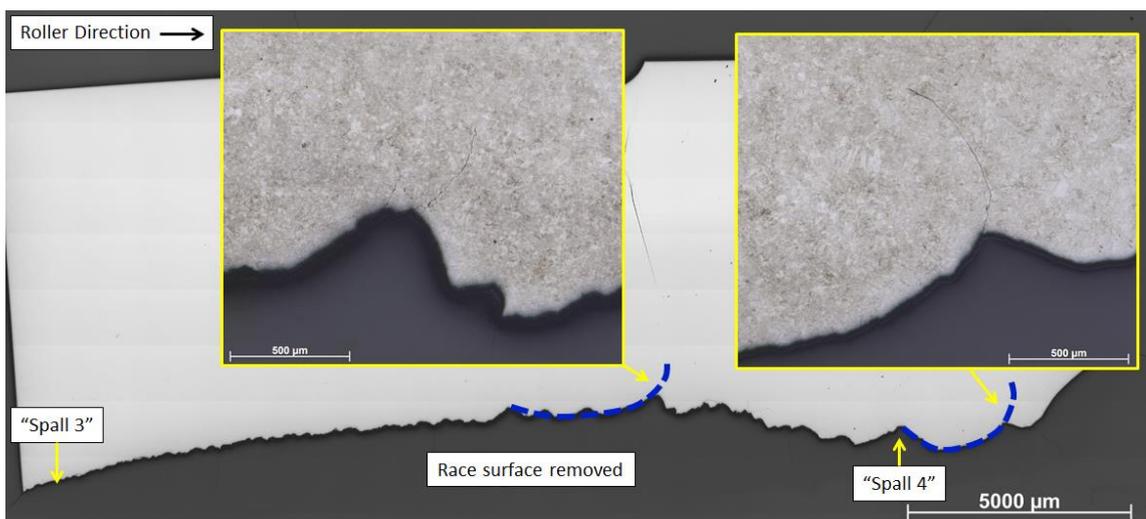
Figure 44: Sample FE13961 (see Figure 40). The micro-section shows a close up of deviations towards the gear teeth. Photo: AIBN/QinetiQ

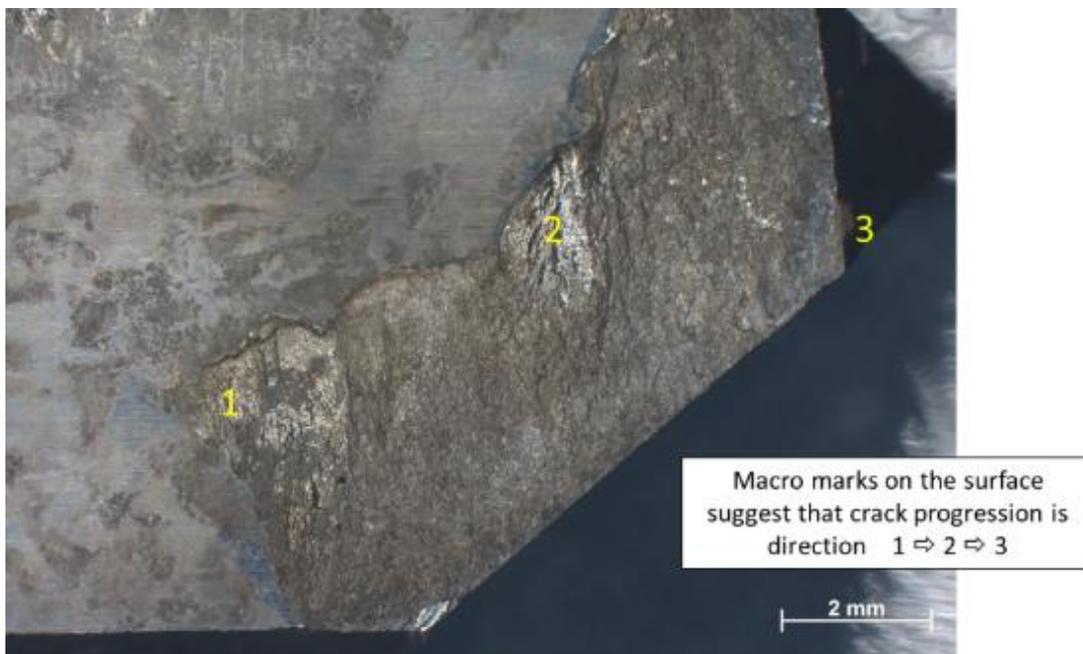
Figure 47: Figure showing the crack between spalls 1, 2 and 3 after removal of the race surface. Photo: AIBN/QinetiQ

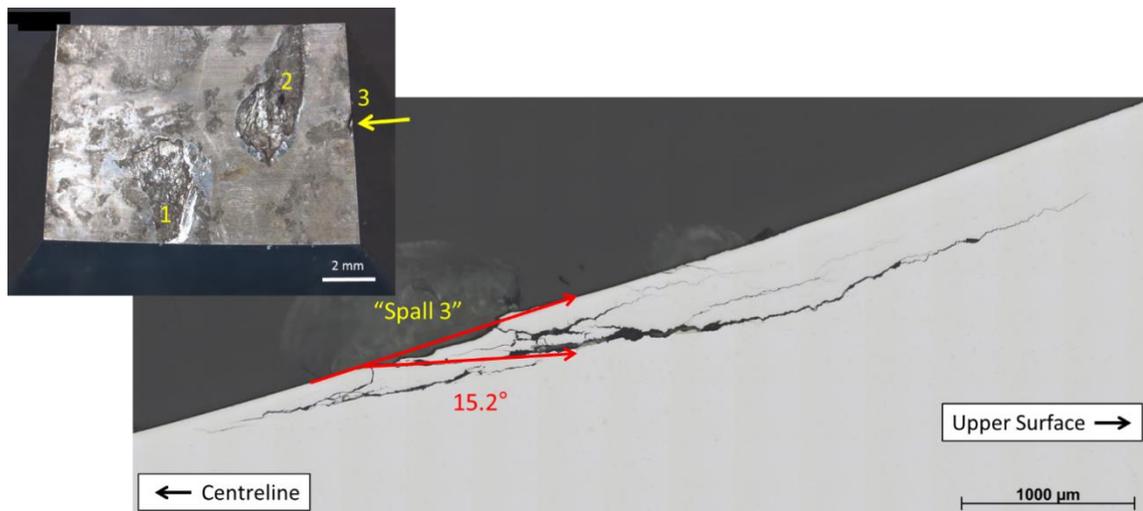
Figure 48: A transverse micro-section of spall 3 with the angle crack propagation of 15.2°. Photo: AIBN/QinetiQ

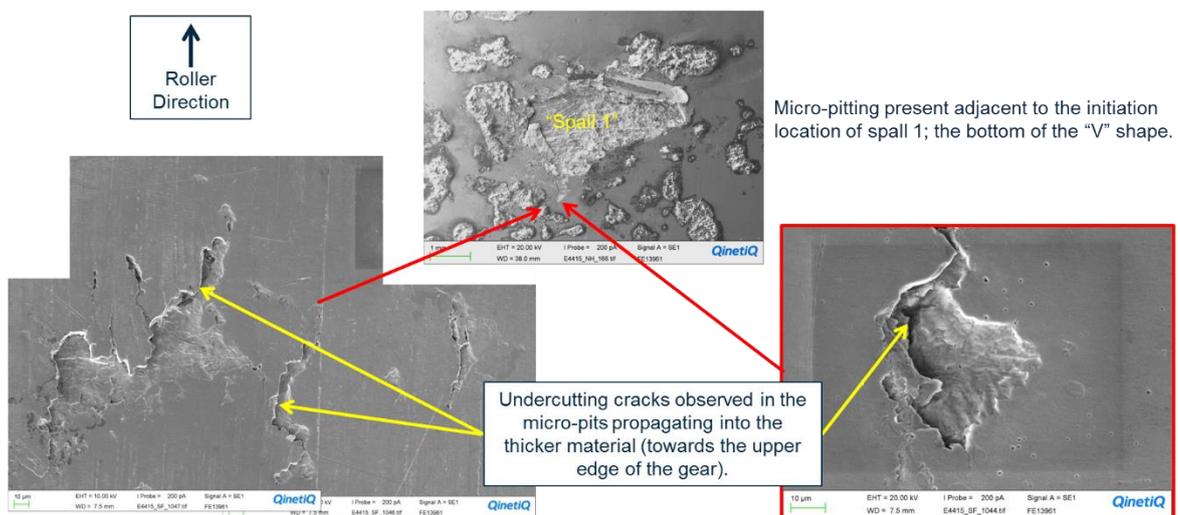
Figure 49: The micro-pits in the area in front of spall 1 Photo: AIBN/QinetiQ

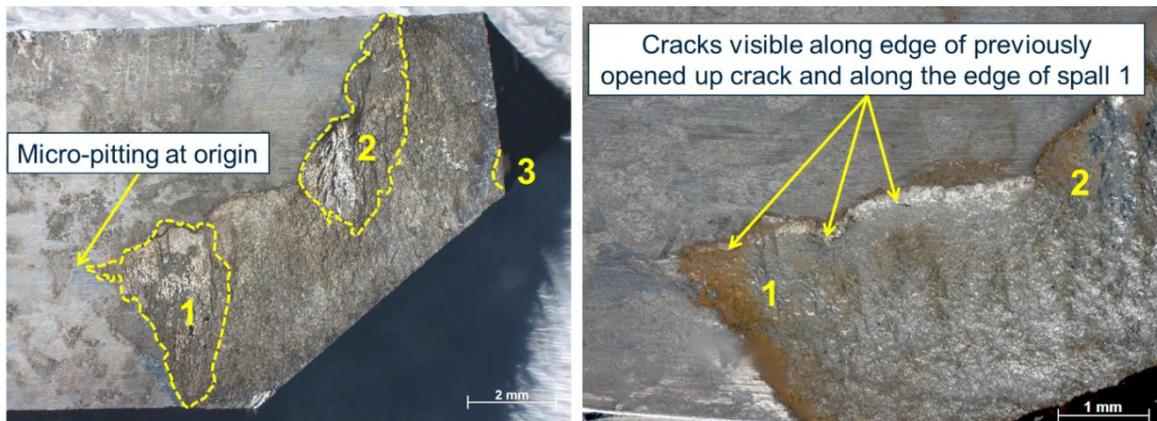
Figure 50: Fracture surface showing the extent of spalls 1 and 2. Photo AIBN/QinetiQ

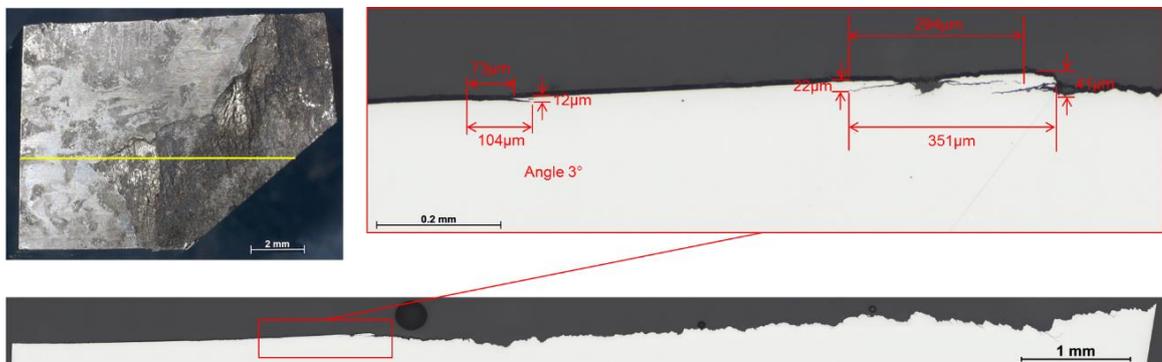
Figure 51: Micro-section 14.8 mm from top of gear showing Spall 1 and adjacent micro-pits with small cracks. The micro-cracks emerge from the micro-pits at a shallow angle into the material in the roller direction and inclined towards the upper edge of the gear. Photo AIBN/QinetiQ

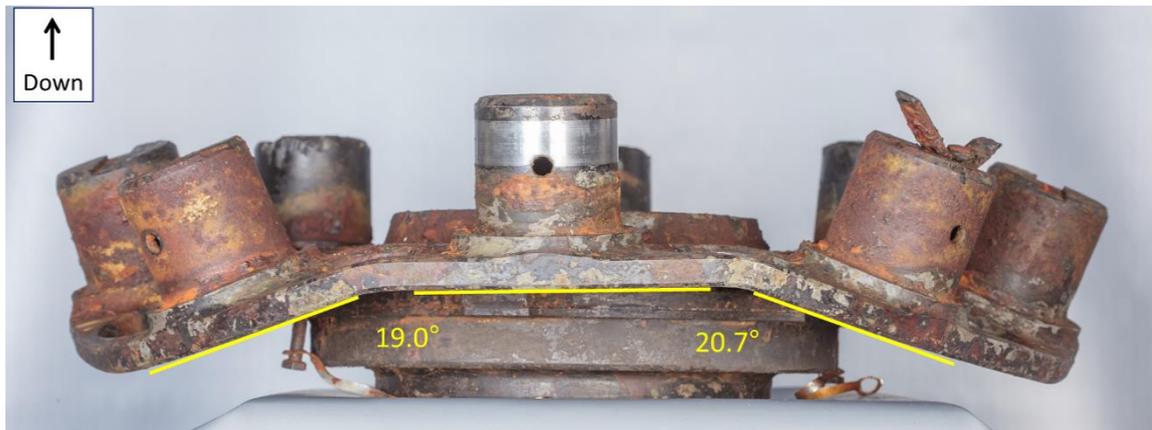
Figure 55. Deformation of carrier is symmetrical around the fractured planet gear. Photo: AIBN/QinetiQ

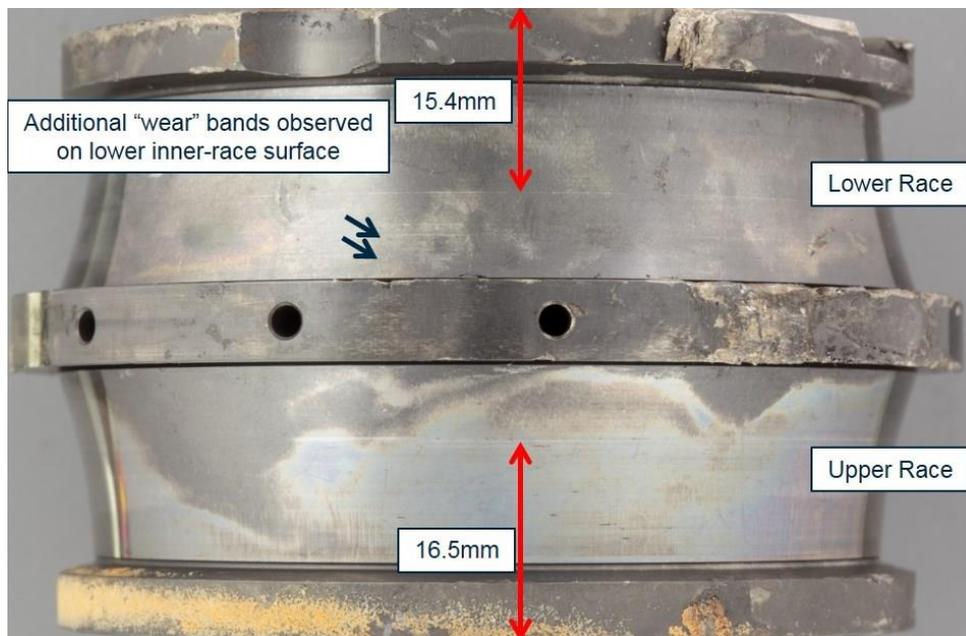
Figure 56: Circumferential ‘wear’ bands on the second stage planet gear inner race observed on both upper and lower race surfaces after cleaning. Photo: AIBN/QinetiQ

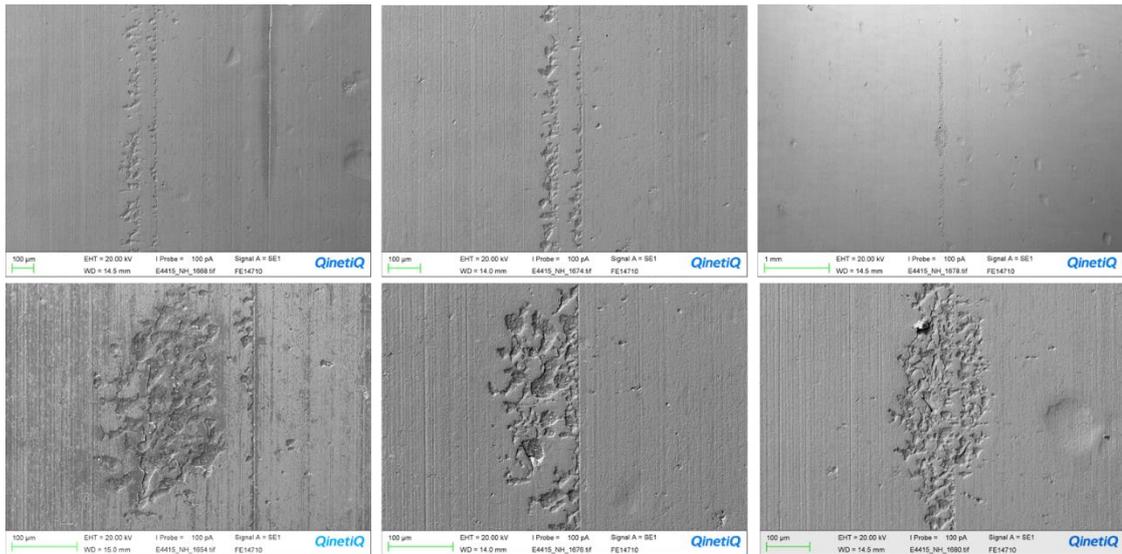
Figure 57: Examples of imperfections on the upper race surface. Photo: AIBN/QinetiQ

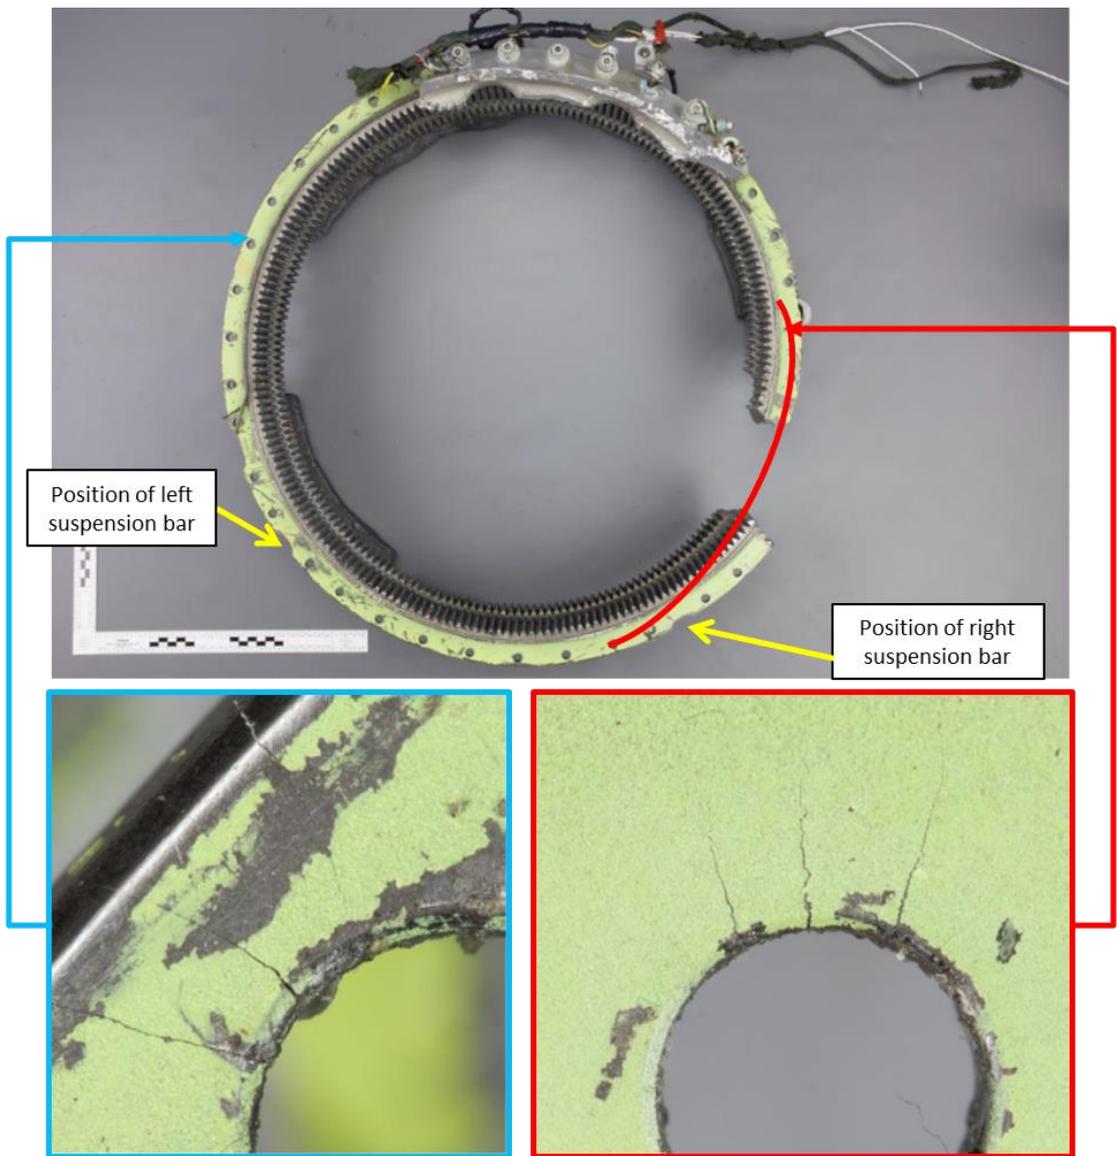
Figure 59: Epicyclic ring gear. Cracks at fastener holes suggests the flange of conical housing were intact when the fixed ring split and moved outwards. Photo: AIBN/QinetiQ

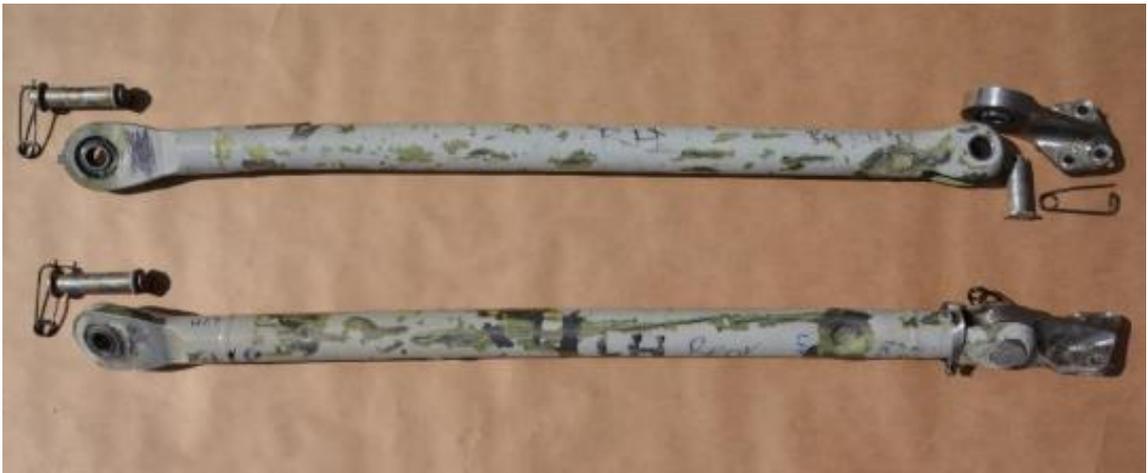
Figure 61: Left and right aft suspension bars with clevis pins, safety pins (only one shown in each position) and fuselage fittings. Both suspension bars have indentations from gear teeth.
Photo: AIBN

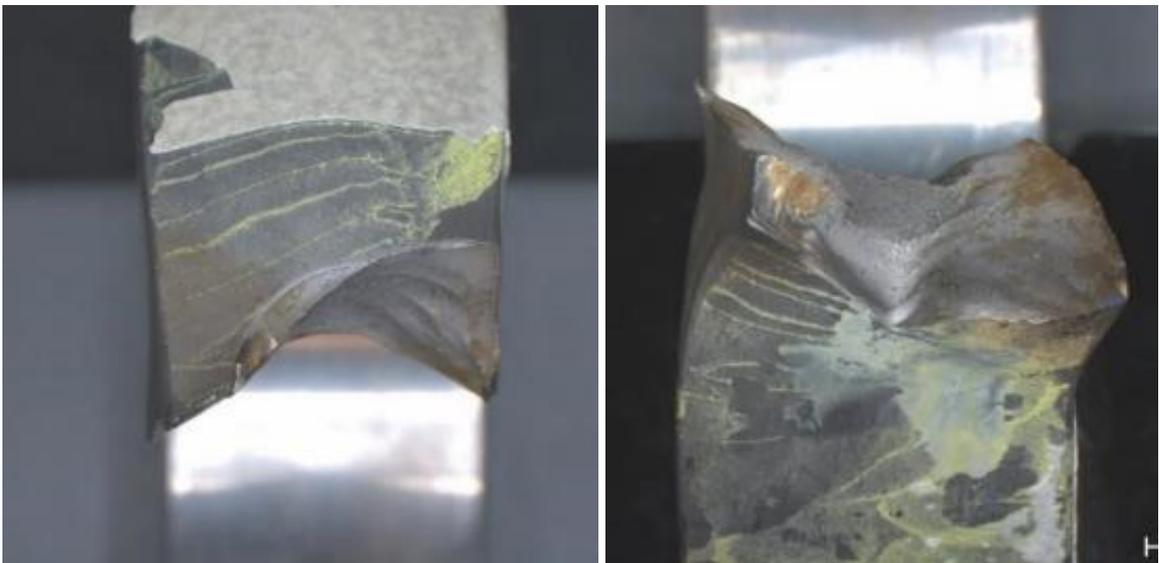
Figure 64: Upper forward suspension bar, mounting lug. Top fracture viewed from above (left photo). Bottom fracture viewed from below (right photo). Photo: AIBN/QinetiQ

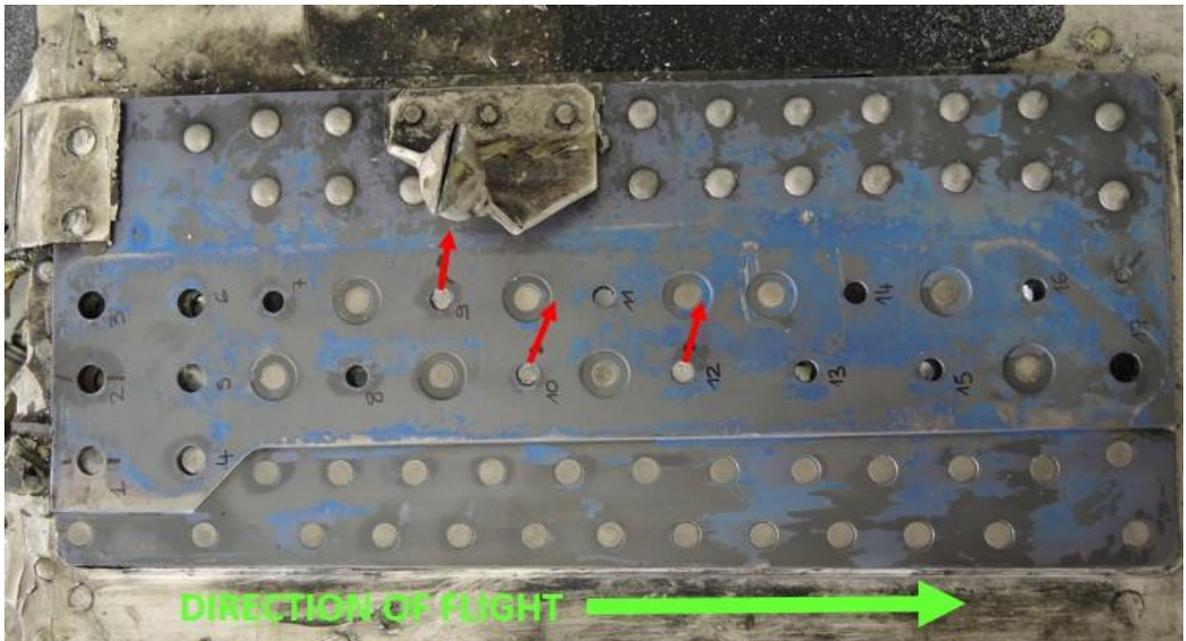
Figure 66: The flexible plate aft attachment had detached from the fuselage plate. The photo shows the support plate at the transmission deck. 7 out of 17 broken bolts were still in place. Red arrows indicate direction of overload in shear (towards the port side of the helicopter). Photo: AIBN

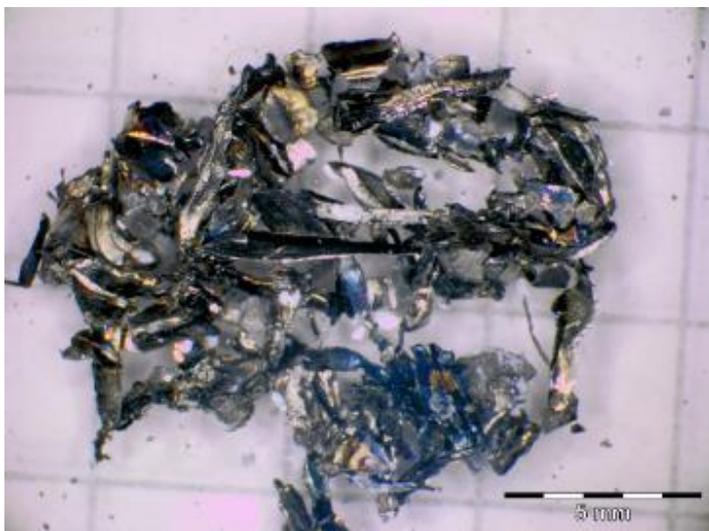
Figure 67: Metal debris from the MGB magnetic plug. Photo: AIBN/NDL

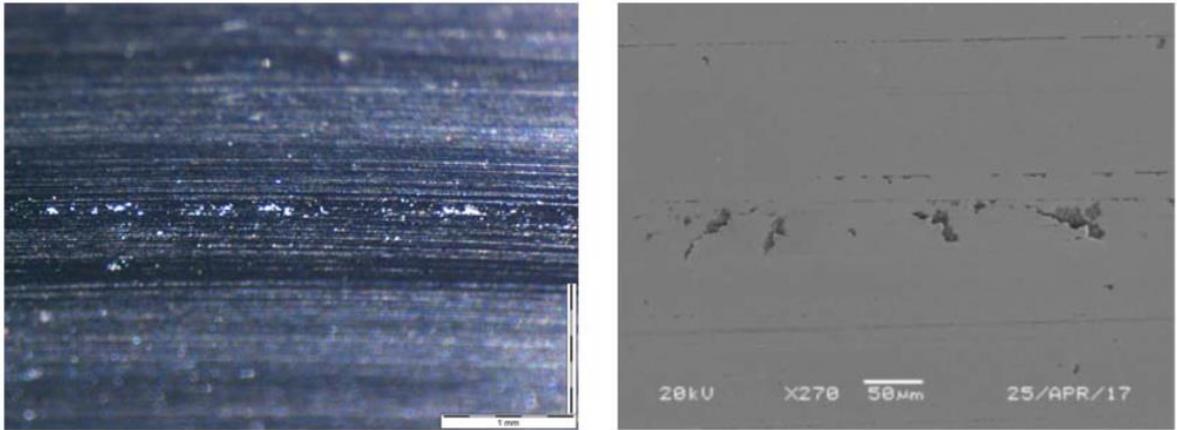
Figure 72: Micro-pitting within the dark line on gear M5769. Photo: Airbus Helicopters
