REPORT

SL 2019/01

REPORT ON AIR ACCIDENT IN PORT OF BERGEN, HORDALAND COUNTY, NORWAY, 10 MAY 2017 INVOLVING AIRBUS HELICOPTERS AS 350 B3, G-HKCN

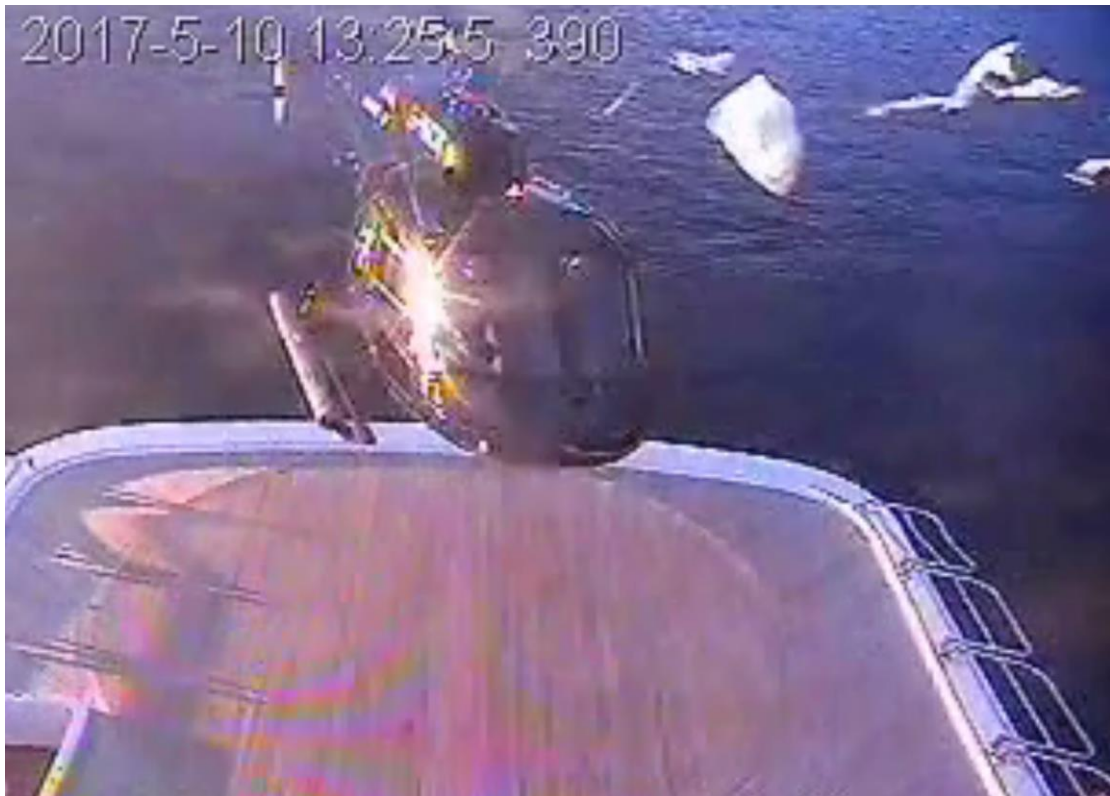
- 1.1.1.7 As the helicopter approached the helideck on the yacht, it stopped in low hover over the helideck for approximately 15 seconds³, until a tarpaulin covering a jet fuel bowser located forward on the helideck detached and was blown up in the main rotor. The commander grabbed the controls and attempted to manoeuvre the helicopter aft and to the left to avoid the tarpaulin, which was on its way to blow into the main rotor due to the rotor downdraft. He did not have time to make a difference before the tarpaulin caused considerable damage to the main rotor when it encountered the rotor blades and was ripped to shreds (see Figure 1).

Figure 1: The helicopter as the tarpaulin hit the main rotor. Photo: CCTV M/Y Bacarella

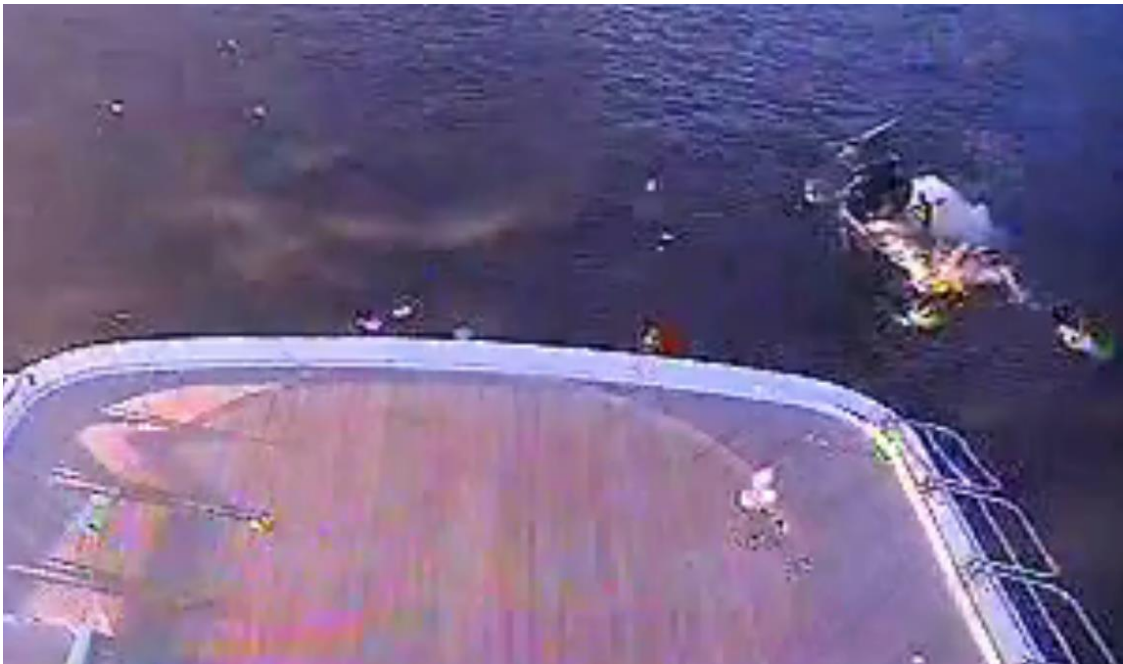
Figure 2: The helicopter crashed tail first. Photo: CCTV M/Y Bacarella

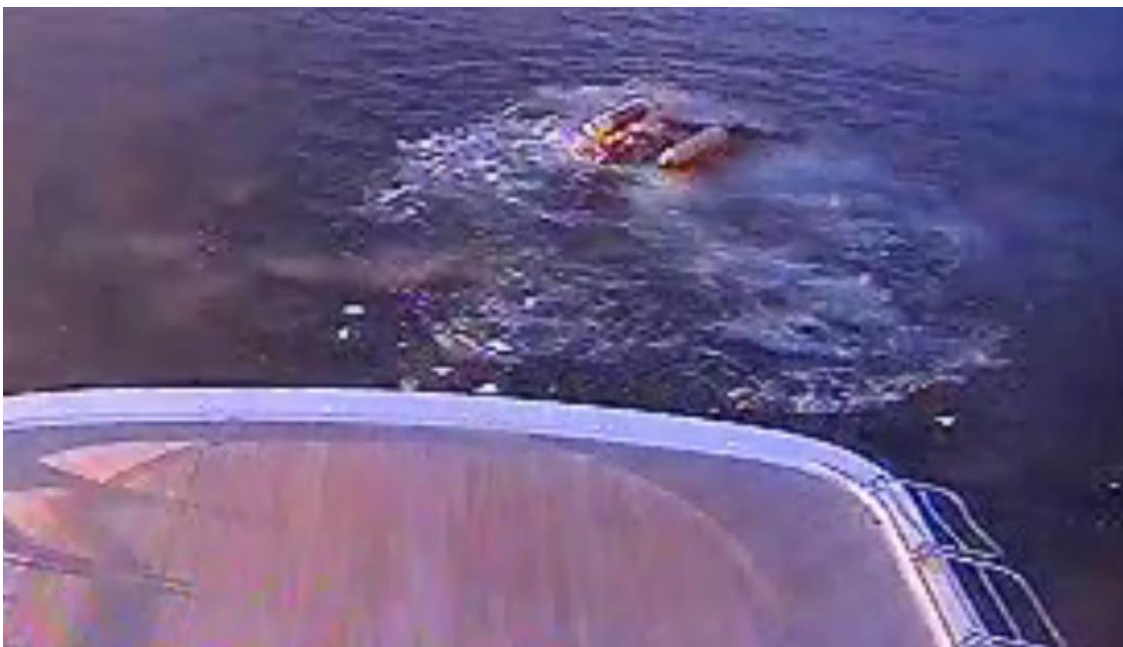
- 1.1.1.11 The commander was able to evacuate through the left door, but realised that the helicopter was sinking, as the floats did not inflate. The floats were armed as they passed the coastline on their way out to the Port of Bergen. The emergency floatation gear on AS 350 helicopters do not inflate automatically. He dived into the helicopter and managed to activate the switch on the right hand collective to inflate the floats. Thereby he prevented the helicopter from sinking (see Figure 3).

Figure 3: The helicopter remained floating upside-down due to the inflated floats. Photo: CCTV M/Y Bacarella

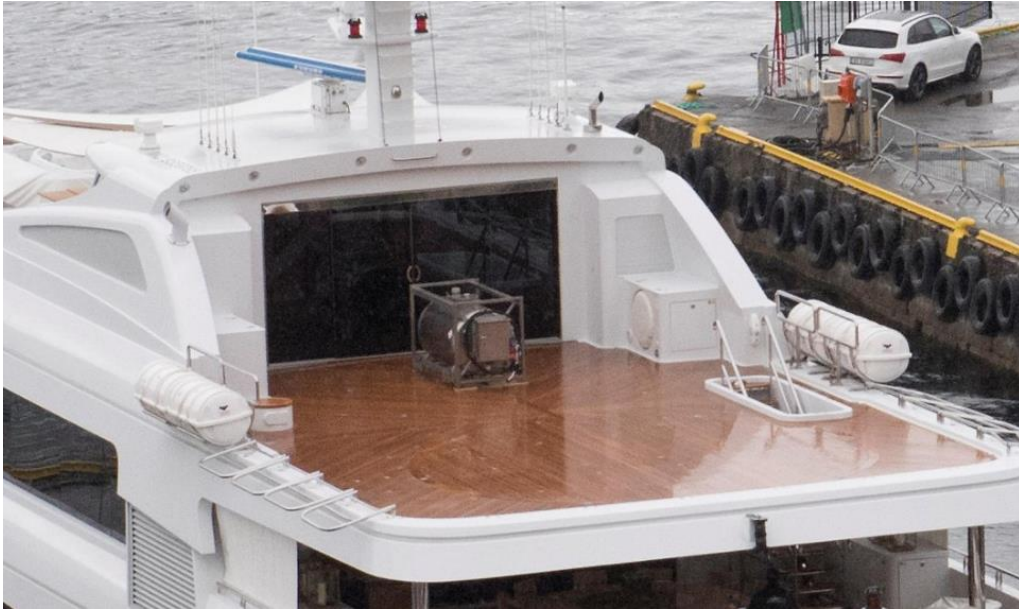
- 1.10.1.3 The yacht was not originally equipped with a fuel bowser for refuelling of helicopters. During the planned trip along the Norwegian coast, the intention was to use the helicopter for sightseeing from the yacht. For this purpose, a fuel bowser with a capacity of approximately 900 litres was placed on the helideck (see figure 4).

Figure 4: Helideck on M/Y Bacarella with provisional jet fuel bowser. Photo: Bergensavisen newspaper

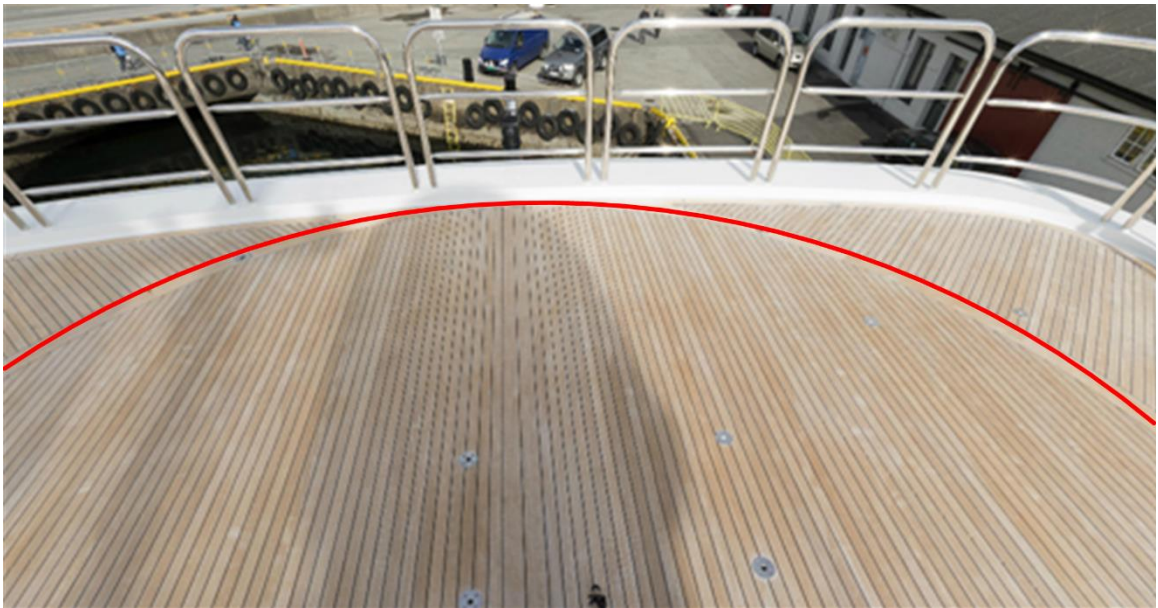
Figure 5: Aft part of helideck landing zone marked in red. Photo: The police. Illustration: AIBN

- 2.2.2 The yacht's helideck was marginally sized, and the helicopter's tailboom would have to stick out aft of the helideck when it had landed. This required precise manoeuvring of the helicopter. In addition, due to the aerodynamic conditions (ground effect) created by the design and size of the helideck, the helicopter behaved differently than it would when landing on a larger landing surface. These circumstances, combined with the flying pilot's low experience on the AS 350 B3, resulted in a low hover over the helideck that lasted for approximately 15 seconds. This caused the main rotor's pulsating downdraft to make the tight fitting, but unsecured tarpaulin to "creep" upwards on the fuel bowser's frame, and finally blow up from the bowser and through the main rotor disc.

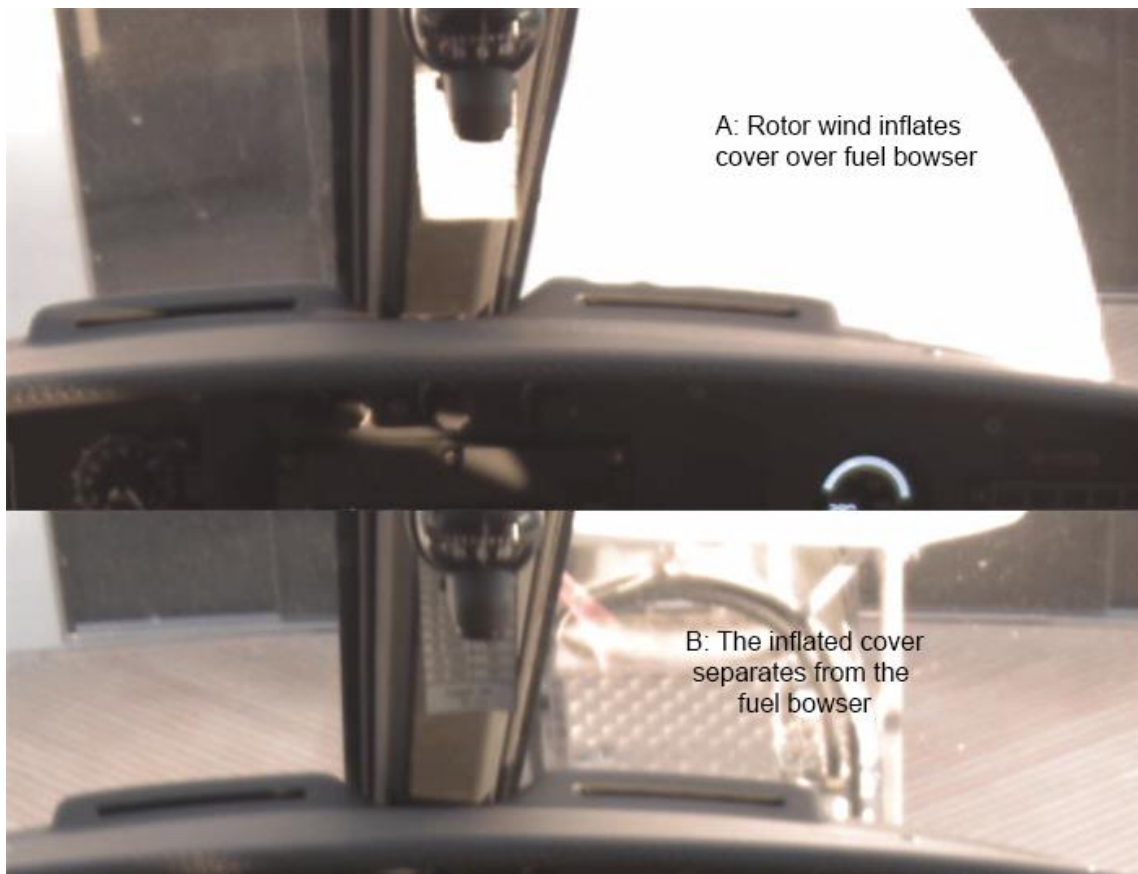
- 1.1.2.5 The custom made tarpaulin covering the jet fuel bowser was not lashed down using the affixed eyelets. The tarpaulin's fit around the fuel bowser's frame was so tight that lashing was considered necessary only in windy conditions and when in open waters. The cruise was to be in coastal waters.

Figure 6: Sequence of photos showing the tarpaulin as it leaves the jet fuel bowser. Photo: The helicopter's Appareo 1000 camera

- 2.4.2 A decision was made to have a tarpaulin made to cover the jet fuel bowser when it was not in use. Despite of the tarpaulin being made with eyelets which made it possible to lash it down, this was not done. According to instructions in the Helicopter Operations Manual's checklist describing preparation before helicopter operations all loose items must be secured. Since the tarpaulin fitted tightly around the fuel bowsers frame, it was not regarded as a loose item and it was decided not necessary to secure it in coastal waters. The tarpaulin came on board the day before the accident, the same day as the fuel bowser came on board. The tight fit of the tarpaulin and the fact that both the fuel bowser and the tarpaulin were new to the yacht's crew may have resulted in the tarpaulin not being considered as loose equipment that needed to be lashed down.

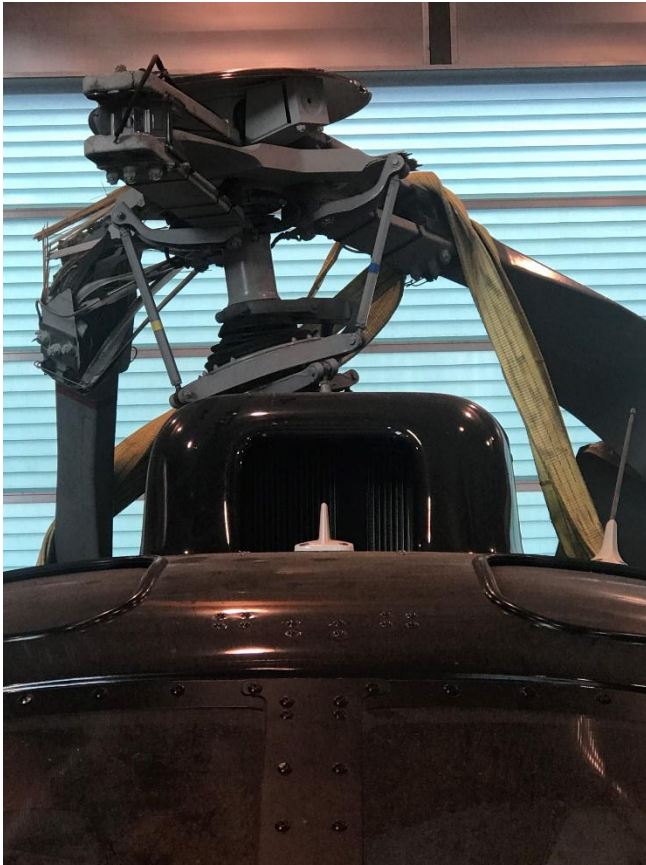
main rotor was further damaged when the rotor blades impacted the water. Due to the impact, the main gearbox shifted to the right (see Figure 7).

Figure 7: Main gearbox displacement. Photo: AIBN

- 2.3.2 Phase 2: The helicopter impacted the water tail first. This caused substantial damage to the helicopter's tail section; the tailboom was nearly torn off. When the main rotor hit the water and stopped abruptly, this caused impact shock which resulted in further damages to the rotor head's Starflex hub, blade sleeves and the rotor blades. The two right hand main gear box suspension bars were torn off, and the main gear box shifted to the right.

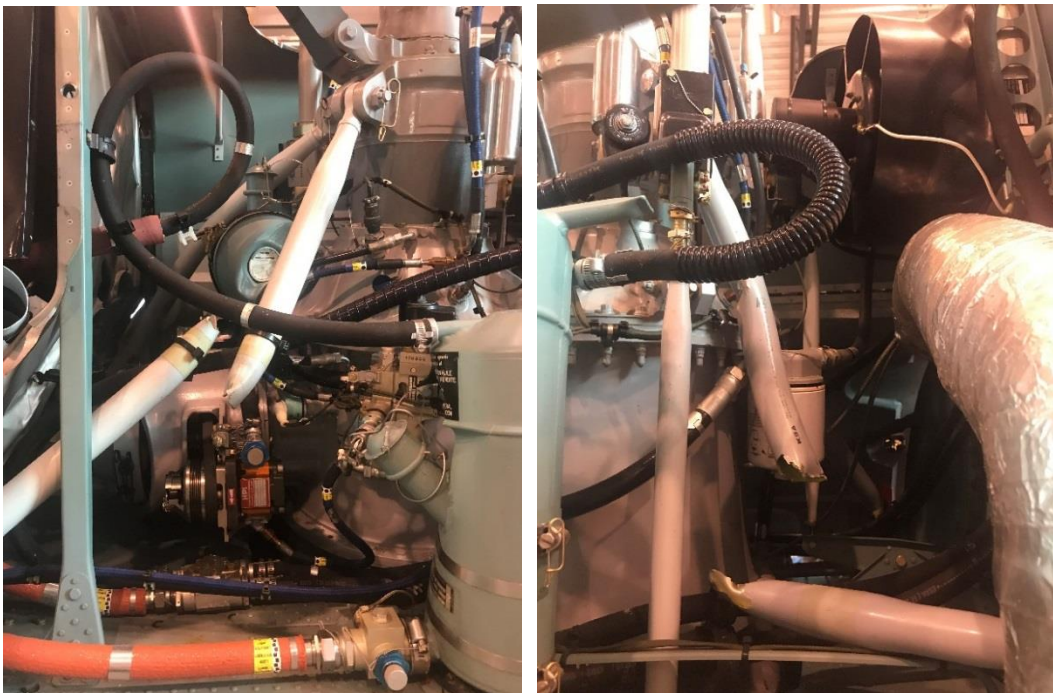
The two right hand side main gearbox suspension bars broke off. The two on the left hand side were bent (see Figure 8).

Figure 8: Forward and aft right hand MGB suspension bars. Photo: AIBN

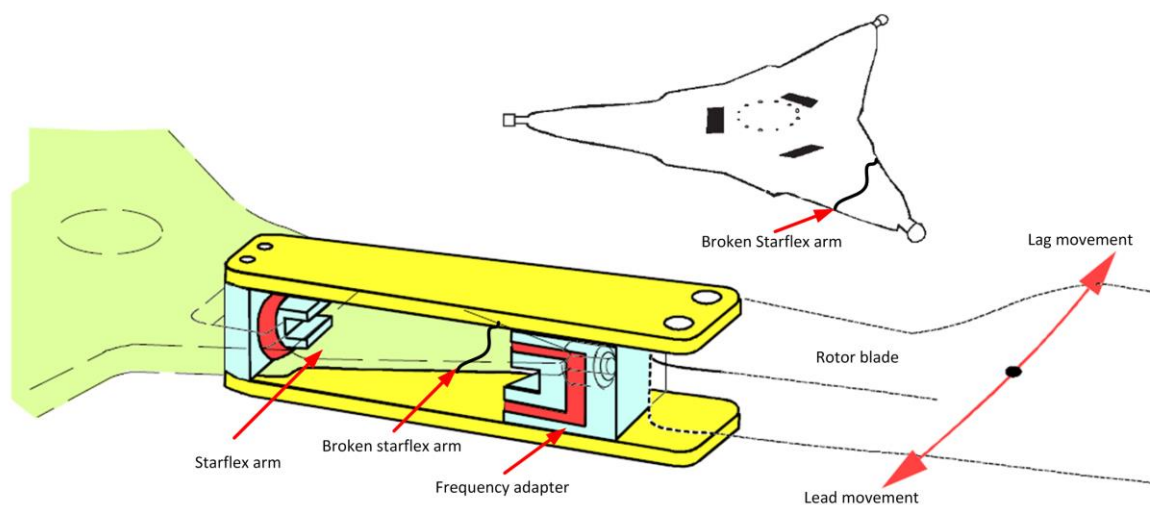
- 2.3.1 Phase 1: When the tarpaulin hit the main rotor, the rotor was damaged in such a manner that significant vibrations occurred. These vibrations could be observed on the Appareo 1000 video recording, where the imagery suddenly became blurry. Such damages are known from other accidents as a result of plastic sheets, tarpaulins or bulk cargo bags being blown through the rotor disc and thereby hitting the leading edge of a rotor blade⁷. The Starflex (main rotor composite hub) arms are vulnerable for impact shocks caused by materials hitting the attached rotor blade. In other accidents of similar nature, Starflex arms have broken off. A broken Starflex arm will allow large lead/lag movements of the blade since the frequency adapter no longer is attached to the Starflex main rotor hub. The consequence will be a major imbalance in the rotor disc and this will generate heavy vibrations. Loss of control of the helicopter is the most probable outcome of such damages to the Starflex (see Figure 10).

Figure 10: Effect of broken Starflex arm. Illustration: AIBN/Airbus Helicopters
