# REPORT

SL 2020/11

## REPORT ON AIR ACCIDENT AT RØLDALSFJELLET IN ULLENSVANG MUNICIPALITY, VESTLAND COUNTY, NORWAY ON 17 FEBRUARY 2019 INVOLVING A ROBINSON R44 II, LN-ORH

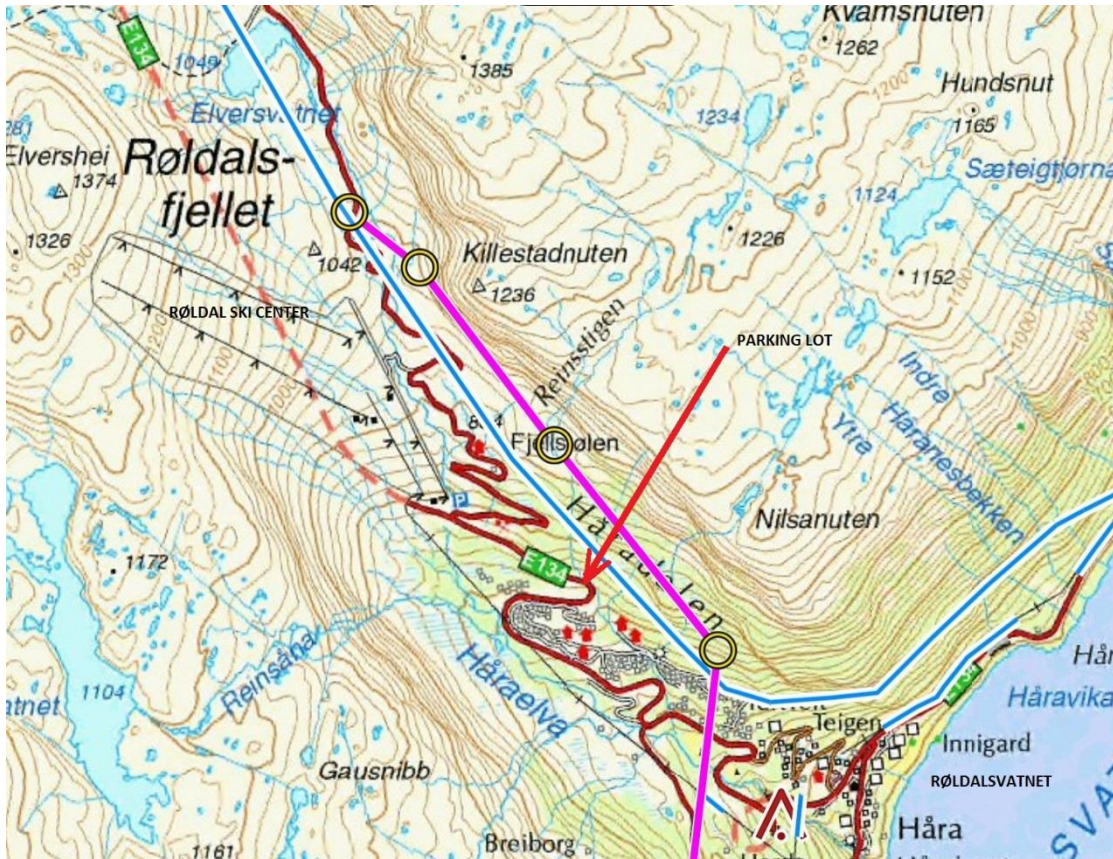
- 1.1.5 The commander of the Fonnaflly helicopter has explained to the AIBN that he stopped the helicopter near the top of the ski center as he found that the weather conditions were too poor to continue the flight. In retrospect, the friend has expressed regret to the AIBN that he did not interfere more in the decision process when they discussed the weather conditions and the imminent flight. However, he was not in a formal position to intervene.

Figure 1: The magenta line shows the Fonnaflly helicopter flight track. The pilot turned back at the point indicated by the last yellow circle, as he considered visibility to be too poor to continue the flight. The power line that runs through the valley is indicated by a blue line. Source: Fonnaflly AS

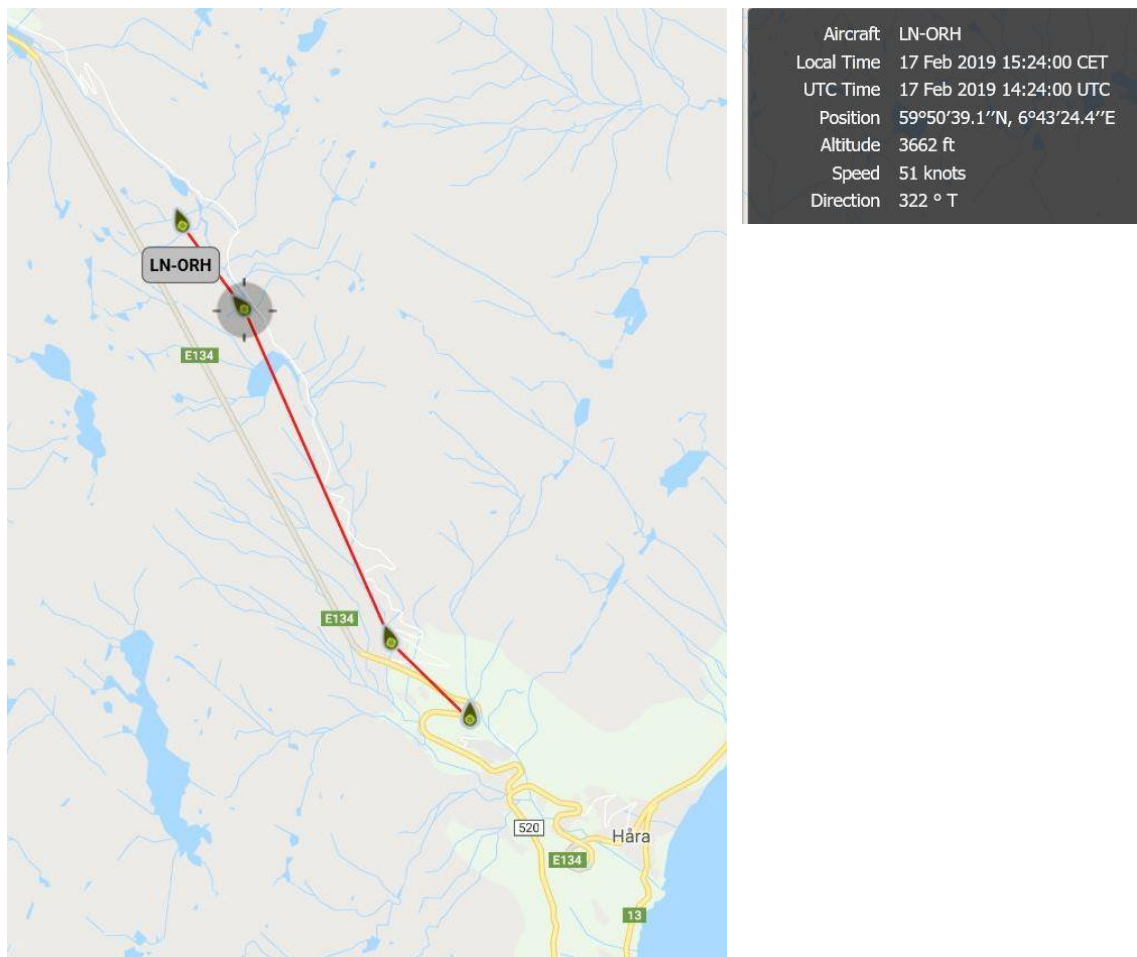
Figure 2: The LN-ORH's track and position at 1524 hours, approximately five minutes after take-off from the parking lot at Røldal Terrasse (the information in the black text box shows the helicopter's penultimate position on the map). Source: Former owner of the helicopter (Spidertrack)

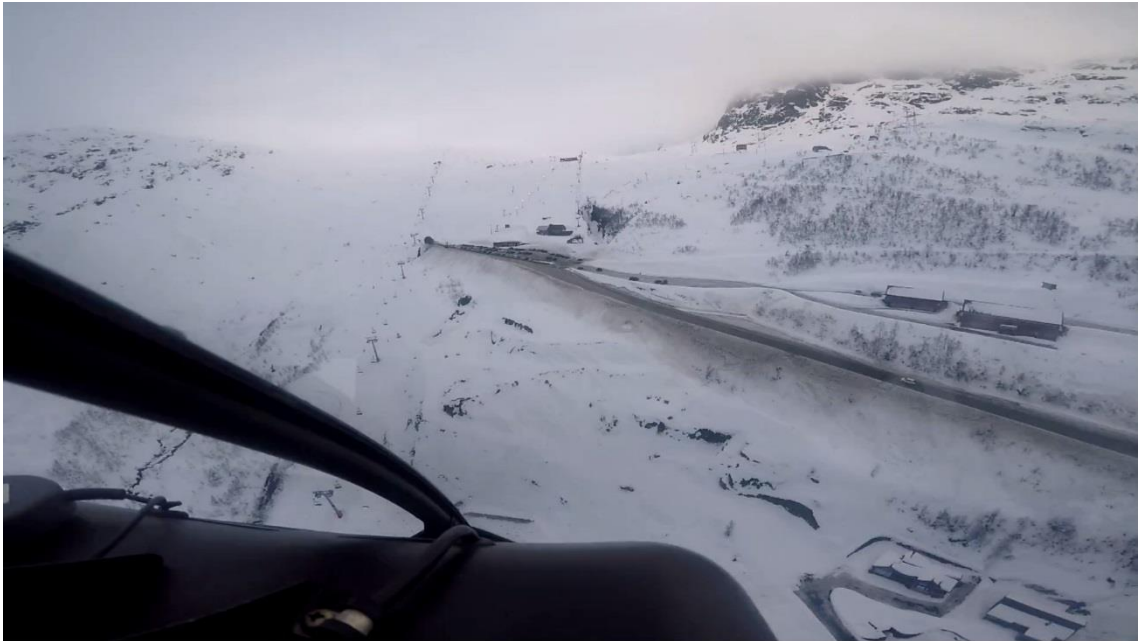
*Figure 3: LN-ORH shortly after take-off from the parking lot. Source: Video from the helicopter*

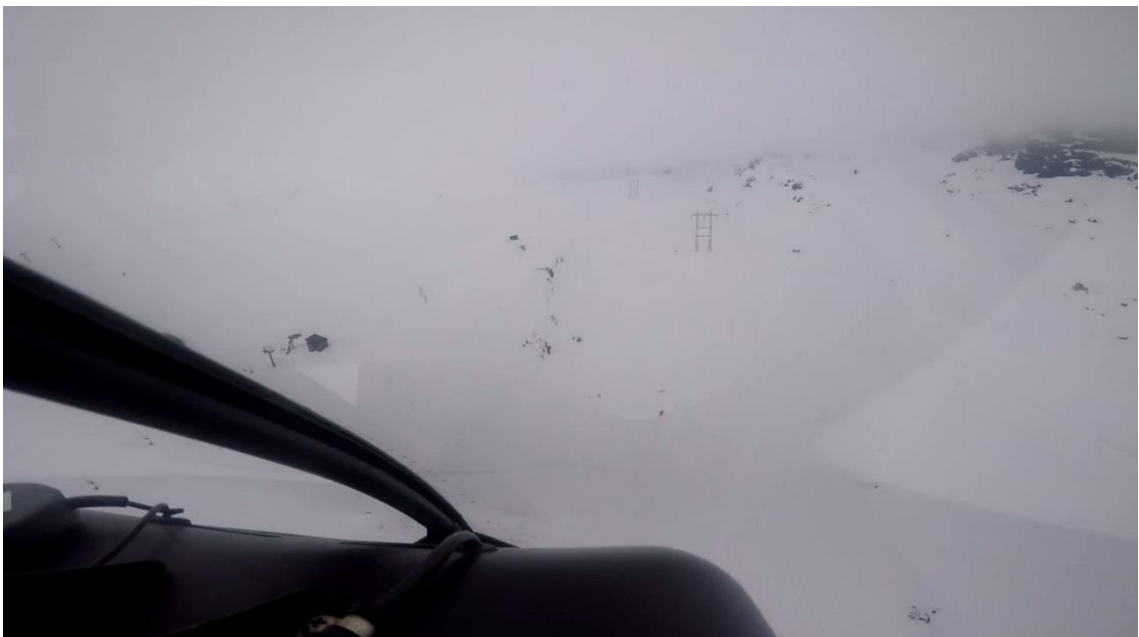
*Figure 4: LN-ORH about to pass the top of the ski slope at Røldal Ski Center. Two power line pylons can just be seen in the center of the photo. Source: Video from the helicopter*

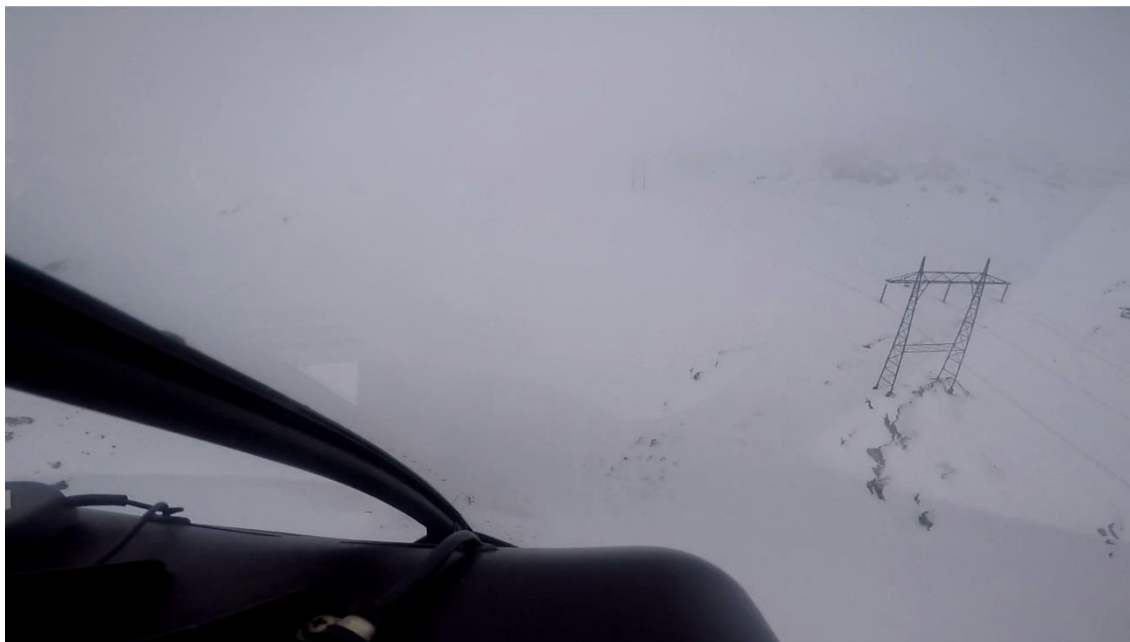
*Figure 5: The LN-ORH flying along the power line at a low altitude. One pylon to the right and the next pylon are barely visible near the middle of the photo. Source: Video from the helicopter*

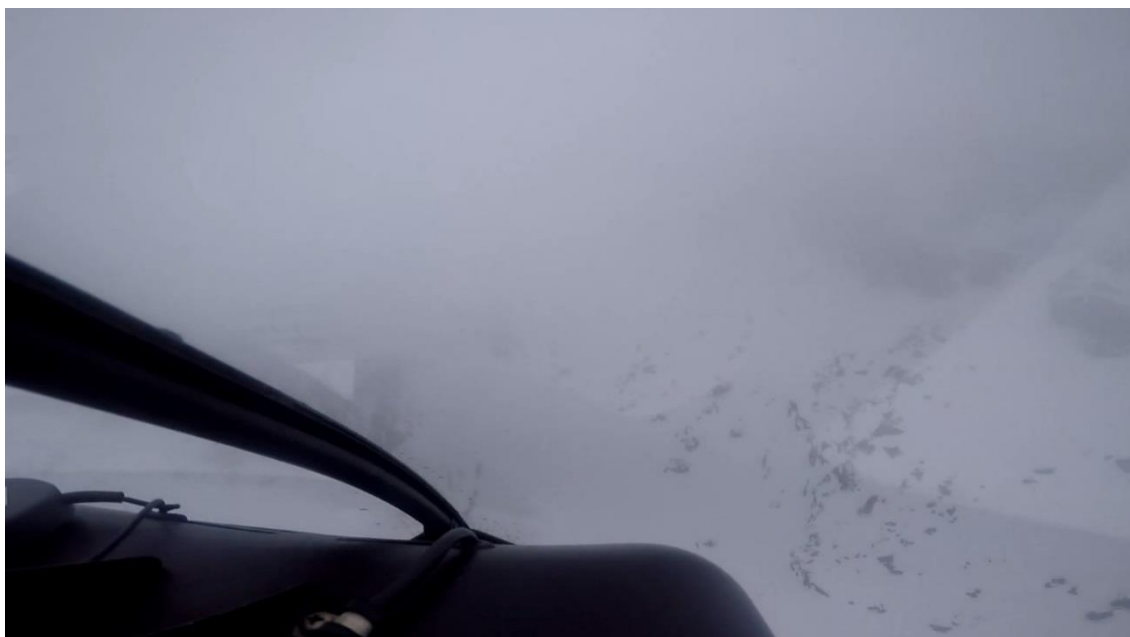
*Figure 6: The LN-ORH has stopped and is about to initiate a right turn. Source: Video from the helicopter*

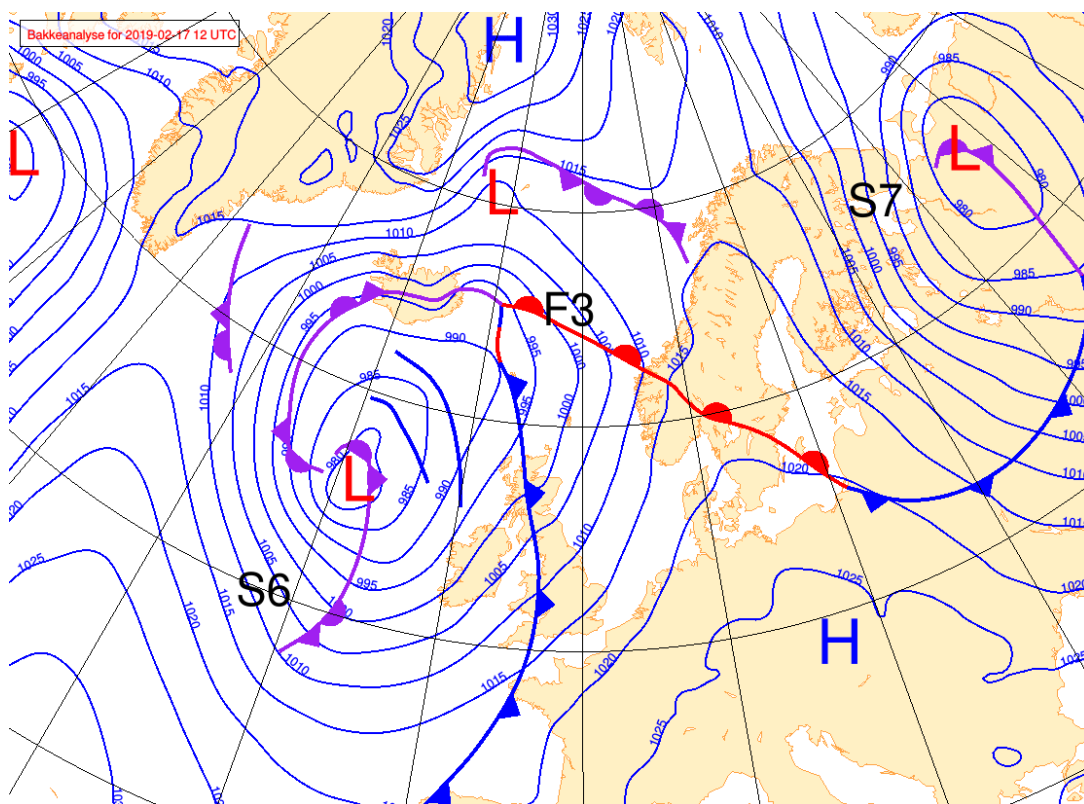
Figure 8: Ground analysis from the Norwegian Meteorological Institute at 1300 hours local time (12 UTC).

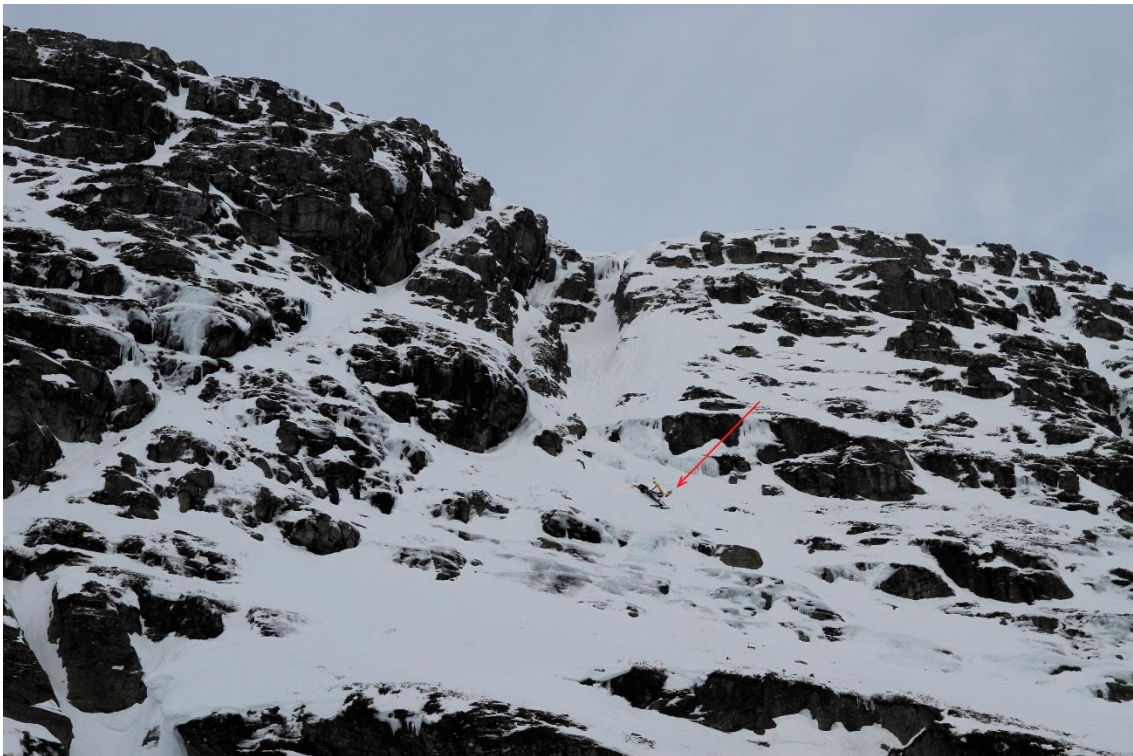
1.12.1.1 The LN-ORH crashed into a partly snow-covered escarpment near Eskjeflota in Røldalsfjellet between Røldal and Seljestad in Vestland. The mountainside faced southwest and had a slope of approximately 50°. The accident site is approx. 1,170 meters above mean sea level (3,840 ft), about 150 meters above the old road at the bottom of the mountain pass.

Figure 9: The accident site. Red arrow points at the wreckage. Photo: The police

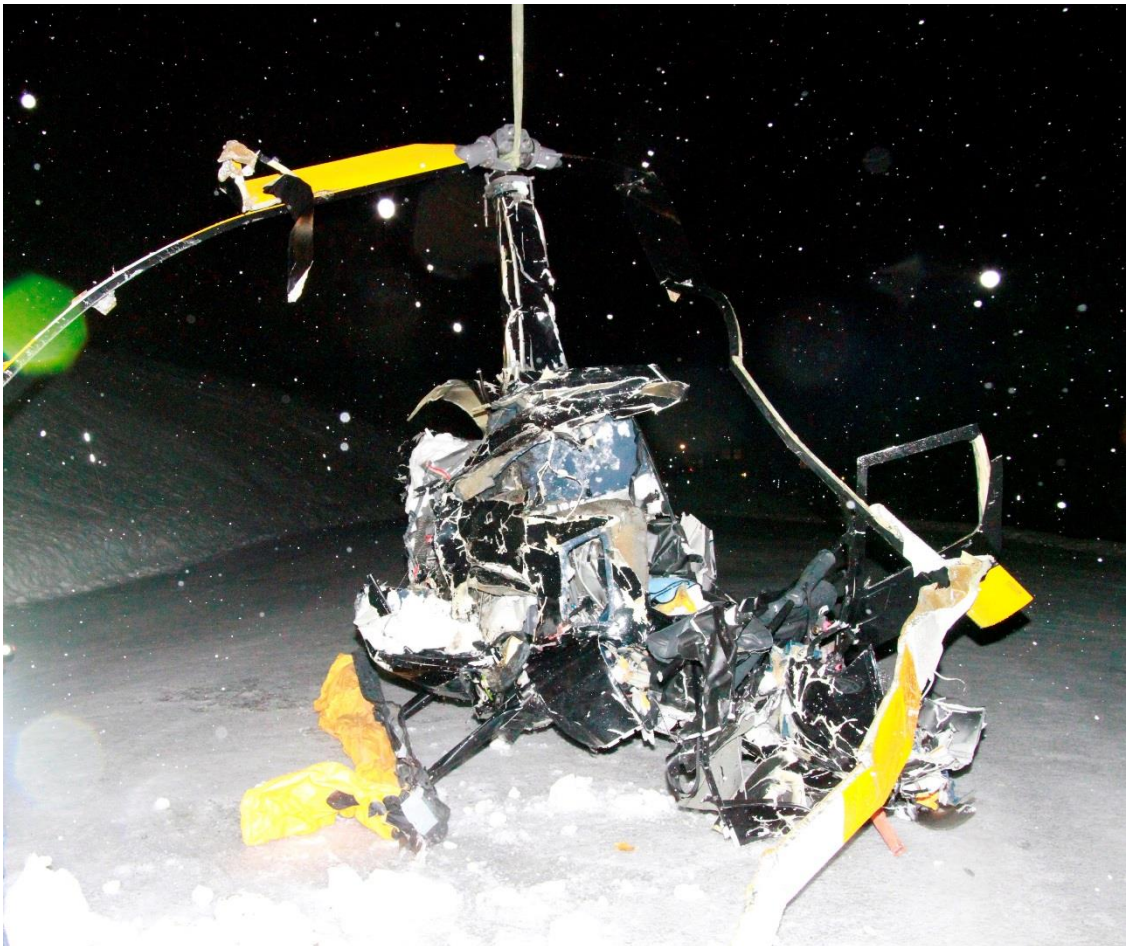
1.12.2.3 The helicopter wreckage has been examined with particular focus on the flight controls, rotors, engine, and power train. The investigations have not identified any technical faults with the helicopter or any of the helicopter systems that had an effect on the course of events.

Figure 10: The helicopter wreckage after it was brought down from the mountain. Photo: The police
