REPORT

SL 2020/12

REPORT ON AN AIR ACCIDENT AT SEA APPROX. 11 NM SOUTH OF MANDAL, NORWAY ON 22 JUNE 2019 INVOLVING A PIPER PA-28-161, LN-MTJ, OPERATED BY SOLA FLYING CLUB

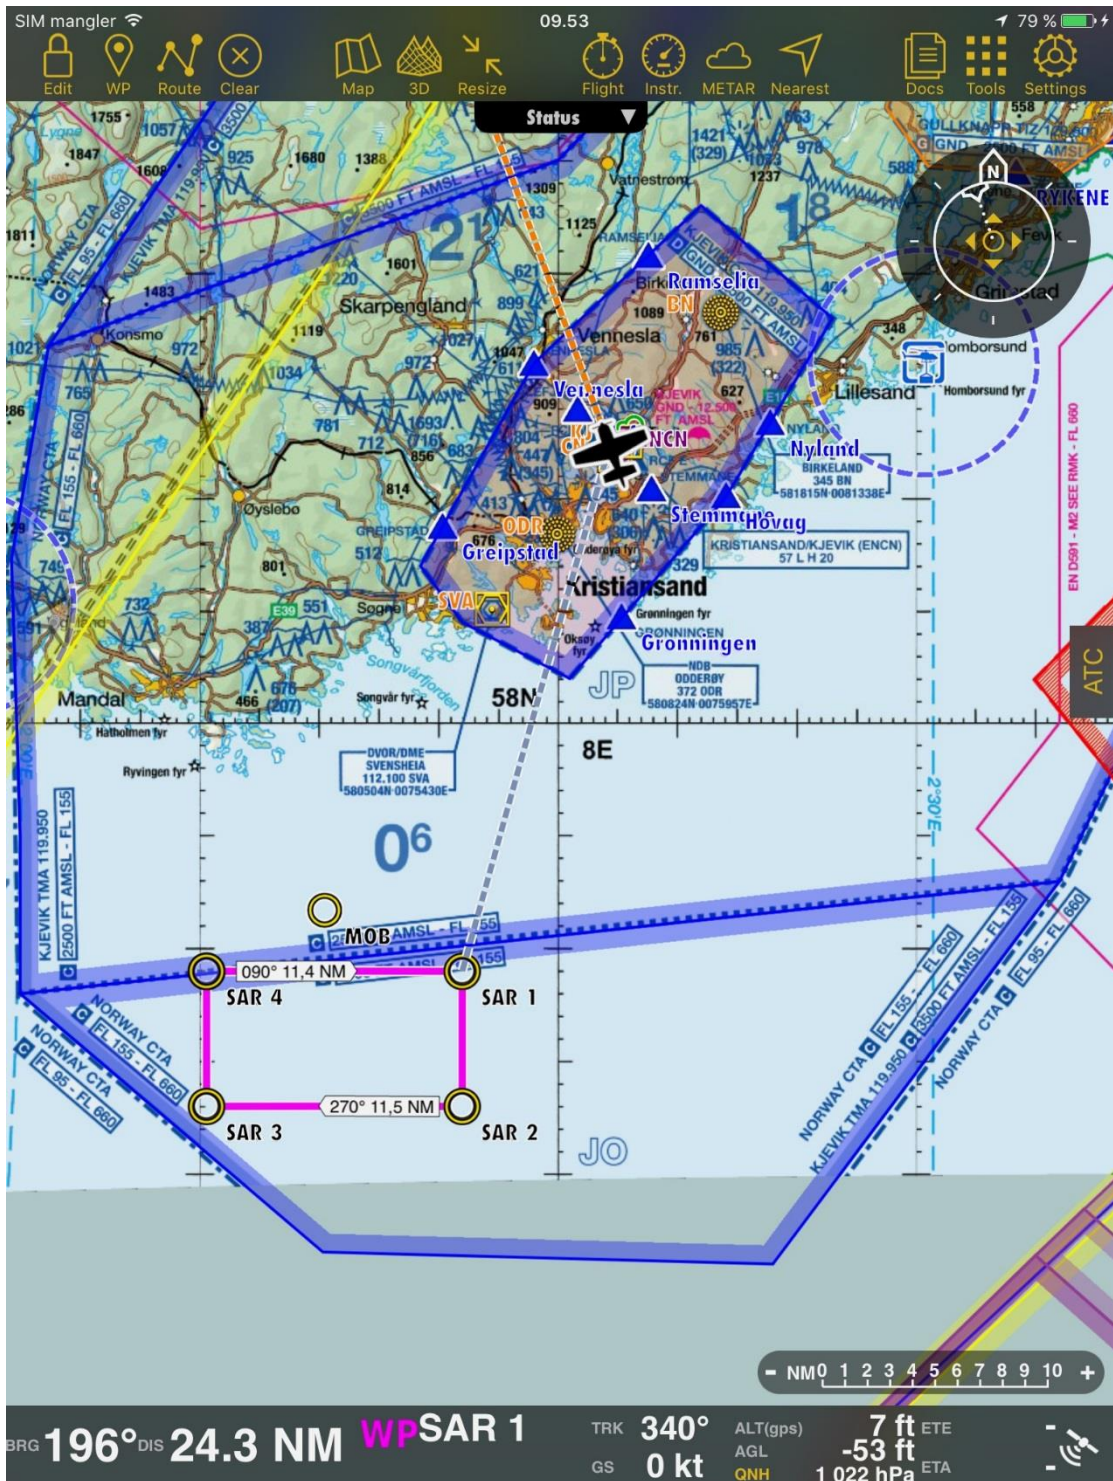
Figure 1: Tablet screen shot showing the Air Navigation Pro software with the search area coordinates (magenta) and the course from Kjevik Airport. The Kristiansand Airport Kjevik (ENCN) control zone is indicated in blue (the smallest area around the airport). Source: Air Navigation Pro screen shot
