RAPPORT LUFTFART 2025/04

Luftfartsulykke ved Seterfjellet i Alta kommune, Finnmark fylke 20. mai 2024 med Robinson R44 Raven II, LN-OBN

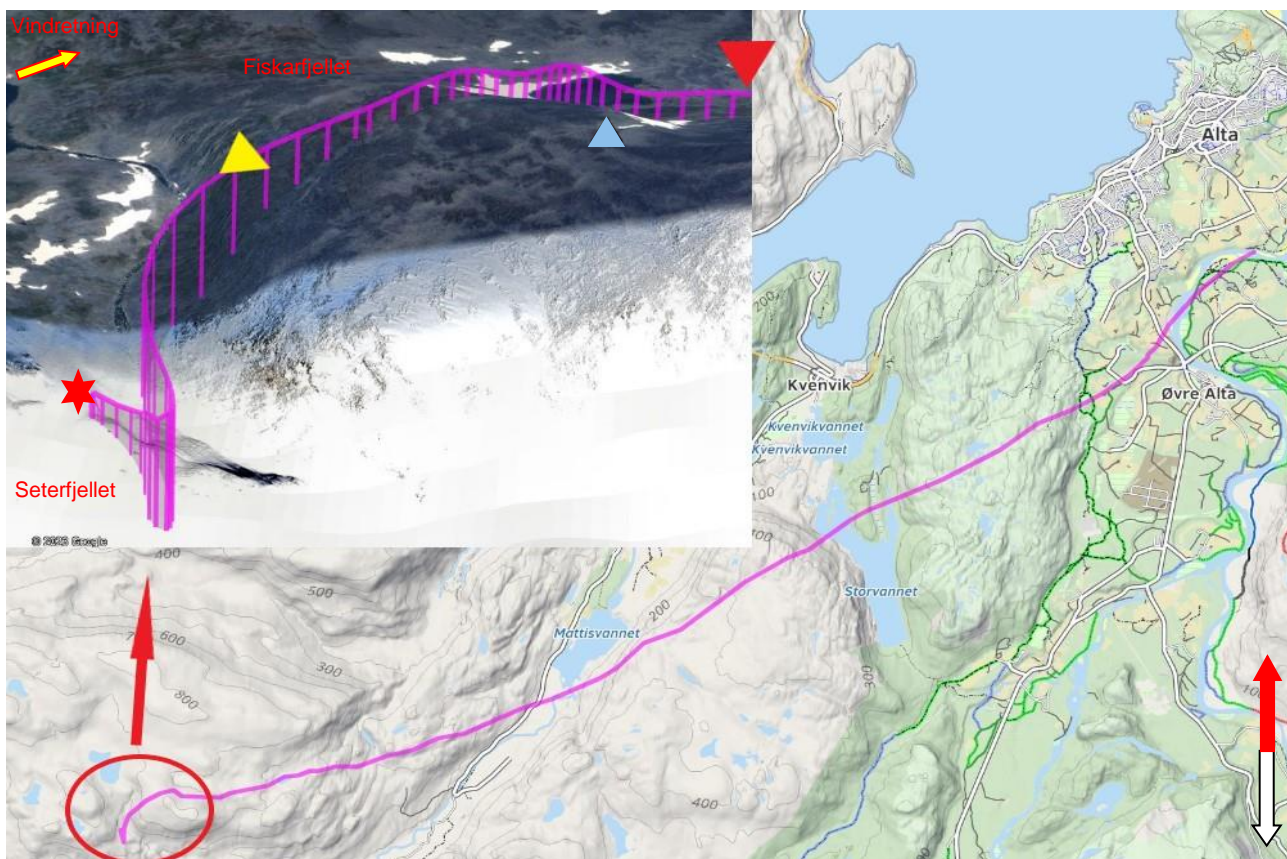
Figur 1: Helikopterets rute mellom Elvestrand og ulykkesstedet. Den røde ringen viser området for profilen i det innfelte bildet. Kart: © norgeskart.no / Google Earth / SHK

Ved den røde trekanten som er angitt på figur 1 så flygeren den første skyen og korrigerte kursen for å unngå denne. Da han nådde fram til punktet merket med blå trekant på toppen av fjellet så han mer skyer og opplevde turbulens. Over fjellkanten, indikert med gul trekant, besluttet flygeren å snu og svingte helikopteret, først til venstre for så å snu tilbake til Alta med en høyresving.

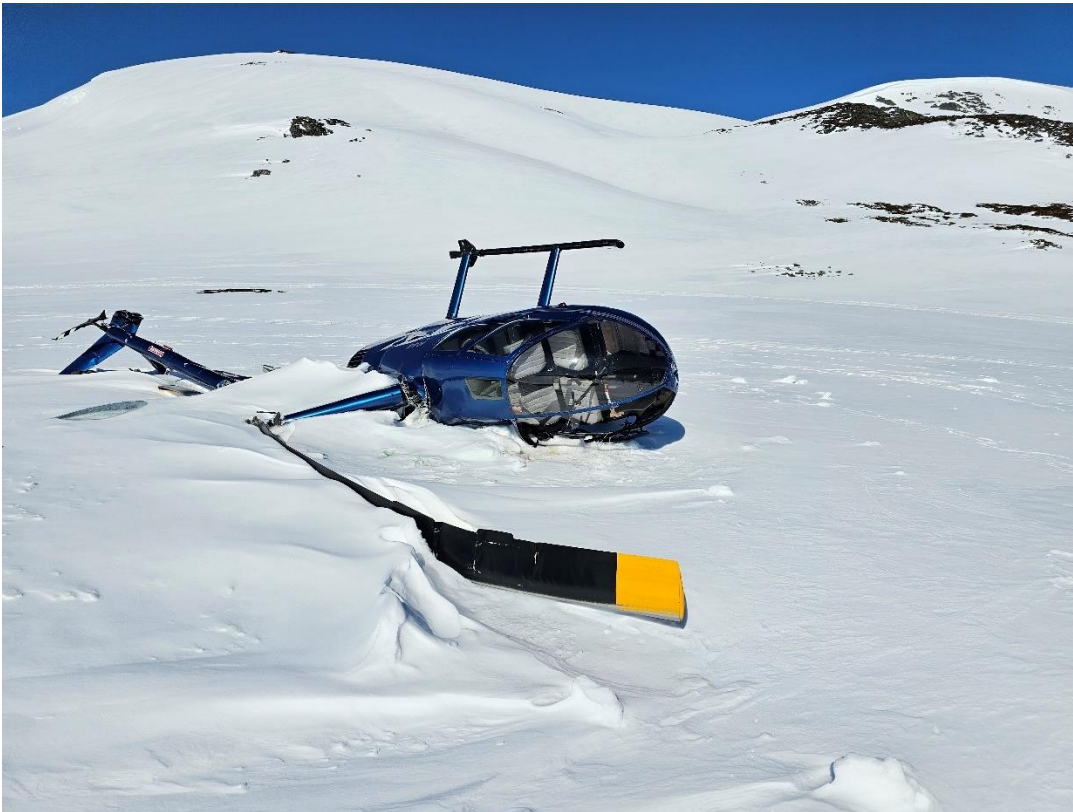
Flygeren var kjent med forholdene langs traseen han nylig hadde fulgt og ville derfor følge samme vei tilbake. Han har forklart at høyresvingen ble vanskelig grunnet kraftig vind og turbulens. Etter at helikopteret hadde snudd og var på vei tilbake til Alta opplevde flygeren at helikopteret ble presset ned av kraftig vind og turbulens. Flygeren løftet collectiven så langt som mulig for å få maksimalt løft, men helikopteret klarte ikke å stige og traff derfor bakken. Sammenstøtet var med lav energi. Halen og hovedrotorbladene traff bakken først og helikopteret tippet deretter mot høyre før det stoppet, se figur 2.

Figur 2: Helikopteret liggende på høyre side på havaristedet. Bildet er tatt mot vest med Seterfjellet i bakgrunnen, to dager etter ulykken. Foto: SHK

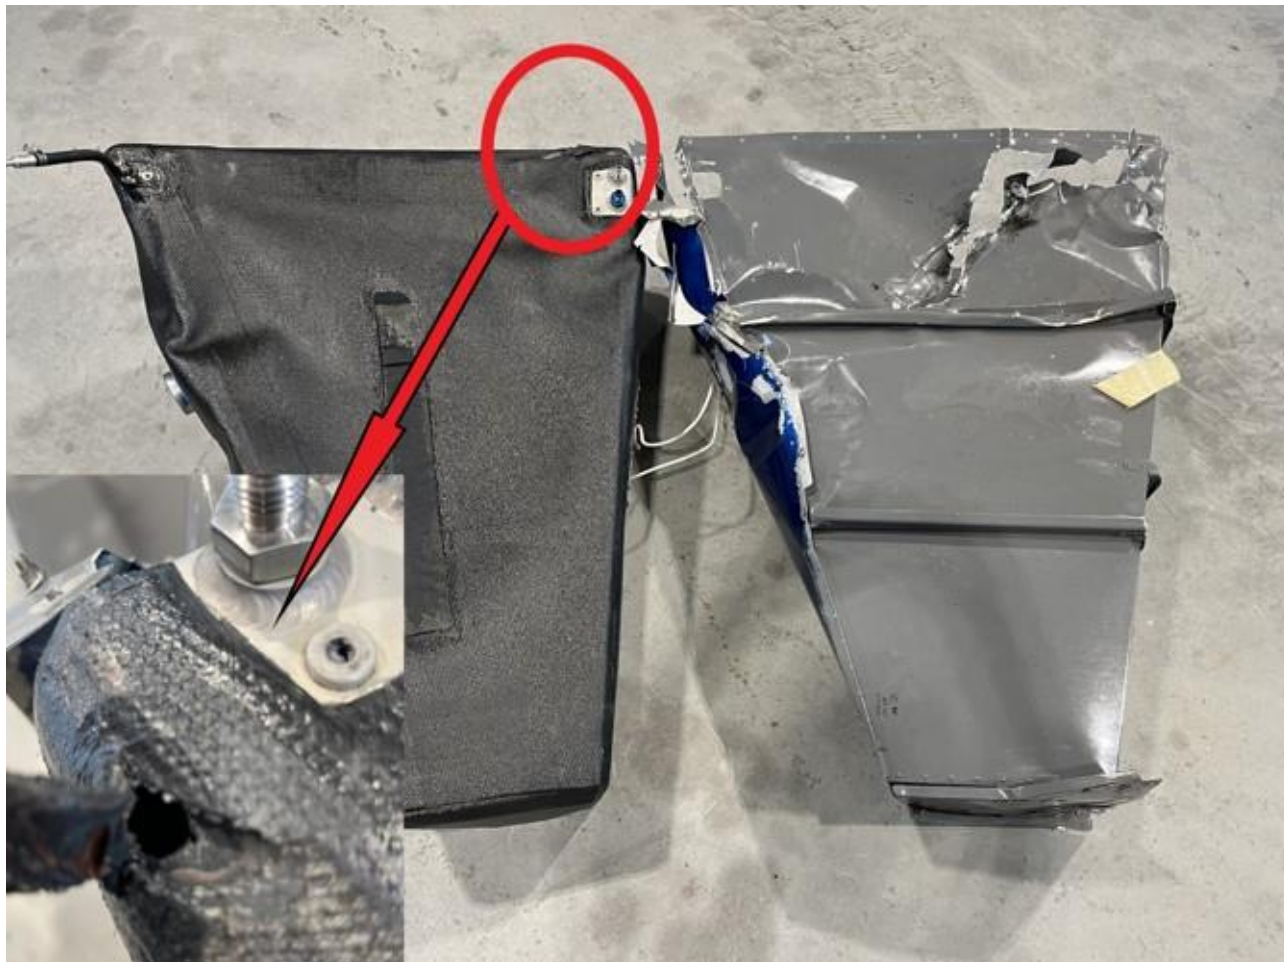
I forbindelse med ulykken brakk et stag mellom helikoptrets ramme og det fremre girkassefestet på venstre side. Dette penetrerte hovedtankens aluminiumsstruktur og blæretank slik at det oppstod en lekkasje, se figur 3.

Figur 3: Det innfelte bildet viser hullet hvor girkassefestet penetrerte blæretanken, i tillegg til aluminiumstrukturen som omslutter selve tanken på LN-OBN. Foto: SHK

Da staget til girkassen penetrerte den venstre blæretanken og aluminiumsstrukturen oppstod en lekkasje. Da EASA publiserte AD 2014-0070 ble det satt krav til modifisering av drivstoffsystemet med obligatorisk installasjon av blæretanker. Modifikasjonen har bidratt til å forbedre sikkerheten, da de krasjbeskyttede tankene av gummi forhindret en brå og massiv drivstofflekkasje. Gummitanken gjorde at hullet ble mindre, og at tanken delvis tettet mot staget til girkassen. En integraltank hadde antagelig revnet på samme måte som aluminiumstrukturen, og drivstoff kunne da ha truffet motorens varme deler. At lekkasjen ble redusert i omfang og hastighet bidro til en redusert risiko for brann. Videre var det risikoreduserende at helikopteret ble liggende på siden med rotormasten pekende nedover slik at drivstoffet ikke direkte traff motorens varme deler.

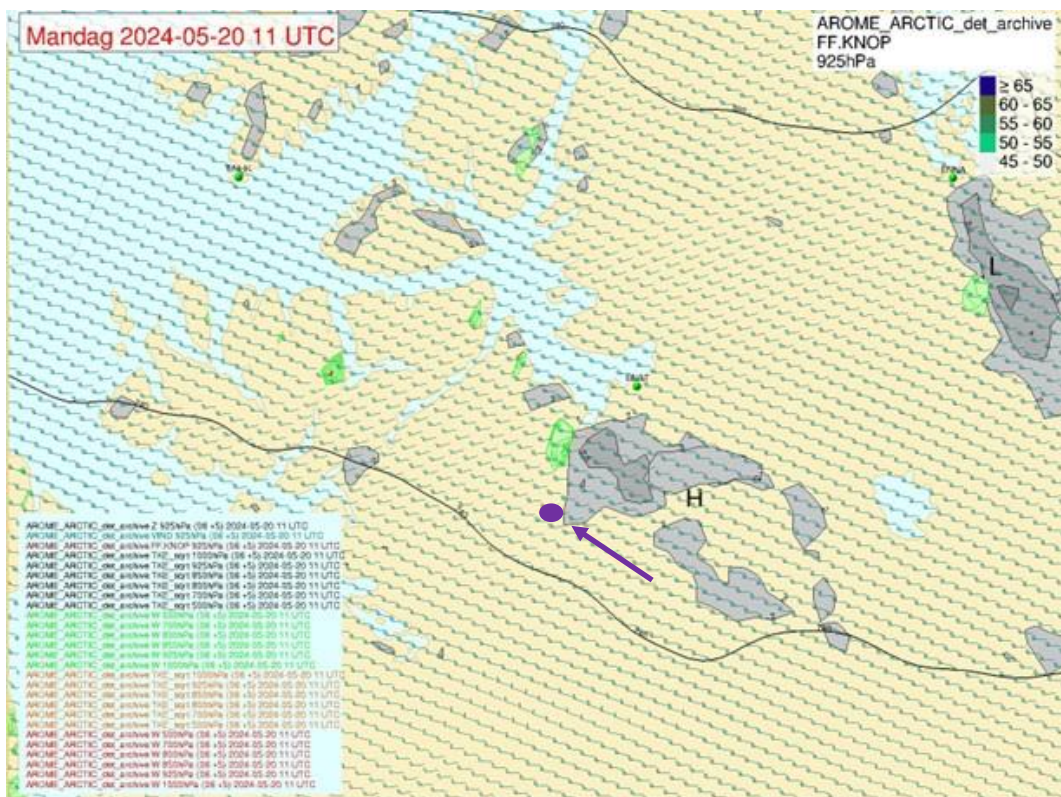
mekanisk turbulens med fallvinder⁴ på lesiden av fjellet. Fallvind kommer gjerne i kast, og noen ganger helt uventet. Fallvinder kan utgjøre en stor fare for luftfartøy da de kan bli presset ned mot bakken og ikke ha nok ytelse for å opprettholde tilstrekkelig løft. Ulykkesstedet ligger i et fjellområde som sannsynligvis kan skape turbulens ved vind fra vest. Figur 7 viser bakketurbulens i havariområdet.

Figur 7: Modellering av bakketurbulens. Grønn indikerer moderat fjellbølgeturbulens på lesiden (øst-sørøst) av noen fjell. Ulykkesstedet markerer med lilla punkt og pil. Illustrasjon: Meteorologisk institutt / SHK

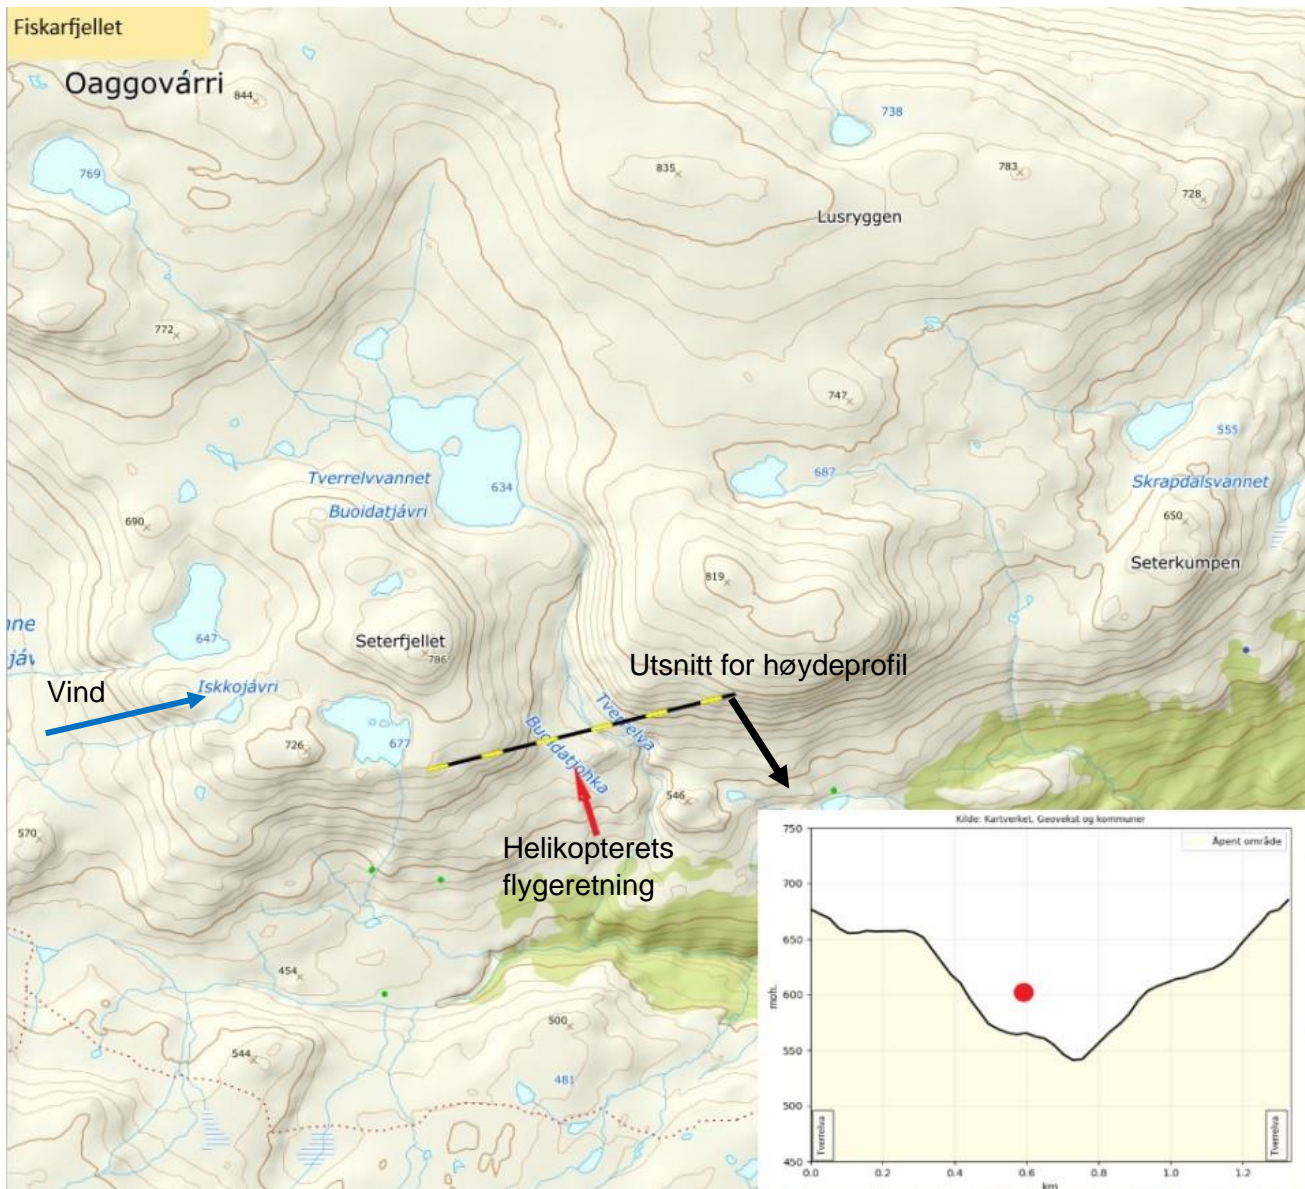
Flygerens forklaring og Meteorologisk institutts simulering av det aktuelle været underbygger at fallvinder og turbulens kan ha oppstått da helikopteret havarerte, se figur 8.

Figur 8: Høydeprofilen på det aktuelle stedet sammen med helikopterets posisjon etter at det hadde snudd.
Kart: © norgeskart.no / SHK
