**REPORT ON THE SERIOUS INCIDENT AT OSLO AIRPORT GARDERMOEN ON 21
SEPTEMBER 2004 INVOLVING FLIGHT KAL520 BOEING 747-400F REGISTERED
HL7467 OPERATED BY KOREAN AIR**

REPORT ON SERIOUS INCIDENT

Designation of type: Boeing 747-400F
Registration: HL7467
Owner: Korean Air
Operator: Korean Air
Crew: 3
Passengers: None
Incident site: Oslo Airport Gardermoen, Norway (ENGM),
N60 12 10 E011 05 02
Incident time: Tuesday, 21 September 2004, time 1302

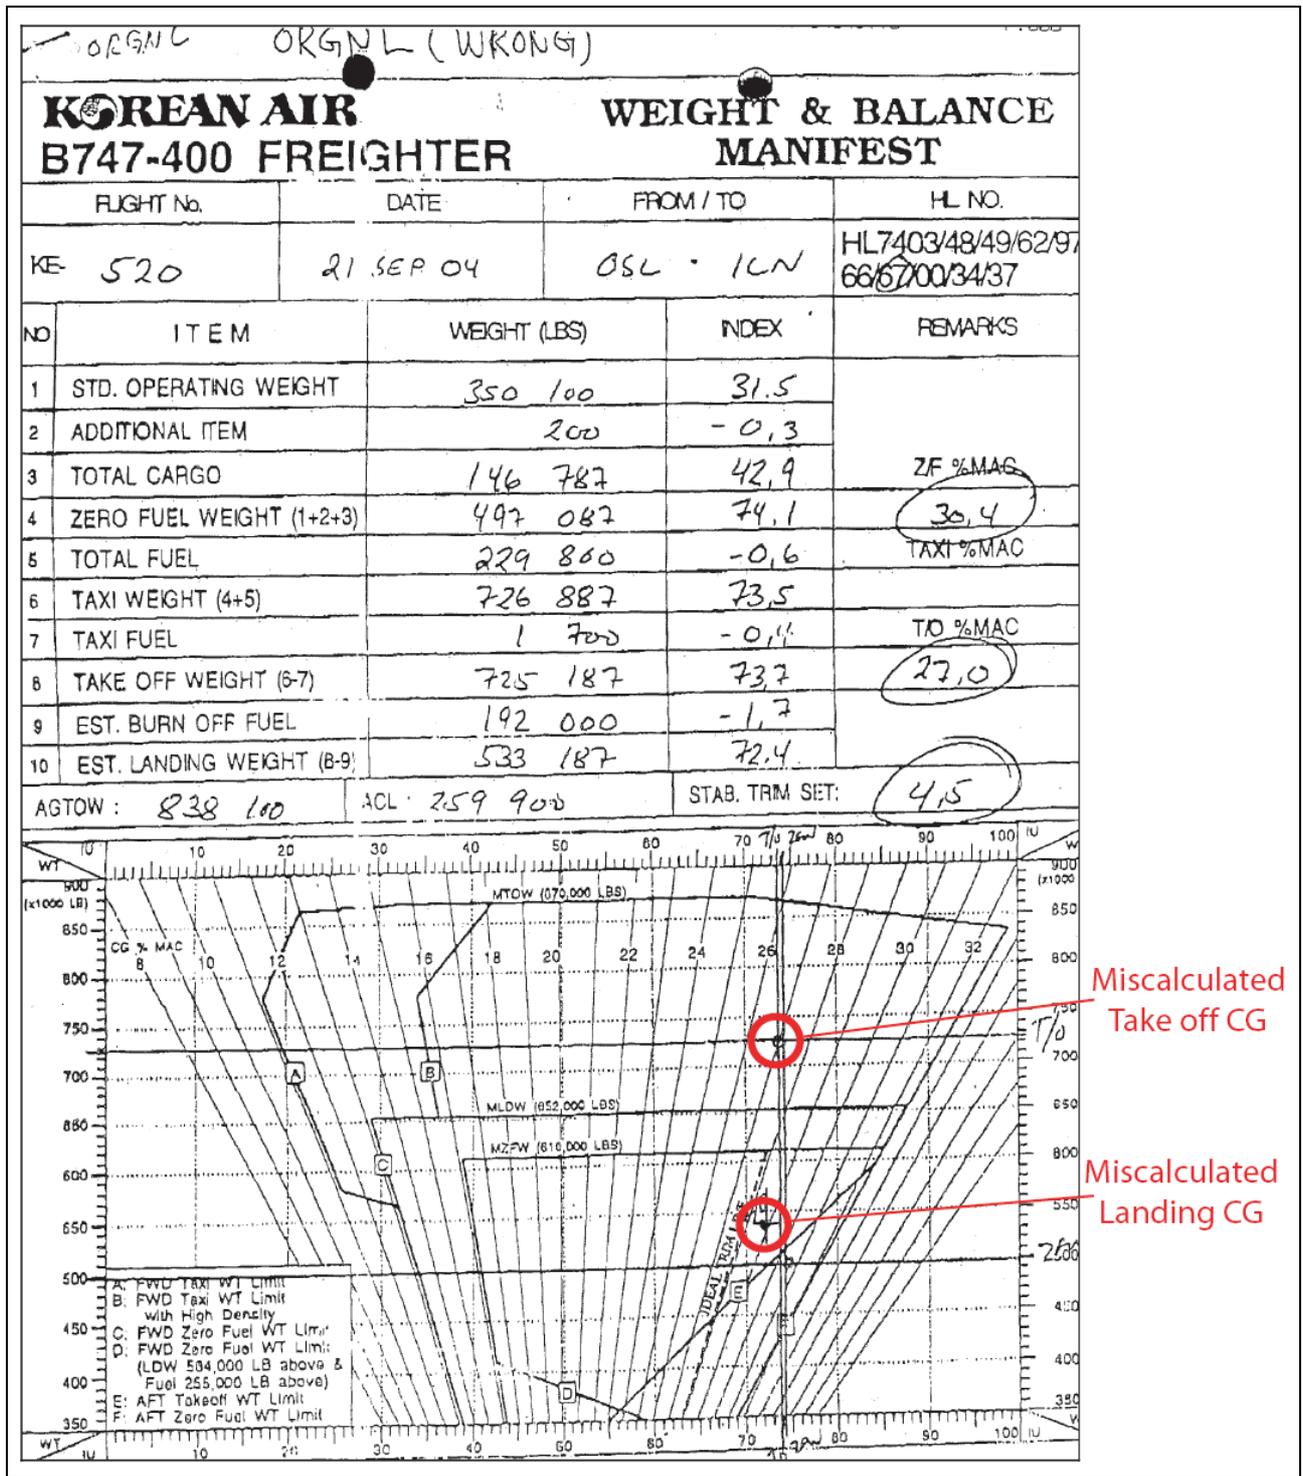
Fig. 3. M & B Manifest of 21 Sep 2004

The wrong CG location was caused by a mistake during loading. During load planning the Load Master mistook the Standard Operating Mass (SOM) Centre of Gravity (CG) Mean Aerodynamic Chord (MAC) percent number for the Index Unit (IU) number. Hence the aircraft was misloaded to a CG of 37.8% MAC, which was 4.8 % aft of the aft limit of 33 % MAC. The mistake was not discovered by the Load Master, SAS Cargo or Korean Air Supervisor. Nor was the mistake discovered by the Commander who accepted and signed the cargo loading manifest before take-off.

- 1.1.2 During load planning the Load Master mistook the Standard Operating Mass (SOM) Centre of Gravity (CG) Mean Aerodynamic Chord (MAC) percent number for the Index Unit (IU) number. Hence the aircraft was misloaded to a CG of 37.8% MAC, which was 4.8% aft of the aft limit of 33% MAC. The mistake was not discovered by the Load Master, SAS Cargo or Korean Air Supervisor. Nor was the mistake discovered by the Commander who accepted and signed the cargo loading manifest before take-off.

1.18.1.3 The above procedure was based on three levels of control. First the Load Master himself checked the calculations. Then a Korean Air Supervisor from Korean Air Denmark visiting SAS Cargo/SGS at ENGM checked the loading calculations. Finally the Commander verified that the mass and balance of the aircraft was within limitations.

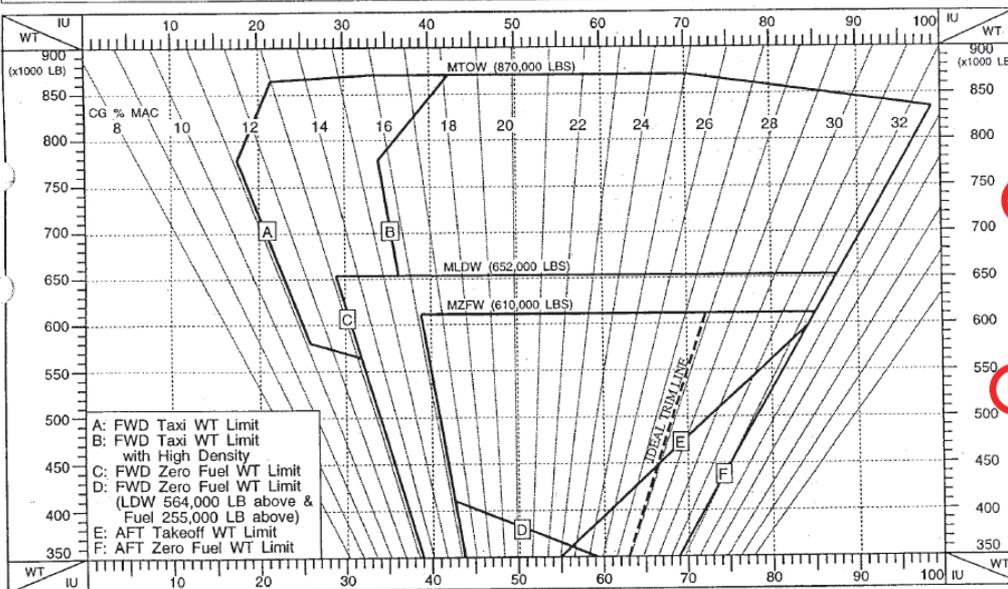
- TOM 725,187 lbs
- CG percent MAC: 37.8%. Aft limit 33% (4.8% exceedance)
- TOM IU 111.0
- Stab trim 2.0

- ELM 533,187 lbs
- CG percent MAC: 40.2%. Aft limit 33% (7.2% exceedance)
- ELM IU 101.0

Corrected Take off CG

Corrected Landing CG

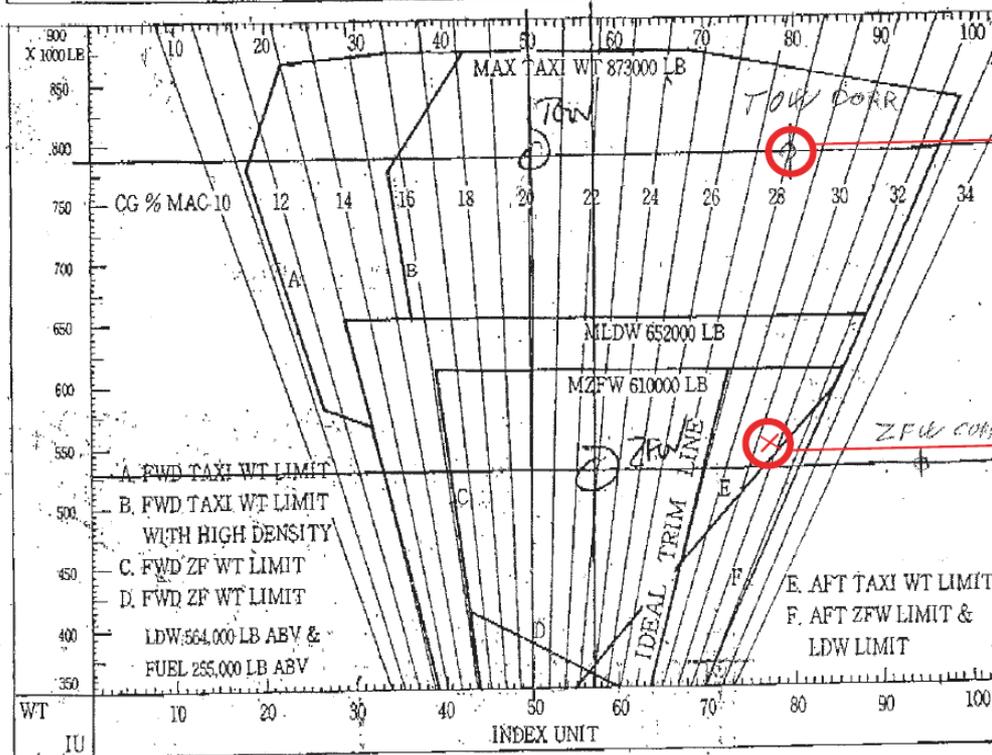
Fig. 5. M & B Manifest of 29 June 2004

1.18.4.2 In this incident the Load Master mistook the 30.5% MAC value for the correct UI of 67.3.
