REPORT

Sjø 2010/01

REPORT ON MARINE ACCIDENT
FEDERAL KIVALINA - IMO NO. 9205885
GROUNDING AT ÅRSUNDØYA, NORWAY
6 OCTOBER 2008

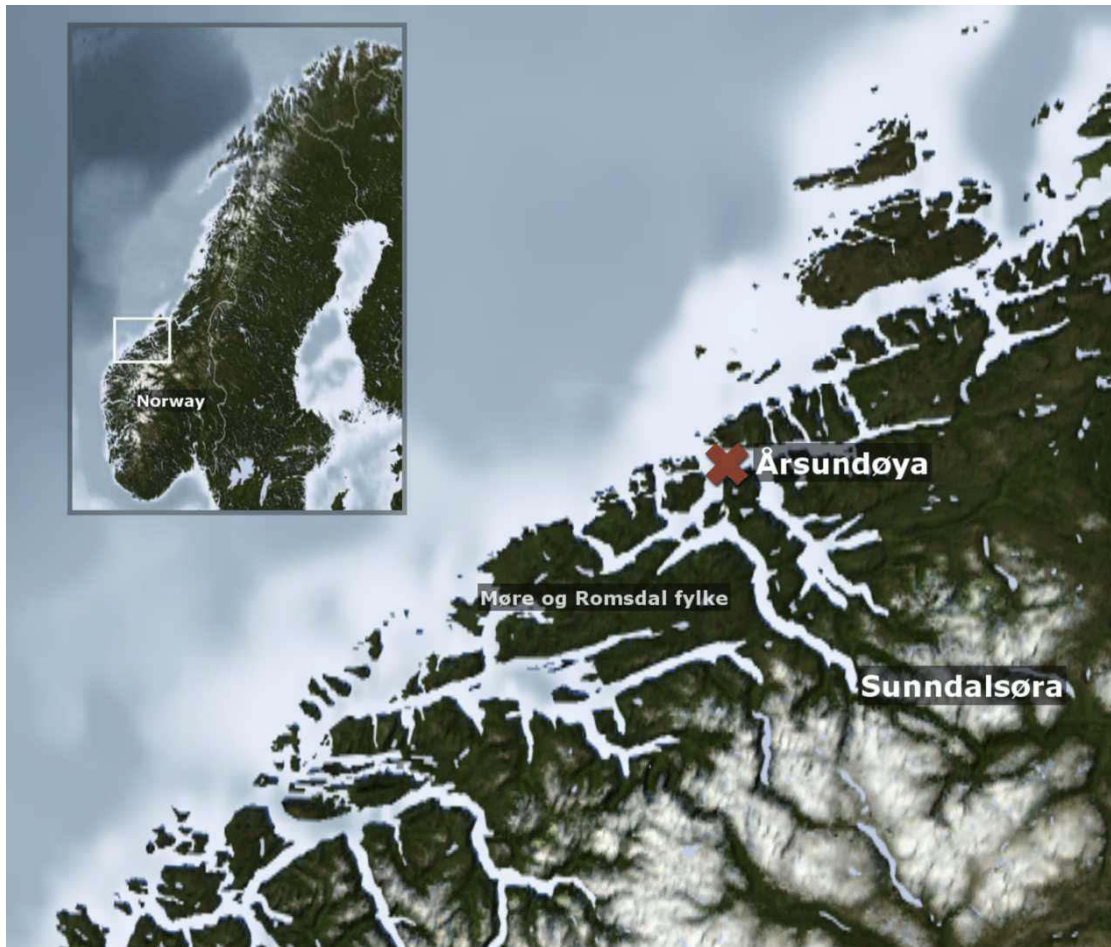
Figure 1: Grounding of the Federal Kivalina, 6 October 2008 at Skarvberneset, Årsundøya.

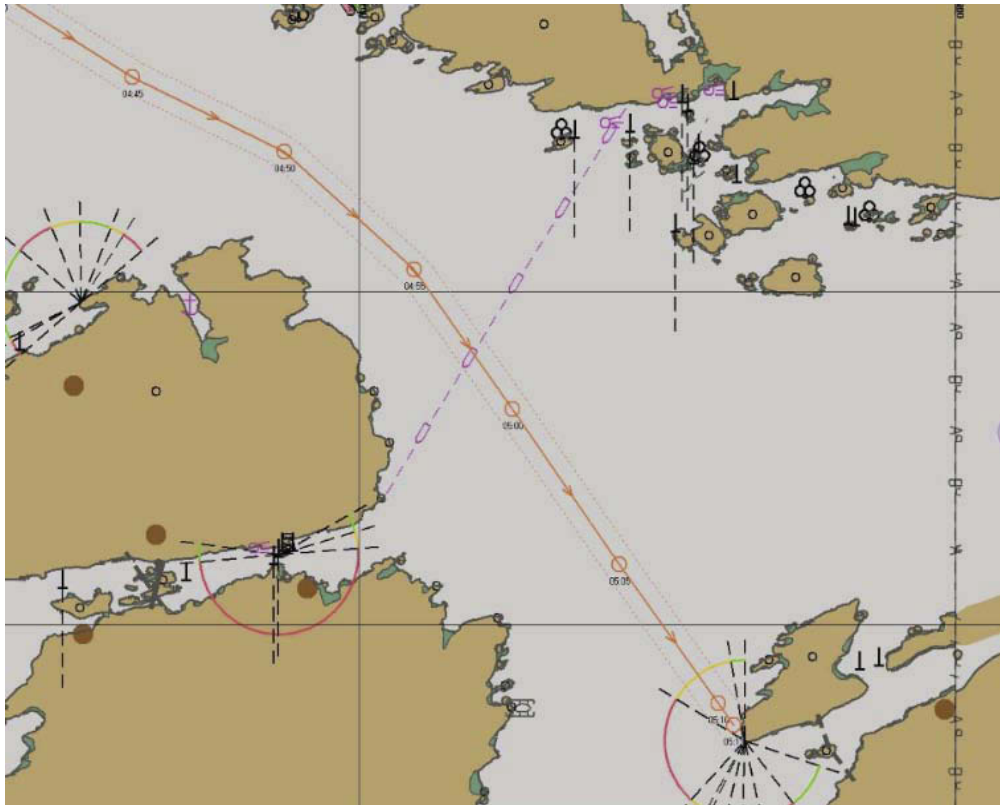
The ship only made a few degrees of the turn before running aground on Skarvberneset, Årsundøya. It took less than 45 seconds from when the chief officer called for the master's attention until the ship ran aground. The ship ran

aground at a speed of 12 knots and came to a standstill just before 0511 hours. The distance between the bow and land at the beacon light on Skarvbergnestet was about 10 metres.

Figure 7: The ship's movements from Talgsjøen (0445 hours) and south-eastwards to the accident site at Skarvbergnestet, Årsundøya (0511 hours).

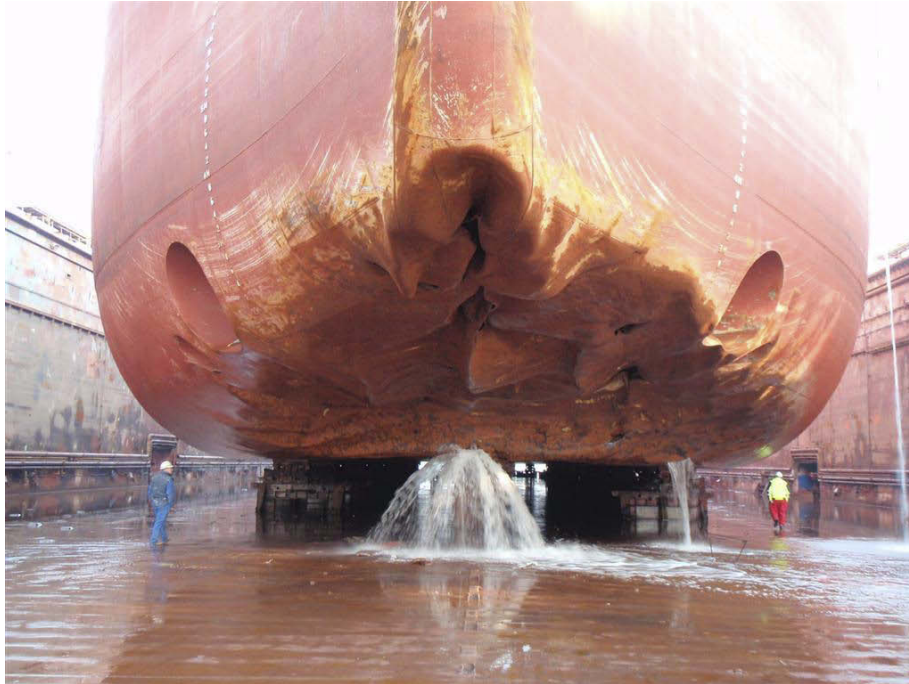
The extent of the damage was limited to material damage to the ship's hull. The hull damage was limited to the bow section and water intrusion to the forward compartments and up to about 5.5 metres above the baseline. The affected forward compartments were the forepeak, bow thruster room, double bottom tanks (ballast) Nos. 1 and 3, port and starboard sides. A bulge also formed in the bulkhead

between the forepeak and cargo hold No. 1, but no water intruded into the cargo hold.

Figure 8: The picture is from the dry-dock in Gdansk and shows the ship seen from the front. The impression is from frame 200 and forwards. For the reader's information, the thruster tunnel is located between frames 211 and 241. In addition, there was damage to the longitudinal girders and shell plating at frame 116. About 130 tonnes of steel was replaced. Photo: DNV

After unloading the cargo, the classification company DNV assessed the extent of the damage, and the ship was permitted to sail under its own power to Gdansk, Poland for final repairs.

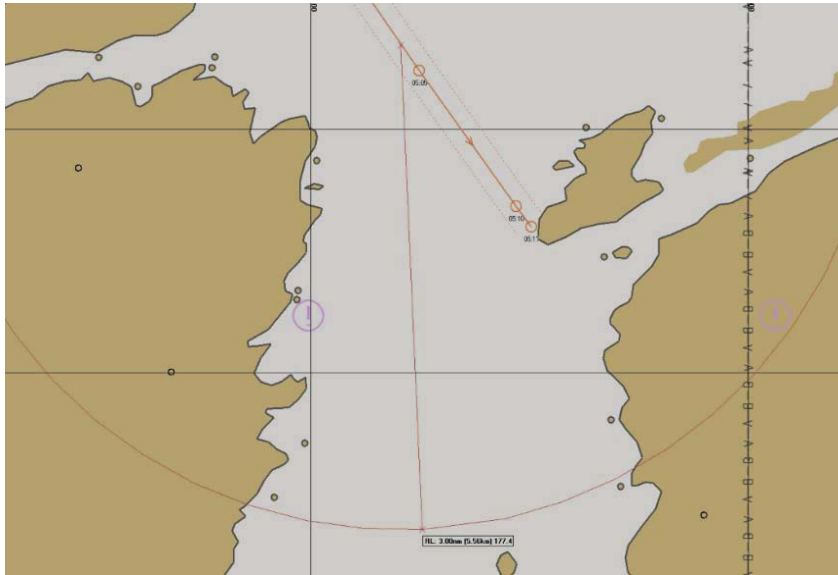
Figure 10: The minimum area (red arc) shown with an overview chart with a radius of 3 nautical miles at 0504 hours.

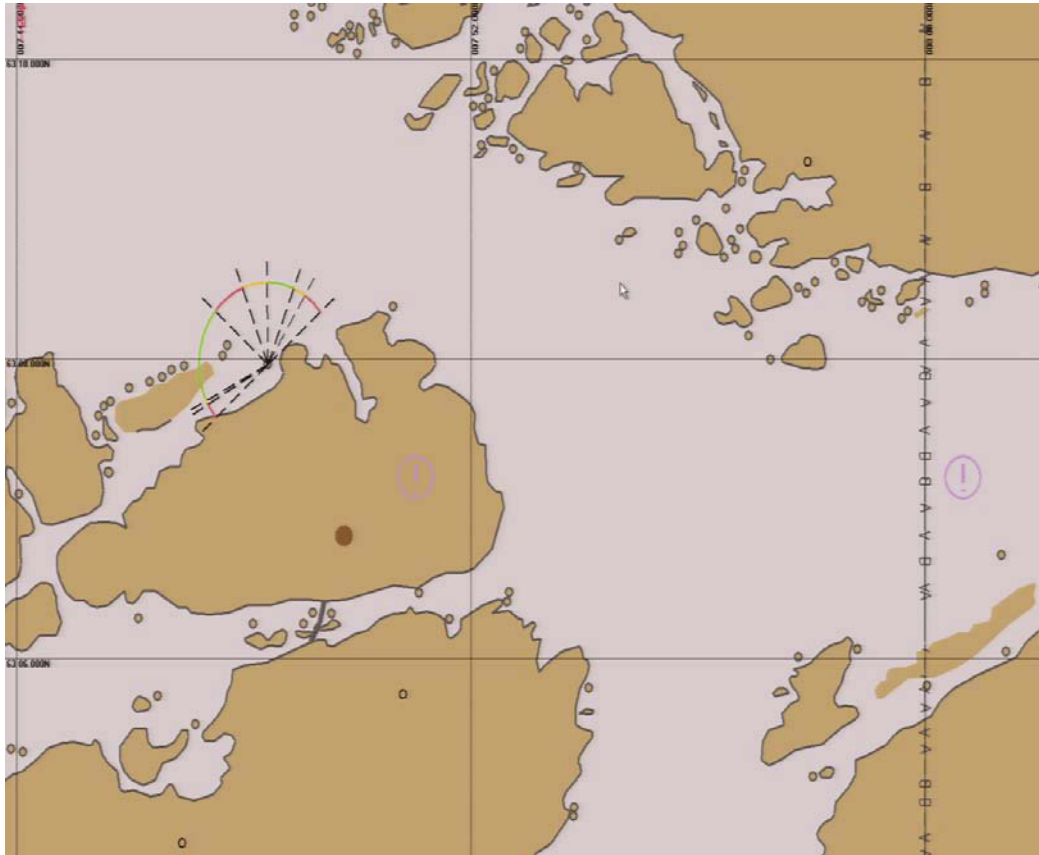
Figure 11: Reconstruction of what was shown on the ship's ECDIS before and when the accident occurred. For Talgsjøen, the overview map (ARCS) only showed the contours of land, but no details such as depths, buoys, beacons and beacon lights. The reconstruction may differ somewhat from what was actually shown.

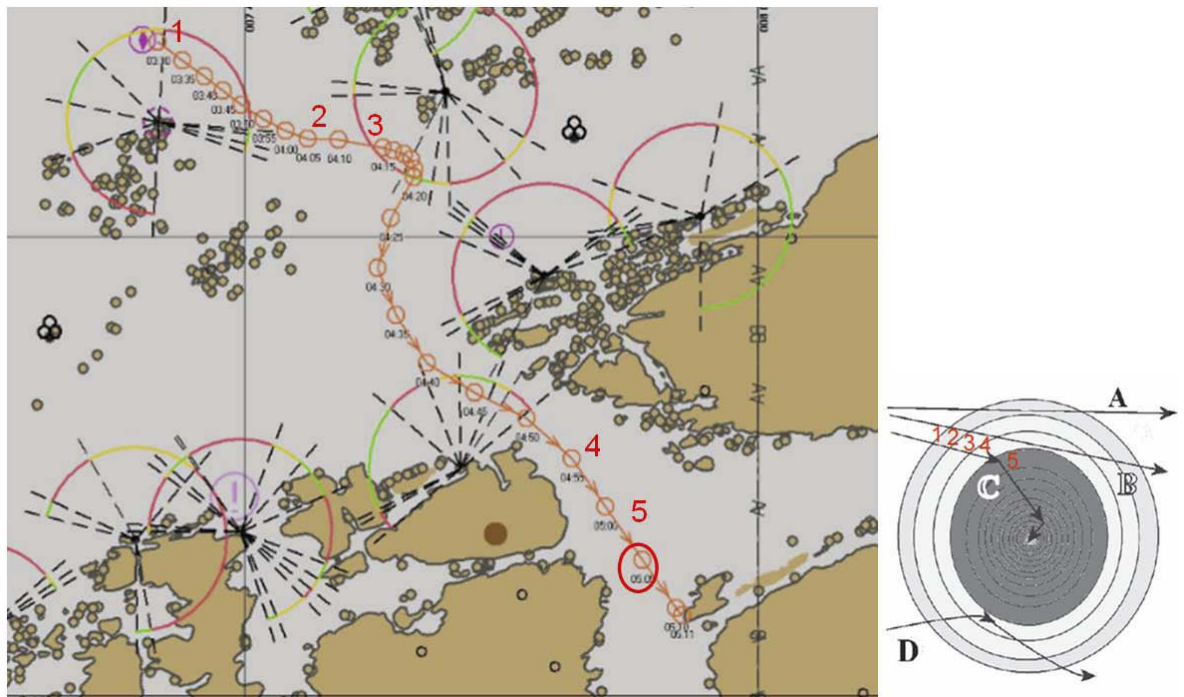
Figure 17:
On left: the red circle indicates the area where, according to the pilot, the ship should have changed course to starboard. This is approx. 1.2 nm from Skarvbergnestet, 6 minutes before the ship ran aground. On right: Illustration of the loss of control (1-5) on board the *Federal Kivalina* based on the 'black hole model'.

The model illustrates the gradually increasing loss of control in relation to navigation, ref. the above figure.

4: After the course was set for the beacon on Skarvberneset, Årsundøya, the pilot was busy clarifying the wind conditions at the quay facility, and whether the ship should anchor.

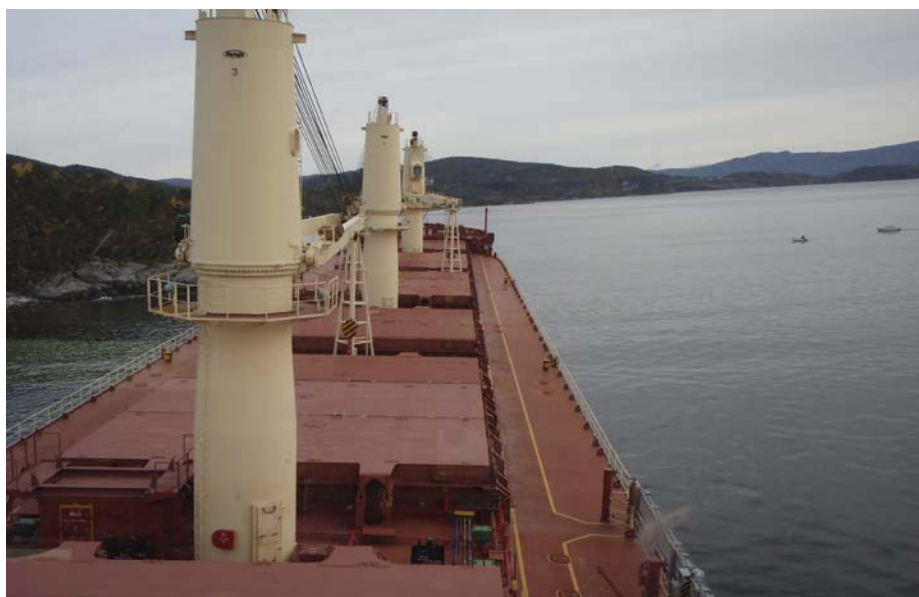
Figure 13: View from the bridge. Photo taken when the ship was aground.
