REPORT

Mar 2010/10

REPORT ON INVESTIGATION OF MARINE ACCIDENT SUNDSTRAUM IMO NO 8920567 AND KAPITAN LUS IMO NO 9077551 COLLISION IN ØRESUND 3 JULY 2009

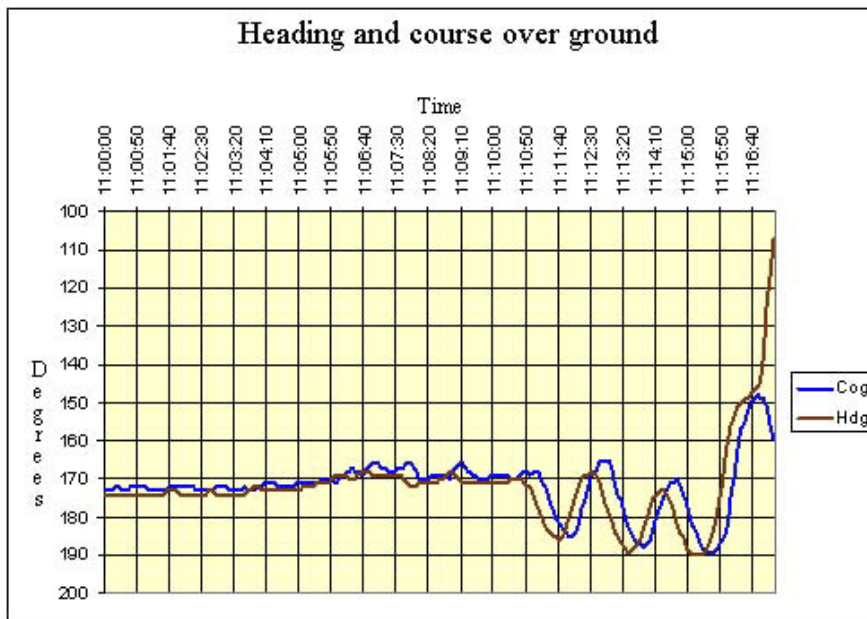
Figure 5: Diagram showing *Sundstraum*'s course over ground (Cog) and heading (Hdg) in the last few minutes before the collision. The diagram is based on information from *Sundstraum*'s S-VDR.

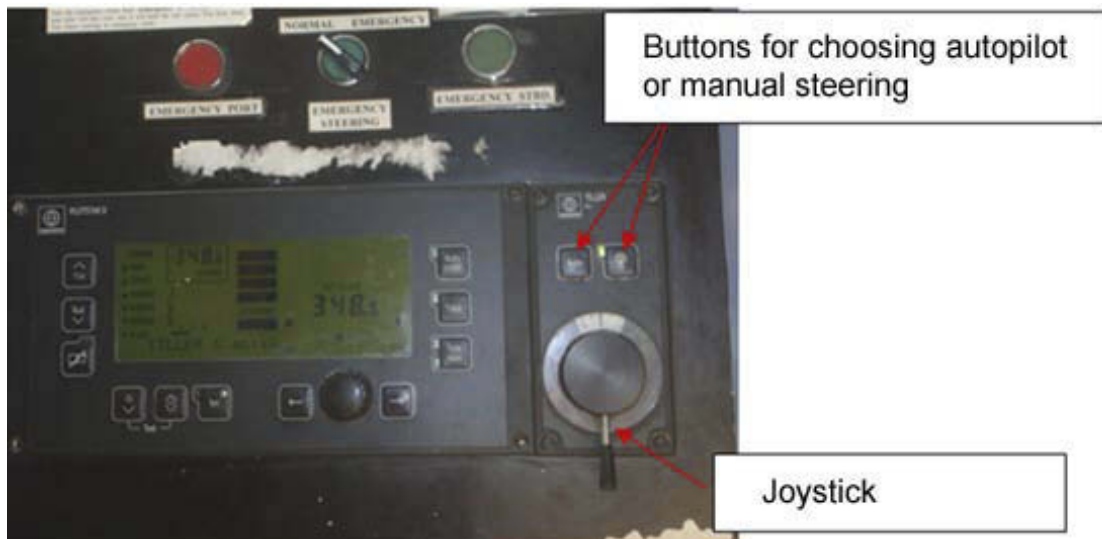
whether control actually was switched from autopilot to manual steering. The Master tried to turn the rudder to starboard with the joystick (see Figure 11), but observed that the vessel continued to turn to port. He also observed on the rudder indicator that the rudder did not move.

Figure 11: Autopilot located on the central manoeuvring console. A joystick can be seen at the right in the picture. A switch for changing from normal to emergency steering and buttons for emergency steering can be seen just above the autopilot consol.

A company investigation into the accident was carried out by Fleet Management Europe Ltd. The investigation concluded inadequate bridge manning level, unfamiliarity of the watch officer with the ship's steering system and inadequate passage planning and execution as the root causes of the accident. The operators' investigation also concludes that a peculiar design of the joystick for manual steering is a direct cause for the accident.

As corrective measures the operator has decided to implement different control measures to verify that the ship's crew comply with the operator's procedures regarding manning, planning and execution of the passage. The operator has passed a message to all vessels on the subject to make them aware of the incident, its causes and what needs to be done to prevent same. A course to be developed in the FMEL training institute focusing on this incident and the lessons learnt. The joystick for manual steering is changed to one with another design.

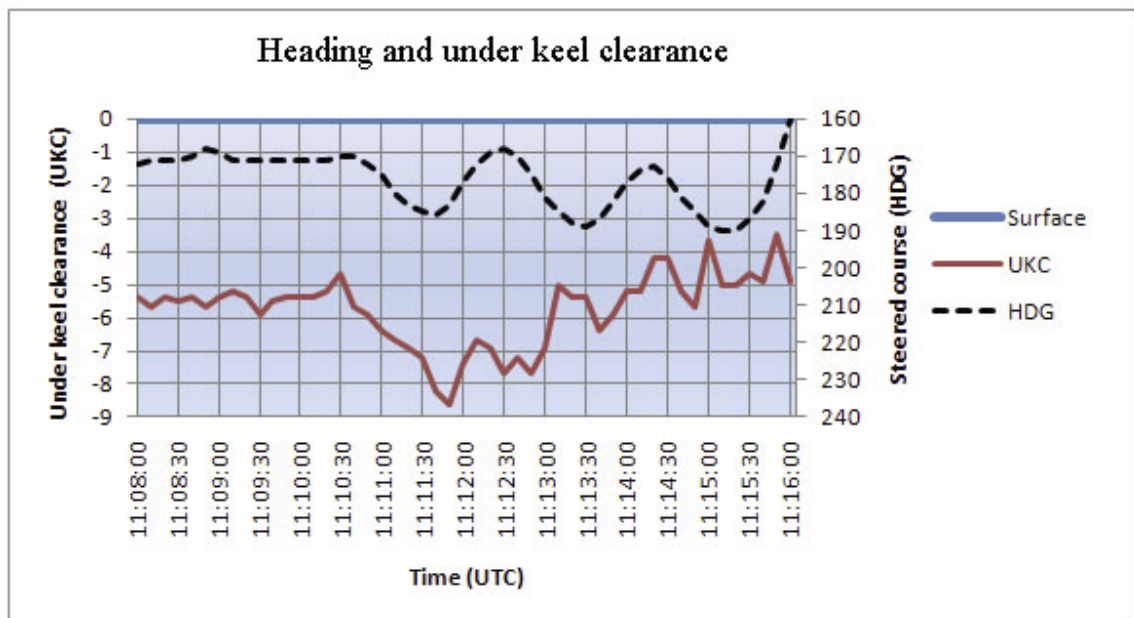
Data on the ship's echo sounder have been extracted from *Sundstrøm's* S-VDR. The echo-sounder's oscillator is located forward, just behind the bow thruster tunnel, and thus reflects the water depth under the ship's bow. In the experience of the today's operator, the echo-sounder shows the correct depths. Echo-sounder data are shown in Figure 17 and related to the ship's steered courses in the period before the collision.

Figure 17: Sketch showing available water depth below the ship's bows and heading in the period 11.08.00 to 11.16.00.

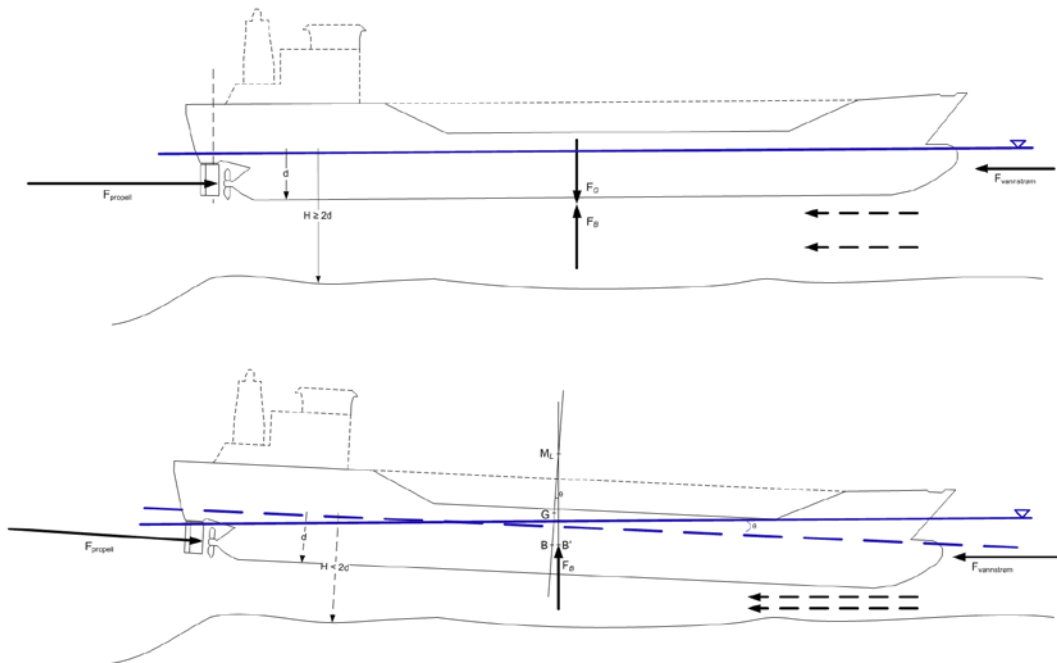
The squat effect is due to pressure changes owing to the relative speeds of ship and water. This effect is heightened when water depth and waterway breadth are restricted. When the ship moves into shallow water, there is less space under the ship for water to pass. This causes a change in the relative speed of ship and water and hence a change in pressure (see Figure 18).

Figure 18: Two illustrations of a vessel moving forward. The uppermost illustration shows the vessel in deeper water. The lowermost illustration shows a vessel with bow trim as a result of the squat effect. This effect is the result of a combination of speed, draught and water depth.

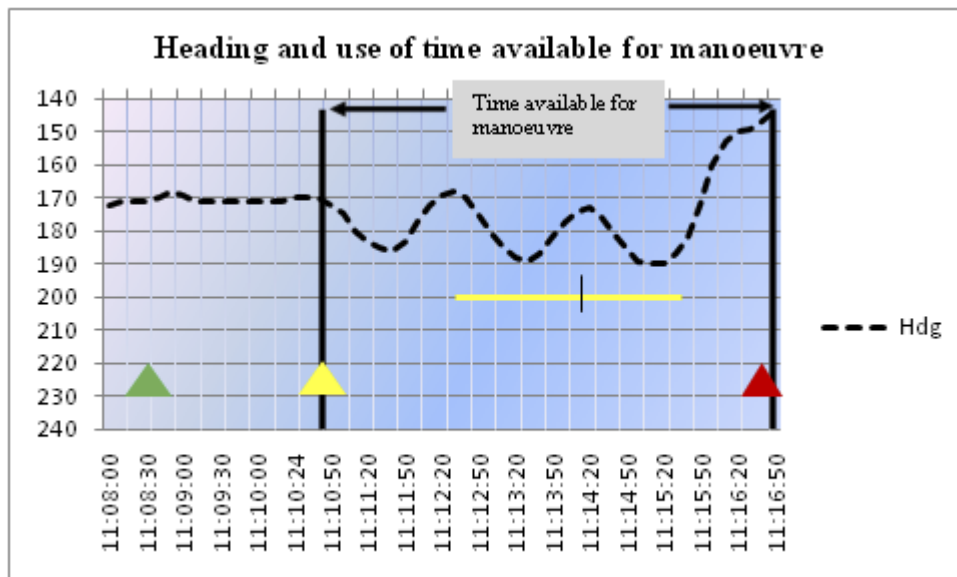
Figure 19: Shows *Sundstraum*'s headings in the last few minutes before the collision. The period when the situation was normal is illustrated with a green triangle. The times when the movement pattern changed and when the vessels collided are illustrated with yellow and red triangles, respectively. The horizontal yellow line illustrates the period when the officer tried to contact the Master and the period when the officer and the Master discussed how to navigate in Drogden.

On the basis of the autopilot settings that have been quoted, with a maximum rudder angle of 5 degrees to initiate a course change and a maximum counter rudder angle of 5 degrees to stabilise the ship on its course, calculations have been made for the ship model’s movement during a forced zig-zag movement with corresponding rudder gain. The calculations were made assuming bow trim in shallow water and assume an allowed course deviation of up to 5 degrees. Similar calculations were carried out for a zig-zag manoeuvre with a 5 degree rudder angle and application of counter-rudder at a 1 degree change in course. These calculations were also made assuming bow trim in shallow water. The ship model’s calculated response under such a manoeuvre was plotted together with the rudder gain in Figure 21. The ship’s real movements, based on information from *Sundstraum*’s S-VDR, are shown in Figure 19.

The view of today`s operator is that a rudder limit of 5 degrees is small for navigating with autopilot in narrow waters. In view of how the ship oscillated, it is the operators view that the ship was on autopilot and that the autopilot settings have damped the heading changes and the oscillation rate. Their view is that the way the autopilot was set, and taking into account the depth conditions, the ship could have oscillated as shown in the graph in Figure 19.

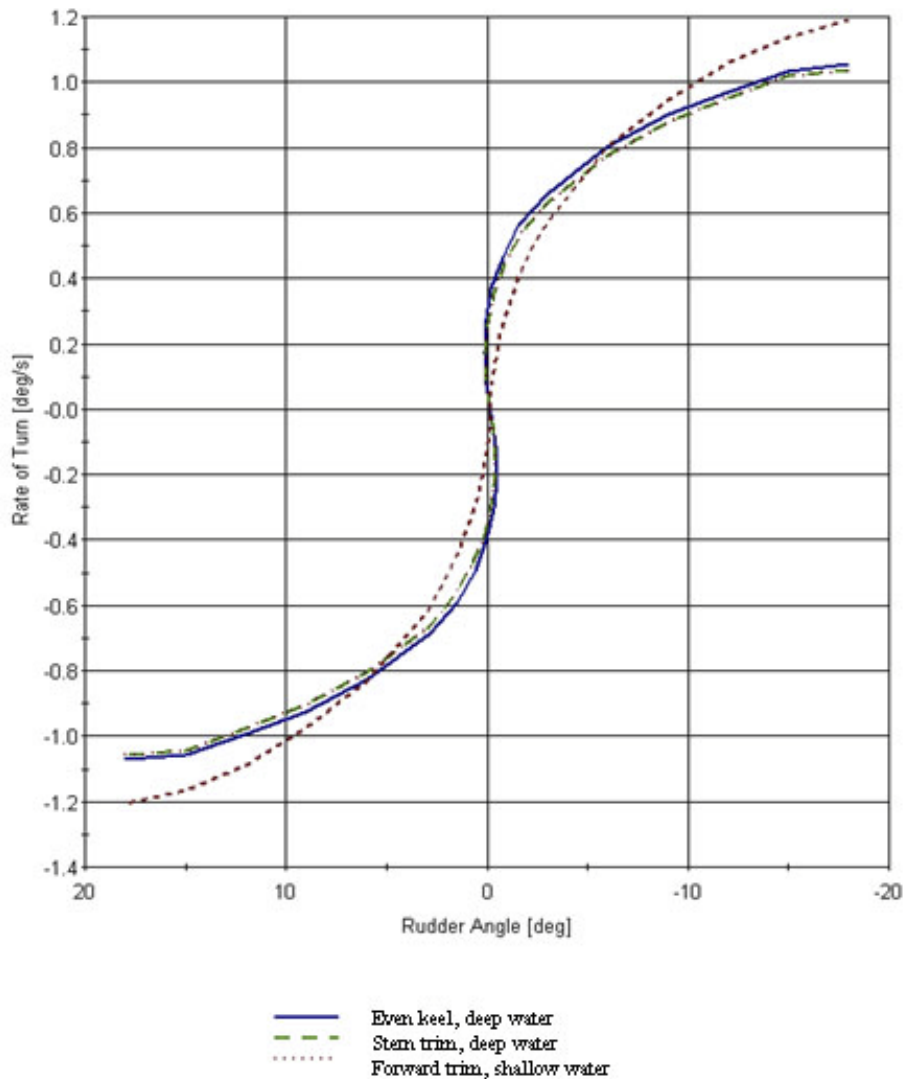
It is concluded from MARINTEK's simulations that the vessel probably dipped forward (bow trim) as a result of the squat effect when it moved into shallower water. It is further concluded that the directional stability was not appreciably changed as a result of the squat effect. The simulated spiral tests of the ship model show no appreciable change in shape (see Figure 20). This is explained as due to the fact that the destabilising effect of the trim influence is counteracted by the stabilising effect of reduced water depth.

Figure 20: Shows the values that were arrived at under simulated spiral tests. The values show that the ship model is marginally stable/slightly unstable for the various conditions that were investigated.

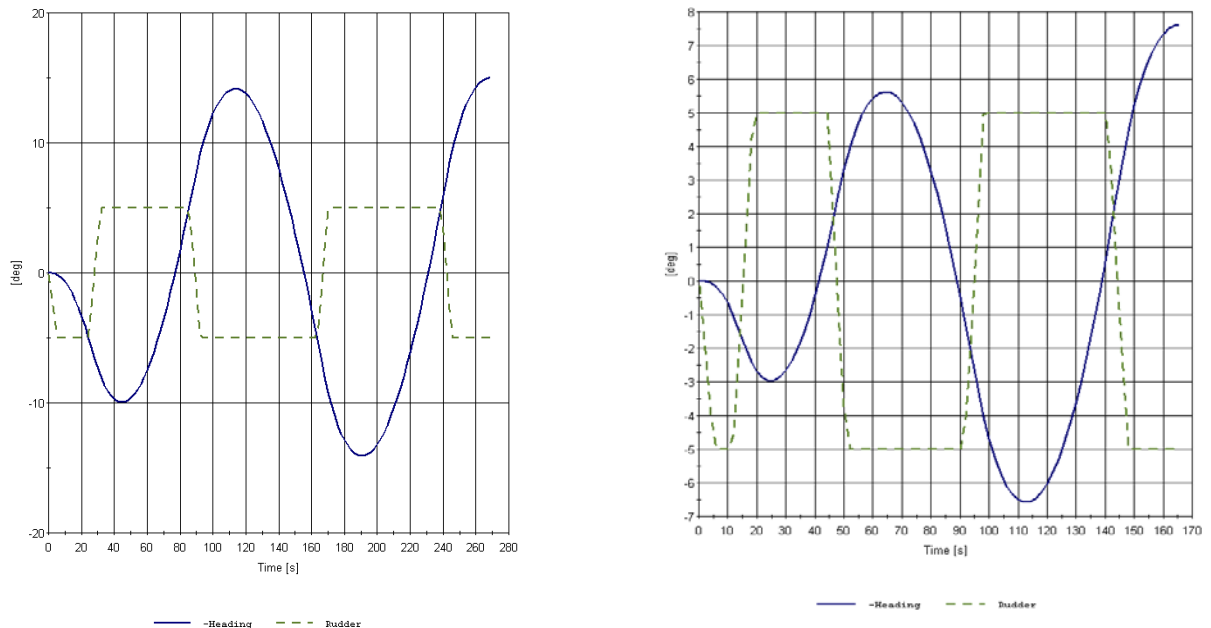
Figure 21: To the left, simulation of 5/5 zigzag test for a ship in shallow waters where counter-rudder is applied when the initial course is changed 5 degrees. To the right, a similar simulation, but now the counter-rudder is applied when the initial course is changed 1 degree.
