# REPORT

Sjø 2012/09

## REPORT ON INVESTIGATION INTO MARINE ACCIDENT M/V GODAFOSS V2PM7 GROUNDING IN LØPEREN, HVALER ON 17 FEBRUARY 2011

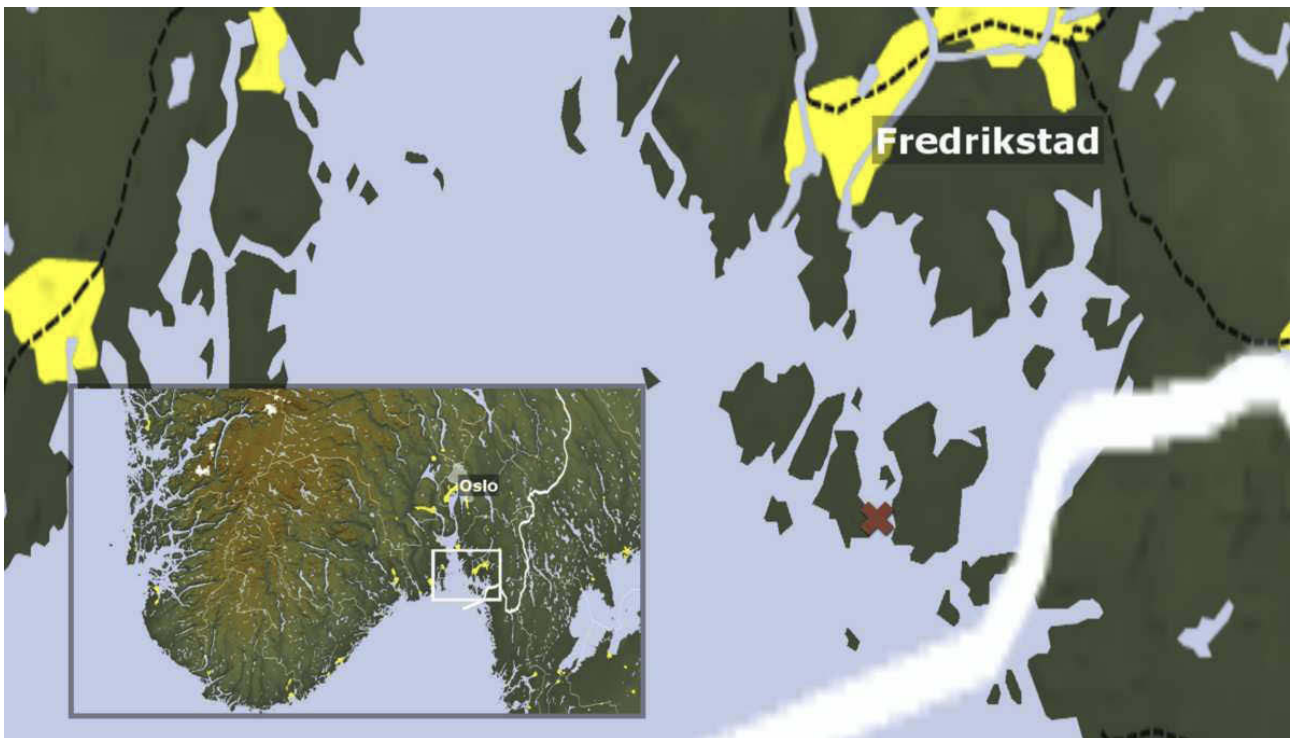
Figure 1: The container vessel *Godafoss* grounded on 17 February 2011 at Kvernskjærgrunnen in Løperen, Hvaler municipality.

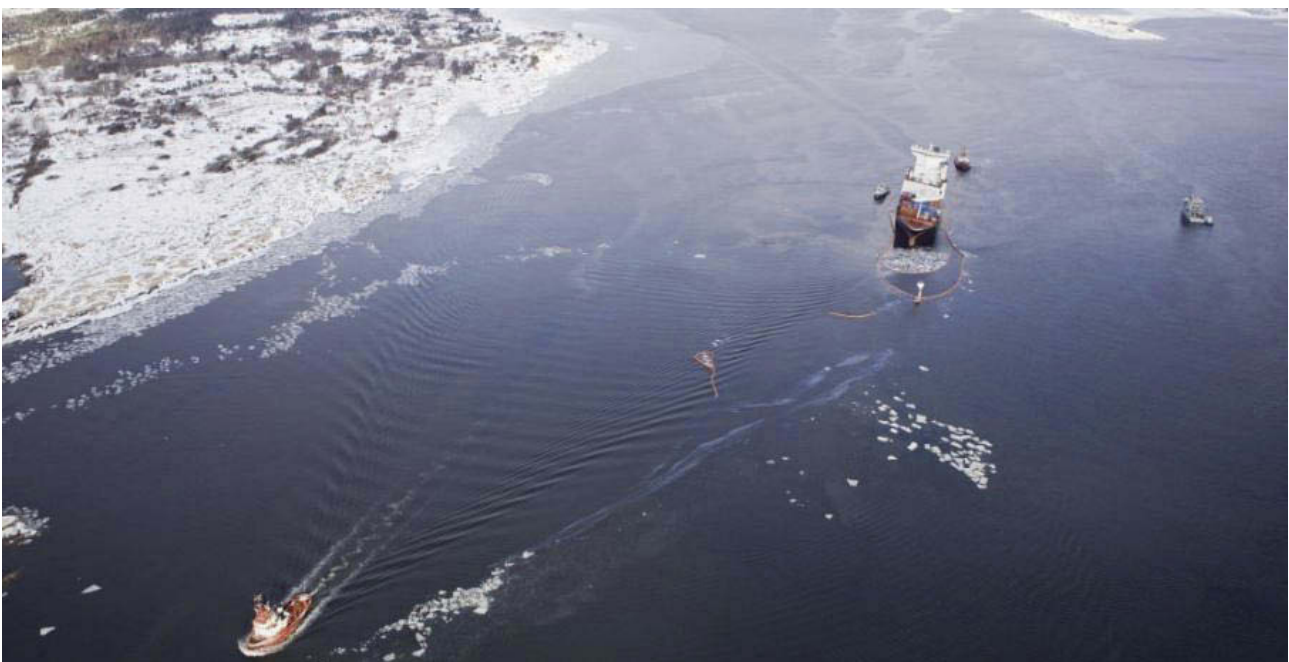
Figure 2: *Godafoss* aground at Kvern skjær beacon on 18 February 2011. Photo: Fredrikstad Blad

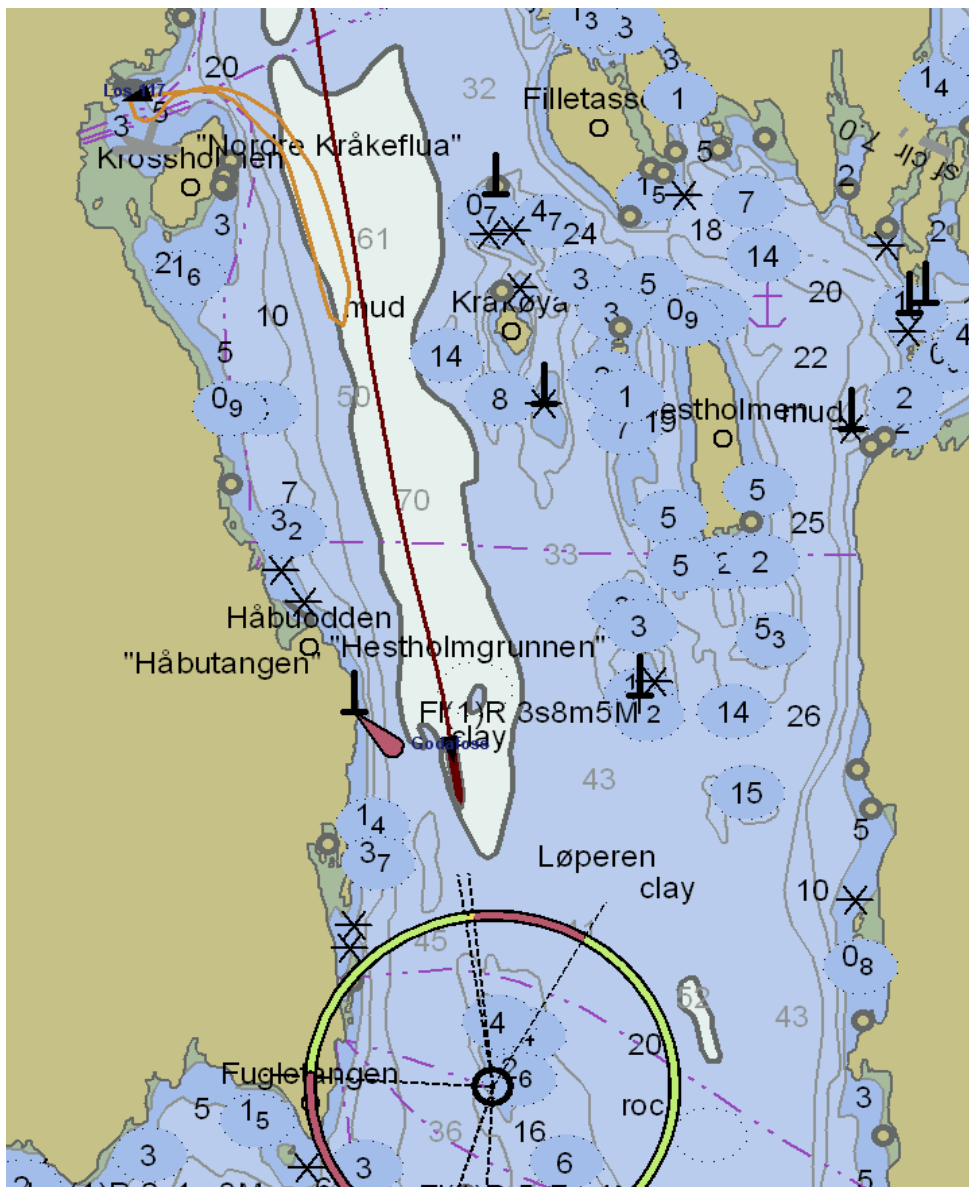
At 19:48 *Godafoss* made a slight course adjustment to port. At that time, its speed had increased to 9 knots and the distance to Kvernskjærgrunnen was 0.75 nmi (1,389 metres). In this area, it should be possible to observe red flashes to starboard from the Håbutangen and Fugletangskjær lateral lights. The vessel was still on the boundary between the white and red sectors of Kvernskjærgrunnen beacon. (Figure 4:)

Figure 4: The voyages of Godafoss and the pilot boat Los 117. The nautical chart shows the position of the vessels at 19:50 (local time). This was just after Godafoss has passed due east of Håbu. The red line indicates the voyage of Godafoss. The yellow line indicates the voyage of Los 117. The chart shows the sector lights from the white, red and green sectors of Kvernsholmen beacon.

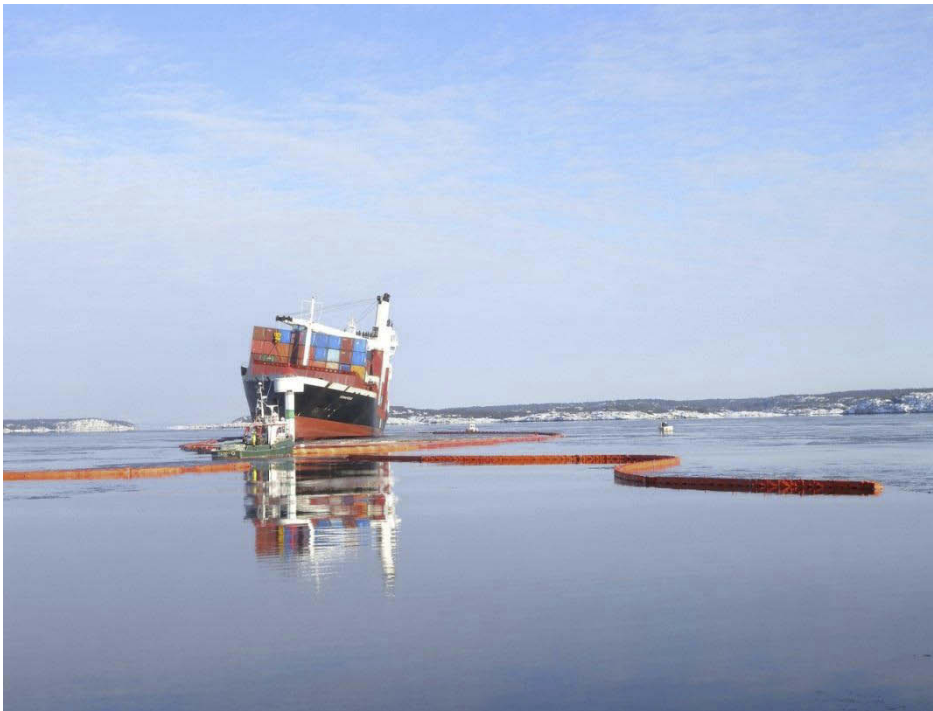
Figure 5: Godafoss on Kvernskjærgrunnen on 18 February 2001 with a list of approximately 7 degrees to port.

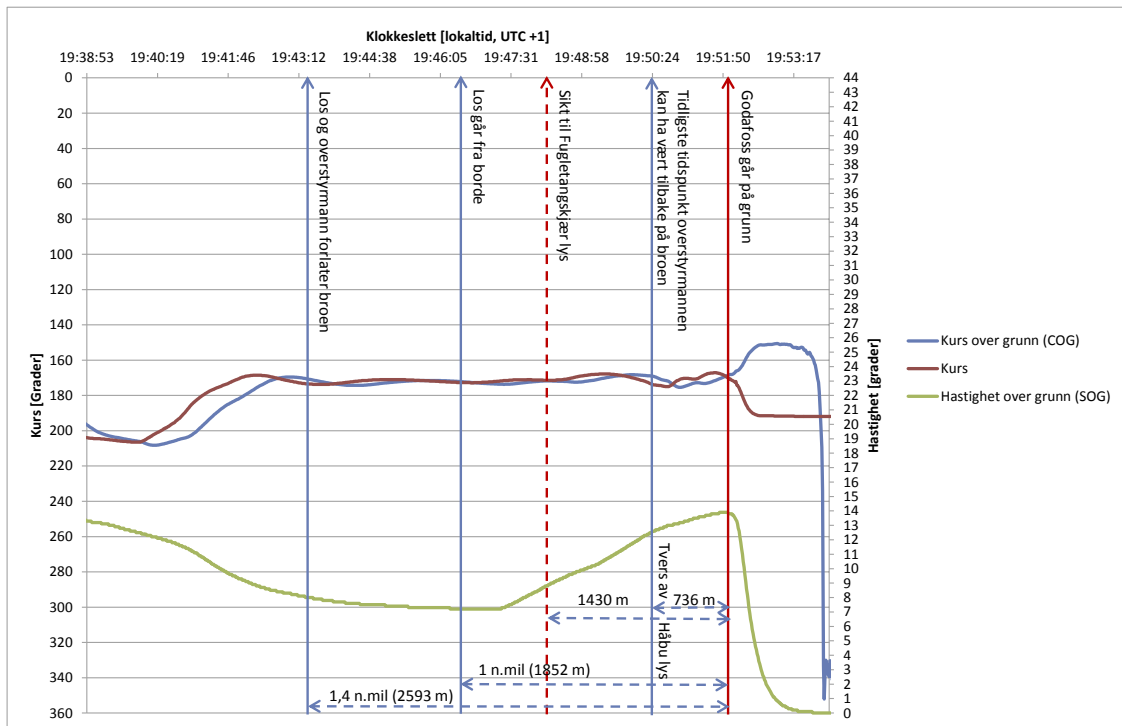
Figure 7: Graphic representation of Godafoss' changes in course and speed in the period immediately before and at the moment of grounding. Times are stated in local time (UTC+1).

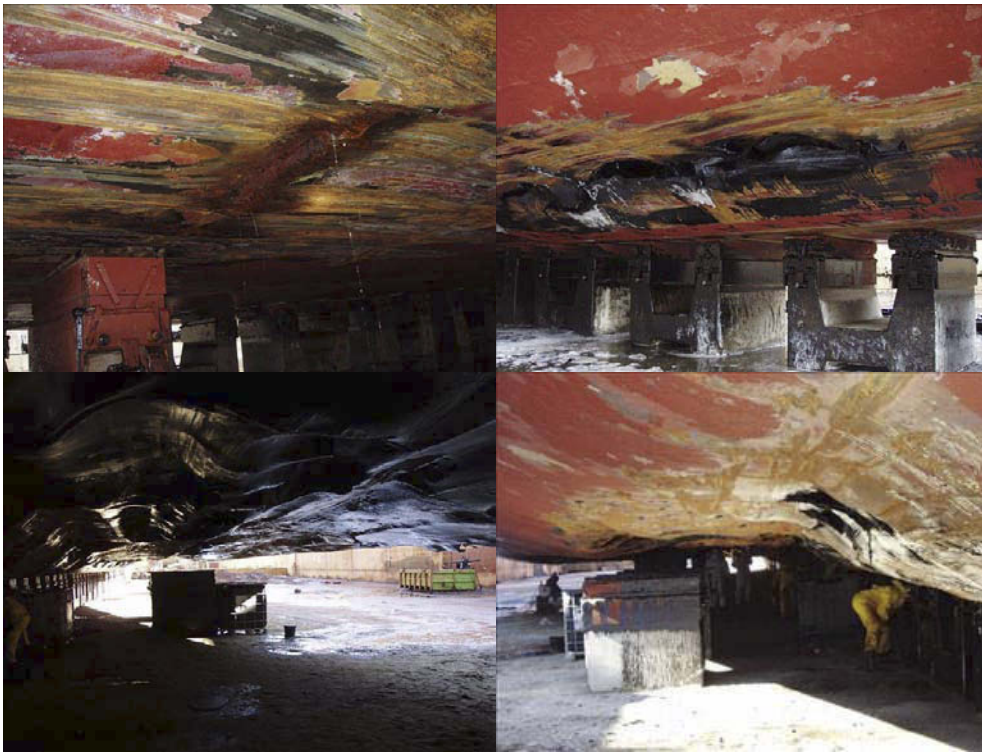
Figure 8: Godafoss under tow to the yard in Odense in Denmark, where DNV conducted the classification society's survey in the period between 5 March and 14 April 2011. All photos were taken by DNV while the vessel was undergoing repair.

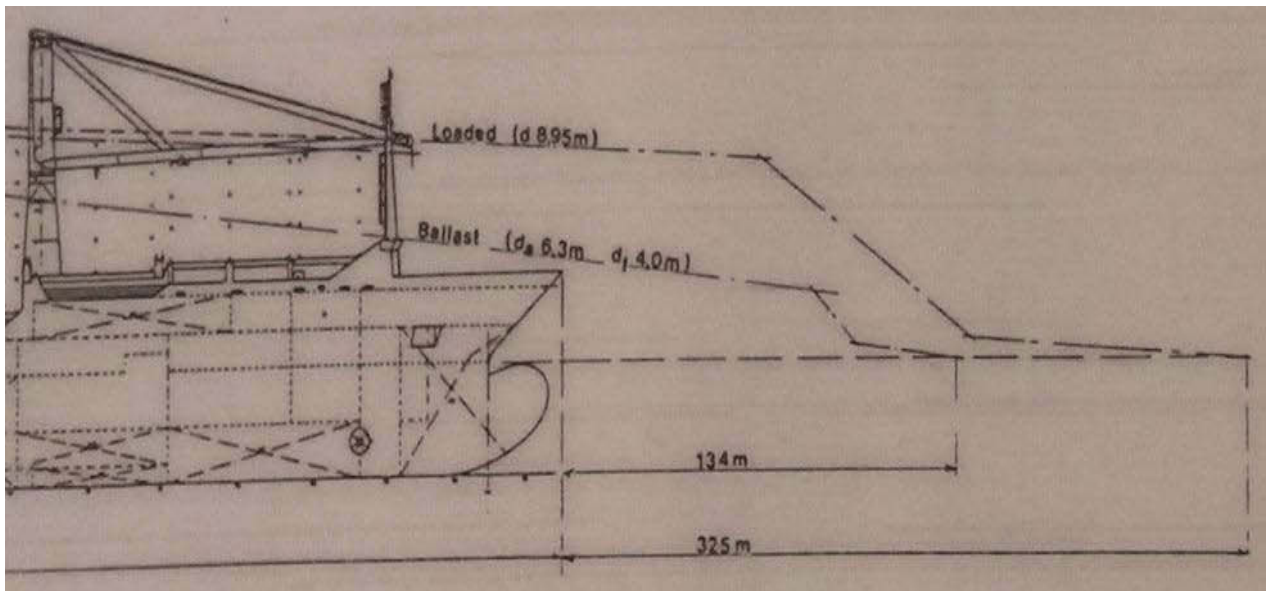
Figure 10 shows a drawing that was posted on the bridge. It shows a visibility line marked 'Loaded (d 8.95 m)', drawn relatively high above the point marking the top of the first three tiers of containers. The visibility line's point of intersection with the sea is stated to be 325 m forward of the bow. The other visibility line on the sketch is marked 'Ballast (da 6.3 m df 4.0 m)' with a visibility line plotted 134 m forward of the bow.

Figure 10: Sketch regarding lines of sight posted on the bridge of Godafoss.

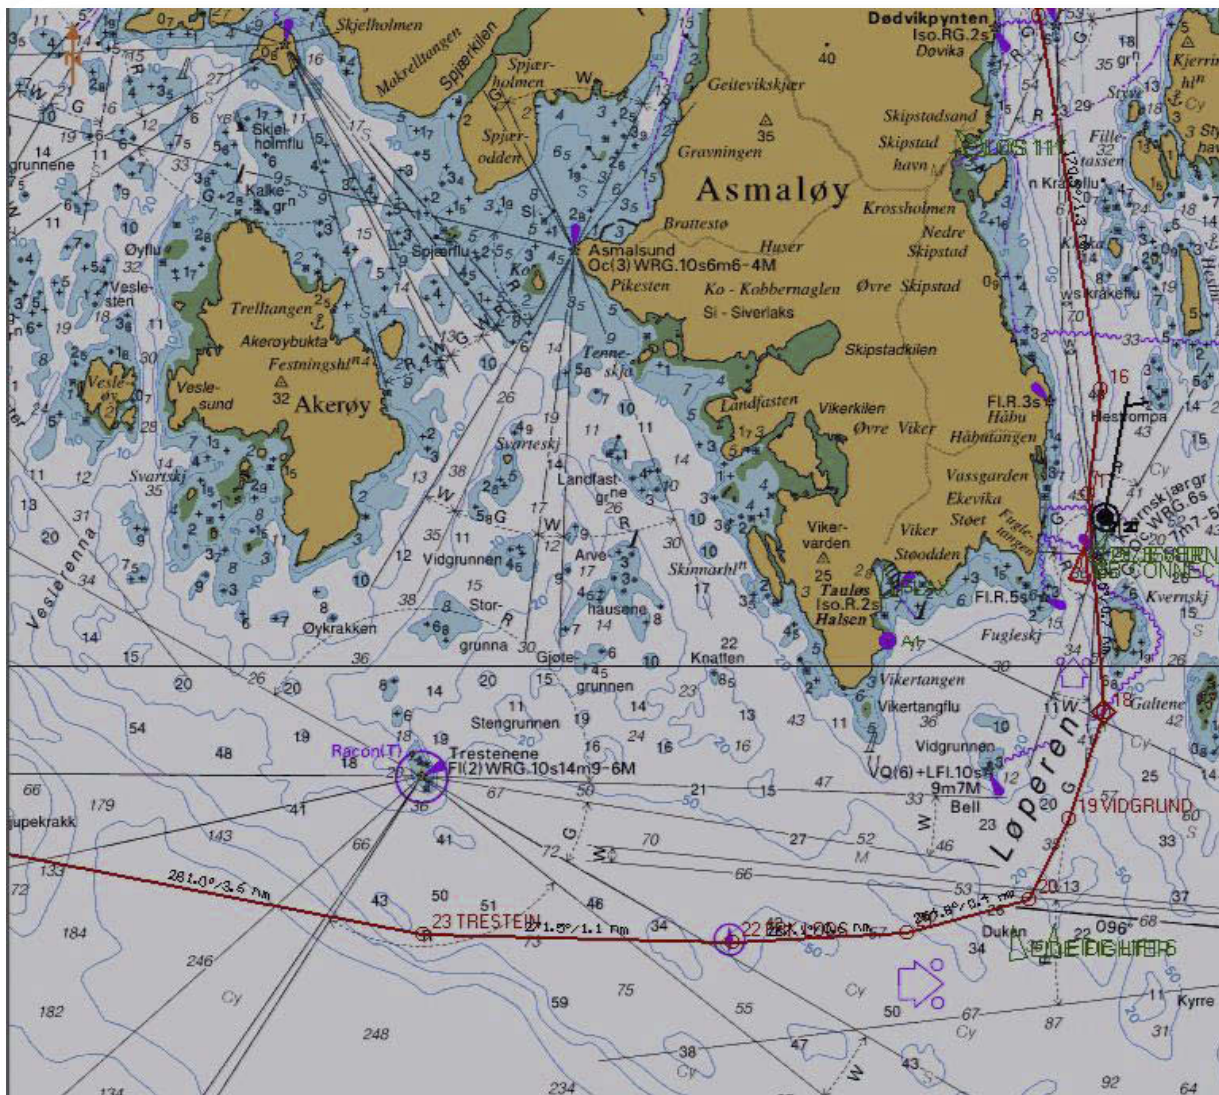
A passage description from Fredrikstad to Hälsingborg was retrieved from the electronic chart system. The route was plotted in an extremely approximate way, and passed over shallows and rocks in some places. When the deck officers were asked why this was so, they replied that the electronic chart system could only be used as a kind of reference, and could not normally be used to control the voyage in this area.

Figure 12: Reconstruction of what was shown by the electronic chart system at the time of the accident. The red line indicates the planned route between Fredrikstad and Hälsingborg.

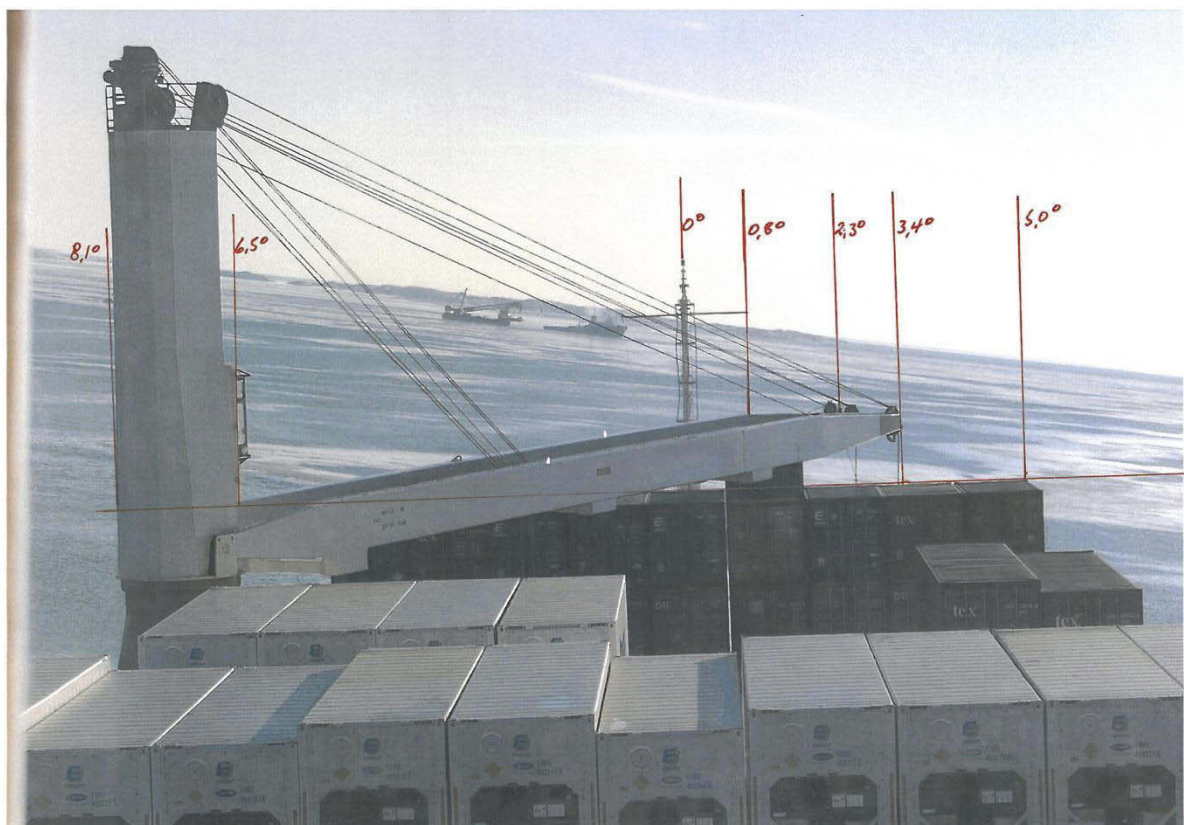
The calculations were carried out for the loading condition mentioned in section 1.4.2, loading condition II.

6.5° Port, above forward boom	0.8° Stb., above bend in forward boom	2.3° Stb., above forward boom tip	3.4° Stb., above aft boom tip	3.4° Stb., above forward edge of containers	5.0° Stb., above forward edge of containers
The visibility line meets the sea's surface forward of the bow [m]	341	607	650	638	339	340
Kvernskjærgrunnen beacon disappears from sight forward of the bow [m]	194	379	410	402	192	193
