# REPORT

## Sjø 2013/02

## REPORT ON THE INVESTIGATION OF A MARINE ACCIDENT NORDLYS LHCW - FIRE ON BOARD DURING APPROACH TO ÅLESUND 15 SEPTEMBER 2011

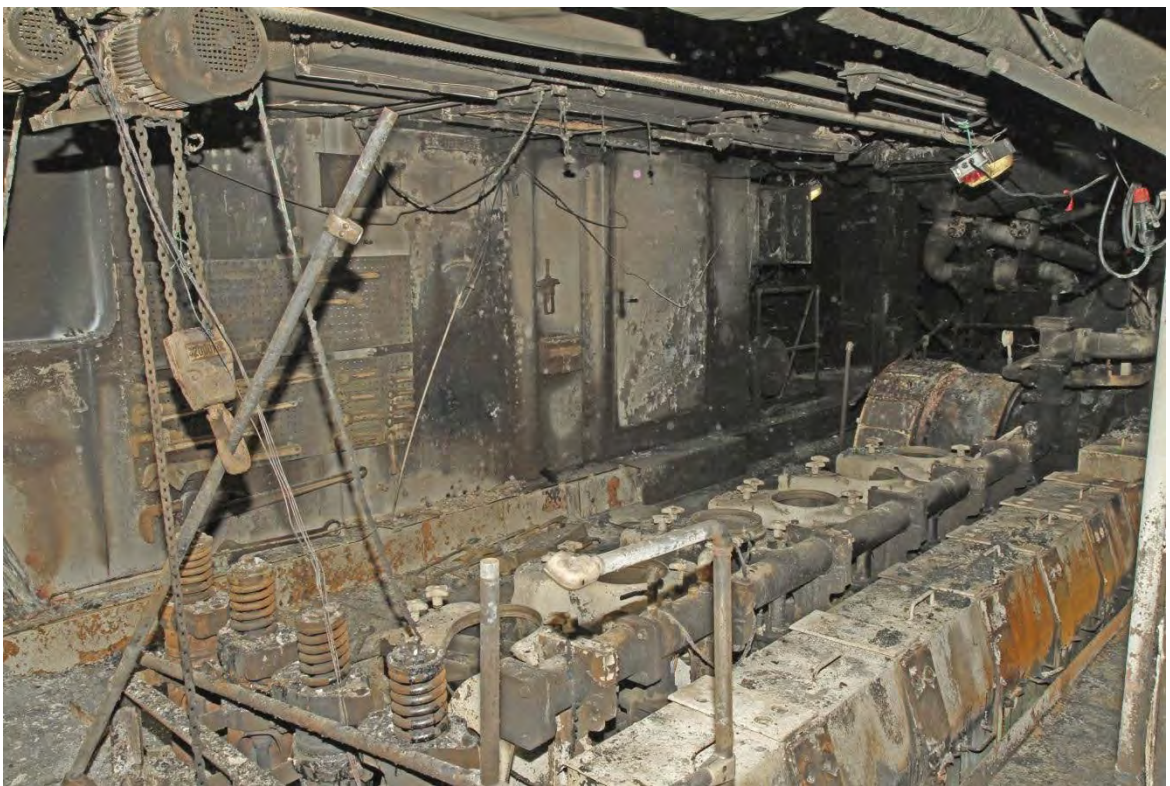
*Figure 4: Starboard side of the main engine room looking aft from the forward gallery. The top of the starboard main engine can be seen in the foreground. The bulkhead dividing the workshop from the engine room can be seen in the background, with the aft entrance door in the middle of the photo. Photo: The police.*

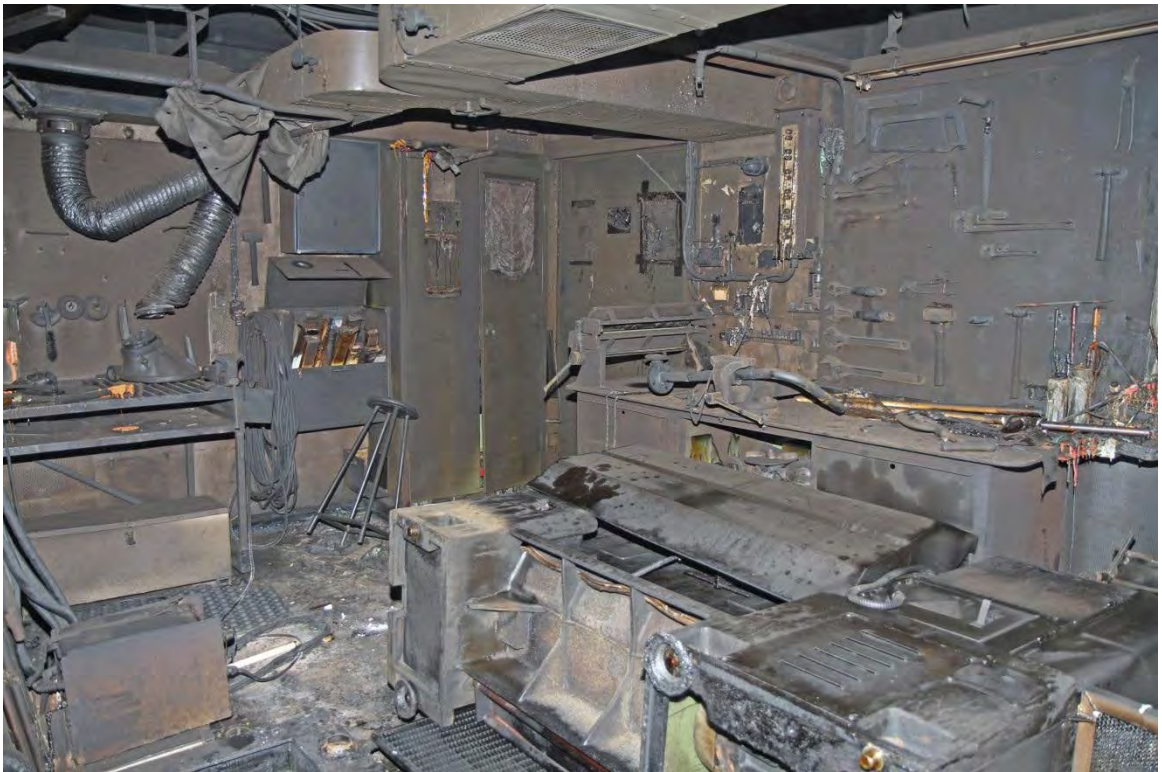
*Figure 5: The interior of the workshop on the starboard side, where the first engineer, repairman and apprentice were standing when the fire broke out. Photo: The police.*

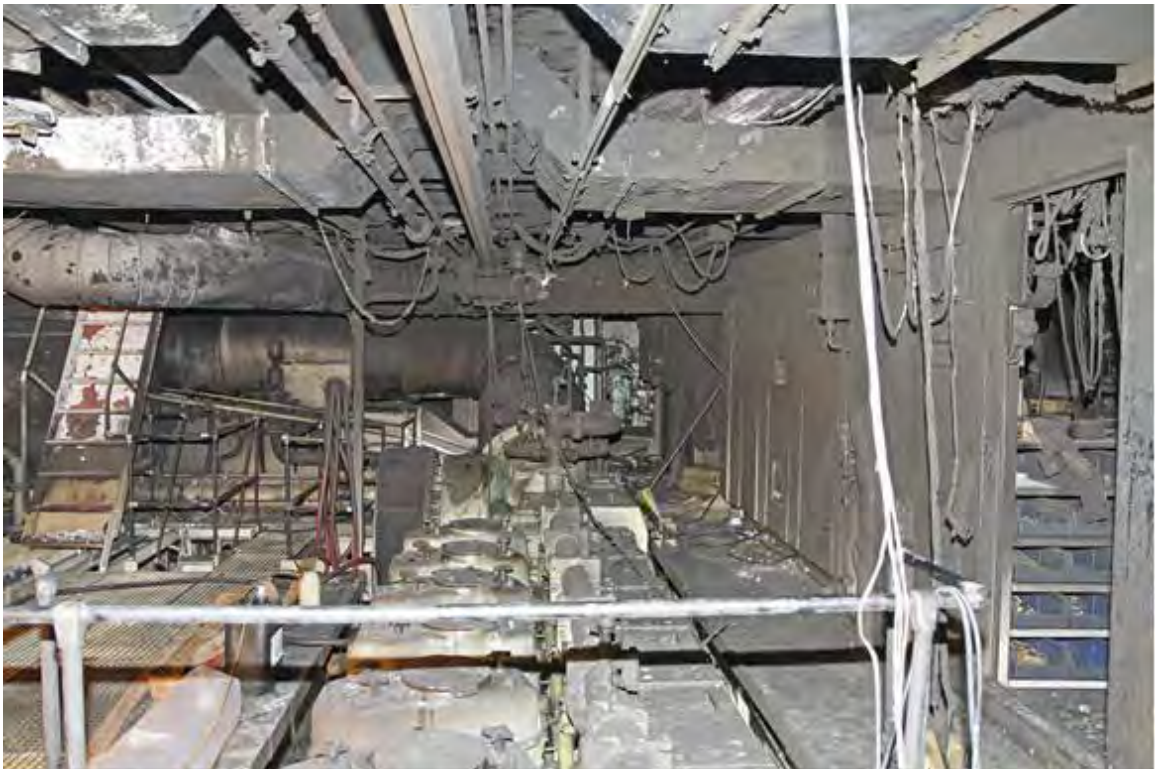
*Figure 6: The port side of the main engine room looking aft from the forward gallery. The top of the port main engine is included in the photo. The door to the incinerator room can be seen on the right. Photo: The police.*

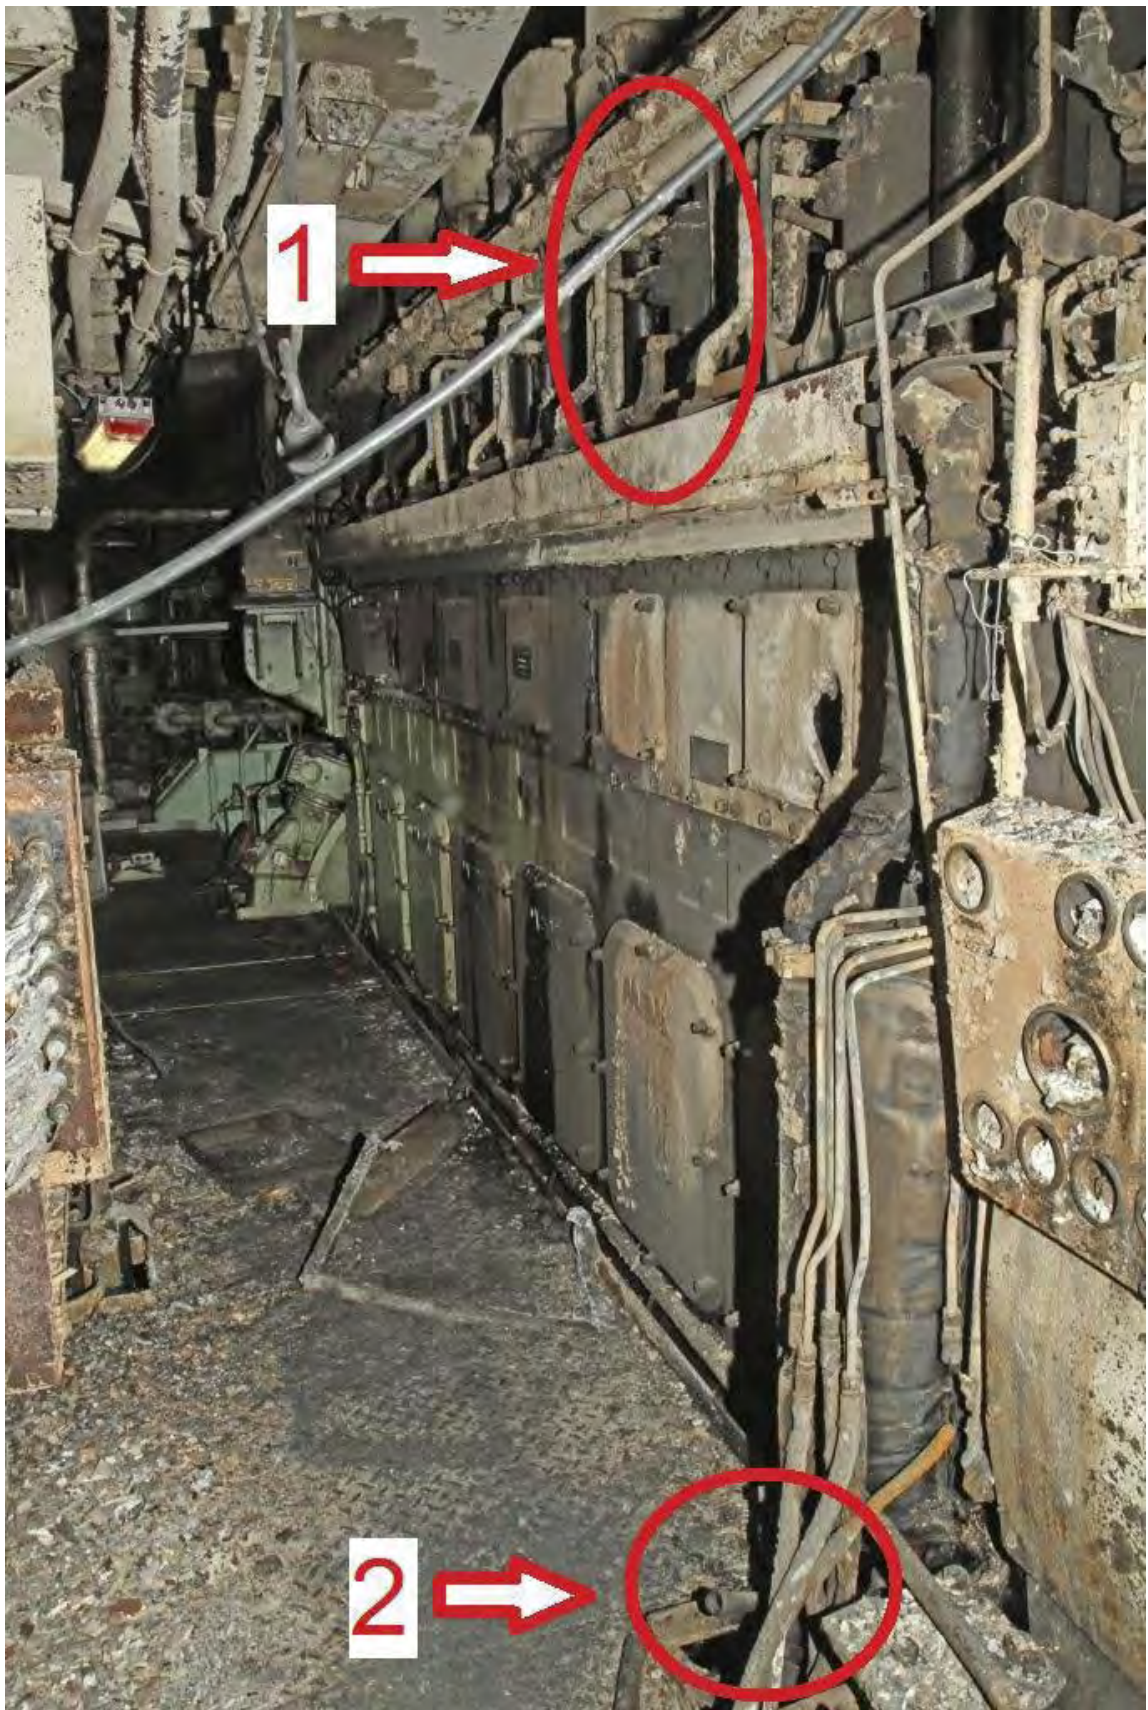
Figure 14: Starboard side of the starboard main engine viewed from above and looking aft at tank-top level. The numbers denote: 1) fuel injector pump for cylinder no 5, and 2) drainage pipe on fuel return line. Photo: The police.

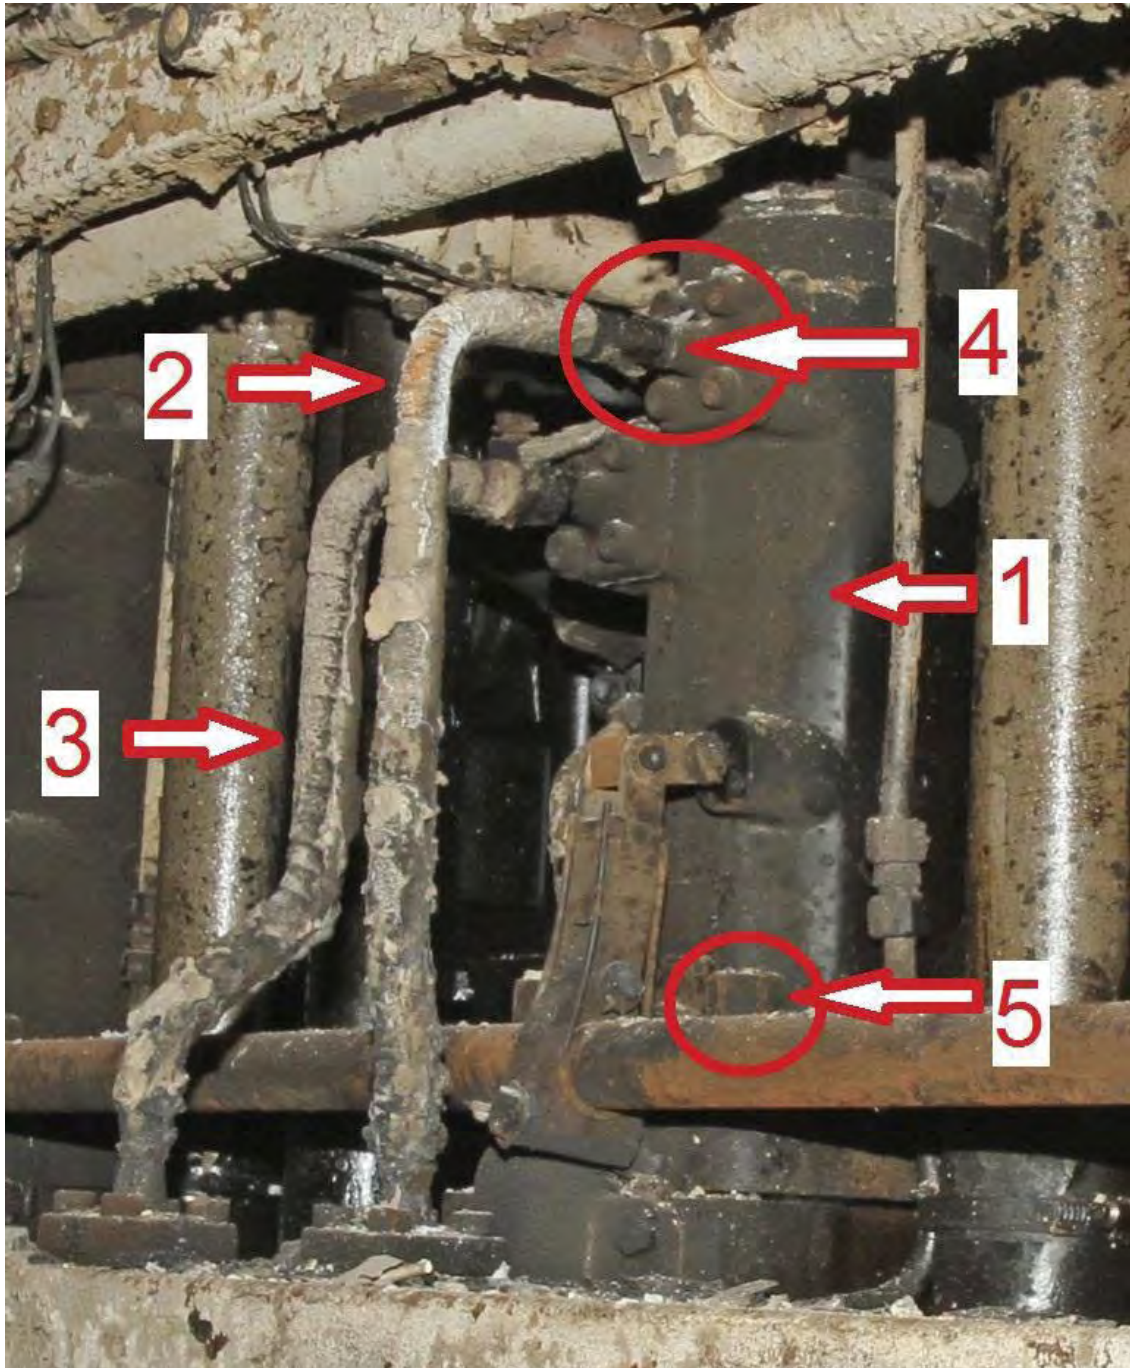
When the pipes were removed, another breakage was discovered in the supply pipe, in addition to one in the pipe feeding lube oil to the pump. There was some doubt as to whether the feed pipe was already broken or whether it broke during removal, as a breakage may have been concealed by the insulation material.

Figure 15: The fuel injector pump for cylinder no 5. The numbers denote: 1) The pump, 2) Return pipe, 3) Feed pipe, 4) Breakage, 5) Fastening bolts. Photo: The police.

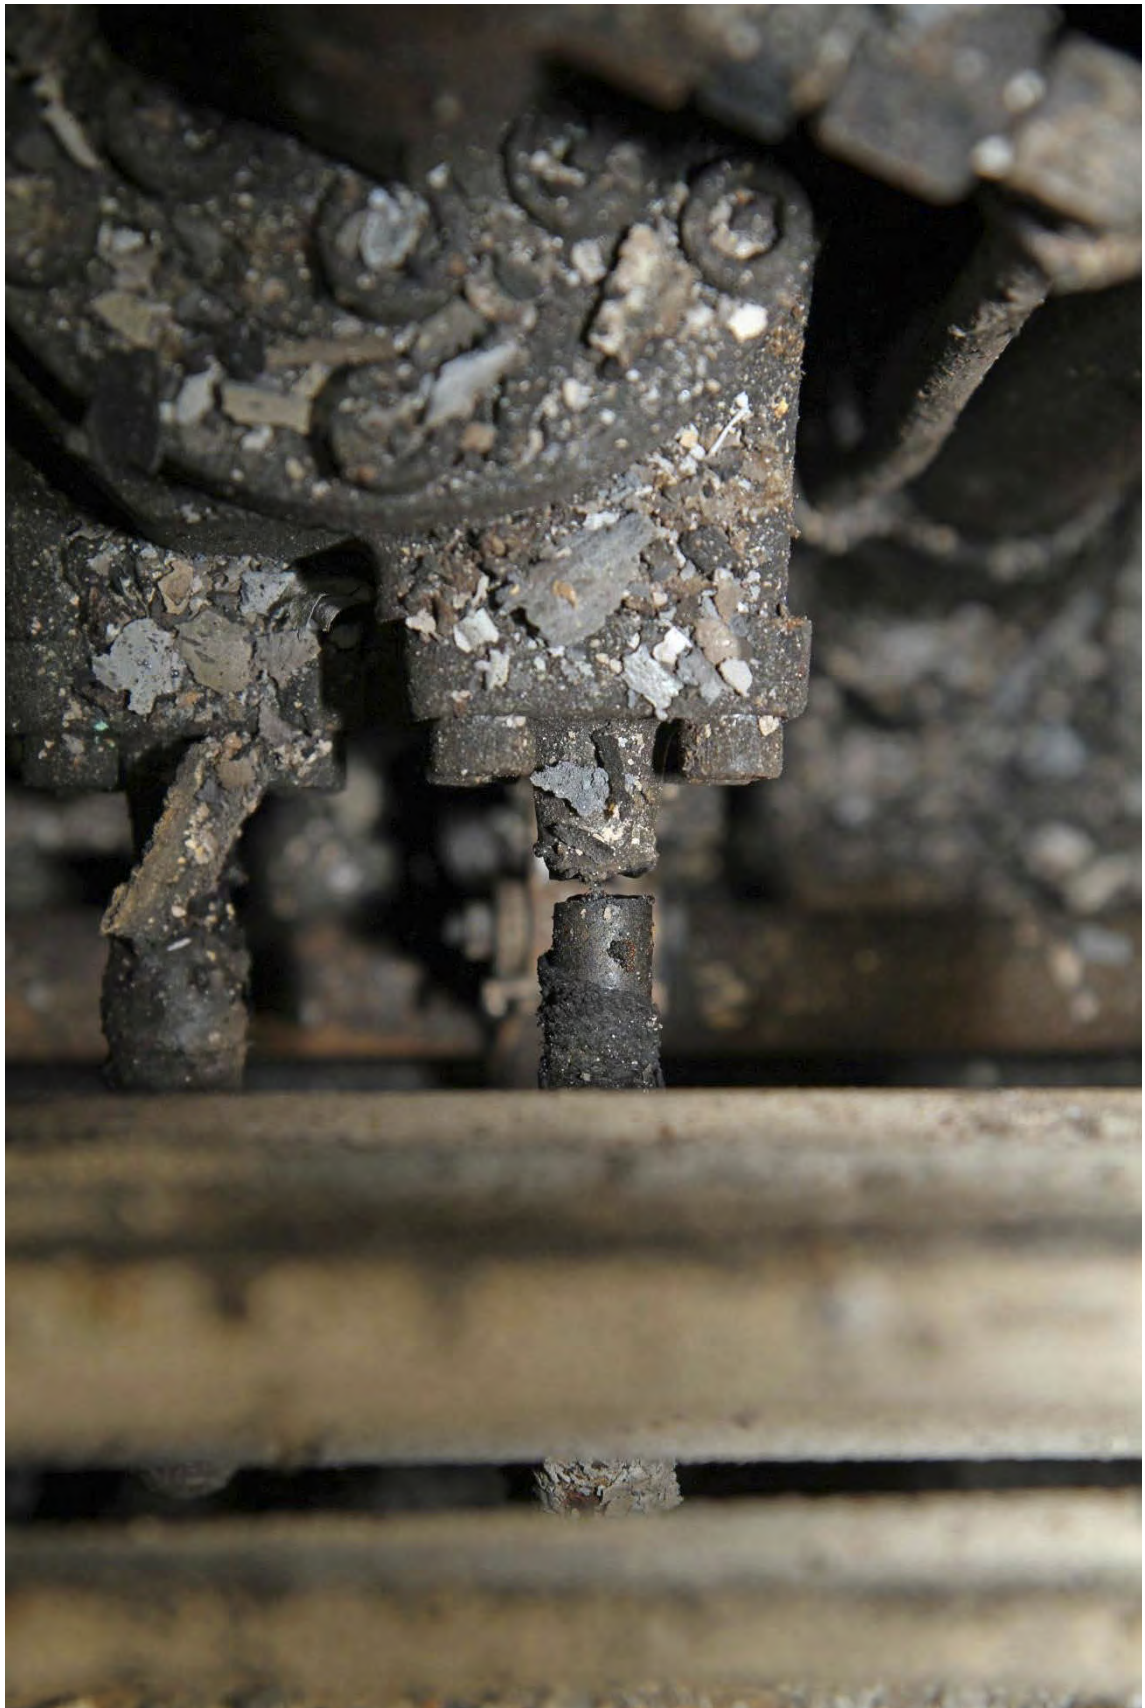
*Figure 16: The breakage in the fuel return pipe (see ref. 4) in Figure 15) where it was attached to pump no 5, viewed from above. Photo: The police.*

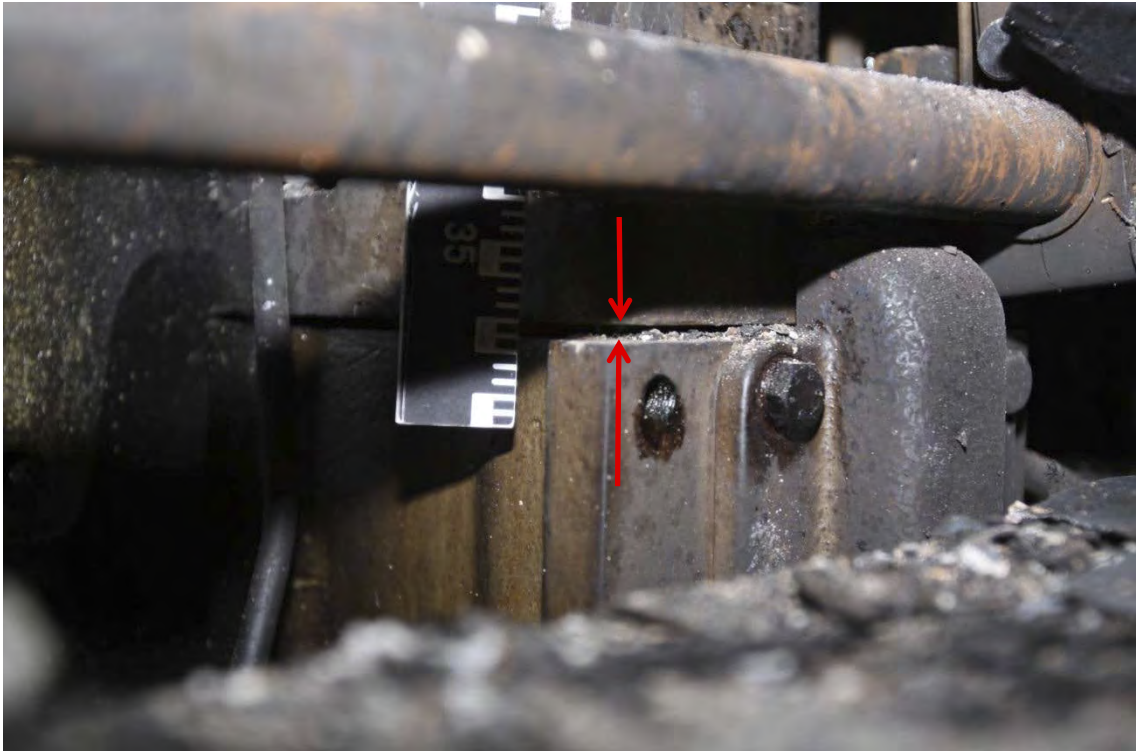
In connection with further on board examination of fuel injector pump no 5, it was observed that the bolts holding the pump were so loose that they could be unscrewed by hand. Because the bolts were loose, the pump was able to move approximately 2–3 mm up from the base on which it rested, i.e. the whole pump may have been pressed upwards every time the camshaft revolved, a movement that would impose cyclical stresses on the low-pressure pipes. At nominal revolutions, the camshaft rotates at approximately 250 revolutions per minute. On average, the main engines are in operation for approximately 20 hours in every 24 hours, which means that the system will have been exposed to approximately 3.6 million such movements from 3 September 2011, when the pump was last replaced, until the fire occurred.

Figure 17: The gap between fuel injector pump no 5 and the base. Photo: The police.

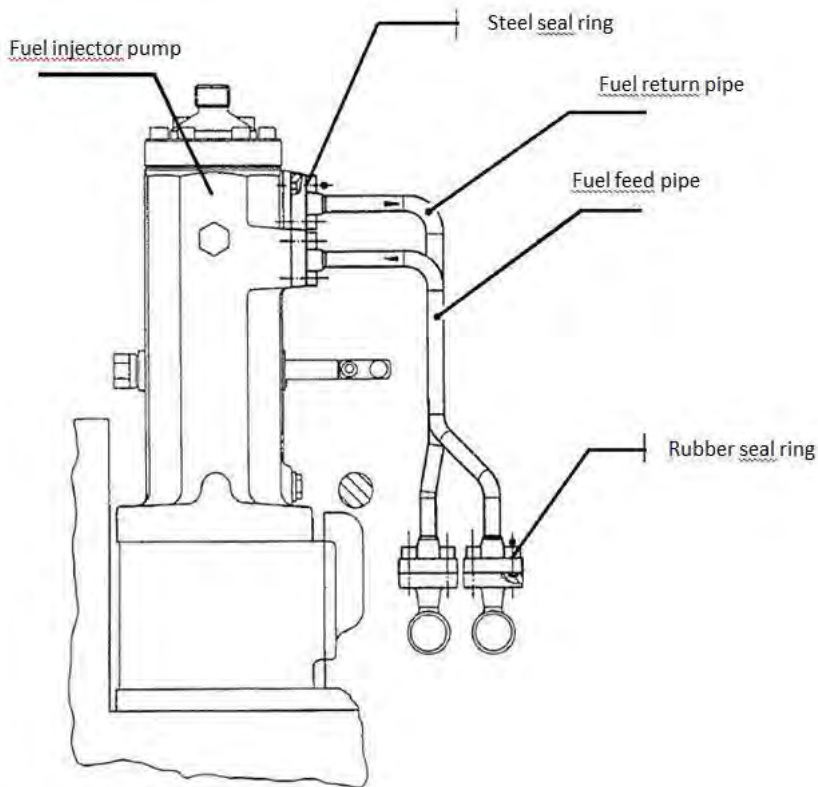
After the fire, when the AIBN removed the pump, it found that the seals between the fuel pipes and engine, on the one hand, and between the fuel pipes and the fuel injector pump, on the other, had been switched around.

Figure 18: Schematic drawing of a fuel oil injector pump. According to the engine manufacturer's specifications, steel seal rings shall be used on the upper flanges while rubber seal rings shall be used on the lower flanges.

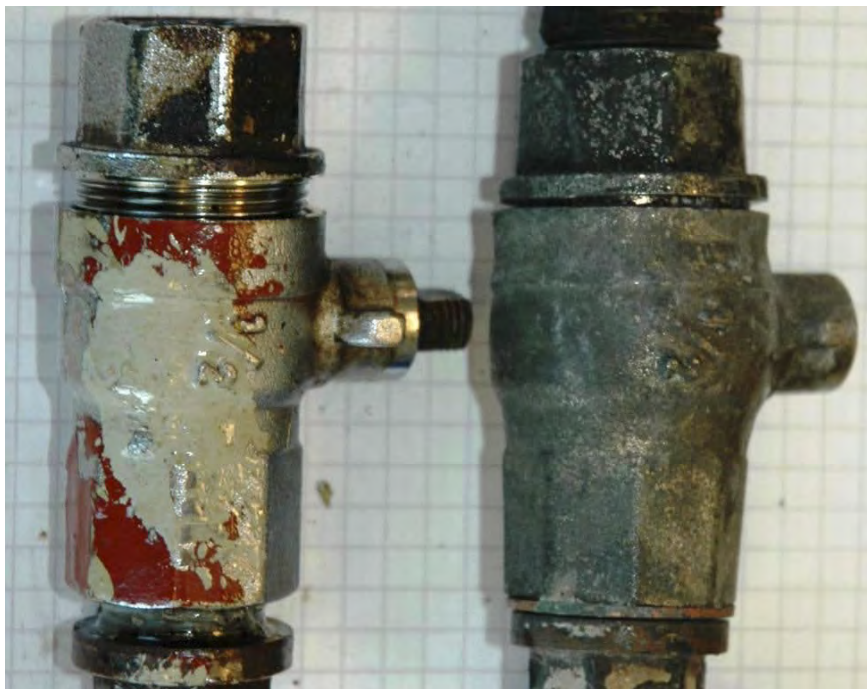
The AIBN has examined the thread alignment of the two valves in more detail. Disconnection of the port valve required several full turns, while one turn was sufficient to disconnect the starboard valve.

Figure 22: Ball valve from drainage pipe. The reference valve on the left was installed on Nordlys' port main engine, while the valve on the right was installed on Nordlys' starboard main engine. Photo: The Norwegian Armed Forces' laboratory service.

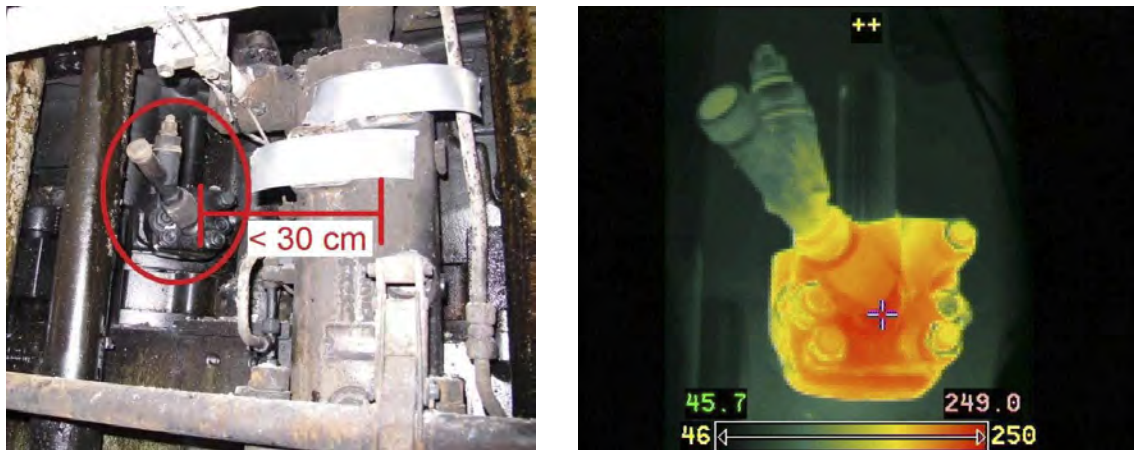
SINTEF NBL carried out measurements on board *Richard With* on 17 October 2011 and found the insulation to be in a similar condition to that observed by the AIBN on board *Nordlys*. Temperatures of up to 274 °C were measured on the indicator valves. Other un-insulated hot surfaces were also found, including on the exhaust manifold and flange for the turbocharger. Measurements on the exhaust manifold showed temperatures as high as 360 °C.

Figure 23: The photo to the left shows the indicator valve between cylinder no 4 and cylinder no 5 on the starboard main engine, and the distance to fuel injector pump no 5 (with the pipes removed). The indicator valve was found to have no insulation. The thermographic image on the right is of the same valve on board *Richard With*. Left photo: AIBN. Right photo: SINTEF NBL.

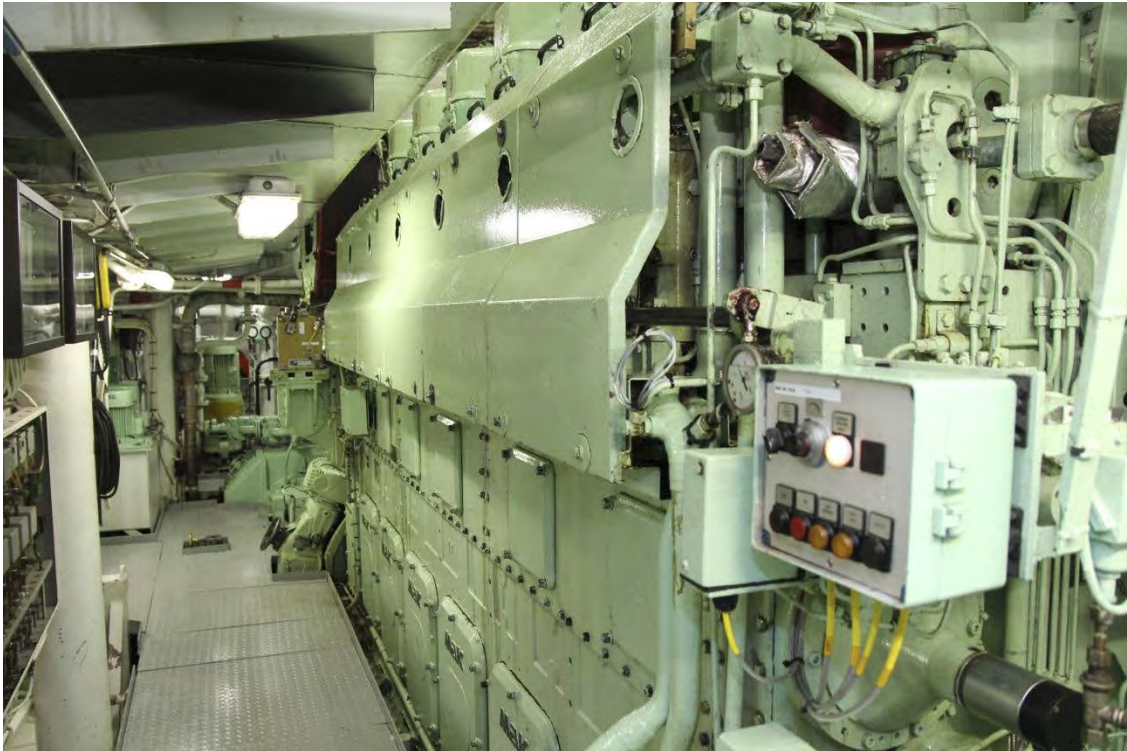
*Figure 24: The main engines are delivered by the engine manufacturer with cover plates covering the upper part of the starboard side of the engine. These plates had been removed on board Nordlys. The photo shows the cover plates on the starboard side of the starboard engine on board the sister ship Kong Harald. Photo: SINTEF NBL.*

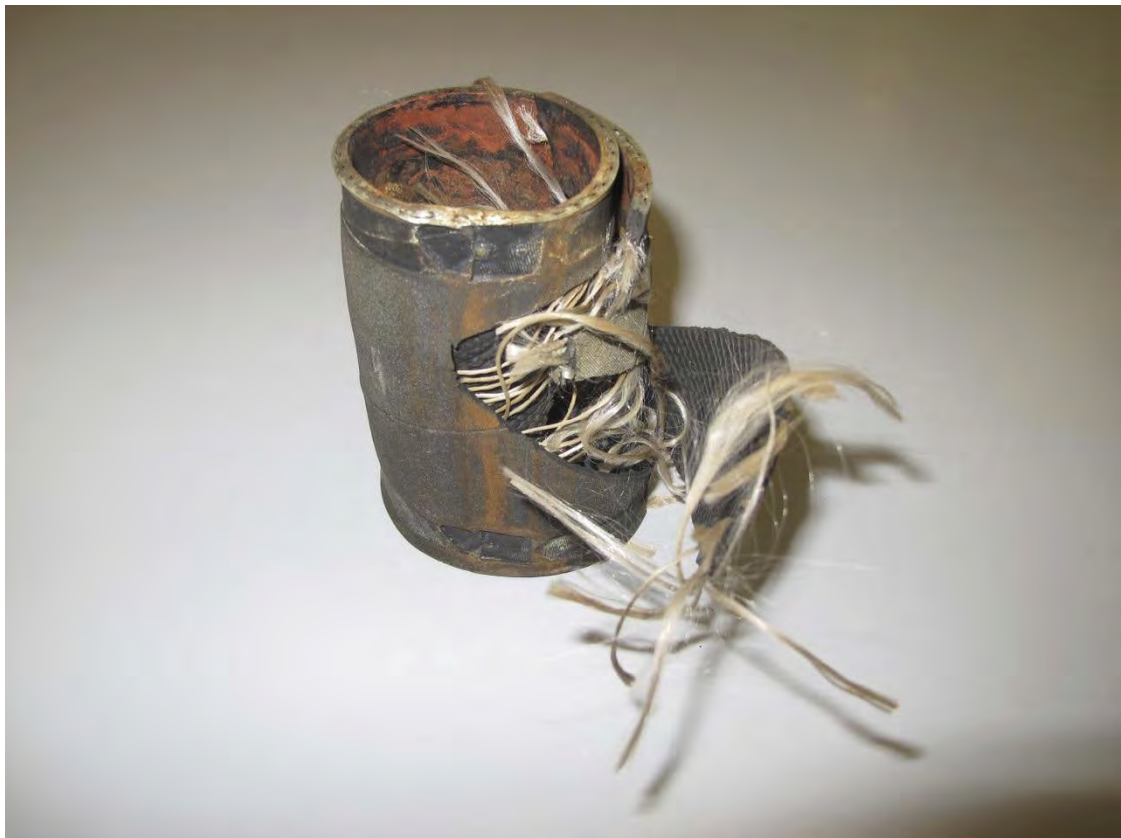
Figure 25: The photo shows the ruptured cooling water hose. Photo: AIBN.

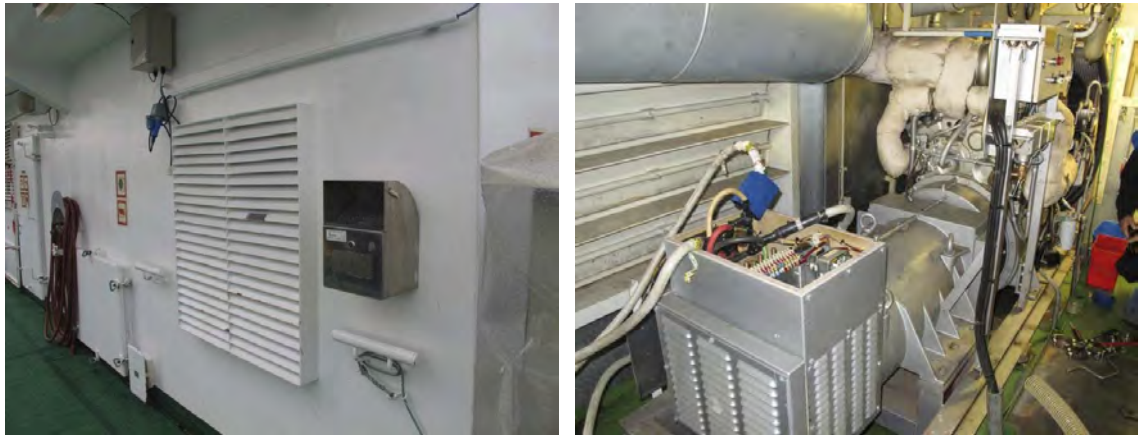
Figure 26: The photo on the left shows the aft damper in the generator room, viewed from the outside. The photo on the right shows the starboard damper viewed from inside the emergency generator room. Photo: AIBN.

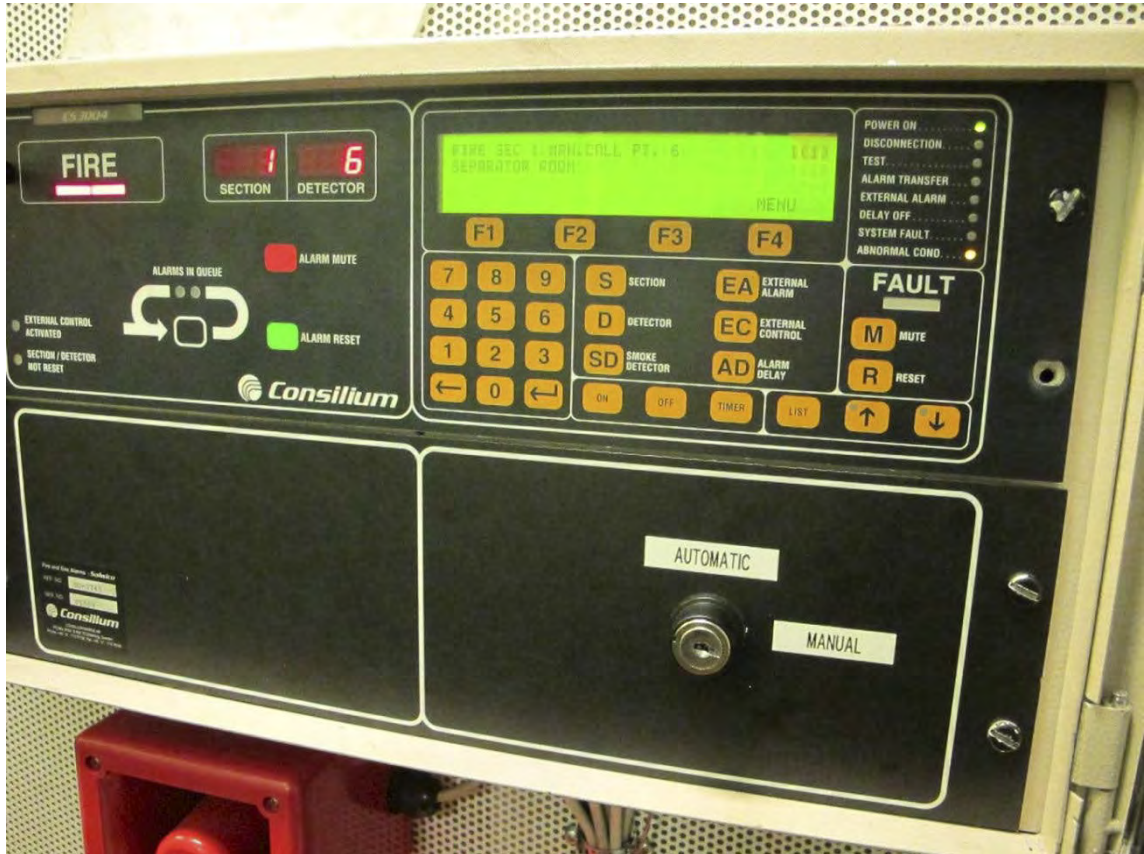
Figure 29: The photo shows the panel for the local application fire-extinguishing system. When the AIBN conducted its on board investigations, it was observed that the panel, which is located in the engine control room, was set to manual mode. There was no key in the switch for switching between manual and automatic extinguishing. Photo: AIBN.

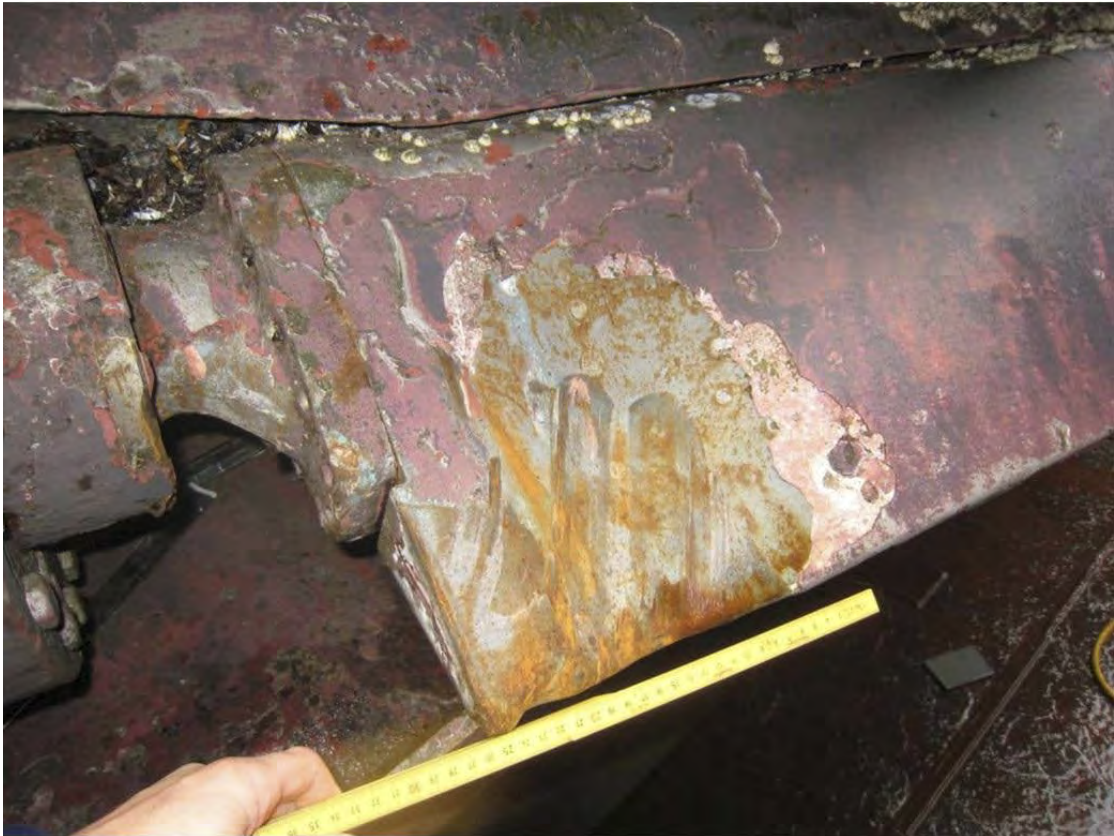
Figure 38: The photo shows the marks/damage sustained on the starboard stabiliser fin, at the end closest to the hull, after it penetrated the skin. Photo: DNV.

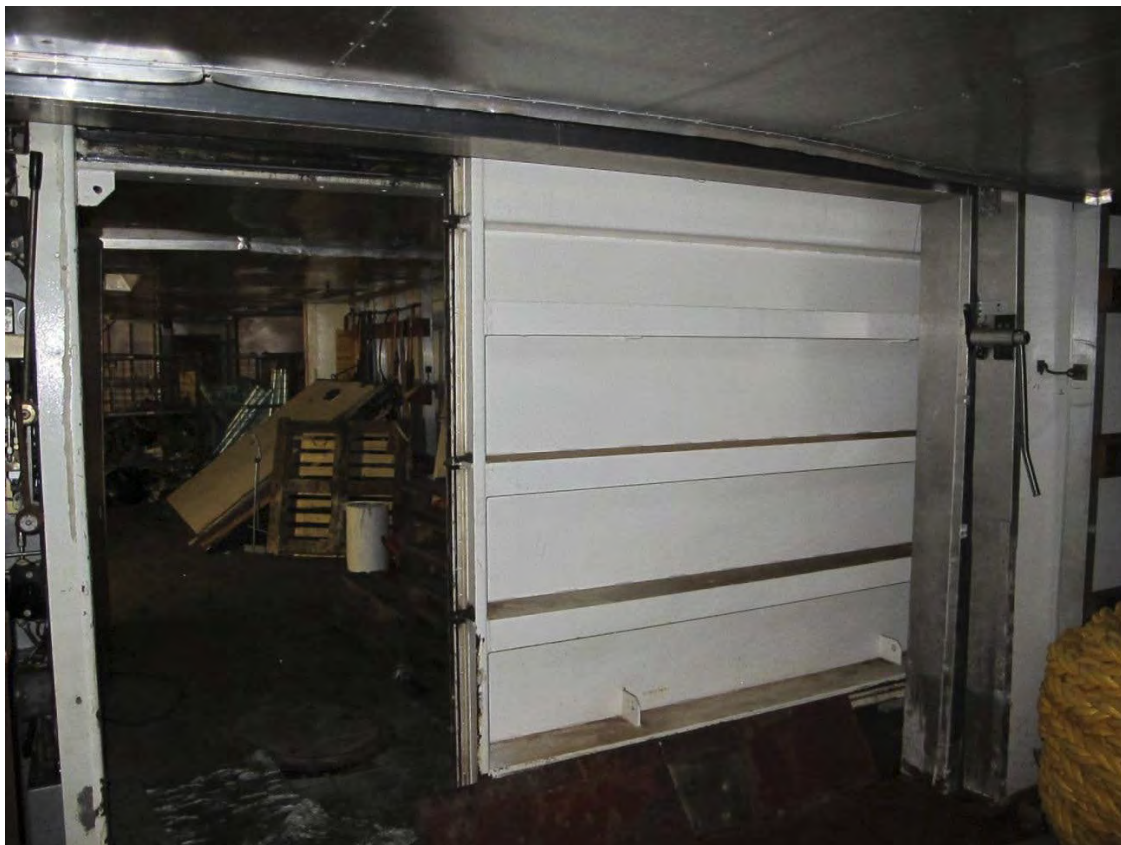
Figure 39: The photo shows the watertight sliding door between cargo hold no 1 and cargo hold no 2. The investigation found wear on seals on the underside of the door. Photo: AIBN.

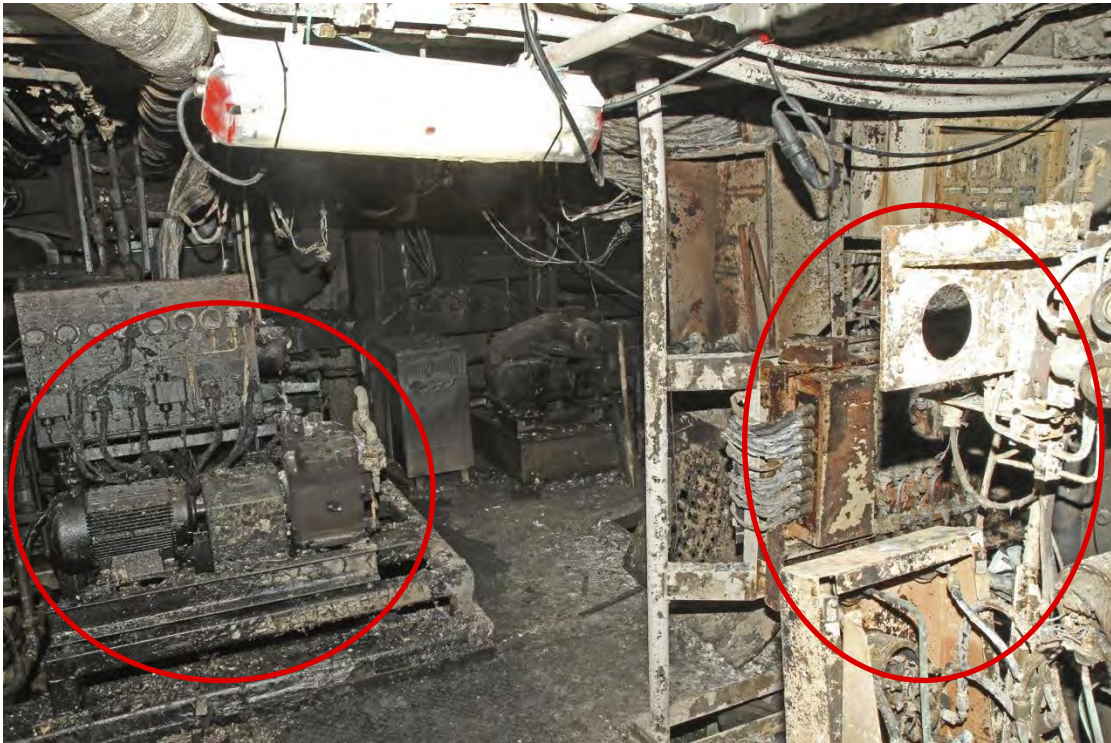
Figure 44: The photo shows the cooling compressor on the left. The cooling compressor was contaminated by diesel oil that had not been burnt away in connection with the fire. Components fitted to the starboard main engine can be seen on the right. The combustible material had been burnt away. Photo: The police.

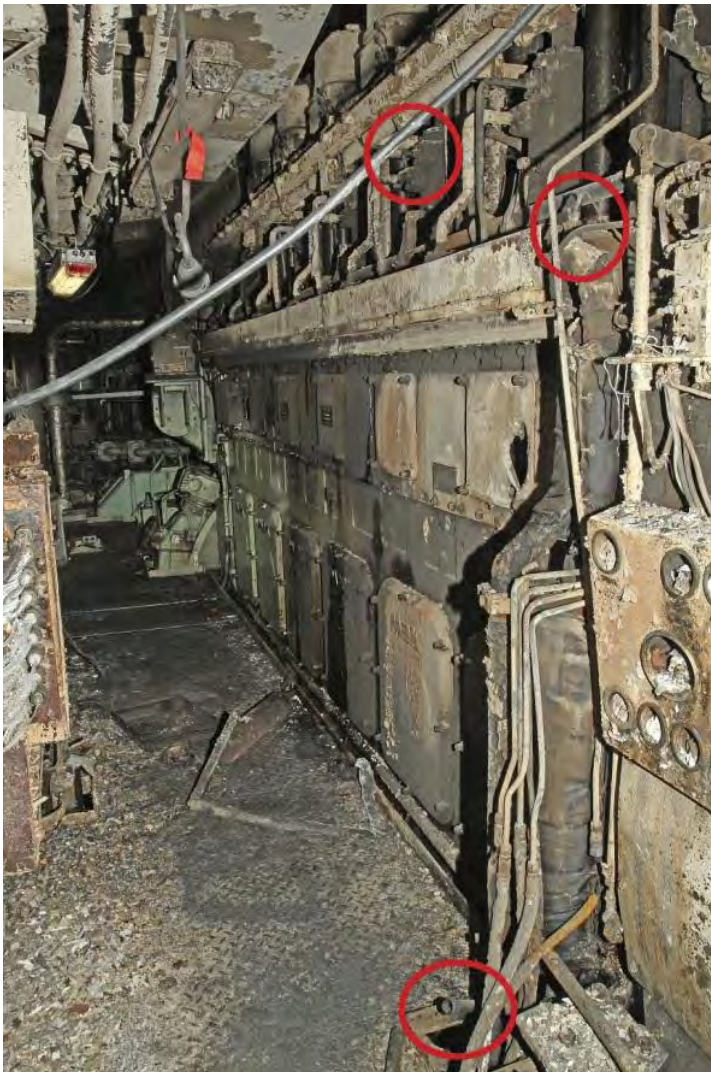
*Figure 45: Position of the temperature sensor, ringed in at the top right of the photo, on top of the fuel rack. In other words, the sensor was placed in the immediate vicinity of both leakage points, ringed in at the top and bottom of the photo, respectively. Photo: The police.*

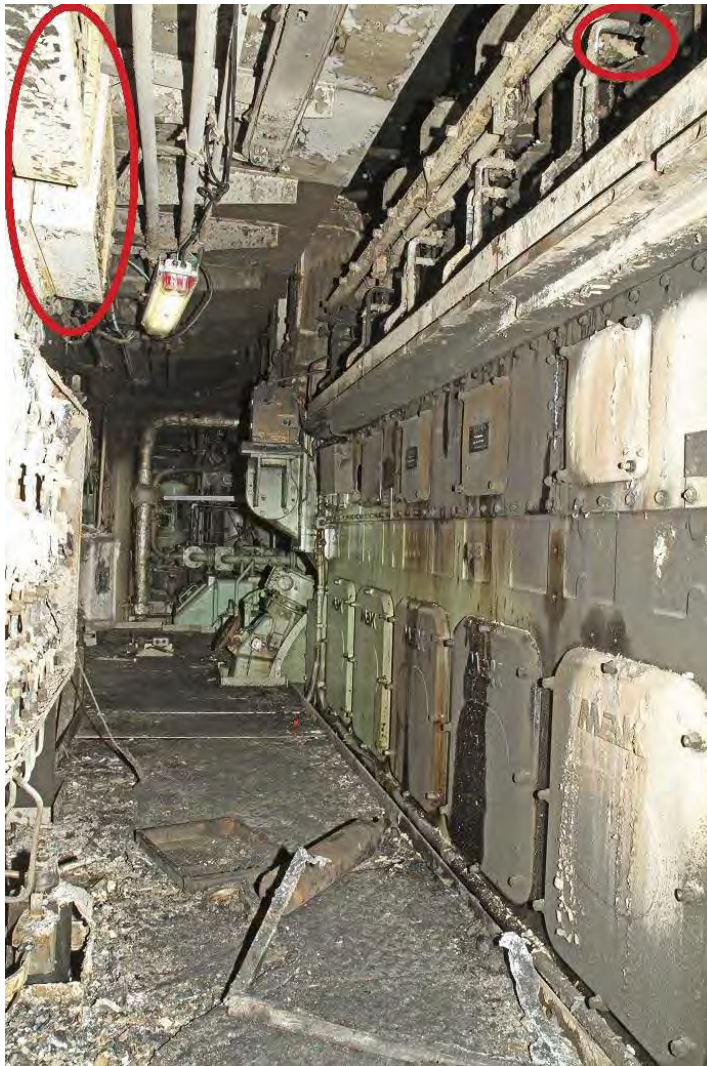
Figure 46: The SAU8 and SAU12 control cabinets, ringed at the top left of the photo, were at a horizontal distance of about one metre from the leakage at fuel injector pump no 5, ringed in at the top right of the photo. Photo: The police.

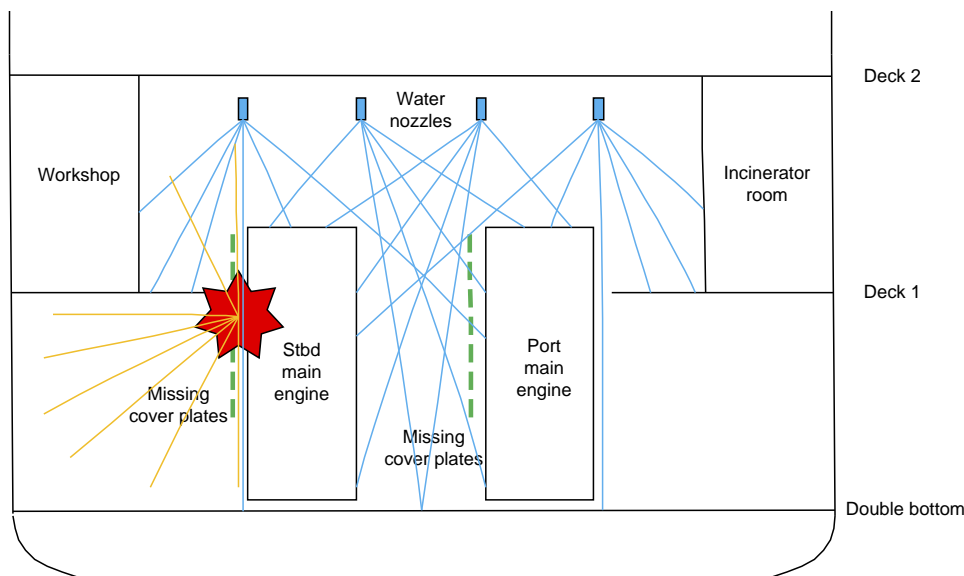
Figure 47: Schematic drawing showing the spread of diesel and the location of water nozzles looking aft in the engine room. The spread of diesel would most likely have been reduced had the cover plates on the starboard side of the main engines not been removed.

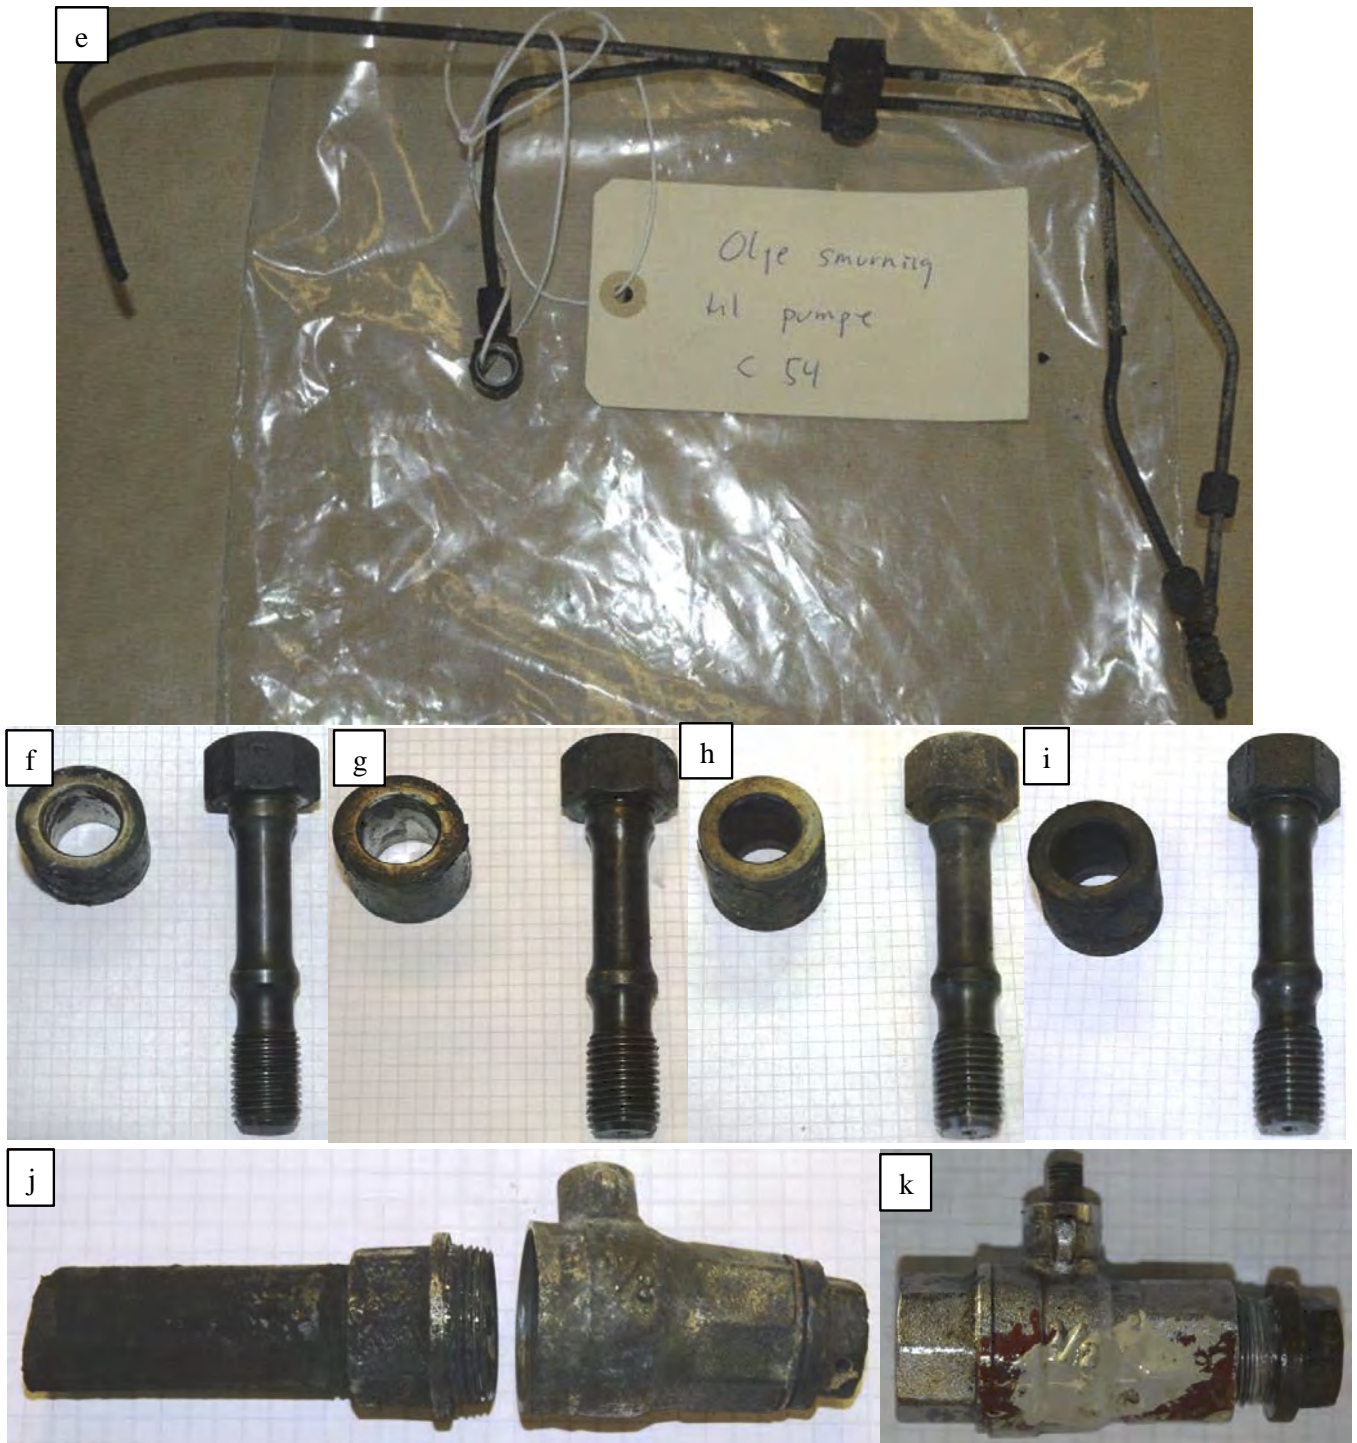
Figur 1 Bilder av deler mottatt for undersøkelse. a: Flens til drivstoffrør (retur) sylinder 5 med brudd merket C12. b: Flens til drivstoffrør (tur) sylinder 5 med brudd merket C15. c: Drivstoffrør med flens til drivstoffpumpe til sylinder 5, C12-returrør og C15-turrør. d: Drivstoffrør med flens til drivstoffpumpe til sylinder 1 mottatt som referanse, C35 og C38. e: Rør for smøring til drivstoffpumpe til sylinder 5 med brudd merket C54. f-i: Bolter med foring for feste av drivstoffpumpe til sylinder 5 merket hhv. C57, C58, C59 og C60. j: Oversiktsbilde av separat dreneringsventil merket (C39 og C1). k: Referanseventil merket C40.
