# REPORT

## Sjø 2013/02

## REPORT ON THE INVESTIGATION OF A MARINE ACCIDENT NORDLYS LHCW - FIRE ON BOARD DURING APPROACH TO ÅLESUND 15 SEPTEMBER 2011

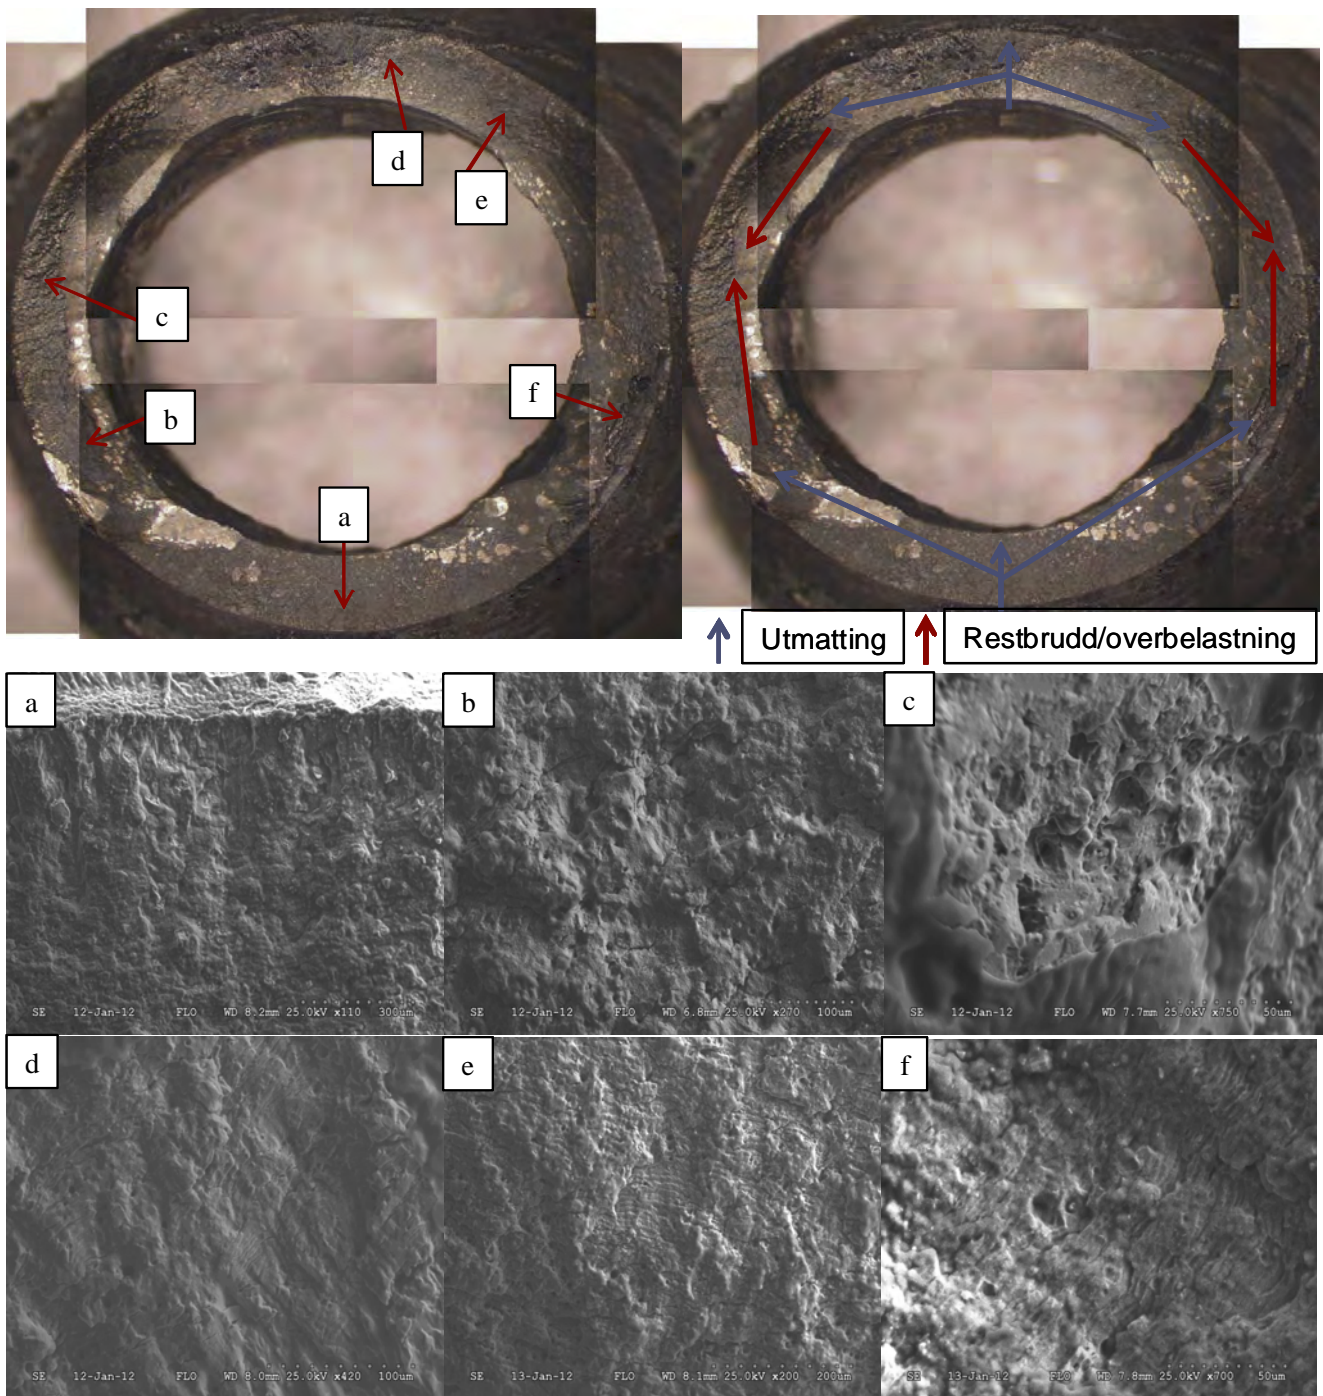
Figur 2 Oversiktsbilde av bruddflate til drivstoffrør C12 (se Figur 1a). Fraktografibilder: a: Mulig initieringsområde med plan bruddflate og lite topografi, antydning til sprekkstopplinj, sannsynlig utmatting. b: Mikrosprekker i overflaten med antydning til sprekkstopplinj, innslag av dimpler tyder på utmatting med relativt store tøyninger. c: I et område med fjernet kontaminering kan det observeres dimpler forenlig med duktil overbelastning. d: Bruddflaten er plan med antydning til sprekkstopplinj forenlig med utmatting. e: Bruddflaten har mikrosprekker med antydning til striert overflate forenlig med utmatting, innslag av dimpler tyder på relativt store tøyninger. f: Bruddflaten har mikrosprekker med tydelig striert overflate forenlig med utmatting, innslag av dimpler tyder på relativt store tøyninger.

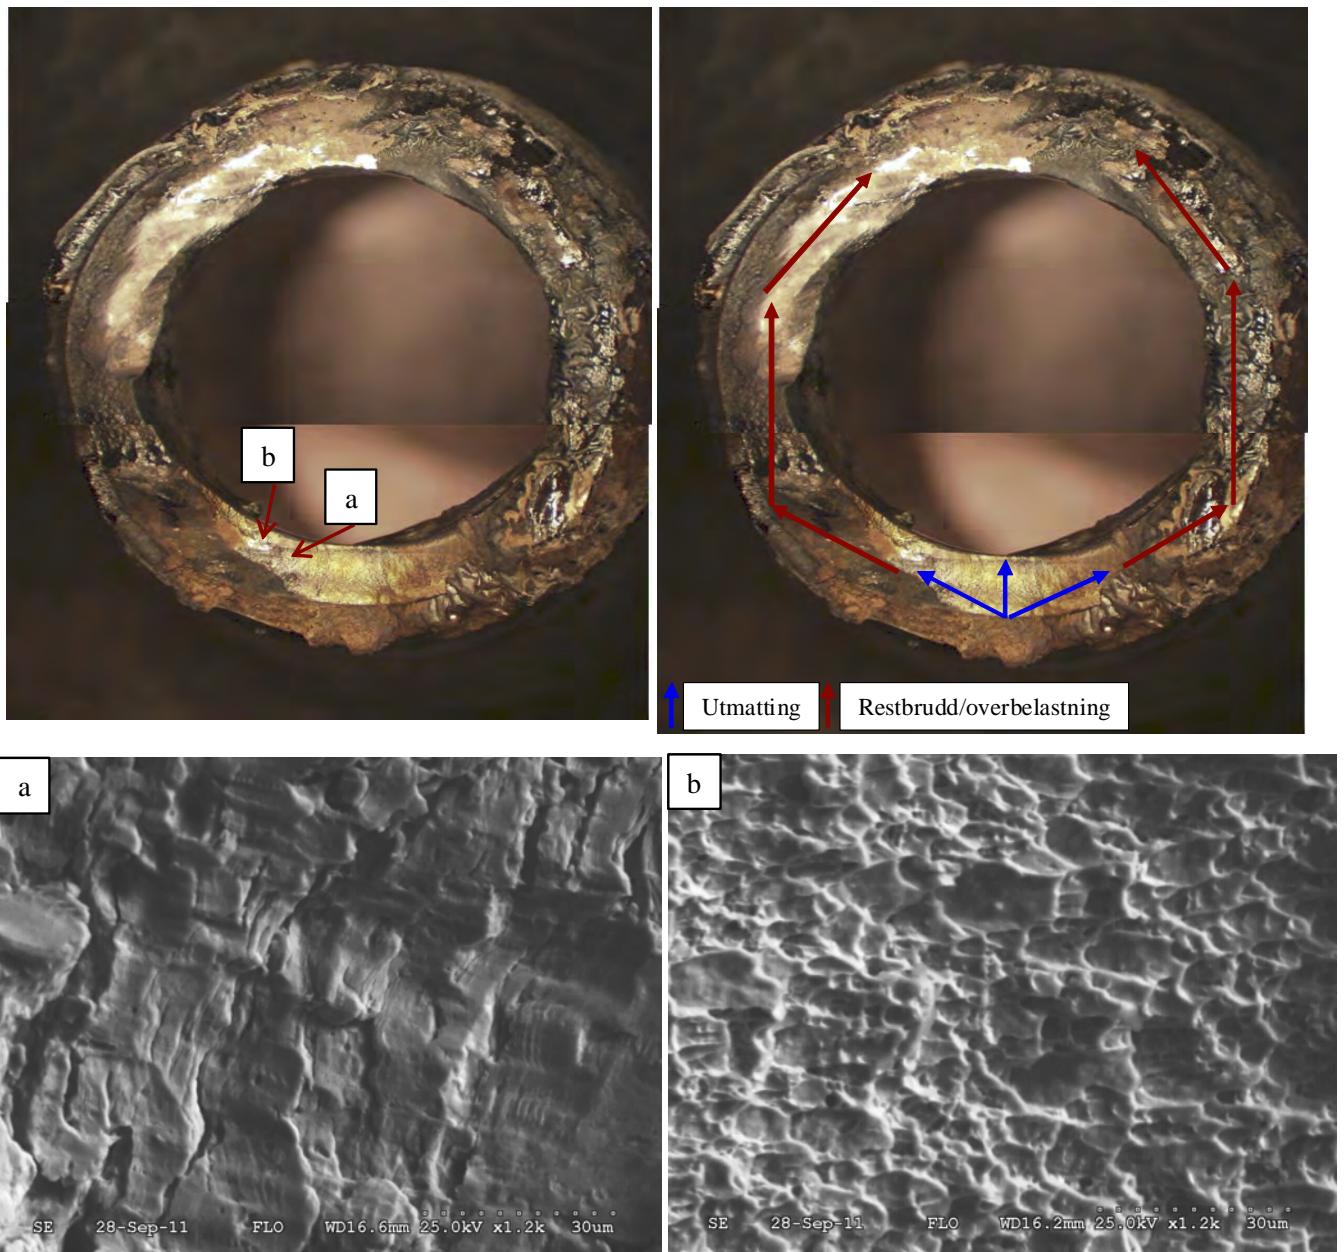
Figur 3 Oversiktsbilde av bruddflate til drivstoffrør C15 (se Figur 1b). Fraktografibilder: a: Mikrosprekker i overflaten med antydning til sprekkestopppliner forenlig med utmatting. c: Tydelig overgang i bruddflaten til dimpler forenlig med duktil overbelastning.

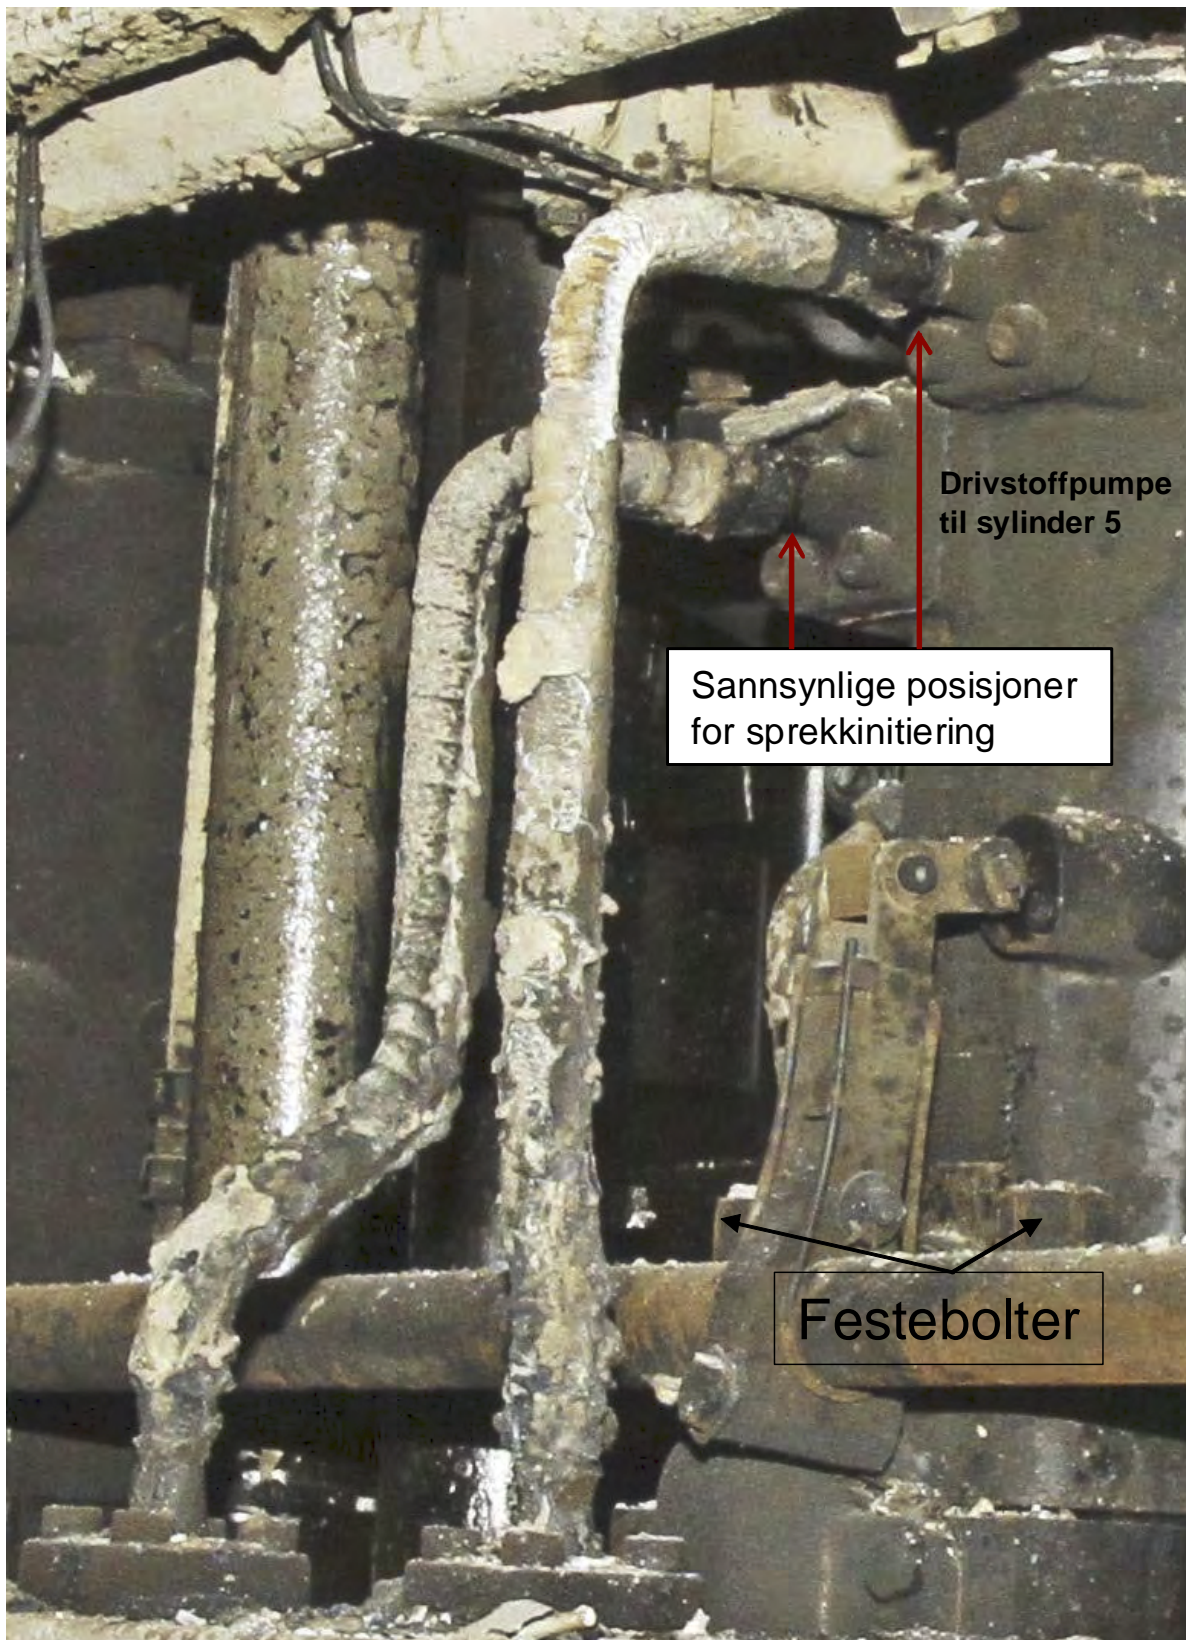
Basert på fraktografiundersøkelsene er sannsynlige sprekkinitieringspunkter angitt i Figur 4.

Figur 4 Bilde av drivstoffrør fotografert i motorrom etter brann. Bildet er mottatt fra Politiet via SHT. Bildet angir sannsynlige sprekkinitieringspunkt basert på fraktografiundersøkelsene.

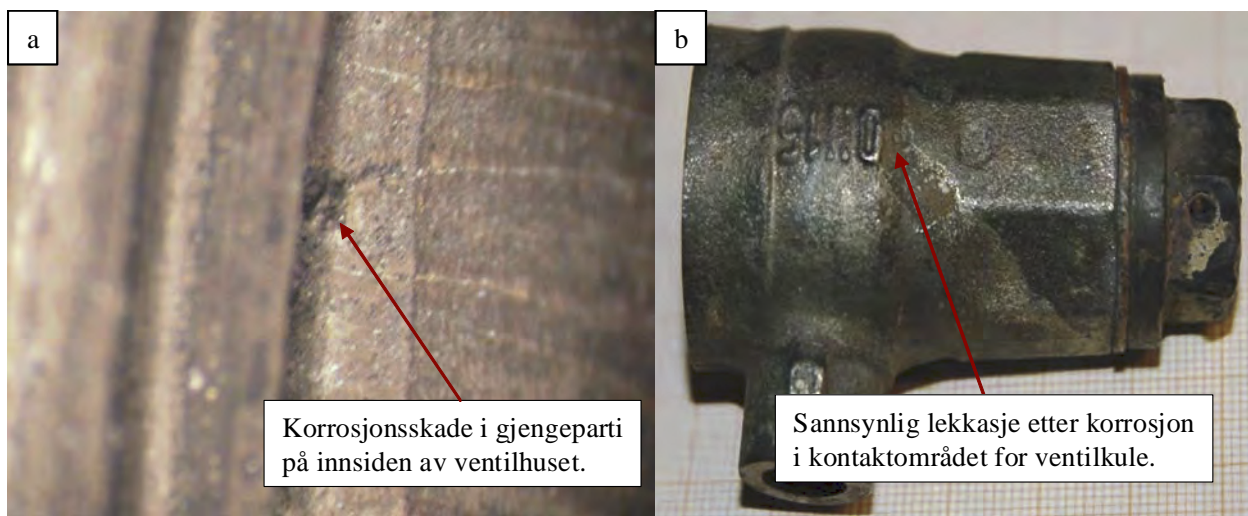
Figur 8ab: Bilder av korrosjonsangrep på ventilhus.

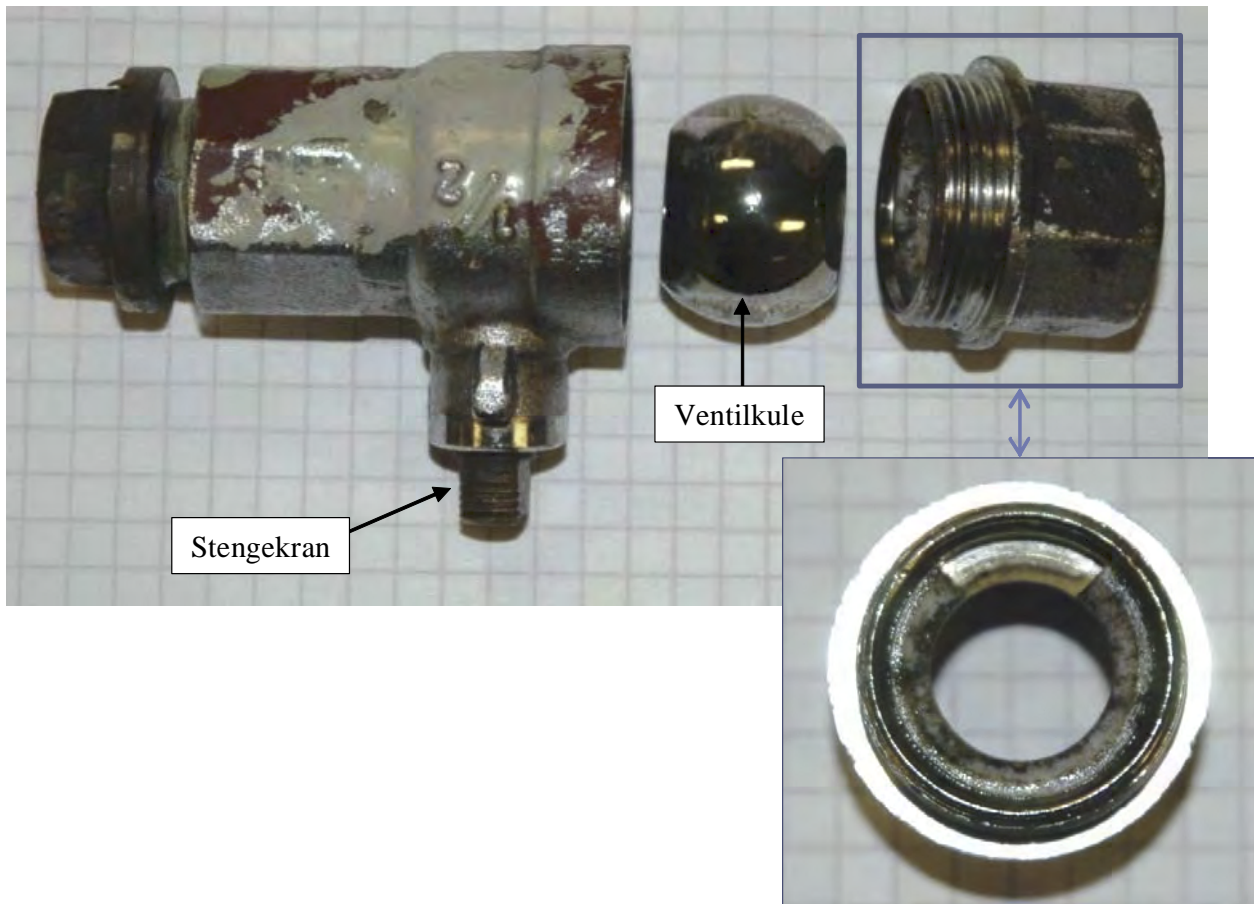
Figur 10 Bilde av demontert referanseventil med bilde av skadet pakning i endeplugg.

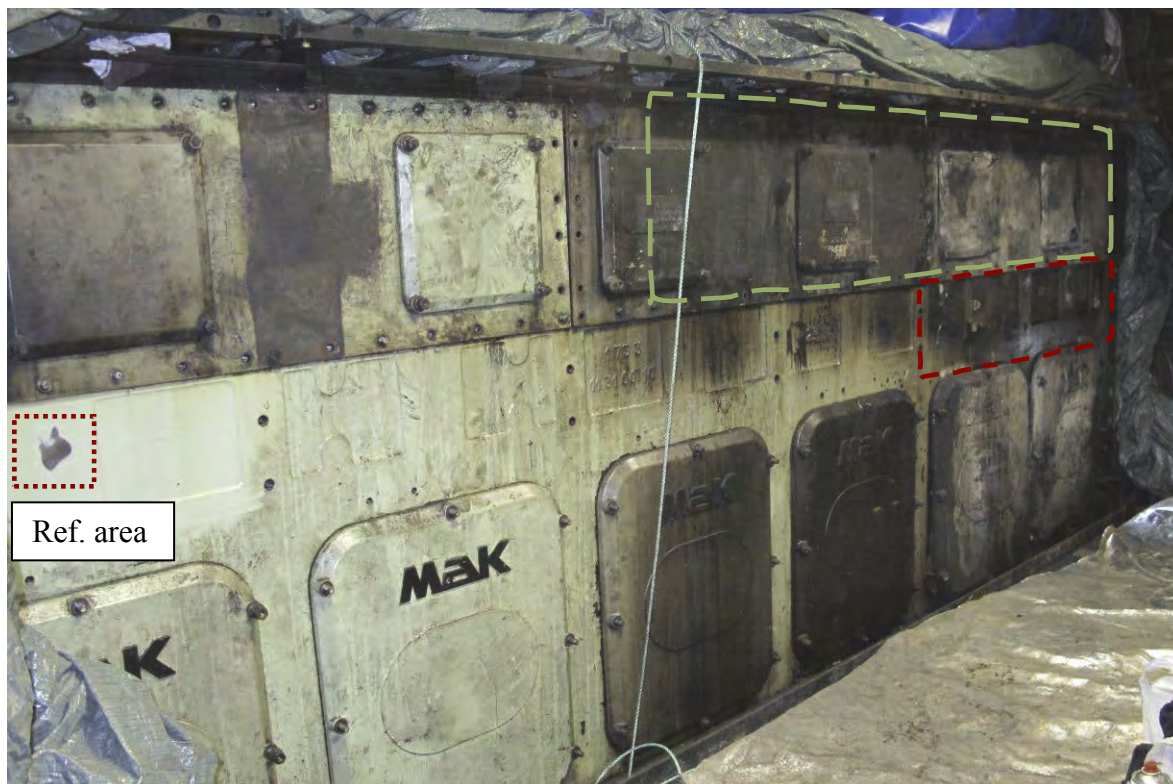
Fig. 1 Overview photo shows the heat affected areas (framed) on the stb. main engine on board the vessel M/S NORDLYS as observed by arrival. The green framed area is the hatch covers for the cam shaft consist of steel plates and hatch ways of aluminum alloy. The red frame indicates the part of the engine block which has suffered heat affection, see Fig. 2.

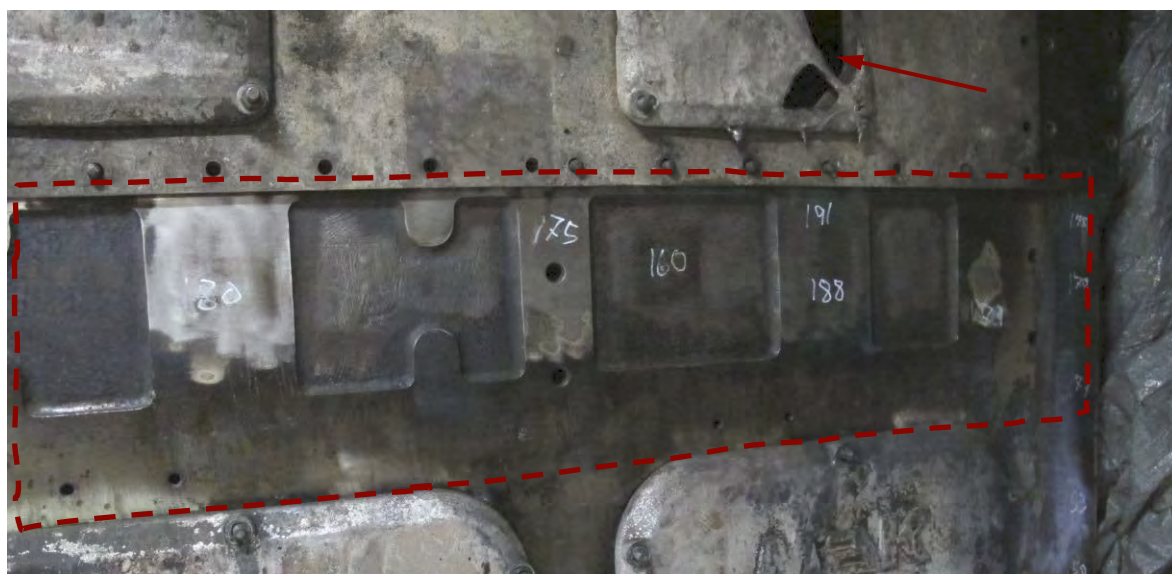
Fig. 2 Close-up of Fig. 1 shows the heat affected area on the engine block. A part of the hatch cover for the cam shaft is visible including the hatch ways of aluminum. A melted area of the hatch way was observed, see arrow. Prior hardness measurements values are indicated by digit.

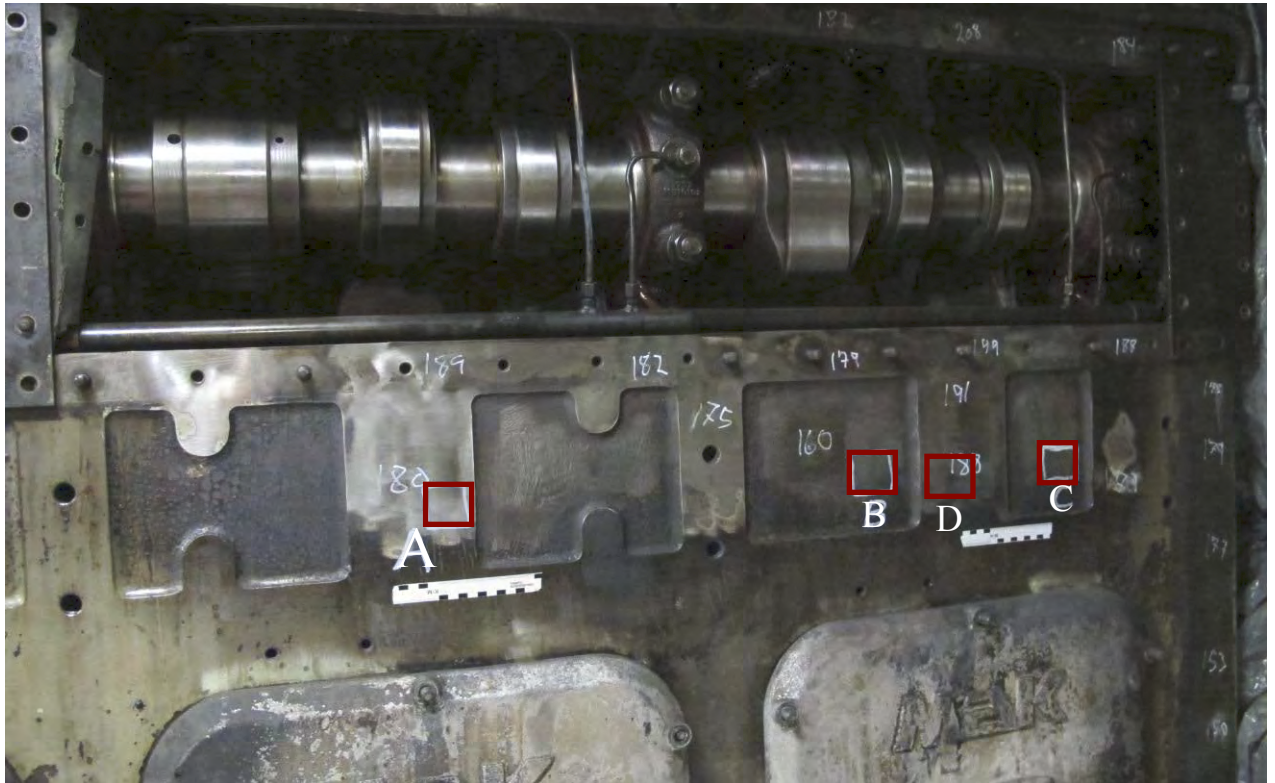
Fig. 3 The same area as shown in Fig. 2, however, the hatch cover is removed. No discoloring was observed at the surface of the cam shaft. The areas labelled A, B, C and D selected for metallographic examination and hardness measurements are indicated by red frames.

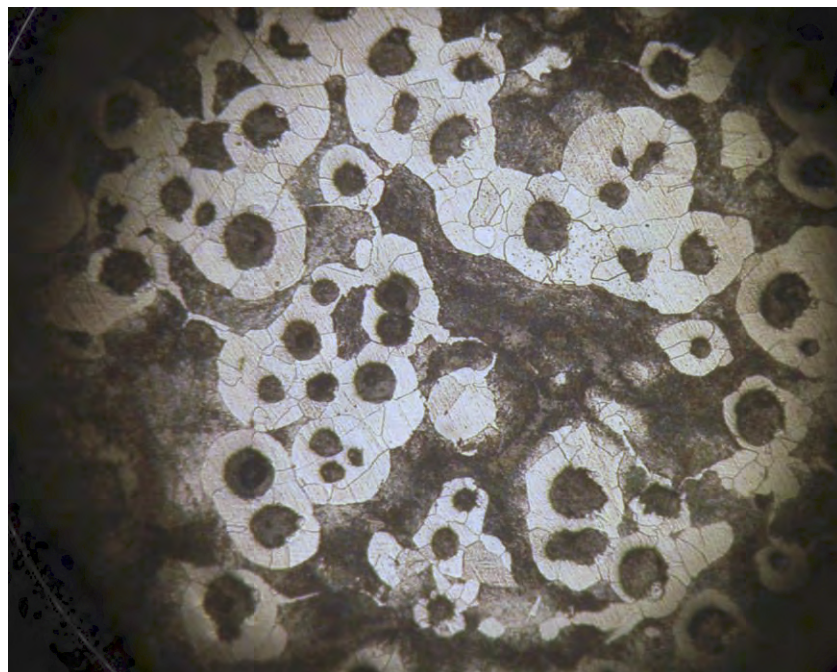
Fig. 8 Area A. The prepared area shows a microstructure characteristic for nodular cast iron as expected. The microstructure consists of ferrite and pearlite with spheroidal graphite. Modification of the microstructure due to heat affection was not observed. Magnification 100 X.

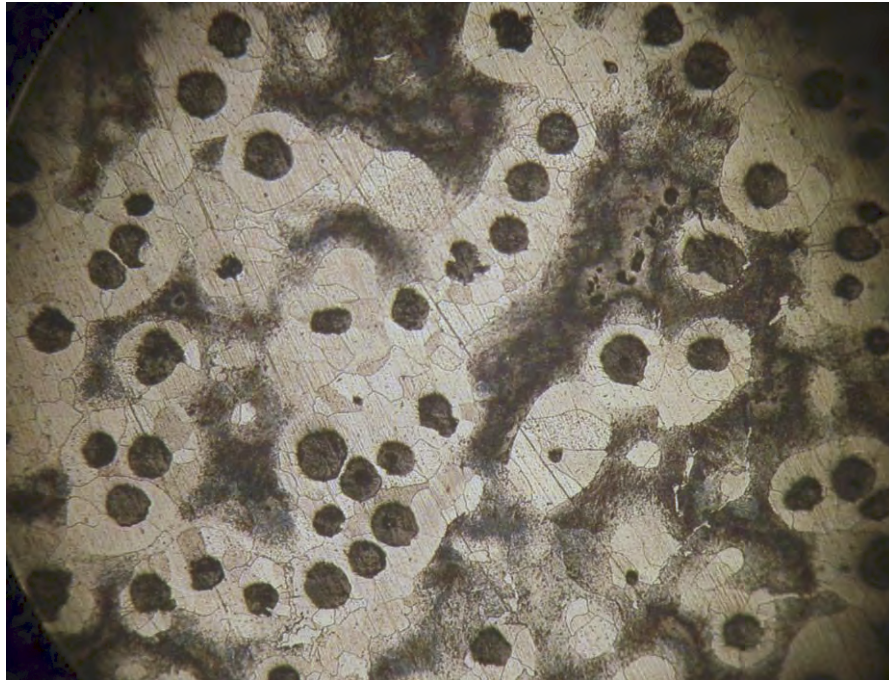
Fig. 9 Area B, representative also for area C. The prepared area shows a microstructure characteristic for nodular cast iron as expected. The microstructure consists of ferrite and pearlite with spheroidal graphite. Compare to the reference area it is observed somewhat more ferrite. Modification of the microstructure due to heat affection was not observed. Magnification 100 X.

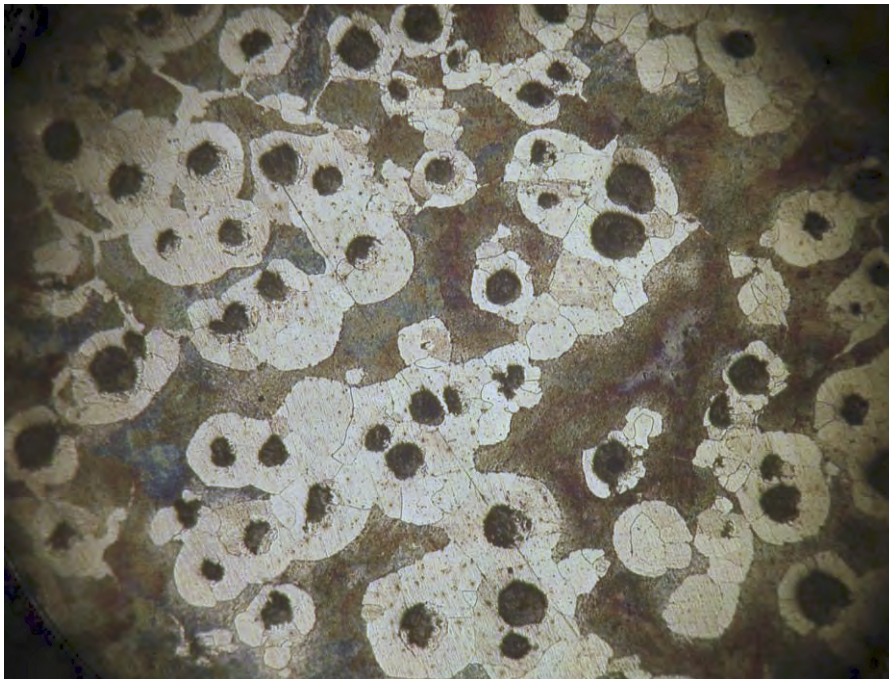
Fig. 10 Area D. The prepared area shows a microstructure characteristic for nodular cast iron as expected. The microstructure consists of ferrite and pearlite with spheroidal graphite. Modification of the microstructure due to heat affection was not observed. Magnification 100 X.
