# REPORT

## Sjø 2013/10

## REPORT ON MARINE ACCIDENT ON BOARD BW SUEZ EVERETT 9243148/LAVK5, OCCUPATIONAL ACCIDENT IN THE INDIAN OCEAN 25 APRIL 2012

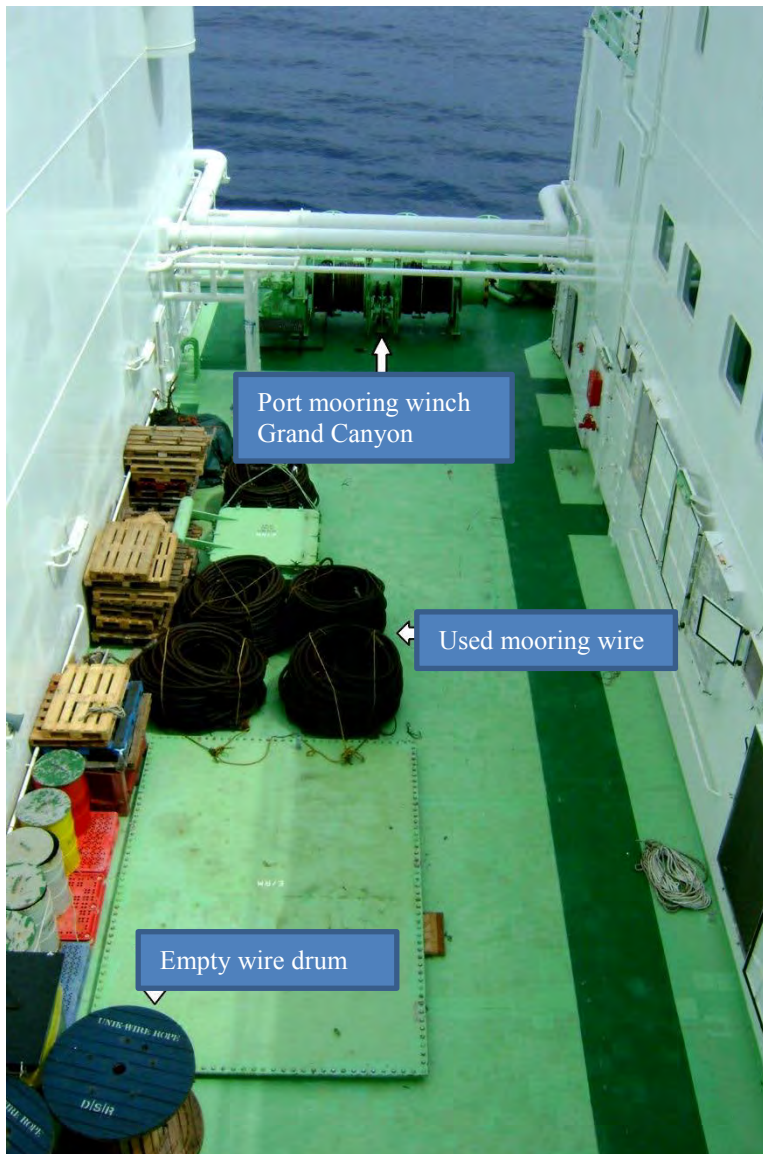
Figure 3: The 'Grand Canyon'. Photo: AIBN.

After leaving Japan, a total of five old wires were reeled off and stored in coils on deck in the 'Grand Canyon' (see Figure 3). This made it possible to carry out monthly maintenance routines and general maintenance of winches and the empty winch drums. Extraordinary maintenance was also being carried out on the ship's ballast tanks, and one extra bosun and two extra able seamen were on board during this period to carry out this work.

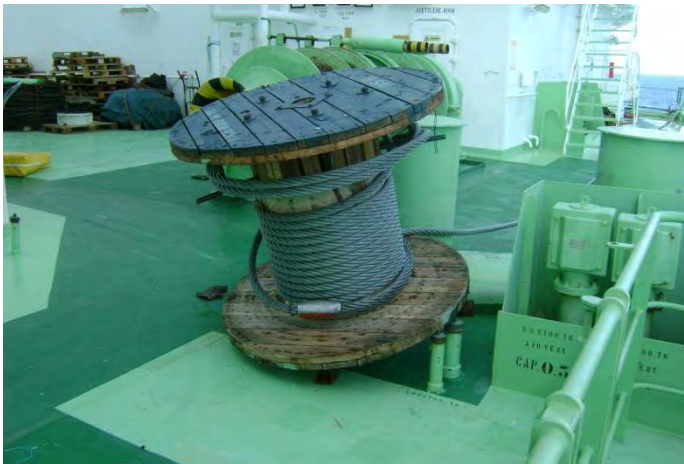
After the accident, there were 15 turns of wire left on the drum from which wire was payed out. The drum had a diameter of approximately 70 cm, which gives a circumference of 2.20 m. This means that there was about 33 m of wire left on the drum after the accident.

*Figure 4: Drum with 15 turns of wire left, stopped against the port bollard in the Grand Canyon.  
Photo: BW Suez Everett*

It is assumed that there were a few more turns of wire on the drum at the time when it left its near-midship position in the Grand Canyon. There was a distance of 17 m from the drum's original position to the bollard where it stopped. Assuming that half this length was reeled off as the drum shifted across the deck, the AIBN has calculated that there was still 18 turns of wire left on the drum when the incident occurred. This means that the total weight of the wire and drum at the time of the incident was around 472 kg.

assumes that the force this represented caused the drum to shift to the port side at great speed and stop when it hit the port bollard.

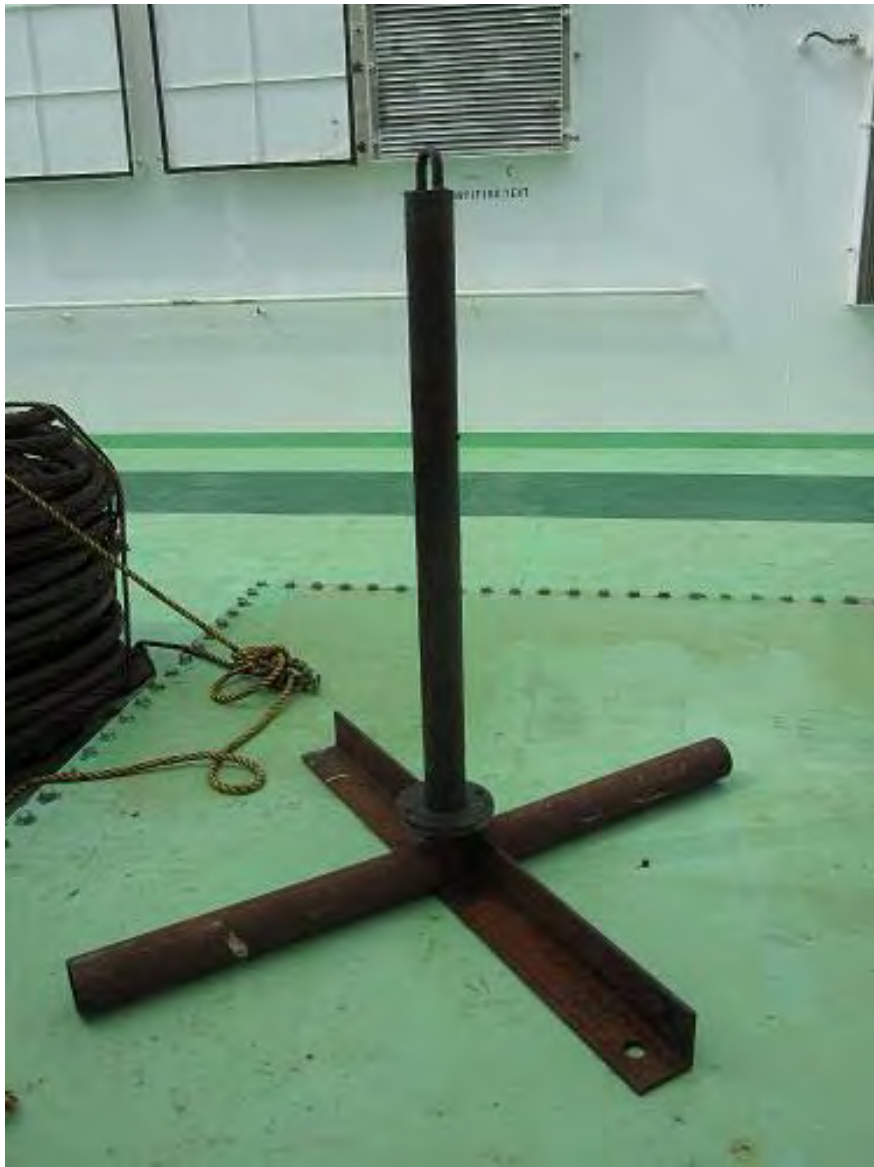
The steel-cross stand had been made on board the ship and had previously been used for similar jobs. However, it proved to be a little too short for the wire drums that were taken on board on this occasion.

The lifting appliance had a lifting lug welded onto the top of a steel pipe, which was in turn welded to the centre of a steel cross. The wire drum was placed around the steel pipe so that it could rotate freely on a disc that had been slipped onto the steel pipe. The steel-cross stand holding the drum was then to be hooked onto the provisions crane, hoisted up and secured using rope (see Figures 5 and 7).

*Figure 5: Steel-cross stand for wire drums. Photo: BW Gas.*

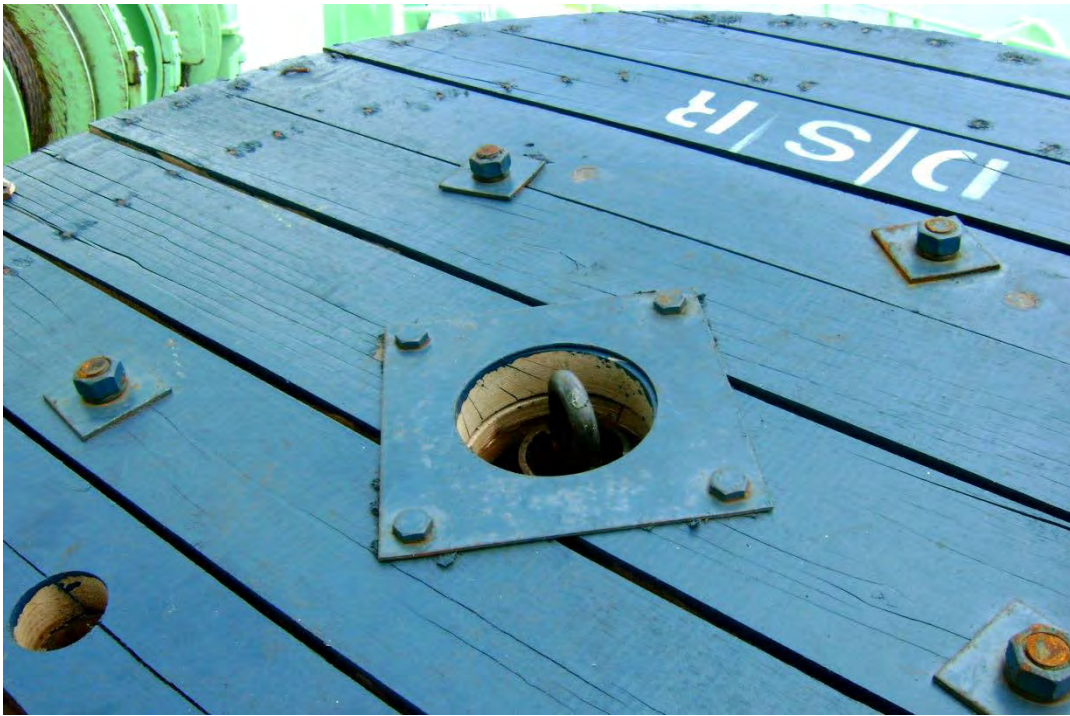
The old drums that the tool had been made for were 1.33 m high, while the new drums were 1.50 m high. The pipe on the steel cross was approximately 1.50 m high, which made it impossible to insert the provisions crane's hook directly into the lifting lug (see Figure 6).

Figure 6: Steel-cross stand viewed from the top of a drum. Photo: BW Suez Everett

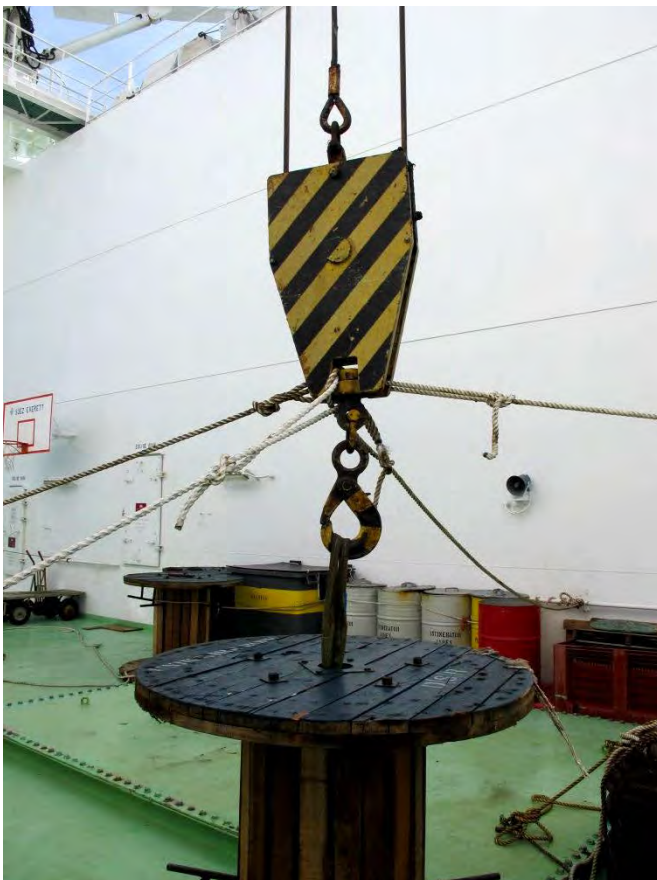
The deck crew therefore used a wire sling, which was hooked onto the provisions crane, and secured the arrangement against sideways movement using rope (see Figure 7).

Figure 7: Drum suspended from the provisions crane. A wire sling was used, not a strap as shown in the photo. Photo: AIBN.

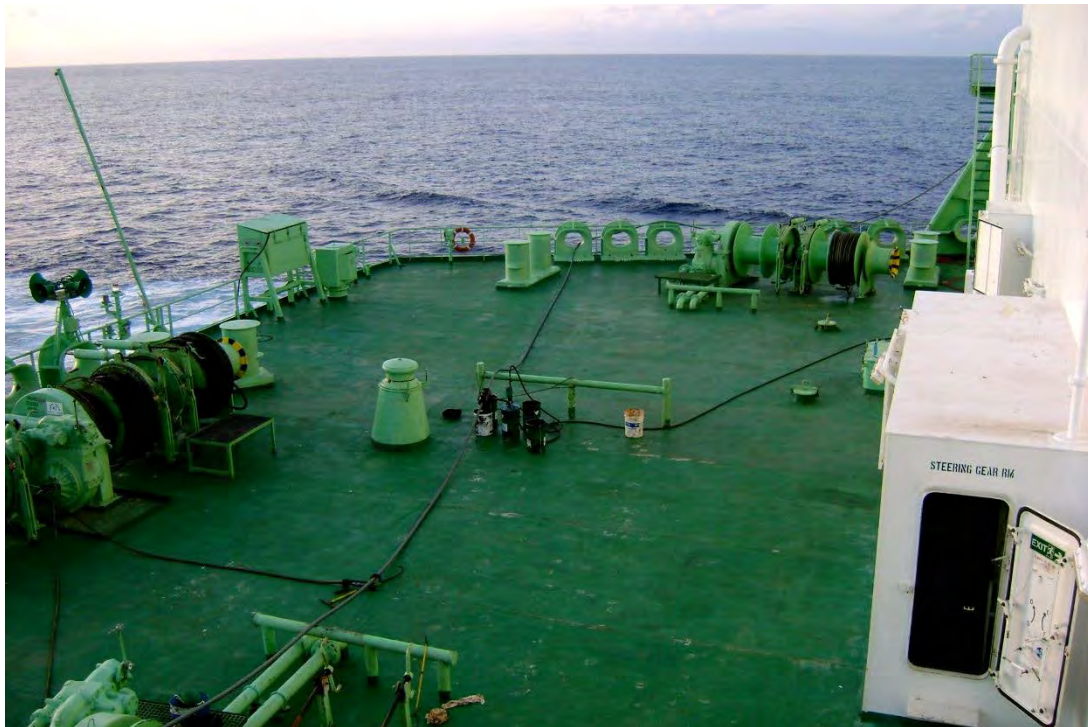
Finally it was nonetheless decided to let the wires follow previously used routes. This meant that sections of wire were passed outside the railings and in through the mooring hole that provided the best angle in relation to the winch in question (see Figures 8 and 9).

Figure 8: View of the port side of the poop deck, with wire pulled through the port mooring hole aft and across the deck to the starboard mooring winch. Photo: BW Gas.

The distance from the wire grease applicator (in the middle of the photo, Figure 8) to point B is 10 m. Since additional grease was applied to the wire while it was being reeled onto the mooring winch, it was possible to identify the point at which this treatment stopped and the ungreased wire began. The part of the wire that was in the water after the accident had been reeled onto the winch without grease being applied. Afterwards, the AIBN was therefore able to measure, with a high degree of accuracy, the number of metres of ungreased wire on the winch drum.

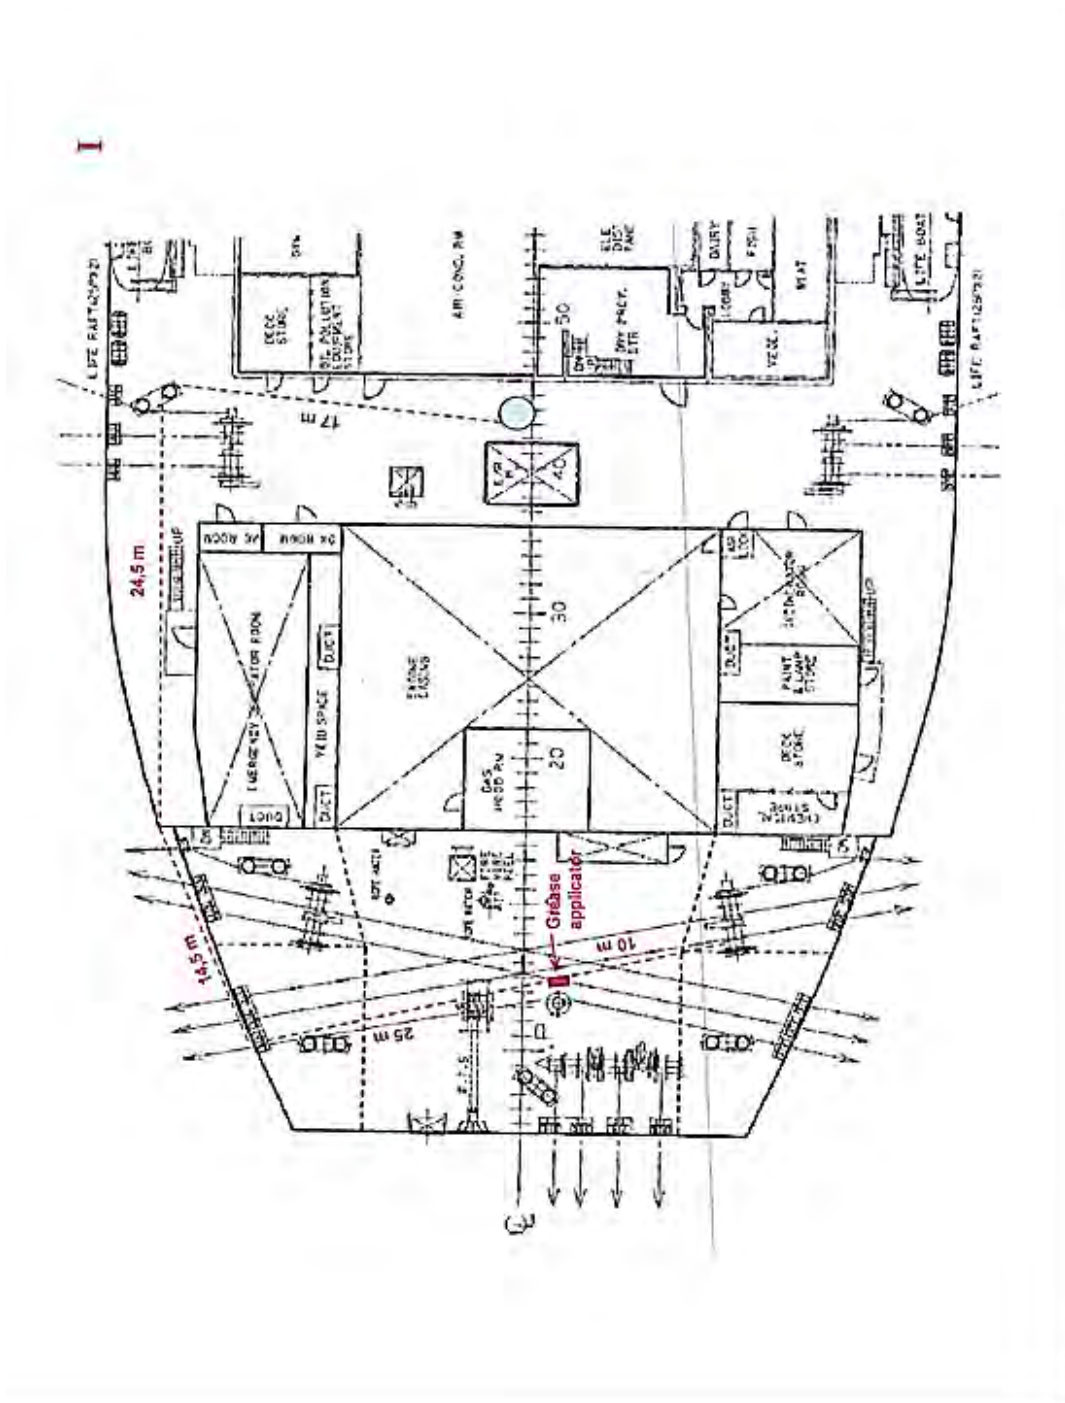
Figure 9: The wire route (red dotted line) from the winch (blue) in the Grand Canyon to the starboard winch on the poop deck. The 14.5-metre section along on the port side aft shows where the wire was passed outside the railings along the ship's side. Illustration: BW Gas.

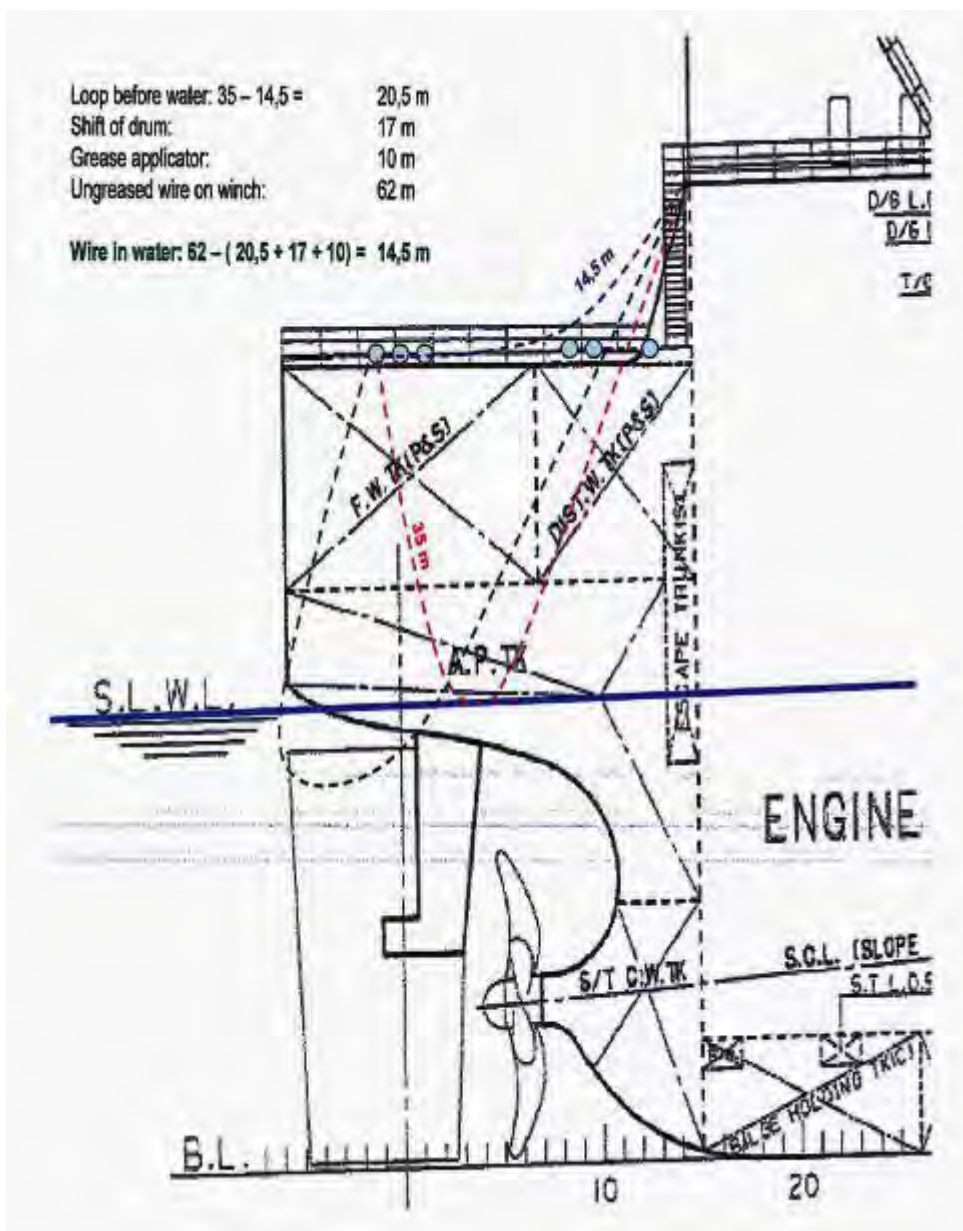
Figure 10 shows the chosen route and the estimated length of wire that may have hung into the water in the form of a half loop as calculated by the AIBN. The distance from the drum's original position to where it was stopped by the bollard on the port side of the Grand Canyon was measured to be 17 m. The blue dotted line in Figure 10 shows the distance between the point on the deck above to which the wire was routed (in the following referred to as A) and the port mooring pipe (in the following referred to as point B), and was measured to be 14.5 m when there was no slack in the wire between the points. A half loop from point A to point B that just touches the water has been measured to be 35 m.

Figure 10: The line diagram shows the starboard side of the hull. The starboard side is completely identical to the port side as regards mooring pipes etc., the routing of the wire and the measurements that were subsequently carried out. Illustration: BW Gas.

The AIBN believes that it may have been a combination of excessive slack in the wire outside the railings and the rolling movement of the ship that caused the drum to shift towards port. There was not much wire left on the drum, and therefore little friction against the deck. The vessel made good speed through the water, and as the wire probably hit the water at the same time as the ship tilted, the AIBN assumes that the drum moved across the deck and hit the ordinary seaman in the back before stopping against a bollard on the port side.
