# REPORT

## Sjø 2014/05

## REPORT ON MARINE ACCIDENT ON BOARD THE MOTOR FERRY MF RØST - LDWE, NEAR SKROVA ON 18 MAY 2013

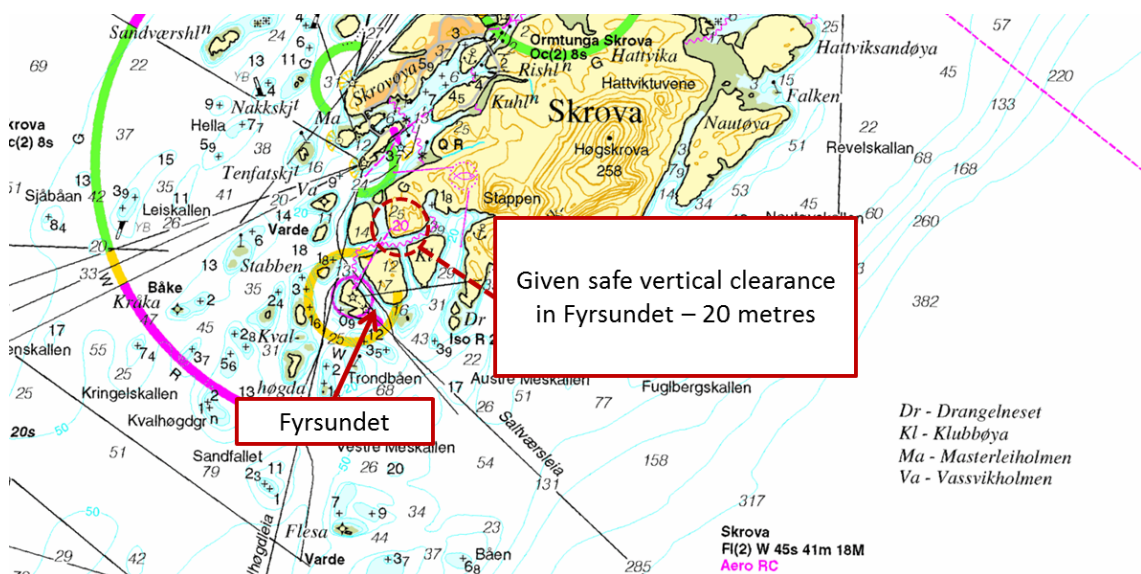
When the service was operated by *MF Vågan*, it had used Fyrsundet<sup>1</sup> as an alternative to the regular route between Skrova and Skutvik. There is an overhead span of three high-voltage power cables across the sound in Fyrsundet. The power company Lofotkraft raised the overhead cables in 1993 at the request of the company that operated *MF Vågan* at the time, so that the cables did not interfere with the safe passage of the vessel, whose air draught (greatest mast height) is stated to be 18.9 m. According to Nautical Chart No 73, Fyrsundet has a safe vertical clearance of 20 metres, while the warning signs posted ashore at the sound indicate 22 metres.

Figure 3: Detailed map section from the Norwegian Mapping Authority's Nautical Chart No 73 (corrected as of the date of 'Etterretning til sjøfarende' (Efs)<sup>2</sup> No 16/13 covering Skrova, Skrova lighthouse and Fyrsundet, indicating a safe vertical clearance of 20 metres.

The Accident Investigation Board Norway recommends that the Norwegian Coastal Administration take steps to ensure that the correct safe vertical clearances are unambiguously communicated so that they are clear to seafarers.

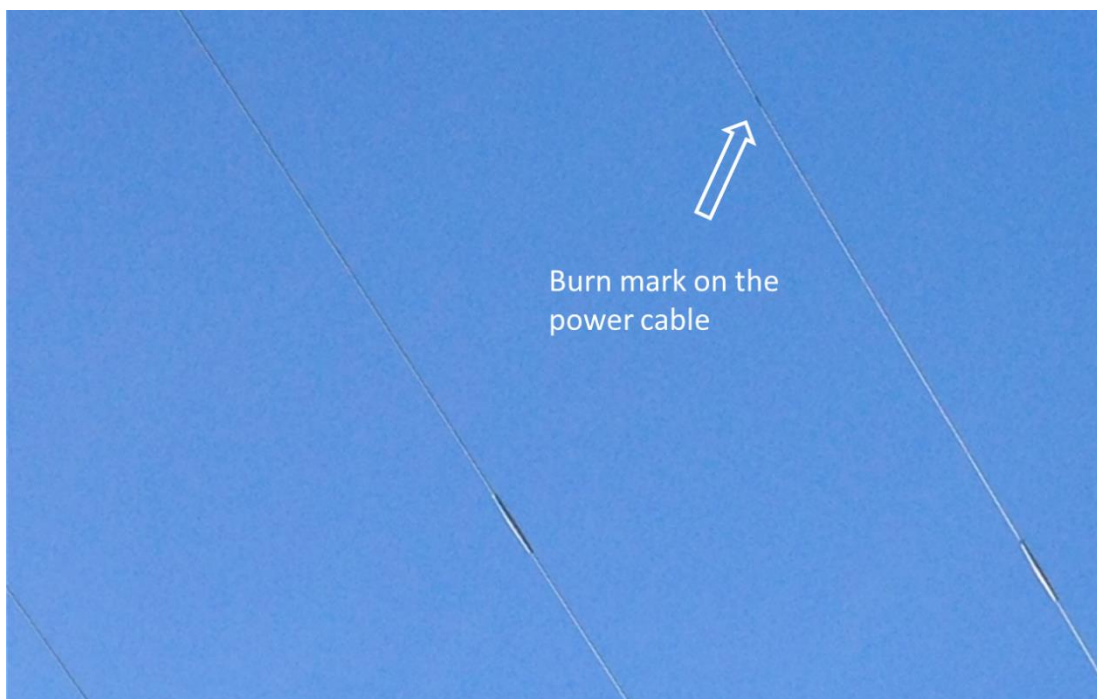
Witness observations of a strong flash of light, the burn mark found on one of the power cables (Figure 4), the short circuit registered by the power company and burn marks at the tip and lower end of the fishing rod are all consistent with that there having been momentary direct contact between the fishing rod and the high-voltage power line.

Figure 4: The three overhead high-voltage cables across Fyrsundet. On the upper right, a burn mark can be observed on the cable where it probably came into contact with the fishing rod. Two of the cables in the photo have 'connecting sleeves' from previous repairs. Photo: Lofotkraft

The fishing rod was made of an electrically conductive carbon material. The observed burn marks and the voltage drop recorded by the power company at the time when *Røst* sailed through Fyrsundet show that electricity found earth through the fishing rod. This constitutes another safety problem (SP6). The AIBN cannot determine whether the chief mate would have died as a result of the injuries sustained from high-voltage exposure alone. The AIBN has chosen not to analyse this finding further.

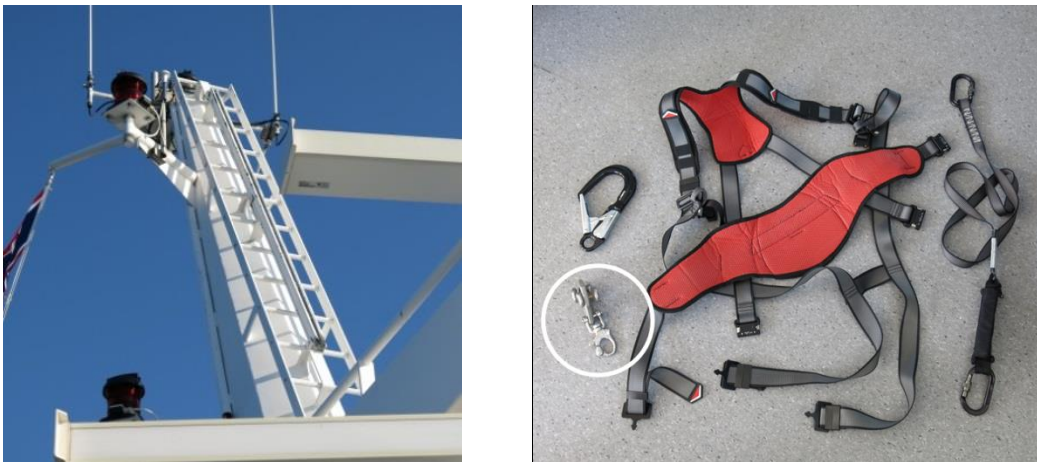
Ladder skid rails and pertaining fastening devices (Figure 5) for climbing up into both the fore and aft masts were available on board *MF Røst*. In the event of a fall, an automatic locking mechanism in the fastening arrangement between the safety harness and the skid rail would prevent the user from falling down. This particular equipment was not used by the deceased in connection with his task in the fore mast.

Figure 5: Left: ladder and skid rail in the fore mast. Right: harness and fastening device for the skid rail (ringed in). Photo: AIBN

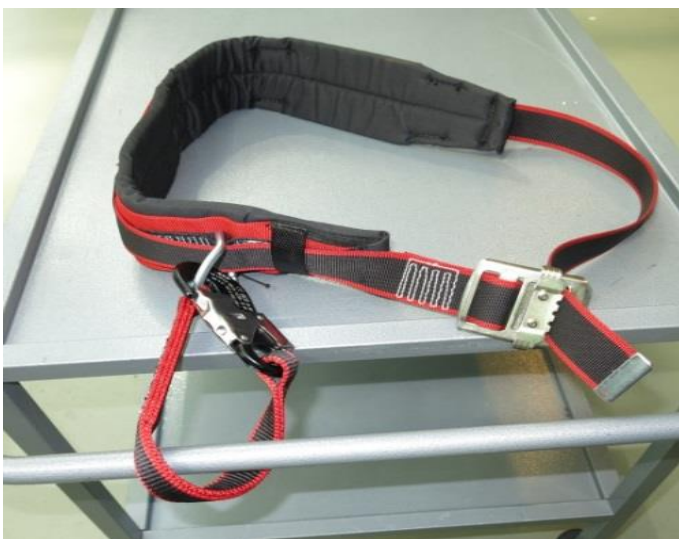
Figure 6: Safety belt with snap hook. Photo: AIBN

It was the equipment shown in Figure 6 that was used in connection with the task in the fore mast. The belt was still in place around the deceased's hip after the fall, and how well he had fastened/secured the strap and snap hook, if at all, is thus uncertain. The strap and snap hook did not show signs of stress or damage of any kind, and appeared to be in good condition after the accident. The fastening device for the skid rail shown in Figure 5 can also be used with the hip belt.

The contact between the earth potential and one of the phases produced a voltage potential of 12.7 kV. The AIBN assumes that it instantly incapacitated the chief mate. The chief mate was found with the safety belt fastened around his body. The fastening device on the belt was intact. The AIBN therefore believes that he had not attached the safety belt to the mast when he raised his arm towards the overhead cable. The AIBN does not rule out the possibility that he may have disconnected the safety belt from the mast in order to be able to reach higher or for some other reason. The post-mortem report shows that the injuries sustained when he fell from the mast were fatal.

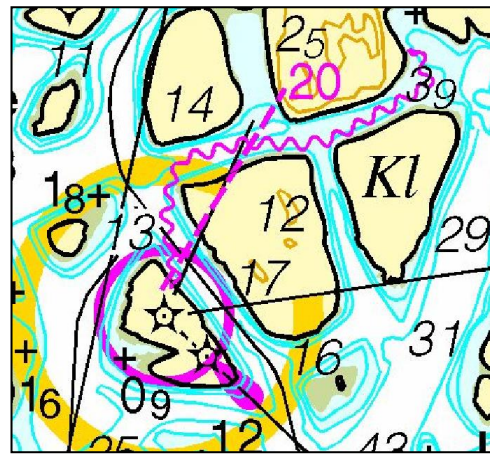
Figure 12: From Nautical Chart No 73 (2008). 20 metres safe vertical clearance shown in magenta. Source: the Norwegian Hydrographic Service

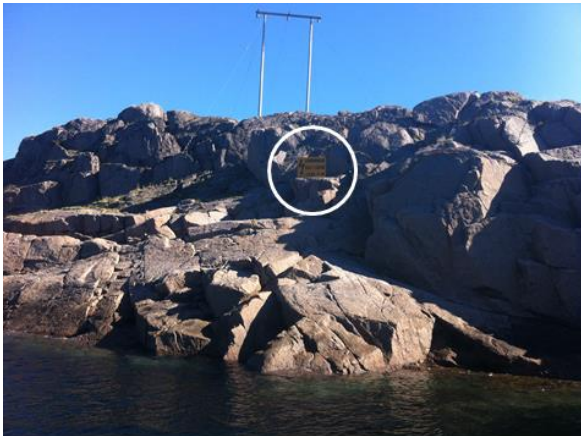
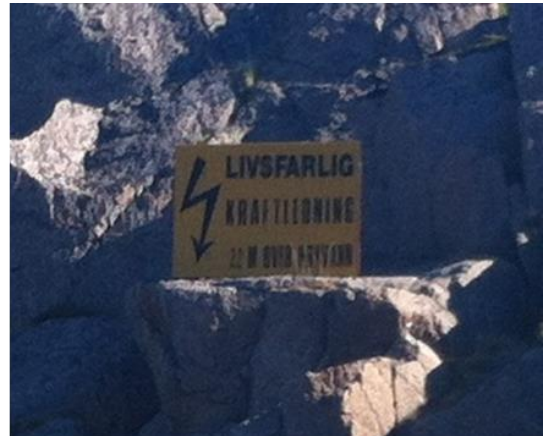
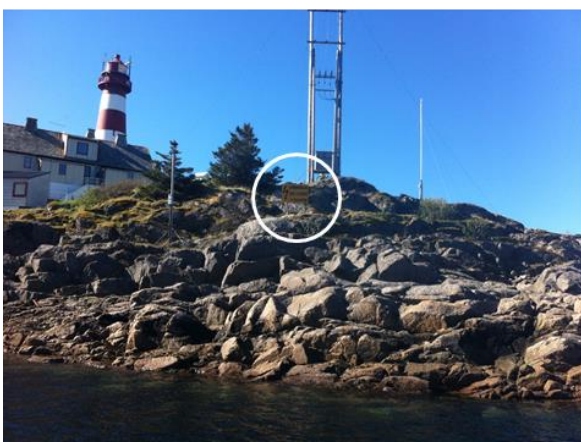
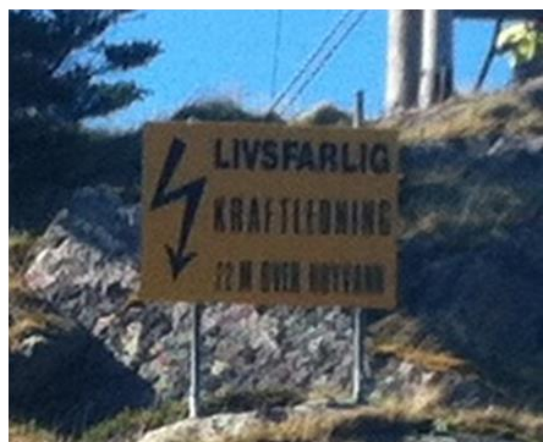
At the time of the accident, the overhead cables across Fyrsundet were marked by yellow signs posted ashore below the span on both sides of the sound. The signs carried the text: 'Life-threatening danger, power cable 22 m above high tide'.

Figure 13: Signs with information about the overhead cables posted by the cable masts on both sides of Fyrsundet. The white circles show where the signs are located. Photo: Lofotkraft

In the AIBN's opinion, the doubt about the safe vertical clearance caused by this sign may have contributed to the initiative taken by the crew of *Røst* to clarify whether the vessel could safely sail through the sound (see also section 2.3.1).

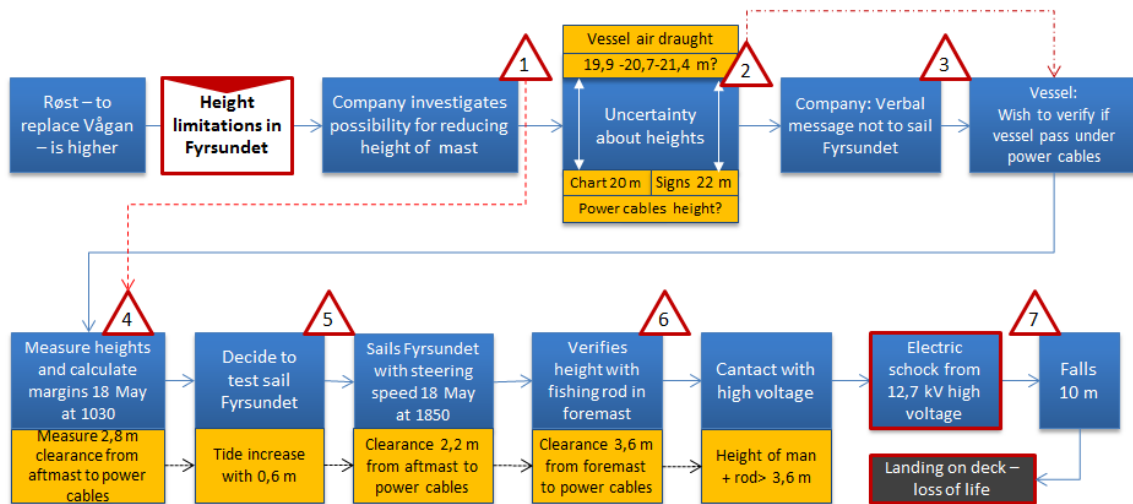
The AIBN has identified a total of seven central safety problems, defined as nonconformities with safe or expected functions. These safety problems are reviewed in more detail in section 2.2, with a discussion of those factors that the AIBN believes contributed directly to the accident.

Figure 16. Schematic diagram of how the accident came about. Identified safety problems are marked as warning triangles. Source: AIBN
