# REPORT

## MARINE 2016/03

## REPORT ON MARINE ACCIDENT – FOUNDERING OF THE FISHING VESSEL LEIF ROALD AFTER GROUNDING AT BRAKAN IN HUSTADVIKA, 17 JANUARY 2015

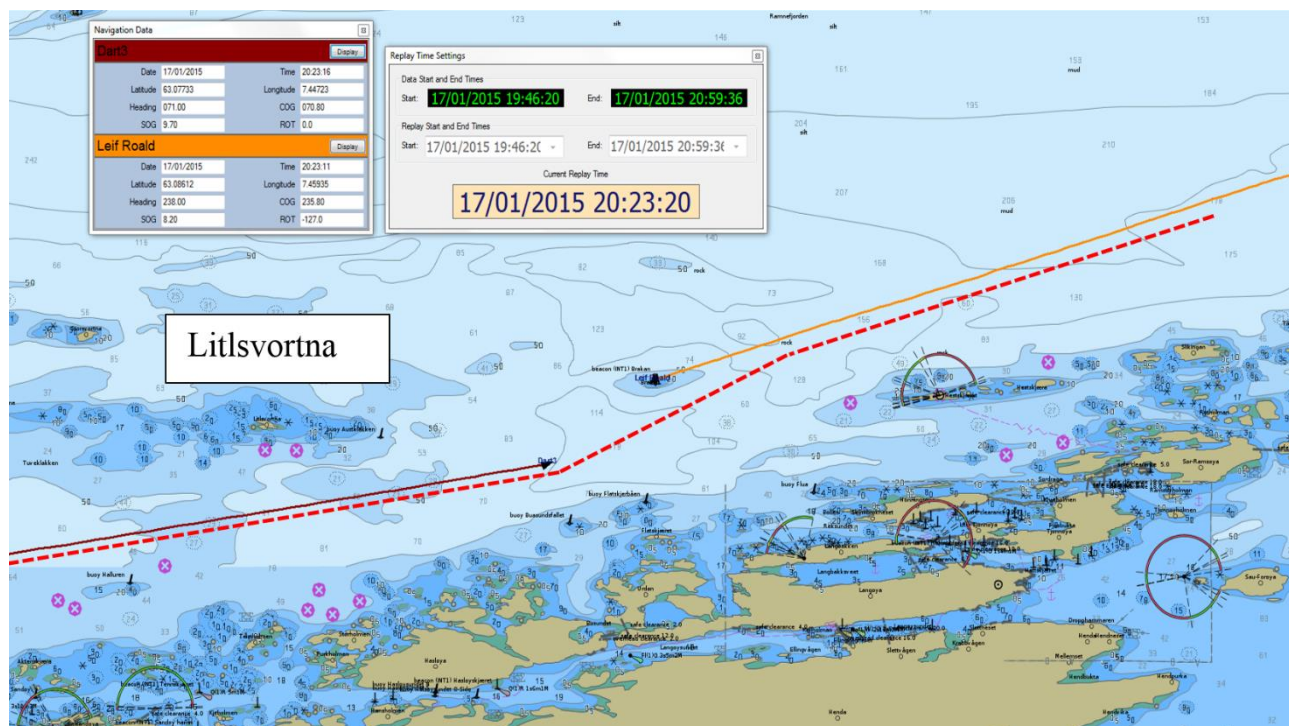
During this period the vessel was still on autopilot and following the course line on the Olex. According to the skipper they intended to follow a course line between Hestskjær and Brakan. The broken red course line (see Figure 2) is a reconstruction, based on what the skipper believed had been saved on a previous voyage. This was the course line he

Shortly before running aground, however, he registered the Litlsvortna rocks approximately 1.5 nautical miles ahead. He wanted to pass them to starboard. At the same time, his attention was focused on a vessel that was approaching from the south. This was the Danish-registered tanker *M/V Dart* (in the following called *Dart*). *Leif Roald* was slightly west of the planned course line, but the skipper chose to maintain course and speed in order to pass *Dart* port-to-port.

At that point the skipper understood the area between *Leif Roald* and Litlsvortna to be free of rocks and reefs etc. and he did not get a radar echo from Brakan.

Figure 2: At approximately 20:24 UTC (21:24 local time) the grounding was a fact. The figure shows *Leif Roald's* course (unbroken yellow line), the planned course line (broken red line) and *Dart's* course (unbroken magenta line). Map: The Norwegian Coastal Administration. Illustration: Fruholmen Drift AS/AIBN.

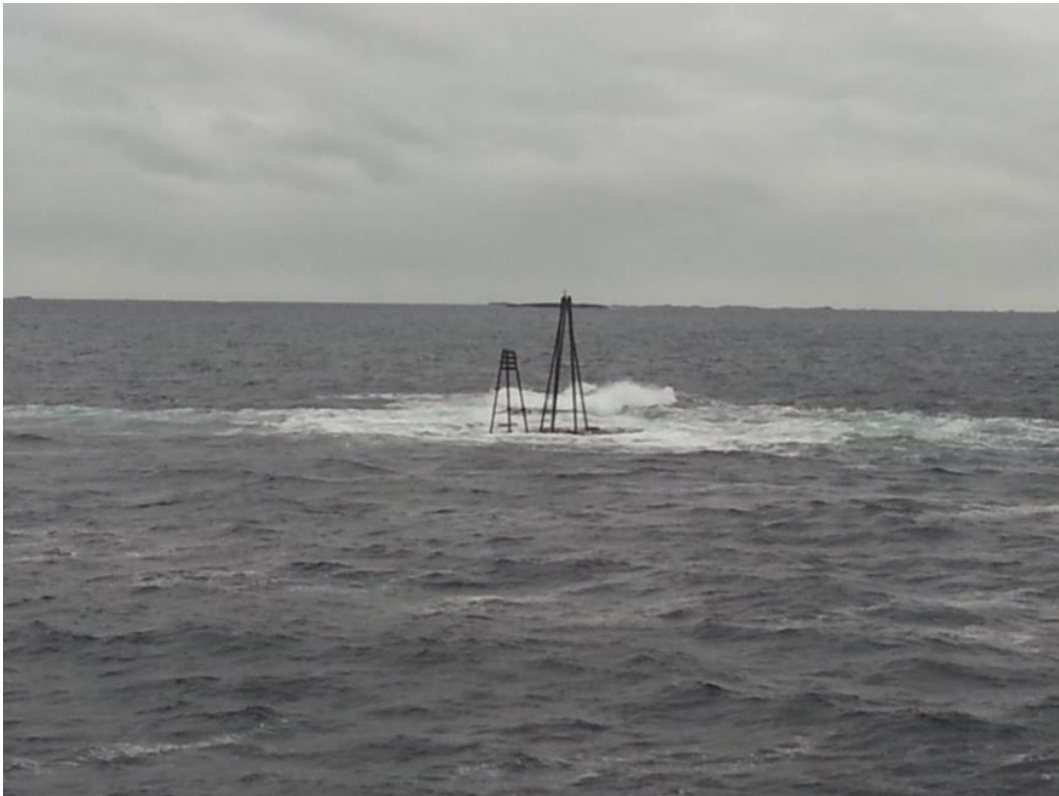
Figure 3: Brakan, November 2014, around high tide. A provisional navigational installation is in place to the right of the old beacon, as was also the case at the time of the accident. Photo: The Norwegian Coastal Administration (NCA)

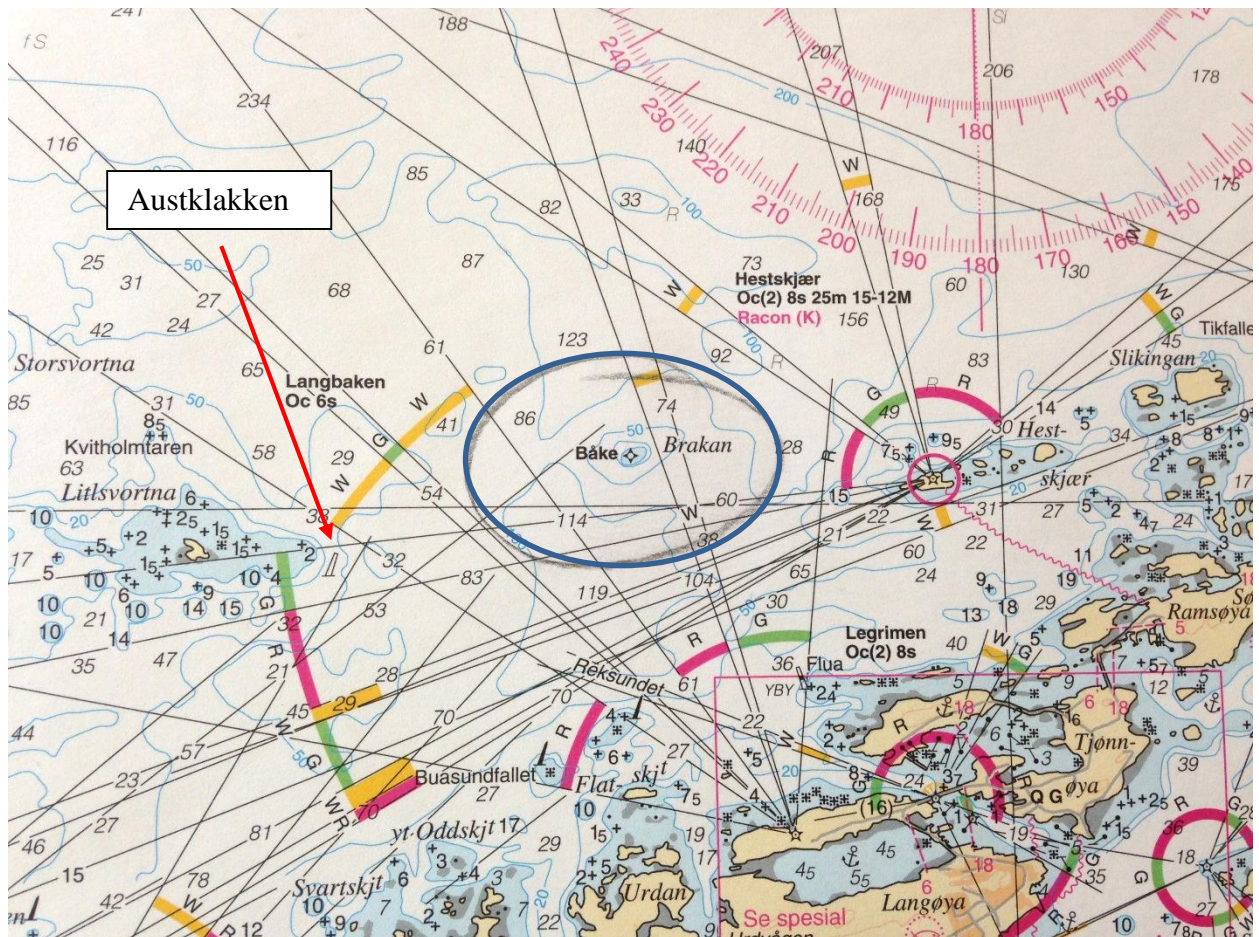
Figure 5: Section of Nautical Chart No 35, the Brakan reef (marked with a blue ring by the AIBN) is marked with a beacon symbol. The red buoy east of Litlsvortna is Austklakken (marked with text and a red arrow by the AIBN). Map: © The Norwegian Mapping Authority. Illustration: AIBN

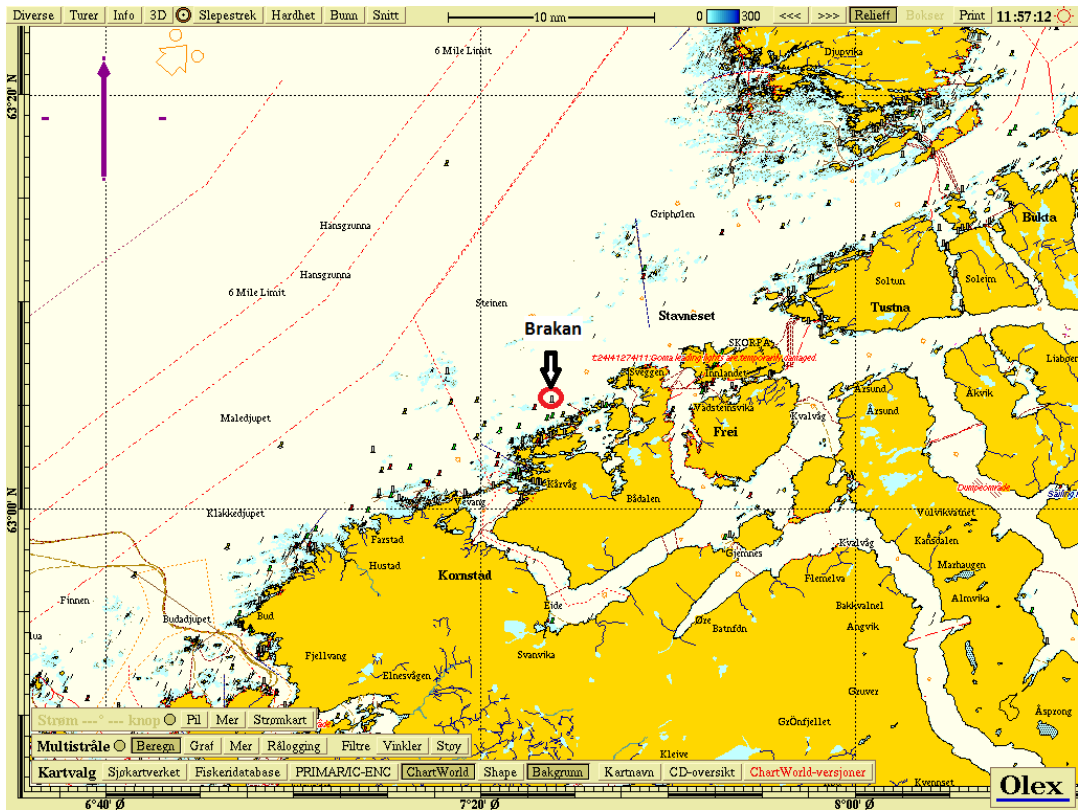
Figure 6 shows a small-scale Chart World chart of the area in the scale 1:500 000 (overview chart).

Figure 6: Olex chart plotter with Chart World chart in the scale 1:500 000. Brakan is marked with a red ring and text by the AIBN. Illustration: Olex AS/AIBN

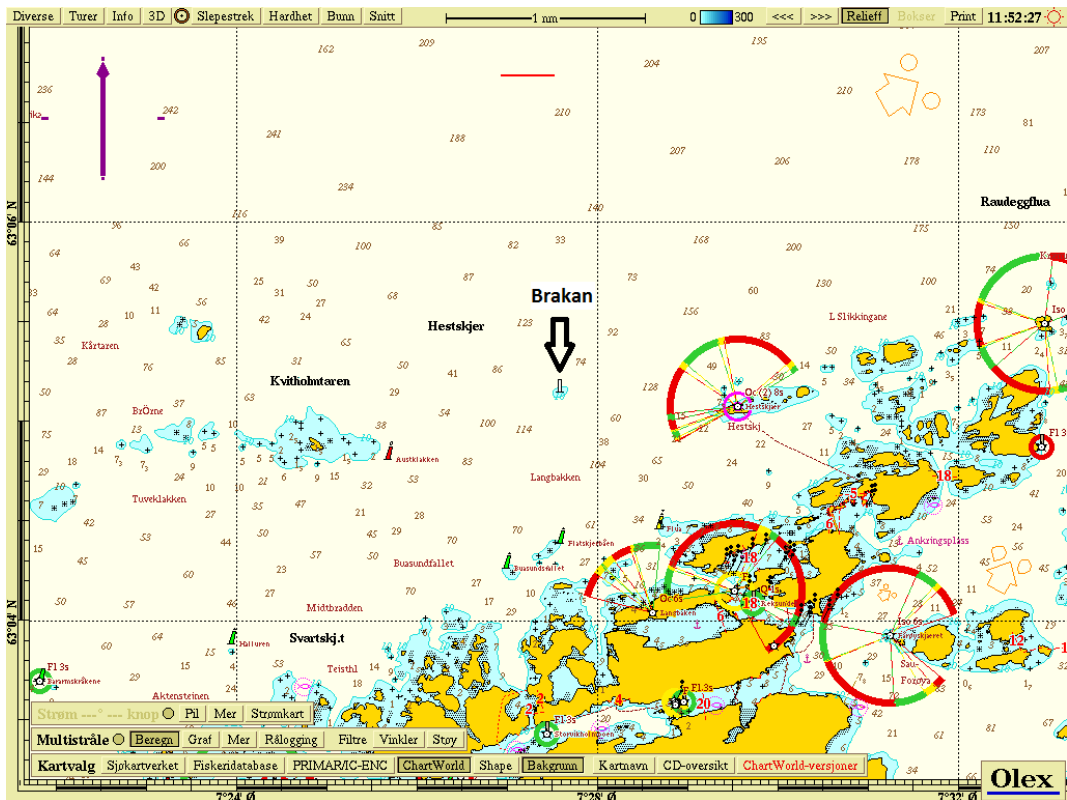
Figure 7 shows a large-scale Chart World chart in the scale 1:50 000 (detailed chart).

Figure 7: Olex chart plotter with Chart World chart in the scale 1:500 000. Brakan is marked with an arrow and text by the AIBN. The figure also shows how depth contours are marked in blue. Illustration: Olex AS/AIBN

The manufacturer of the chart plotter confirms that depth contours<sup>9</sup> which identifies shallows and seamarks cannot be deselected for any scale of presentation of the charts, suited for navigation purposes. However, the symbol for one's own vessel can appear disproportionately large compared with the seamark symbols, when zoomed out on a small-scale electronic nautical chart. If the electronic chart plotter is not used for navigation purposes but e.g. is used for a general large overview of a whole country, depth contours and seamarks will disappear, while own vessel's symbol will always remain.

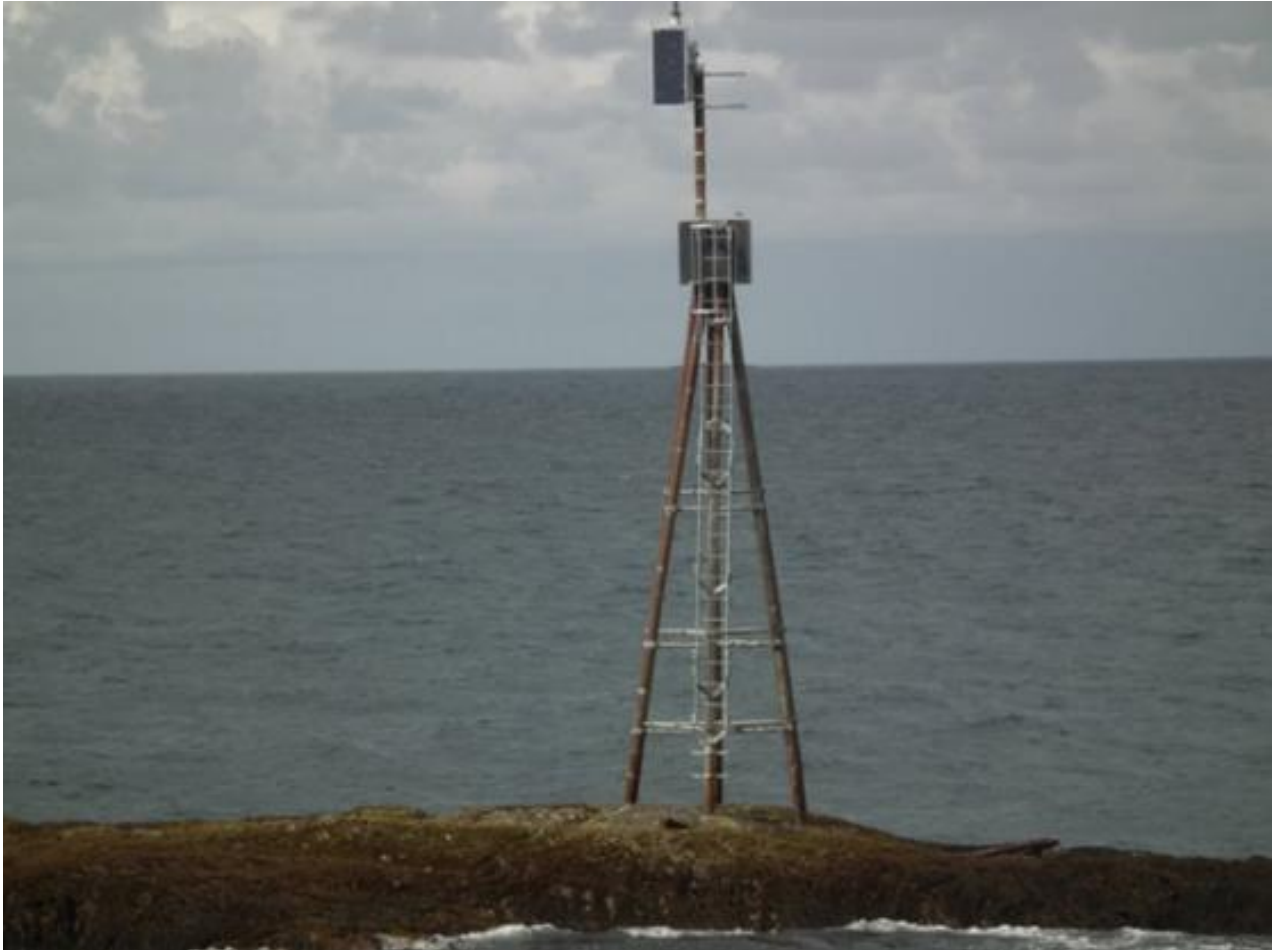
Figure 8: The beacon at Brakan was first lit on 15 July 2015. Photo: The Norwegian Coastal Administration (NCA)

The Norwegian Coastal Administration completed the navigational installation at Brakan on 15 July 2015. The beacon is now equipped with a light (white light)<sup>10</sup>.
