REPORT

Marine 2016/10

REPORT ON MARINE ACCIDENT - CAPSIZING OF VIKING 7, LG8351, NORTHWEST OF MEHAMN ON 6 JULY 2014

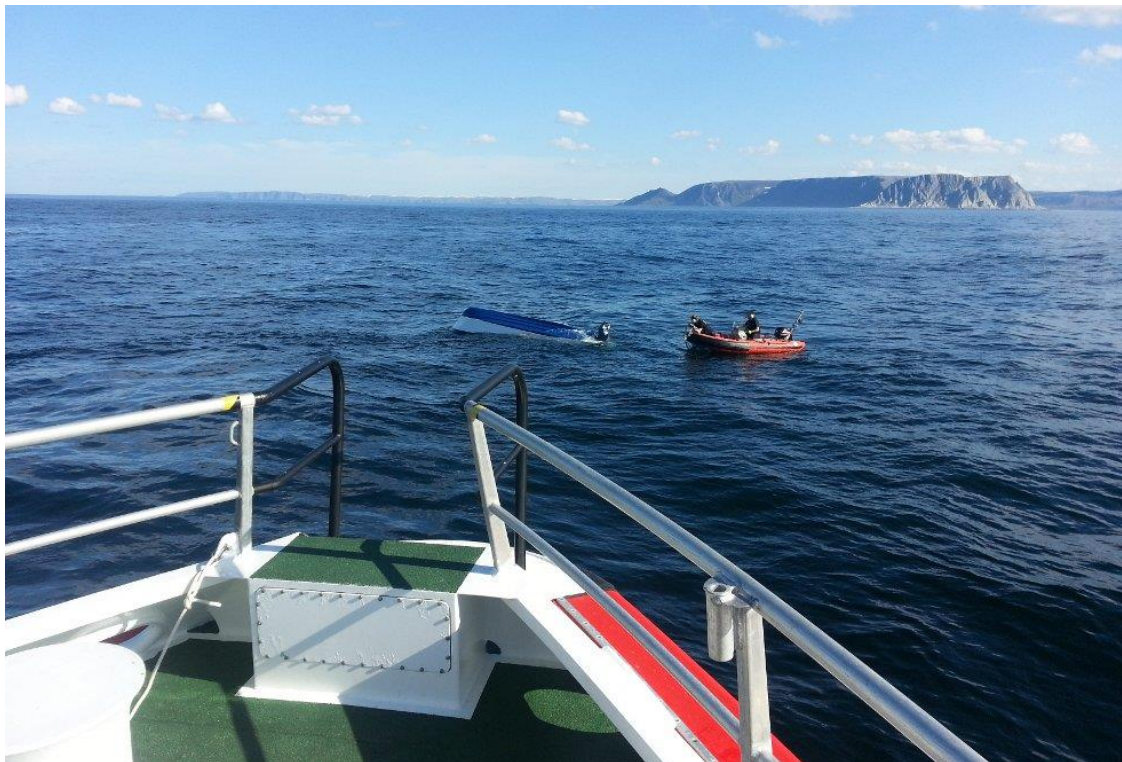
Figure 2: 'Viking 7' floating keel-up after capsizing. Photo: The SAR vessel 'Odin'.

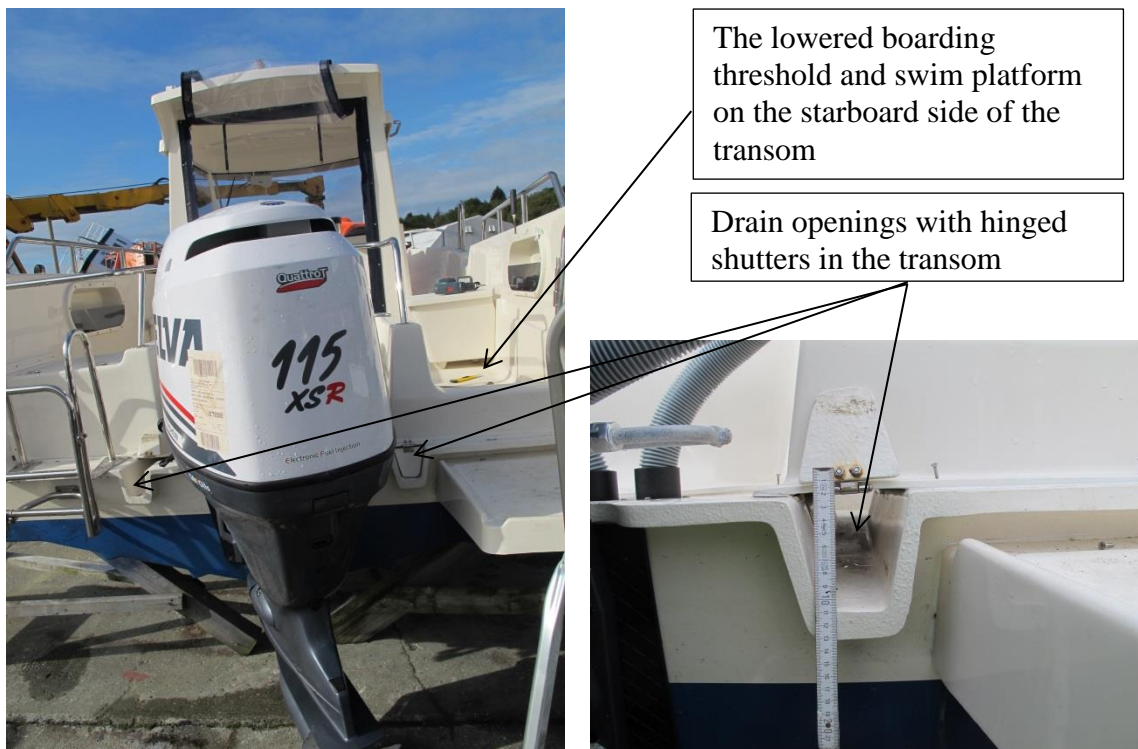
Viking 7 was designed with a self-draining inner liner. Two drain openings in the transom, both fitted with shutters, were intended to ensure that any water accumulating above the inner liner would be drained at the stern; see Figure 4. According to the boat manufacturer, the height of the drain openings above the waterline had not been considered in light of the requirements set out in the Regulations of 20 December 2004 No 1820 on the Production and Placing on the Market of Recreational Craft, etc. This was stated to be because it had been documented, through practical tests, that the boat would withstand swamping. The AIBN was told that these practical tests had been carried out in accordance with the general requirements for buoyancy and flotation in swamped condition; see 1.8.2.2 below. The test to which the boat manufacturer referred documents the vessel's buoyancy and flotation, but in the opinion of the AIBN, it cannot be used as grounds for deviating from the provisions on freeboard to the waterline of downflooding openings; see 1.8.2.1 below.

Figure 4: 'Viking 7' was arranged with two drain openings in the transom. The boat also had a lowered threshold in the transom to facilitate boarding. Photo: AIBN

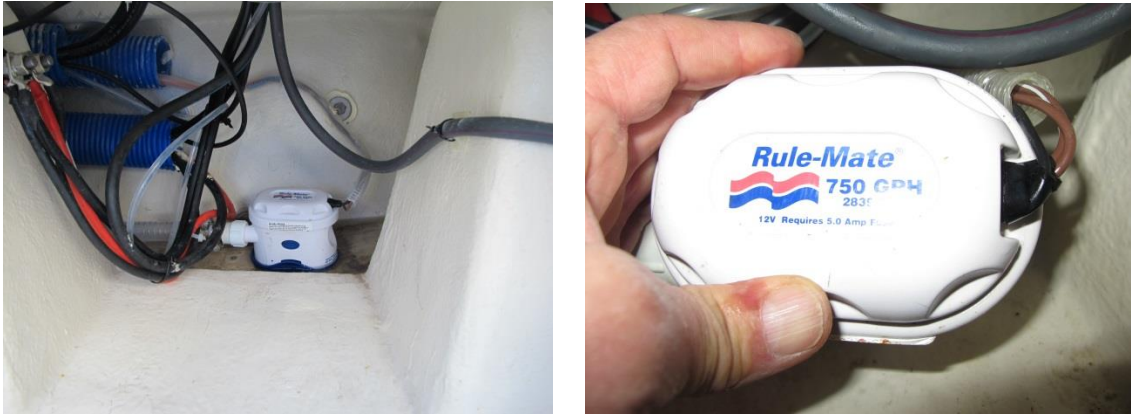
An electric pump had been installed at the stern in the space below the inner liner. The pump model was a Rule Mate 750 gph 2,839 lph. As indicated by the model designation, the pump had the capacity to pump out 2,839 litres per hour, or 47 litres per minute. The pump was equipped with a flotation valve, and, according to the user manual, would start automatically when the water level reached 7 cm above the base of the pump. The pump was connected directly to the battery so that the auto-start function would always work provided the battery was charged. The pump could also be started manually, regardless of the water level, by means of a switch on the wheelhouse control panel. The switch was spring-loaded, so it had to be depressed for as long as the pump was operated manually. When pressure was no longer applied to the switch, it automatically reverted to auto-start mode.

Figure 5: 'Viking 7' was arranged with a bilge pump at the stern below the inner liner. Photo: AIBN

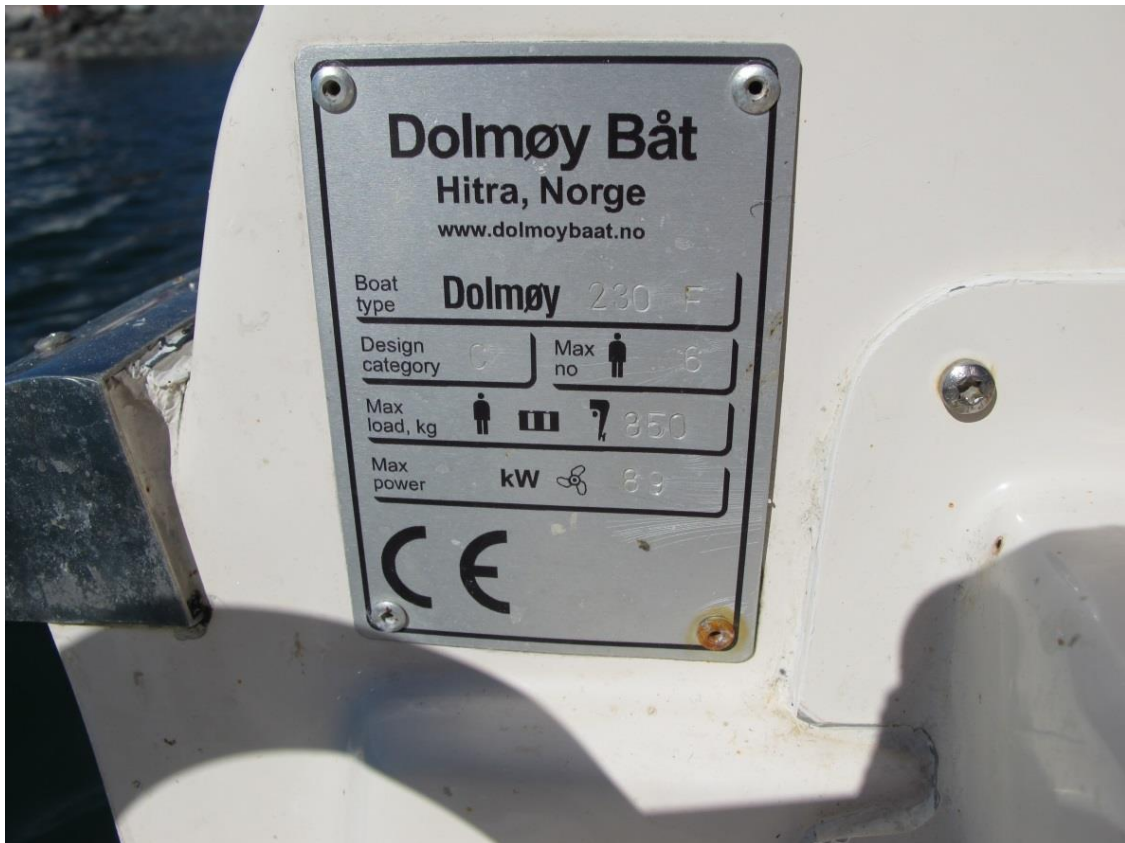
According to the CE mark and the user manual accompanying the first boats in the Dolmøy 230 Fisker series delivered by the manufacturer, the maximum permitted number of persons on board was 6, and the maximum permitted total weight of persons, cargo, equipment, motor and fuel was 850 kg. In March 2012, however, the manufacturer made a downward adjustment, limiting the number of persons to 4-6 in combination with a total load to 775 kg.

Figure 7: Photo of the manufacturer's plate as it appeared on the first boats in the Dolmøy 230 Fisker series. According to the manufacturer's plate, the maximum permitted number of people on board was 6, and the maximum permitted total weight of persons, cargo, equipment, motor and fuel was 850 kg. The maximum permitted number of persons was subsequently adjusted downwards to 4-6, in combination with a total load of 775 kg. Photo: AIBN

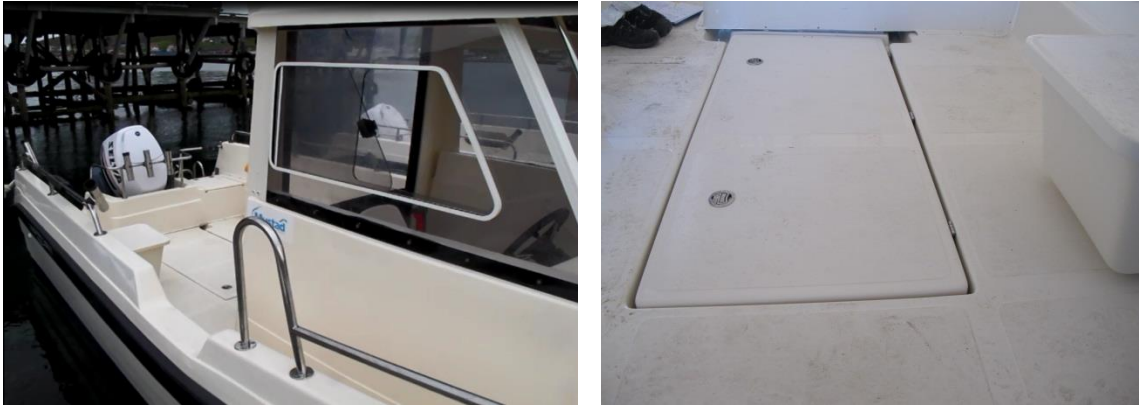
for watertightness; see 1.8.2.3 above. The hatch should therefore be reckoned with as a potential downflooding opening, regardless of whether or not a gasket had been installed.

Figure 8: The hatch in the inner liner aft of the wheelhouse. The hatch was hinged on the port side. It was fitted with two simple cleats on the starboard side. The openings for draining the inner liner are visible on both sides at the aft end of the hatch. Photo: AIBN

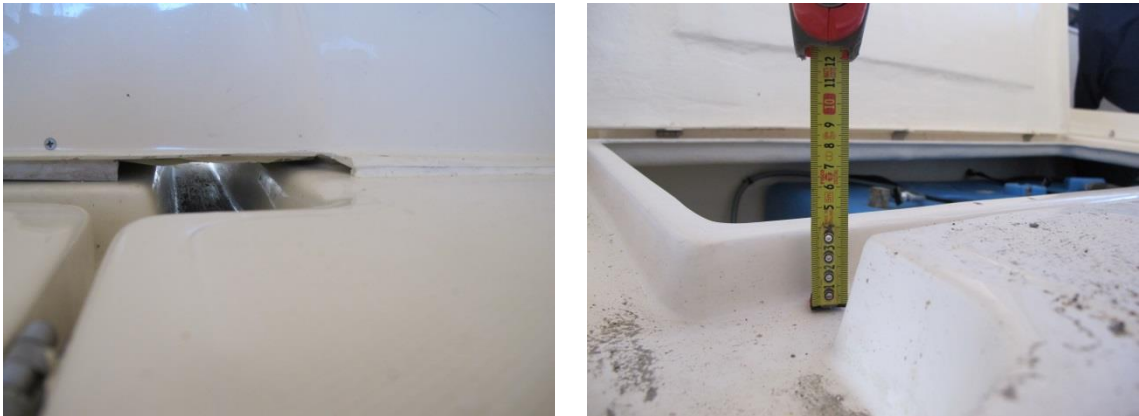
Figure 9: The photo on the left shows the starboard drain opening. The photo on the right shows the hatch coaming, the top of which was 35 mm above the bottom of the drain channel and 20 mm below the inner liner level. Photo: AIBN

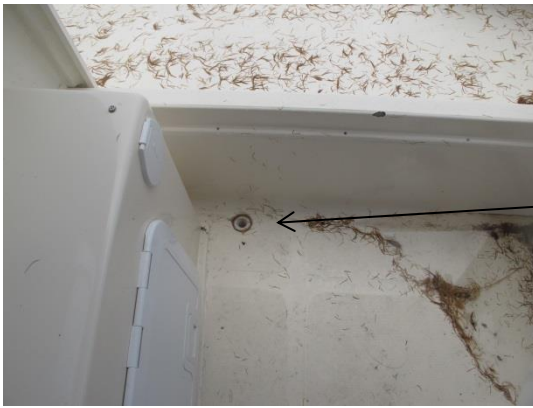
Drainage had been arranged from the cockpit to the space below inner liner. Below the inner liner a hose had been fitted to carry the water from the cockpit to the space below the flush hatch aft of the wheelhouse. The drain hole in the cockpit, which was not arranged with any means of closure (for example a stop cock), was a potential downflooding point; see Figure 10.

Drain hole that led the water from the cockpit down into the space below and towards the stern under the inner liner

Figure 10: The drainage hole in the cockpit. The opening, which did not have any means of closing, was located on the starboard side at the aft end of the cockpit. Photo: AIBN

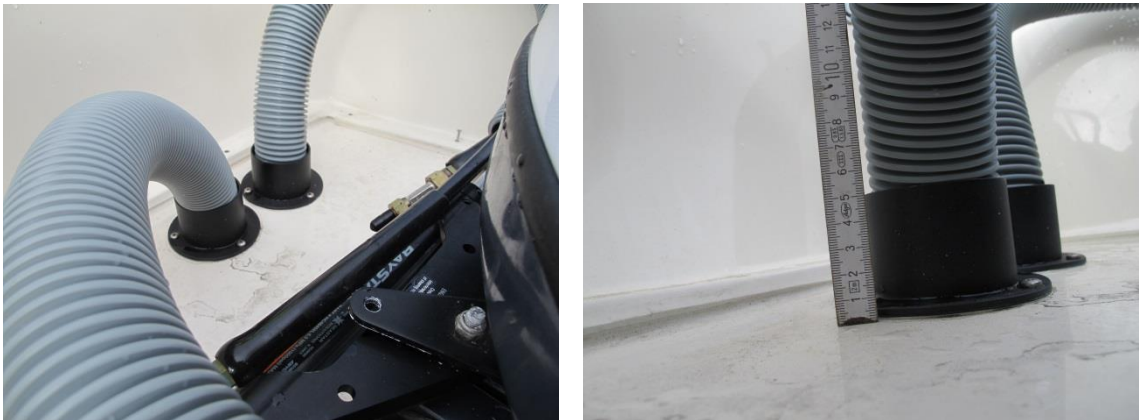
The size of the feedthroughs for the cables and fuel supply line were adapted to the dimensions of the cables and pipe. The cables/pipes had also been bundled into flexible conduits that were fastened to the hull with collars. The collars were stiff, however, so that there was a small gap between the collars and the conduits.

Figure 11: The arrangement for the cables and the fuel supply line for the motor. Photo: AIBN

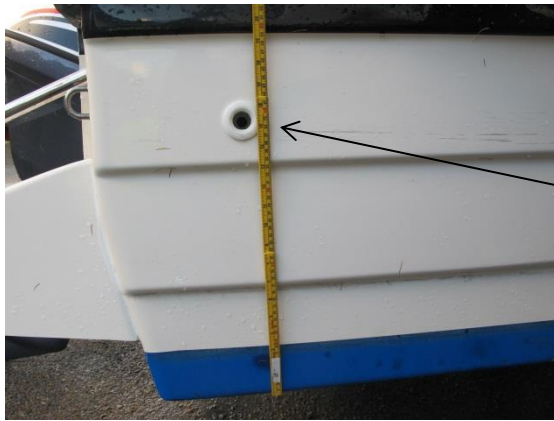
The hull was arranged with an outlet for discharging bilge water on the starboard side aft, approximately 380 mm above the bottom of the craft; see Figure 12.

Outlet for discharging bilge water from the pump placed under the inner liner aft

Figure 12: Outlet for discharging bilge water from the pump under the inner liner aft. The outlet penetrated the hull on the starboard side aft, approximately 380 mm above the bottom of the craft. Photo: AIBN

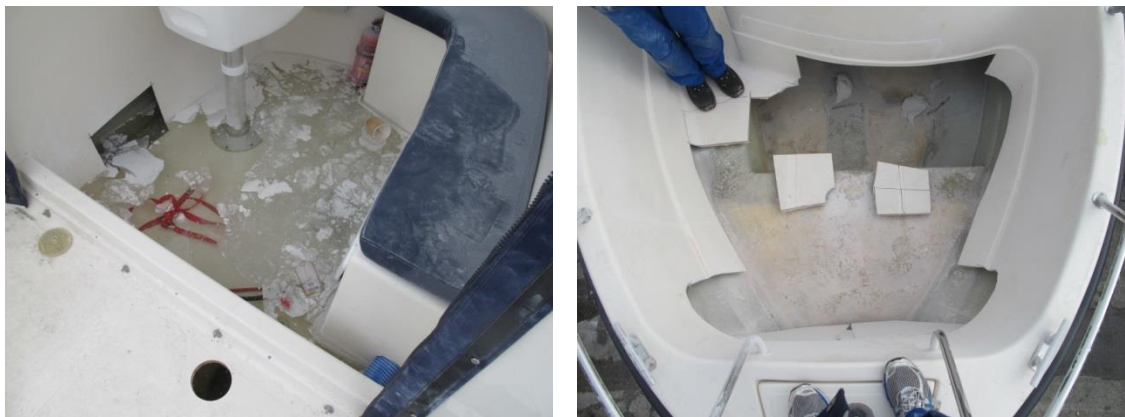
As the water level in the space that was being filled rose, so did the water level below deck further forward.

Figure 16: The photo on the left shows how the cockpit is filled with water. The photo on the right shows how the space below the inner liner is also being filled with water at the bow end. Photo: AIBN

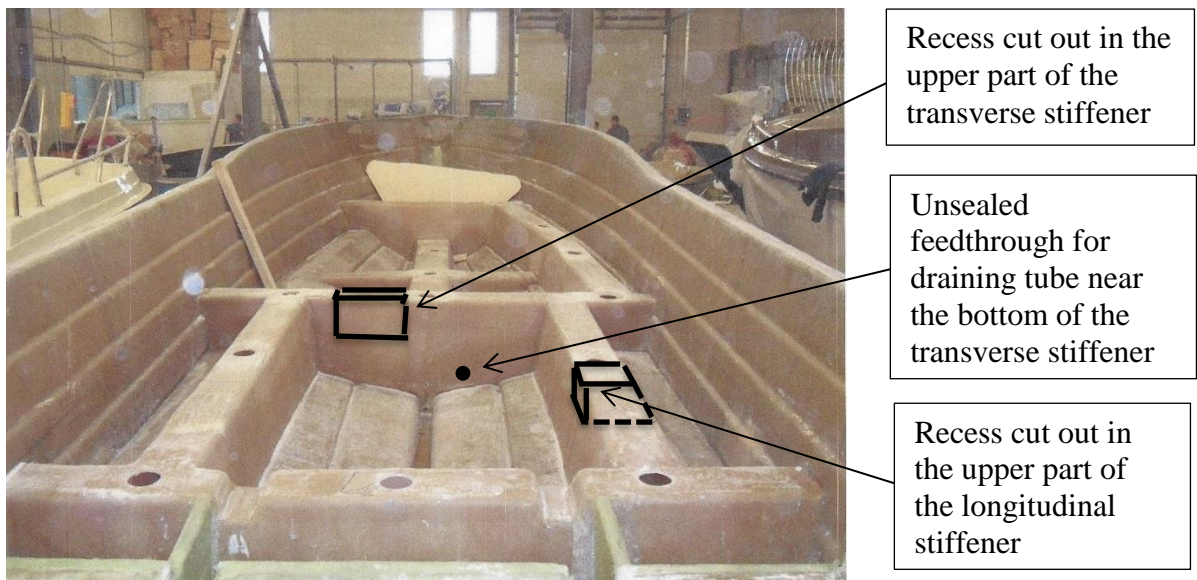
Further examination showed that the feedthrough for the drain tube from the wheelhouse through the transverse stiffener at the forward end of the space below the flush hatch was not watertight. However, the amount of water that flowed through the stiffener around the feedthrough for the drain tube was less than the amount that entered the space below the hatch, so the spread of water to the forward part of the craft was delayed during the initial flooding phase. Later in the flooding phase, however, a larger opening in the stiffener became immersed so that the space forward of the stiffener eventually filled up at the same speed as the space aft of the stiffener. In addition to the two openings in the stiffener, a recess had been cut in the upper part of the longitudinal stiffener on the starboard side below the flush hatch in the inner liner. Figure 17 shows where the openings in the stiffeners were located in the space below the flush hatch.

Figure 17: Illustration showing the openings in the stiffeners in the space below the flush hatch. Photo: Dolmøy Gjestebrygge AS

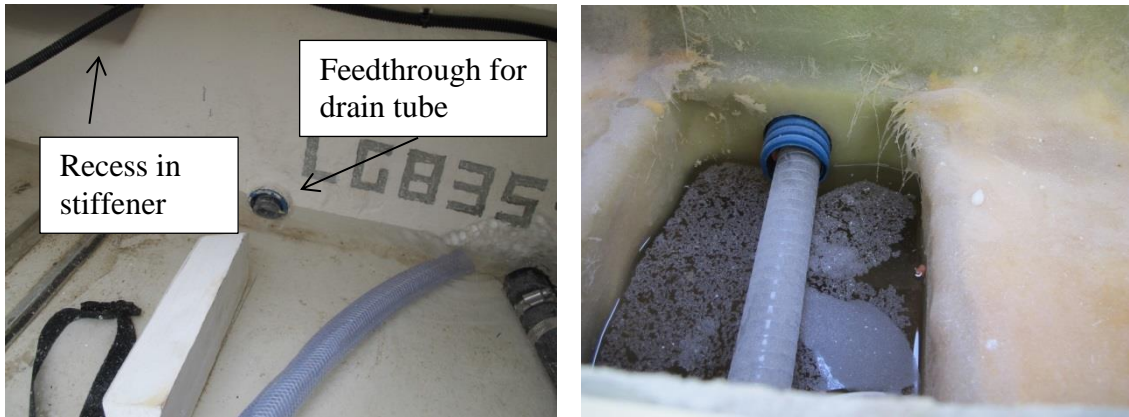
Figure 18: The photo on the left shows the unsealed feedthrough for the draining tube from the wheelhouse viewed from abaft, i.e. from the space below the flush hatch in the inner liner. Part of a larger recess in the stiffener through which water could flow unimpeded from aft to fore below the inner liner can be seen in the upper left corner. The photo on the right shows the feedthrough for the draining tube from the wheelhouse viewed from the forward end, i.e. from the space below the wheelhouse. Photo: AIBN

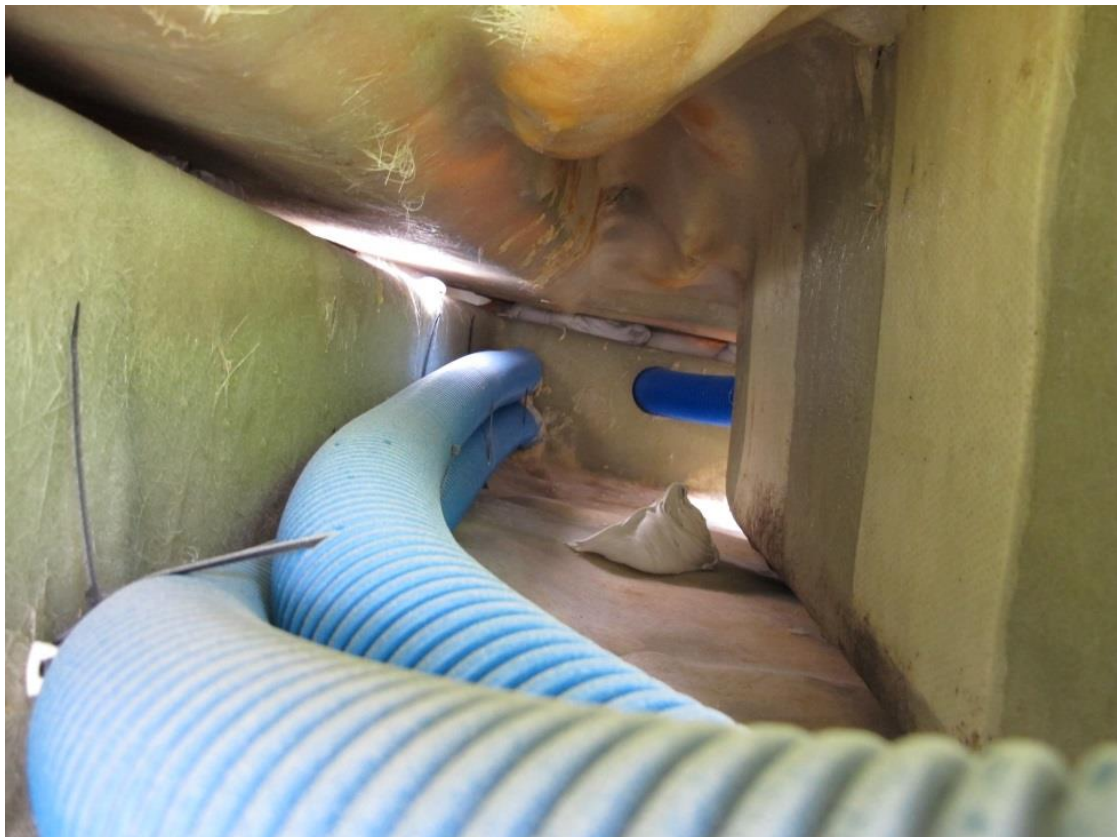
In addition to finding that water could move freely below the inner liner, the investigation showed that relatively large volumes of space below the inner liner on the starboard side had not been filled with foam, including on the starboard side of the wheelhouse and forward of the wheelhouse.

Figure 19: Volume (not filled with foam) below inner liner on the starboard side of the wheelhouse. Photo taken from the forward end, looking towards the stern. Photo: AIBN

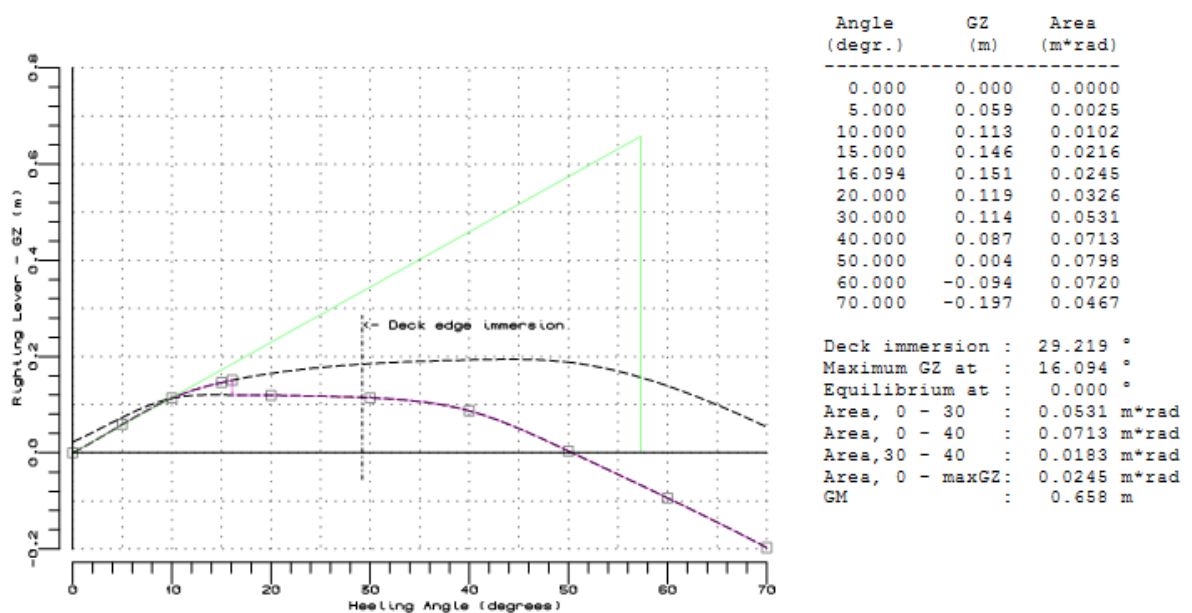
The calculations show that before *Viking 7* started to take in water, its metacentric height (GM) was 0.658 metres when the fishing tourists and the guide were evenly distributed around on board (two tourists near the bow, two tourists aft and one tourist and the guide amidships). Based on the manufacturer’s load limits, the craft had a GM of 0.770 metres with 6 people on board. Figure 23 shows the righting lever (GZ) curve in the accident condition (actual loads) before ingress of water. Two GZ curves are shown in the figure. The upper (black) GZ curve shows the righting lever assuming no ingress of water through the downflooding openings. The lower GZ curve shows the righting lever assuming that water ingressed through the downflooding openings and filled the space above the inner liner. In the latter case it is assumed that the inner liner is watertight, so that water does not flow into the voids between the outer hull and the inner liner.

Figure 23: The boat’s static stability in the accident condition before ingress of water with the tourists evenly distributed on board. The upper (black) GZ curve shows the righting lever assuming no ingress of water through the downflooding openings. The lower GZ curve shows the righting lever assuming that water has ingressed through the downflooding openings and filled the space above the inner liner. Illustration: AIBN

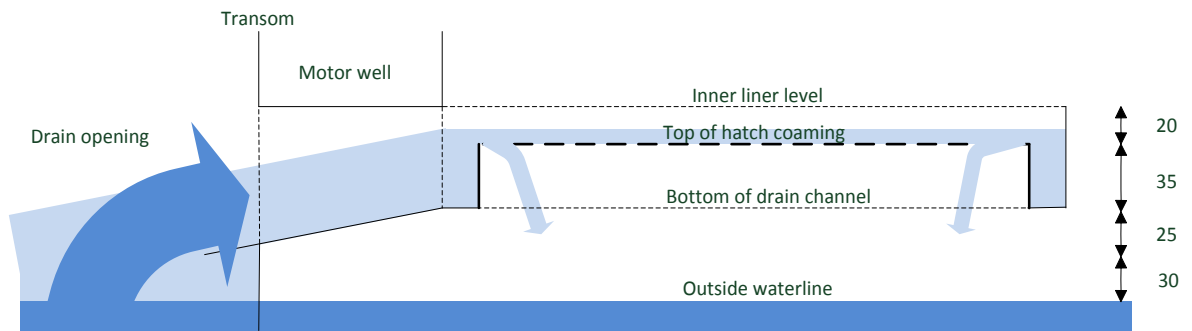
Figure 24: Schematic section drawing of how the water ingressed. The height of the hatch coaming above the water line was approximately 90 mm in the accident condition. The drawing is not to scale. The measurements are given in mm. Illustration: AIBN

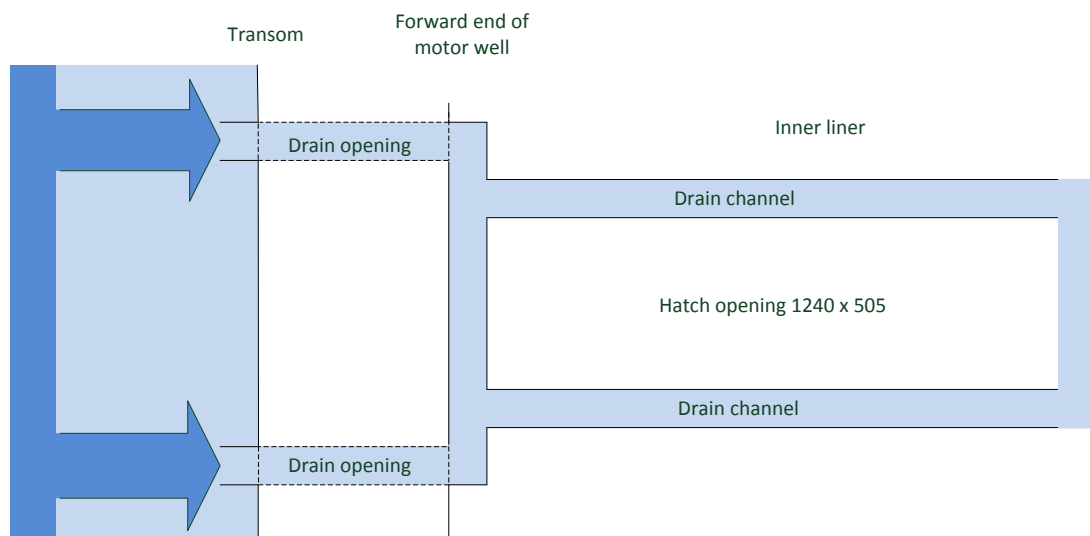
Figure 25: Schematic plan drawing of how the water ingressed. The AIBN believes that water accumulated in the drain channel around the hatch in the inner liner and, because the hatch cover was not watertight, the water flowed through the hatch opening (over the top of the coaming) into the space below the inner liner. The drawing is not to scale. The measurements are given in mm. Illustration: AIBN

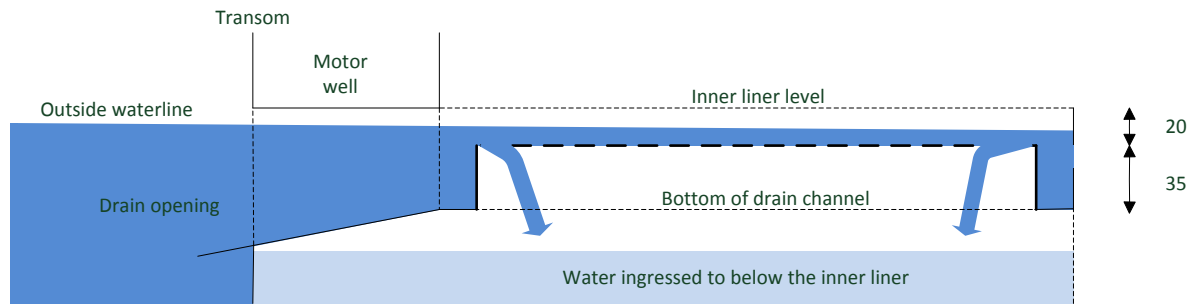
As water ingressed to the interior of the boat, the draught increased, further reducing the height from the water line to the top of the hatch coaming. This probably increased the speed of the water ingress. Because the drain channel was below the inner liner level, the guide and the fishing tourists did not notice what was happening.

Figure 26: Schematic outline of the sequence of events after the draught and trim had increased as a result of the ingress of water, so that the waterline was higher than the top of the hatch coaming. Illustration: AIBN

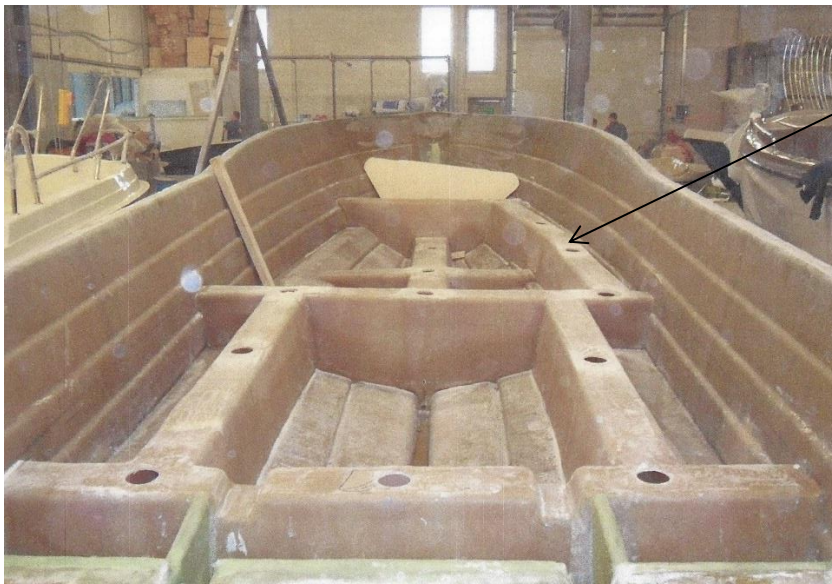
Moreover, the space under the inner liner was asymmetric as a consequence of the wheelhouse being located on the port side; see Figure 27. This asymmetry led to the boat heeling to port as the hull filled up with water.

Asymmetric stiffening and foaming of the hull

Figure 27: The photo shows the asymmetric hull structure, a consequence of the wheelhouse being located on the port side. Photo: Dolmøy Gjestebrygge AS

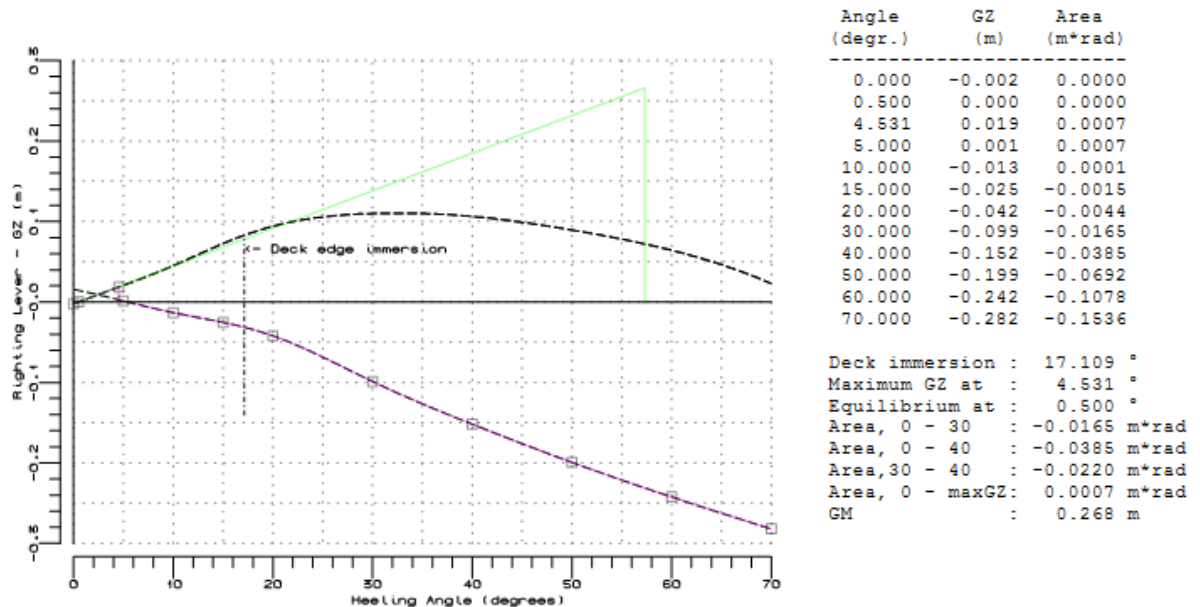
Because of the ingress of water the boat’s stability was gradually reduced, and with 1.0 tonne of water inside, its righting lever would have approached zero; see Figure 28. The risk of the boat capsizing was therefore high.

Figure 28: Righting lever (GZ) curve in the accident condition with 1.0 tonnes of water below the inner liner. In this condition the downflooding point is immersed at zero heeling angle, so the lower curve represents the boat’s actual GZ curve. Illustration: AIBN

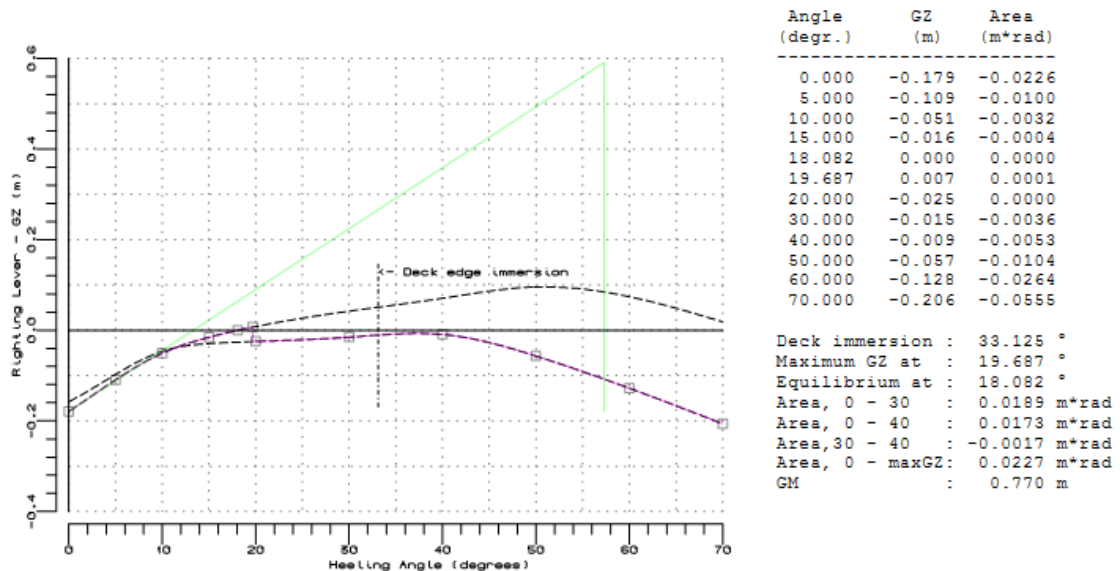
The AIBN's calculations show that the boat would have listed 18.08° had it been loaded in accordance with the manufacturer's load limits while carrying six persons on board and if they had all moved to the starboard side. Hence, in theory, the boat met the requirement for the maximum heeling angle (21.2°) resulting from such passenger movements. In practice, however, the boat's righting lever in this condition would have been so marginal as to cause it to capsize; see Figure 29. The calculations also show that the requirement for freeboard to the waterline (10 cm) of downflooding openings (both the drain openings and the threshold on the starboard side) would not have been met with 5, let alone 6, persons moving all the way to one side. Consequently, the boat would not have met the requirements set out in the Regulations of 20 December 2004 No 1820 on the Production and Placing on the Market of Recreational Craft, etc. with 6 (or even only 5) persons on board.

Figure 29: The craft's stability when loaded in accordance with the manufacturer's limits with six persons positioned on the starboard side. Illustration: AIBN

The marginal stability of the boat in this condition can be explained partly by the small amount of residual freeboard to the waterline of the downflooding openings and partly by a hard chine in the hull being lifted (23 cm) out of the water on the port side.
