REPORT

Marine 2017/03

REPORT ON MARINE ACCIDENT - COLLISION BETWEEN CLIPPER QUITO LAPW7 AND LURONGYU 71108 IN THE YELLOW SEA 12 OCTOBER 2015

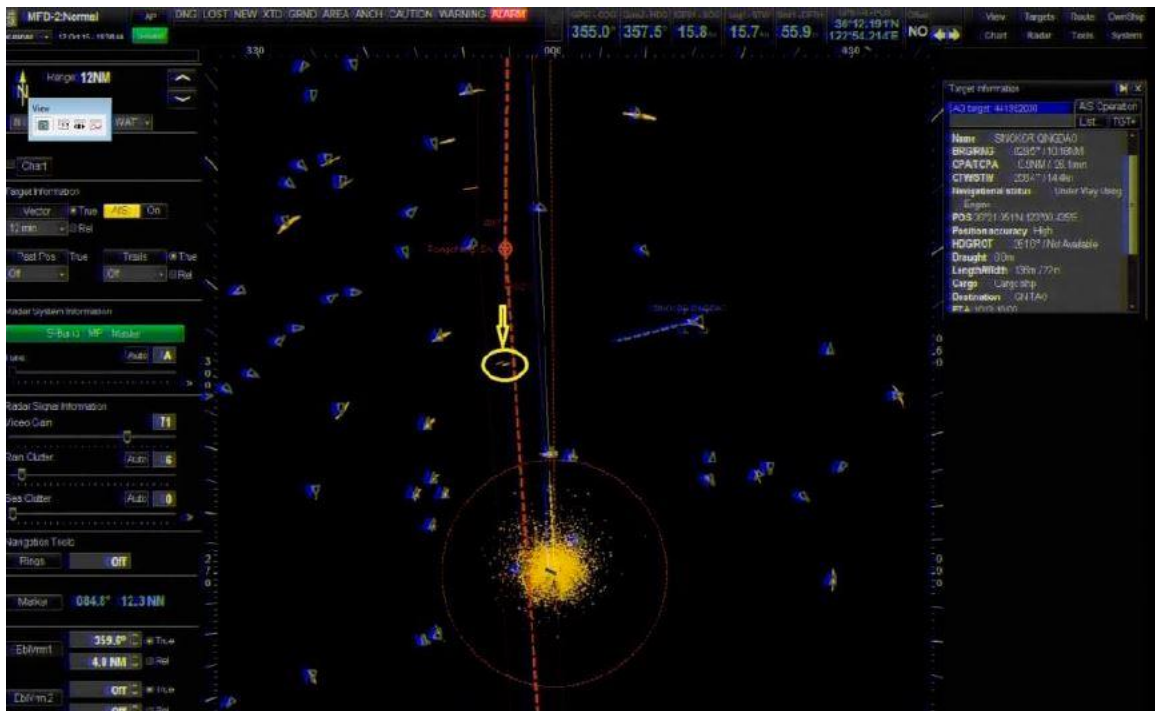
Figure 4: A radar image of the S-band radar at 19:40. The radar echoes of both ‘*Lurongyu 71108*’ and ‘*Lurongyu 52263*’ were approx. 7 nm away from *Clipper Quito*, and is marked with a yellow circle. VDR source: Solvang ASA

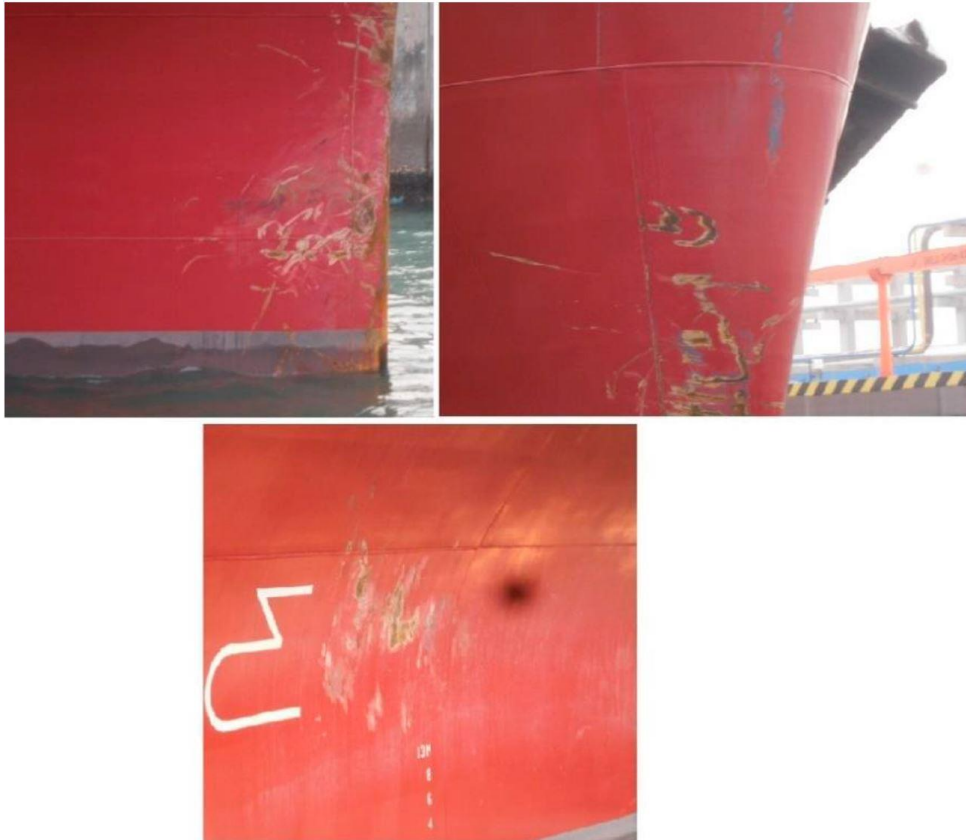
On the port side of the bow of *Clipper Quito*, there was a 15–20 mm deep dent of approximately 200 mm in diameter. Many scratch marks and blue paint marks could be seen at the bow and on both sides of the bow.

Figure 5: The photos show the marks/damage on both sides of 'Clipper Quito's' bow.
Photo: Solvang ASA
