REPORT

Marine 2018/06

REPORT ON WORK ACCIDENT ON BOARD THE NORMAND MAXIMUS OFF THE COAST OF BRAZIL ON 21 FEBRUARY 2017

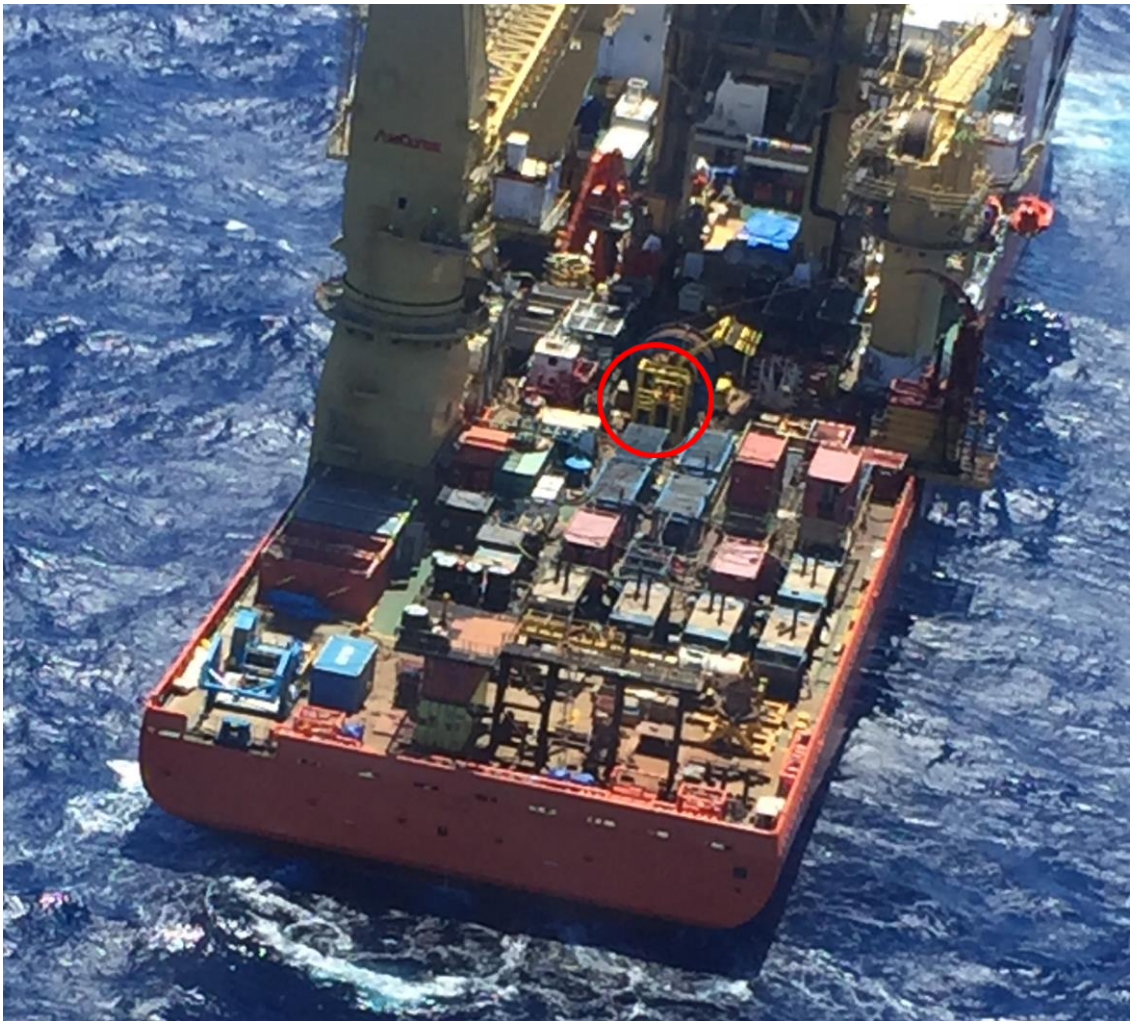
Figure 3: The system installed for use in the pre-commissioning assignment consisted of a number of components placed on the open aft deck of the CSV Normand Maximus. The accident site is marked with a red circle. Photo: The Brazilian Navy

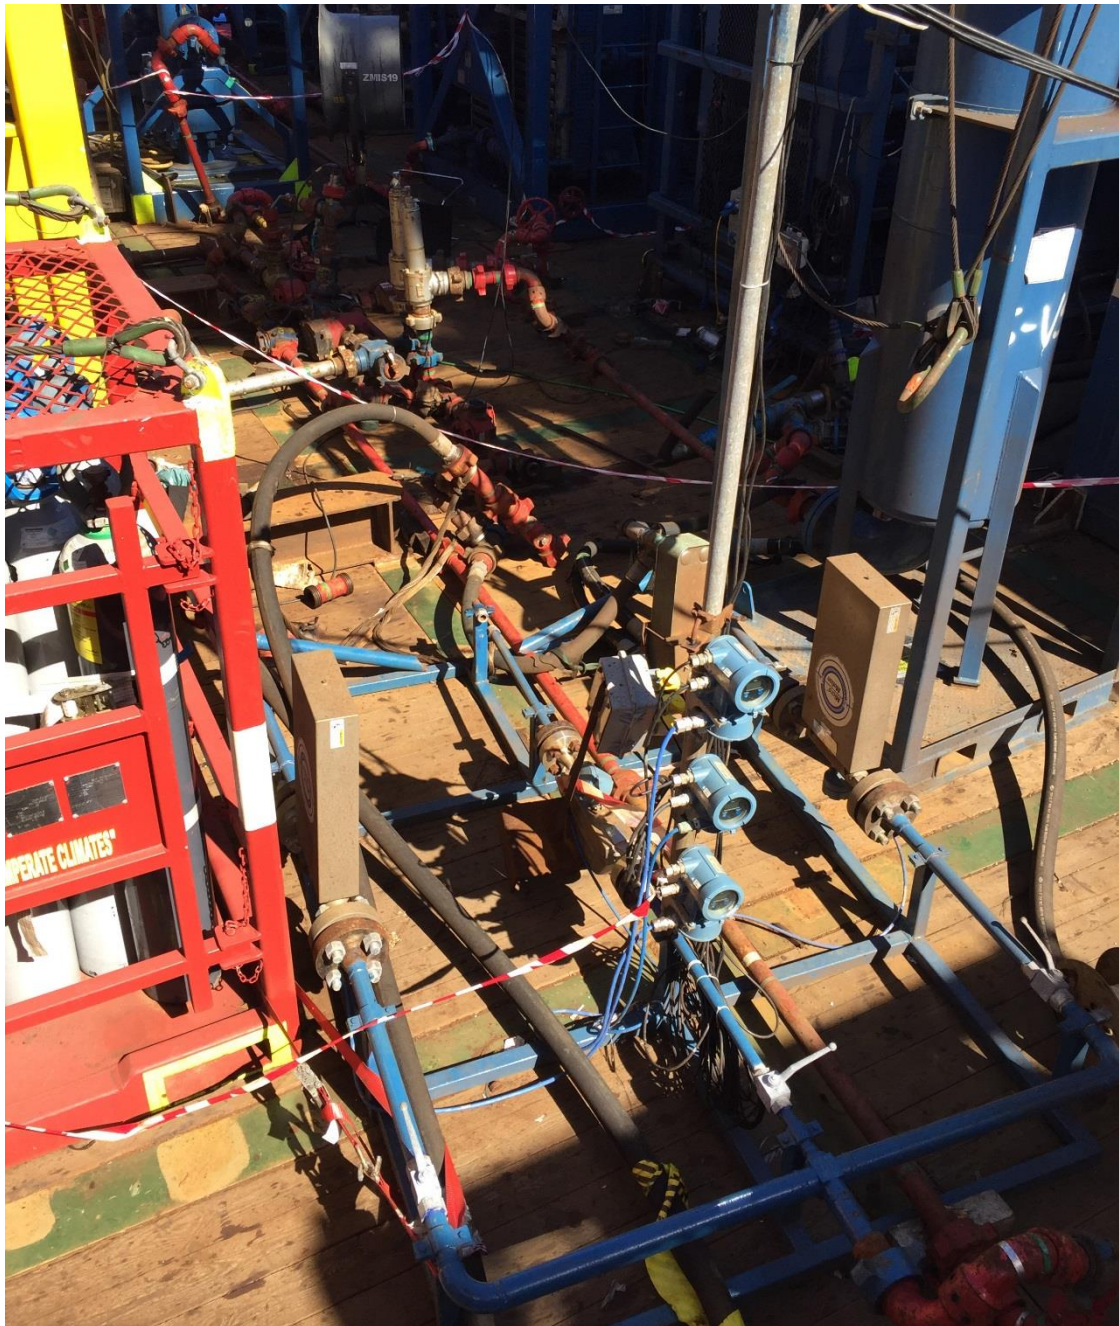
Figure 4: Pipes, hoses and valves placed between components on the open deck. Photo: The Brazilian Navy

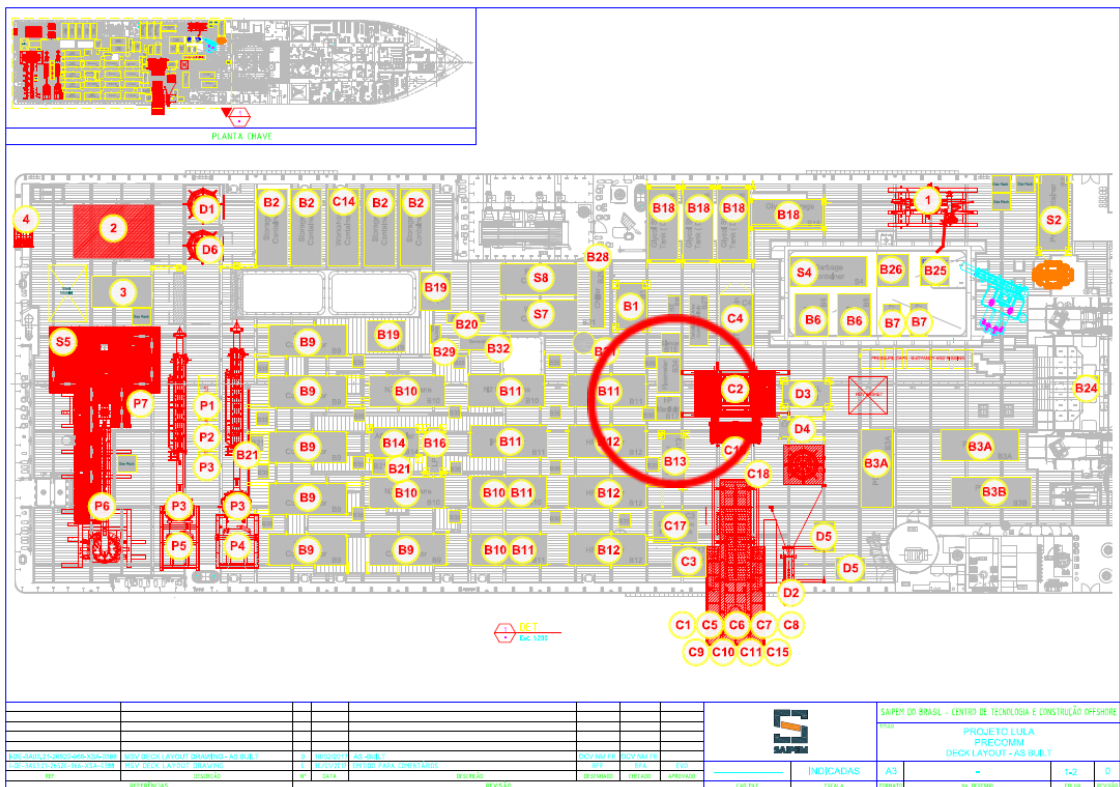
Figure 6: The layout of the main deck with all the components used during the operation. The accident site is marked with a red circle. Source: Solstad Offshore AS

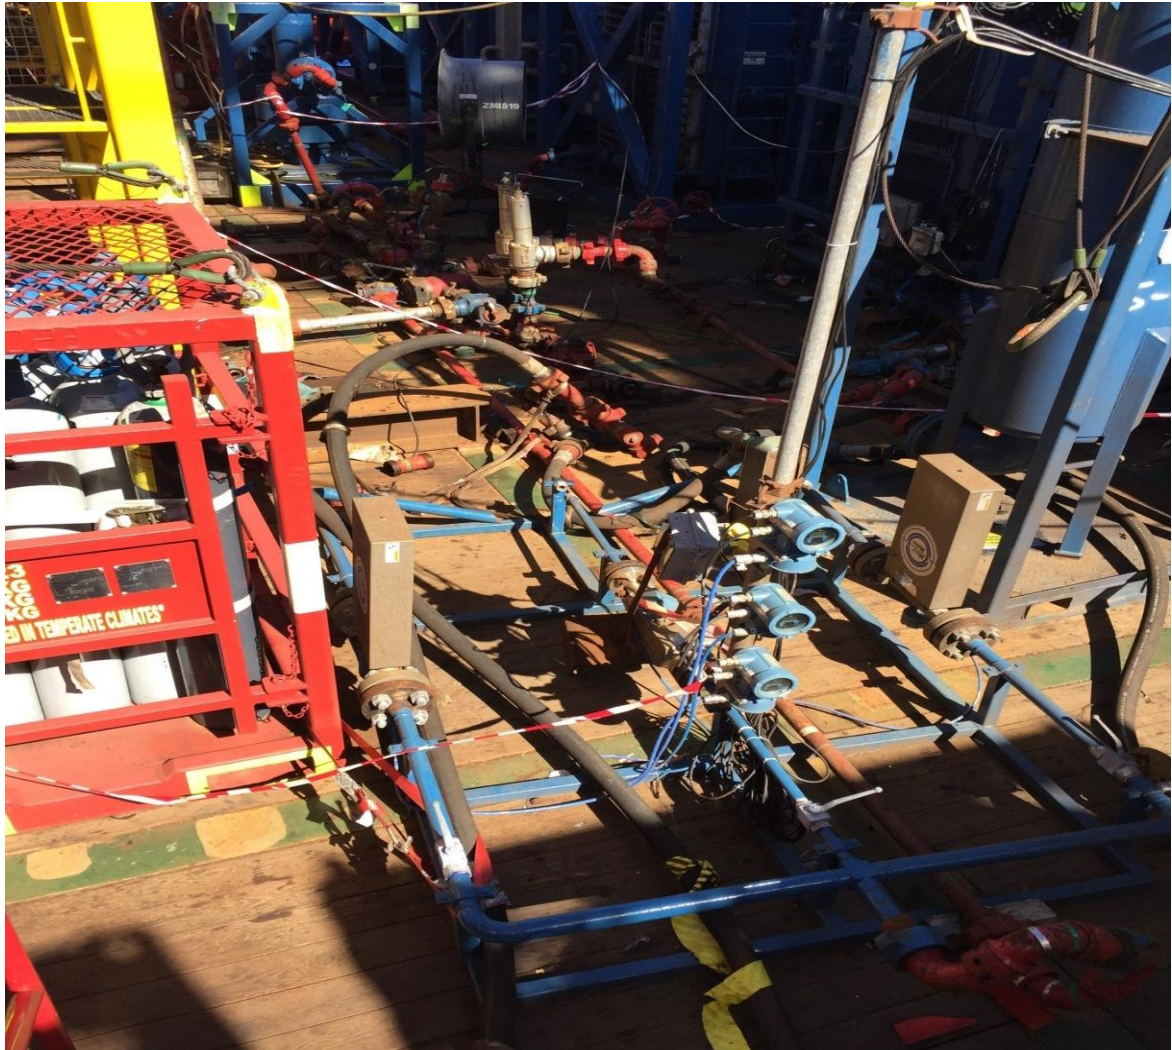
At 6:15 p.m. on February 21, 2017, during the MEG recovery process and pressure reduction of the underwater system, an accident occurred at the pre-commissioning facility positioned on the main deck of the vessel, causing one fatality and four injured. The pre-commissioning facility positioned on the main deck of the vessel is a temporary and independent installation.

Photo 2: Installation overview

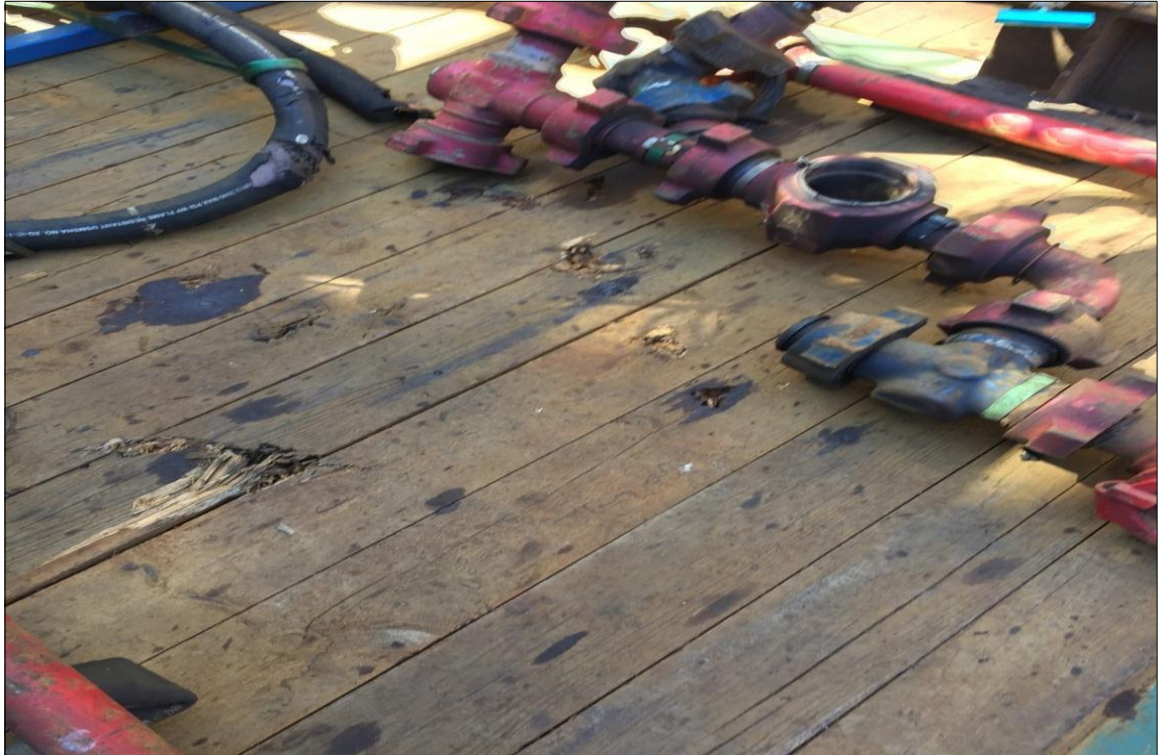
a) Several material broken and broken steel pipes; faulty locking and relief valves; high pressure hoses (2,500 psi capacity), belonging to the pre-commissioning system, were torn and with broken steel mesh;

Photo 3: Pre-commissioning system equipment

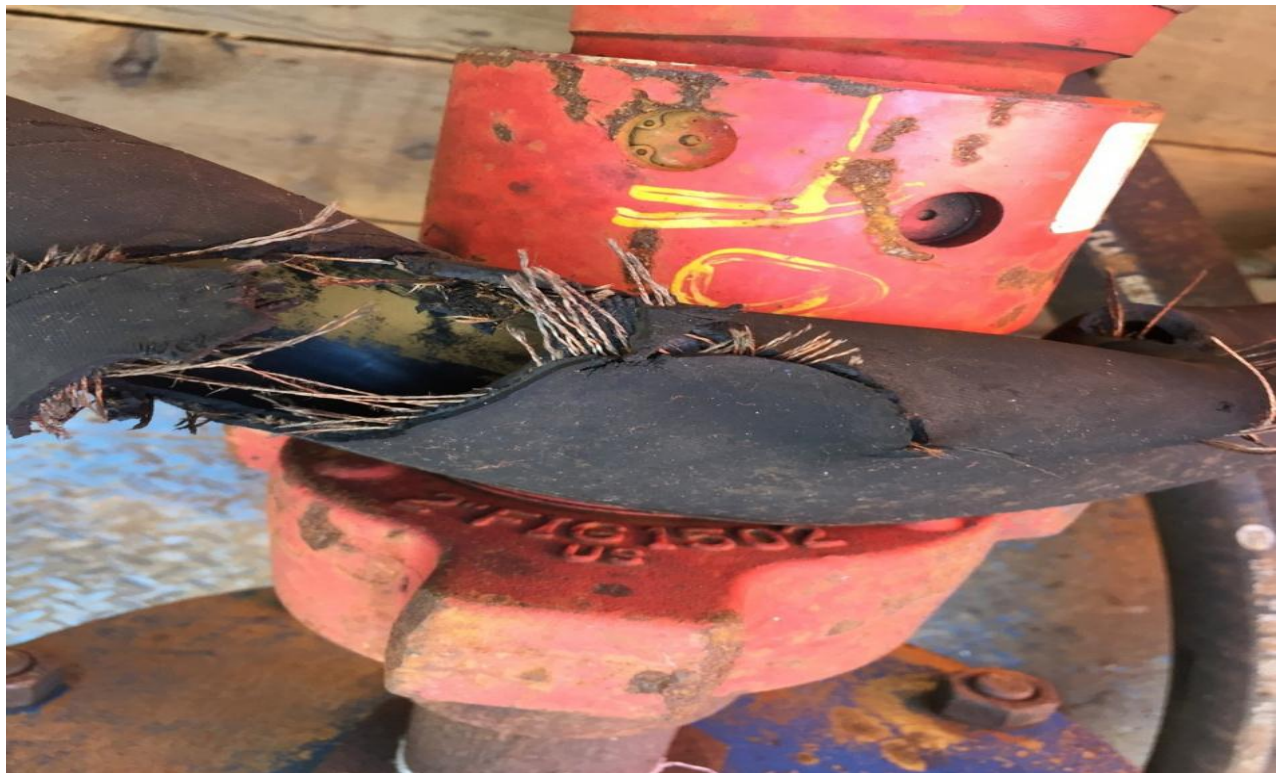
Photo 4: Faulty pre-commissioning system hoses

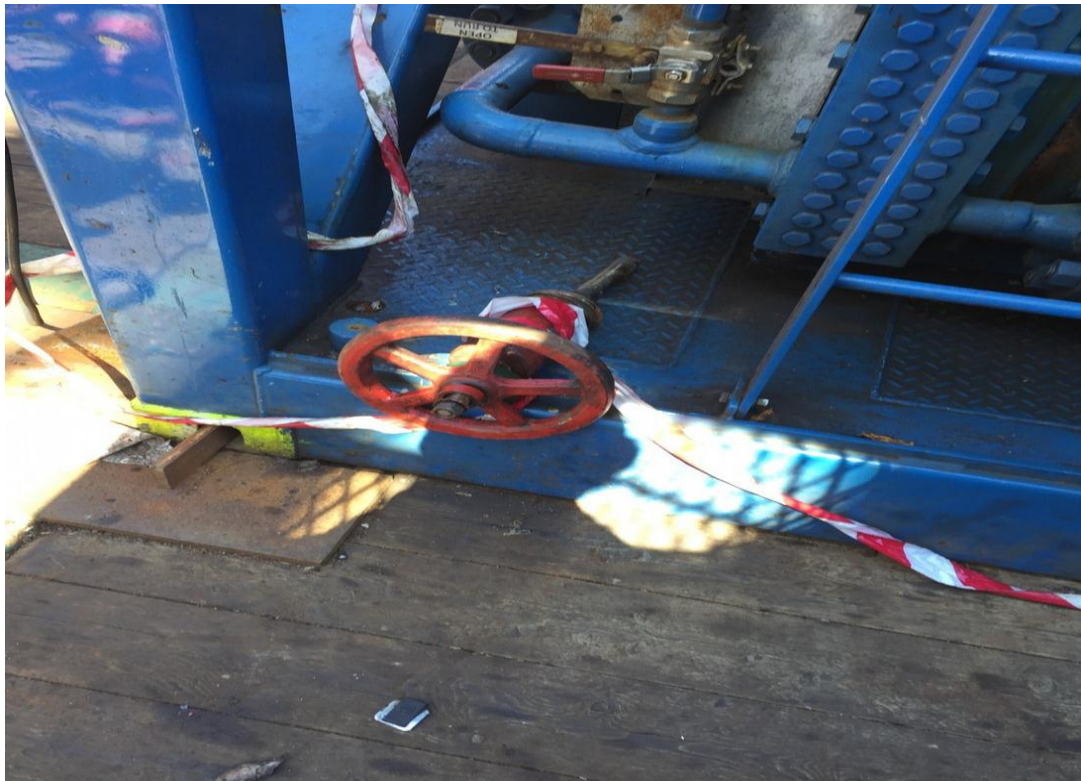
At the time of the accident, at 06:15 hours, the General Supervisor was positioned in front of the flow control valve and depressurising (choke valve), controlling the flow rate.

Photo 9: "Choke valve" failed

- The use of a manually actuated flow control and depressurising valve was the determining factor for the death of the General Supervisor, since his positioning in the operation was frontal to the valve and, when it was exploded, it was directly hit by the steering wheel of equipment, so was shown to be inadequate and fatal. For this type of system, equipment with remote actuation must be used in order to increase the individual protection of the operators.

- Valve commands and monitoring of local flow, temperature and pressure variables should be done remotely, in scanned and automatic form, to increase the individual protection of the equipment.
- It is essential that there are safety valves in the pre-commissioning installation, thus avoiding the occurrence of an accident caused by an excessive increase of pressure above the permitted limits.

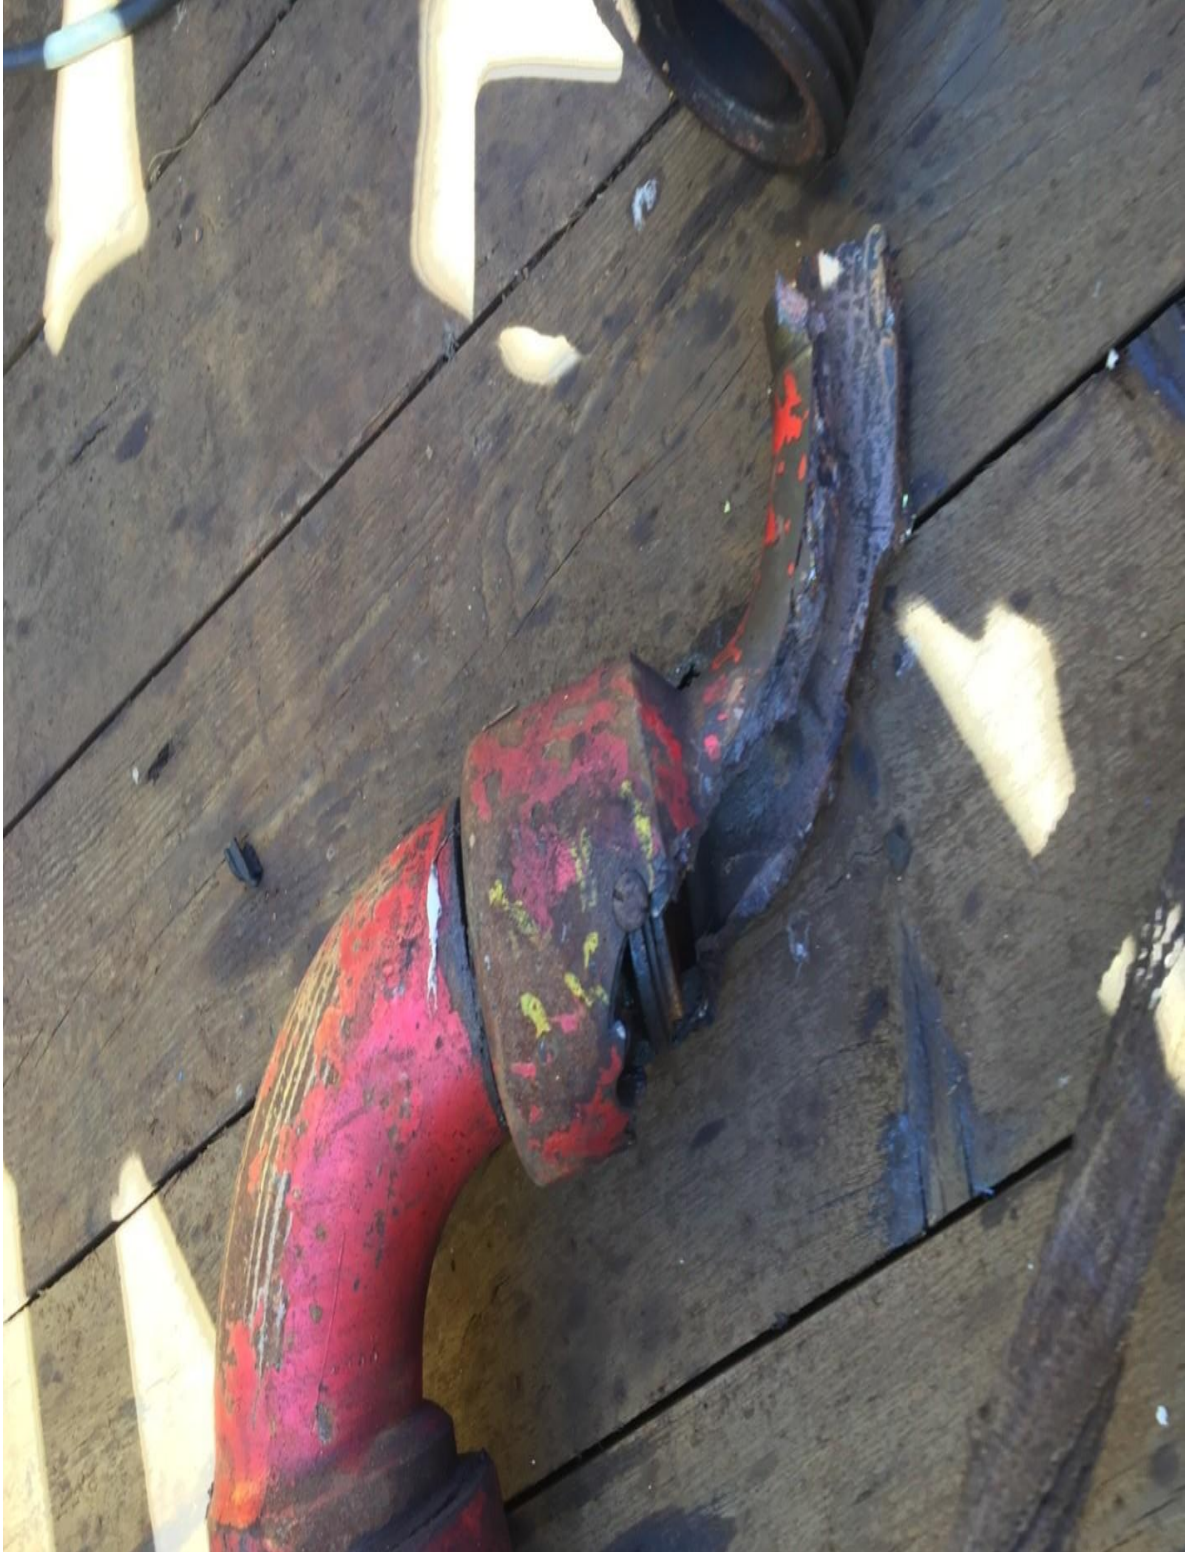
b) installation was without supports; the structures had no fixation and were loose, as well as pipes, valves and connections belonging to the system presented corrosion on their surfaces; two pressure and temperature loggers, members of the project scope (according to the approved procedure), were positioned on the main deck and not installed;

The inspection carried out by the investigators at the ship's facilities found that the vessel was not structurally damaged, nor were its organ systems damaged. The faults were restricted to the installation of the pre-commissioning system of the LULA EXTREMO SUL stretch 1 well lines, in the section installed provisionally on the main deck, aft section.

Photo 10: Faulty installation (1)
