Statens
Havarikommisjon
for Transport

Sjø 2018/06

RAPPORT OM ARBEIDSULYKKE OM BORD I NORMAND MAXIMUS UTENFOR KYSTEN AV BRASIL 21. FEBRUAR 2017

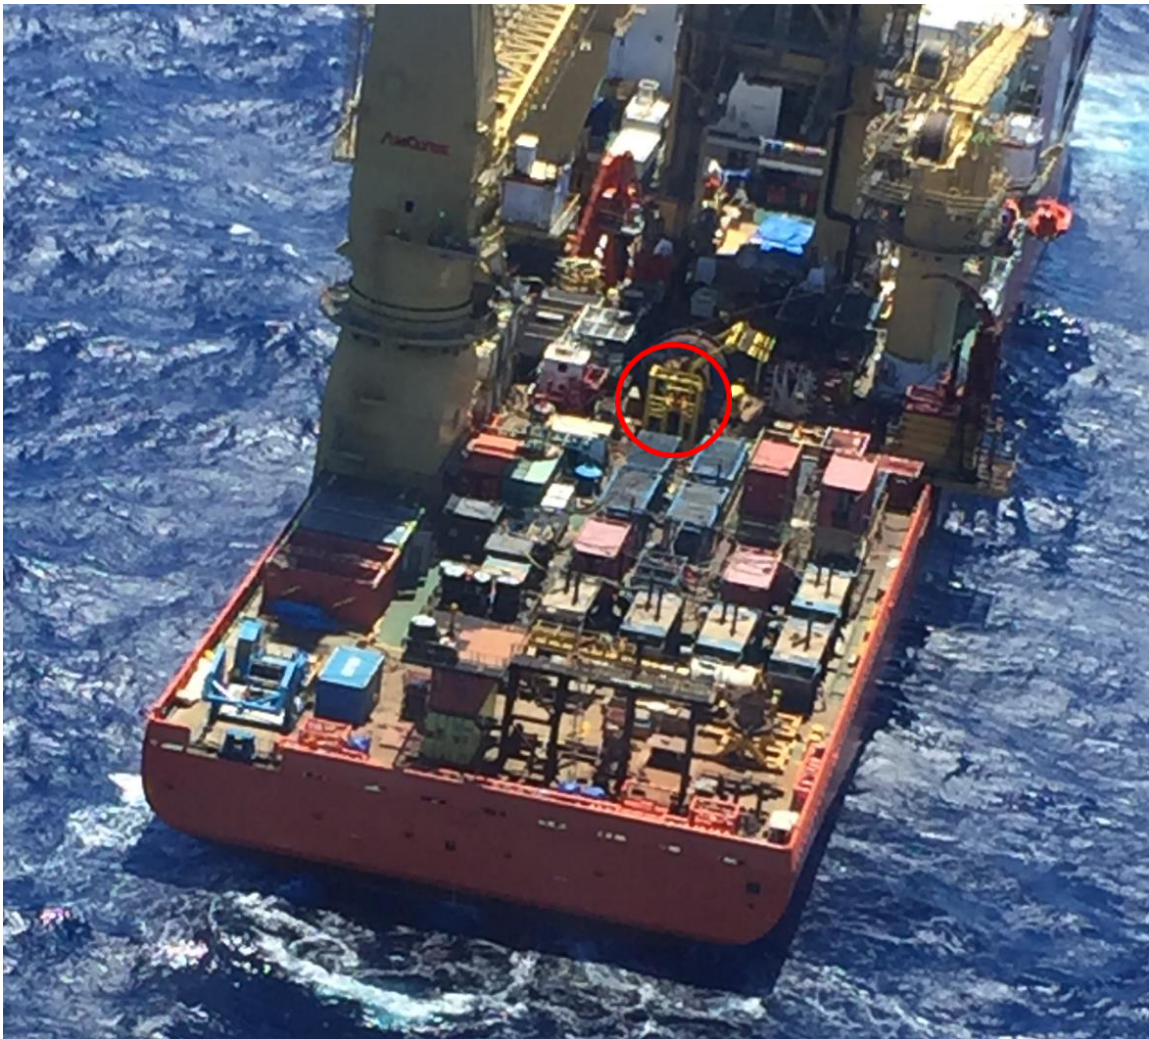
Figur 3: Installasjonen av anlegget for gjennomføring av pre-commissioning oppdraget besto av en rekke komponenter på det utvendige dekket akterut om bord i CSV Normand Maximus. Ulykkesområde er merket med en rød ring. Foto: Brazilian Navy

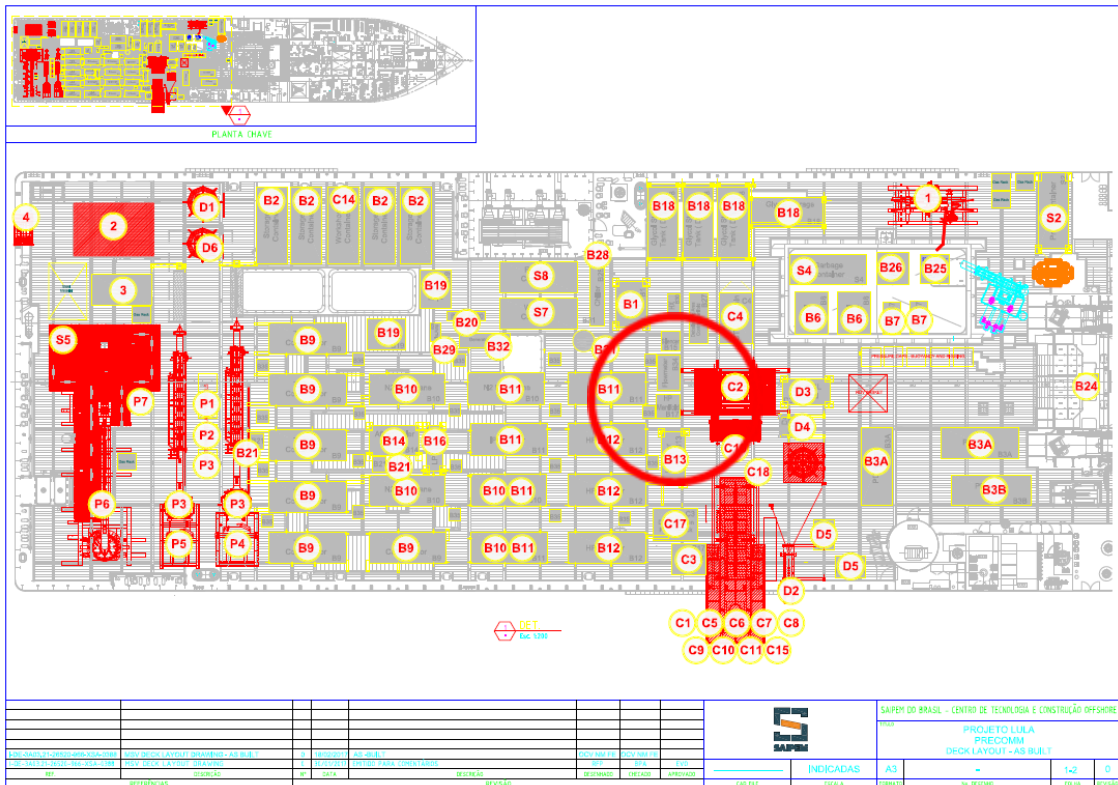
Figur 6: Layout av hoveddekket med inntegning av alle komponentene som var i bruk i operasjonen. Ulykkesområde er merket med en rød ring. Kilde: Solstad Offshore AS

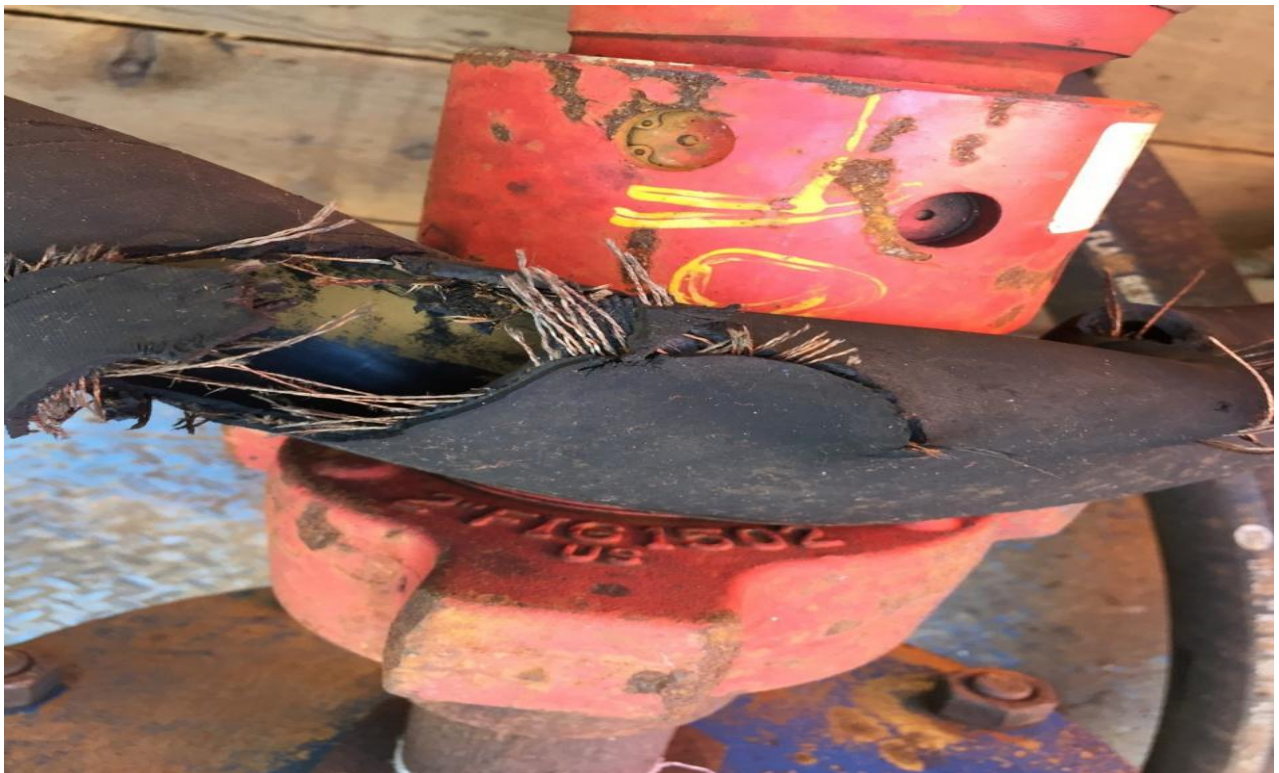
a) Several material broken and broken steel pipes; faulty locking and relief valves; high pressure hoses (2,500 psi capacity), belonging to the pre-commissioning system, were torn and with broken steel mesh;

Photo 4: Faulty pre-commissioning system hoses

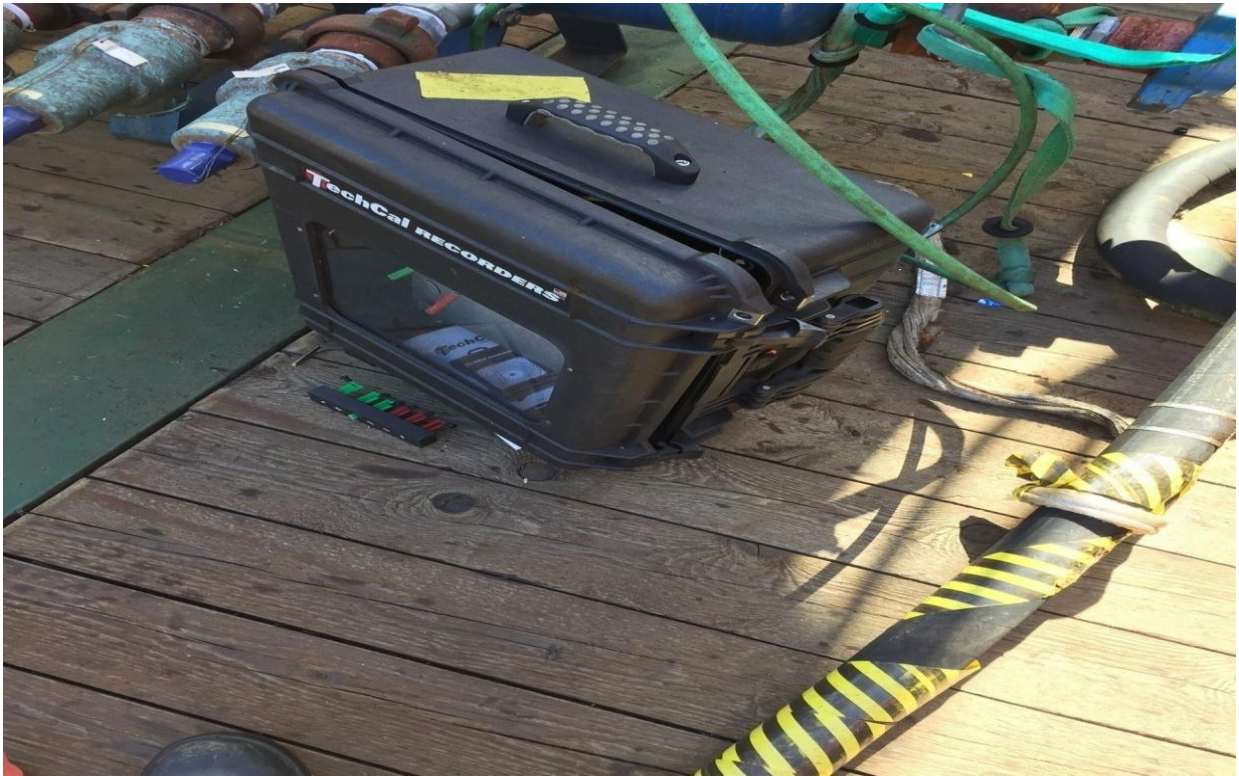
Photo 5: Pressure and temperature recorders not installed

b) installation was without supports; the structures had no fixation and were loose, as well as pipes, valves and connections belonging to the system presented corrosion on their surfaces; two pressure and temperature loggers, members of the project scope (according to the approved procedure), were positioned on the main deck and not installed;

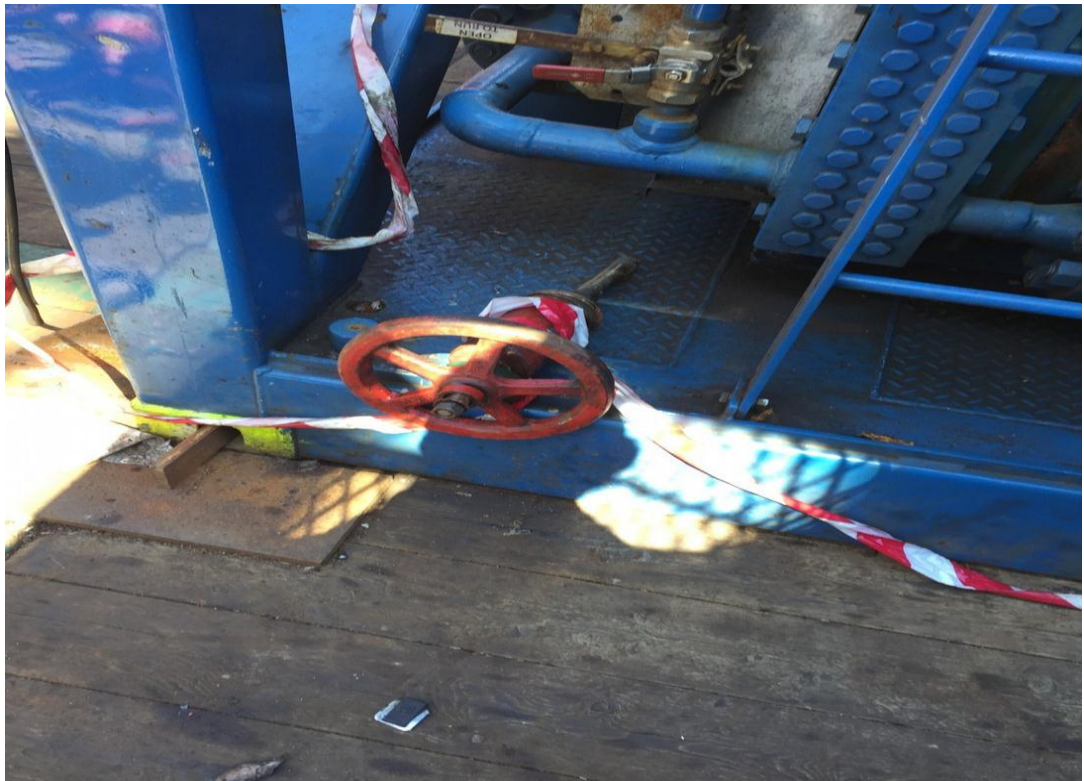
At the time of the accident, at 06:15 hours, the General Supervisor was positioned in front of the flow control valve and depressurising (choke valve), controlling the flow rate.

Photo 9: "Choke valve" failed

- The use of a manually actuated flow control and depressurising valve was the determining factor for the death of the General Supervisor, since his positioning in the operation was frontal to the valve and, when it was exploded, it was directly hit by the steering wheel of equipment, so was shown to be inadequate and fatal. For this type of system, equipment with remote actuation must be used in order to increase the individual protection of the operators.

- Valve commands and monitoring of local flow, temperature and pressure variables should be done remotely, in scanned and automatic form, to increase the individual protection of the equipment.
- It is essential that there are safety valves in the pre-commissioning installation, thus avoiding the occurrence of an accident caused by an excessive increase of pressure above the permitted limits.

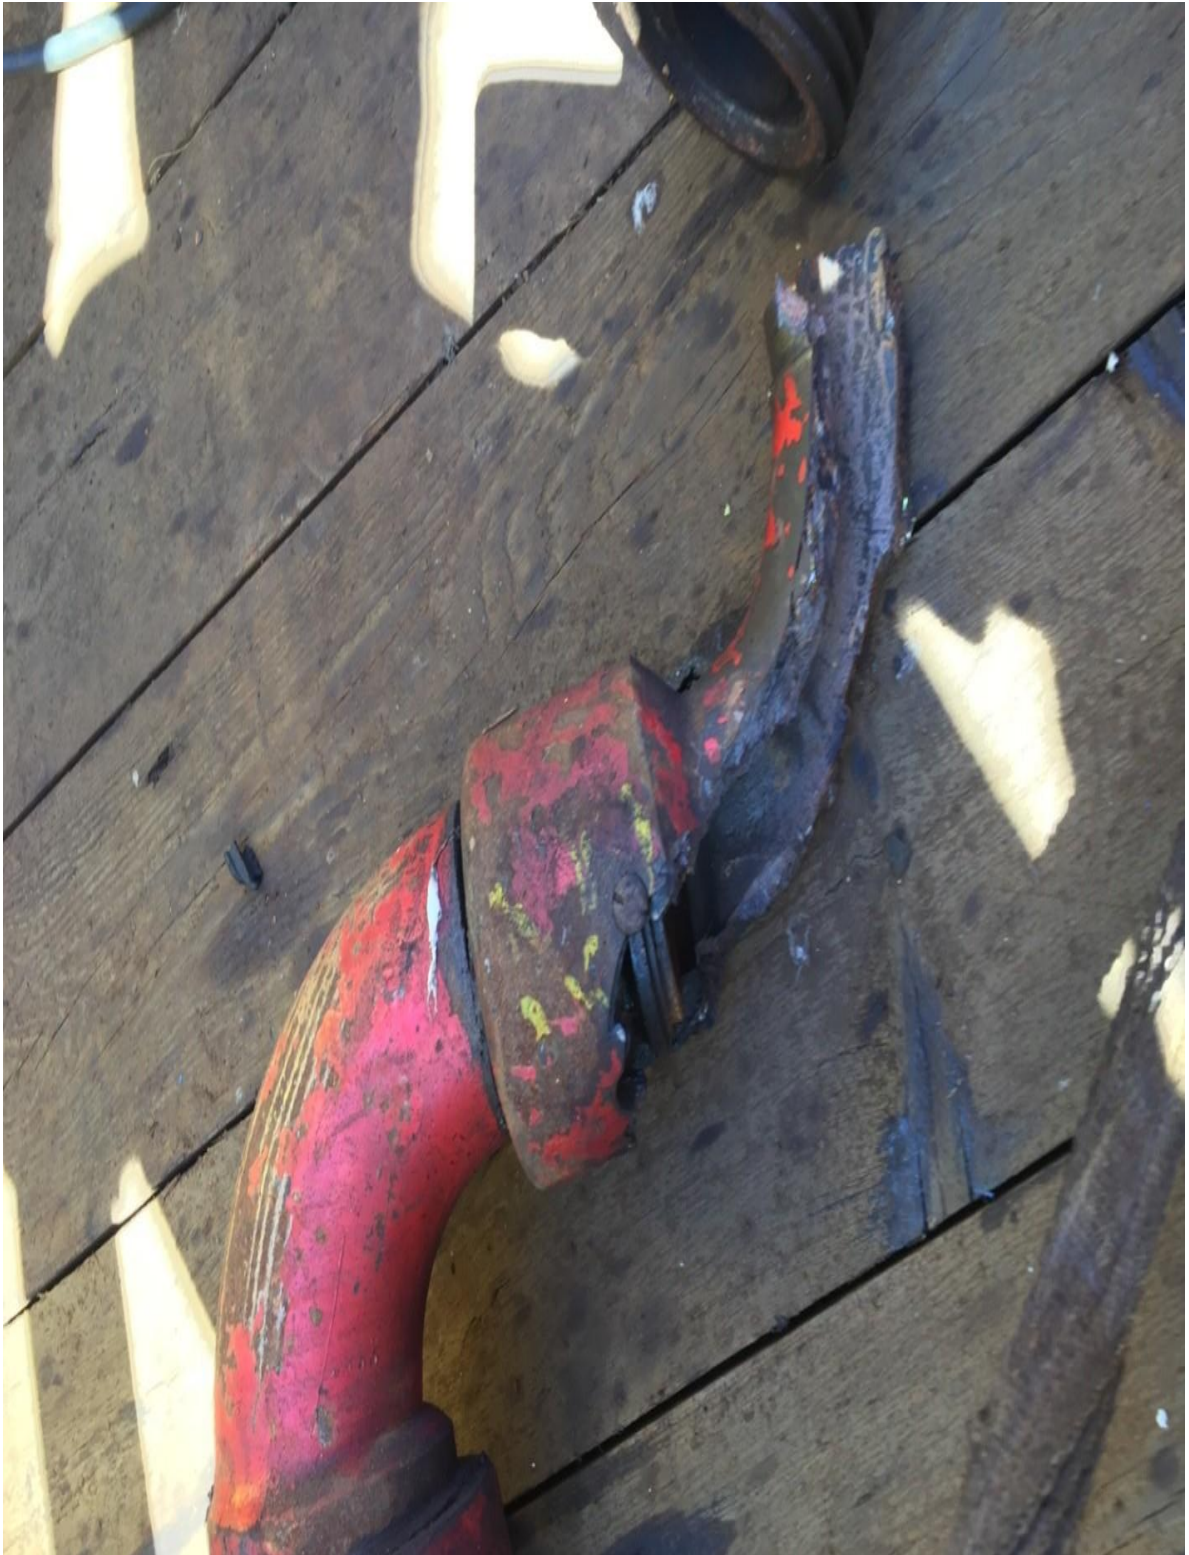
The inspection carried out by the investigators at the ship's facilities found that the vessel was not structurally damaged, nor were its organ systems damaged. The faults were restricted to the installation of the pre-commissioning system of the LULA EXTREMO SUL stretch 1 well lines, in the section installed provisionally on the main deck, aft section.

Photo 10: Faulty installation (1)

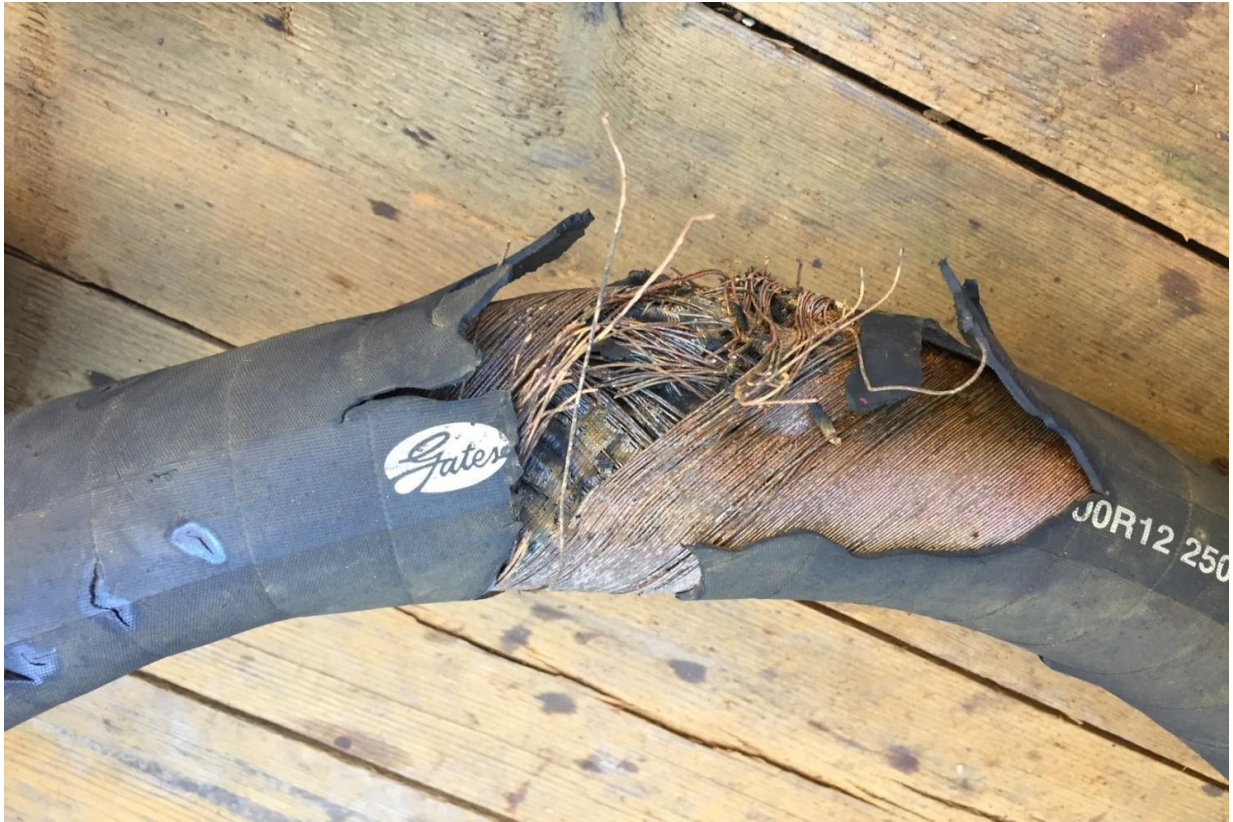
Photo 11: Faulty installation (2)
