REPORT

Marine 2019/03

REPORT ON MARINE ACCIDENT – AURORA EXPLORER, IMO NO. 9196723 ALLISION WITH QUAY AND PASSENGER INJURIES, BARENTSBURG, SVALBARD 15 JULY 2018

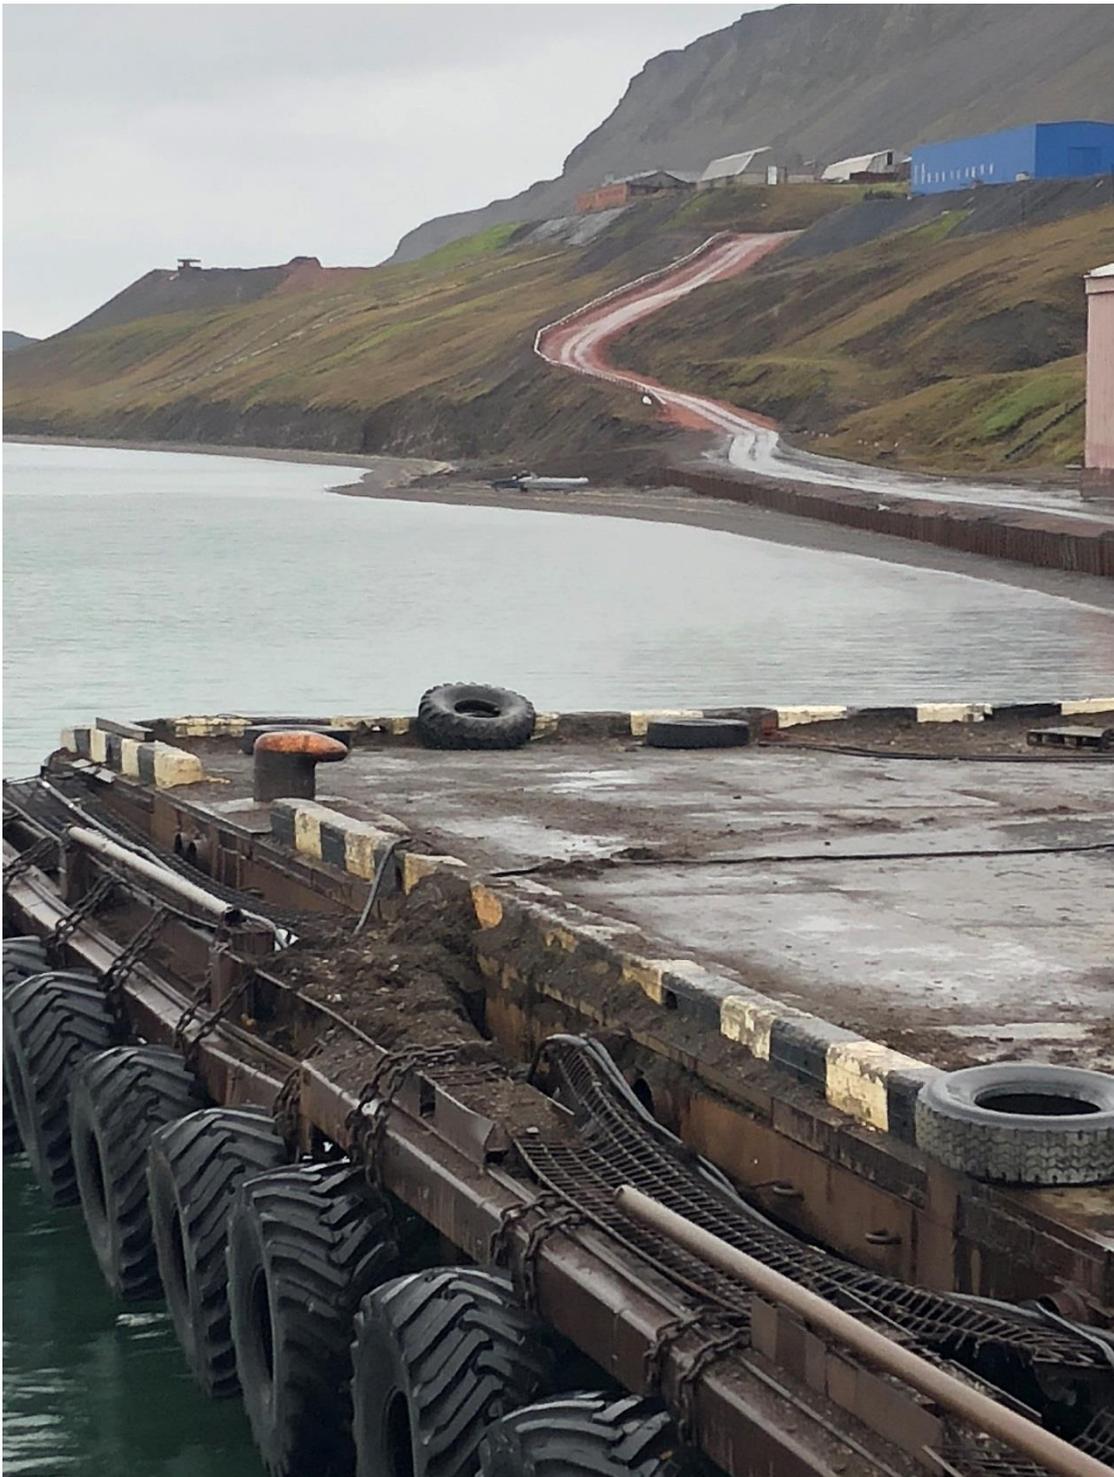
According to the master, speed was reduced to around 3 knots. Around 10-20 metres from the quay, the port engine suddenly increased power. The vessel swung uncontrollably to starboard, which led to the starboard foredeck colliding with the fenders (large rubber tyres) on the concrete quay.

Figure 3: Quay and fender arrangement at the relevant quay in Barentsburg, Svalbard.
Photo: AIBN

The submerged part of the starboard hull (the rapier) passed in under the quay. The collision led to passengers and crew being thrown forwards on the open deck and in the saloon below. The vessel sprang back from the fenders after impact, causing people to be thrown about again. The master disengaged both engines immediately after the collision. When he then re-engaged them in combinator mode, the engine, steering and manoeuvre handles functioned normally. *Aurora Explorer* was then moored with her starboard side against the quay. The collision caused injuries of varying severity to 37 passengers and

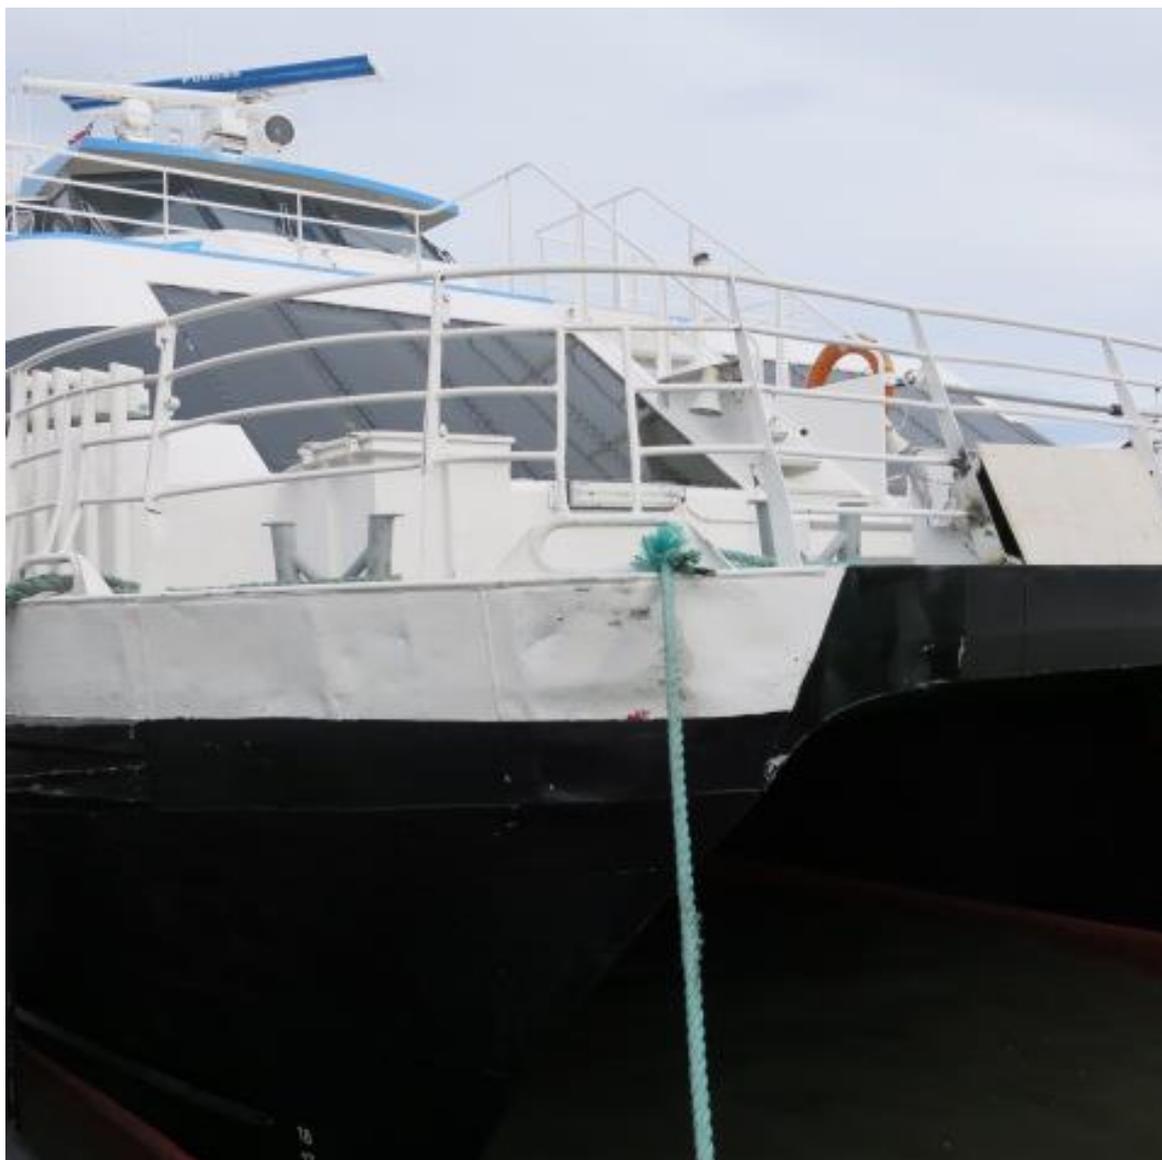
When the port engine increased power, the vessel swung to starboard and the starboard side of the hull took the force of the collision with the fender on the quay. The vessel suffered only minor damage above the waterline, with no water ingress. No emissions/pollution of the sea were recorded.

*Figure 4: Aurora Explorer at the quay in Longyearbyen after the collision. The collision with the quay in Barentsburg caused only minor damage to the starboard hull and searchlight.
Photo: AIBN*

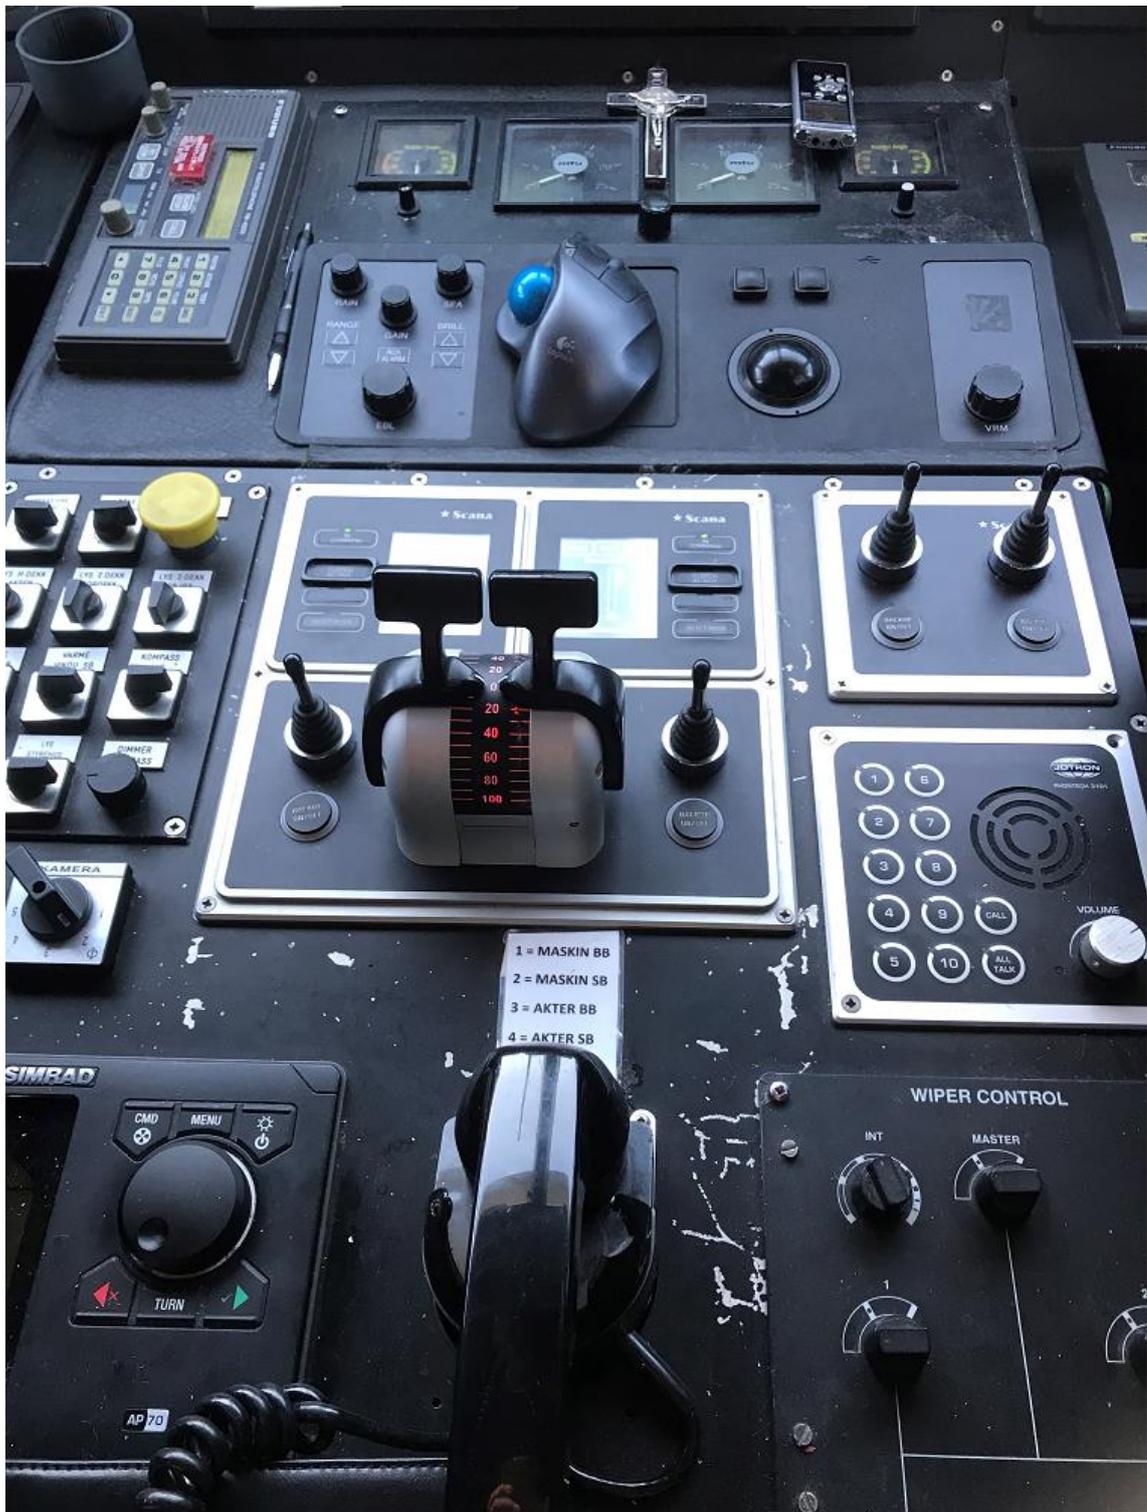
Figure 5: The manoeuvre console on board Aurora Explorer. Photo: AIBN

unavailable. In Figure 5, which shows the manoeuvre console, joysticks can be seen on each side of the manoeuvre handles. If back-up mode was selected on one or both of the drive lines, pitch was controlled by the joystick, while rpm was controlled with the manoeuvre handle. Pitch ahead would increase if the joystick was pushed forward, and pitch astern would be increased if the joystick was moved backwards. Rpm/total output increased if the manoeuvre handle was moved forward. Rpm/total output would be at its lowest when the manoeuvre handle was at the null point and would increase again if the handle was then moved backwards.

Brunvoll Mar-El AS confirmed to the AIBN that when the manoeuvring system is set to back-up mode and pitch is selected ahead or astern with the joystick, then the manoeuvre handle's only effect, whether it is moved to ahead or astern, will be to increase power (rpm).

The Norwegian Maritime Authority therefore introduced an extra cover, as an immediate precaution, to exclude the possibility of unintentional use.

The Norwegian Maritime Authority introduced an immediate precaution, where the buttons for constant rpm on the manoeuvre console are protected by an extra cover to exclude the possibility of error.
