REPORT

ROAD 2015/02

REPORT ON FIRE IN A HEAVY GOODS VEHICLE IN THE GUDVANGA TUNNEL ON THE E16 ROAD IN AURLAND ON 5 AUGUST 2013

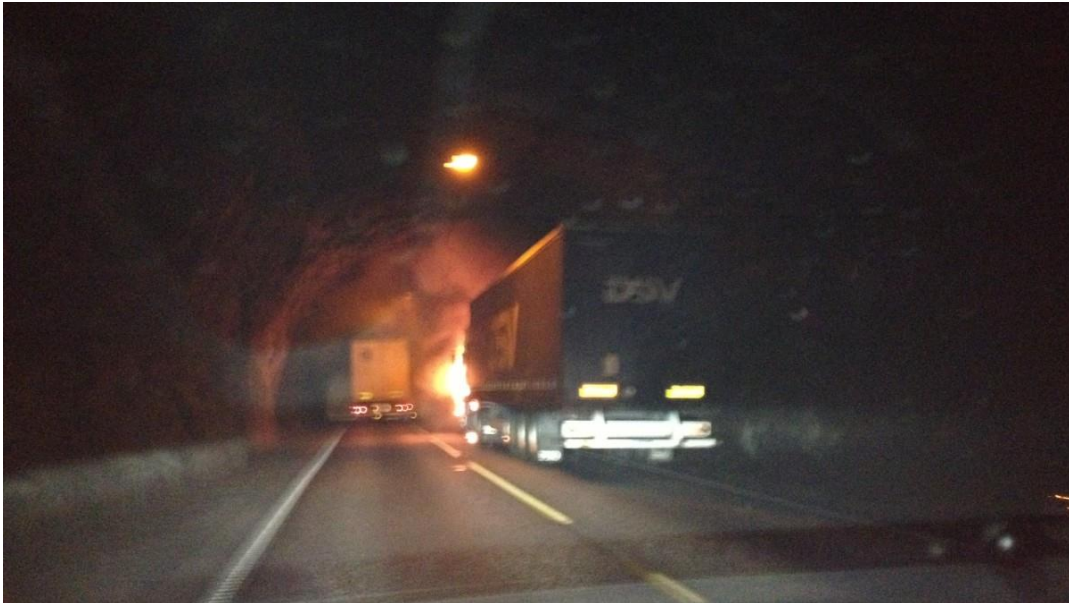
He pulled in to the right, turned on the hazard warning lights and came out of the vehicle. That was when he saw flames below the driver's cabin on the left side. The driver first tried to put out the fire using a 6 kg fire extinguisher that he had in the vehicle, but could not do so before the extinguisher was empty. He then tried to get hold of more fire extinguishers, but none of the other vehicles close by had any available. Nor were there any fire extinguishers in the tunnel near the place where the vehicle had stopped. When interviewed by the police, the driver said that he had asked people in the nearest vehicles to notify the police and the ambulance and fire services.

Figure 2: The heavy goods vehicle in an early phase of the fire. Photo: Monika Blikås

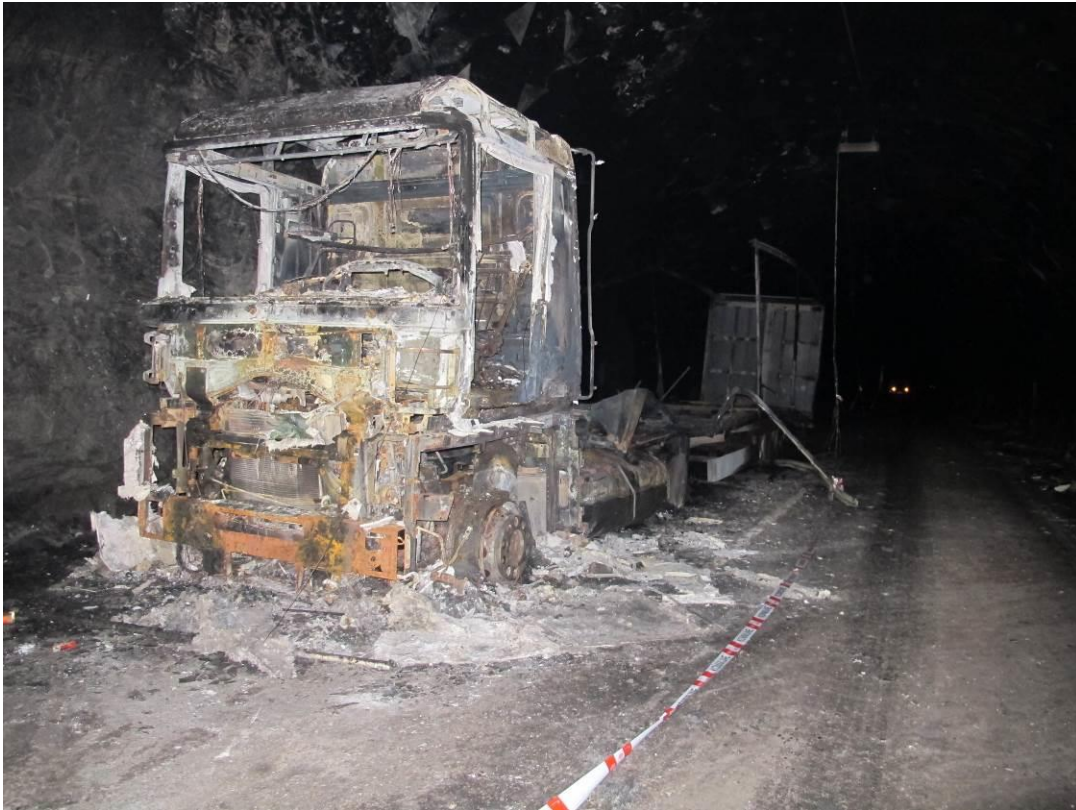
Figure 3: The heavy goods vehicle after the fire in the Gudvanga tunnel. Photo: the AIBN

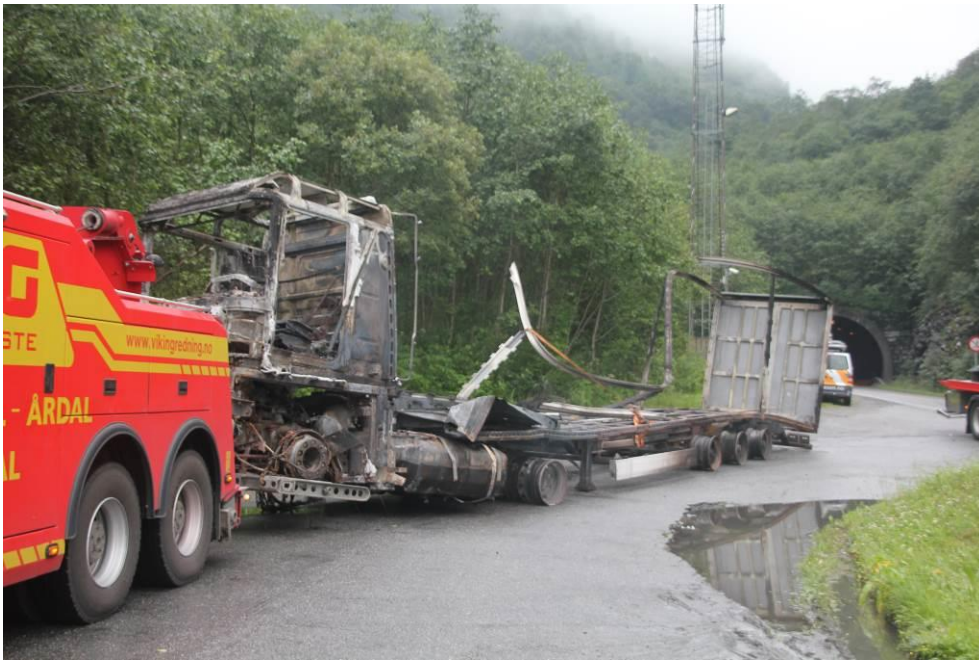
The fire in the heavy goods vehicle started in the engine compartment on the left side of the engine. It developed rapidly and spread to the whole vehicle in the course of approximately 20 minutes. When the fire service had extinguished the fire after approximately 55 minutes, the whole vehicle was burnt out. Only incombustible materials remained. Figure 6 shows the heavy goods vehicle after it had been pulled out of the tunnel.

Figure 6: The heavy goods vehicle after it had been pulled out of the tunnel. Photo: the NPRA

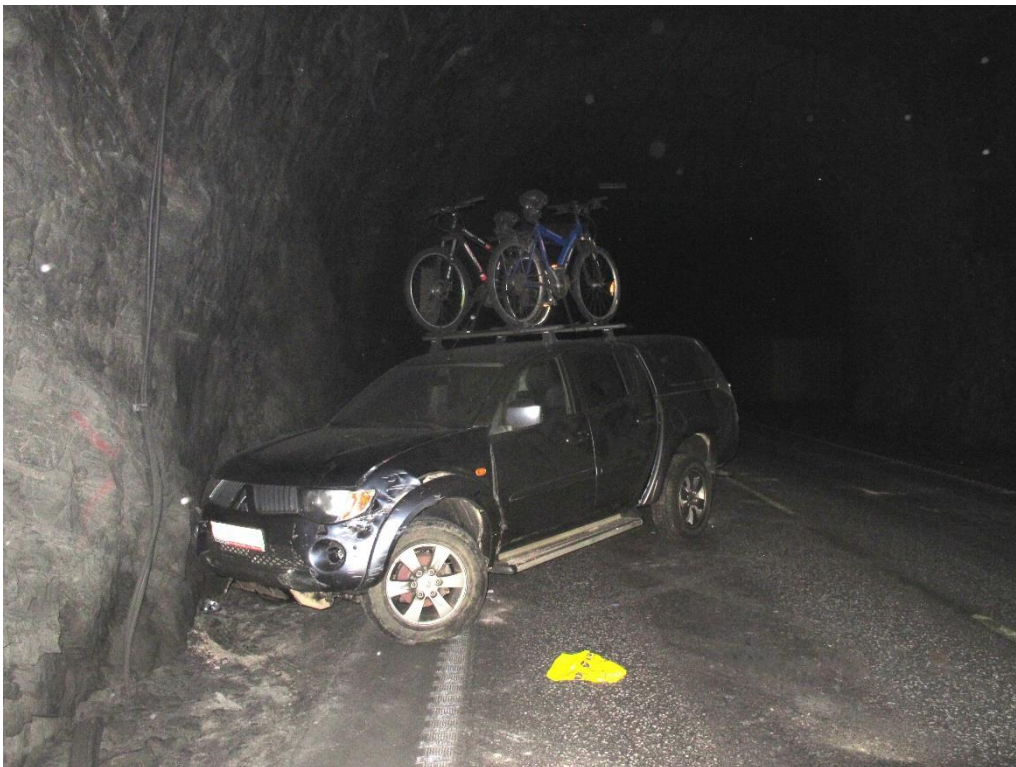
The other vehicles that were left in the tunnel as the fire developed were covered in soot. Some of them also had internal soot and smoke damage. Several drivers tried to evacuate by driving out of the tunnel. Due to minimal visibility, several cars hit the tunnel wall, which caused extensive external damage to some of them.

Figure 7: One of 16 vehicles that were left in the tunnel, approximately 7.8 km from the tunnel entrance at Gudvangen. Photo: the AIBN

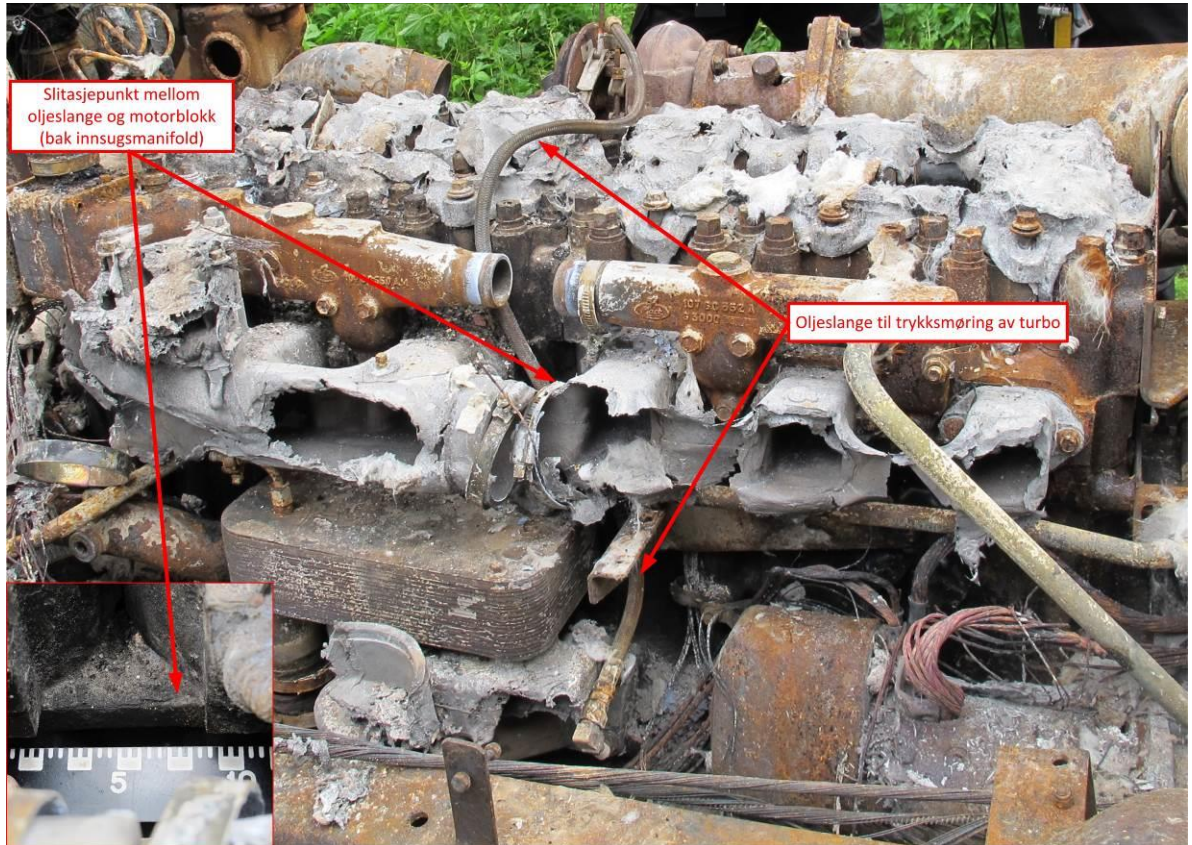
During the examination to determine the possible cause of the fire, two wear holes were found in the braided protection around the pressure hose feeding oil to the turbo. This line leads from the oil cooler to the turbo and passes through the gap between the intake manifold and the engine block, see Figure 9.

Figure 9: The pressure hose between the oil cooler and the turbo. The inset photo shows the point on the engine block against which the hose had rubbed. Photo: the AIBN

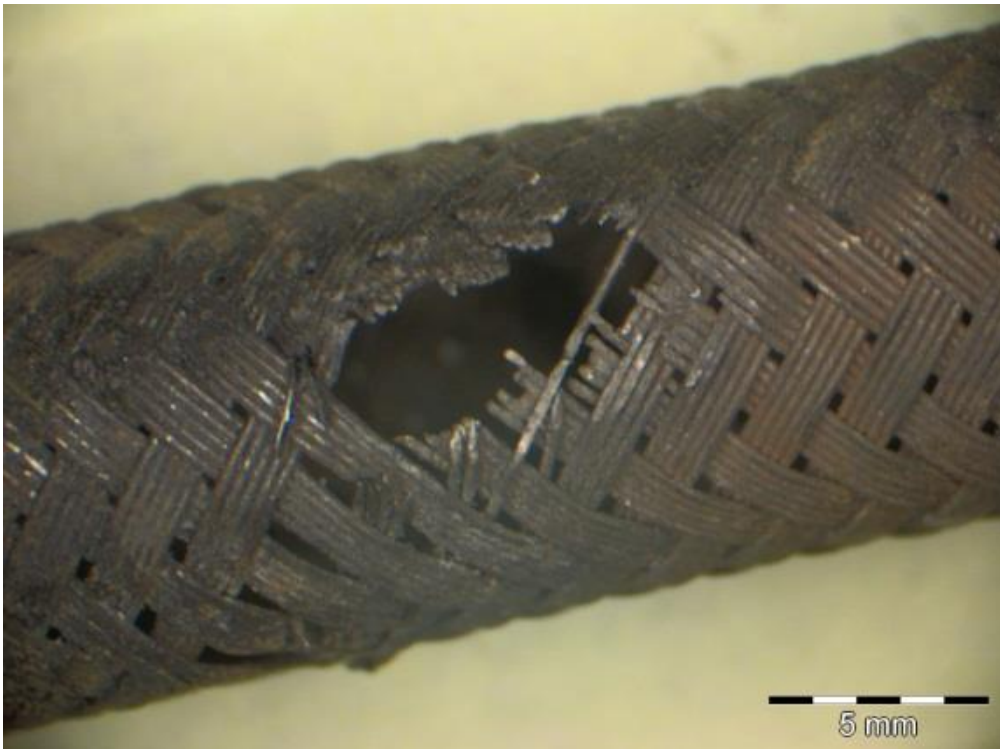
One of the holes in the steel braiding was approximately 10 mm long and 5 mm wide. The other hole was approximately 4 mm long and 1 mm wide. Between these holes, the steel braiding had been partially worn away, but there were no holes in the braiding in this area. The whole length of hose inside the braiding had burnt up.

Figure 10: Close-up photo of a wear hole in the braided protection. Photo: the police

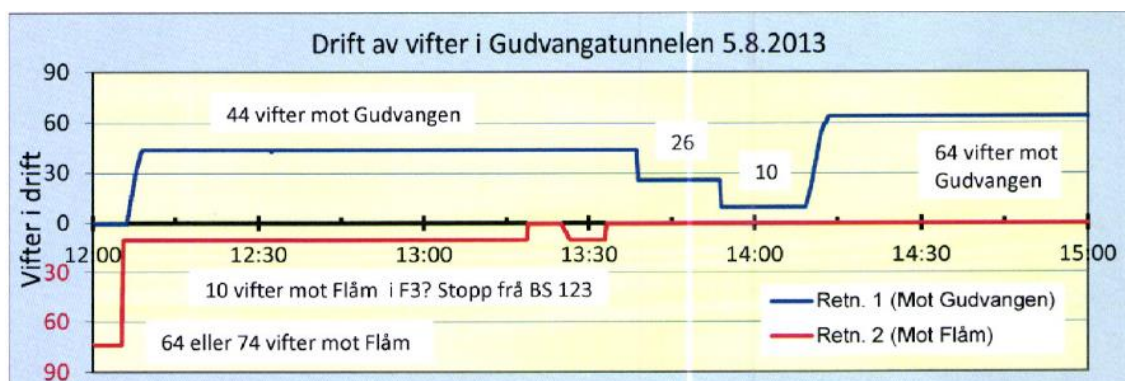
When the ventilation direction was reversed, 44 of the fans started blowing air towards Gudvangen, while 10 fans continued to blow air towards Aurland. These ten fans continued to blow air towards Aurland for about one and a half hours after the ventilation direction had been reversed towards Gudvangen. When the ventilation direction was reversed, the air flow rate was reduced from approximately 3 m/sec in the direction of Aurland to approximately 2 m/sec in the direction of Gudvangen. During the period between 13:00 and 13:30, the average air flow rate towards Gudvangen was 2.48 m/sec, see Figure 15.

Figure 14: Operation of the fans in the Gudvanga tunnel on 5 August 2013. Source: the NPRA

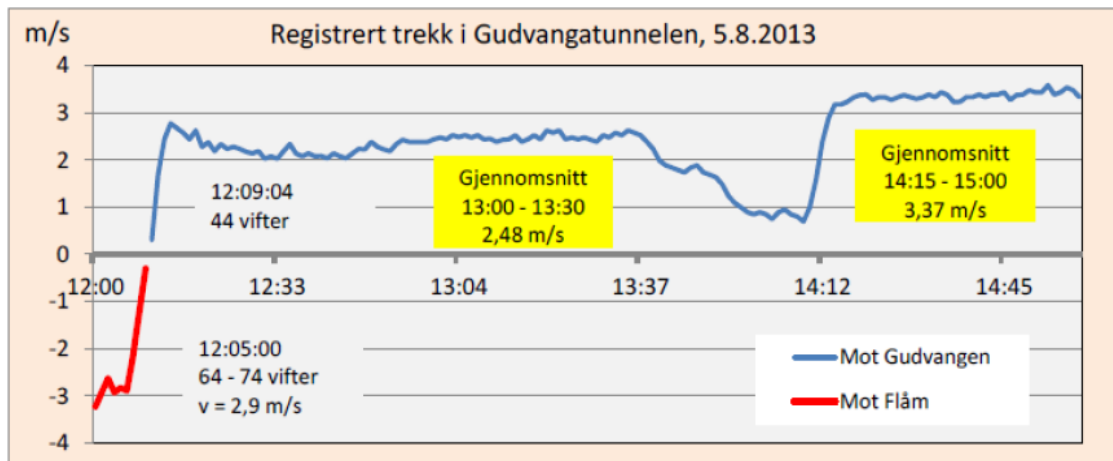
Between 13:37 and 14:12, first 18 of the 44 fans stopped, and then another 16. The reason why the fans stopped was most probably that the telephone/fire cabinets were opened (see section 1.13.4.1). During a period of around 15 minutes (between 13:54 and 14:09), only 10 fans were working in the direction of Gudvangen. By that time, the 10 fans that had previously blown air towards Aurland had also stopped, see Figure 14. This meant that for a while, the air flow rate towards Gudvangen was as low as approximately 0.8 m/sec.

Figure 15: Registered air flow rates in the Gudvanga tunnel on 5 August 2013. Source: the NPRA

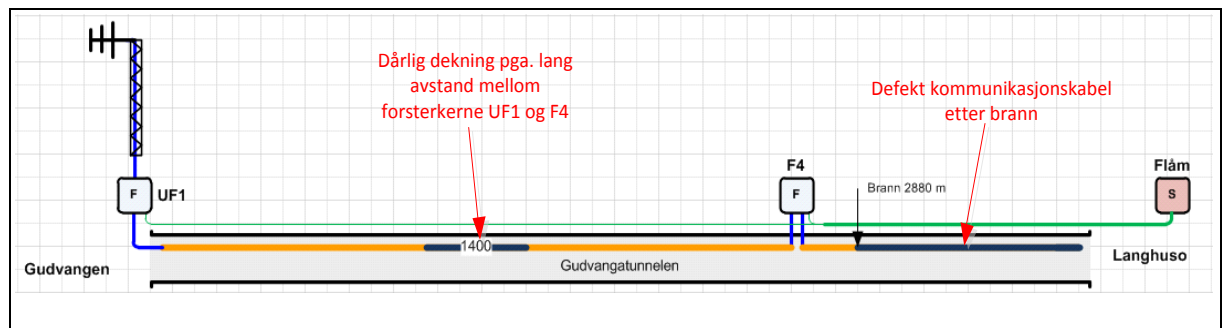
The Gudvanga tunnel has a 1 400 m long mid-section of poor coverage. As several other tunnels in the Aurland district also has poor or no radio coverage, the NPRA Western Region had equipped Aurland fire service with a portable amplifier to compensate for this. The range of such equipment can vary according to where in the tunnel it is used.

Figure 16: Overview of communication and radio coverage inside the Gudvanga tunnel after the fire on 5 August 2013. Source: the NPRA

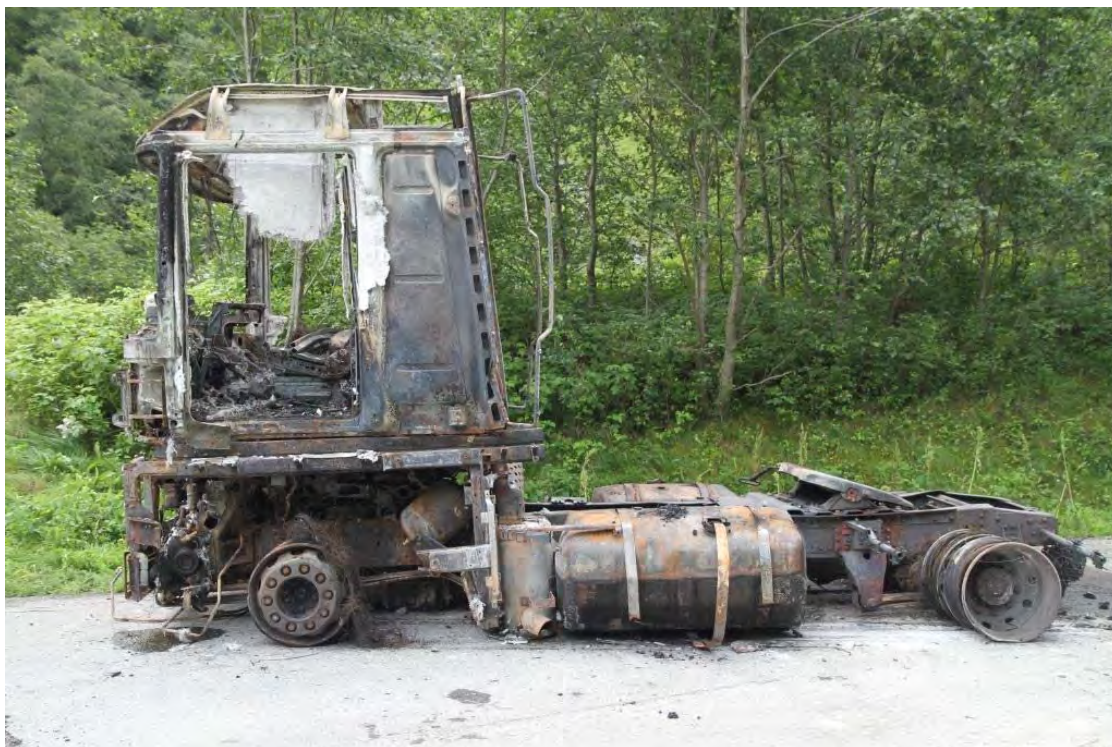
Figur 2-2 og Figur 2-3 viser restene av vogntoget etter at brannen var sløkket. Av figuren kan vi se at alt brennbart materiale, både på trekkbil og semitrailer, synes å være helt oppbrent.

Figur 2-2 Bilde av den utbrente trekkvognen. Foto: SHT.

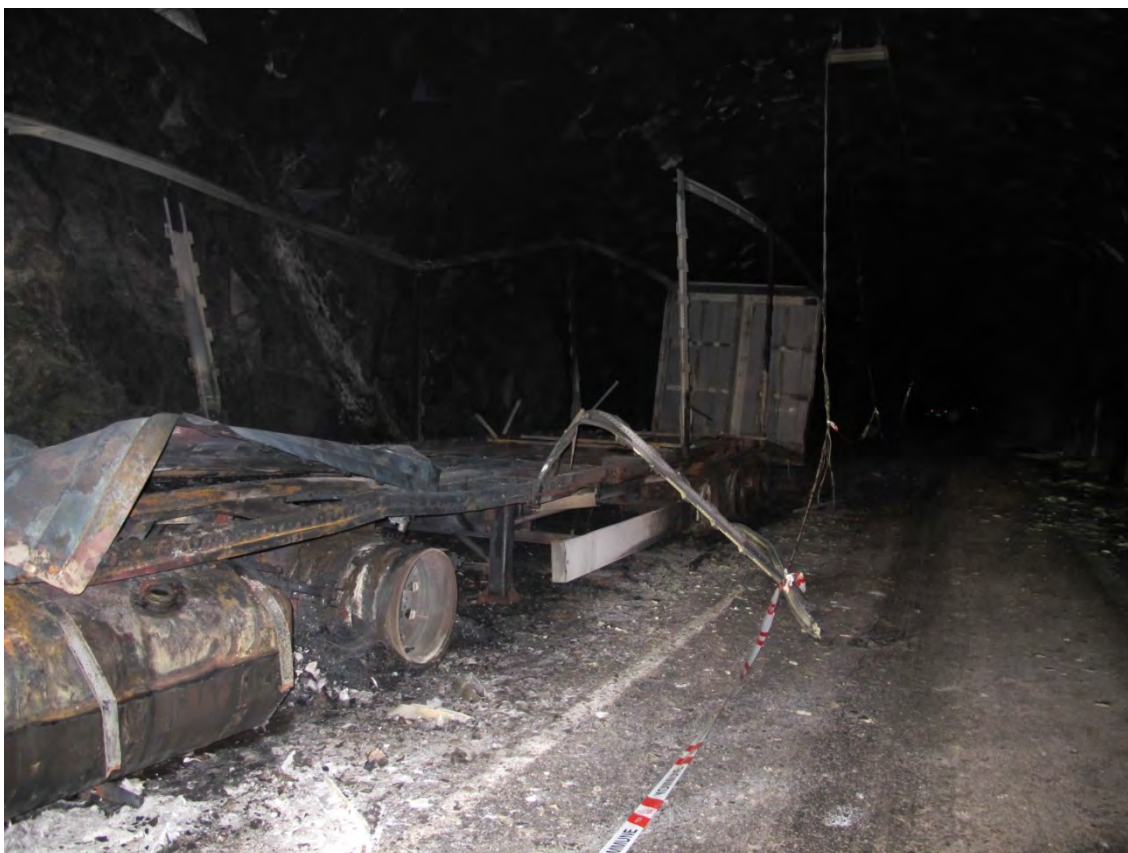
Figur 2-3 Bildet viser den utbrente semitraileren. Foto: SHT.
