# REPORT

## Road 2015/05

## REPORT ON HEAD-ON COLLISION BETWEEN TWO HEAVY GOODS VEHICLES ON THE E39 ROAD BY THE LAVOLL TUNNEL IN FLEKKEFJORD ON WEDNESDAY 22 OCTOBER 2014

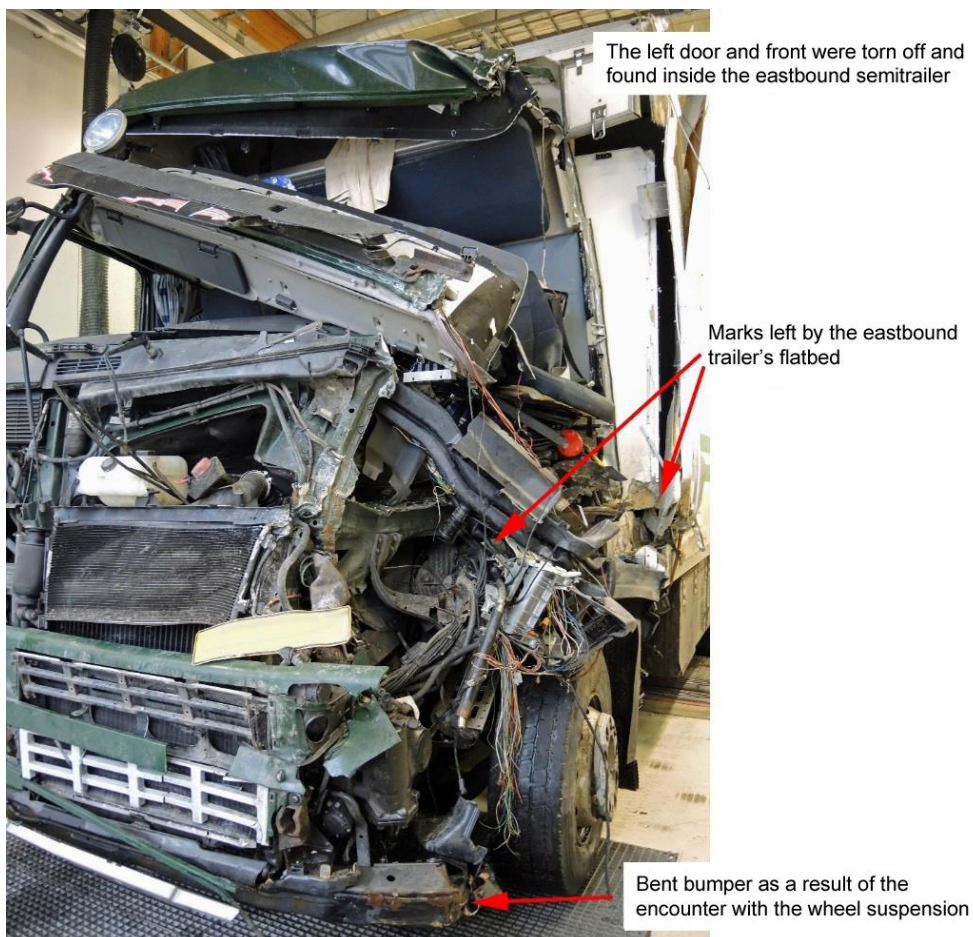
The left wall of the driver's cab took most of the damage and was completely crushed. Traces were found that showed that the flatbed of the semi-trailer had hit both the driver's cab and the left part of the tractor cabinet. The bumper bore traces of the collision with the eastbound semi-trailer's forward wheel suspension; see Figure 6.

Figure 3: Damage to the driver's cab of the westbound heavy goods vehicle. Photo: AIBN

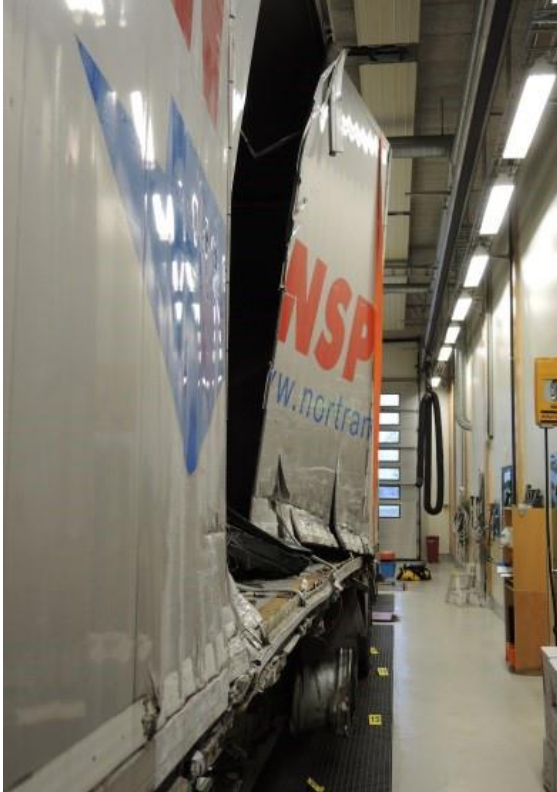
The heavy goods vehicle's tractor was not damaged in the collision. The semi-trailer's side wall was damaged in the collision with the westbound heavy goods vehicle and the rear side panel on the left side was marked by the encounter with the crash barrier on the right-hand side of the opposite lane. See Figure 4 and Figure 5.

Figure 4: Damage to the left side of the semi-trailer. Photo: AIBN

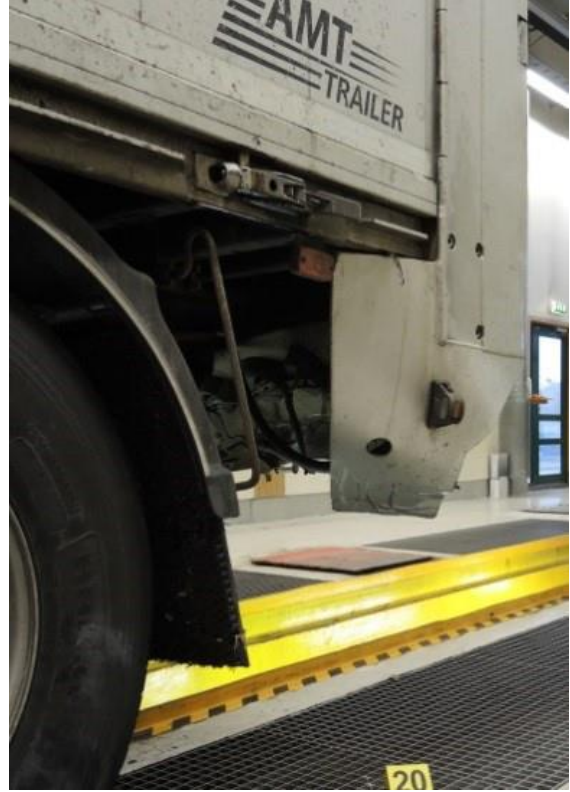
Figure 5: The left side panel is marked by the encounter with the crash barrier on the right-hand side of the opposite lane. Photo: AIBN

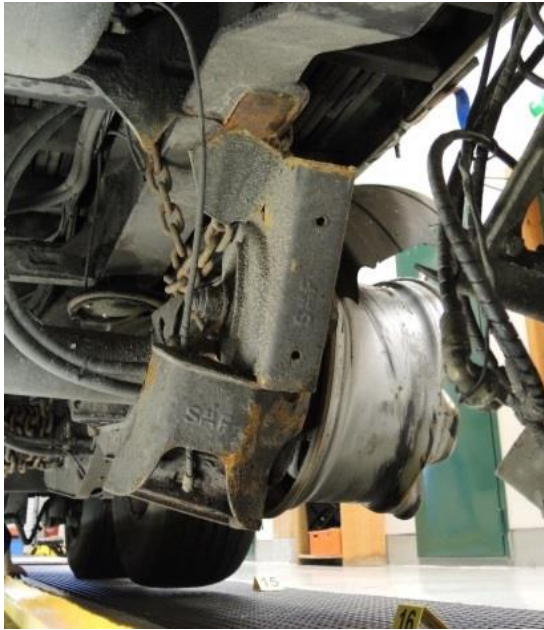
The suspension rod for the left wheel on the semi-trailer's forward axle came off in the collision and showed traces of having been hit by the westbound vehicle's bumper; see Figure 6. The door of the westbound vehicle was found inside the semi-trailer after the collision; see Figure 7

Figure 6: The torn-off left suspension rod on the forward axle. Photo: AIBN

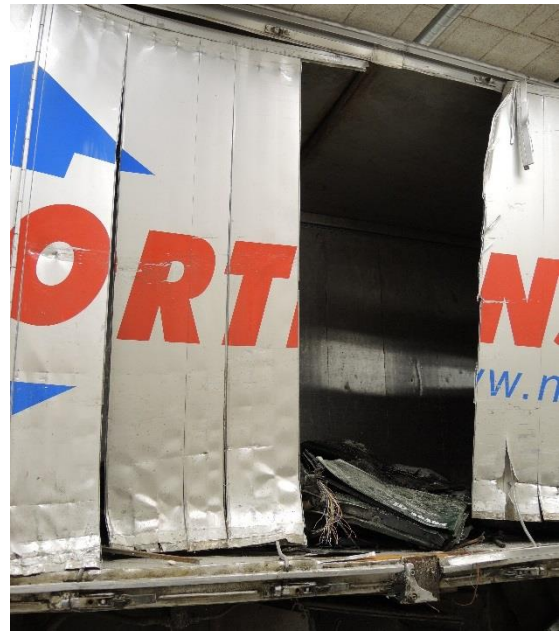
Figure 7: The door of the westbound vehicle inside the semi-trailer (photo taken after salvaging). Photo: AIBN

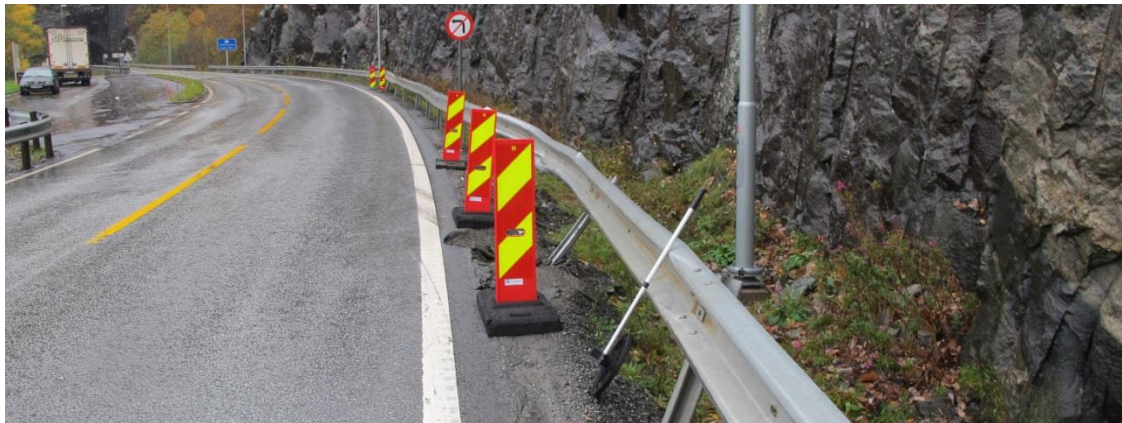
The crash barrier on the right-hand side of the westbound lane was damaged when the accident occurred. The barrier posts in Figure 8 mark the westbound heavy goods vehicle's final position, while the barrier posts seen in the distance (approximately 30 m behind) mark the point of impact with the eastbound vehicle's semi-trailer. Tyre marks were also found on the edge line, indicating that the westbound vehicle may have been pushed back towards the right. Figure 9 and Figure 10 show the heavy good vehicles' final positions after the collision.

Figure 8: Damages to the crash barrier looking westwards. The closest barrier posts mark the final position of the westbound heavy goods vehicle. Approximately 30 m behind them in the photo, we find marks from the eastbound semi-trailer. The photo was taken the day after the accident. Photo: AIBN

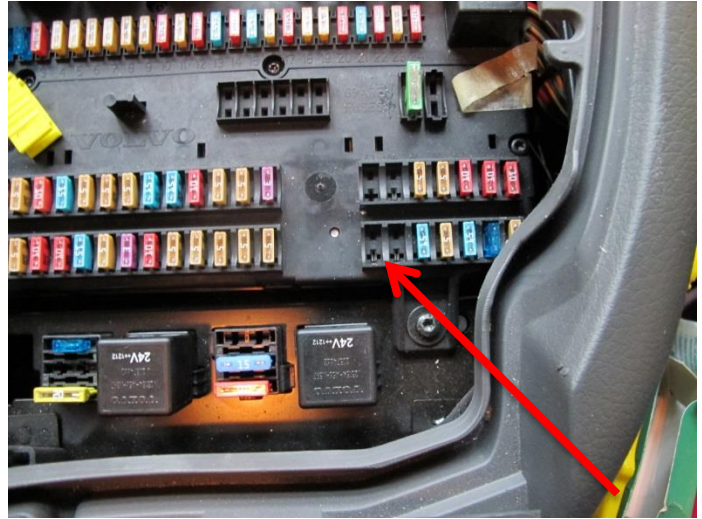
Brake tests of the tractor were carried out after the accident. The tractor had only been transferred from the accident site to the Driver and Vehicle Licensing Office at the time of these tests. The brake test showed a calculated retardation of  $4.4 \text{ m/s}^2$ . The tractor was not damaged in the accident, and when the tractor was inspected, the key had not been in the ignition switch since the accident. The ABS plug for the semi-trailer had suffered corrosion in several places, including on the pin for transmitting fault signals to the dashboard. On closer inspection, it was also discovered that the fuse for the semi-trailer's ABS had been removed. During the investigation, it has not been possible to ascertain when or by whom this fuse was removed.

Figure 12: The 'Supply ABS/EBS trailer' fuse is missing (fuse no 70). Photo: AIBN

The modulator is programmed in such a way that when the braking system is running on emergency power, the module is activated every time the driver steps on the brake pedal, and power is supplied to the ABS and ALB functions only. When the 'Supply ABS/EBS trailer' fuse is missing, the semi-trailer modulator will run on emergency power.

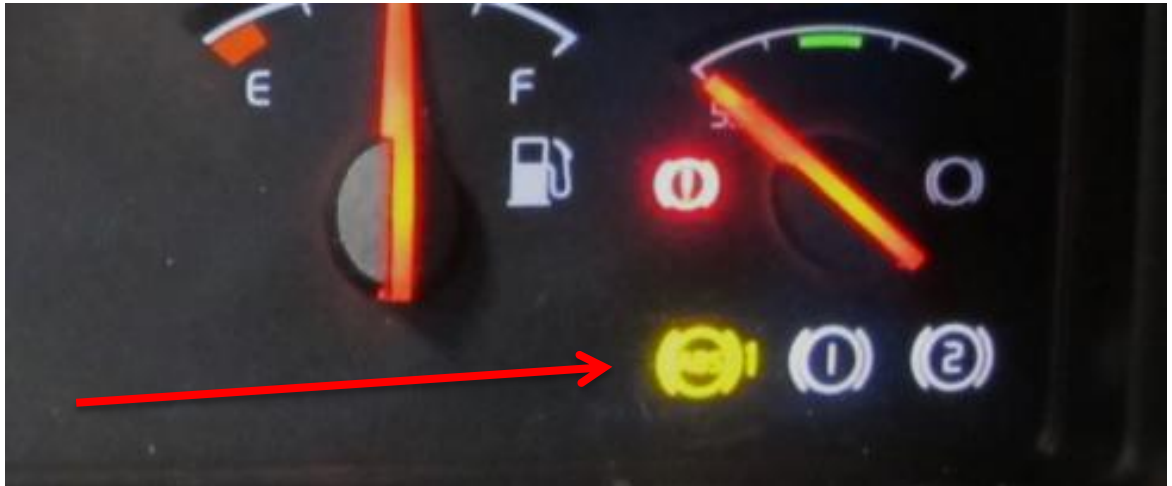
A yellow ABS-1 fault (fault signal for semi-trailer) was observed on the dashboard when the ignition was turned on. An EBS fault was also indicated on the dashboard when the fuse was installed.

Figure 13: Dashboard display, without ABS power supply fuse for trailer. The yellow warning light means that it is connected to a trailer with ABS fault. (The arrow indicates which lamp was lit when driving.) Photo: AIBN

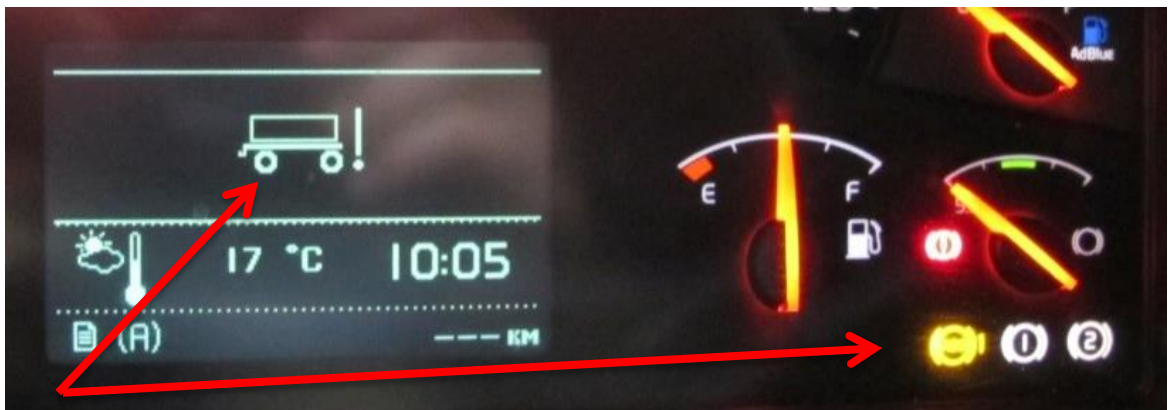
Figure 14: Dashboard display with ABS fuse for trailer installed. The EBS fault was now indicated on the dashboard. (The arrows show the lamps that would have been lit with the fuse installed.) Photo: AIBN

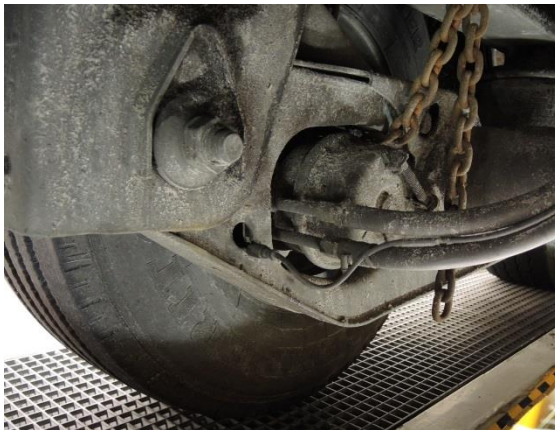
The investigation showed that the left ABS sensor on the middle axle was disconnected, while there was no damage to the cable or mountings. Measurements on the right ABS sensor on the middle axle showed that it was defective.

*Figure 15: Right wheel on the second axle, ABS connected but with contact failure. Photo: AIBN*

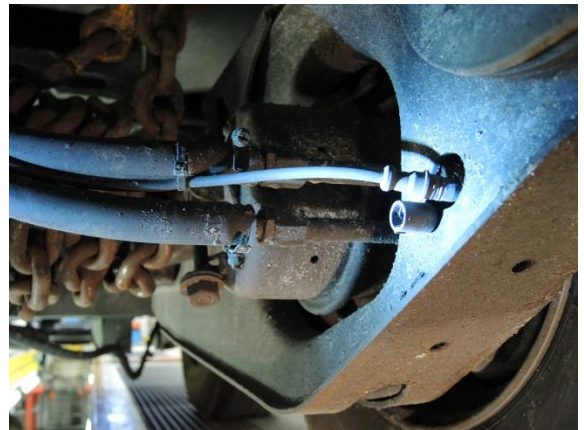
The front axle has no wheel rotation sensors, so if neither of the ABS sensors on the middle axle are working, both the front and middle axles will be without an anti-lock braking system.

*Figure 16: Left wheel on second axle. ABS sensor not connected. Photo: AIBN*
