REPORT

Road 2016/05

REPORT ON FIRE IN TANK TRAILER IN THE SKATESTRAUM TUNNEL IN SOGN OG FJORDANE ON 15 JULY 2015

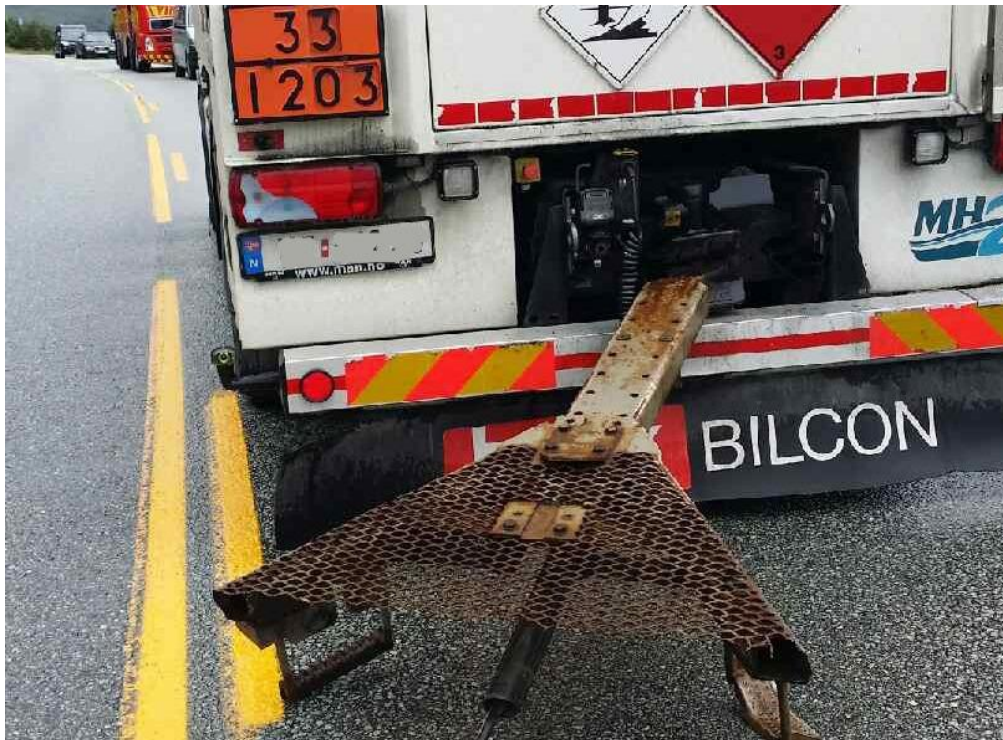
Figure 2: Remains of the trailer drawbar attached to the truck after it had broken at the point where it was attached to the trailer. Photo: The police

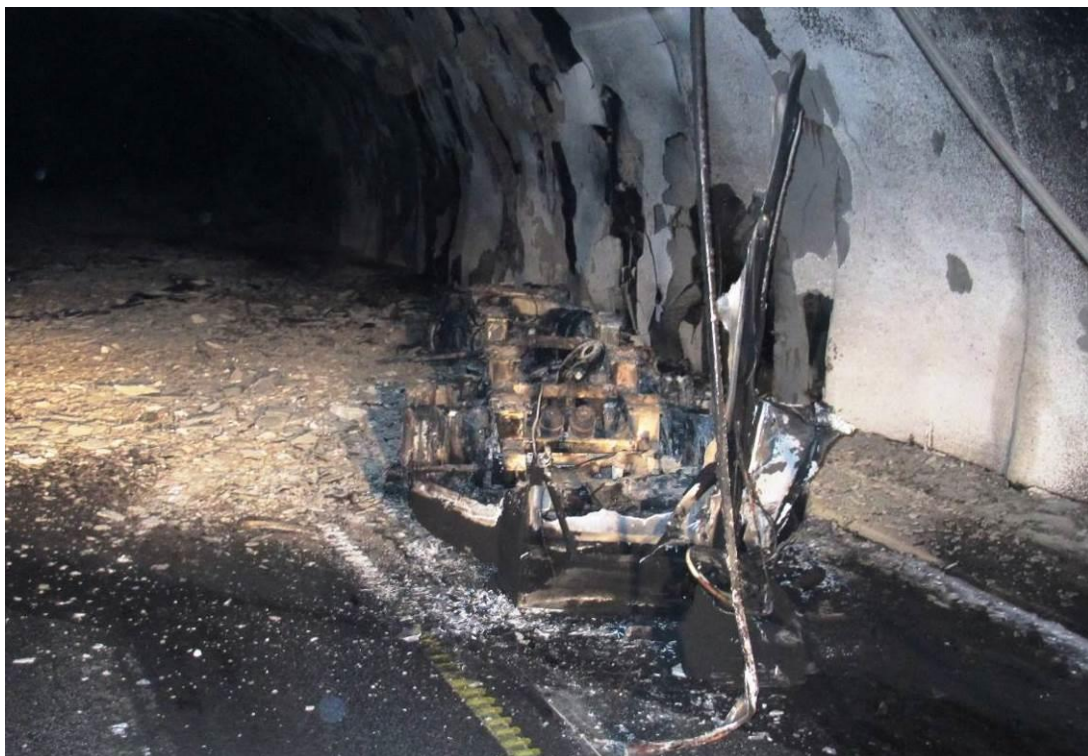
Figure 4: The remains of the tank trailer as left behind when it had broken loose from the truck. Photo: AIBN

Figure 4 shows damage to the tank trailer and the tunnel.

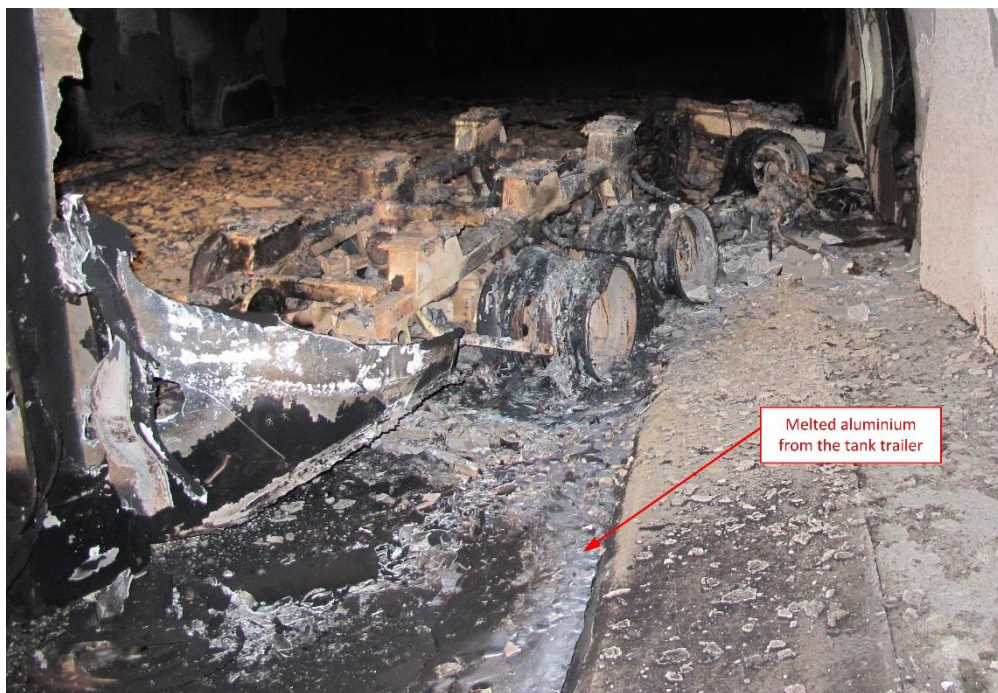
The trailer that broke loose from the tank truck was completely destroyed in the fire that started when the trailer's cargo of 16,500 litres caught fire. Only burnt-out remnants of the trailer's front and rear axles remained when the fire had been extinguished; see Figure 6.

Figure 6: The remains of the tank trailer where it ended up inside the tunnel. Photo: AIBN

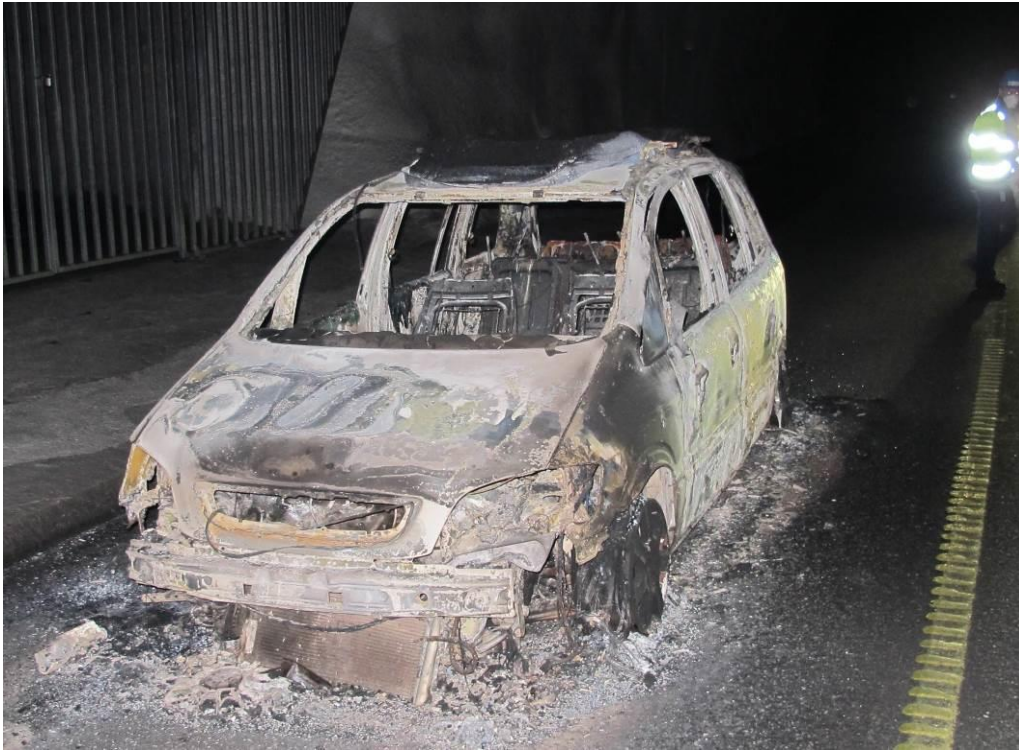
One of the passenger cars that followed the road tanker into the tunnel was left approximately 150 metres behind the tank trailer, because it could not be driven. The passenger car that was left behind was completely burnt out; see Figure 7.

Figure 7: The passenger car that was left approx. 150 metres behind the tank trailer was completely burnt out. Photo: AIBN

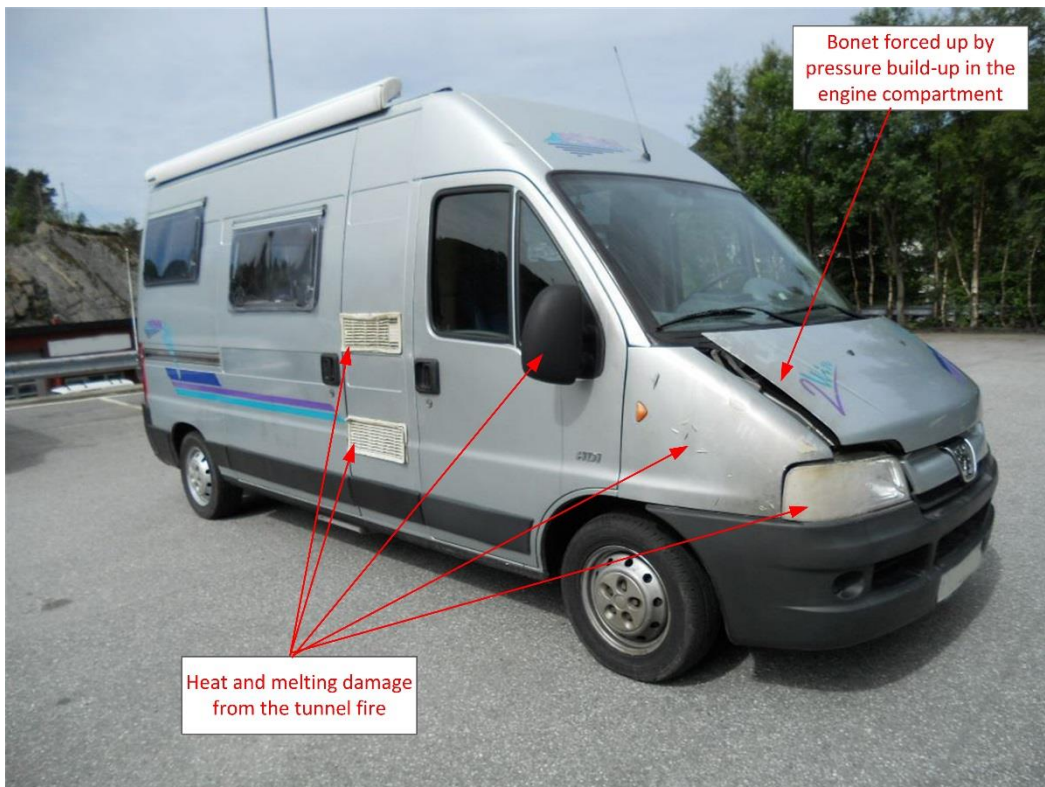
The camper van was 5–10 metres from the tank trailer when the petrol was ignited. The van sustained pressure damage in the engine compartment, bonnet and bonnet hinges, in addition to heat damage and melting damage to the surfaces on the right-hand side and damage to the headlights.

Figure 8: Damage to the camper van. Photo: Gjensidige

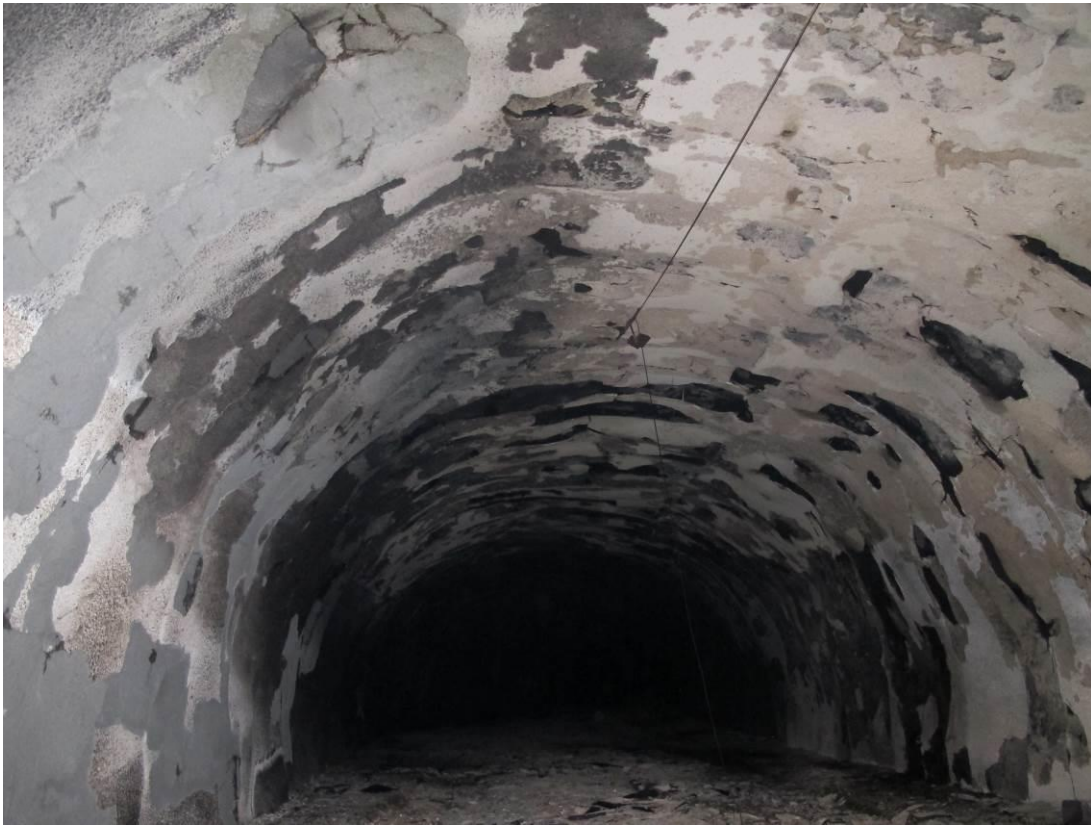
The fire that broke out in the leaking petrol rapidly generated intense heat and thick smoke. In the area of the tank trailer, much of the sprayed concrete lining on the tunnel walls and ceiling broke and fell into the roadway. This caused the fire to spread to the insulation material (PE foam) that was installed behind the sprayed concrete lining.

Figure 9: Shows damage to the tunnel bore in the area of the tank trailer, viewed in the direction towards which the smoke was ventilated. Photo: AIBN

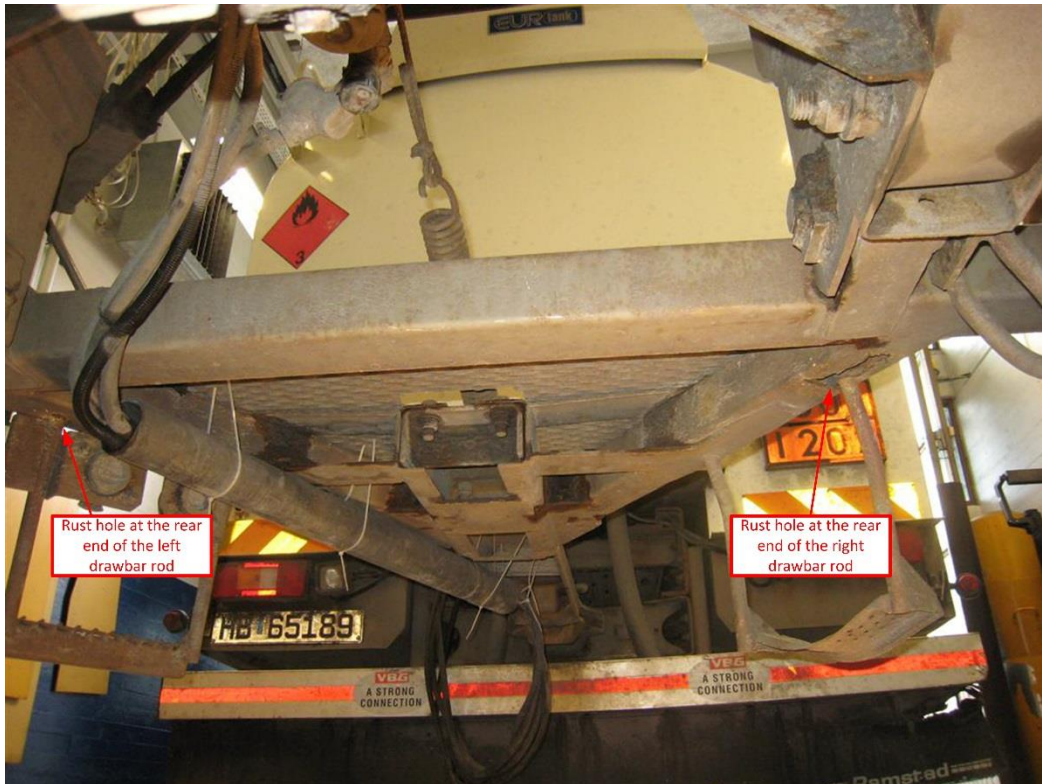
- Drawbar rust damage. See Figure 12 and detailed photos in Figure 13 and Figure 14.
- Uneven brakes and weak brakes.
- Cracks and extensive rust damage in the front axle mounting brackets.
- Cracks in the spring suspension for the second axle.
- Broken spring in the third axle.
- Various light faults.
- Faulty earthing points and strain relief fittings/bushings for various cables.
- Various cracks in tank/chambers.

Figure 12: Rust damage to the drawbar found in the NPRA's inspection of the trailer in May 2011. Photo: NPRA

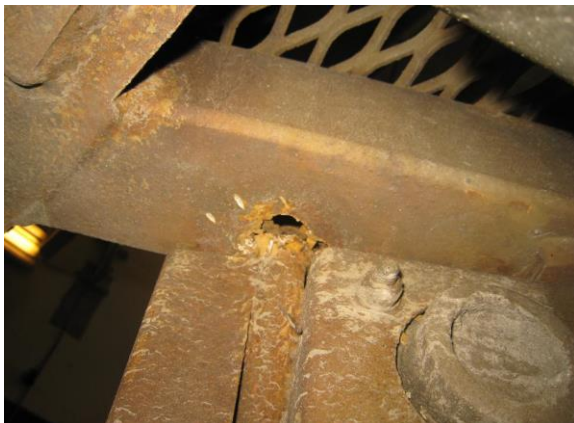
Figure 13: Rust damage in left drawbar rod. Photo: NPRA

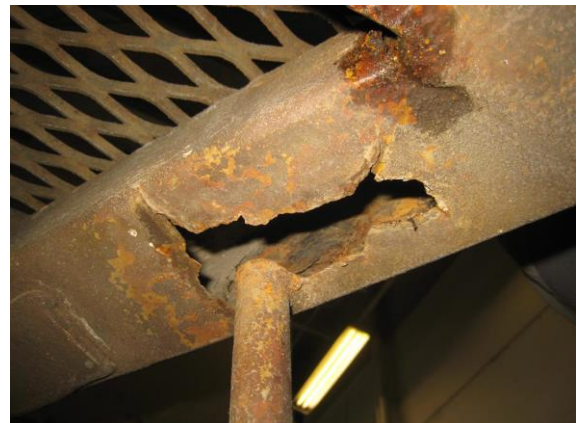
Figure 14: Rust damage in right drawbar rod. Photo: NPRA

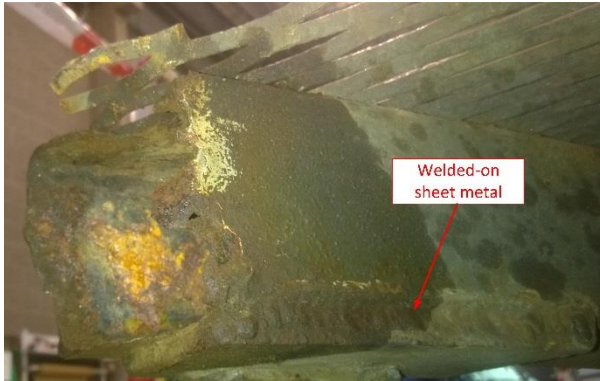
The rust damage was repaired by welding sheets of metal onto the rusted parts of the trailer drawbar. The sheet metal was welded onto the outside of the corroded areas, without removing any of the rust and without any further assessment of the extent of the

internal corrosion damage to the drawbar rods. The sheet metal was joined to the drawbar by welded seams along the drawbar rods. No seams were welded at the front or rear ends of the two pieces of sheet metal. The two pieces of sheet metal that were welded to the drawbar rods are shown in Figure 15 and Figure 16.

Figure 15: Sheet metal welded onto the left drawbar rod during repair work. Photo: AIBN

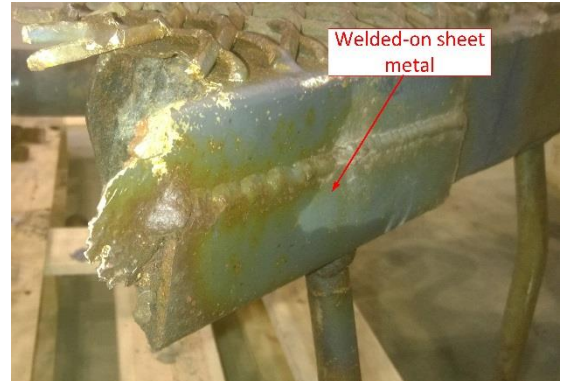
Figure 16: Sheet metal welded onto the right drawbar rod during repair work. Photo: AIBN

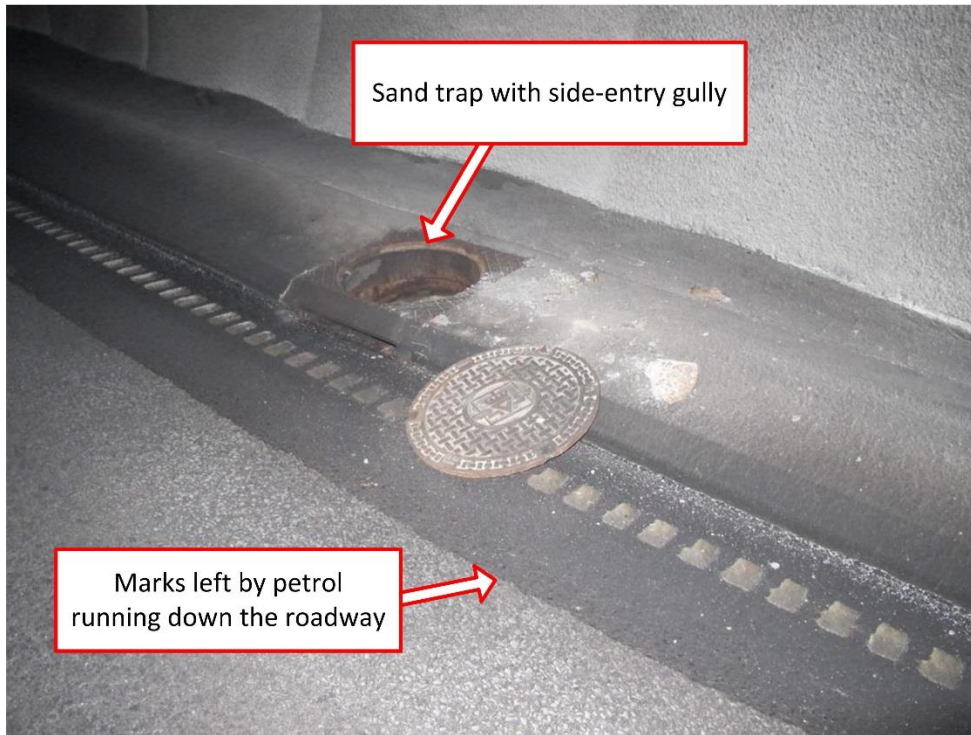
Figure 18: Sand trap with side-entry gully where the petrol ran past. Photo: AIBN

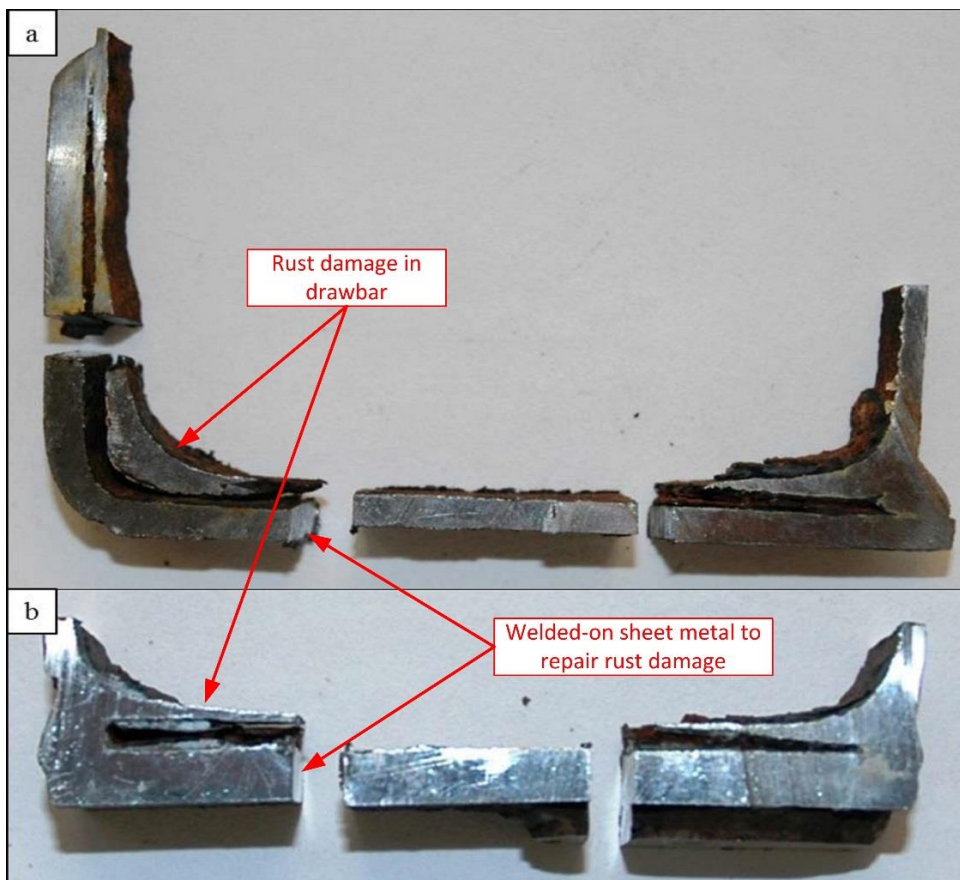
Figure 22: Cut-through section of the right (a) and left (b) drawbar rods in the area where pieces of sheet metal had been welded on during rust repairs. Photo: The Norwegian Defence Laboratories

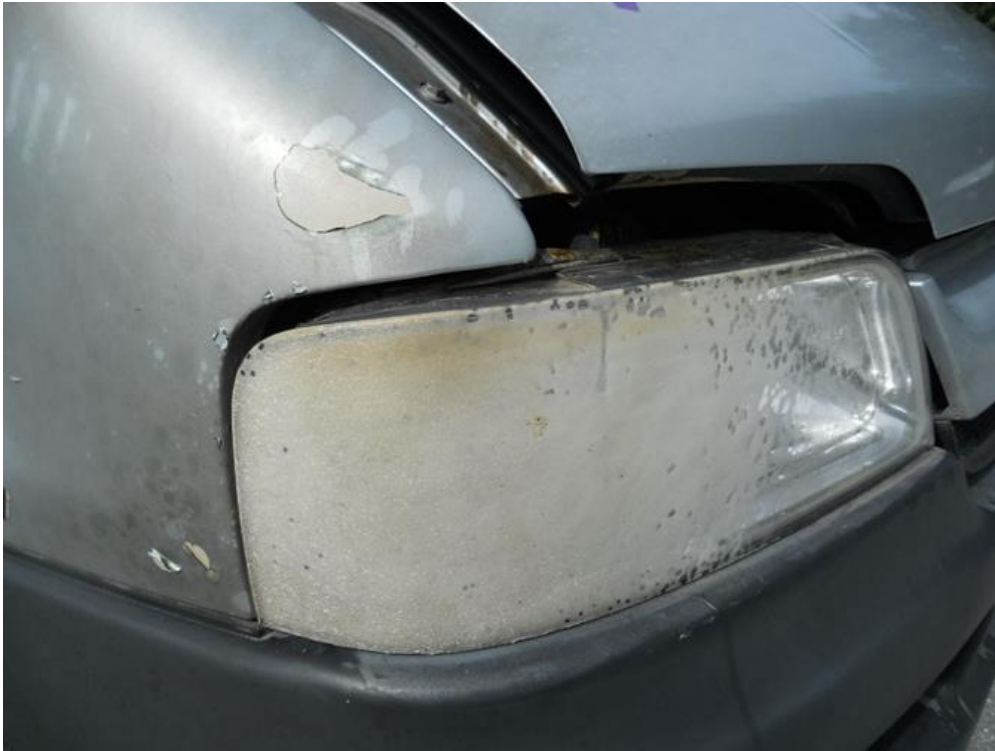
Figure 23: Close-up photo of the bonnet of the camper van that was driving behind the road tanker and stopped behind the trailer. The photo shows that the bonnet has been lifted up, probably as a result of a pressure change in the engine compartment. Photo: Gjensidige

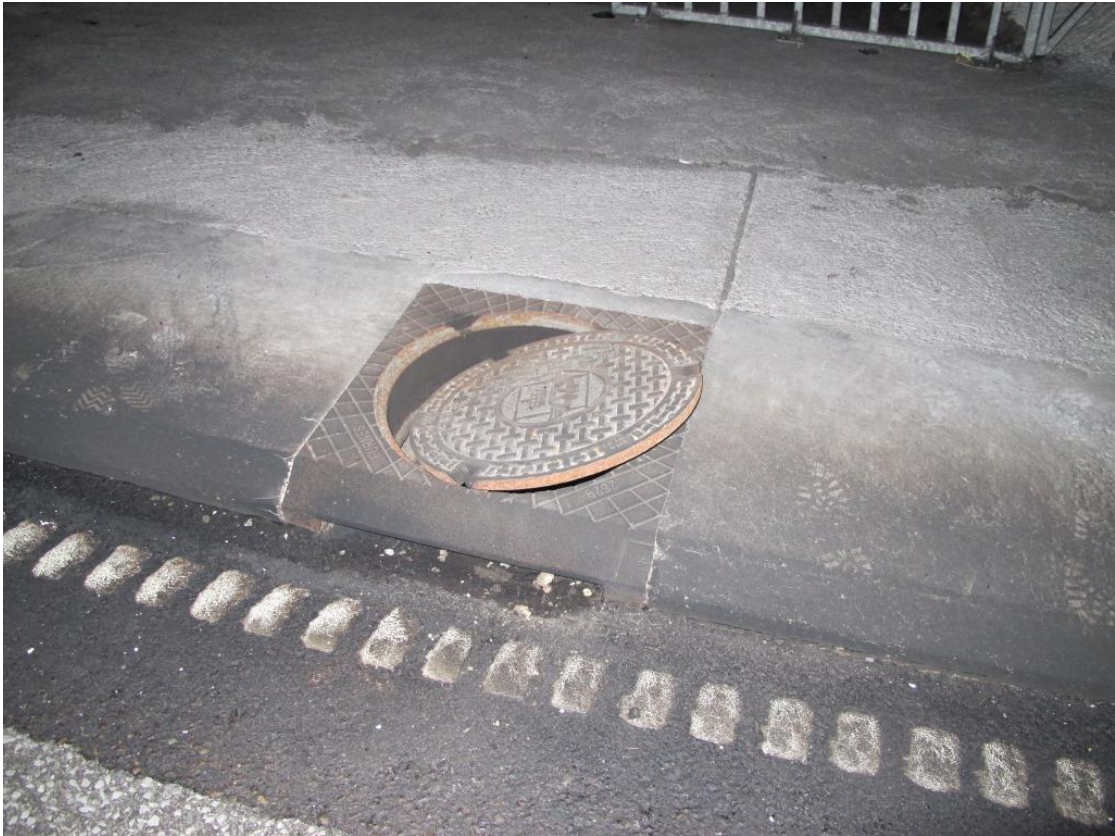
Figure 30: Sand trap with gully approximately 270 metres below the scene of the fire. The photo shows dark marks caused by petrol running past the gully. Photo: AIBN

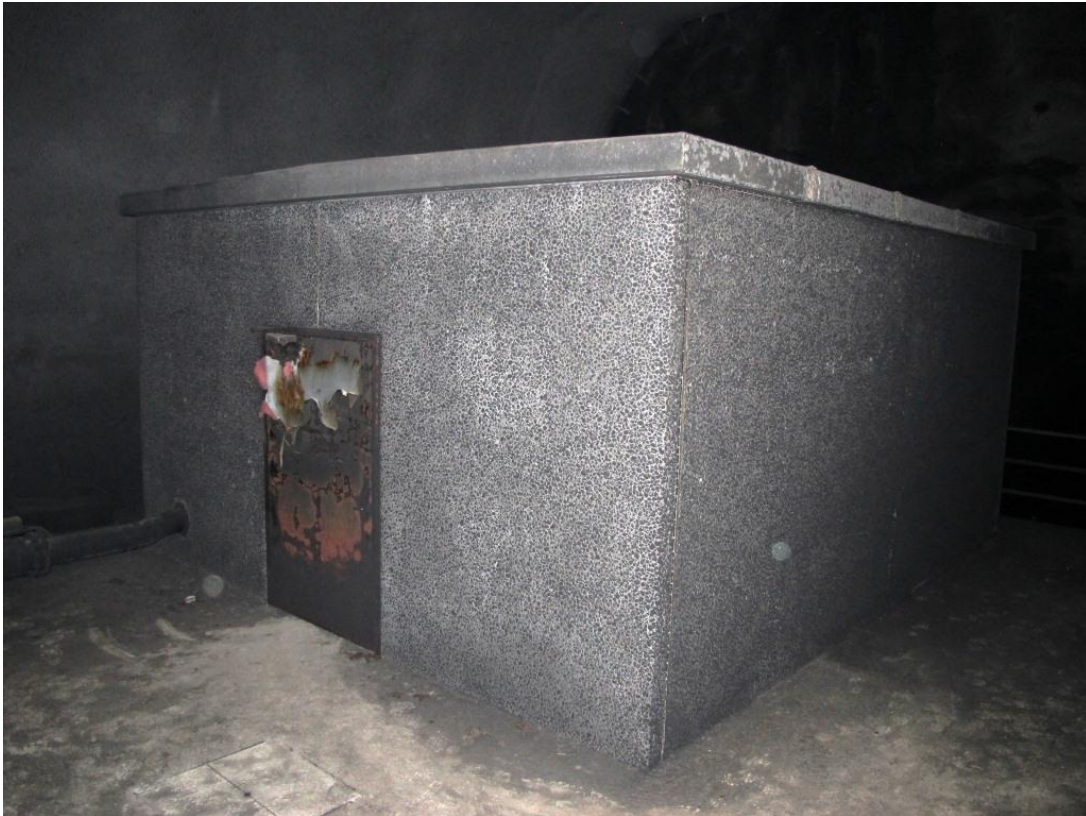
Figure 31: The pumping station at the bottom of the tunnel with fire and soot damage to the surfaces. Photo: AIBN

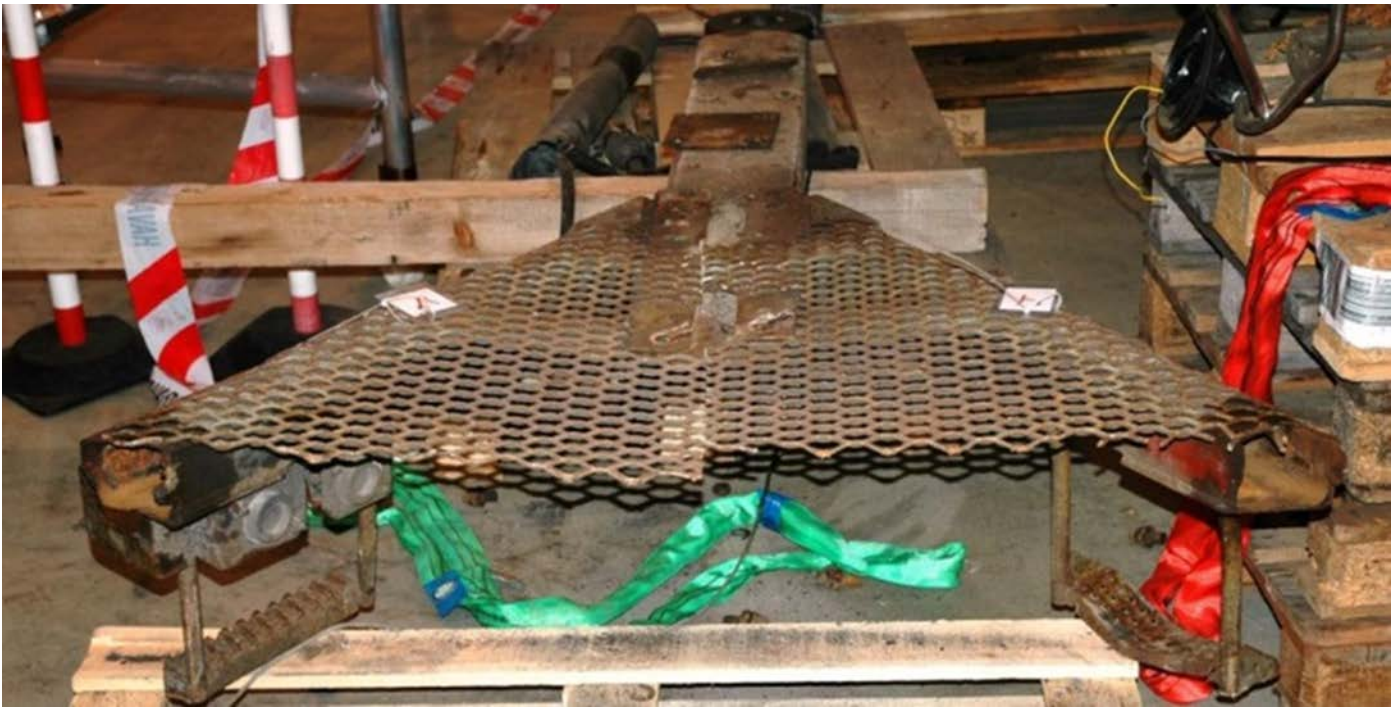
Figure 1 Overview image of failed trailer tongue.

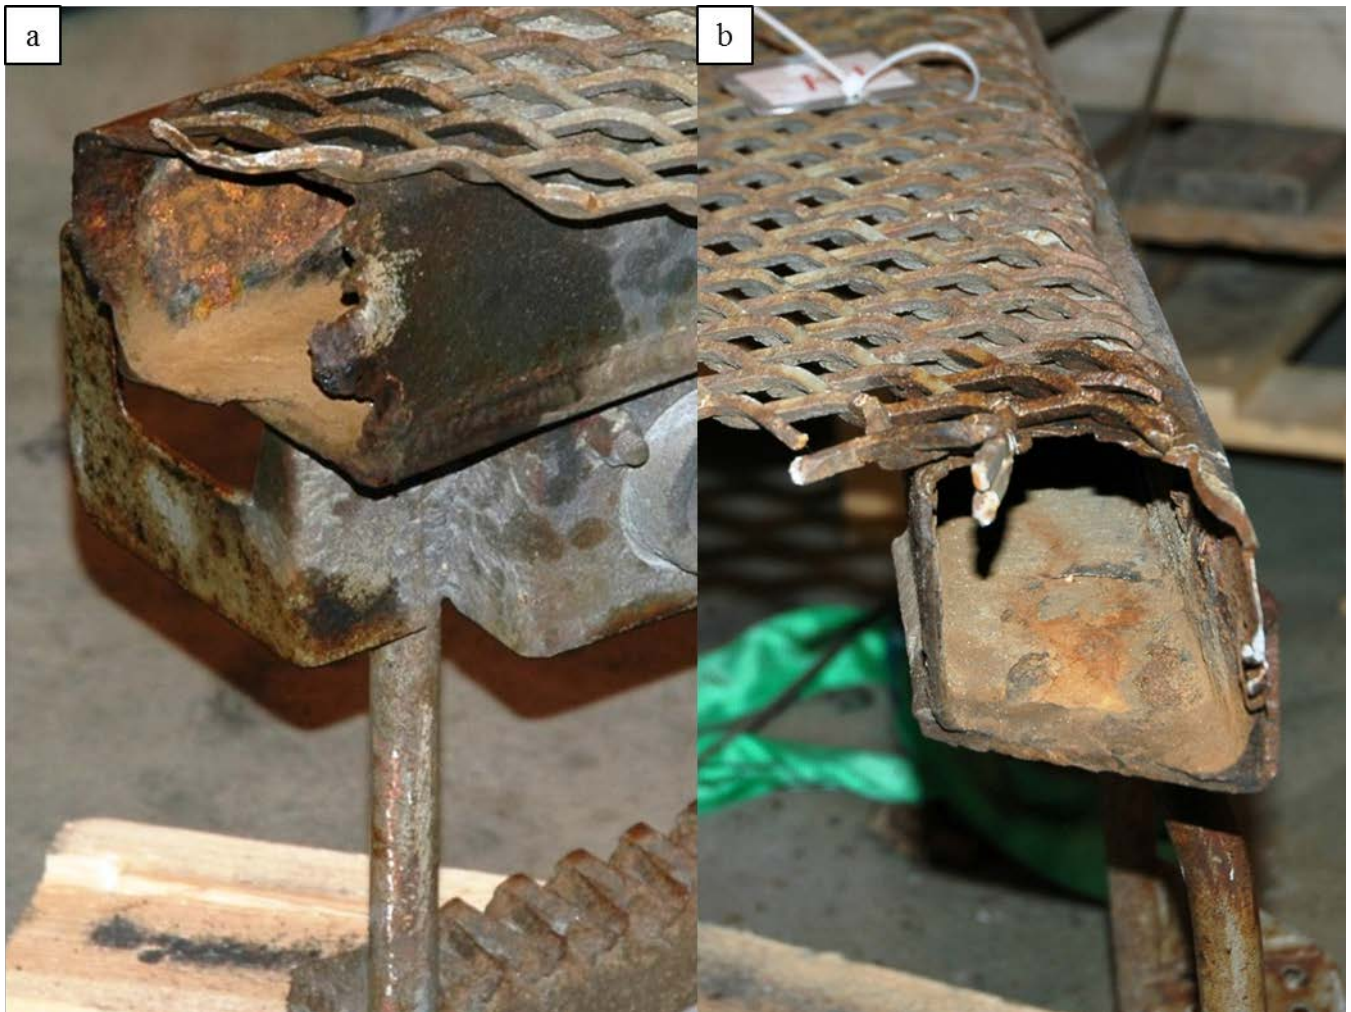
Figure 2a: Image of fracture marked «left side» (V). b: Image of fracture marked «right side» (H).

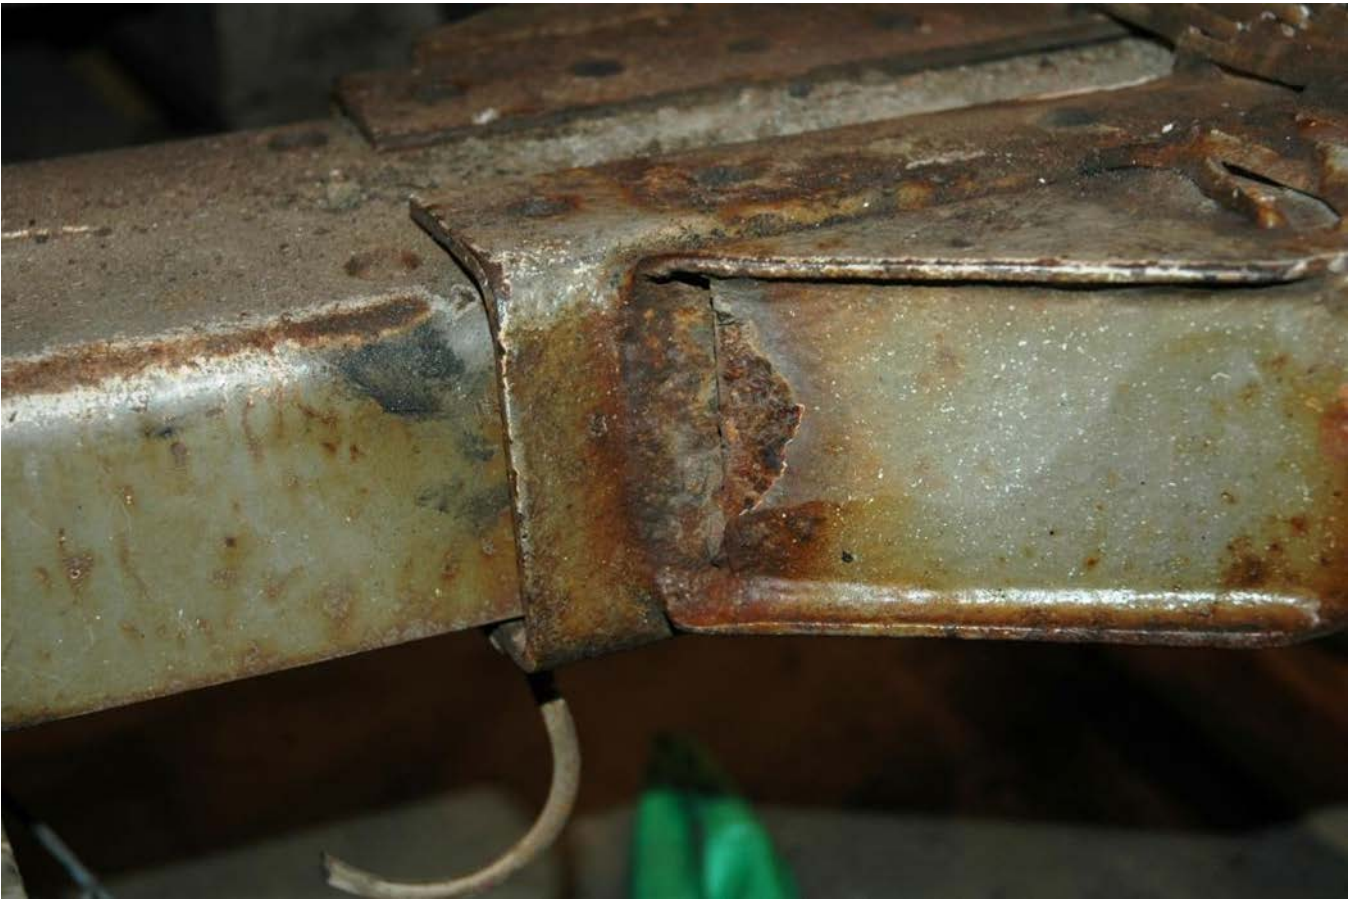
Figure 3 Image of the steel profile welds at the tongue insert showing spacing resulting in moisture entering the inside of steel profile.

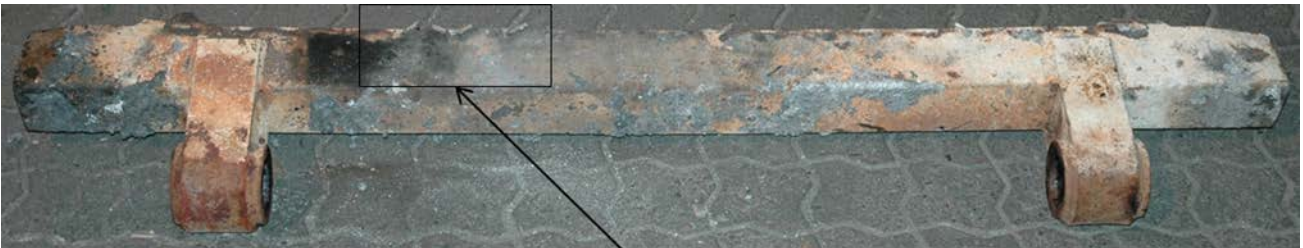
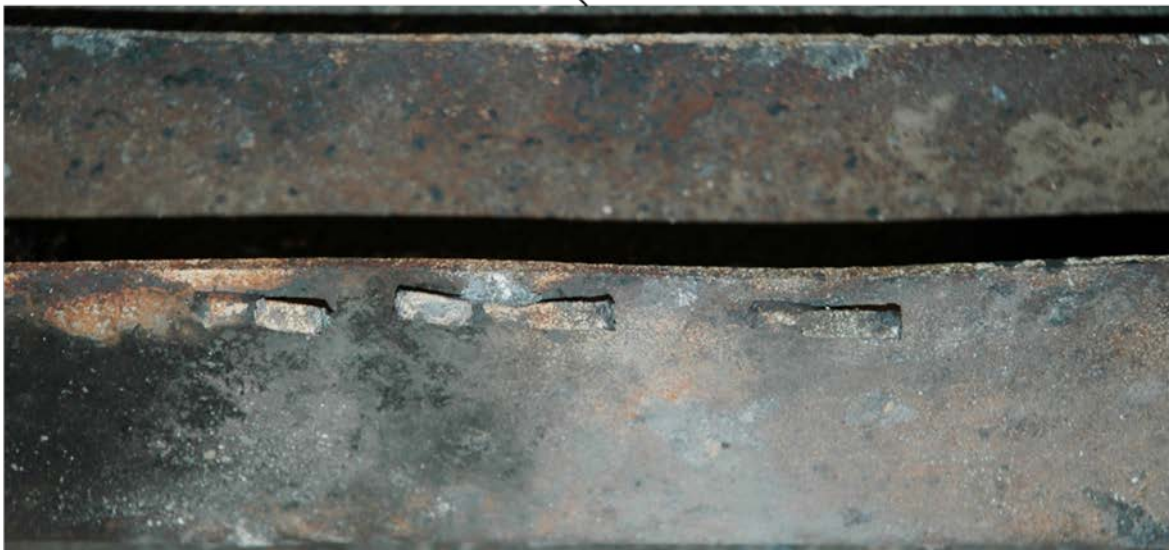
Figure 4 Image of trailer tongue end brace having spot welds and remains of wire mesh.

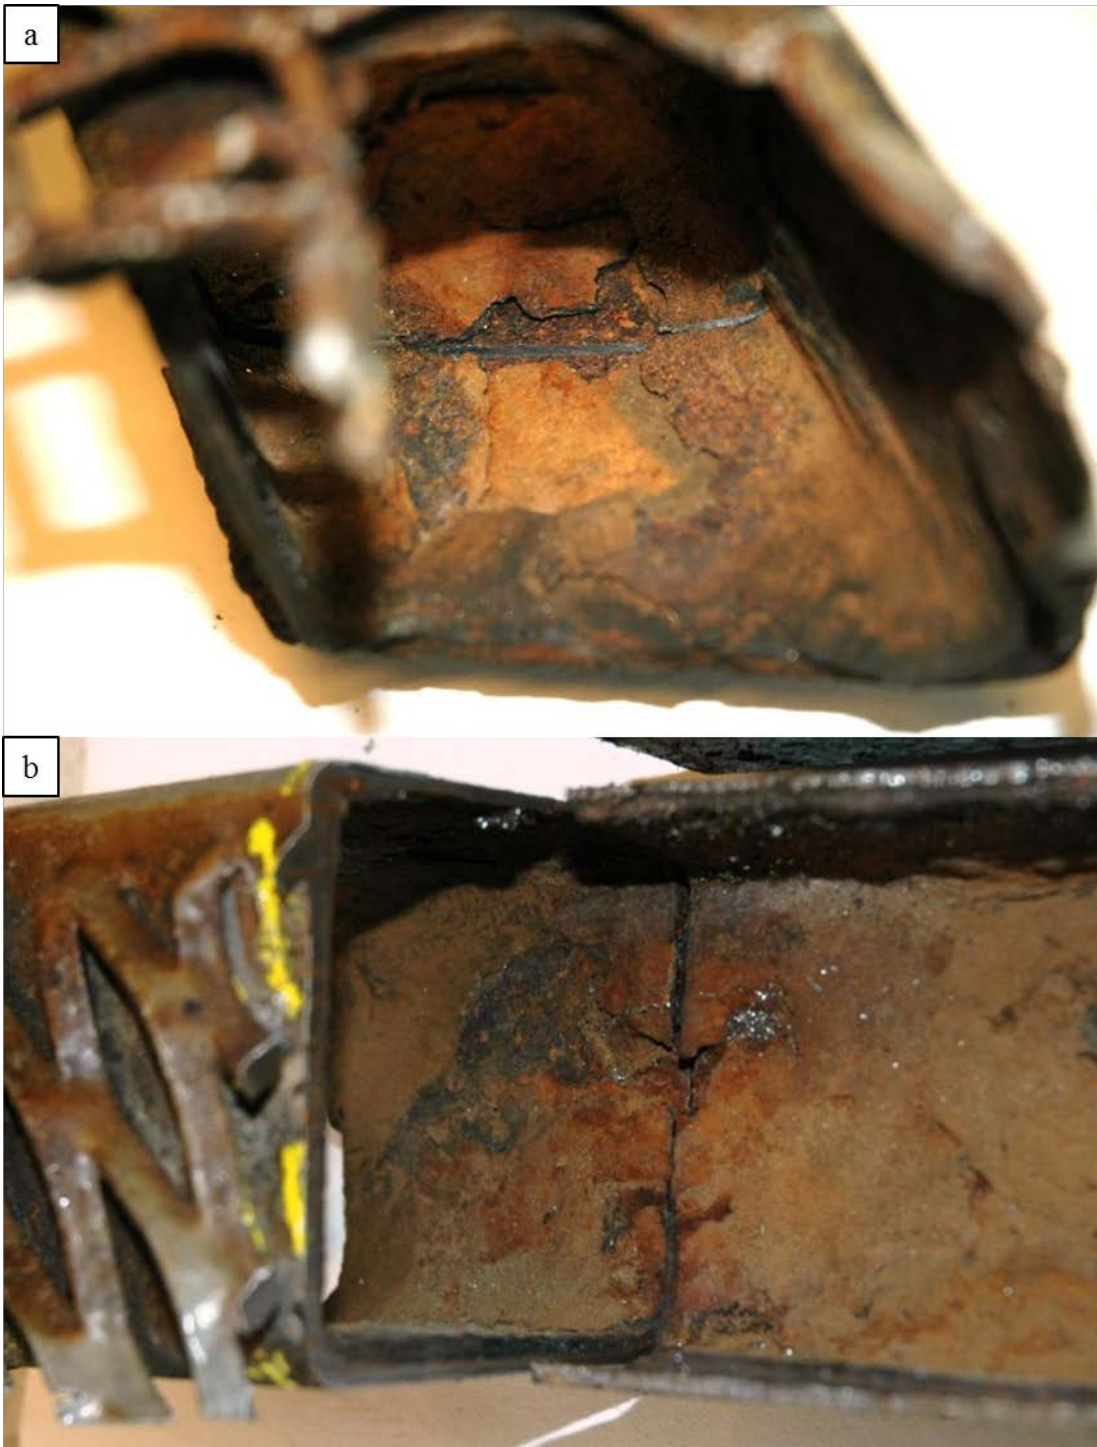
Figure 6 a: Image of through wall thickness corrosion at right side (H), b: Image of through wall thickness corrosion at left side (V).

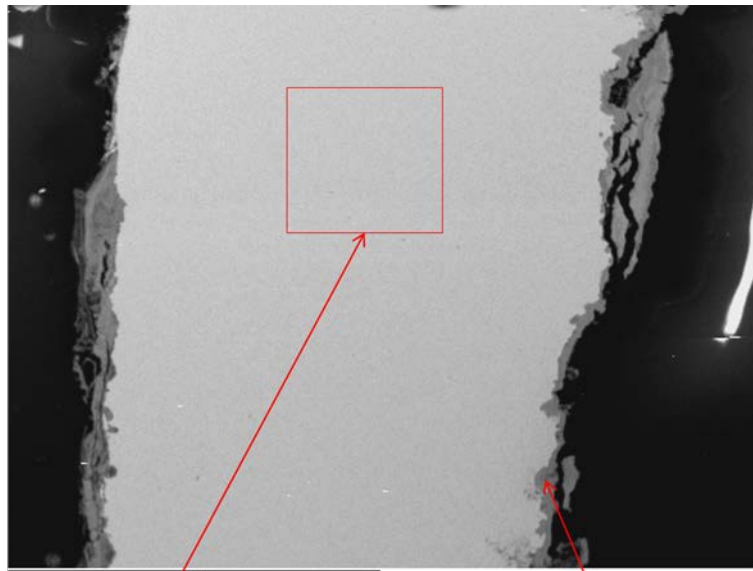
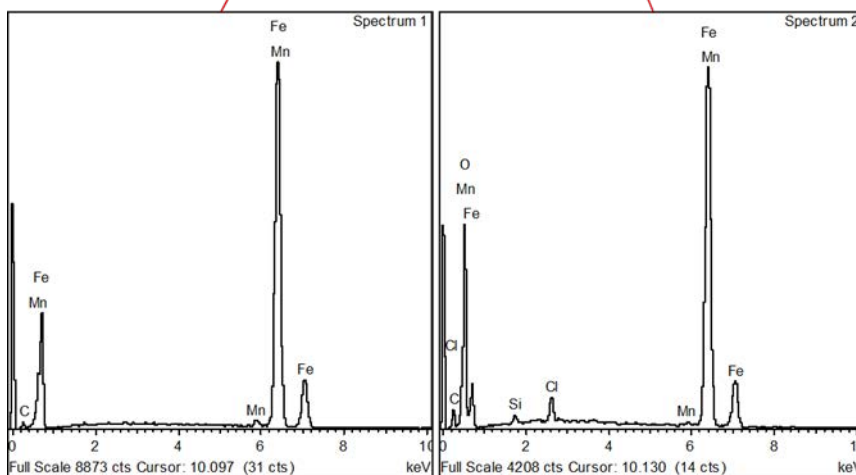
Figure 11 SEM image of a cross section through profile on right side (H). The image shows corrosion on both sides of the profile. The attached EDS spectrums identify a manganese steel base material and corrosion products containing chlorine (Cl).

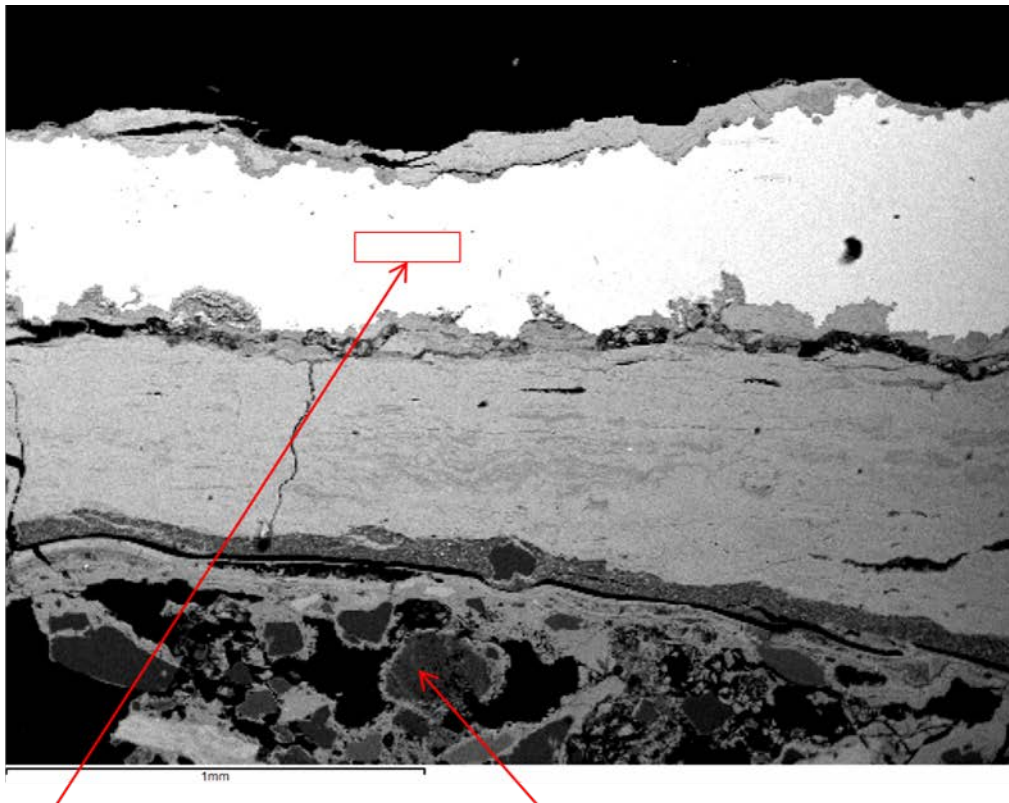
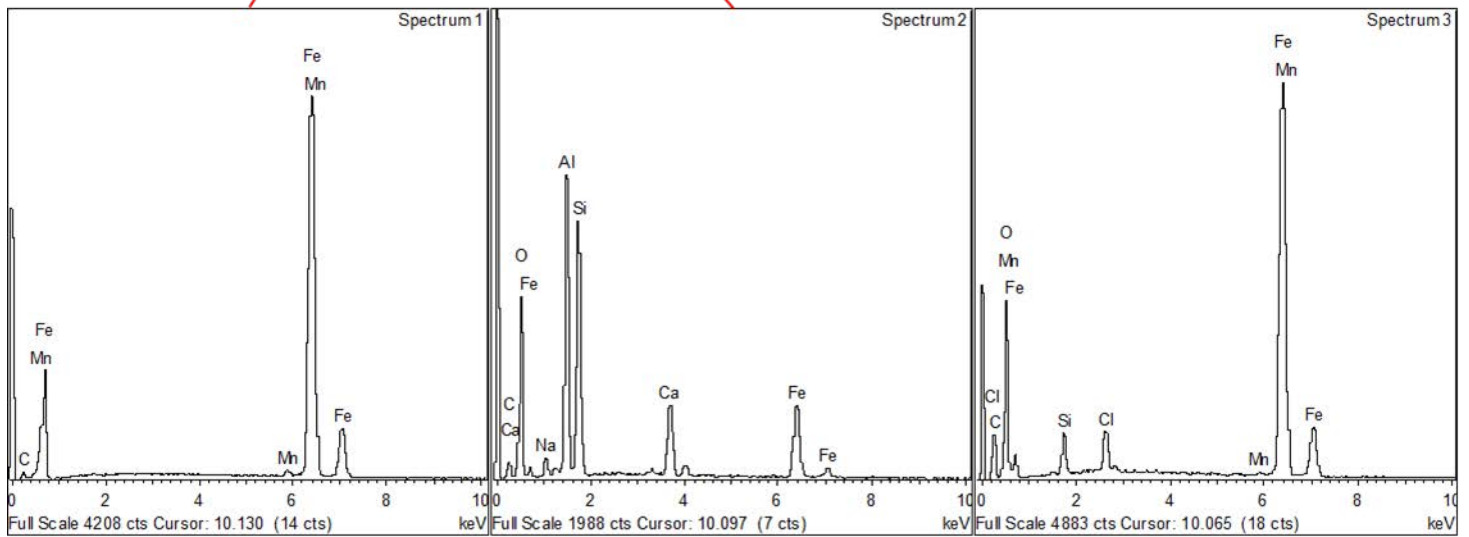
Figure 12 SEM image of a cross section through profile on left side (V). The image shows corrosion on both sides of the profile. The attached EDS spectrums identify a manganese steel base material and corrosion products containing mineral particles (sand) and chlorine (Cl).

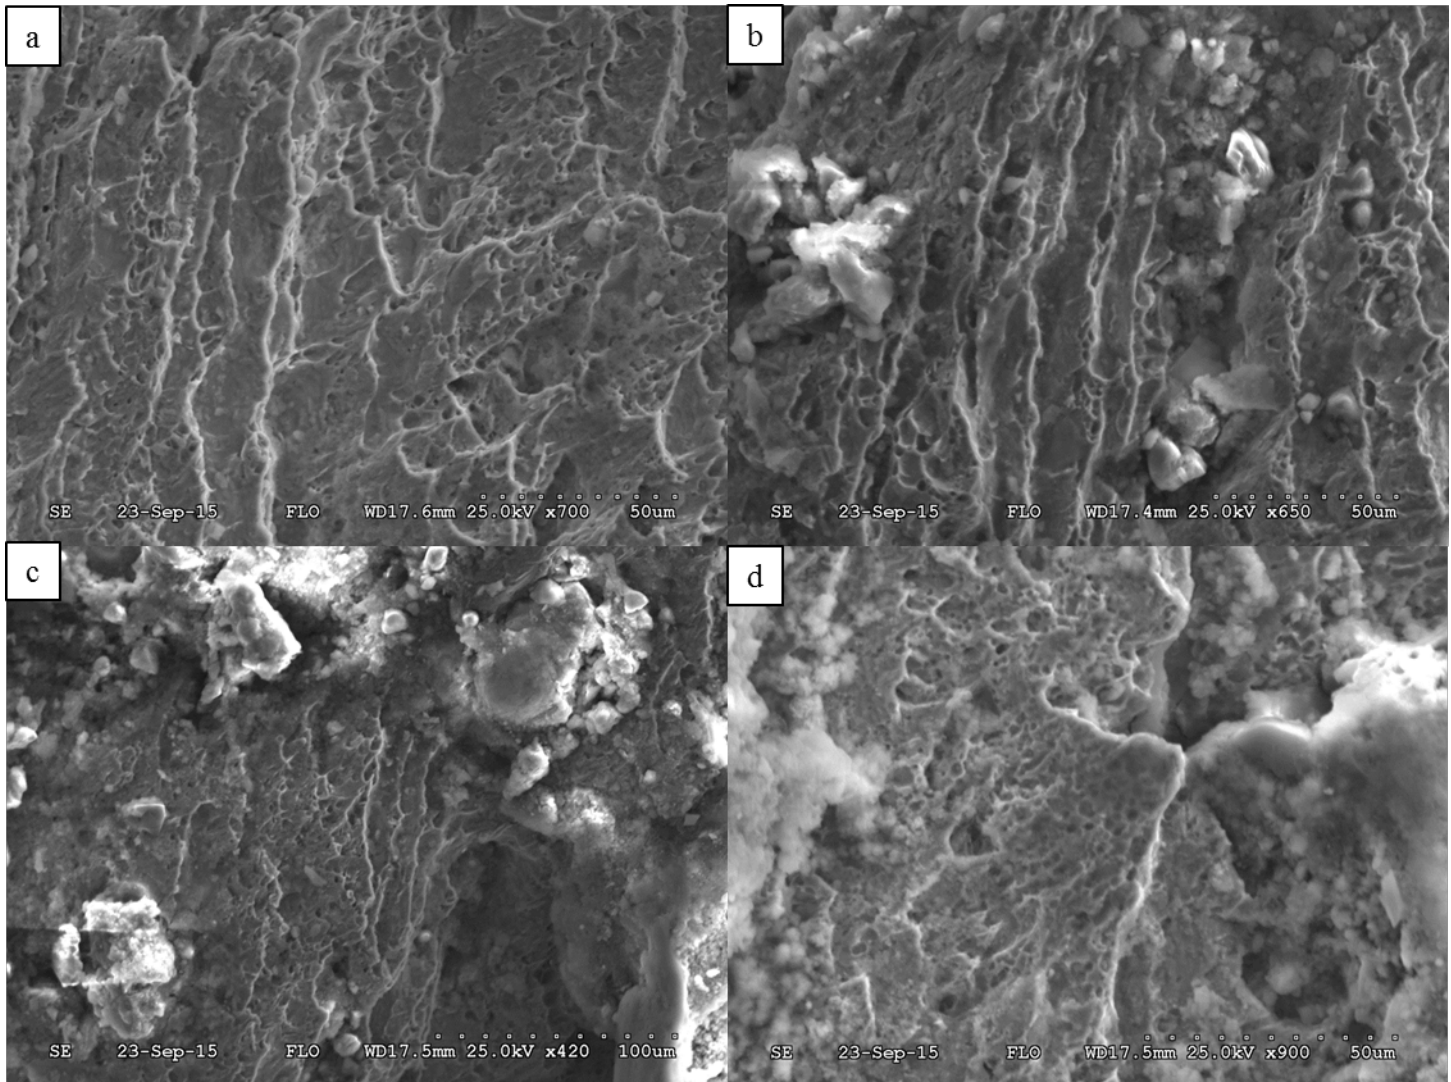
Figure 15a-d: Fractography images in SEM of the area shown in Figure 14d. The images show a dimpled fracture surface and initiation of corrosion occurred post failure.
