REPORT

Road 2016/05

REPORT ON FIRE IN TANK TRAILER IN THE SKATESTRAUM TUNNEL IN SOGN OG FJORDANE ON 15 JULY 2015

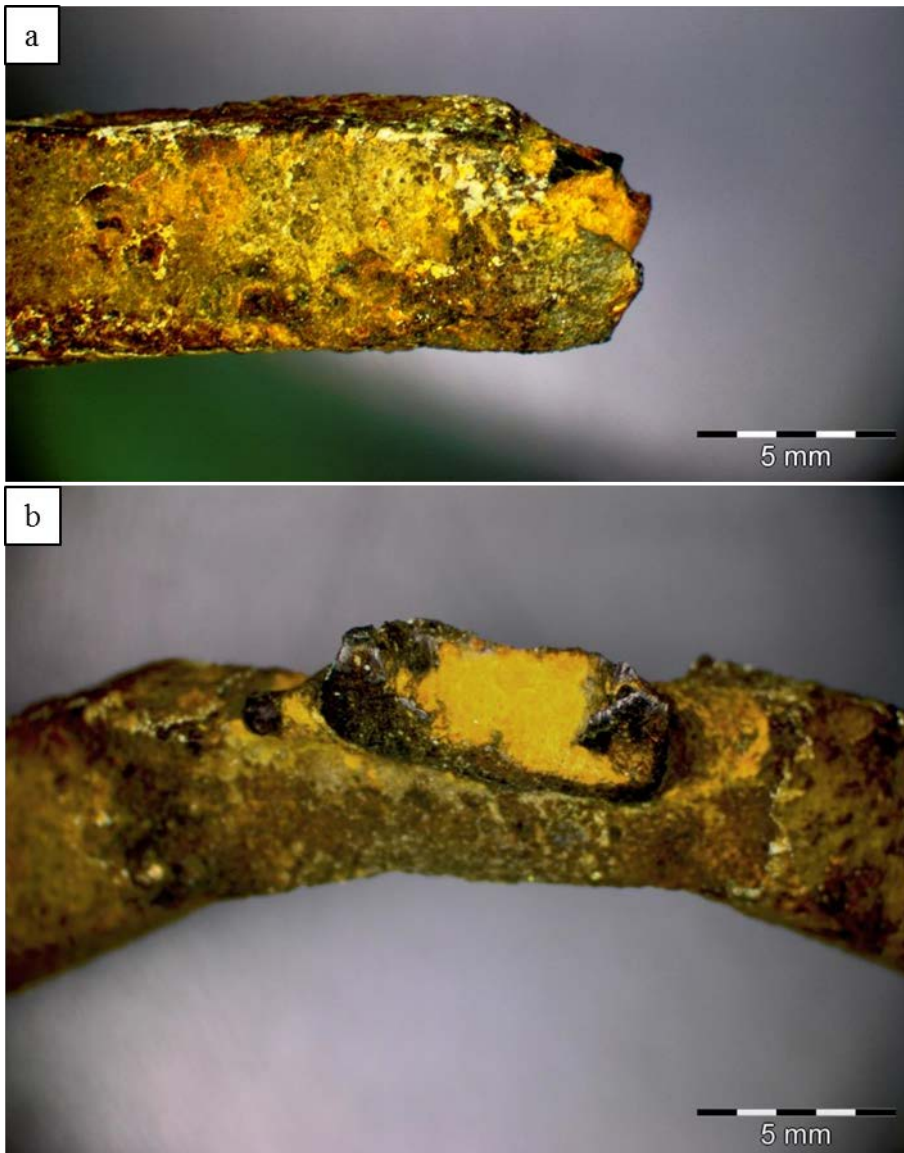
Figure 17 Image of a: failed wire in wire mesh and b: failed spot weld.

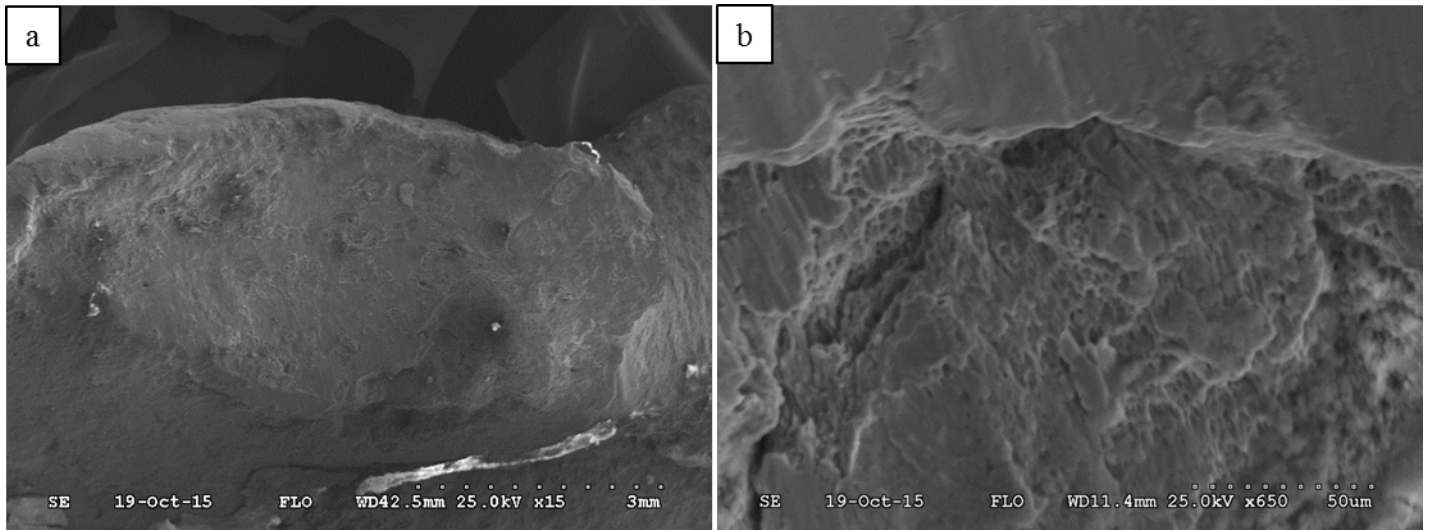
Figure 18a Image in SEM of failed spot weld. b: SEM images showing dimpled fracture surface consistent with overload.

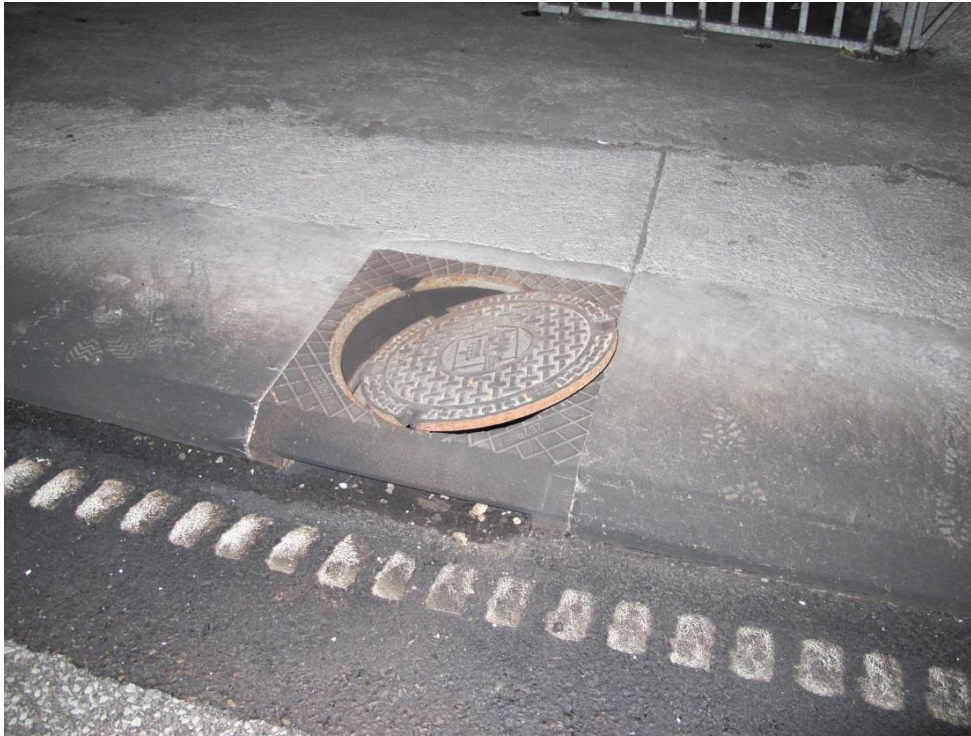
Figure 3: A surface water drain with an opening of 60 by 5 cm that faces the road surface. The black streak (roughly 0.7 m wide in Figure 3) on the road surface is where the greatest portion of the petrol flowed and was ignited (hence the marks). This surface water drain was 187 m down-slope from the trailer.

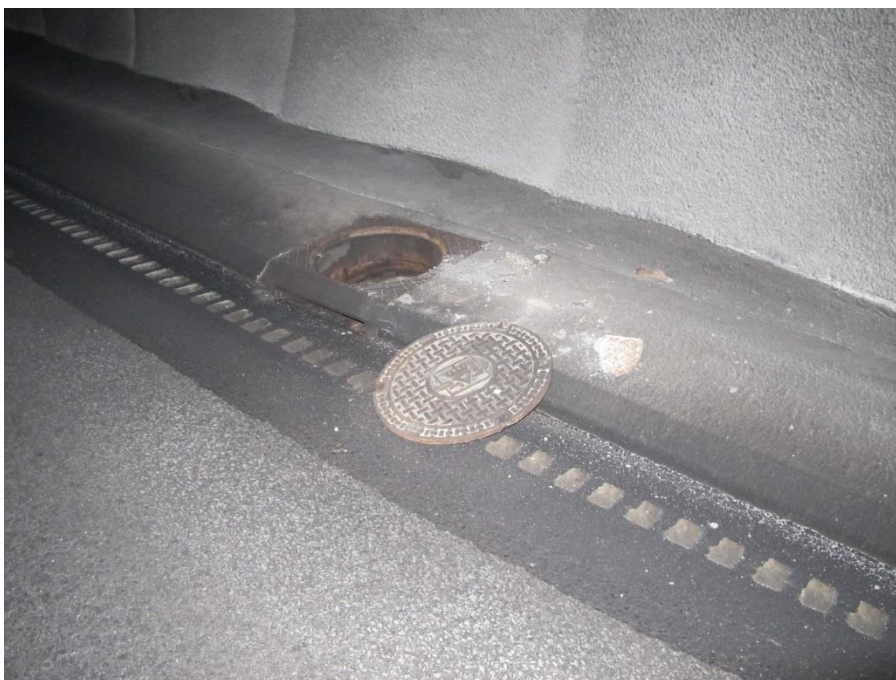
Figure 1: A photograph showing how petrol flowed on the surface of the road, from the trailer and down-slope towards the pumping station at the bottom of the tunnel. The dark section of the road surface shows where the petrol flowed and subsequently burned. The drain cover had a diameter of 0.609 m.

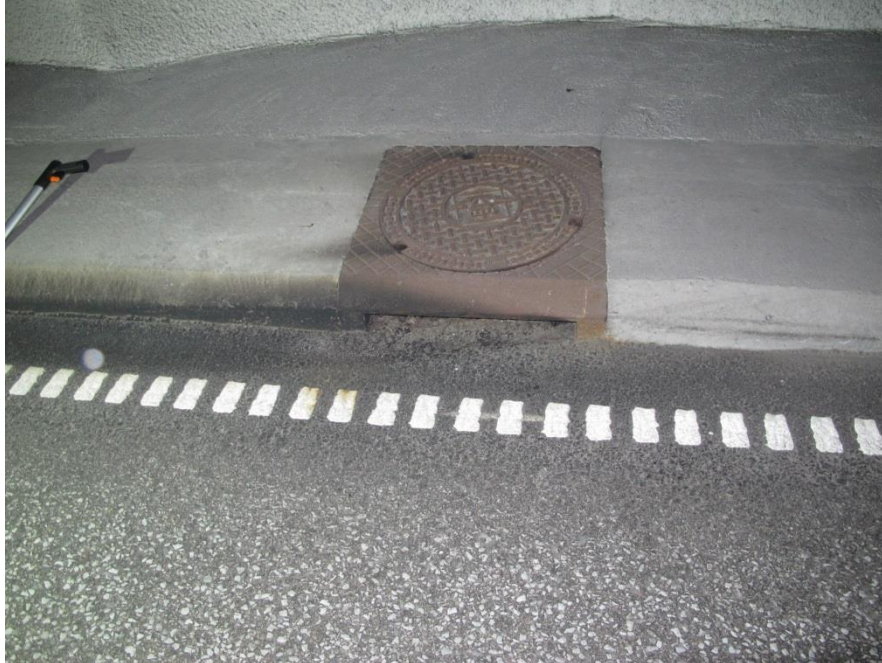
Figure 4: Photograph showing Drain 1, which was furthest down the slope, and which is also visible in Figure 3. Here, the evidence suggests that petrol flowed into, rather than past, the drain. This petrol is calculated to have reached the drain roughly 25 seconds after the start of the fire (3 minutes after the incident occurred); the flame front did so roughly 2 minutes after the start of the fire.

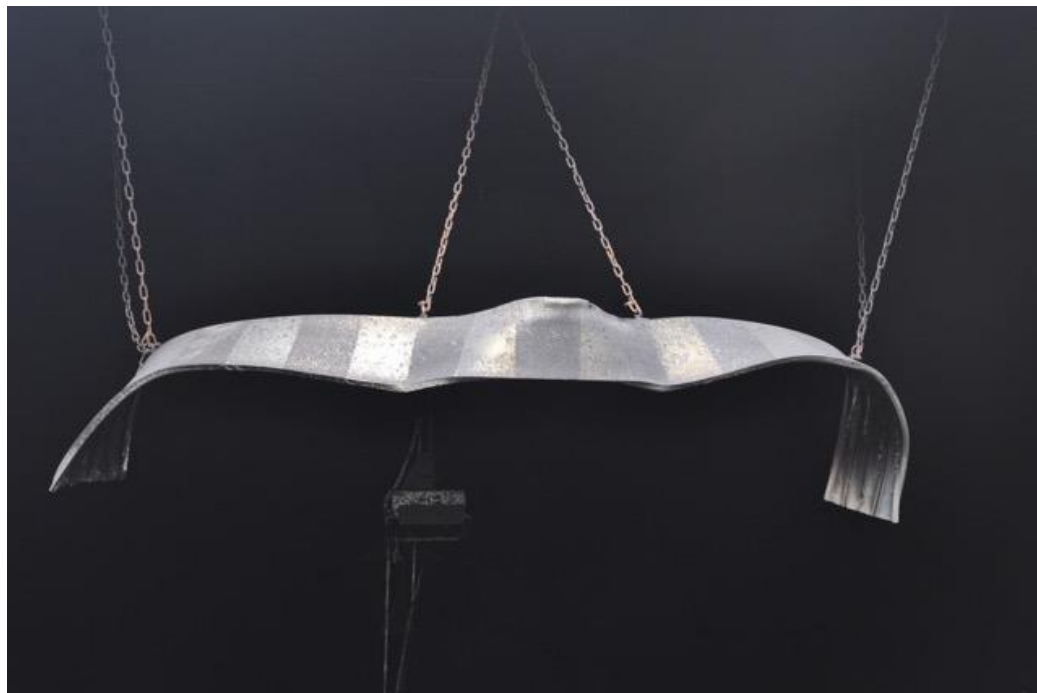
Figure 16: A photograph taken after the fire of the height limit sign at the Hamnen portal (source: NPRÅ).

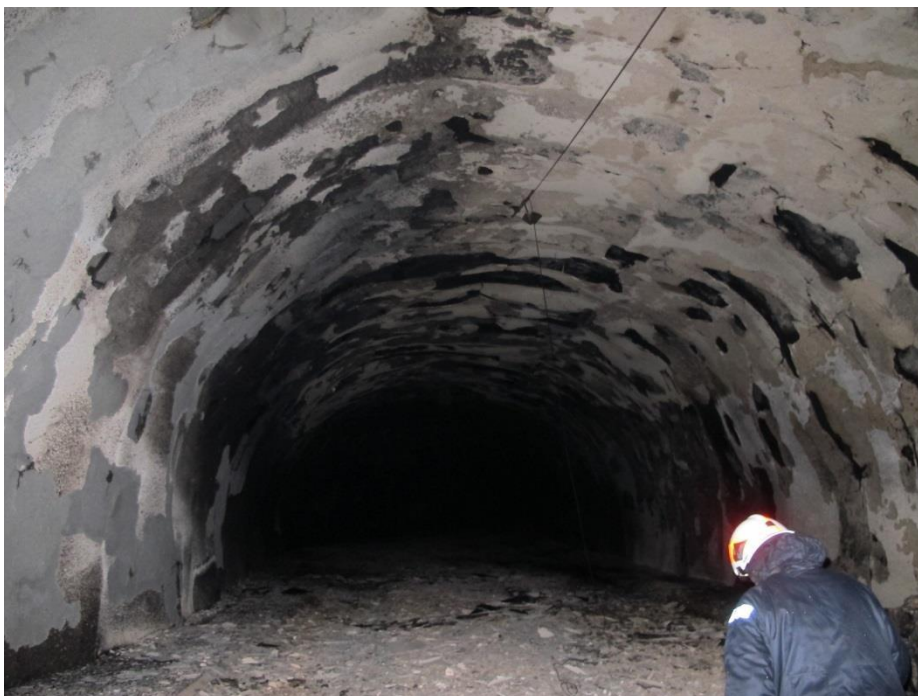
Figure 17: Damage to the shotcrete just up-slope from the trailer.

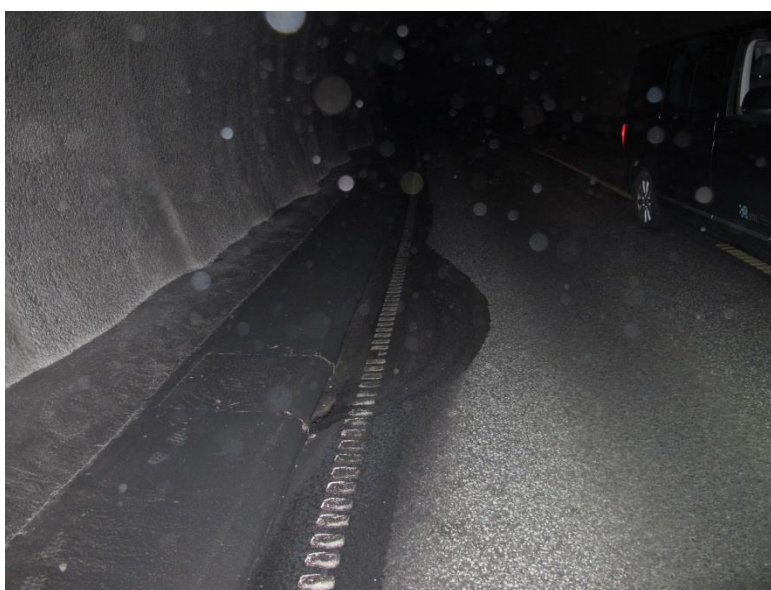
Figure 20: A photograph of Drain 3, showing the discrepant marks that suggest that petrol flowed out of the drain and along the surface of the road.

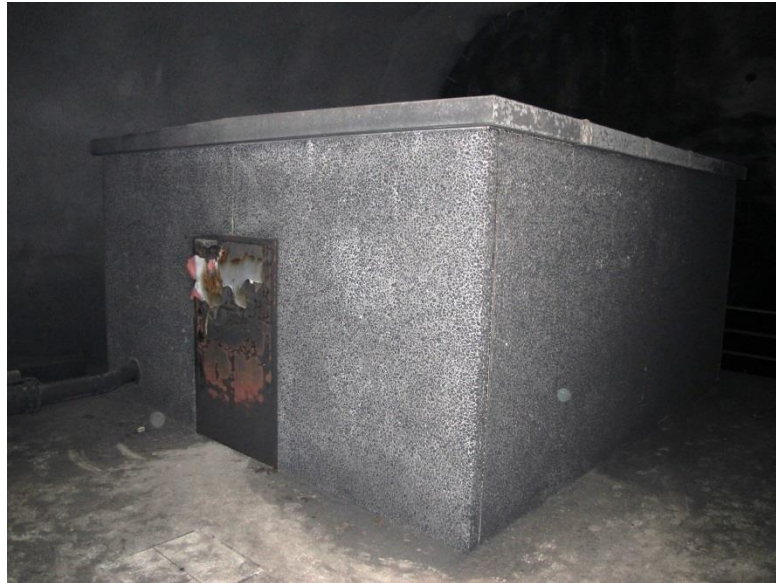
Figure 21: Very marked fire damage on the door of the pumping station, located directly above the sludge basin. Just past the pumping station was a grated floor, which was above the sludge and water basins. There were clear signs of a fire having occurred in the sludge basin.

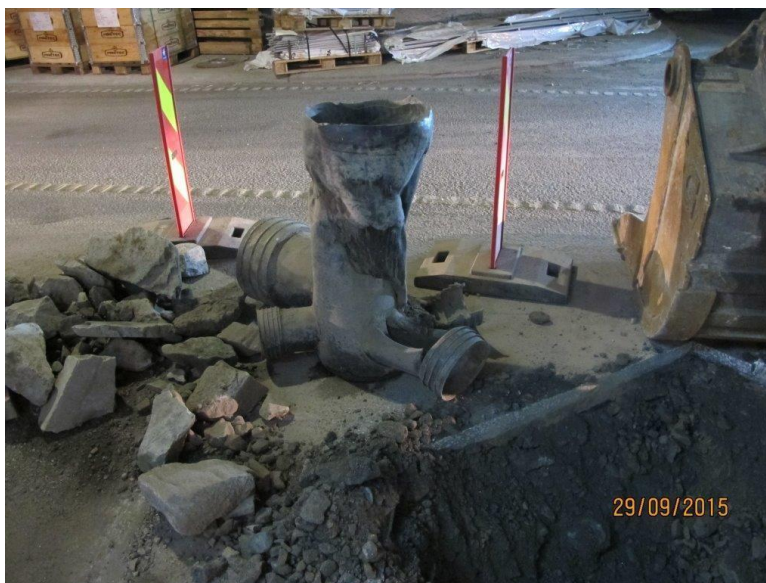
Figure 23: Parts of the rock water drain that was located outside the pumping station. The signs of an intense fire are quite clear.
