REPORT

Road 2017/04

REPORT ON FIRES IN GAS-POWERED BUSES IN HORGVEGEN, RANHEIM, TRONDHEIM ON 17 DECEMBER 2016 AND AT FLATÅSTOPPEN, TRONDHEIM ON 23 NOVEMBER 2016

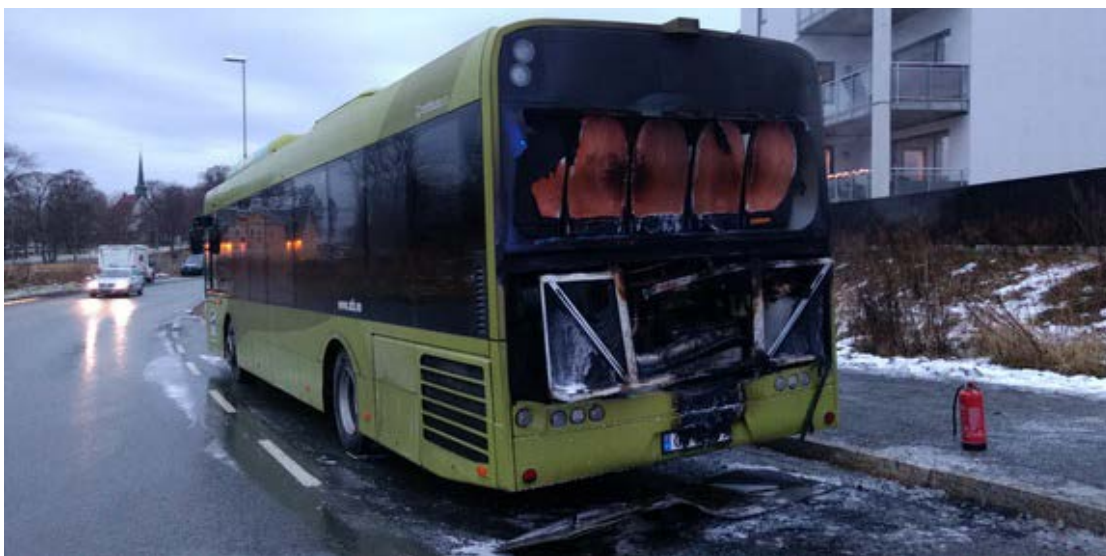
Figure 1: Fire damage to the rear of the bus, the engine compartment cover is lying on the ground behind the bus and the fire extinguisher is empty. Photo: The police

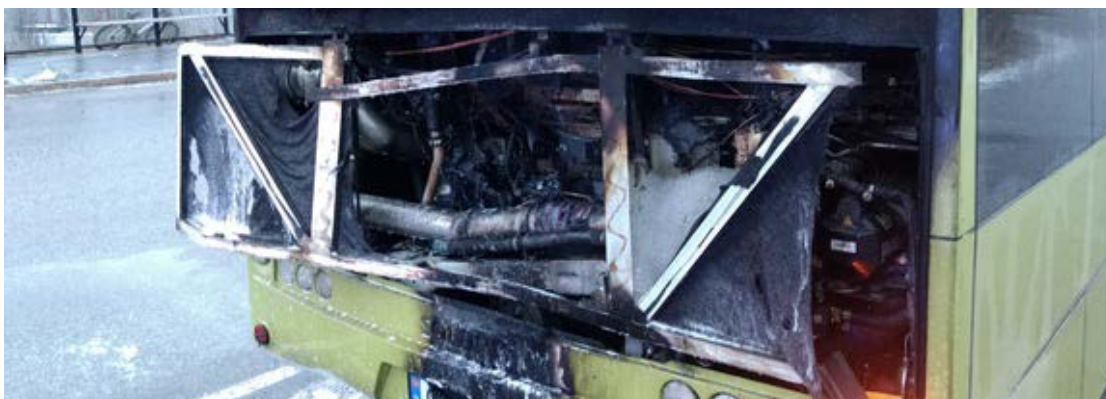
Figure 2: Close-up of the fire damage to the rear of the bus. Photo: The police

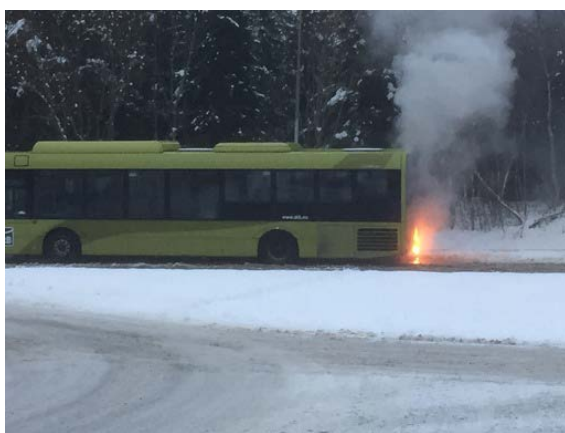
Figure 3: First photo of the fire, taken at 9:15.
Photo: Helge Harsvik

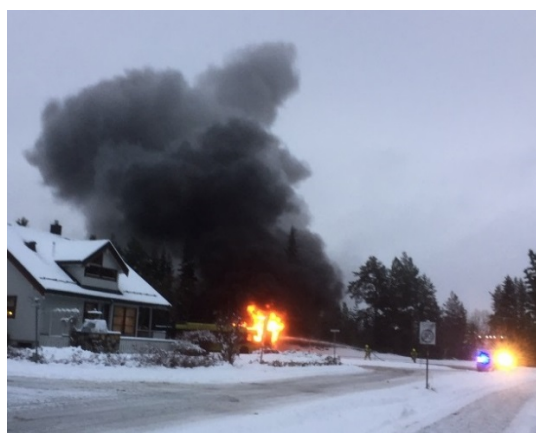
Figure 4: The fire service's extinguishing efforts, at 9:24. Photo: Helge Harsvik

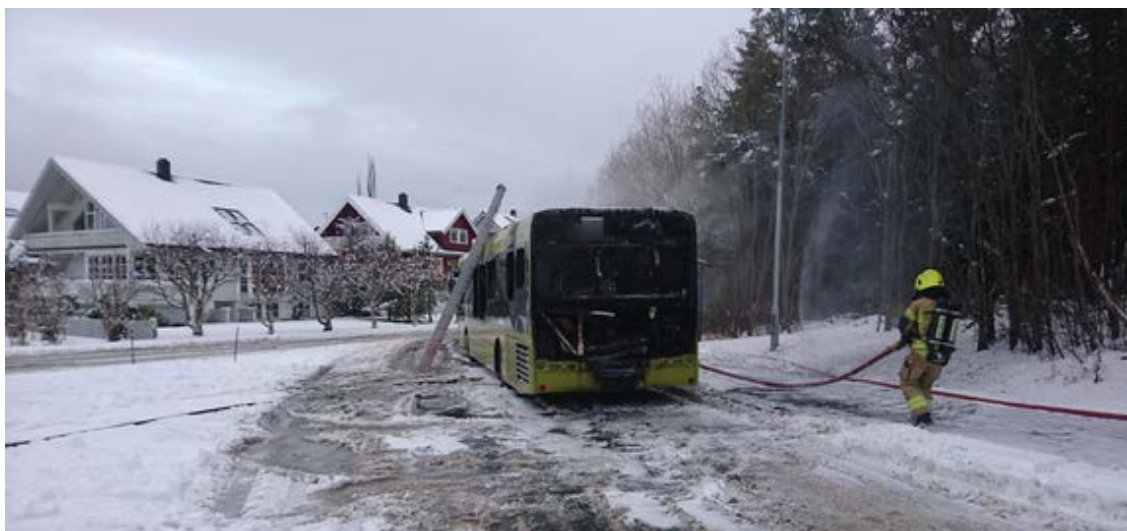
Figure 5: The bus after the fire had been extinguished. Photo: The police

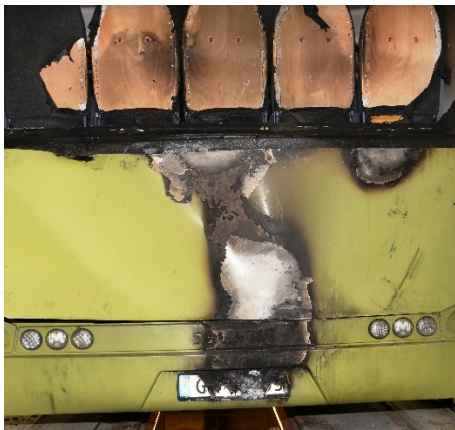
Figure 6: From the fire on 17 December 2016. Rear hatch placed in the position it was in before the fire. Photo: The police

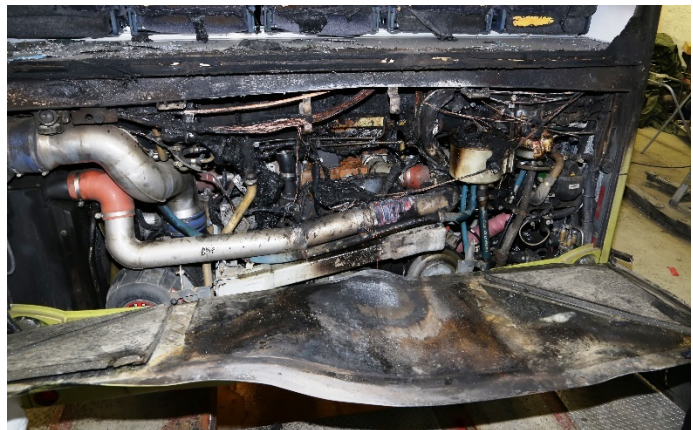
Figure 7: From the fire on 17 December 2016. Melted plastic in the engine compartment and insulation burnt in a V shape on the inside of the rear hatch. Photo: The police

The sound insulation materials used in the two buses did not have good fire resistance. The sound insulation mats vertically installed above the licence plate lights probably contributed to the spread of the fire in that the heat caused them to melt, drip and burn, which in all likelihood added flammable material to the ignition source. Furthermore, the sound insulation material, which was vertically installed, had not been fire-tested for vertical fire spread. In the absence of the fire service's extinguishing efforts, both buses would presumably have been engulfed in a fully developed fire, even if the internal extinguishing system had been activated and a hand-held fire extinguisher used as in connection with the fire on 17 December.

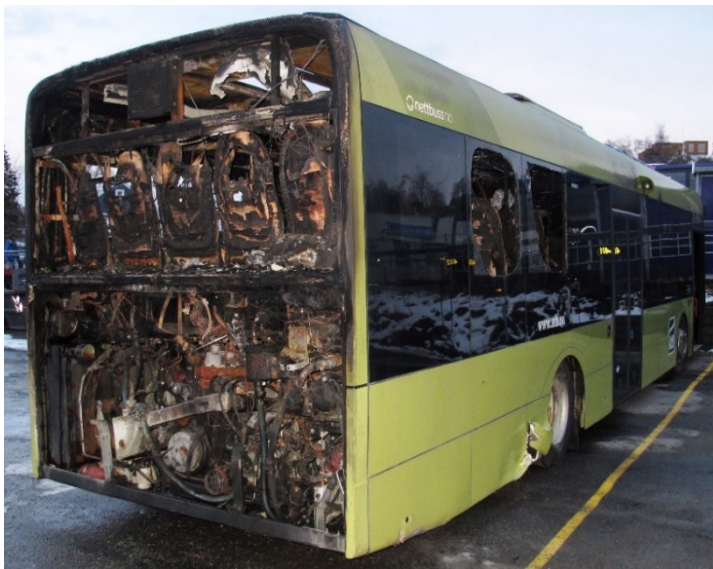
Figure 8: Fire on 13 November 2016. Damage to the engine compartment. Photo: AIBN

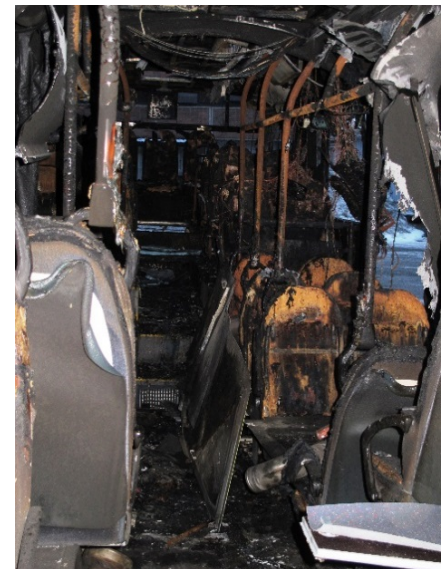
Figure 9: Fire on 13 November 2016. Fire damage to the interior, looking towards the rear of the bus. Photo: AIBN

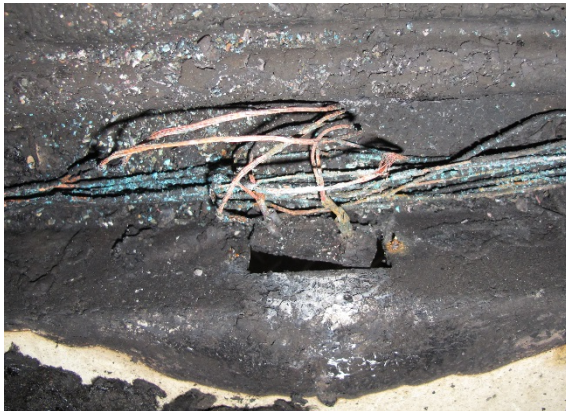
In both buses, the licence plate lights were charred, and the circuit board was visibly deformed at the contact points. In the bus that caught fire on 17 December 2016, the fuse for the licence plate light circuit was still intact, while the cables were burnt through and showed arcing damage.

Figure 10: Licence plate light from the fire on 17 December 2016 with arcing damage to the circuit. Photo: AIBN

The investigation showed that, in connection with the fire on 17 December 2016, cracks had most likely developed in the plexiglass on one of the licence plate lights on the rear hatch some time before the fire. This allowed moisture to ingress into the light, which in turn led to corrosion and subsequent arcing in the circuit board and ignition. The fire has probably spread through the wiring and into the sound insulation mat fastened above the licence plate light on the inside of the rear hatch. The arcing in the licence plate light has not consumed enough power to blow the fuse, but the cables above have probably gradually burnt through. This has resulted in arcing, and the multiplexer's earth-fault protection may have been triggered. Based on the fire-technical examinations and findings from the investigation, the AIBN deems the cause of the fire to be identical in both cases.

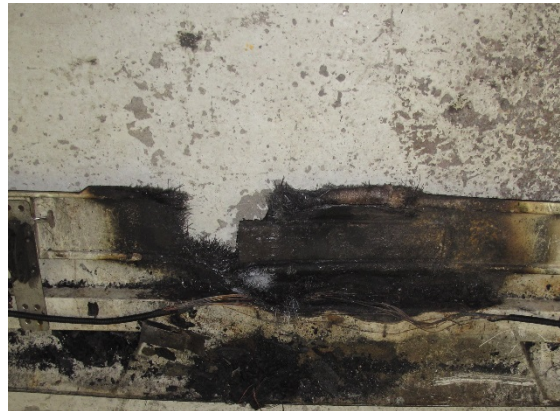
Figure 11: Licence plate light from the fire on 13 November 2016. Photo: AIBN

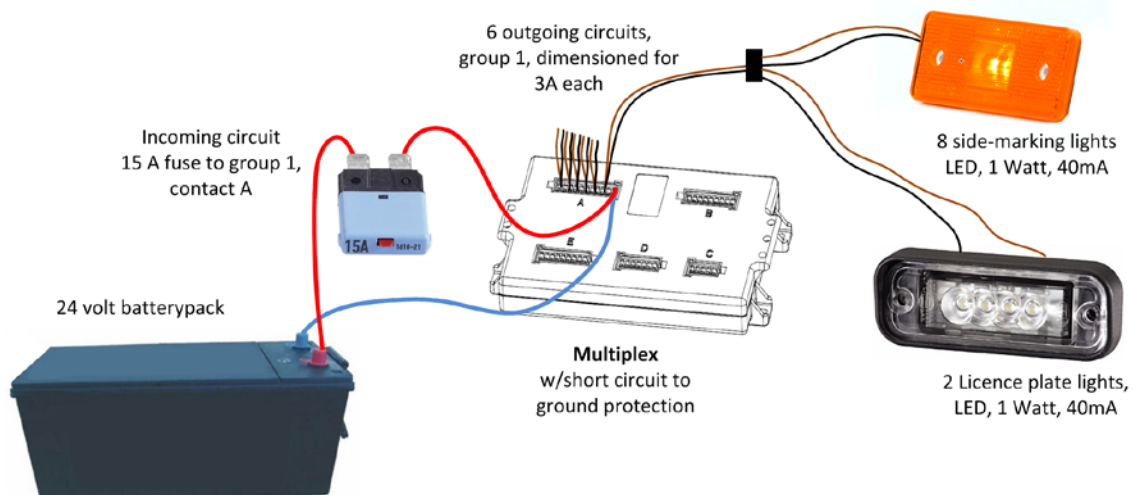
The input circuit for the multiplexer was protected by a 15 A fuse and the power was distributed to a group of six outgoing circuits in the multiplexer. The six outgoing circuits in the group had a wire cross section of 0.75 mm² and were dimensioned for 3 A each, and were only protected by the 15 A fuse on the input circuit and the multiplexer's internal earth-fault protection.²

Figure 13: Simplified sketch of the electrical system from the battery to the licence plate lights. Sketch: AIBN

In the AIBN's opinion, the fuse circuit (15 A) that protected the incoming cables to the multiplexer did not protect the outgoing cables or the licence plate lights. This fuse was thus overdimensioned, so that the currents created in the licence plate lights, which were great enough to give rise to a fire, were not detected. The AIBN also questions why six fuse circuits distributed via the multiplexer, each dimensioned for 3 A, were not separately protected. In the AIBN's opinion, the fires could probably have been avoided had the fuse circuit been dimensioned for 3 A. LED lights draw less electricity than traditional incandescent light bulbs, but are also more complex in structure. Unlike an incandescent bulb, where the current is cut as soon as the filament is broken, faults in LED lamps exposed to moisture can develop over time and create new paths for the current in the circuit board, regardless of whether or not the licence plate light is shining or not.

The Accident Investigation Board Norway recommends that Solaris Norway review and improve the dimensioning of the electrical system on existing and corresponding buses, so that fuse rates will be an effective barrier against fire in case of component failures.

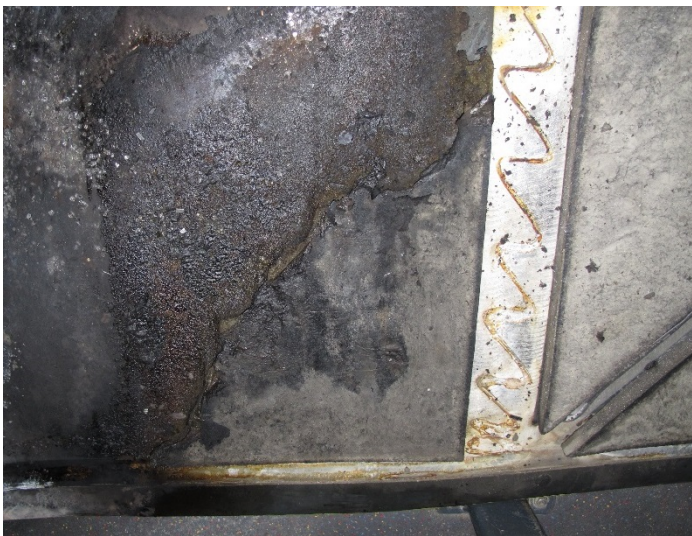
In both buses, the insulation material on the inside of the rear hatches of the engine compartment was of the type T26F/PA/CARBONFLEECE. Information from the material safety data sheets for these insulation mats show that they have been tested for vertical fire spread (< 100 mm/min). The insulation mat primarily consisted of polyurethane, which can ignite, melt and drip if exposed to a source of ignition or sufficiently high temperatures. According to the material safety data sheet, the mats are capable of withstanding a constant temperature of 120 °C, and up to 180 °C for short periods.

Figure 15: Right side of the V-shaped burn in the insulation on the rear hatch on 17 December 2016. Photo: AIBN

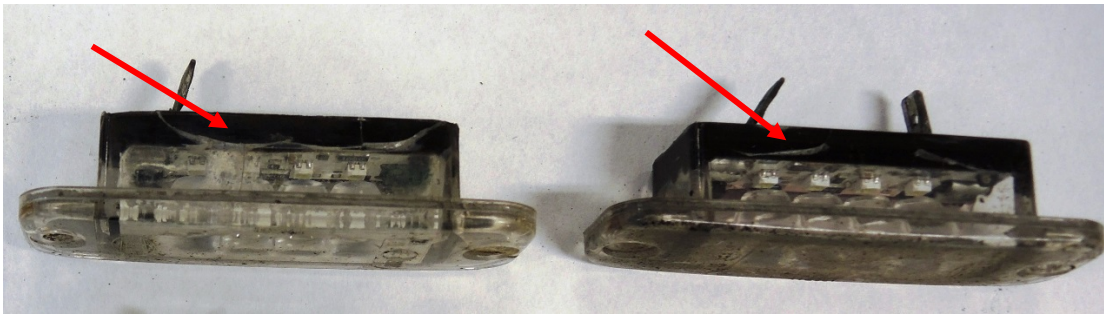
The AIBN observed cracks in the plexiglass of several used and discarded lights that could not be related to impacts from installation or naturally occurring mechanical stress. In lights where cracks were observed, the internal circuit boards were also visibly corroded.

Figure 16: Used licence plate lights. The arrows indicate the longitudinal cracks in the plexiglass. Photo: AIBN

- b) Hella's review of the production process for the licence plate lights found that the cracks had to do with how long the lights were kept in the oven during the moulding process.

The light manufacturer, Hella, has reviewed and modified its internal requirements, production process and quality control. The cracks in the licence plate lights that the AIBN was unable to explain after its technical examination, were already known to Hella. The company has now ascertained that the weaknesses that caused cracks to develop in the plexiglass had to do with the time interval during which the licence plate lights underwent heat treatment in an oven during the moulding process in the production phase. Hella has adjusted this time interval accordingly.

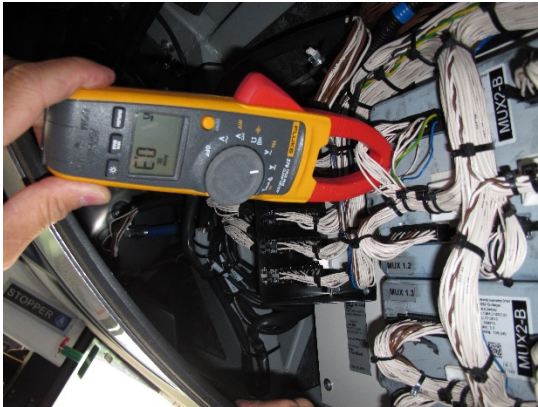
Figure 17: During operation, all the circuits connected to group 1, output A in the bus's multiplexer used 0.3 A. Photo: AIBN

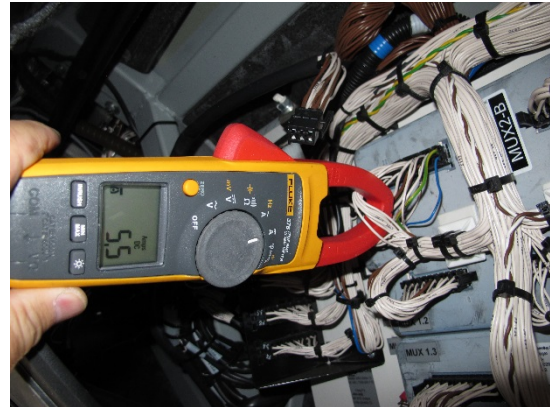
Figure 18: The licence plate lighting circuit at 5.5 A, more than the consumption at the time of the fire in the licence plate light. Photo: AIBN

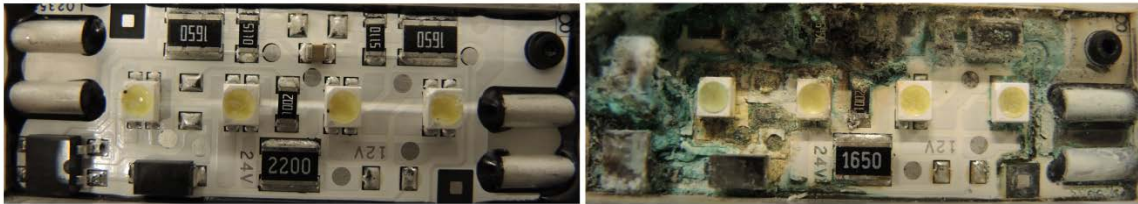
Figure 19: The interior of a new LED light shown on the left, and on the right a defective and corroded one. Photo: AIBN

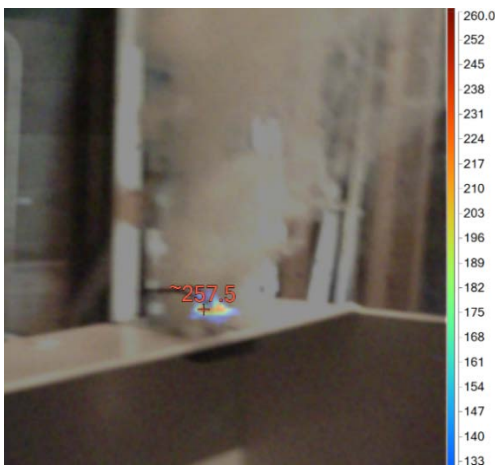
The salt water solution caused some licence plate lights to stop working, and in several cases arcing occurred and caused the light to catch fire. The amperage in the lights was logged during the tests, and currents ranging from 2.5 A to 6 A were measured when the licence plate lights ignited. The lights that caught fire had visible deformation to their exterior surface at the contact points. Abnormal amperages were observed in the licence plate lights, regardless of whether or not they shone.

Figure 20: Fire test of licence plate lights, thermal image just before ignition, temperature approx. 257 °C. Photo: AIBN

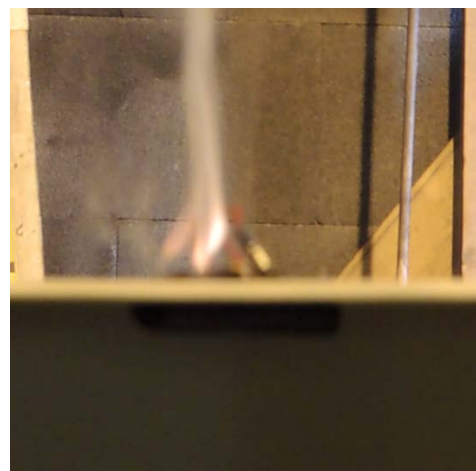
Figure 21: Licence plate light in the same experiment with visible flames. Photo: AIBN
