REPORT

Road 2018/01

REPORT ON TRAFFIC ACCIDENT IN KRISTIANSAND 7 MARCH 2017 INVOLVING A MOBILE CRANE

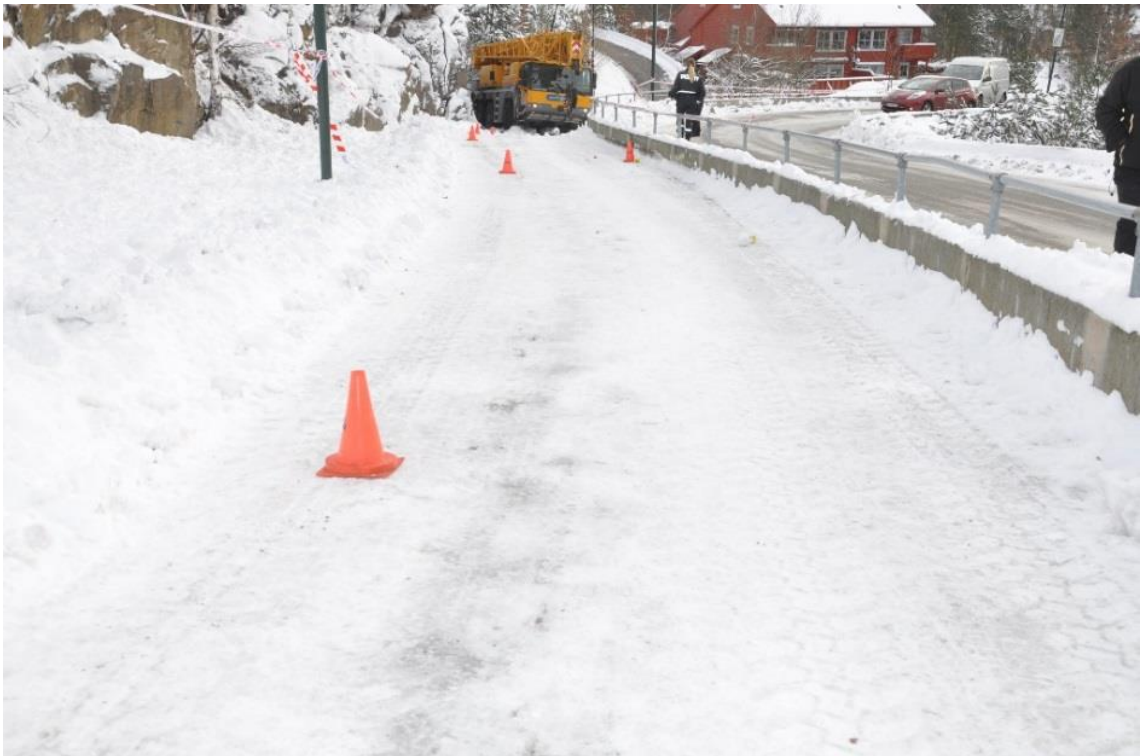
The structure of the front wheels' tyre tracks changed approximately 25 meter from the start of the walkway (see figure 3 first cone). The following is reproduced from the police documents:

Approximately 25 metres from the start of the walkway, the tyre tracks from the right front wheel changed character. A clear imprint of the tyre tread pattern changed to a more glossy tread pattern. The skid mark measured approximately 46 metres. The same type of change, although less pronounced, could be observed in the tracks left by the left front tyre. The glossy tracks from the left front tyre became clearer further down the slope. The wheels on the two rearmost axles had left imprints of the tyre treads in the tracks, indicating that they rotated without skidding.

Figure 3: Tyre tracks and final position of the mobile crane. The first cone marks where the tyre track from the right front tyre changed character. Photo: The police

Approximately 17 metres down from where the crane had been parked, the AIBN observed scratch marks on the railing and debris from the mobile crane; see figure 3. Figure 4 shows the measured tyre tracks left by the mobile crane's front wheels on the walkway until it reached its final position.

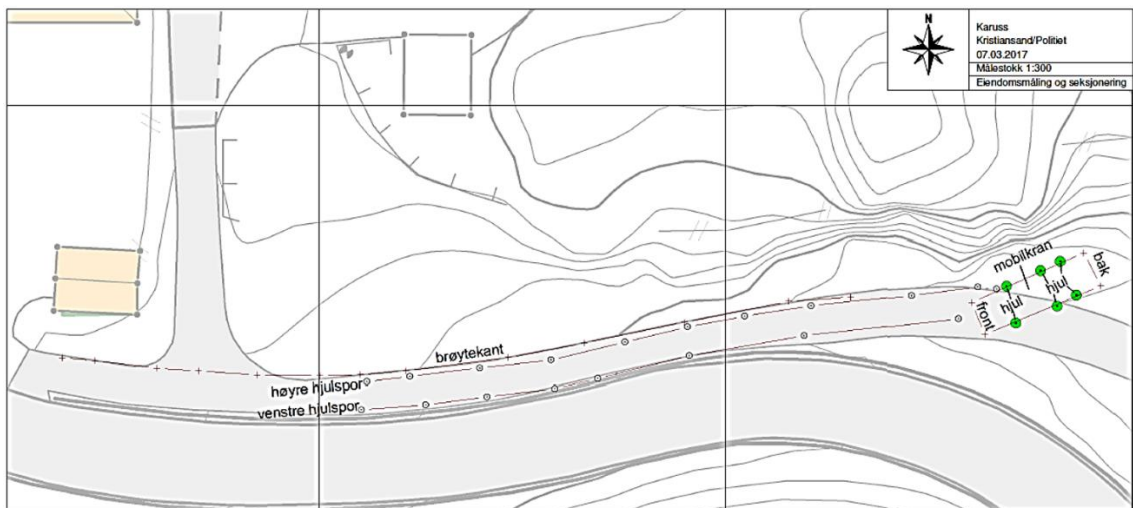
Figure 4: Sketch showing the tyre tracks left by the mobile crane's front wheels along the walkway until the vehicle reached its final position. Illustration: The police

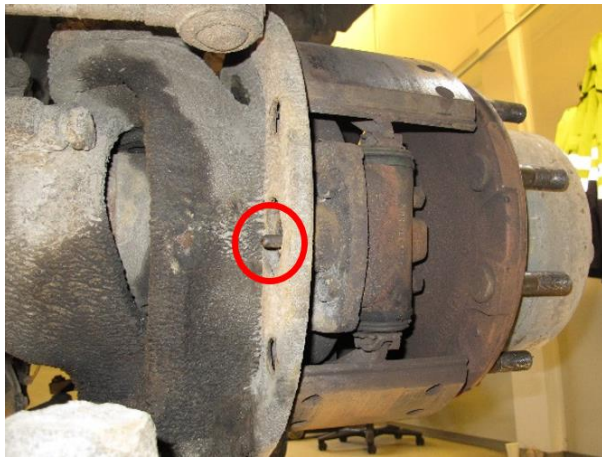
The AIBN wanted to find out why the compressed air being supplied to the brake cylinders on the second axle was not converted to braking power when the parking and service brakes were activated. The brake cylinders and wheel cylinders were dismantled, and it was observed that the expander wedge on the left side was stuck further inside the wheel cylinder housing than normal, see figure 5 and figure 6.

Figure 5: Push rod stuck inside the wheel cylinder on the left side. Wheel cylinder and brake shoe on the left side. Photo: AIBN

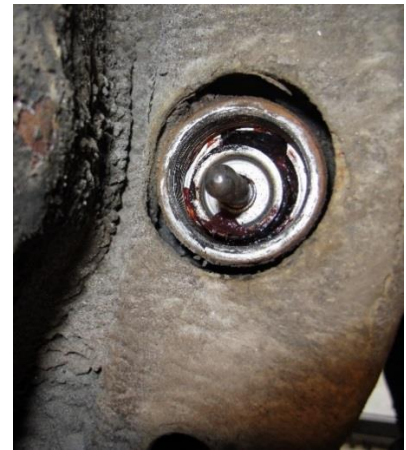
Figure 6: Push rod in expander assembly, wheel brake, left side. Photo: AIBN

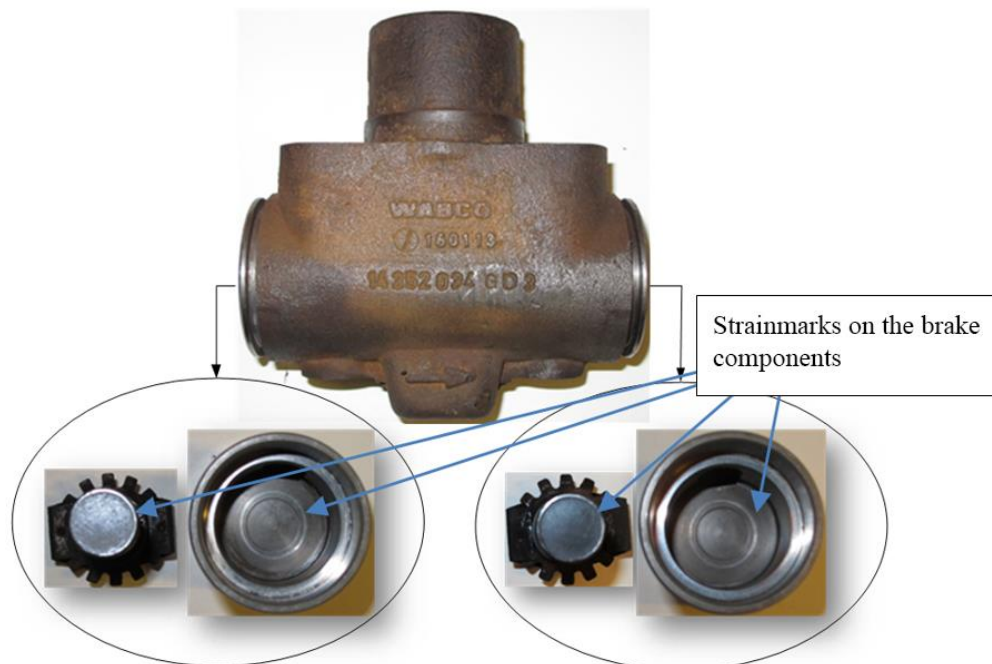
Contact marks in the wheel cylinder showed that all four self-adjusting screws had been in the inner position. Figure 7 shows marks left by the self-adjusting screws. In this position, the self-adjusting screws are outside their working range.

Figure 7: Physical traces of contact between the self-adjusting screw and the bottom of the wheel cylinder pistons on the left side, indicated by the blue arrows. Photo: AIBN

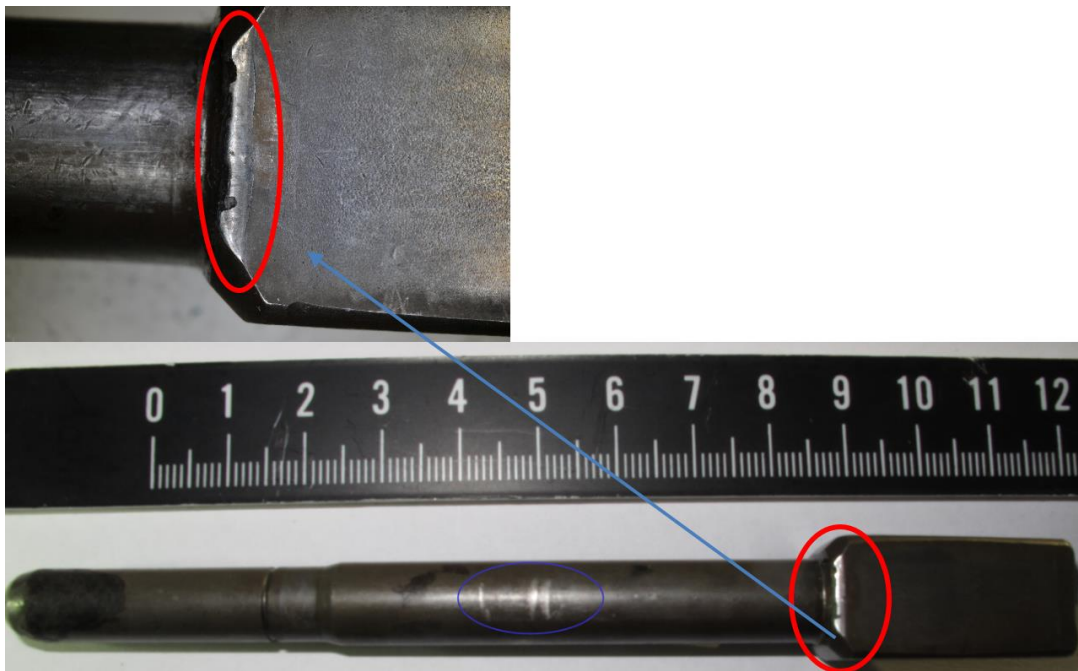
Marks were also found that showed how the rollers in the expander assembly had rolled over the 'top' of the wedge; see figure 8.

Figure 8: Traces of wear from the roller system on the cylindrical area and at the top of the wedge. Photo: AIBN

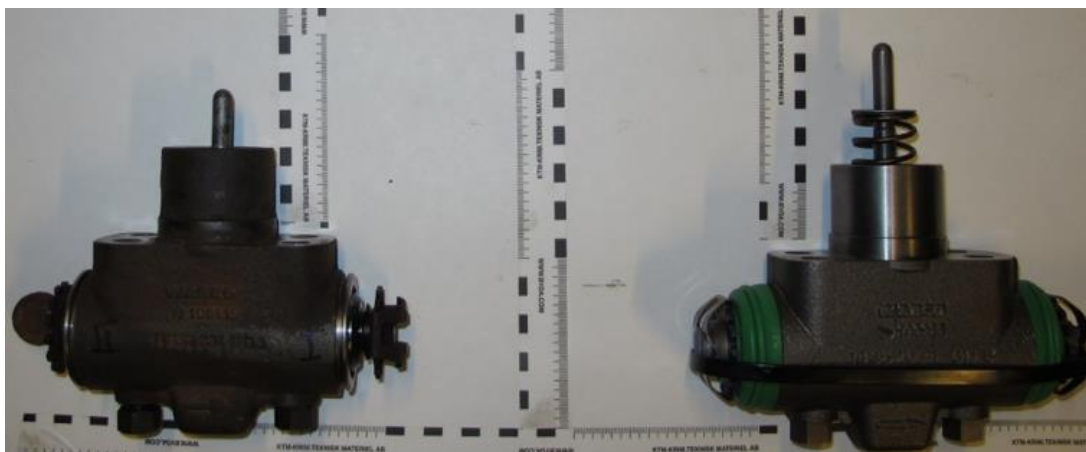
In order to find possible explanations of why the expander assembly's push rod on the left side proved to be stuck too far inside the wheel cylinder when the system was dismantled, we have compared the old components to new ones as shown in figure 9. The component on the left is shown with the push rod positioned approximately as it was when the system was dismantled from the mobile crane, while the component on the right shows the normal position of the push rod when installed.

Figure 9: In the photo on the left, the expander assembly is mounted approximately as it was when it was dismantled, see figure 5 and figure 6. The photo on the right shows how the push rod should normally be positioned in the expander assembly. Photo: AIBN

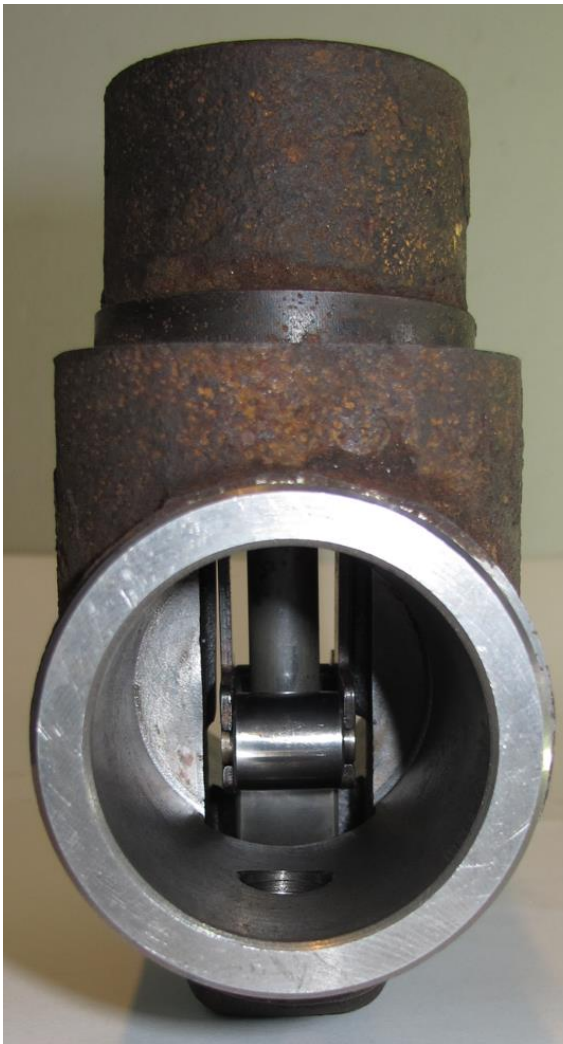
The AIBN has assembled the push rod, roller cage and wheel cylinder as shown in figure 10. Here the wedge is pushed to the bottom of the housing and the rollers, including the roller cage, are positioned as indicated by the traces of load exposure in figure 8. In this case the roller position makes it physically impossible for the rollers to hook onto the bottom side of the piston as described by the manufacturers in annexes C and F.

Figure 10: Roller cage 'slipped across'. Push rod with the wedge at the bottom of the housing and the roller cage at the transition between the wedge and push rod. Photo: AIBN

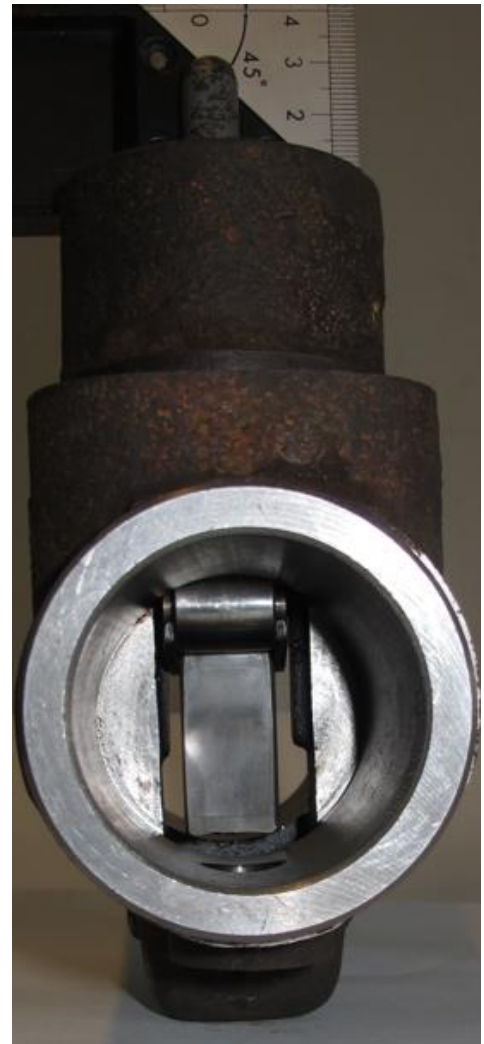
Before it was dismantled, the push rod for the expander assembly was positioned approximately as shown in figure 11.

Figure 11: Assumed position of push rod and roller cage as shown in figure 5 and figure 6. Photo: AIBN

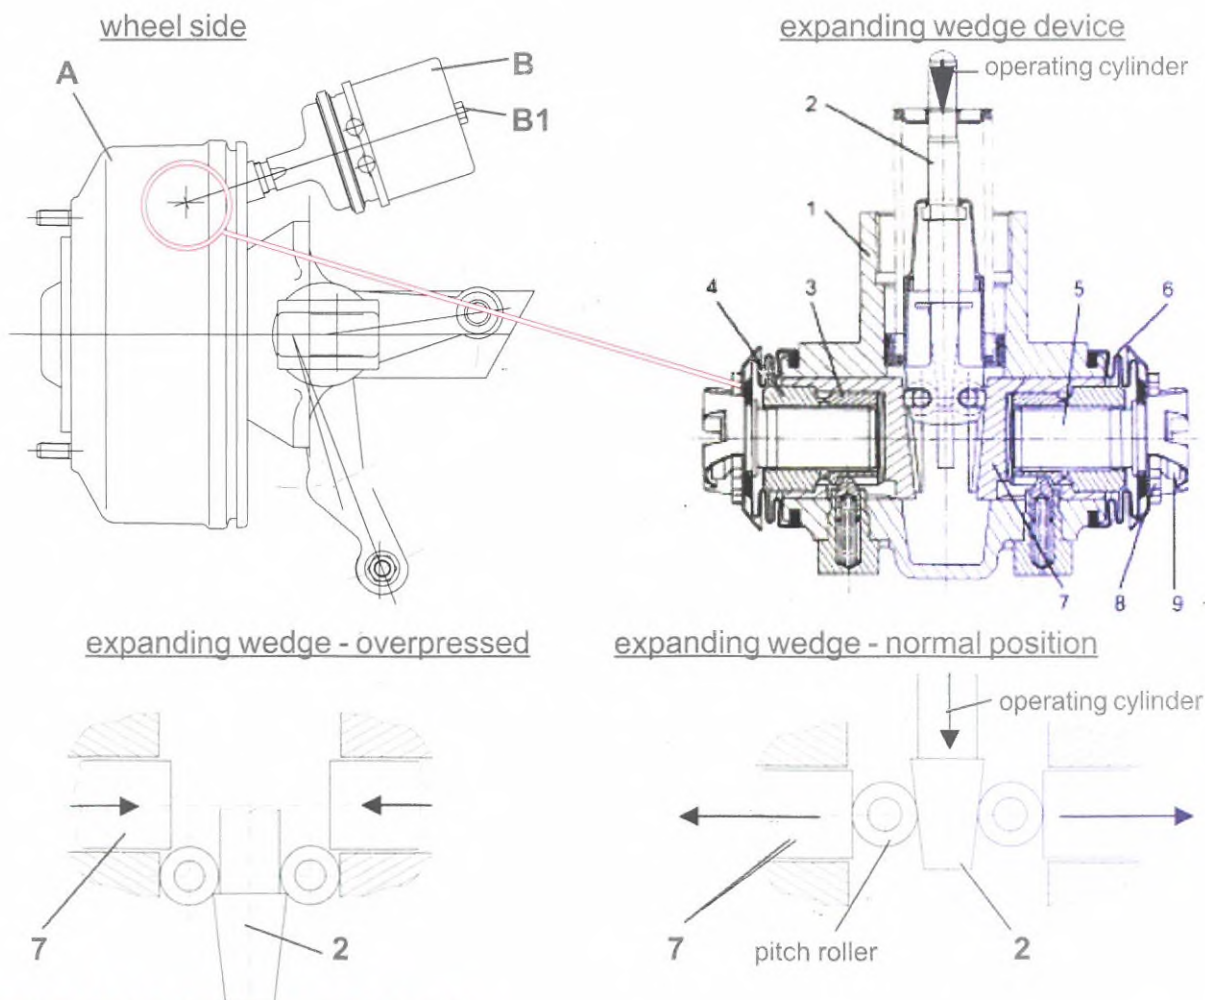
If the expanding wedge (2) is pressed over the edge of piston (7), the expanding wedge (2) is no more reset into its normal position - see below

If the expanding wedge (2) was overpressed (s. below), the expanding wedge device must be repaired or replaced!
