# REPORT

## Road 2018/04

## REPORT ON FIRE IN HEAVY GOODS VEHICLE IN THE OSLOFJORD TUNNEL ON NATIONAL ROAD 23 ON 5 MAY 2017

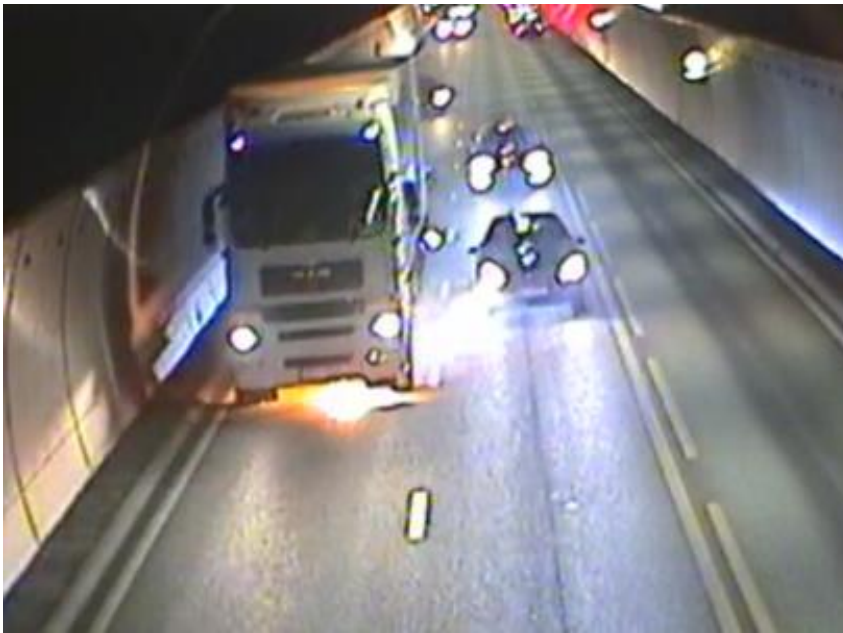
*Figure 2: Triggering event with incipient fire under the heavy goods vehicle. Photo: CCTV image from the tunnel – NPRA*

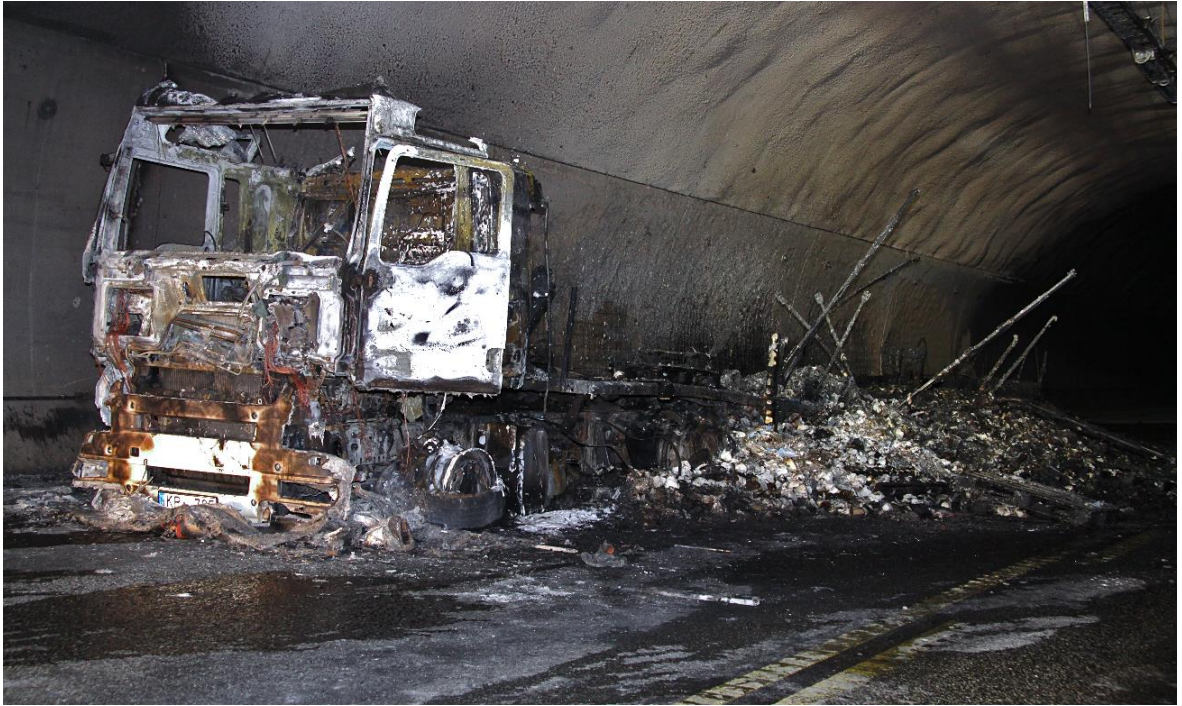
The heavy goods vehicle, including its cargo, was completely burnt out. Non-metal components on and around the heavy goods vehicle were charred, and steel components were partly deformed as a result of the intense heat.

Figure 15: The heavy goods vehicle after the fire had been extinguished, with burnt-out tractor unit and semi-trailer. Photo: The police

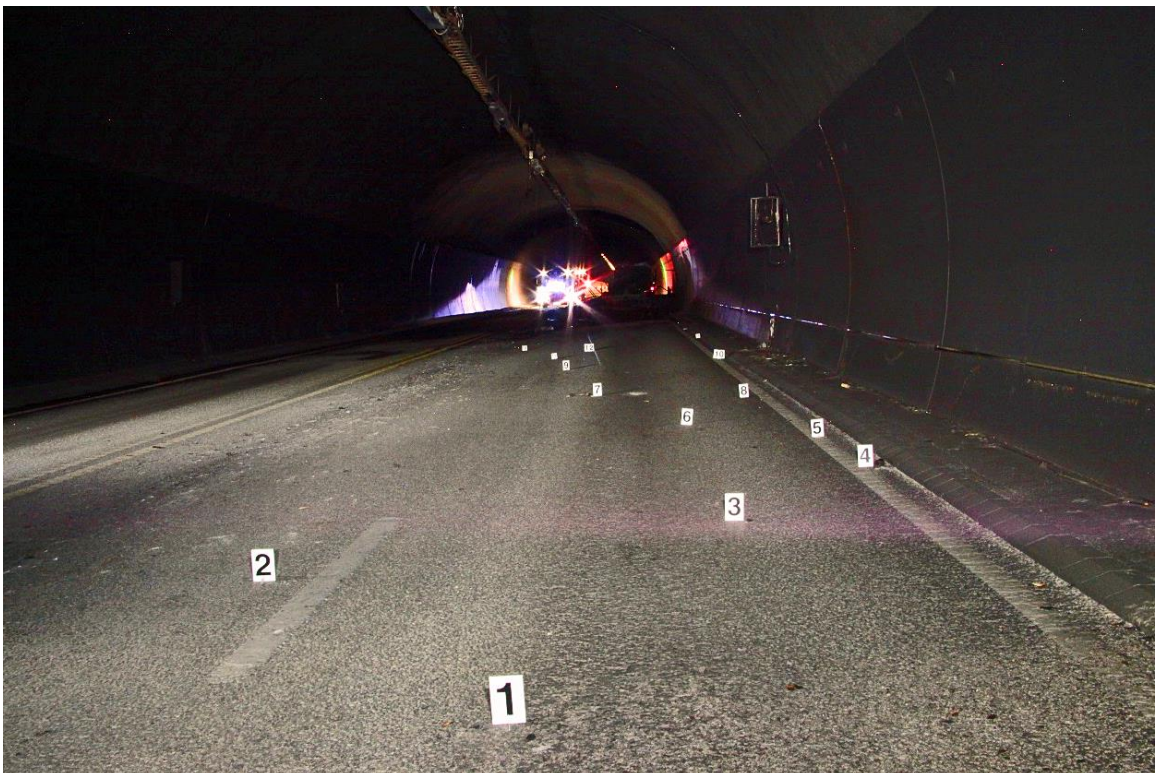
Engine parts from the heavy goods vehicle were found scattered on the road at distances of between 51.2 and 79.3 metres behind the burnt-out vehicle, see Figure 16.

Figure 16: Engine parts from the heavy goods vehicle scattered on the road. Photo: The police

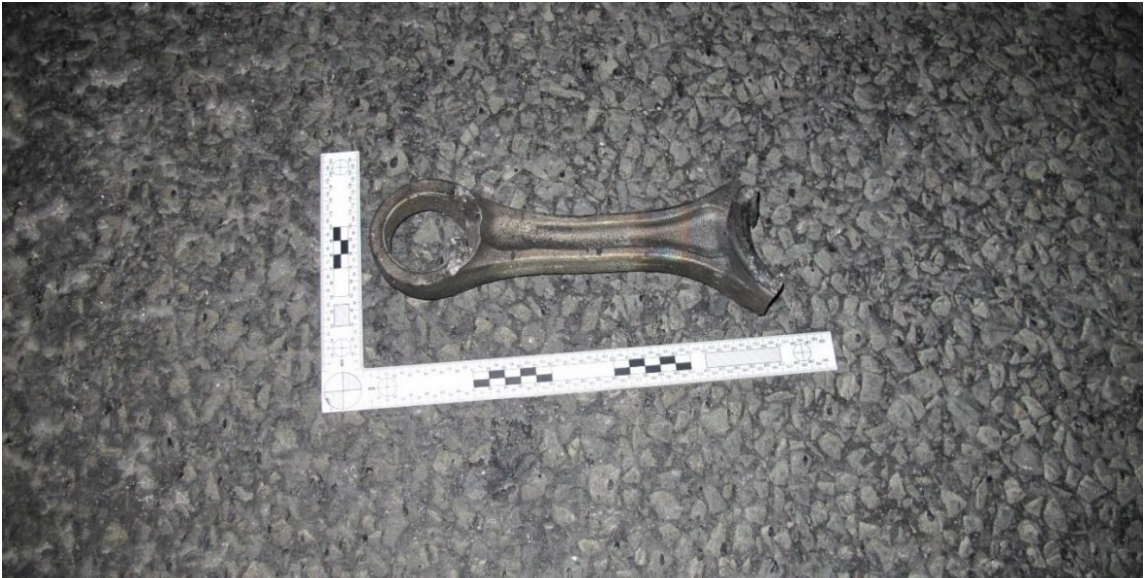
One of the connecting rods from the engine was found in the roadway 67.6 metres behind the burnt-out heavy goods vehicle. Other parts of the engine block and a piston were also found in the roadway behind the vehicle.

*Figure 17: One of the connecting rods from the engine, located in the roadway, 67.6 metres behind the burnt-out heavy goods vehicle. Photo: The police*

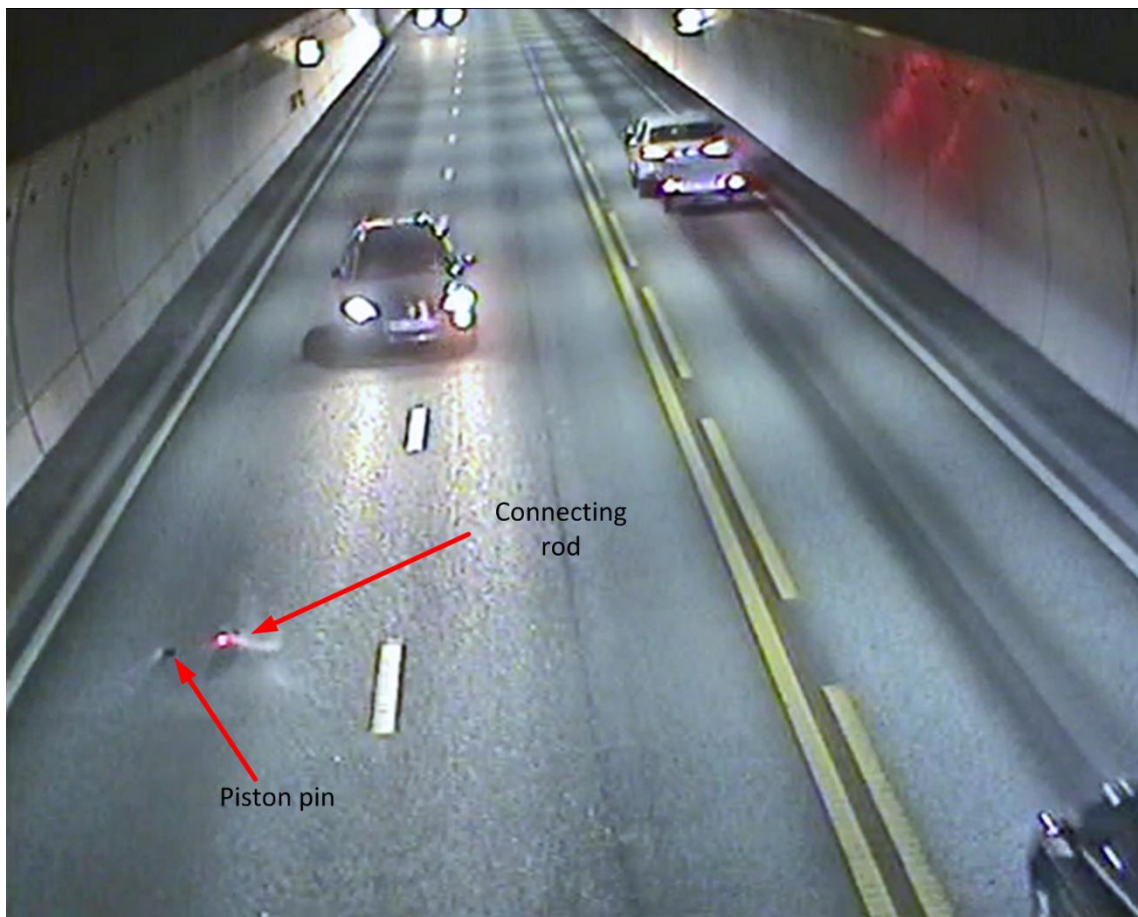
It was soon determined that the engine parts came from the tractor unit's engine. The engine parts had cooled down to the ambient temperature when they were found, but subsequent observations from CCTV footage from the tunnel showed that some of these parts were red-hot when they fell onto the road.

Figure 18: A piston pin and a red-hot connecting rod lying in the roadway inside the tunnel after the engine breakdown. Photo: CCTV image from the tunnel – NPRA

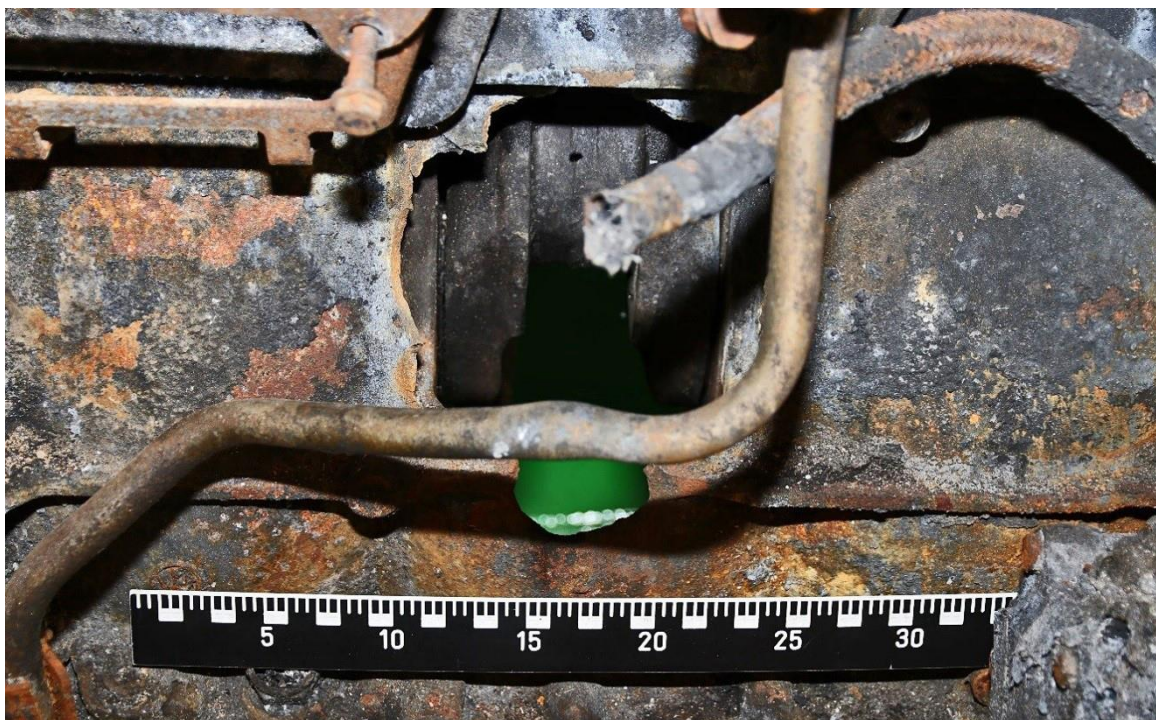
Signs of short-circuiting caused by the engine breakdown were found near the hole in the engine block. These findings indicate that the fire originated in the engine compartment.

*Figure 19: Hole in the lower left side of the engine block. The fuel line on the outside of the engine block had been severed. Photo: The police*

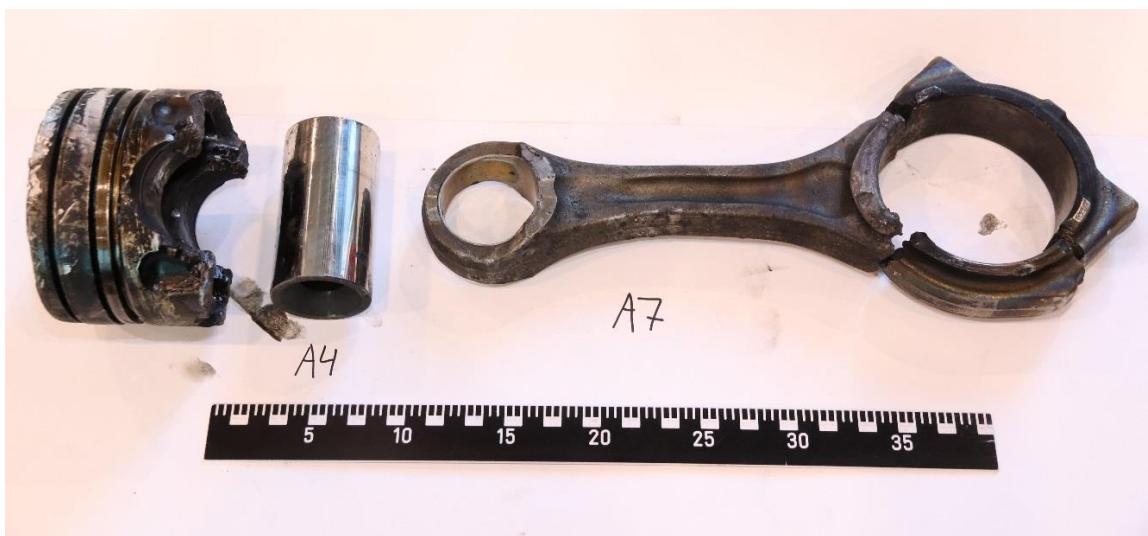
Parts of the connecting rod and the piston from cylinder 4 were also found when the engine was disassembled, see Figure 21. These parts matched those found on the road inside the tunnel.

Figure 21: Parts from cylinder number 4, including the piston, piston pin and connecting rod. Photo: The police

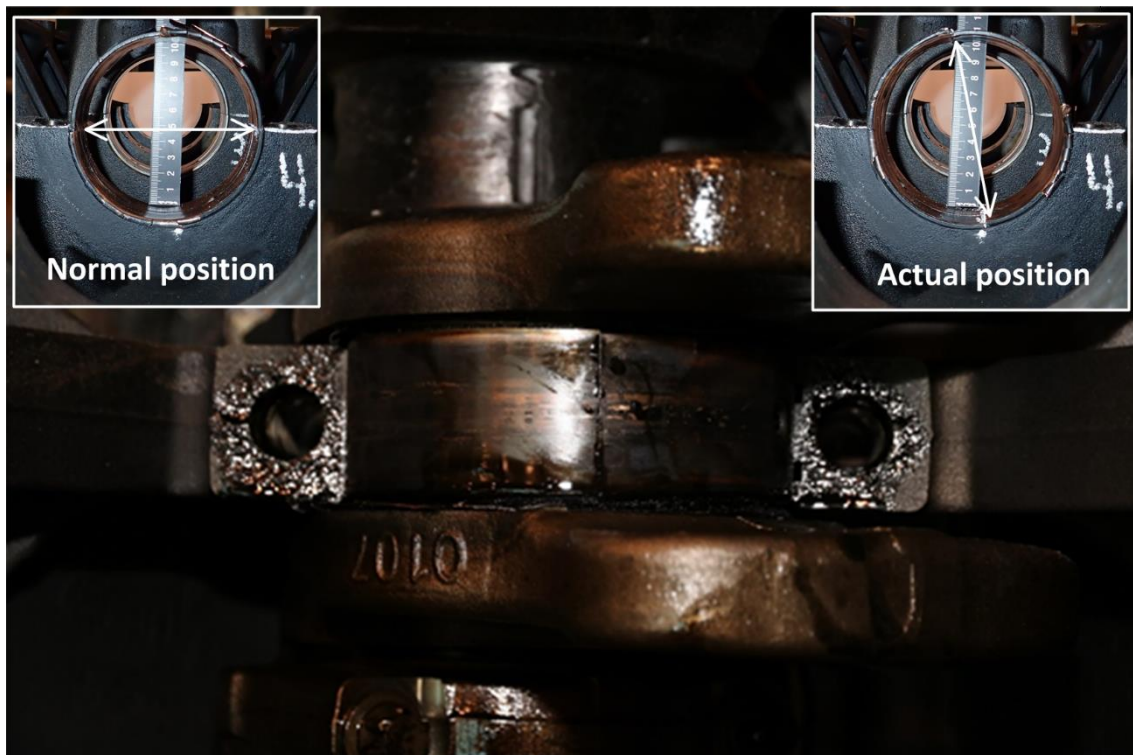
The examination of the damaged engine showed damage to the engine block and crankpin's bearing surfaces where the connecting rod for cylinder number 4 was attached. Disassembly of crankshaft bearing number 4 showed that the bearing halves had come loose and rotated with the crankpin. The rotation of the bearing halves had reduced/blocked the oil supply to big-end bearing number 4. At the same time, it also reduced/blocked the oil supply to crankshaft bearing number 4.

Figure 22 is a photo of the disassembled crankshaft bearing number 4, where the bearing halves had rotated. The normal position of the bearing halves is for the split to be parallel with the split in the bearing block for the crankshaft bearings. Extensive damage was also found in the bearing halves of crankshaft bearing number 4, see Figure 23.

Figure 22: Close-up of the crankpin where the bearing halves of crankshaft bearing number 4 have rotated almost 90°. Photo: The police/AIBN. Illustration: AIBN

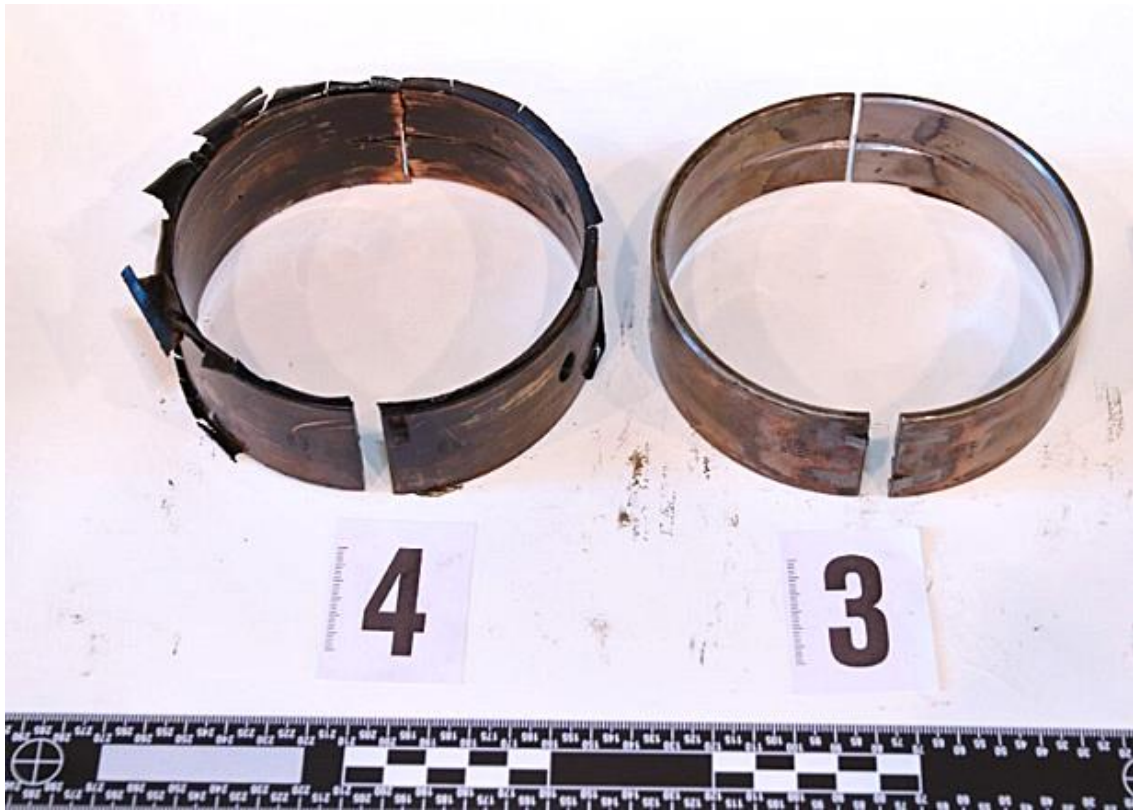
Figure 23: Bearing halves from crankshaft bearing number 4 on the left and from crankshaft bearing number 3 on the right. Photo: The police

The bearing halves of crankshaft bearing number 4 are clearly deformed and discoloured, and the damage is consistent with the bearing halves having rotated and been exposed to high temperatures. Figure 23 shows that the bearing halves of crankshaft bearing number 3 are virtually undamaged.

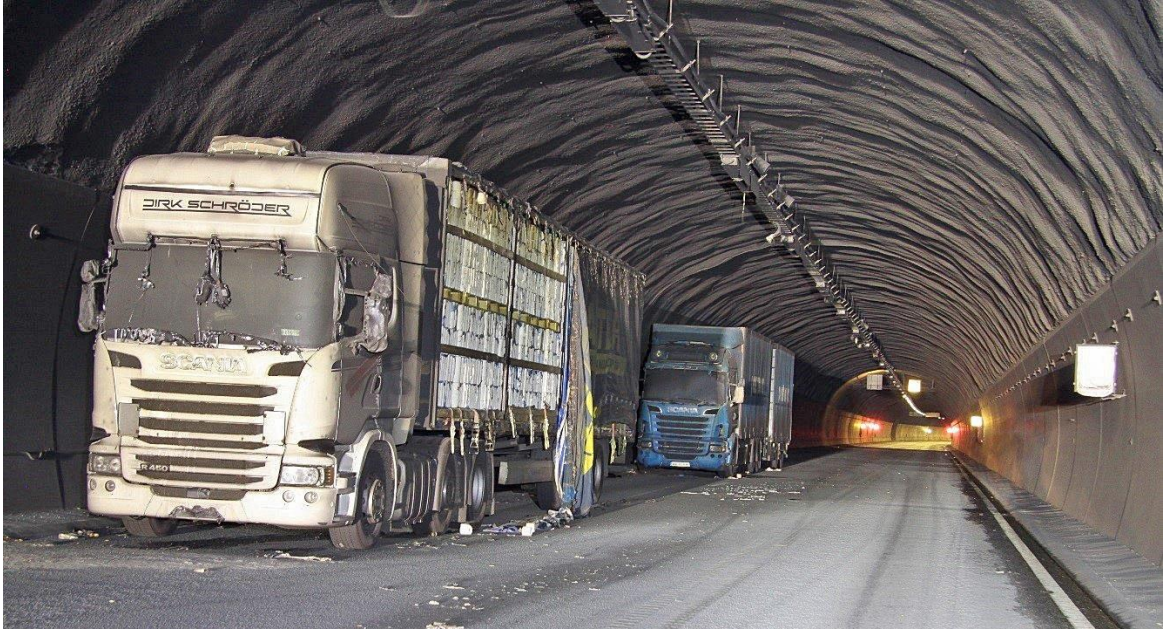
During the incident, there were also incipient fires in these heavy goods vehicles, and the tractor units and some of the cargo sustained heat, melting and smoke damage as a result

of the fire. Plastic components on the exterior of the vehicles were partly melted (bumpers, tarpaulins, mud flaps and mirrors). Neither of the two heavy goods vehicles were in a drivable condition after the fire.

*Figure 24: The heavy goods vehicles located 123 and 156 metres, respectively, behind the burning heavy goods vehicle in the tunnel. Both tractor units had visible heat, melting and smoke damage. Photo: The police*

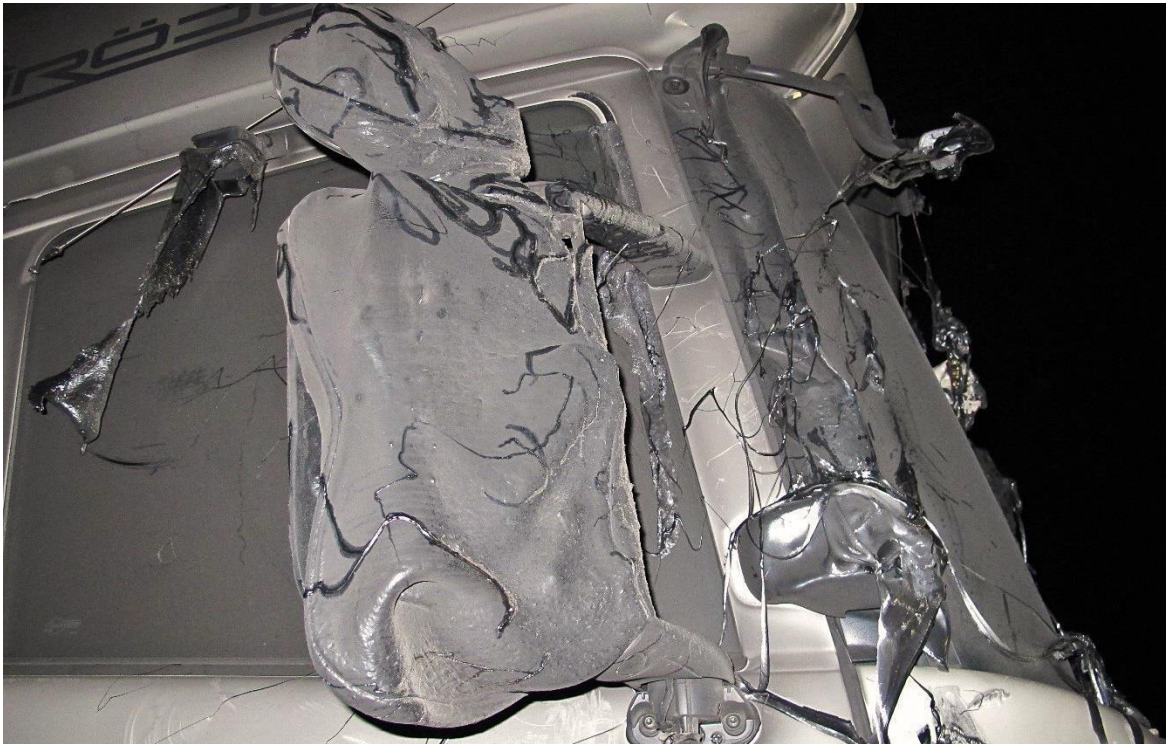
*Figure 25: Heat, melting and smoke damage on the tractor unit of the heavy goods vehicle located 123 metres behind the burning vehicle inside the tunnel. Photo: AIBN*

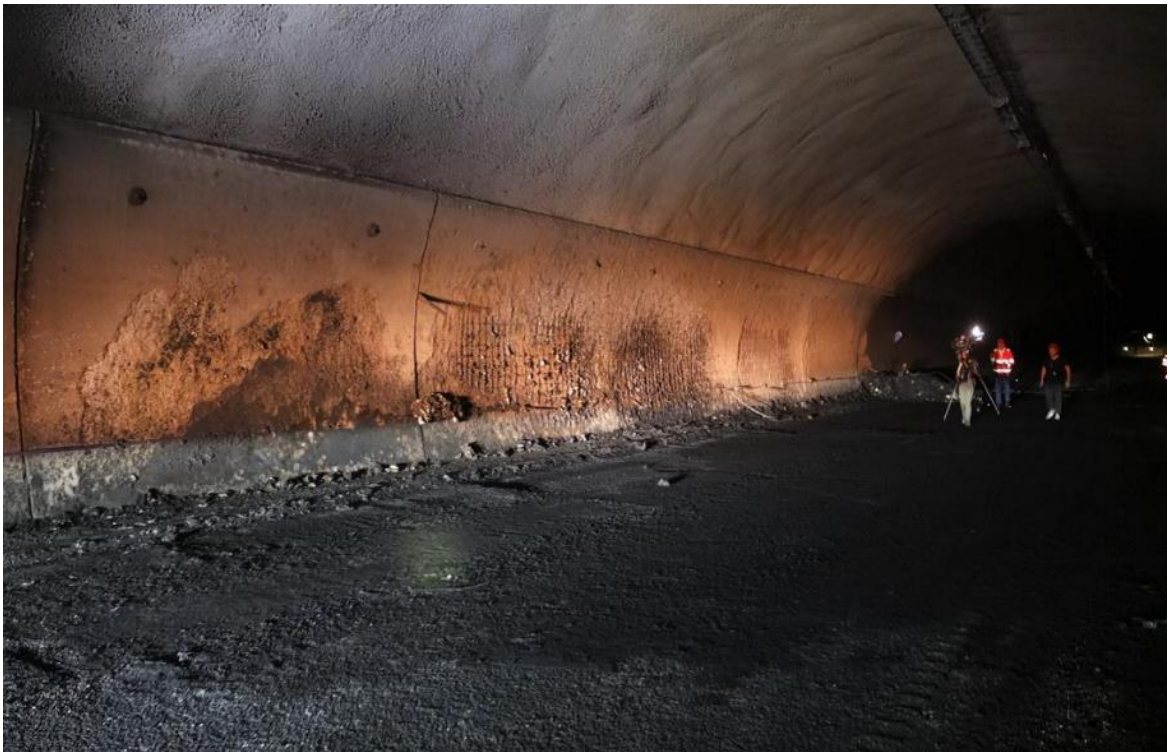
Based on information from the consultancy company Aas-Jakobsen AS, which has inspected and registered damage to the tunnel lining on assignment from the Norwegian Public Roads Administration (NPRA), spalling was found to have occurred, with a maximum depth of approximately 6–8 cm found on wall lining elements on the right-hand side of the tunnel at the scene of the fire (in the direction in which the heavy goods vehicle was travelling). Cracks had occurred on the rock side of these elements as a result of the heat they had been exposed to during the fire.

The damage also included burning/melting of the sealing compound used in the joints between wall elements on both sides of the tunnel, extending approximately 100 metres from the scene of the fire towards the Hurum side of the tunnel. Visible damage to the cable ladder in the tunnel ceiling and its fastening bolts was also found in the same area.

The sprayed concrete tunnel vault was found to be light grey in colour in the area of the fire, which indicates that soot from the fire was burnt off. This occurs at temperatures exceeding 750 °C, with a probable maximum temperature of as much as 1200 °C. On inspection, localised melting/evaporation of PE foam behind the PE vault in the area of the fire was observed on the opposite side of the scene of the fire. This was caused by heat radiating through the wall joints where the sealing compound between the concrete wall elements had melted or burnt away.

Figure 26: Spalling damage to wall elements inside the tunnel. Photo: Aas-Jakobsen/NPRA

As a result of the fire, six wall elements had to be replaced, and the cable ladders, including lighting fixtures and electrical wiring in the tunnel, had to be replaced over a distance of approximately 400 metres. Equipment and labour costs associated with the repair of electrotechnical systems after the fire amounted to approximately NOK 4.5 million. The total costs resulting from the fire are estimated at about NOK 9.5 million.

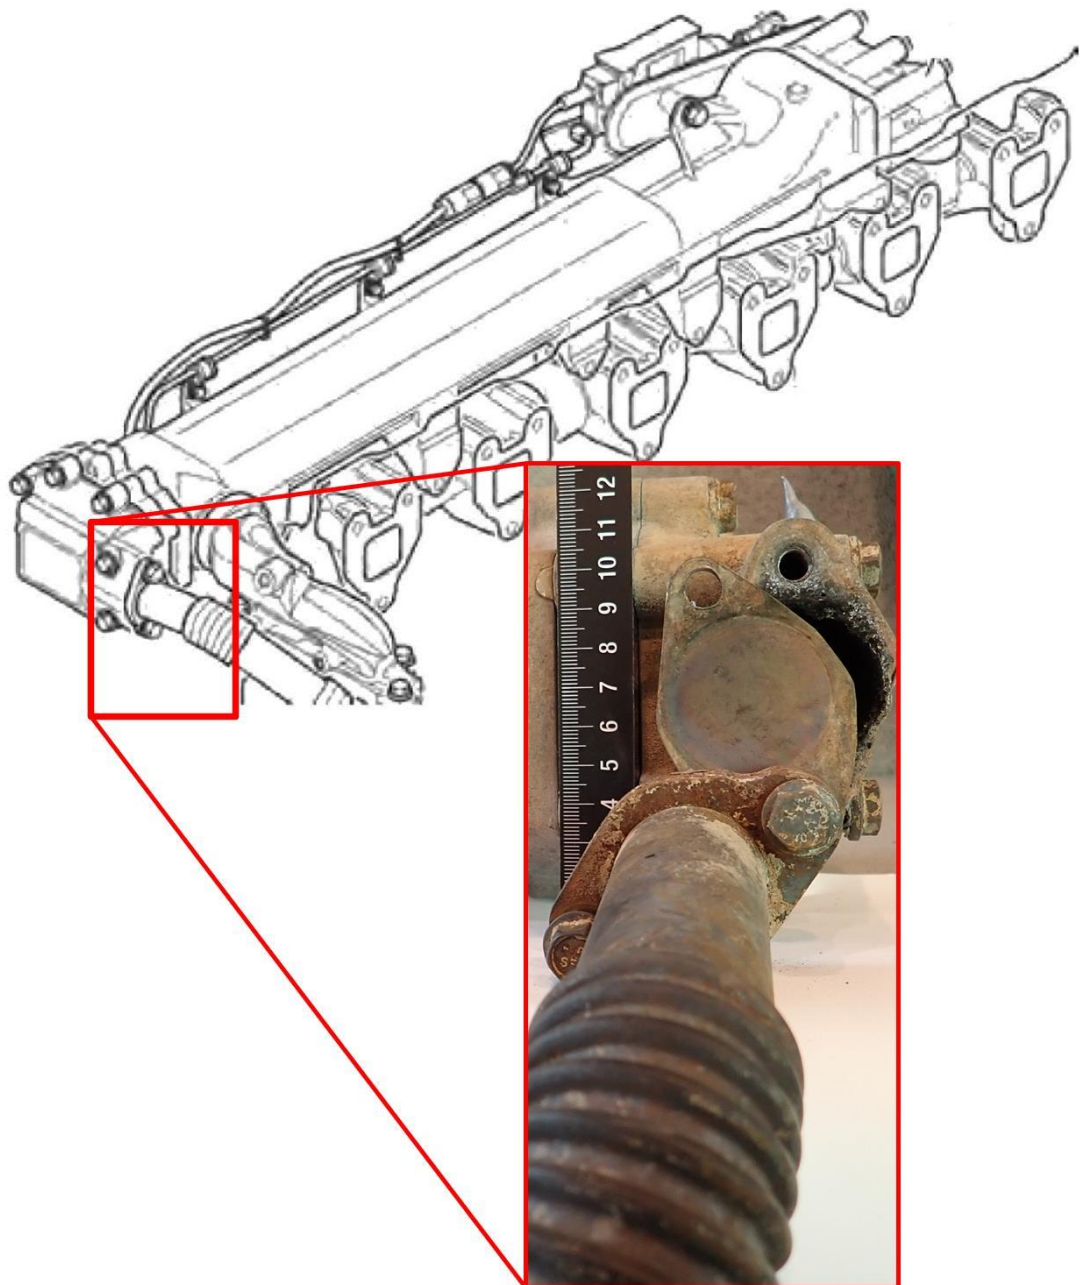
*Figure 30: The EGR system had been disabled by inserting a steel plate in the exhaust channel.  
Illustration: MAN. Photo: AIBN*

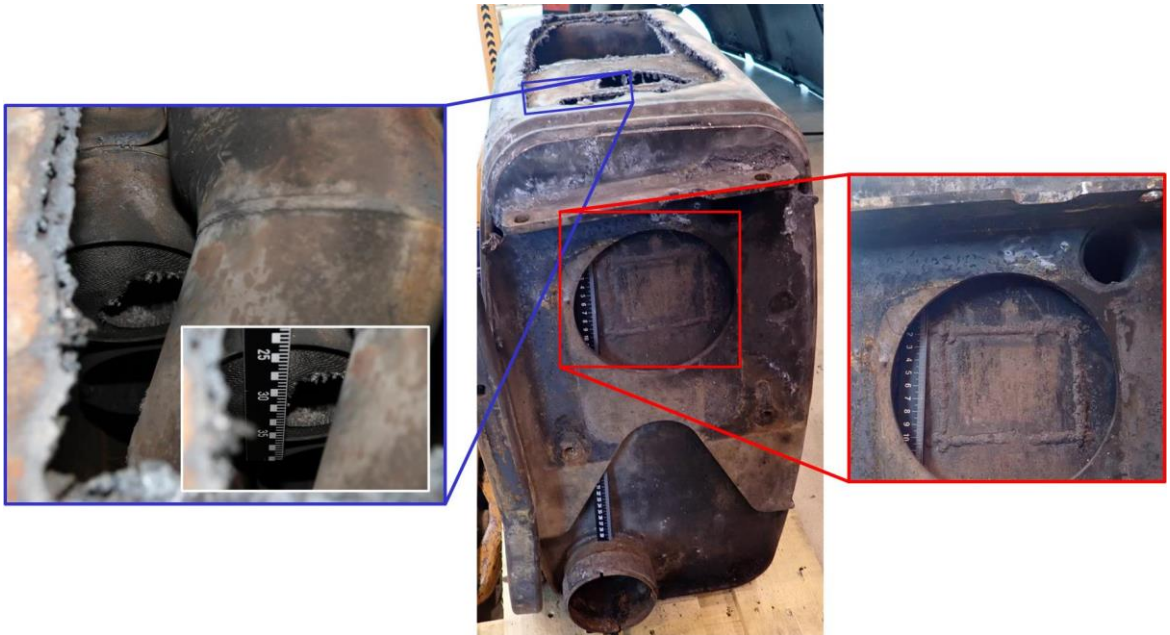
Figure 31: Hole in the particulate filter and hole closed by welding. Photo: The police/AIBN

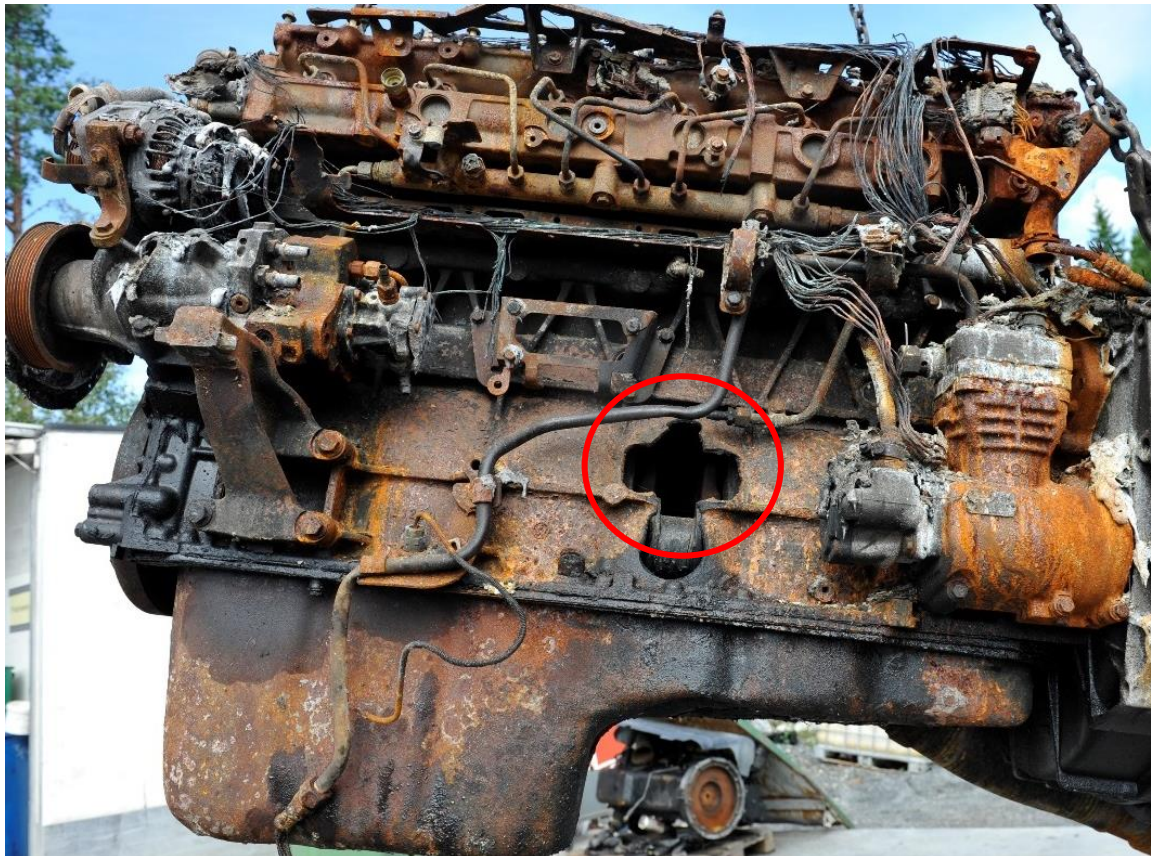
Figure 38: The engine from the tractor unit that caught fire in the Osloffjord tunnel on 23 June 2011. The red circle marks the hole in the engine block. Photo: AIBN

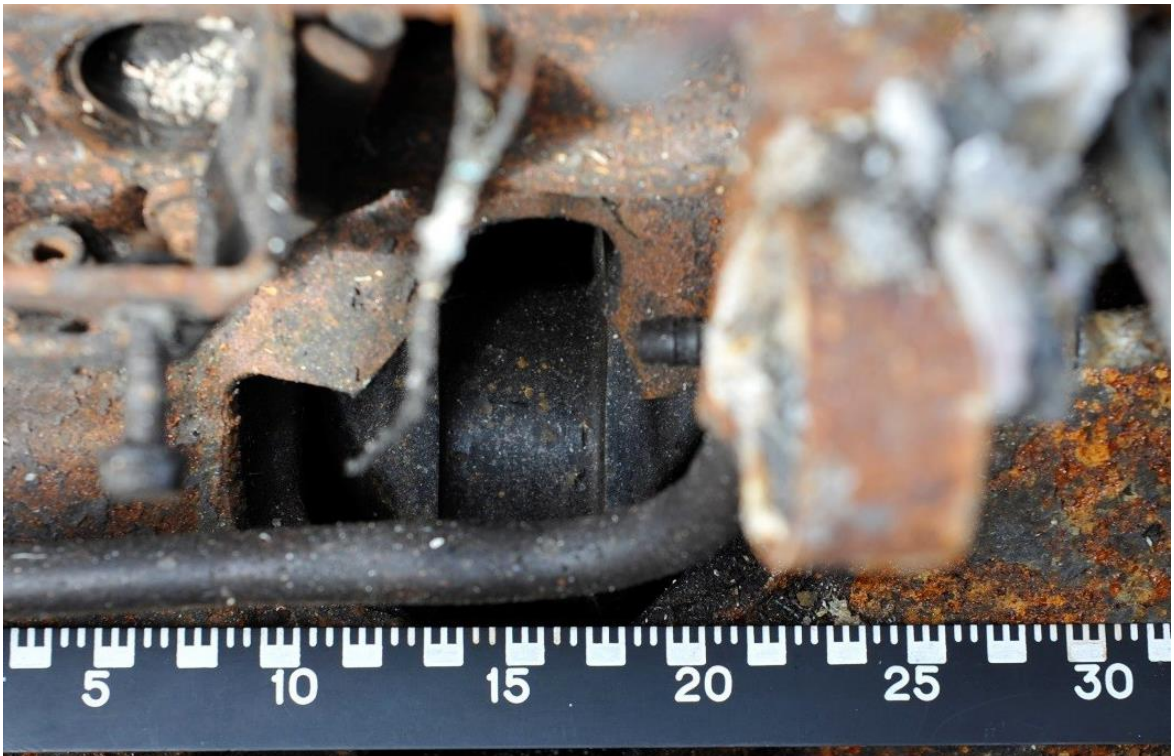
Figure 39: The big-end bearing of cylinder number 4 seen through the hole in the engine block of the tractor unit that caught fire in 2011. Photo: AIBN

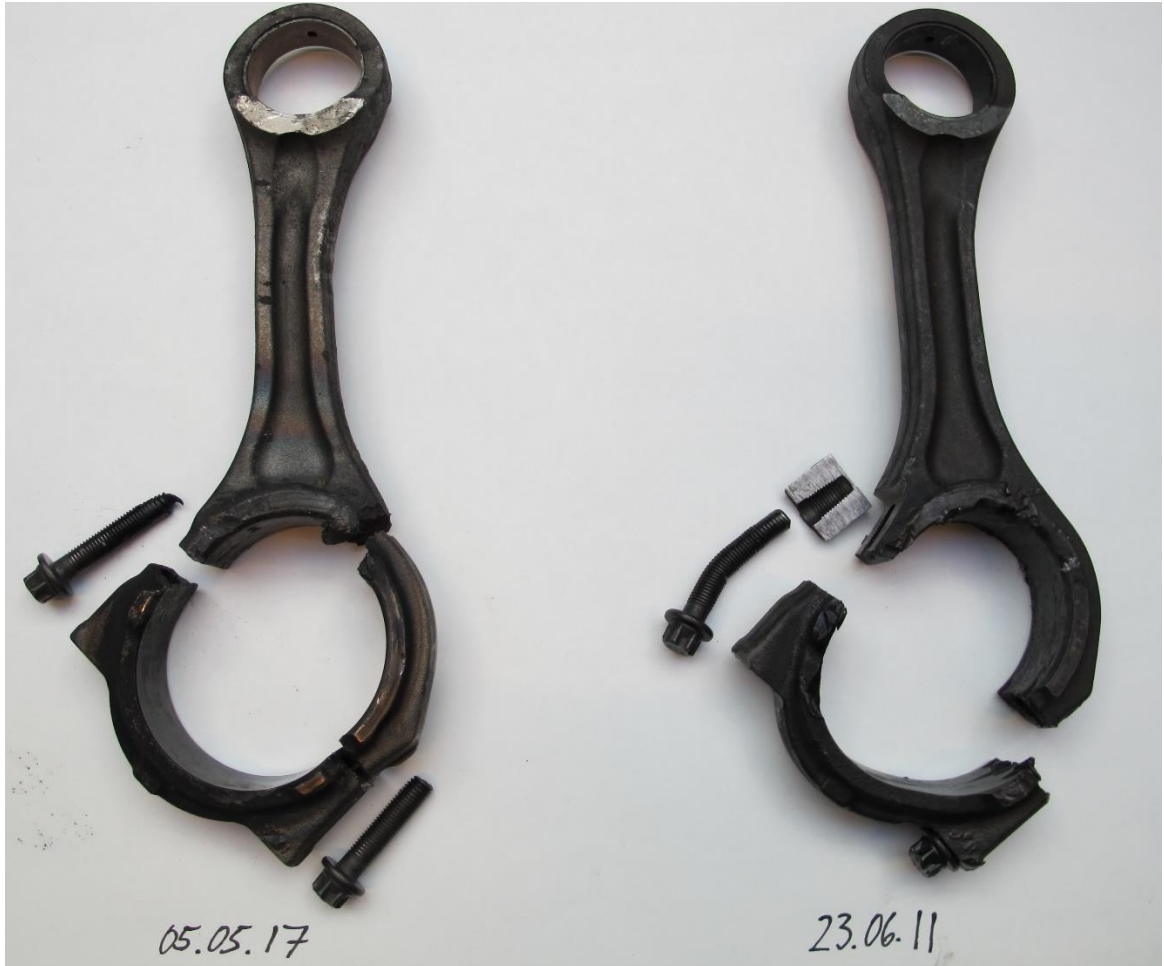
Figure 40: The connecting rods from the fires in 2017 (left) and 2011 (right). Photo: AIBN

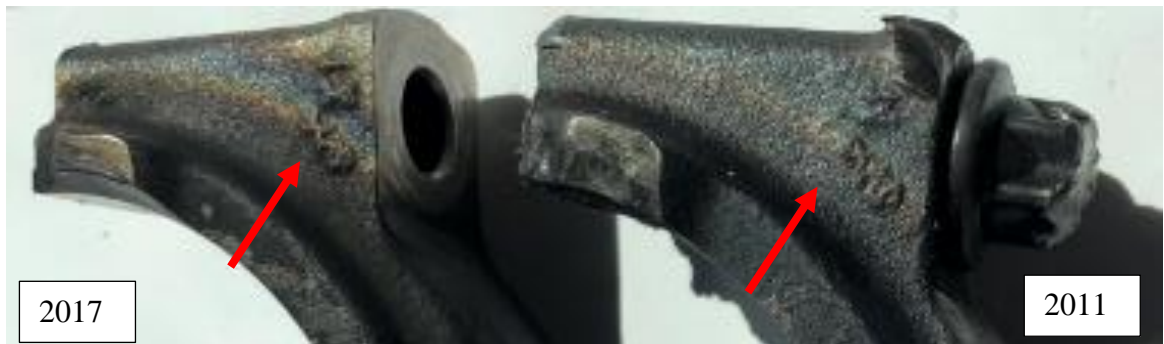
Figure 41: Bearing cap fastening from 2017 (left) and 2011 (right) with discoloration caused by heat. Photo: AIBN
