ROAD 2015/03

REPORT ON RUN-OFF-THE-ROAD ACCIDENT INVOLVING A COACH ON THE E6 ROAD BY TRONES IN NAMSSKOGAN MUNICIPALITY ON 29 JULY 2014

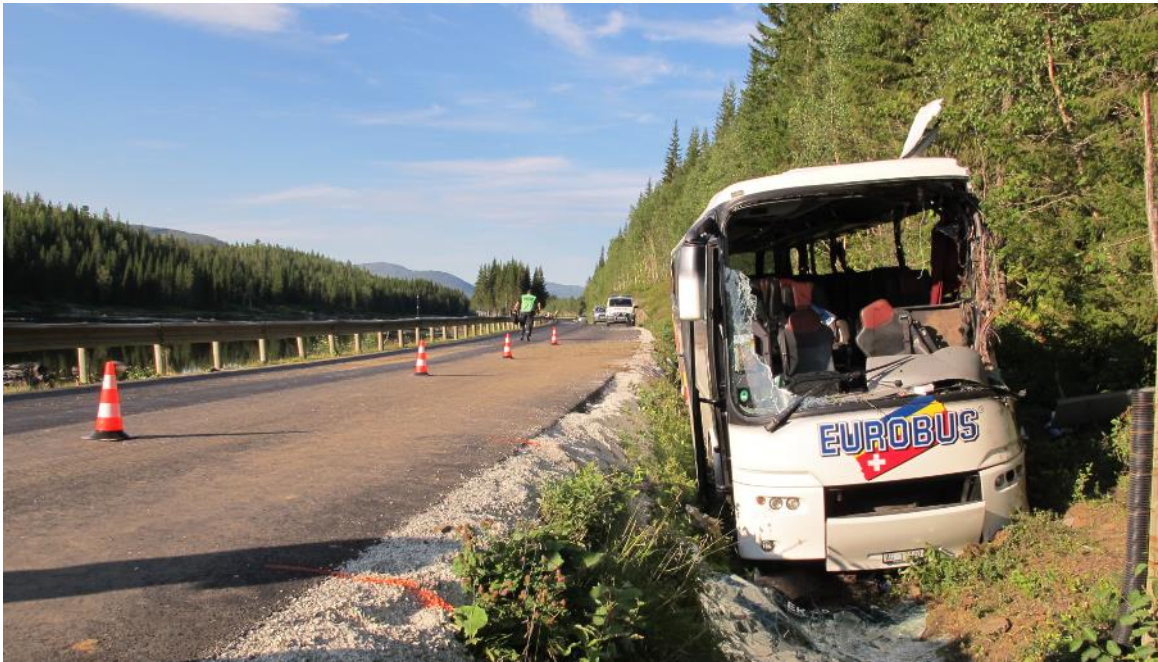
After it had been driven for approximately 20 seconds along the stretch of road with newly laid asphalt, the coach veered off to the left, crossed the opposite lane and ran into the ditch on the left side of the road in the coach's direction of travel. The coach tipped over to the left in the roadside terrain before it hit a boulder and resumed an upright position. It came to a halt standing on its wheels in the ditch, less than 50 metres from

where it first ran off the road. The coach left tyre marks on the road shoulder and in the ditch all the way to its final position.

Figure 2: Final position of the coach. Photo: AIBN

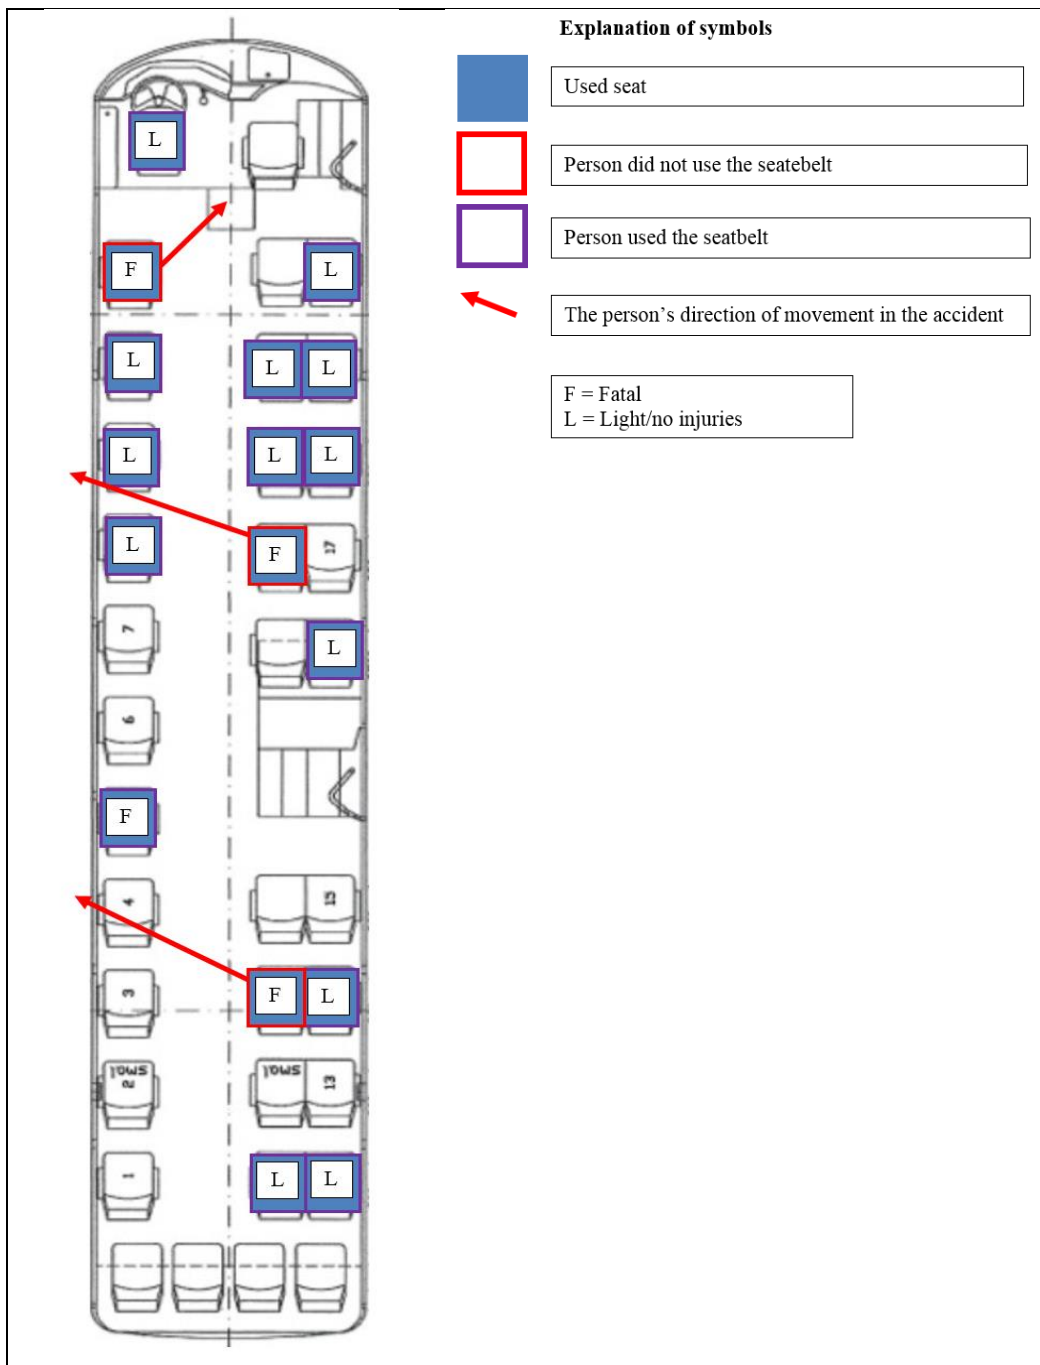
- Two of those who died and did not wear a seat belt were ejected from the coach. They were declared dead on arrival by medical personnel.
- One of those who died and did not wear a seat belt was thrown towards the front of the coach. The person was declared dead on arrival.
- The person who died despite wearing a two-point seat belt suffered head injuries in an impact with a window bar on the left side of the coach. The person died the following day in hospital.

There was a coffee machine next to the rear door of the coach. After the accident, it was found in the seat in front of its original position. The investigation found that the coffee machine was not adequately secured, so that it came loose during the accident.

Figure 3: Overview of where people were seated in the coach, use of seat belts and, where applicable, the direction in which the accident caused them to move. The figure also shows the degree of injury, which is in accordance with Table 1. The categories 'minor injuries' and 'uninjured' have been combined into one category (L – Light/no injuries). The seats of those who died are marked with the letter F. Drawing: VDL. Illustration: AIBN

Despite the driver's efforts to remind the passengers to wear seat belts, there were three people who did not wear seat belts. They died in the accident. Two of them were ejected from the coach, and one was thrown towards the front of the coach. In the AIBN's opinion, all three would probably have remained in their seats had they worn the installed two-point seat belts at the time of the accident. This would probably have prevented fatal injuries.

The fourth passenger who died was wearing the installed two-point seat belt. However, the passenger died as a consequence of suffering head injuries from the impact of a window bar on the left side of the coach. The AIBN believes that this person's injuries would probably have been less severe if a three-point seat belt had been worn with a chest strap across the person's left shoulder. While a two-point seat belt is primarily intended to retain people in their seats, a three-point seat belt would have been able to keep the upper body in place in the seat.

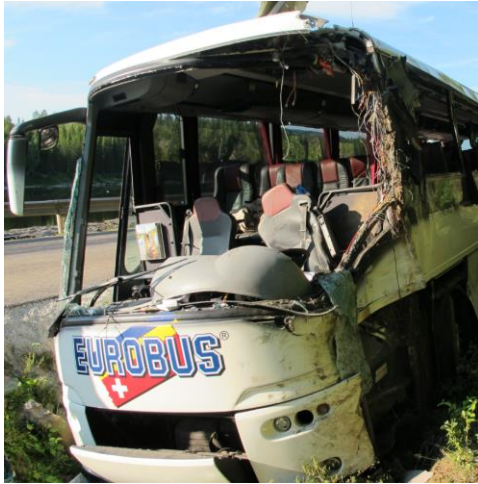
The coach sustained extensive damage to the front and to the left side as a result of the collision with the roadside terrain. All the windows on the left side of the coach were broken and several of the window bars were bent inwards and backwards. Rocks were found in the driver and passenger spaces. Figure 4 and 5 show the damage to the front and to the left side of the coach. In addition, the rear axle of the coach broke in the accident.

Figure 4: Damage to the front. Photo: AIBN

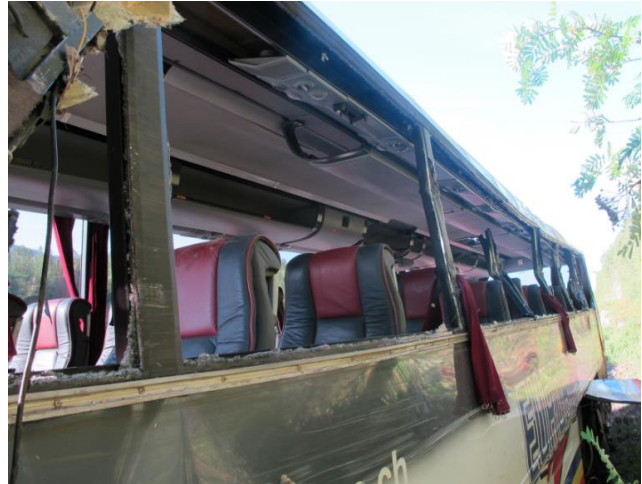
Figure 5: Damage along the left side of the coach. Photo: AIBN

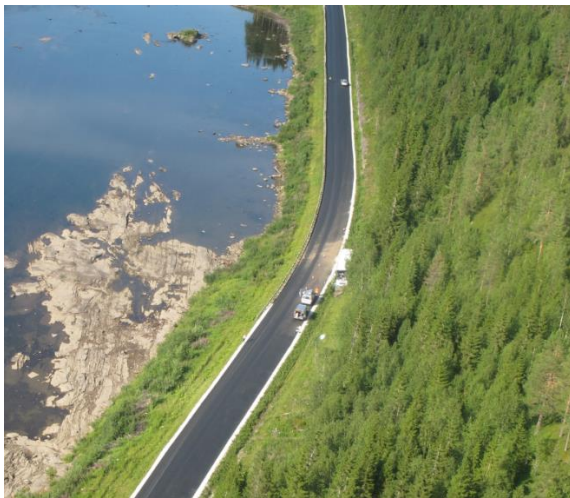
Figure 6: Aerial view of the accident site with the coach in its final position at the centre of the photo. The white stuff along the road is gravel, not road marks. Photo: AIBN

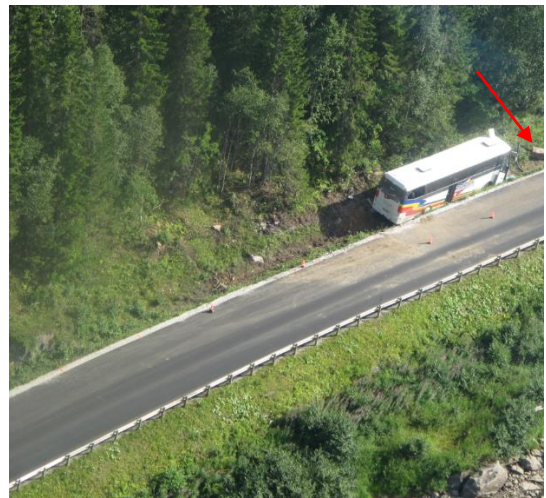
Very close to where the coach ran off the road, there was a rock cutting (see Figure 9) that the coach stayed clear of. Between the rock cutting and the final position of the coach, the roadside terrain consisted of heather, low plants and some rocks. Figure 7, 8 and 9 illustrate the condition of the roadside terrain where the coach tipped over to the side. The coach hit a large boulder that was pushed in front of the coach as it tipped over to the left. This boulder ended up in front of the coach in its final position (see Figure 7).

Figure 7: The accident site with the coach in its final position. The boulder that was pushed in front of the coach is just visible in front of the coach (red arrow). Photo: AIBN

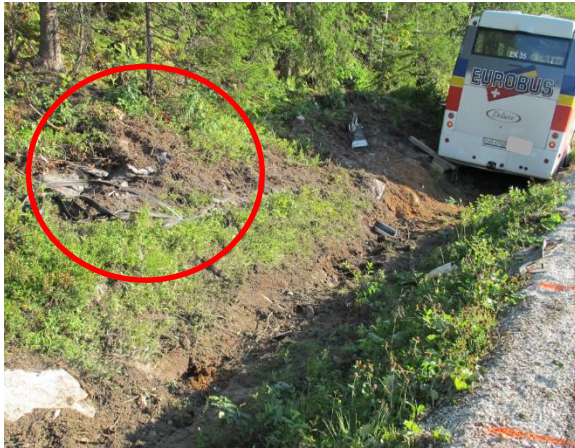
The AIBN measured the inclination from the road to the bottom of the ditch to be about 34° – 38° behind the coach in its final position. The height from the road to the bottom of the ditch was approximately 1.2 metres.

Figure 8: Road shoulder and ditch with the coach in its final position. Also shows the assumed initial location of the boulder that was pushed in front of the coach (red circle). Photo: AIBN

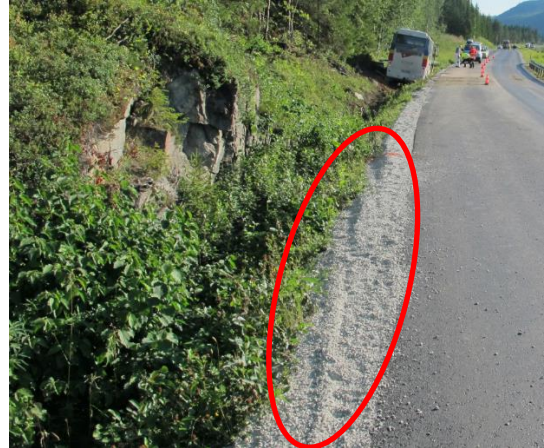
Figure 9: The coach in its final position and tyre marks from the rear left wheel pair in the ditch (red circle). The boulder cutting that the coach stayed clear of can also be seen on the left-hand side of the photo. Photo: AIBN

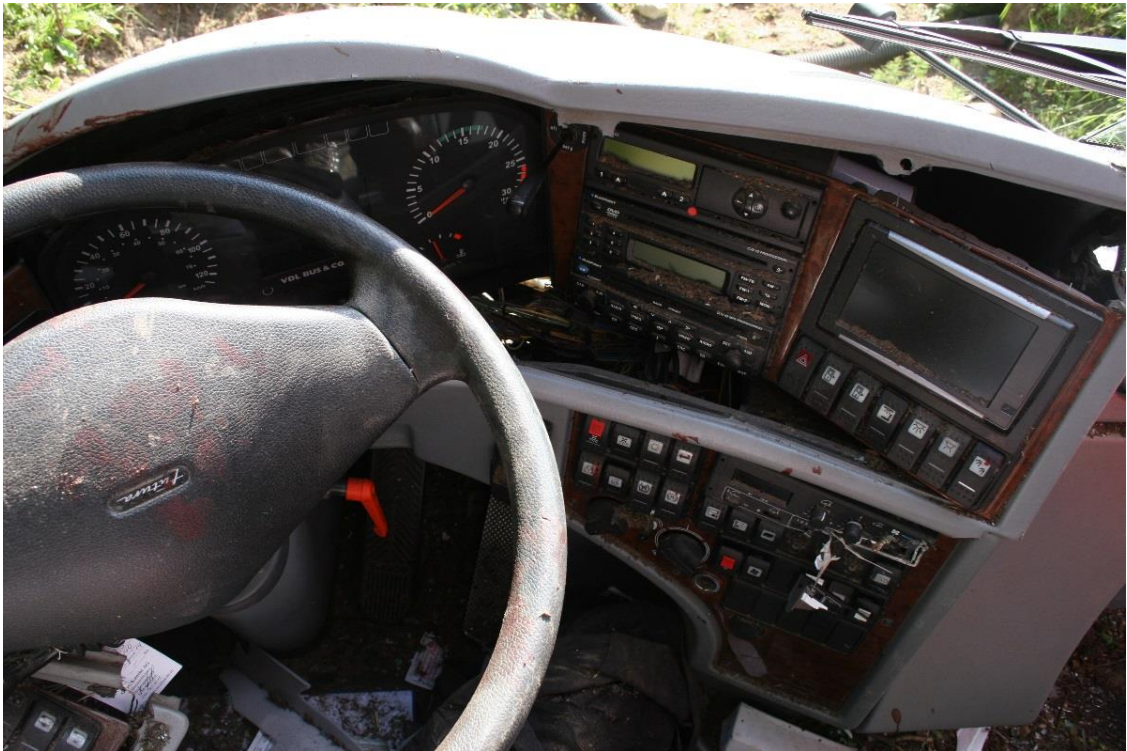
Figure 10: The driver's work station on the coach. The display on the right had GPS and a rear view camera. Photo: The police

No faults or deficiencies that may have contributed to the accident were found in connection with the technical examination of the coach that was carried out by the AIBN in cooperation with the NPRA and the police.

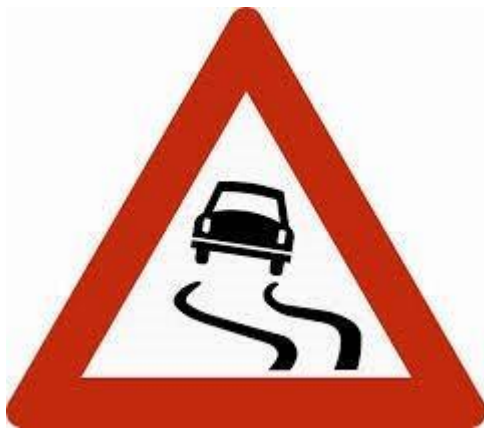
Approximately 100 metres before the stretch of road with newly laid asphalt, a warning sign⁵ had been erected, no 116 'Slippery road surface' (see Figure 11), with a sub-sign underneath (no 804) stating that the warning sign applied for 0.2–2.5 km.

Figure 11: Warning sign 116 Slippery road surface. Source: www.vegvesen.no
