SL Report 2007/25

REPORT ON THE SERIOUS INCIDENT ON HARSTAD/NARVIK AIRPORT EVENES ON 25 NOVEMBER 2004 INVOLVING FLIGHT MYT6286 AIRBUS A320 REGISTERED G-CRPH OPERATED BY MYTRAVEL AIRWAYS UK

Submitted
August 2007

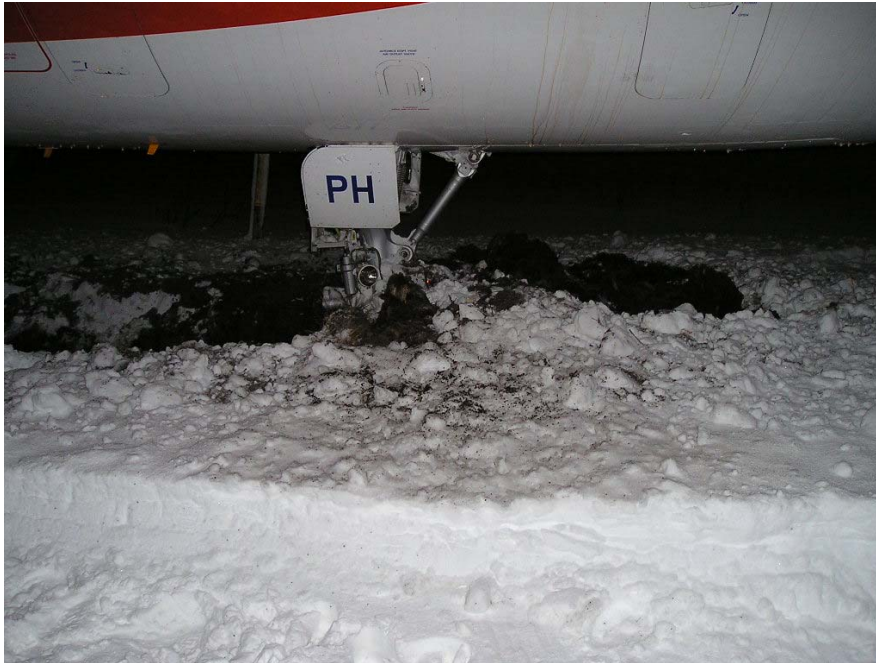
Figure 1. G-CRPH nose wheel sunk in the snow and soil.

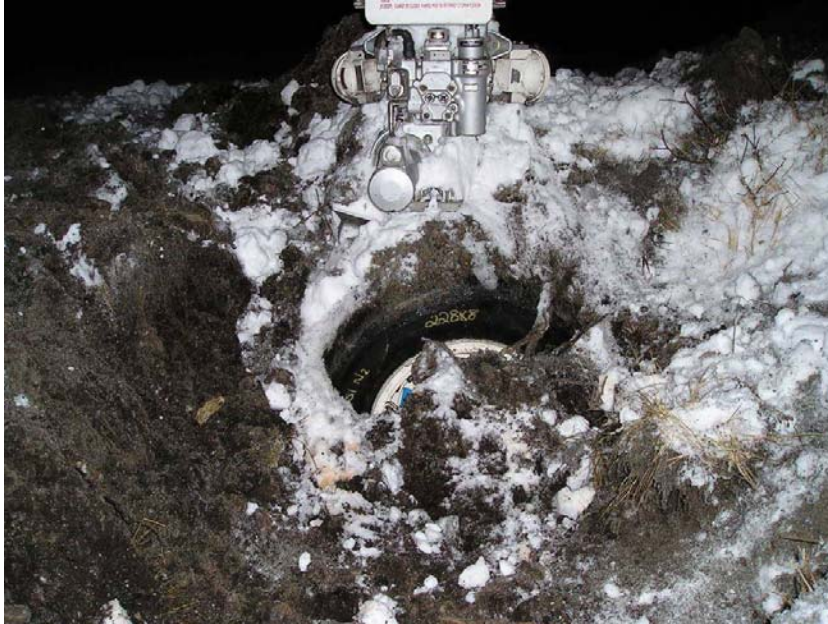
Figure 2. The nose wheel seen from rear.

The aircraft nose wheels ploughed an 8 m long, 1 m wide and 60 cm deep furrow in the soft soil adjacent to the runway. The furrow was caused by the nose wheel, which was twisted 90°, breaking through the frozen unpaved surface (Figures 2 and 5).

- 1.12.2 The aircraft came to rest in the snow and soil on the left side of RWY 35, a position 125 m from the green threshold lights, with its nose 35 m from the runway hard surface edge and its tail 12 m from the runway edge. The aircraft's nose pointed approximately 40° offset from the runway centre line.
- 1.12.3 The nose wheels had ploughed an 8 m long furrow in the soft soil adjacent to the runway (Figure 4). The furrow was approximately 1 m wide and 60 cm deep. The right main wheels had sunk approximately 12 cm into the soil, while the left main wheels did not sink in. (Figures 2 and 3).

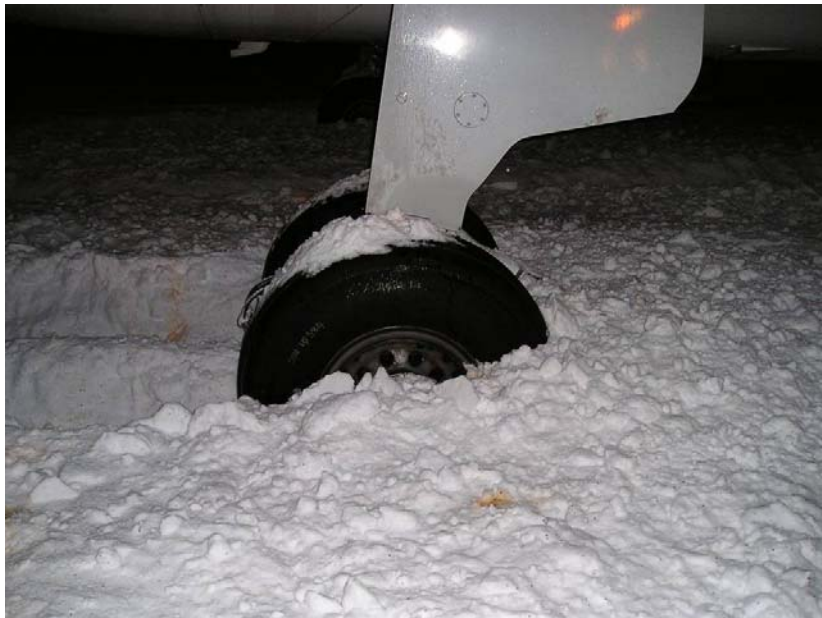
Figure 3. Right main wheels.

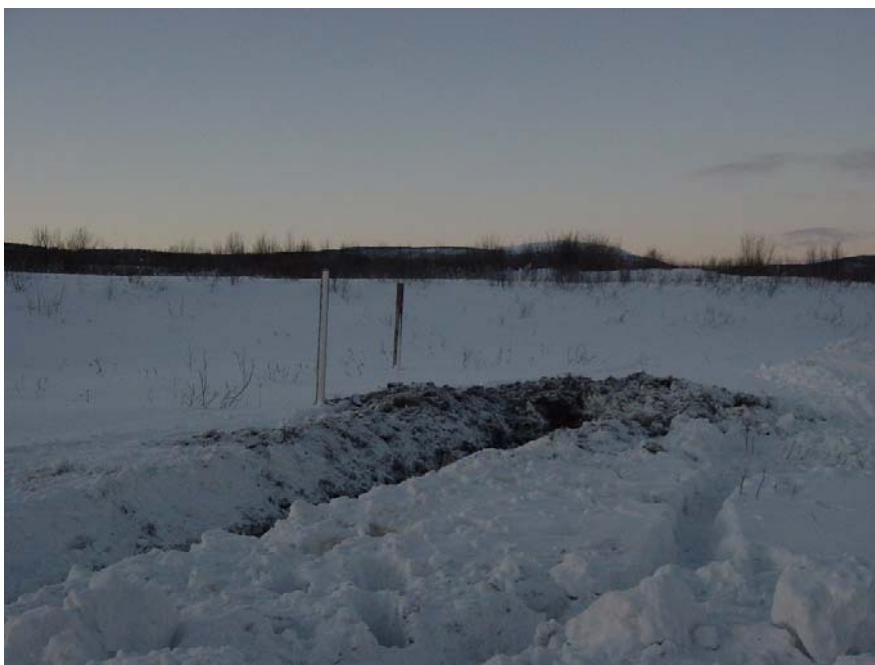
Figure 4. Furrow ploughed by the nose wheel.

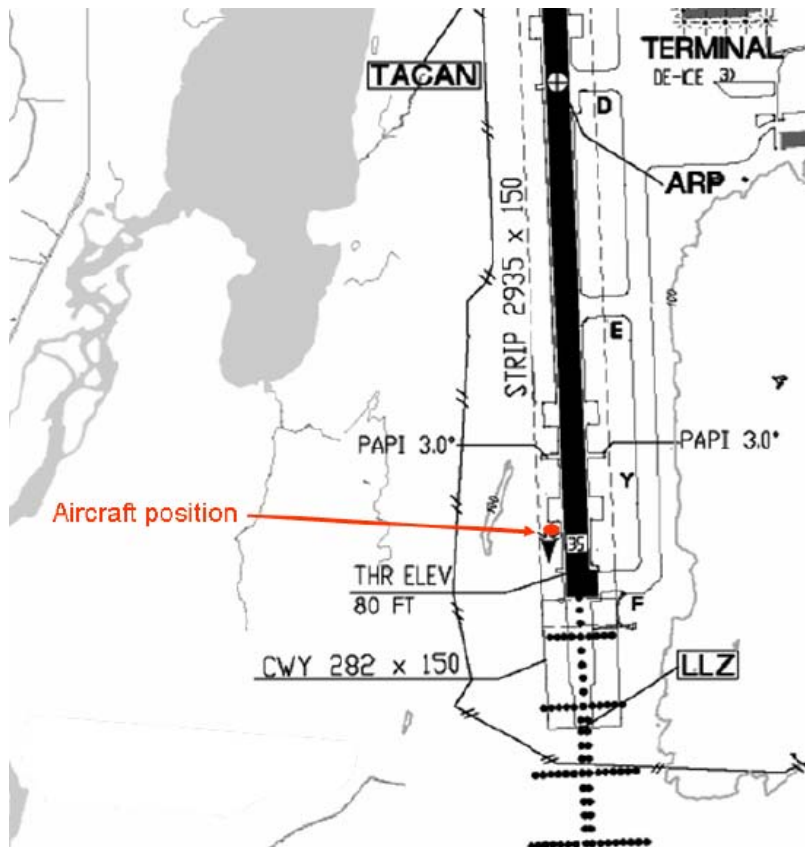
The take off threshold platform at the taxiway F intersection is made of concrete, while the runway and taxiways are made of asphalt. On the last 50 m of this platform Coefficient of Friction (CF) is not measured. This platform is usually more slippery close to the end due to less preparation because of turning restrictions of the sanding and measuring vehicles.

Figure 6. Runway 35 approach end.

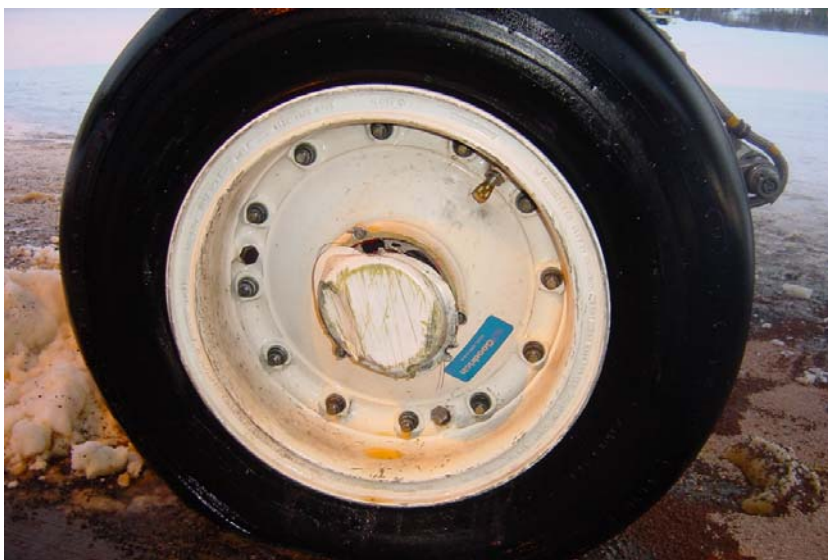
- 1.12.1 The damage to the aircraft was to non-structural items of the nose gear assembly. The left nose wheel tyre was punctured, the left nose wheel hubcap was deformed and one nose leg taxi light was broken.

Figure 7. Left punctured nose wheel with damaged hubcap.
