SL 2008/18

## RAPPORT OM LUFTFARTSULYKKE PÅ RUDSKOGEN I ØSTFOLD 29. OKTOBER 2007 MED ROBINSON HELICOPTER R44, LN-OCA

Avgitt dato: 13.10.2008  
SL Rapport: 2008/18

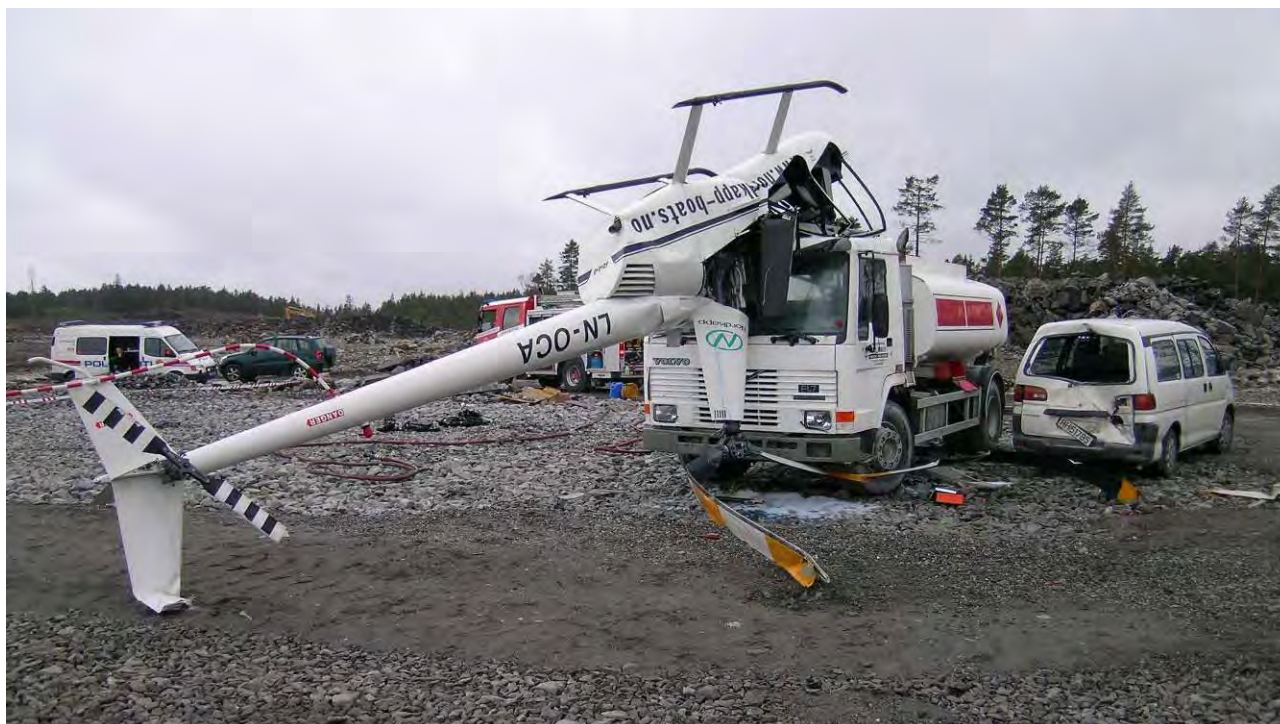
Figur 1: Ulykkesstedet

Fartøysjefen har forklart at planen hans mens han hovret foran knuseverket var å snu helikopteret mot venstre og hovret de om lag 70 m bort til landingsplassen. Fartøysjefen har forklart at helikopteret plutselig begynte å rotere mot høyre som om halerotoren var borte eller hadde stoppet helt. Han anslo at helikopteret roterte ca. to runder mens han forsøkte å få kontroll med pedalene. Han klarte å holde maskinen "level" til den traff hytten på en tankbil med høyre skid, omtrent en meter fra bakken. Deretter rullet helikopteret rundt og opp på taket på bilen og ble liggende opp ned (se Figur 1).

Det var ikke antydning til brann eller røykutvikling. Drivstoffet i en av helikopterets tanker hadde rent ut. Området ble skumlagt. Både helikopteret og tankbilen ble gjort strømløse. Tankbilen inneholdt ca. 7 000 liter diesel. Den stod parkert på stedet for å fylle opp anleggsmaskinene ved behov. Frontruten på tankbilen ble knust i havariet. Dieseltanken fikk bare ubetydelige skader. Et avtrykk på førerhyttas høyre side ca. 1,5 m over bakken og skade på helikopterets høyre skid, bekreftet beskrivelsen av treffpunktet. Rotoren på helikopteret hadde trykket inn bakpartiet på en varebil som stod parkert bak tankbilen. To andre biler som stod parkert på stedet fikk ingen eller ubetydelige skader. Det var ikke folk i noen av bilene.

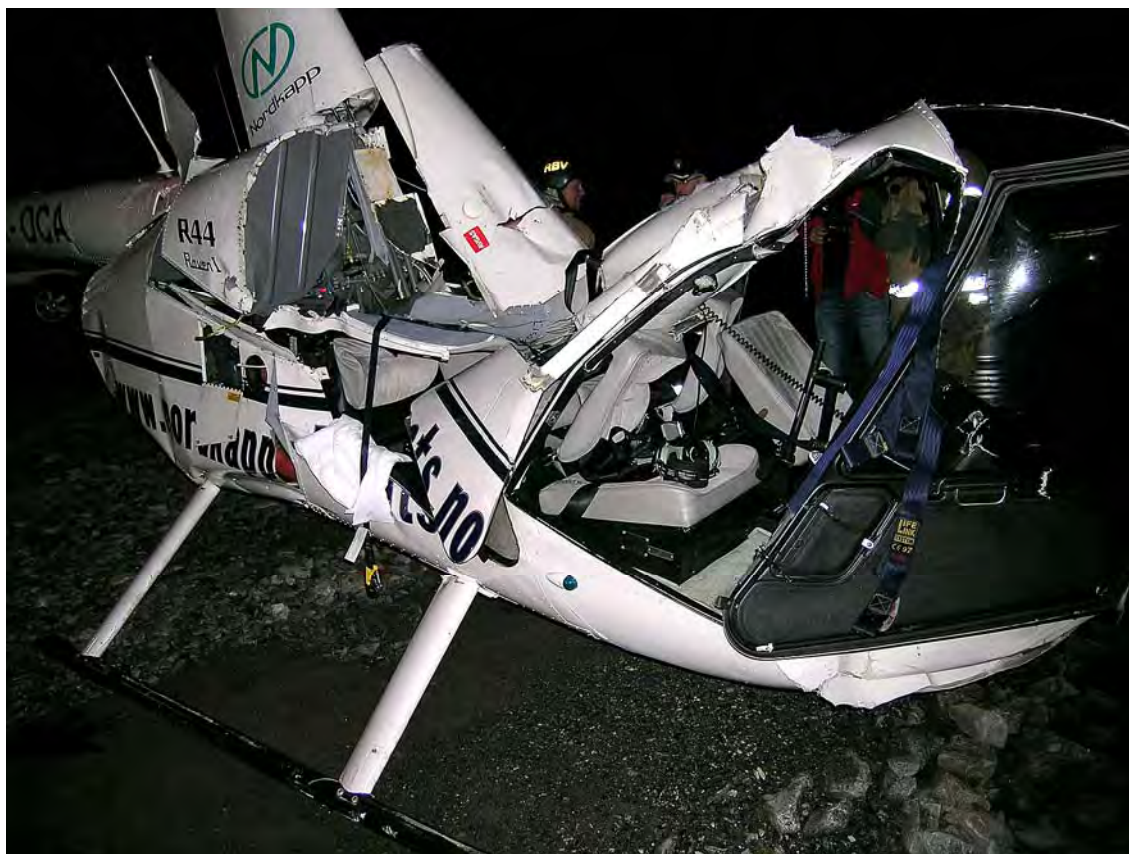
Figur 2: Helikoptervraket slik det så ut da det var heist ned fra taket på tankbilen

Helikopterets kabin fikk omfattende skader i sammenstøtet. Skadene var størst i området ved høyre baksete. Taket var trykket inn, høyre bakdør var deformert og vinduene var knust. Fremre del av høyre skid var knekt. Gulvet foran fartøysjefen var presset opp, høyre pedal var knekt og toppen av seteryggen var knekt forover. Instrumentpanelet var intakt. Hovedrotoren hadde slått i bakken, og rotormasta var knekt bakover. Halebommen hadde moderate skader, og halerotoren var uskadet.

Batteriet satt på plass i nesepartiet på helikopteret. Nødpeilesenderen (Emergency Locator Transmitter, ELT) løste ut i havariet.

Vraket ble fraktet til havarikommisjonens lokaler for nærmere undersøkelser. Det ble ikke påvist brudd i overføringene mellom pedalene og halerotorkontrollen, bortsett fra åpenbare kollisjons-skader. Det var heller ingen ting som tydet på at det var foretatt vedlikeholdsarbeid eller reparasjoner som kunne ført til at riggingen av halerotorkontrollene var blitt feil.

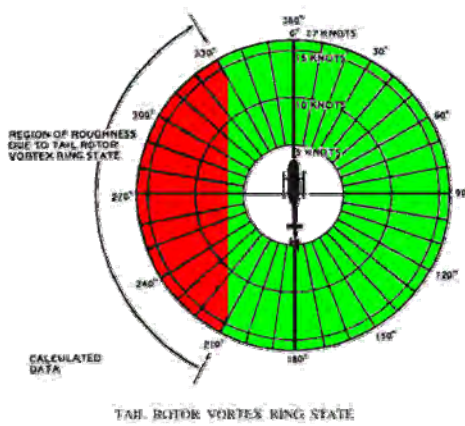
Figur 3: Vindretning som gir fare for "Tail rotor vortex ring state"

Med vind inn fra sektoren 285 til 315 grader, som LN-OCA etter all sannsynlighet hadde, kan i tillegg turbulent luft fra hovedrotoren forstyrre halerotoren (Main Rotor Disc Vortex Interference, ref. Figur 4). Denne luftstrømmen vil endre angrepsvinkelen på halerotorbladene, slik at det blir behov for varierende pedaltrykk for å opprettholde en etablert svingerate mot høyre. Idet halerotoren passerer gjennom sektoren med virvler fra hovedrotoren og effekten forsvinner, akselererer automatisk dreiningen mot høyre. Denne akselerasjonen kan komme overraskende på en uerfaren flyger. Idet dreiningen er kommet så langt at helikopteret får vinden inn bakfra fra høyre, vil også værhaneeffekten bidra til ytterligere akselerasjon mot høyre (Weathercock Stability, ref. Figur 5).
