SL 2009/27

REPORT ON AIR ACCIDENT 21. NOVEMBER 2004
AT LAKE VÅGÅVANNET NORWAY INVOLVING
EUROCOPTER SA 365 N1, LN-OPJ OPERATED BY
NORSK LUFTAMBULANSE AS

AIR ACCIDENT REPORT

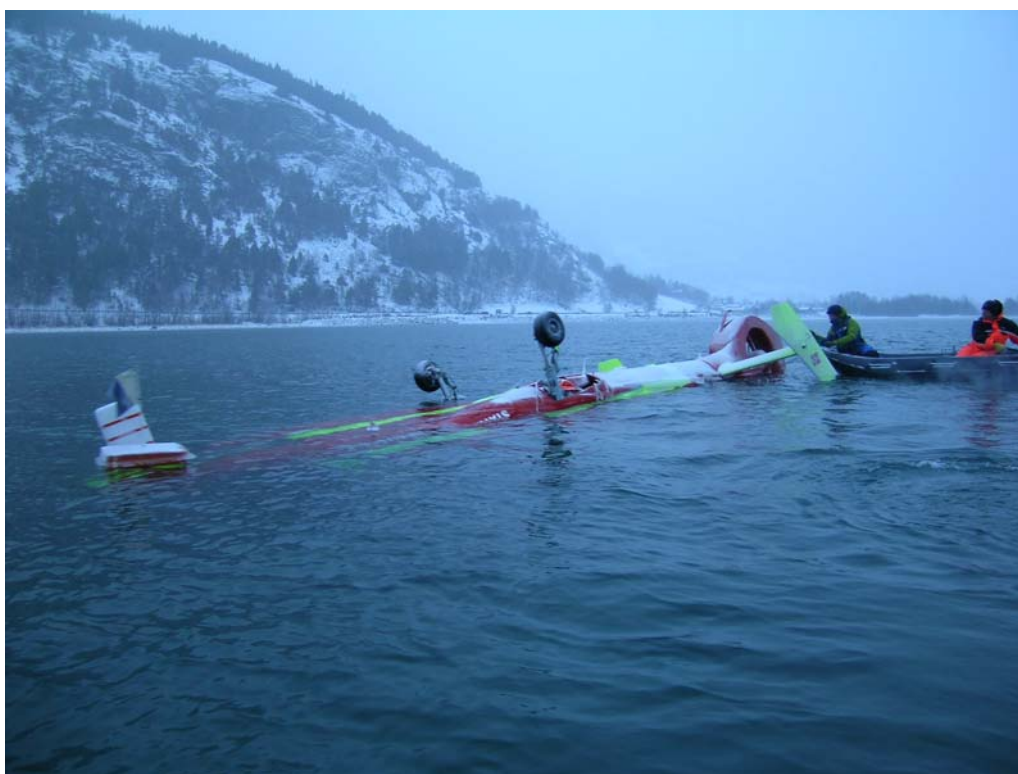
Figure 2: Picture taken facing northeast, the day after the accident. The plastic can which was used as a marker is shown on the left of the picture. The Commander and the Doctor sat in the wheel well closest to the camera.

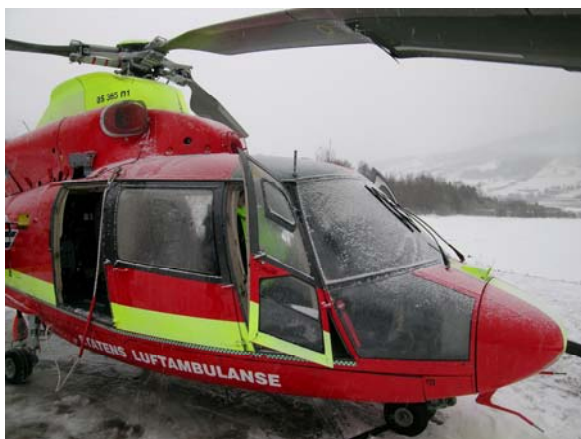
Figure 5: LN-OPJ after it was salvaged. The missing door, rescue line and the damage to the main rotor blades are shown.

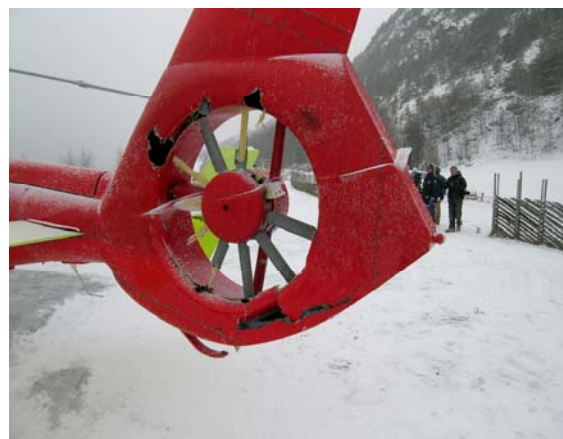
Figure 6: The damage to the Fenestron.

- 1.16.1.1 The Fenestron had sustained major damage (see Figure 8 and Figure 9). All 11 blades were damaged to varying degrees. The tunnel in which the tail rotor was located was damaged along its entire circumference and fragments of the blades lay inside the hollow structure of the tail. The “forward attachment coupling tube” on the tail rotor gearbox had split at its rear attachment point (see Figure 10) and the “aft attachment tube” was snapped at the back edge of the gearbox (see Figure 11).

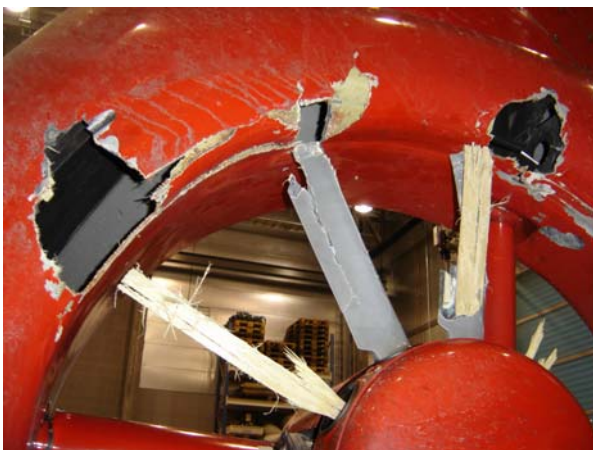
Figure 8: Damage to blades and the tunnel.

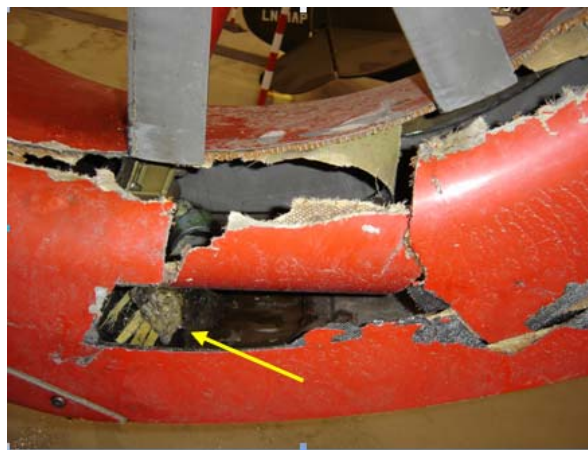
Figure 9: The arrow is pointing at part of a rotor blade that is located in one of the holes in the tunnel.

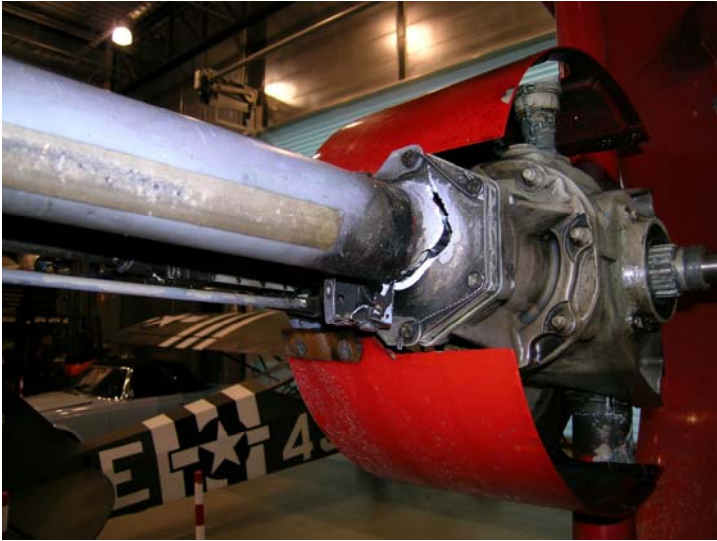
Figure 10: The picture, taken from the left side obliquely towards the back, shows the fracture in the “forward attachment coupling tube”.

- 1.16.2.2 A fracture was also discovered in the "forward attachment coupling tube" (see Figure 10). Combined with structural damage in the "aft attachment tube" (see Figure 11) this made it possible for the entire tail rotor gearbox to be pushed backwards. With a displacement of approx. 20 mm, the teeth in the coupling between the tail rotor gearbox and the drive shaft could come out of mesh. Some damage was observed on the splines on the tail rotor gearbox as shown in Figure 20 below.

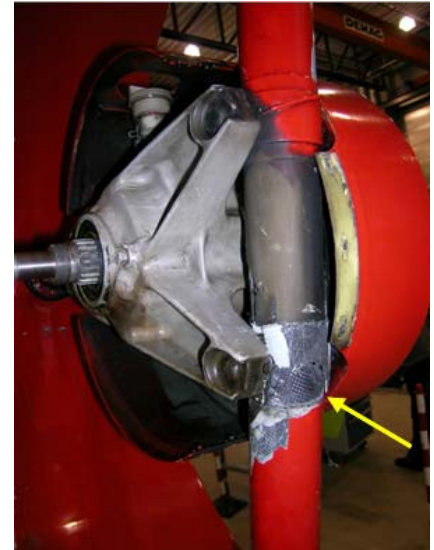
Figure 11: Picture taken from the left hand side obliquely towards the front. The arrow is pointing at the snapping point on the “aft attachment tube”.

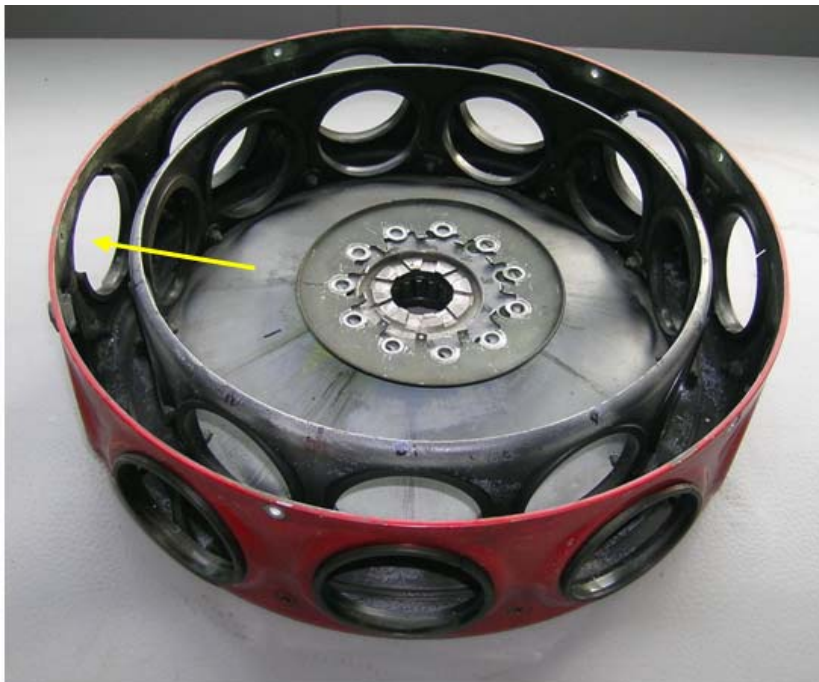
Figure 12: The centre of the tail rotor holds the rotor blades in position by means of bushings. The arrow marks a bushing which has partially disappeared.

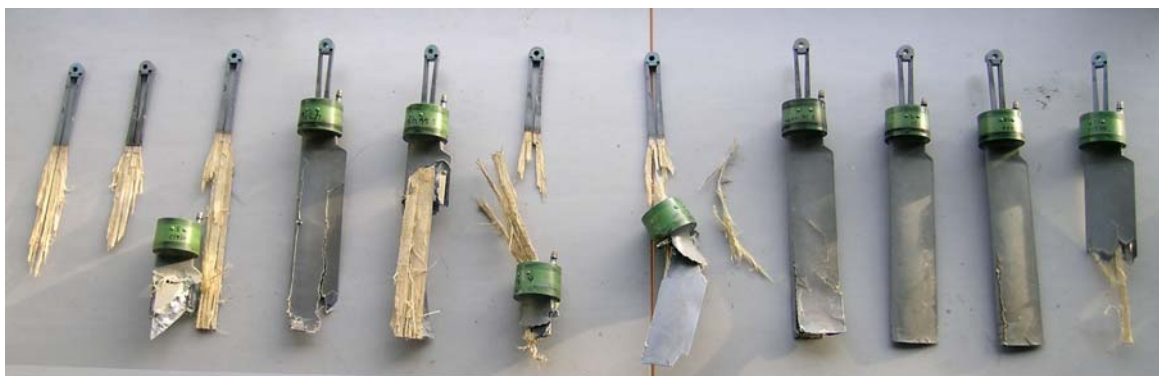
Figure 13: The 11 blades laid out in numbered order. Blade no. 1 to the left.

- Blade no. 1: Only part of the spar and the spool remain.
- Blade no. 2: Only part of the spar and the spool remain.
- Blade no. 3: Part of the spar, full length. Remnants of the fibreglass on the top of the spar. The blade root and parts of the skin were found separately.

- Blade no. 4: Rips along the length of the blade skin on the upper side which coincide with width of the spar. Impact damage at the front edge of the blade tip. Intact blade root.

- Blade no. 5: The blade skin is missing on the upper side and large parts of the blade skin are missing on lower side. Multiple damage to the leading edge of the blade. Intact blade root.

- Blade no. 6: The blade skin is missing entirely. Part of the spar and the spool remain. The blade root with impact damage found separately.
- Blade no. 7: Part of the skin from the upper side of the blade found separately, along with blade root. Otherwise, only parts of the spar and the spool remain.

- Blade no. 8: Several minor rips in the blade skin. Minor damage on the leading edge, the spar and blade root.
- Blade no. 9: Scraping at the blade tip, otherwise undamaged.

- Blade no. 10: Rips along the length of the blade skin close to the leading edge on the upper and lower sides. Otherwise undamaged.
- Blade no. 11: The blade cut approximately in the middle. Only parts of the spar remain at full length. Minor damage on the leading edge of the titanium strip at the fracture point was investigated in more detail (see subparagraph 1.16.1.5). Otherwise undamaged.

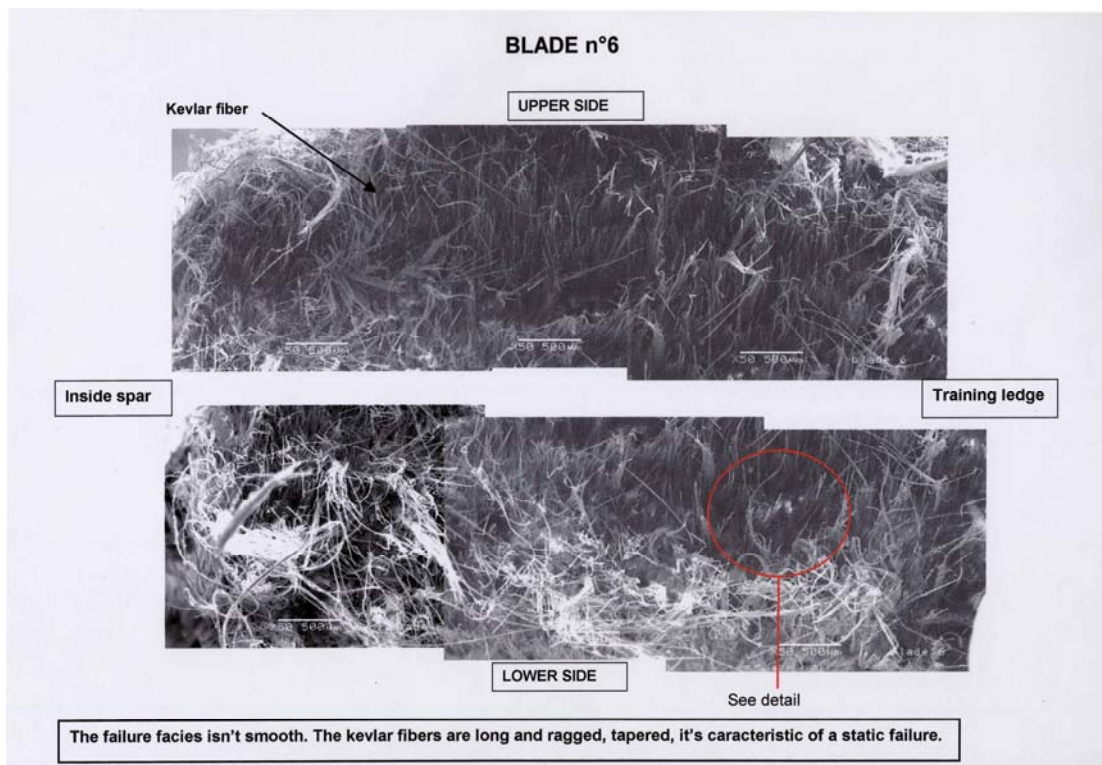
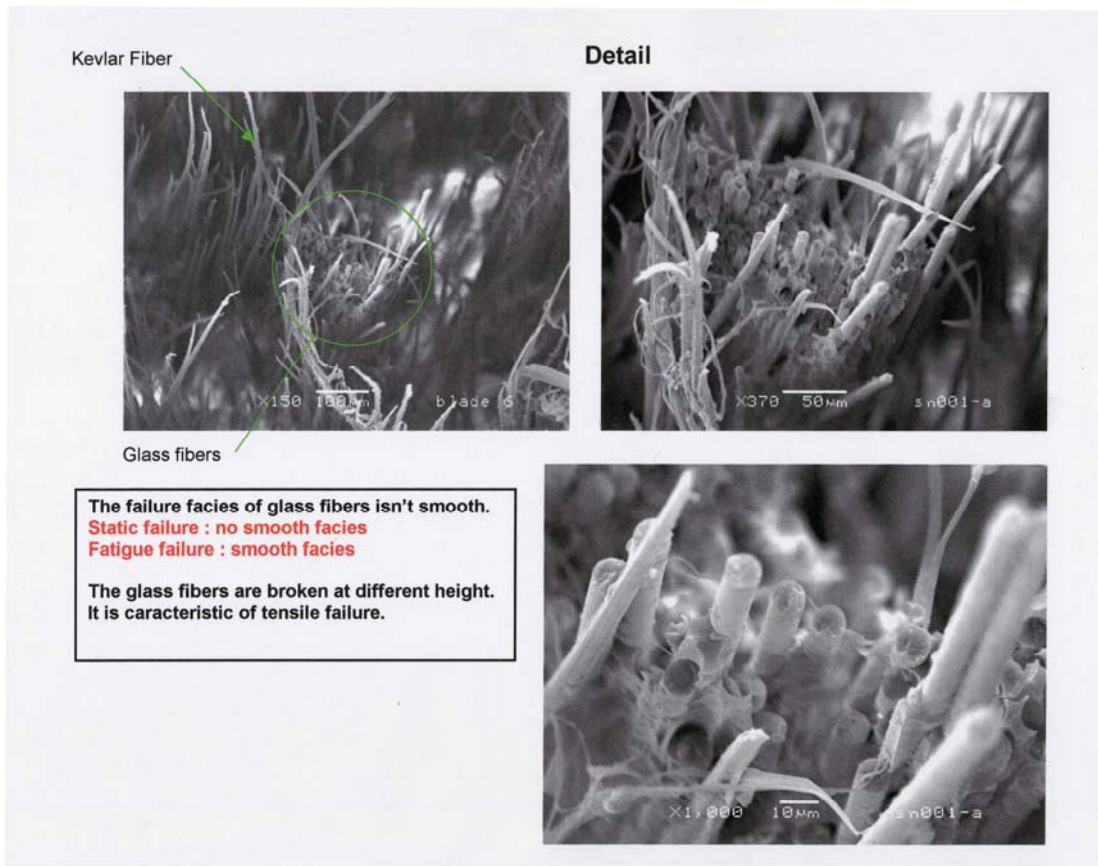
Figure 14: Detail of a typical overload fracture in the blade spar. The fibres are long, ragged and taper off towards the end.

Figure 15: Details from the pictures in Figure 14.

2.3.2 The damage found on the tail rotor blades all point to their being destroyed due to overloading. No failures have been found in glued joints, nor are there any signs of delamination. In addition, no signs have been found to indicate that any fracture has occurred in the Kevlar fibres prior to the accident. It is the opinion of the AIBN that such failures, if present, would most probably have been detected in the material that was examined. Alternatively, the first failure may have arisen in some of the material that was not recovered after the accident. This is something which the AIBN considers fairly improbable. For example, a fracture in a blade could lead to major imbalance, but it is unlikely that such a shortened blade would be further damaged because it can no longer reach into the tunnel wall. That would indicate that at least part of an original fractured surface would remain on the hub.

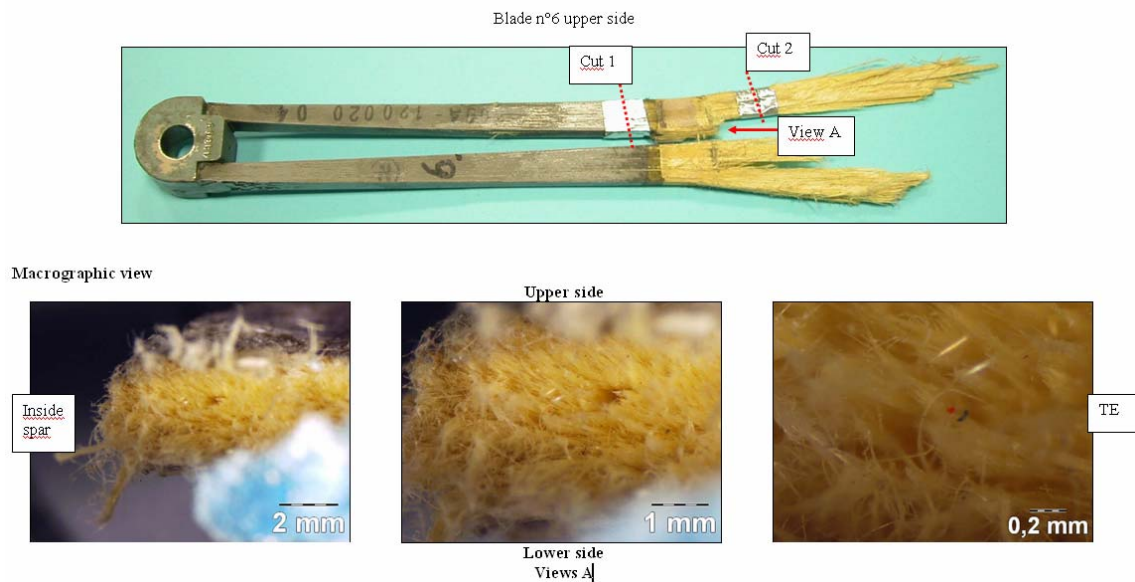
Figure 16: Examples of overload fractures in which the fibres are long, ragged and tapered towards the end.

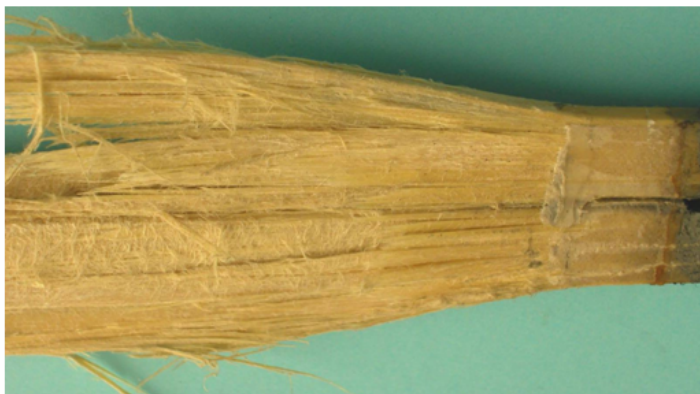
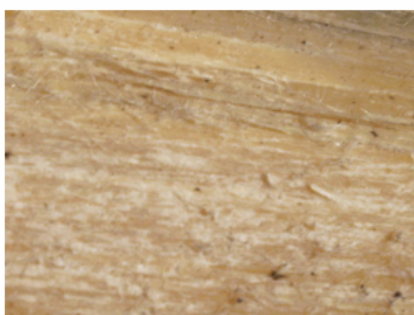
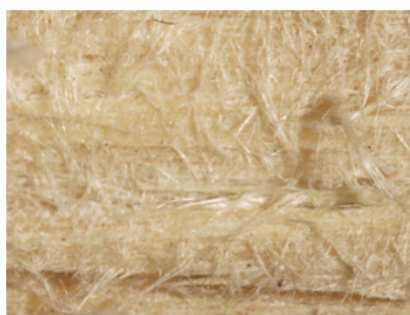
BLADE N°3 M 45653 UPPER SIDE

Figure 17: The two pictures above show examples of surface texture in the joint between the Kevlar spar and the blade skin on blade no. 3. The adhesive joint has not failed (cohesive separation). On the other hand, the material itself has been torn up (uneven and ragged surface).

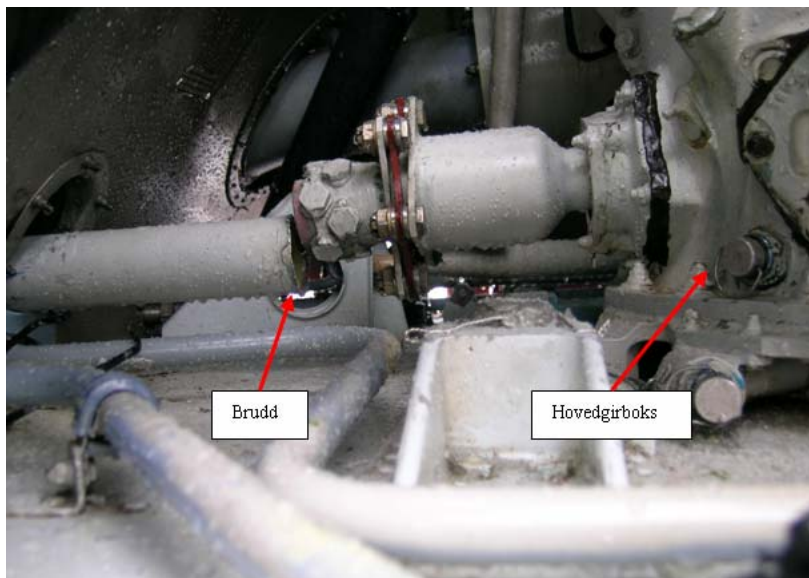
- 1.16.2.1 The tail rotor gearbox drive shaft had fractured just behind the output from the main rotor gearbox (see Figure 19).

Figure 19: Fracture in the tail rotor drive shaft.

"Based on the investigation it is concluded that both the tail rotor driveshaft and the tail gearbox support tube failed due to overload. The driveshaft failed due to overload in torsion."

2.2.1 The investigation has shown that the fracture of the tail rotor shaft right behind the main gearbox was caused by an overload through torsion. It can therefore be established that the fracture did not occur as a result of normal operating loads. One probable explanation is that the shaft fracture arose as a result of the damage to the tail rotor. The overload in the "aft attachment tube" (see Figure 11) and the fracture in the "forward attachment coupling tube" (see Figure 10) can both be explained by a large backward force on the tail rotor gearbox. A force of this type is consistent with a major imbalance in the tail rotor, probably caused by damage to the rotor blades when they were rotating at normal operating speed. Consequently, the "aft attachment tube" and "forward attachment coupling tube" may have become damaged by whole rotor blades or parts of them falling off. If the tail rotor gearbox moved backward by a minimum of 20 mm, the spline coupling at the front of the tail rotor gearbox could come out of mesh with the drive shaft at the same time as the undamaged tail rotor blades would be able to impact with the tunnel wall, slowing the rotor's speed. If a split second later, the gearbox were to be pressed forward because of a dynamic imbalance in the rotor system, the spline coupling might once again go into mesh and lead to a rapid acceleration of the tail rotor. This sudden acceleration could have subjected the drive shaft to abnormally high torque. This scenario most probably led to the damage found at the front of the external splines of the tail gearbox (see Figure 20) and the overload fracture in the drive shaft immediately behind the main gearbox (see Figure 19).

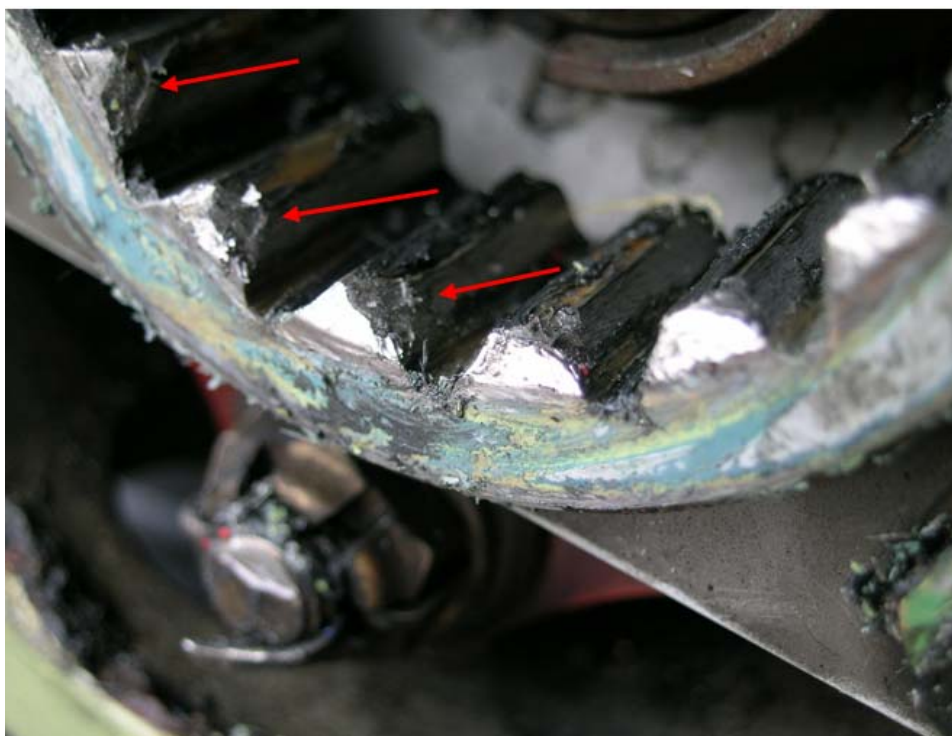
Figure 20: The arrows clearly show damage to the splines in the tail rotor gearbox.
